**PRELIMINARY FOUNDATION INVESTIGATION AND DESIGN REPORT
NESTOR FALLS BRIDGE REHABILITATION OR REPLACEMENT
HIGHWAY 71, NESTOR FALLS, ONTARIO
AGREEMENT 6021-E-0005, WORK ORDER 2
G.W.P. 6055-18-00, SITE NO. 41S-0074/B0
LATITUDE: 49.115225°, LONGITUDE: -93.926147°**

Date: August 28, 2023
File: 34988

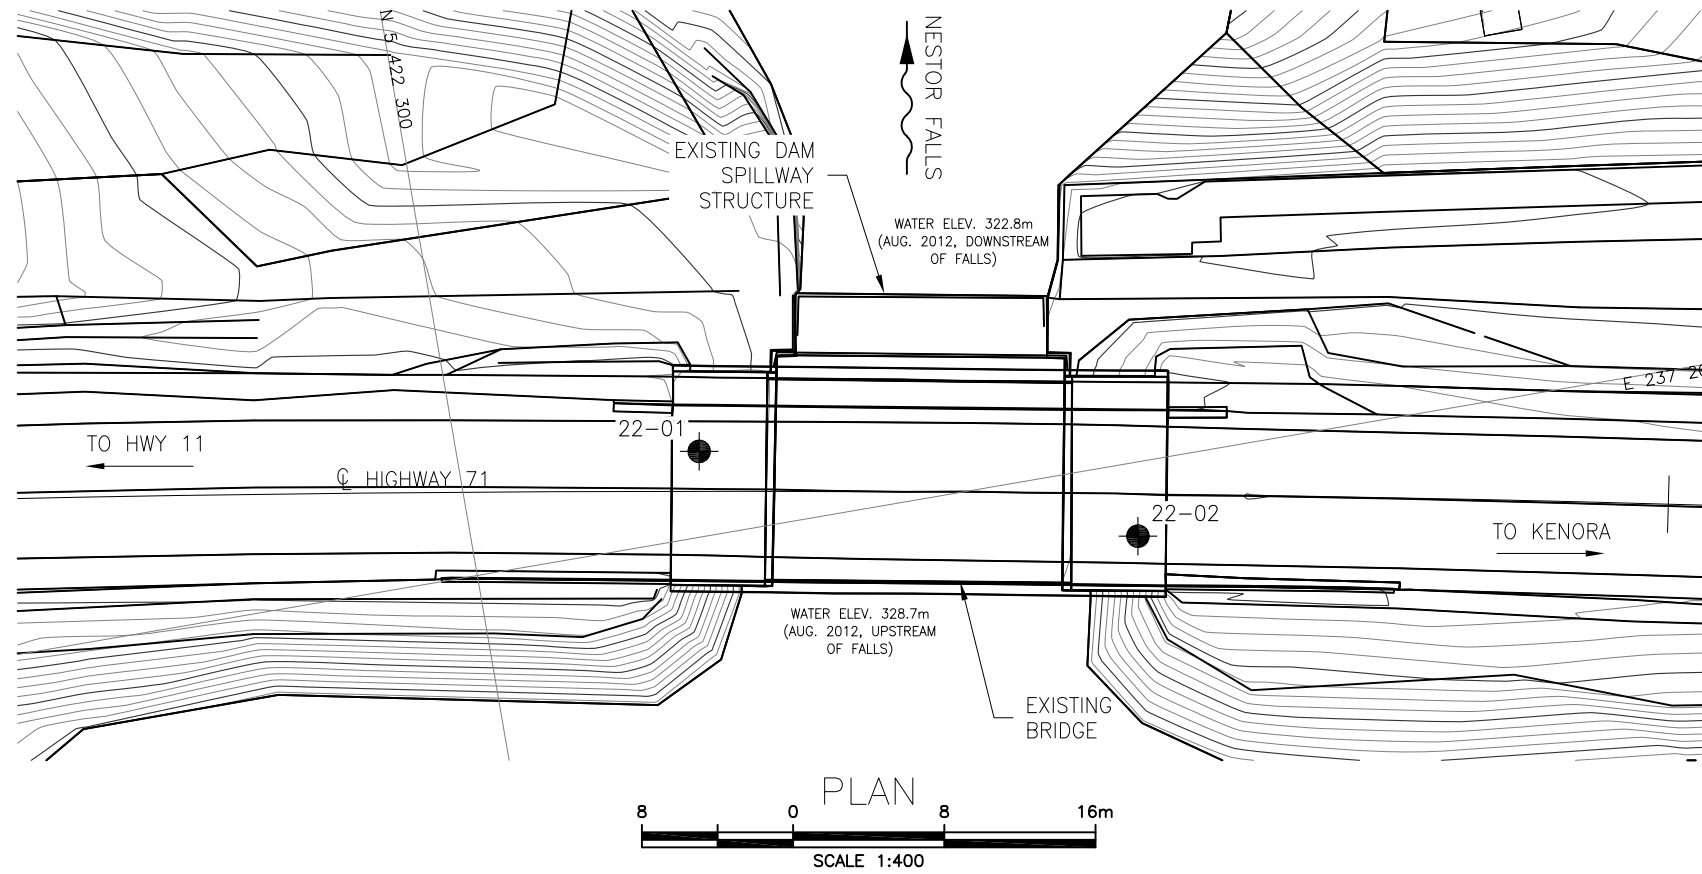
BOREHOLE LOCATIONS AND SOIL STRATA

Details of the encountered soil stratigraphy are presented on the Record of Borehole sheets in Appendix B and on the Borehole Locations and Soil Strata drawing in Appendix A. A general description of the stratigraphy, based on the conditions encountered in the boreholes, is given in the following paragraphs. However, the factual data presented in the Record of Borehole sheets governs any interpretation of the site conditions. It must be recognized that soil conditions may vary between and beyond the borehole locations.

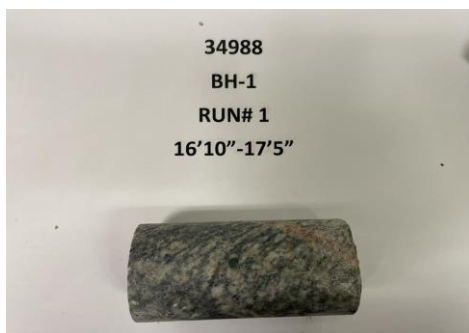
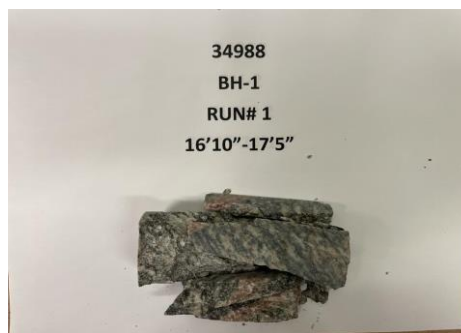
ORIGINAL SPECIMEN

FRACTURED SPECIMEN

AVG. RATE OF STRAIN TO FAILURE:	0.250 MPa/s
MAXIMUM COMPRESSIVE LOAD:	197.7 kN
UNCONFINED COMPRESSIVE STRENGTH:	112.0 MPa
