**FINAL
FOUNDATION INVESTIGATION AND DESIGN REPORT
REHABILITATION OF BRIDGE STRUCTURE No. 40-023
HIGHWAY 35 GULL RIVER NORTH BRIDGE
LUTTERWORTH TOWNSHIP
G.W.P. 5087-11-00
AGREEMENT NO.: 5015-E-0043**

GEOCRES NUMBER: 31D-693

June 2018
Thurber File: 16284

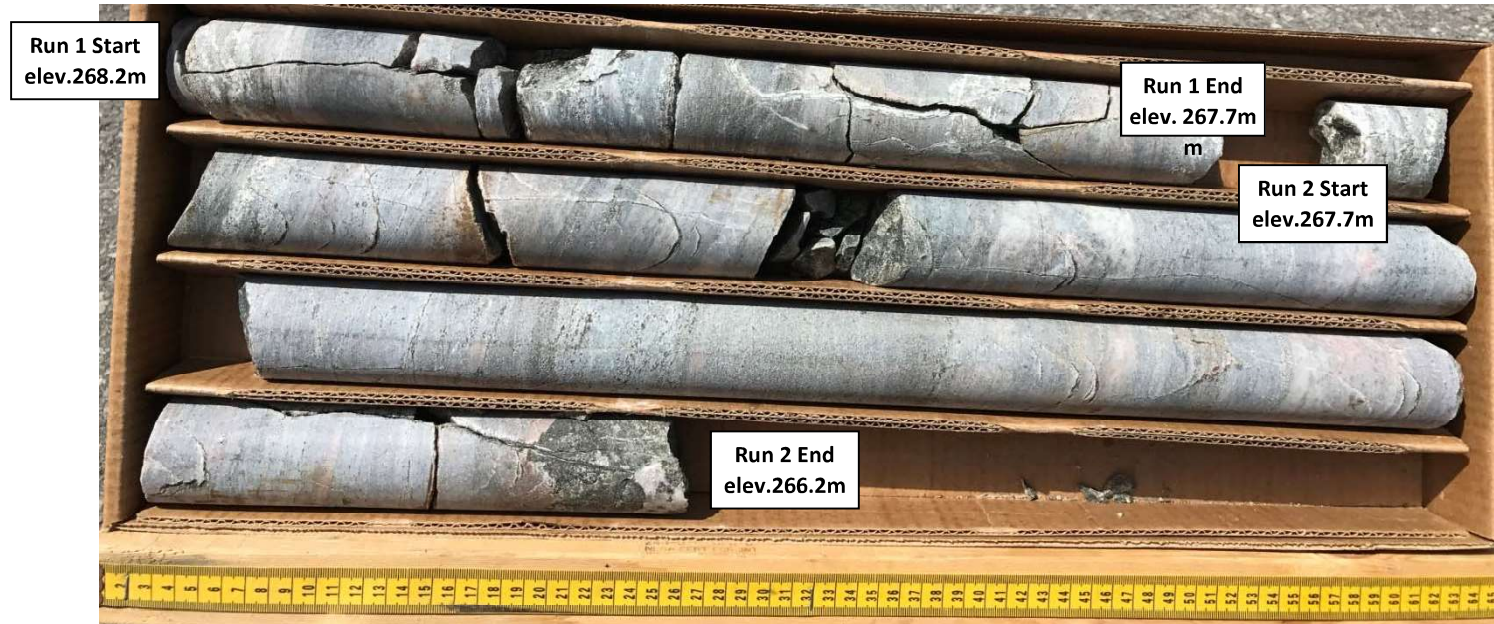
Borehole 17-2
Runs 1 and 2 (of 3)
Elevation 268.2 m to 266.2 m

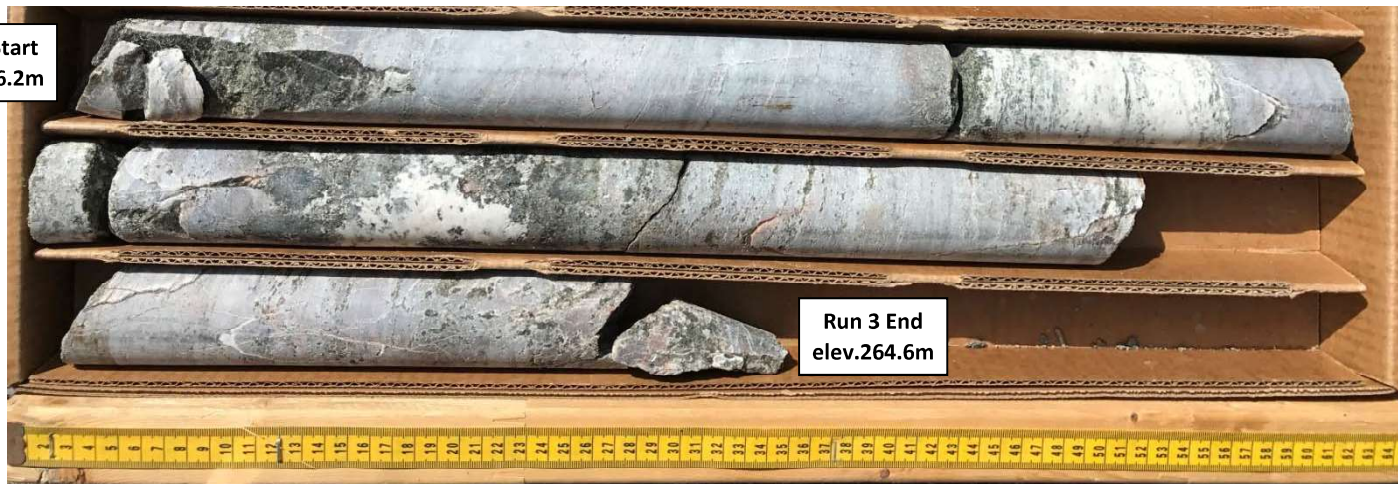
Borehole 17-2
Run 3 (of 3)
Elevation 266.2 m to 264.6 m

Run 3 Start
elev.266.2m

Run 3 End
elev.264.6m
