**FINAL  
FOUNDATION INVESTIGATION REPORT  
REHABILITATION OF BRIDGE STRUCTURE No. 40-023  
HIGHWAY 35 GULL RIVER NORTH BRIDGE  
LUTTERWORTH TOWNSHIP  
G.W.P. 5087-11-00  
AGREEMENT NO.: 5015-E-0043**

June 2018  
Thurber File: 16284

**FINAL**  
**FOUNDATION INVESTIGATION REPORT**  
**REHABILITATION OF BRIDGE STRUCTURE No. 40-023**  
**HIGHWAY 35 GULL RIVER NORTH BRIDGE**  
**LUTTERWORTH TOWNSHIP**  
**G.W.P. 5087-11-00**  
**AGREEMENT NO.: 5015-E-0043**

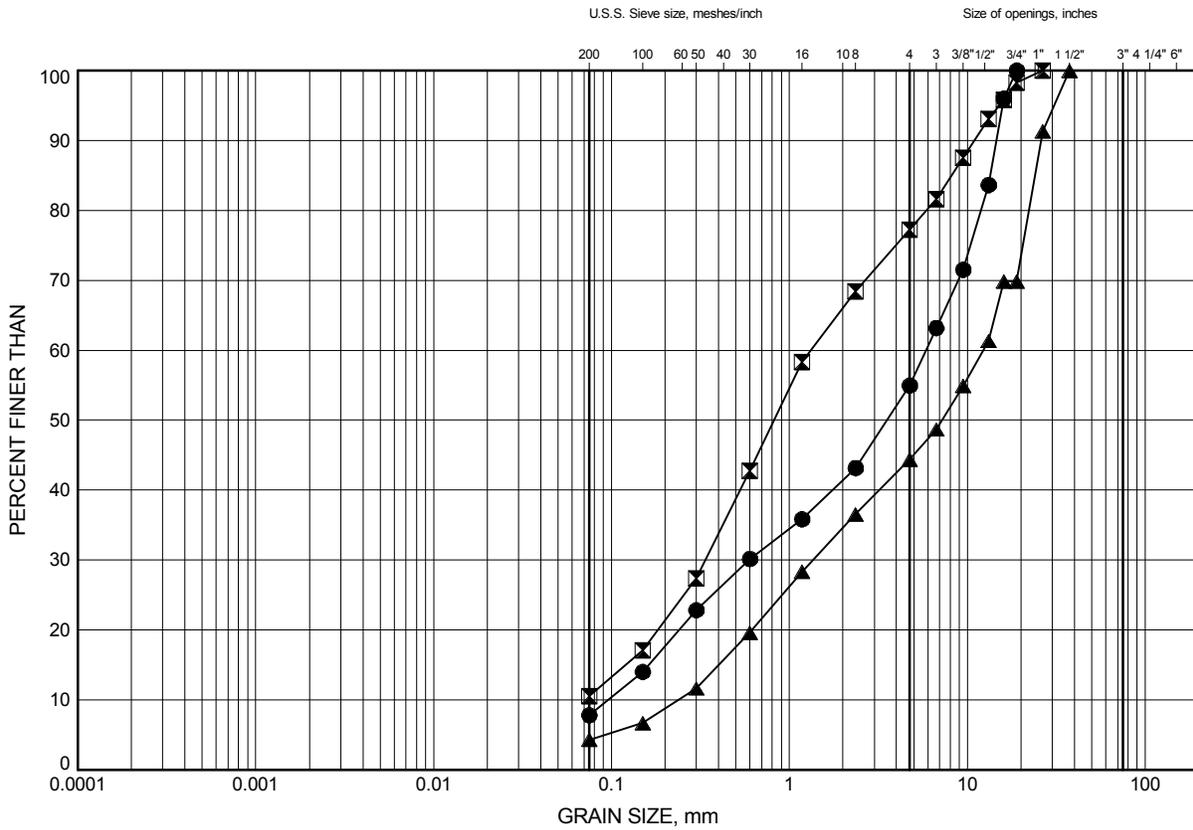
FIGURE C1

## Fill

The moisture content of the granular fill samples tested ranged from 6% to 17%. The results of three grain size analyses conducted on samples of granular fill are summarized in Table 4-1 and illustrated on Figure C1 in Appendix C.

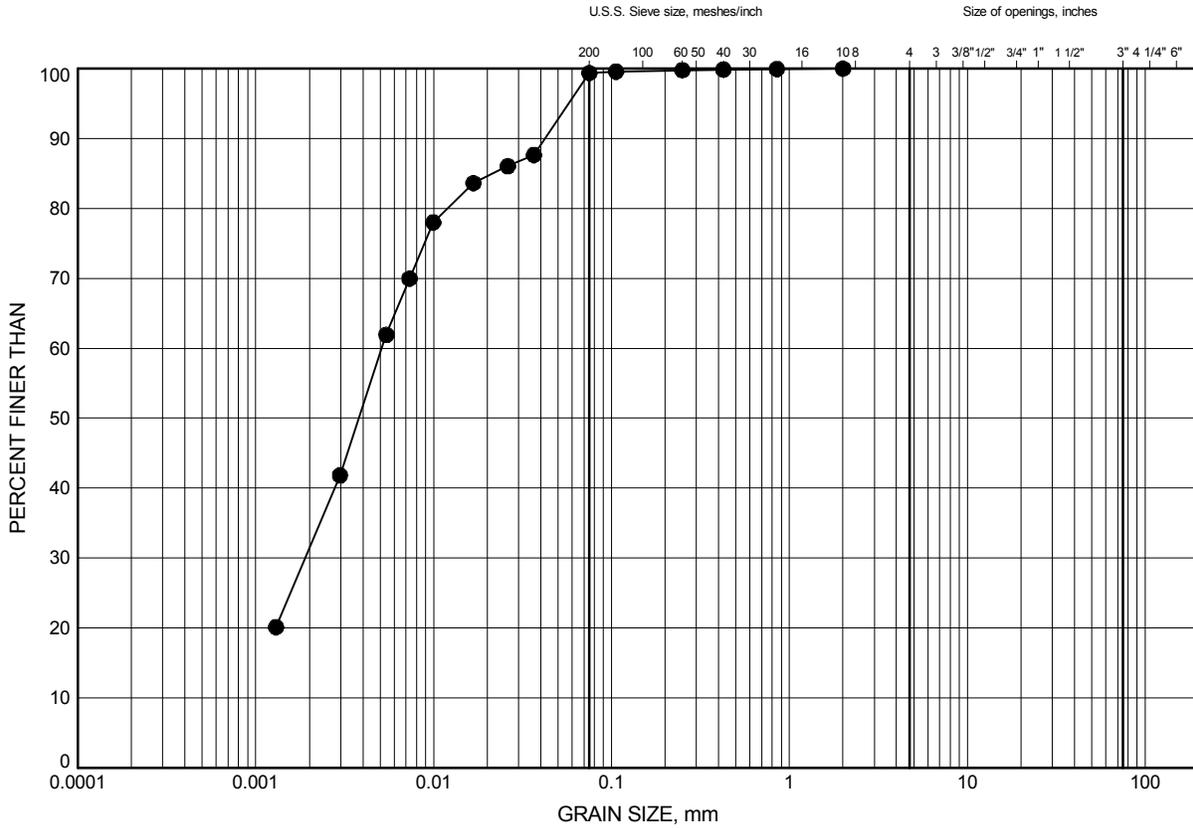
FIGURE C2

Clay (CL-CI)

The moisture content of the clay samples tested ranged from 33% to 37%. The results of a grain size analysis conducted on a sample of clay is summarized in Table 4-2 and is illustrated on Figure C2 in Appendix C.

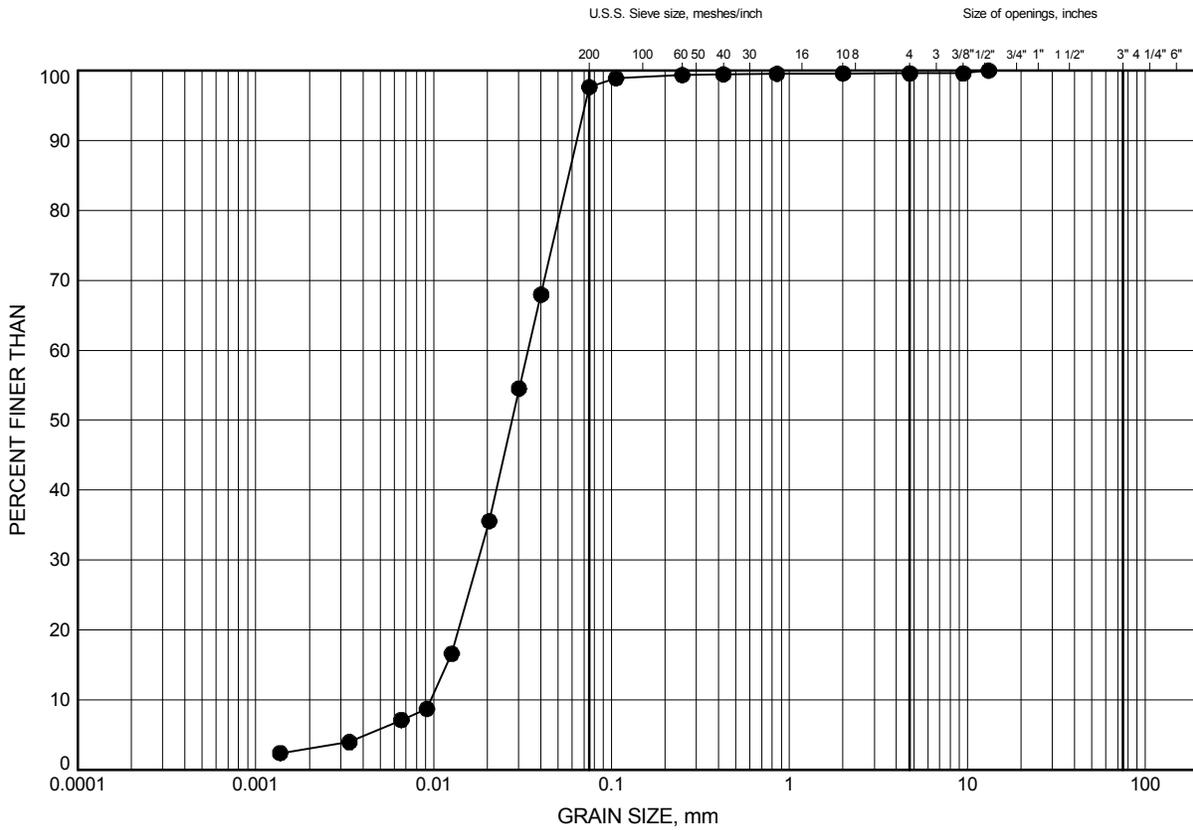
FIGURE C3

**Silt (ML)**

The moisture content of the silt samples tested ranged from 23% to 35%. The results of a grain size analysis conducted on a sample of silt is summarized in Table 4-4 and is illustrated on Figure C3 in Appendix C.

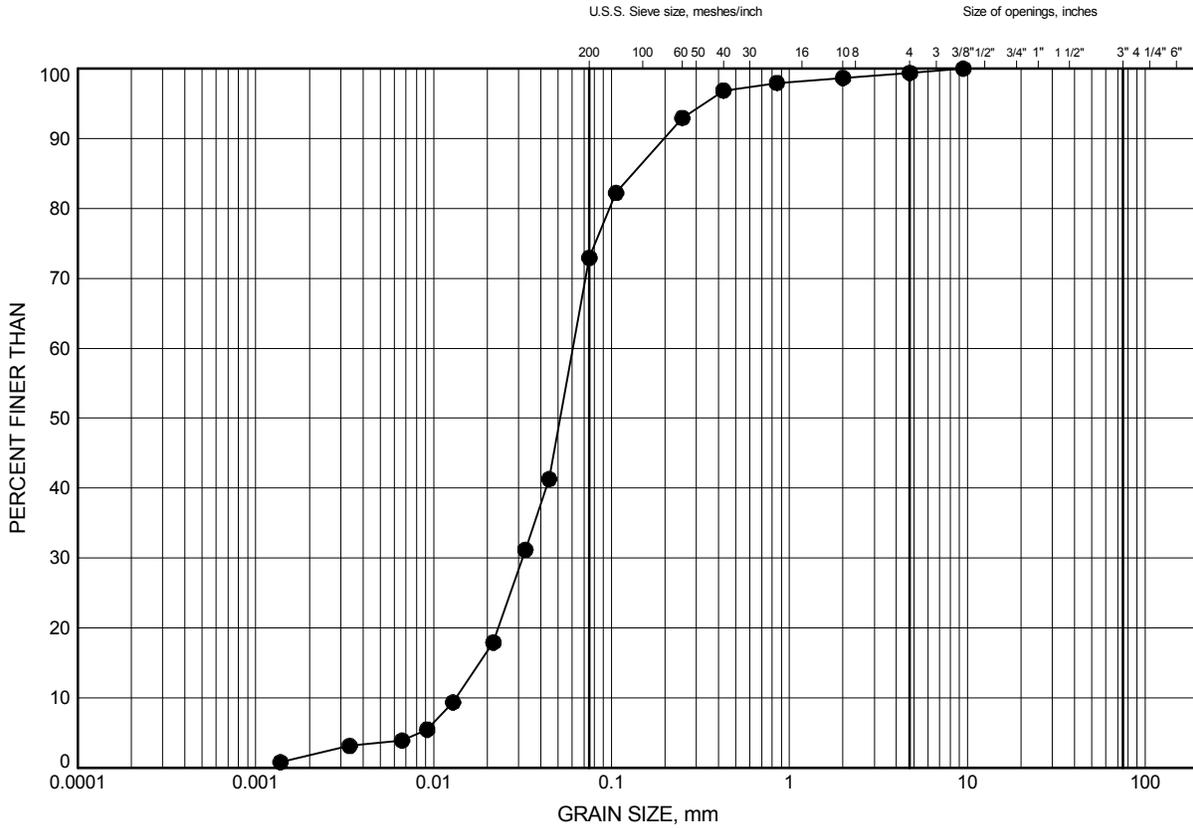
FIGURE C4

**Sandy Silt (ML)**

The moisture content of the sandy silt samples tested ranged from 19% to 29%. The results of a grain size analysis conducted on a sample of sandy silt is summarized in Table 4-5 and is illustrated on Figure C4 in Appendix C.

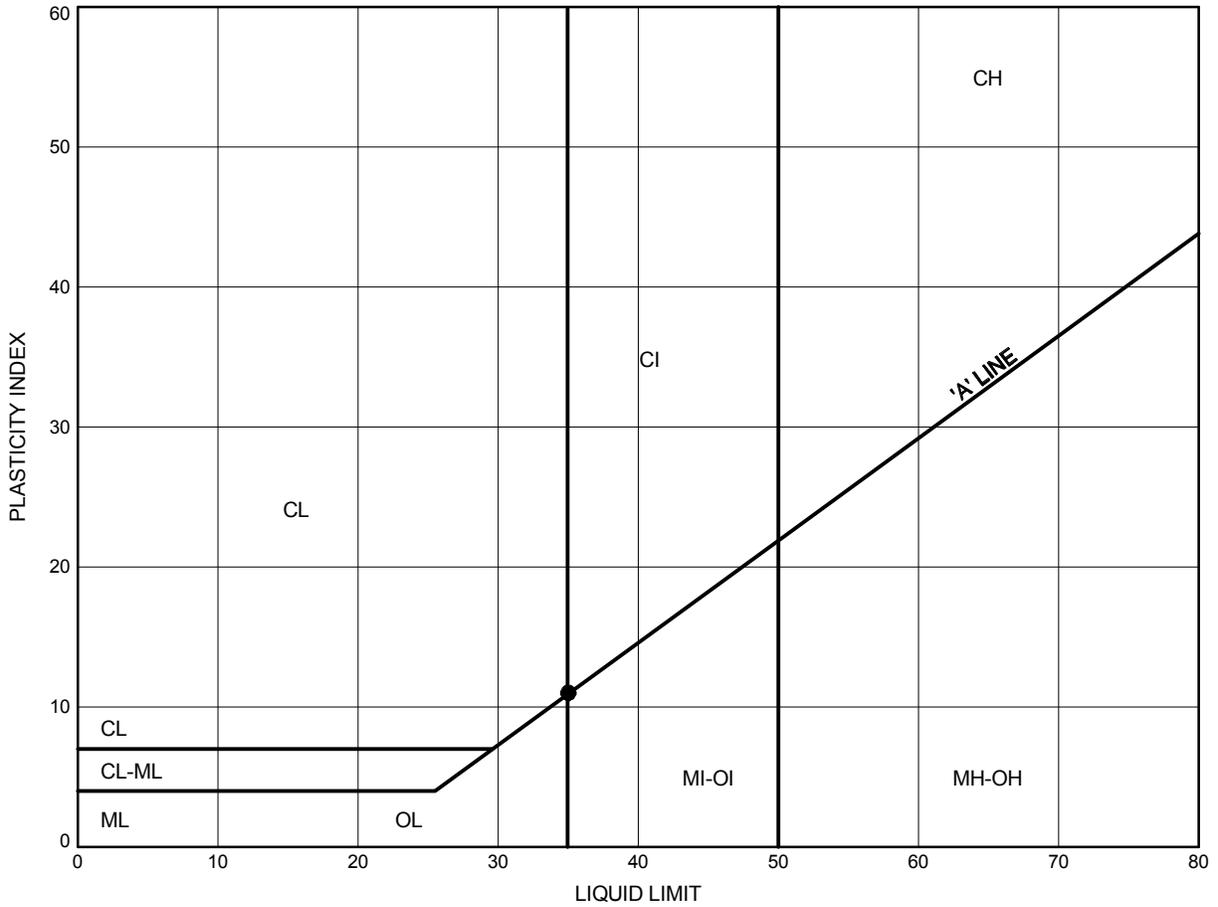
FIGURE C5

Clay (CL-CI)

SYMBOL	BOREHOLE	DEPTH (m)	ELEV. (m)
●	17-1	4.11	270.14

Atterberg Limit testing was completed on one sample of the clay. The results are summarized on the Record of Borehole sheets in Appendix B and the Atterberg Limit graph is included on Figure C5 in Appendix C. The laboratory results are summarized in Table 4-3 and indicate that the clay ranges from low to intermediate plasticity (CL to CI).

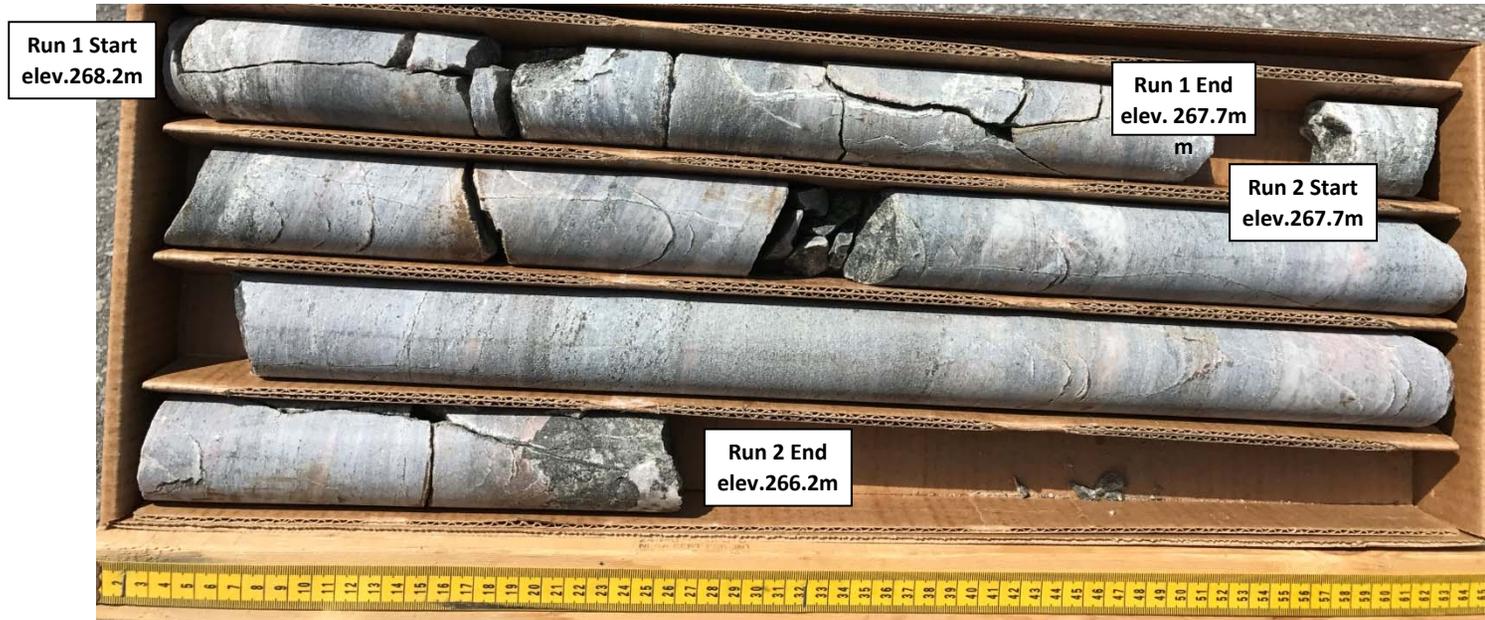
**Borehole 17-2**  
**Runs 1 and 2 (of 3)**  
**Elevation 268.2 m to 266.2 m**

The Total Core Recovery (TCR) ranged from 95 to 100%, the Solid Core Recovery (SCR) ranged from 89 to 98% and the Rock Quality Designation (RQD) ranged from 0 to 80% with typical values from 76 to 80%. Based on the RQD values the bedrock below a surficial weathered zone is classified as good quality.

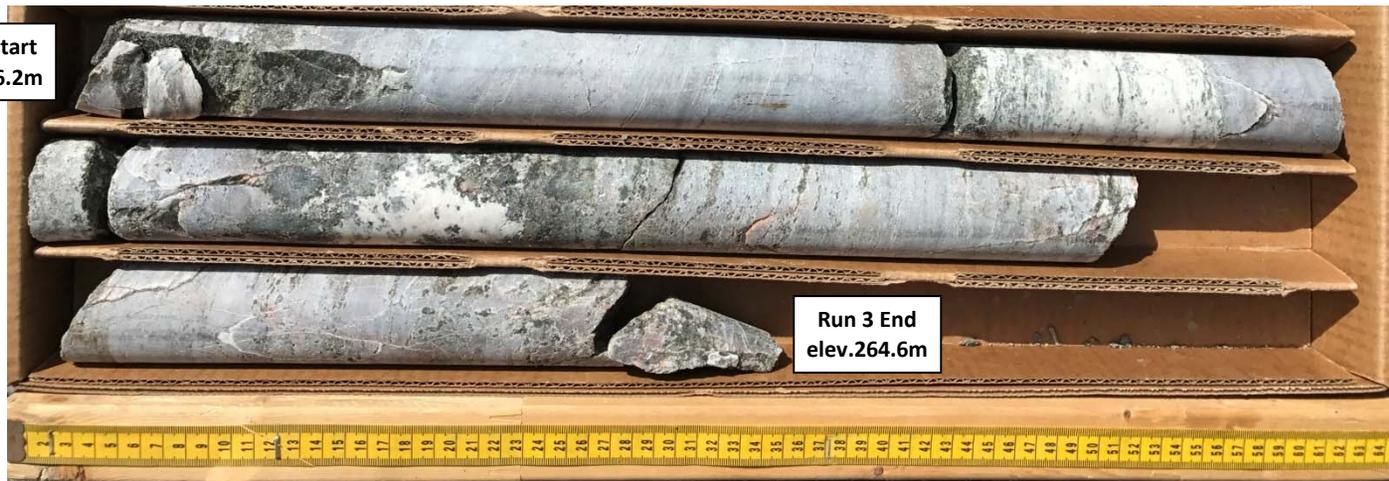
**Borehole 17-2**  
**Run 3 (of 3)**  
**Elevation 266.2 m to 264.6 m**

Run 3 Start  
elev.266.2m

Run 3 End  
elev.264.6m

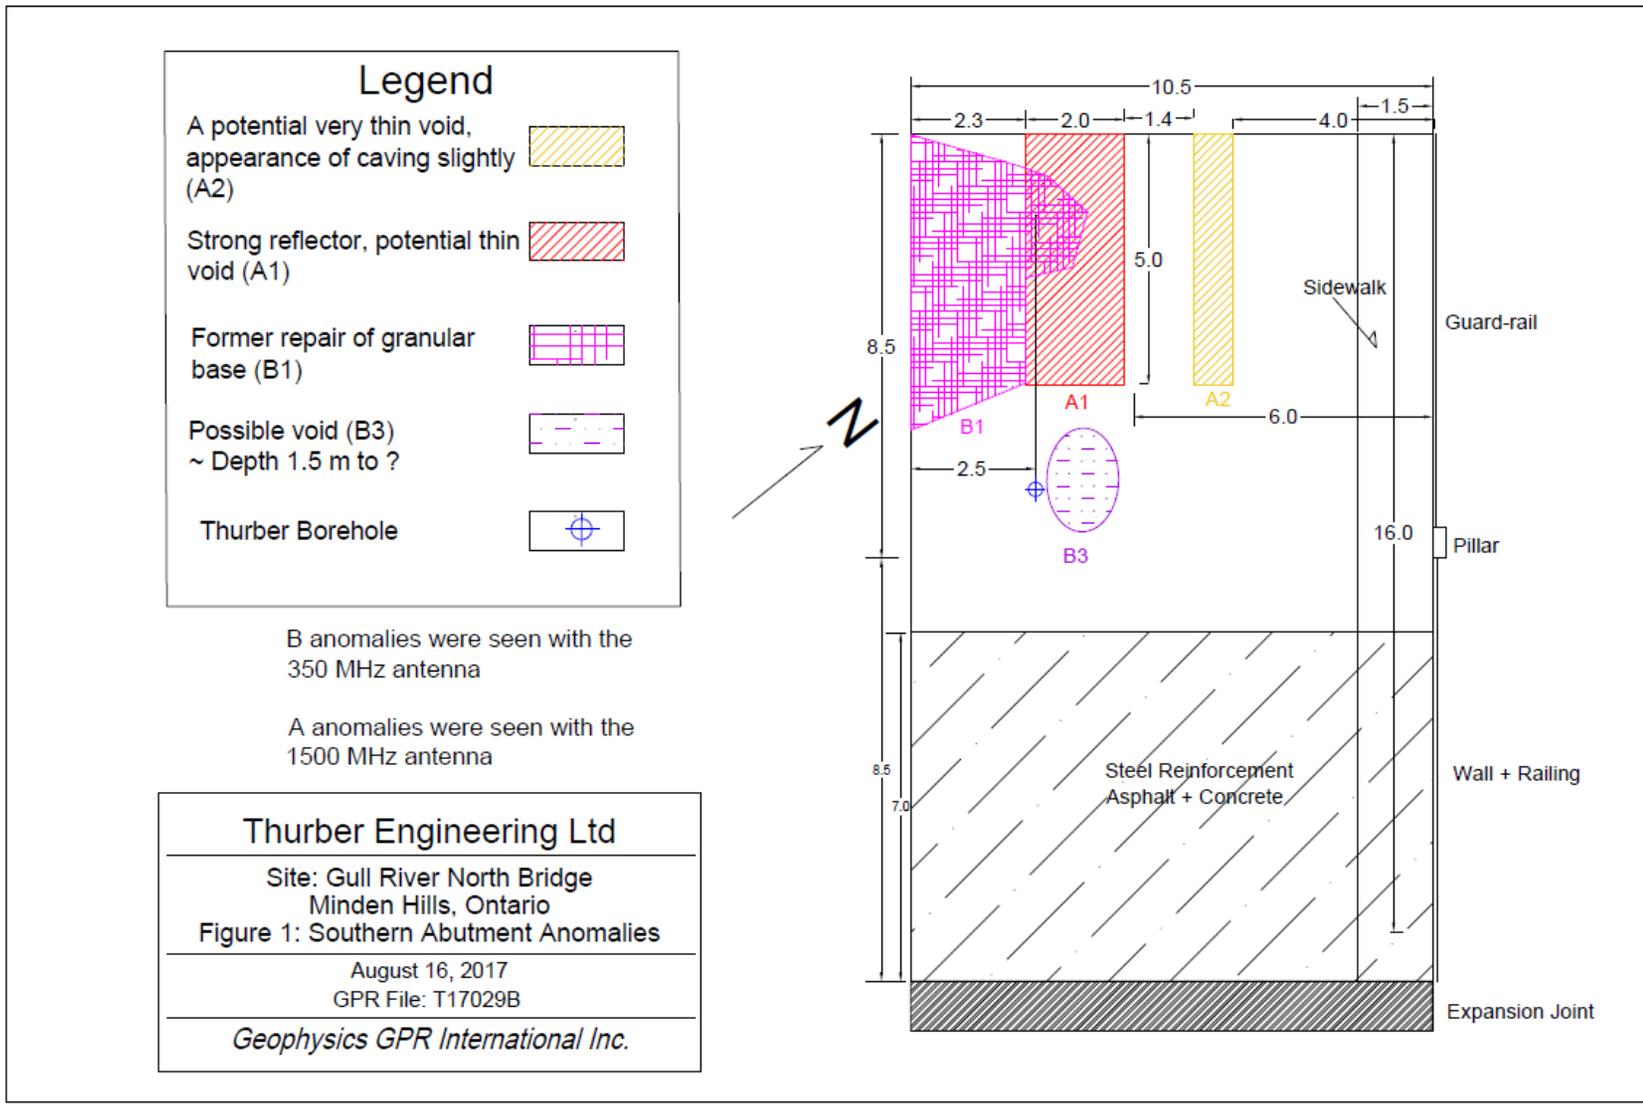
Figure 1: Gull River North Bridge, Southern section. Anomalies represented by coloured hatched areas.

Four types of anomalies were found in the southern abutment (west side in terms of compass) of the Gull River North Bridge. The positions of all features are shown in Figure 1.

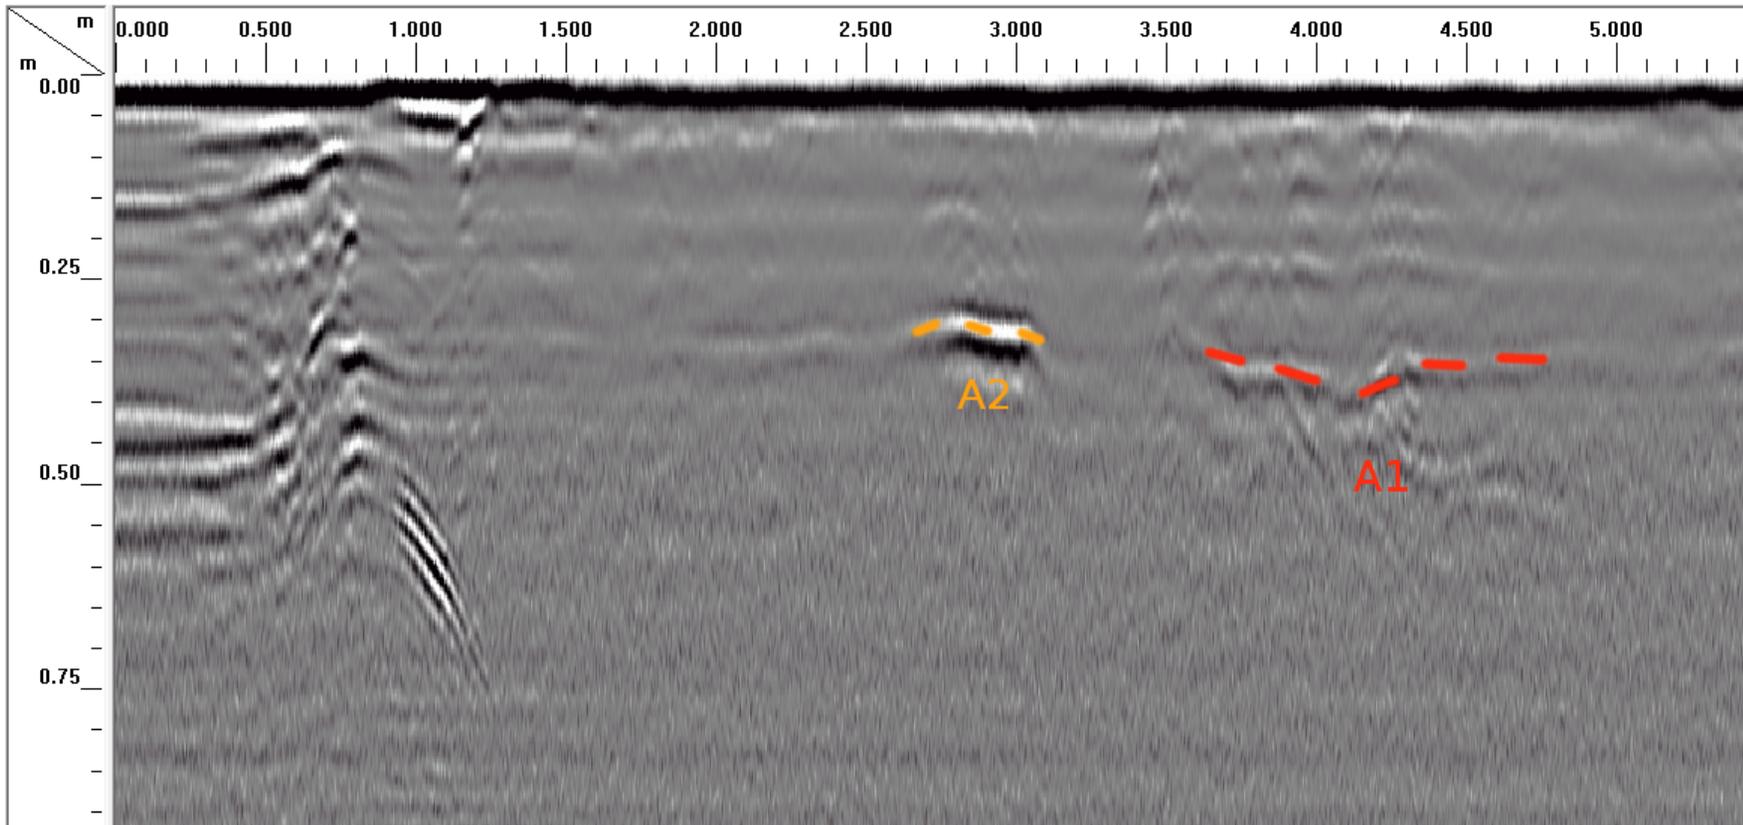
Figure 2: Data collected with the 1500 MHz antenna, showcasing anomalies A1 and A2.

Figure 2 highlights both anomaly types observed with the 1500MHz antenna.

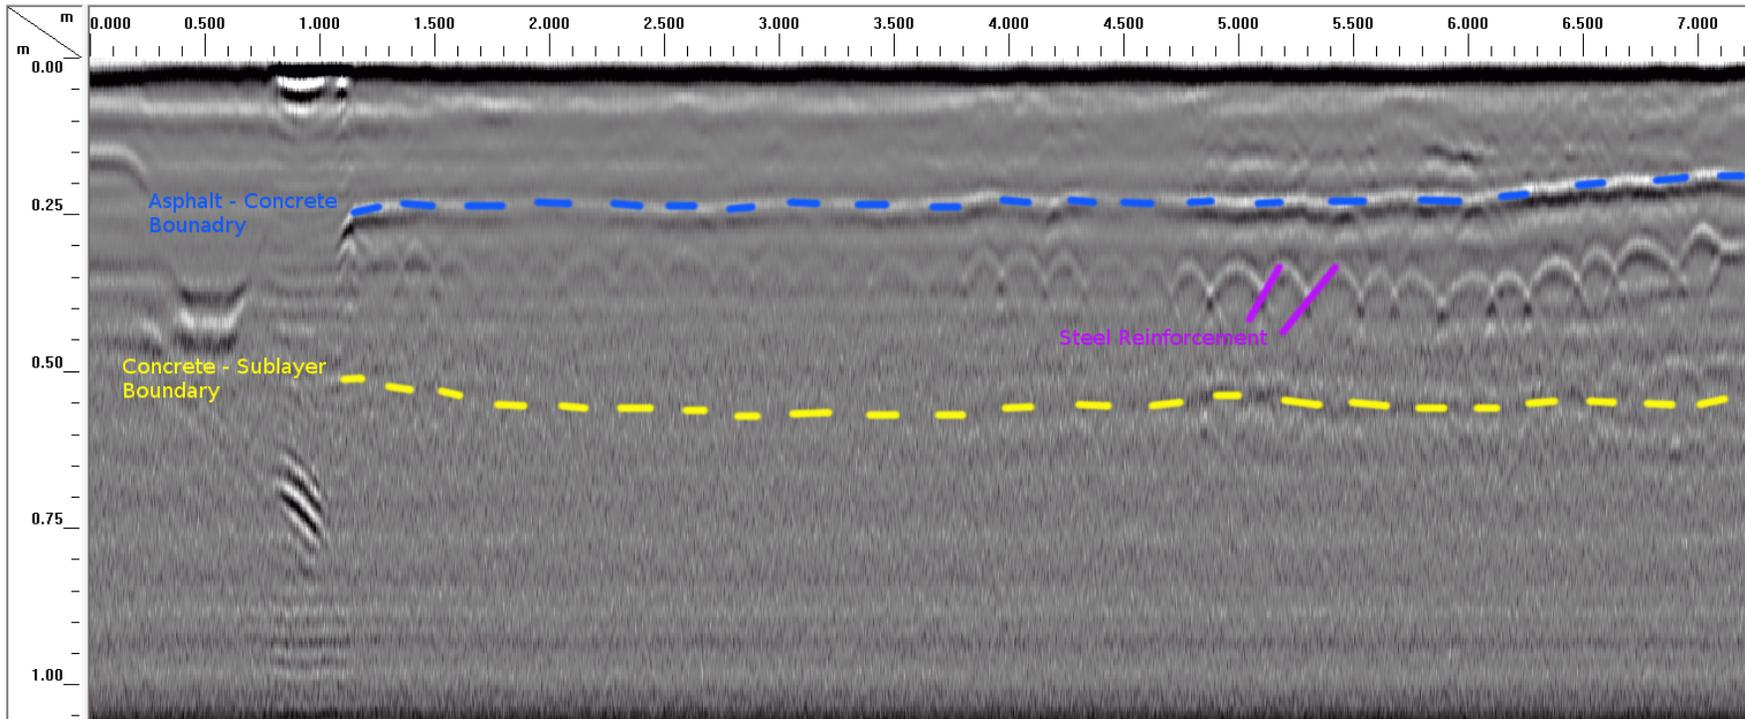
Figure 3: Example of steel reinforcement and subsurface boundaries from the Northern section. Evenly spaced steel reinforcement; 15cm spacing.

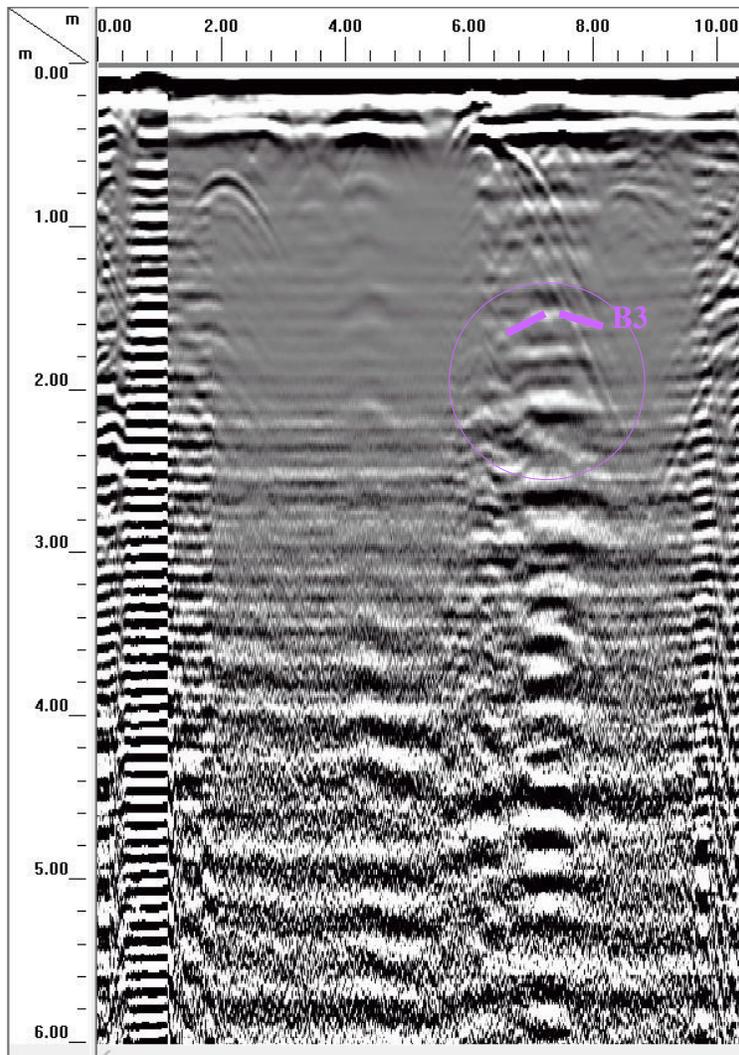
Figure 4: Data collected with the 350 MHz antenna, showcasing possible void at B3.

B3: Is a possible void observed with the 350 MHz antenna at an approximate depth of at least 1.5 m. Figure 4 is an example radar profile image over this target. The top of the void is apparent and the anomalous zone is only centimeters away from an existing borehole that encountered a void at 2.3 meters deep and 60 cm thick. Void thickness is somewhat difficult to measure for ground radar because the radar pulse travels so quickly through the air so it is difficult to observe a reflection from the bottom of the void. The reflector from the top of the void is at 1.5 meters and the follow-up reflection could be 15 cm later. This distance must be multiplied by 5 to account for the speed of the radar pulse in air so the void could be 75 cm thick. There is a stronger follow-up reflector that could double this thickness to 1.5 meters but this is quite uncertain.

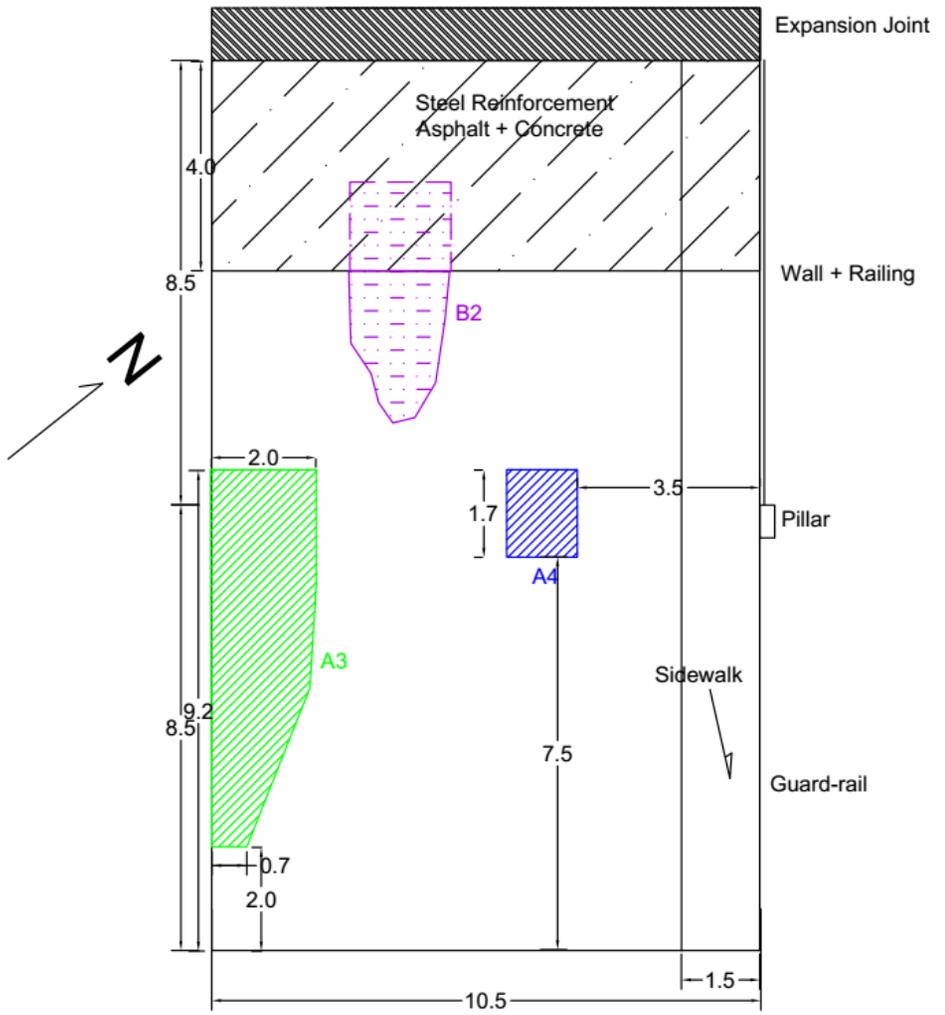
<b>Thurber Engineering Ltd</b>
Site: Gull River North Bridge Minden Hills, Ontario
Figure 5: Northern Abutment Anomalies
August 16, 2017 GPR File: T17029B
<i>Geophysics GPR International Inc.</i>

Three types of anomalies were found in the northern abutment (east side in terms of compass) of the Gull River North Bridge. The positions of all features are shown in Figure 5.

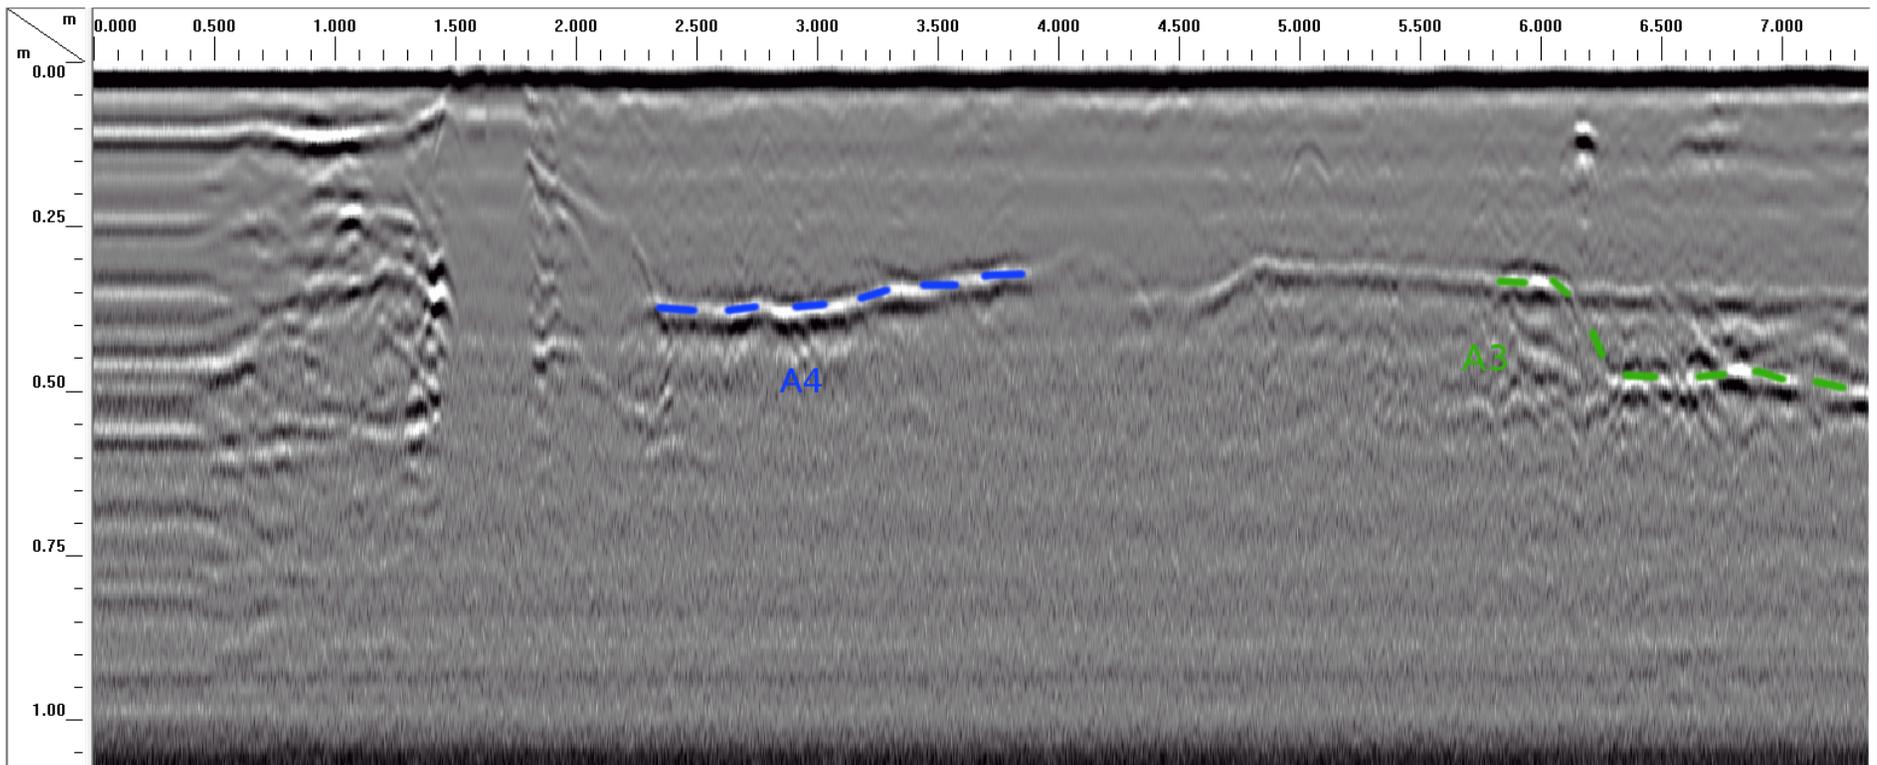
Figure 6: Data collected with the 1500 MHz antenna, showcasing anomalies A4 and A5.

Figure 6 highlights both anomaly types observed with the 1500MHz antenna.

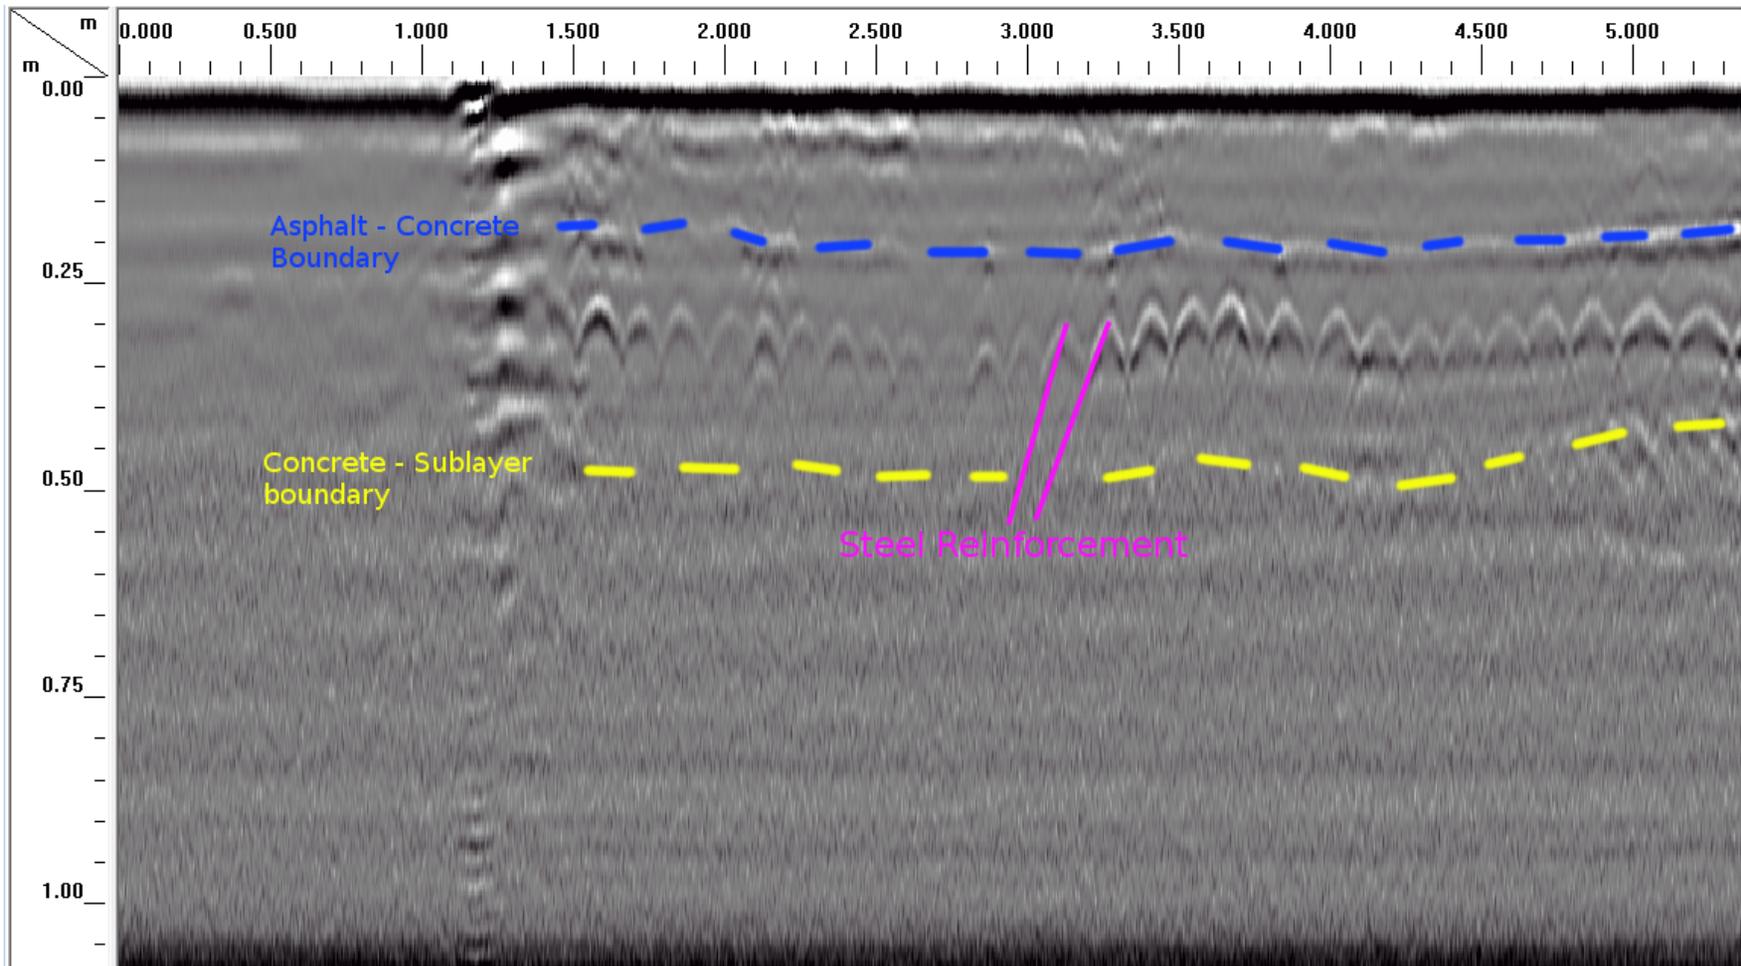
Figure 7: Example of steel reinforcement from the Southern segment, as well as subsurface boundaries. Evenly spaced steel reinforcement; 15cm spacing.
