**FINAL
FOUNDATION INVESTIGATION REPORT
REHABILITATION OF BRIDGE STRUCTURE No. 40-024
HIGHWAY 35 GULL RIVER SOUTH BRIDGE
LUTTERWORTH TOWNSHIP
G.W.P. 5087-11-00
AGREEMENT NO.: 5015-E-0043**

GEOCRES NUMBER: 31D-692

June 2018
Thurber File: 16284

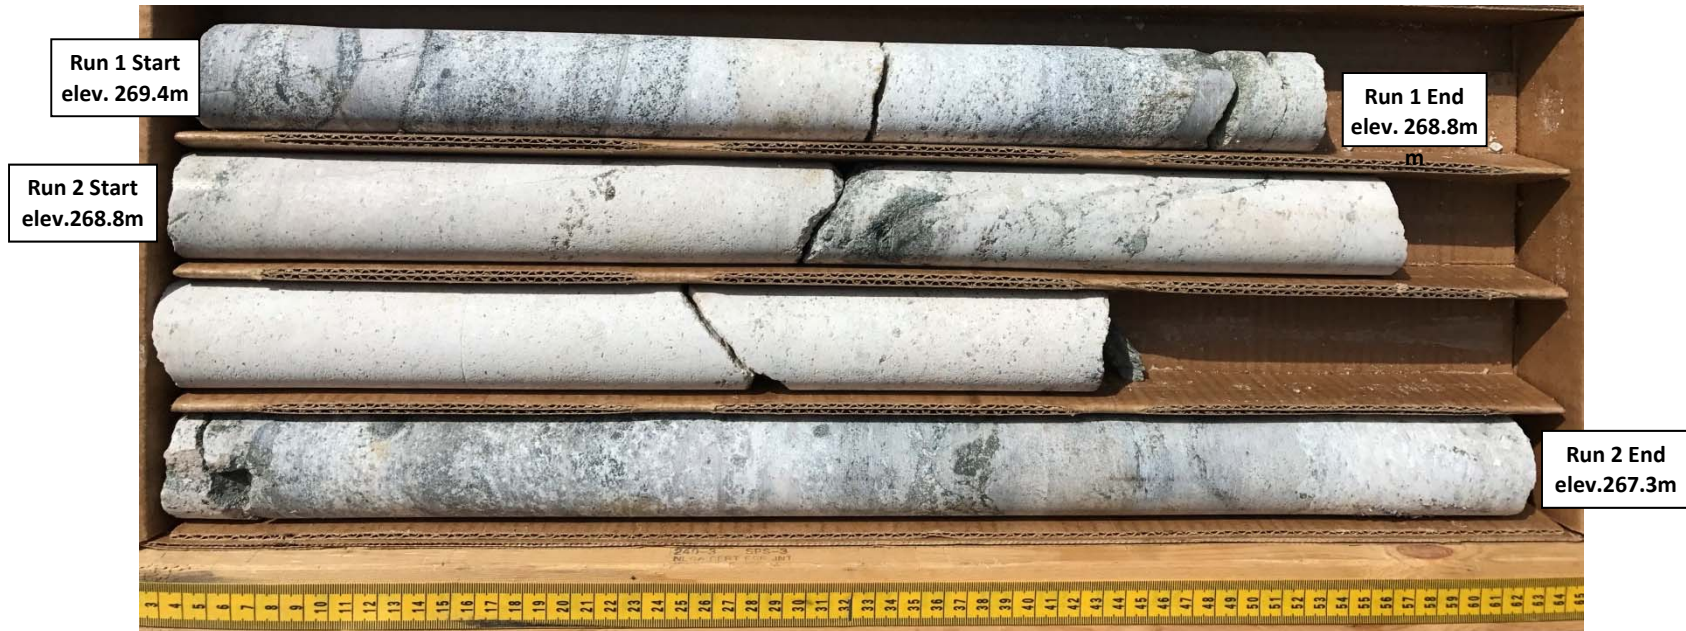
Borehole 17-1
Runs 1 and 2 (of 3)
Elevation 269.4 m to 267.3 m

The Total Core Recovery (TCR) ranged from 87 to 100%, the Solid Core Recovery (SCR) ranged from 87 to 100% and the Rock Quality Designation (RQD) typically ranged from 53 to 98%. The diamond core barrel wore out near the beginning of Run 3 on Borehole 17-2 and no further penetration was achievable. This resulted in a core recovery for Run 3 of less than 100 mm and an insufficient length of core to calculate an RQD for that run. Based on the RQD values the bedrock is classified as fair to excellent quality.

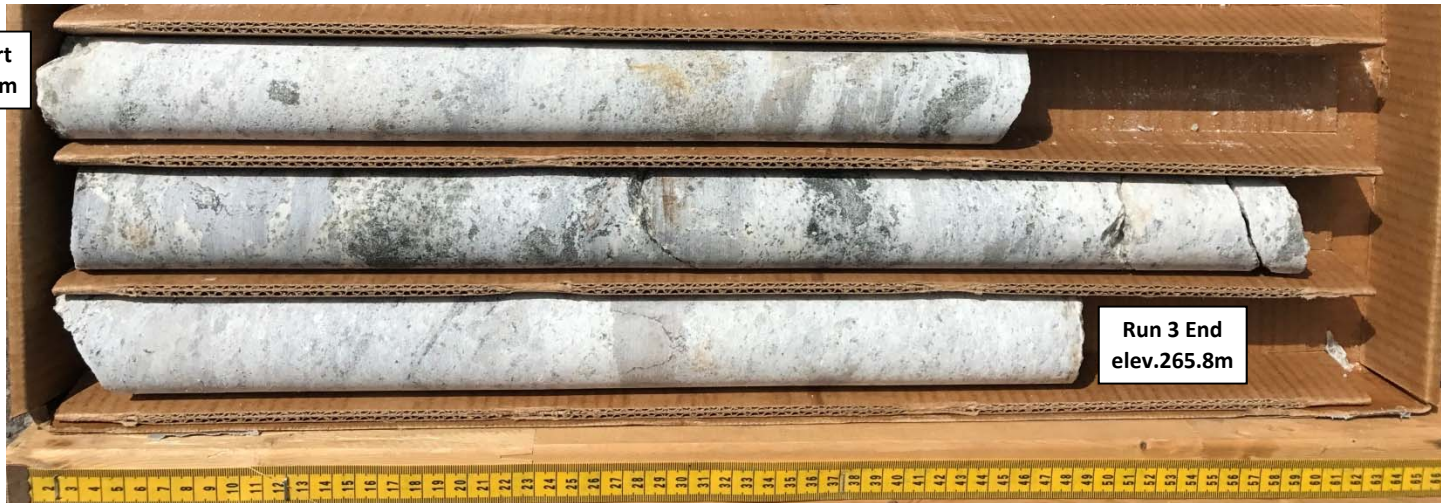
Borehole 17-1
Run 3 (of 3)
Elevation 267.3 m to 265.8 m

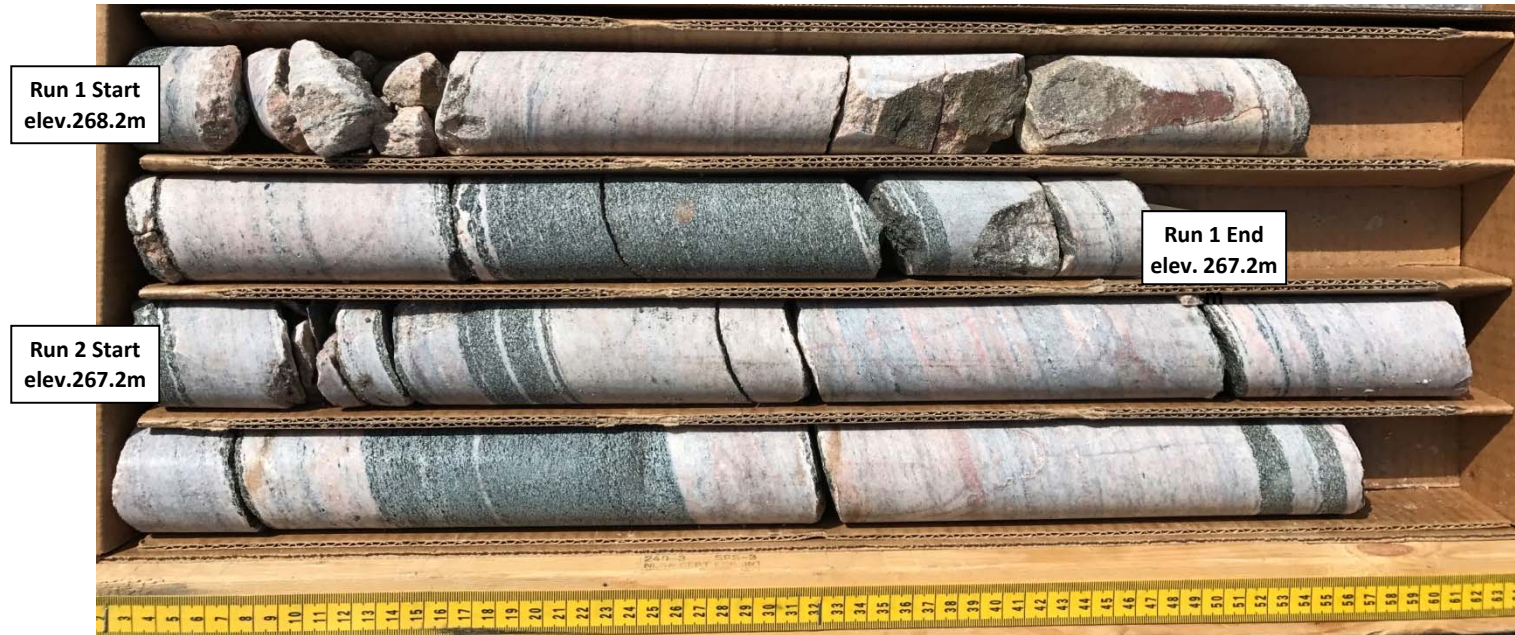
Borehole 17-2
Runs 1 and 2 (of 3)
Elevation 268.2 m to 266.3 m

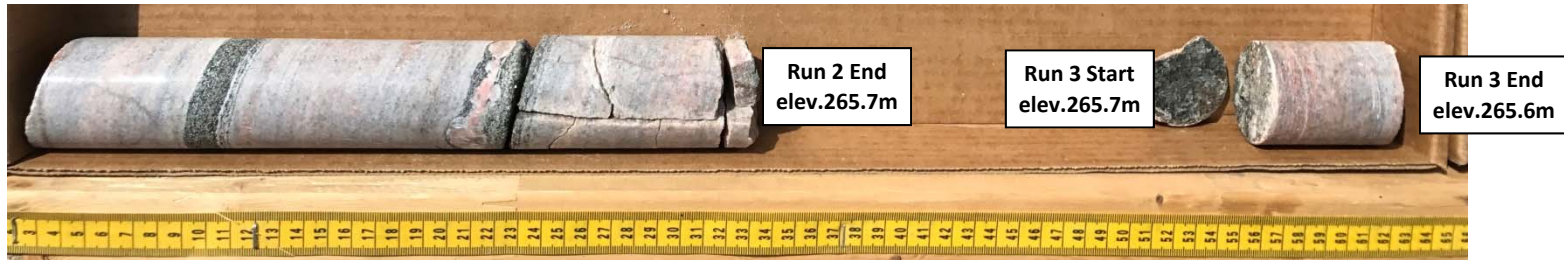
Borehole 17-2
Run 2 and 3 (of 3)
Elevation 266.3 m to 265.6 m

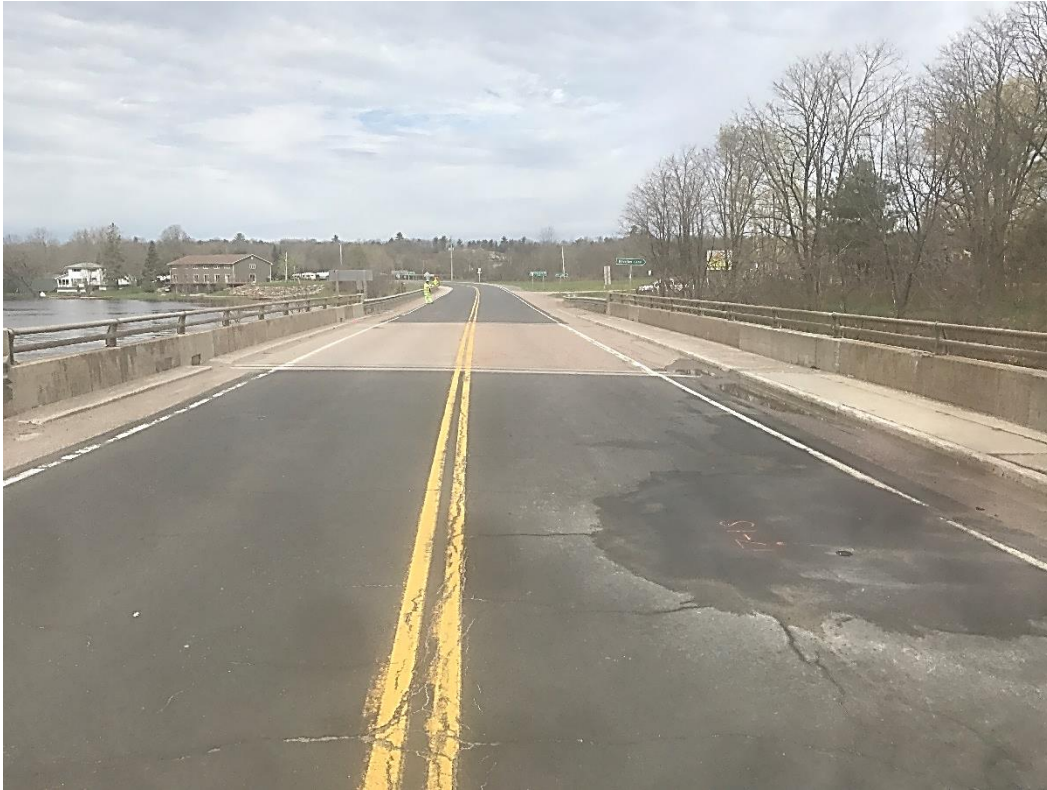
Figure 1: Roadway Platform at Bridge 40-024 looking South (05/11/2017)

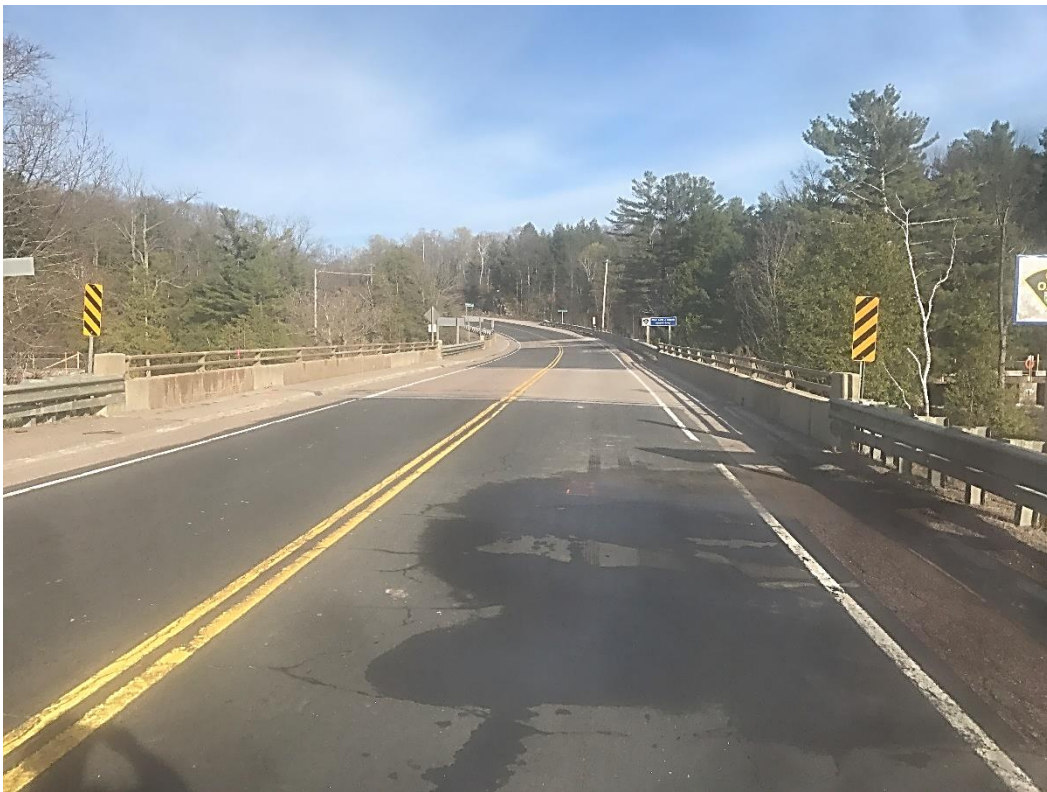
Figure 2: Roadway Platform at Bridge 40-024 looking North (05/10/2017)

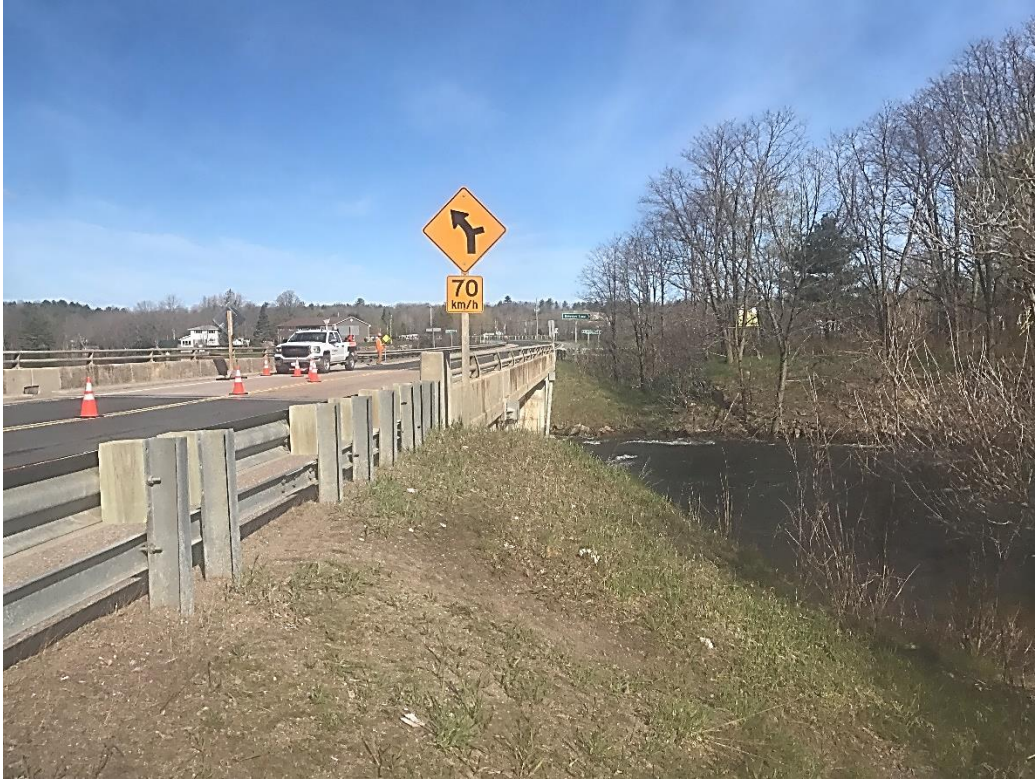
Figure 3: West Side of Bridge Looking South from North Abutment (05/10/2017)

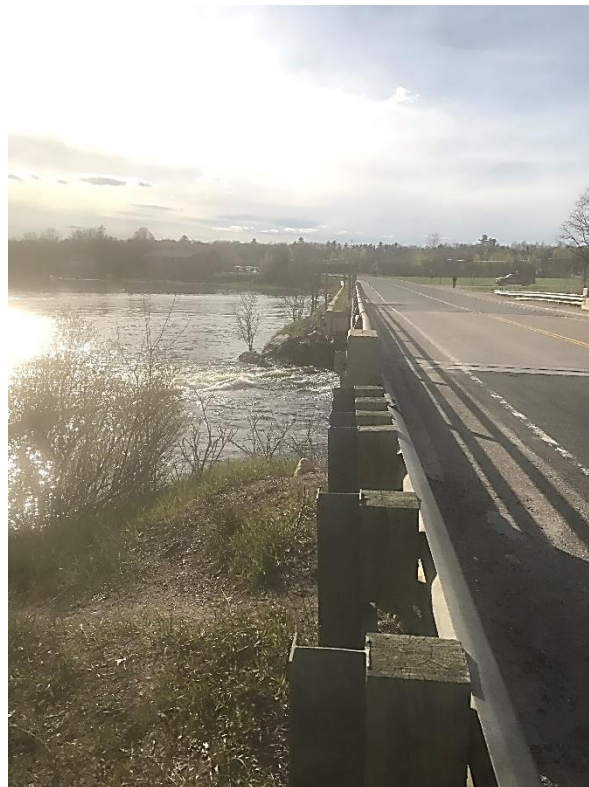
Figure 4: East Side of Bridge Looking South from North Abutment (05/10/2017)
