**FINAL
FOUNDATION INVESTIGATION REPORT
CULVERT REHABILITATION, STRUCTURE NO. 40-117/C
HIGHWAY 35 MINERS BAY CULVERT, LUTTERWORTH TOWNSHIP
AGREEMENT NO. 5015-E-0043**

G.W.P. 5087-11-00

Geocres No.: 31D-691

June 2018
Thurber File: 16284

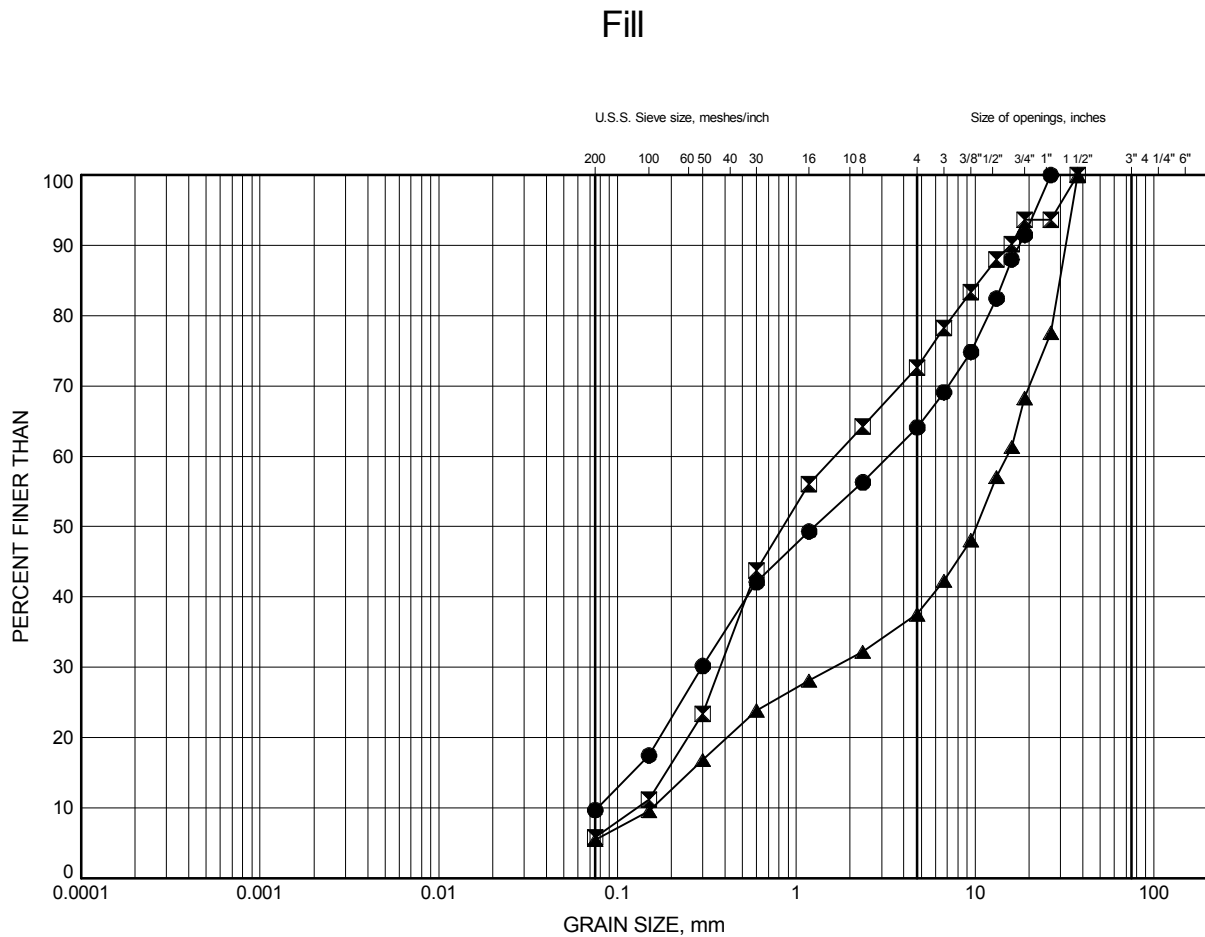
FIGURE C1

GRAIN SIZE DISTRIBUTION

SYMBOL	BOREHOLE	DEPTH (m)	ELEV. (m)
●	17-1	1.07	275.23
⊠	17-2	1.09	275.13
▲	17-2	1.83	274.40

Gradation analyses were completed on three samples of the embankment fill layer. The grain size distribution curves for these samples are included in Figure C1 of Appendix C. The results of the tests are summarized below and are presented on the corresponding Record of Borehole sheets in Appendix B.

Table 4-1: Gradation Results for Embankment Fill

Soil Particle	Percentage (%)	
	Sand with silt and gravel	Gravel with sand
Gravel	27 - 36	62
Sand	54 - 67	32
Silt and Clay	6 - 10	6

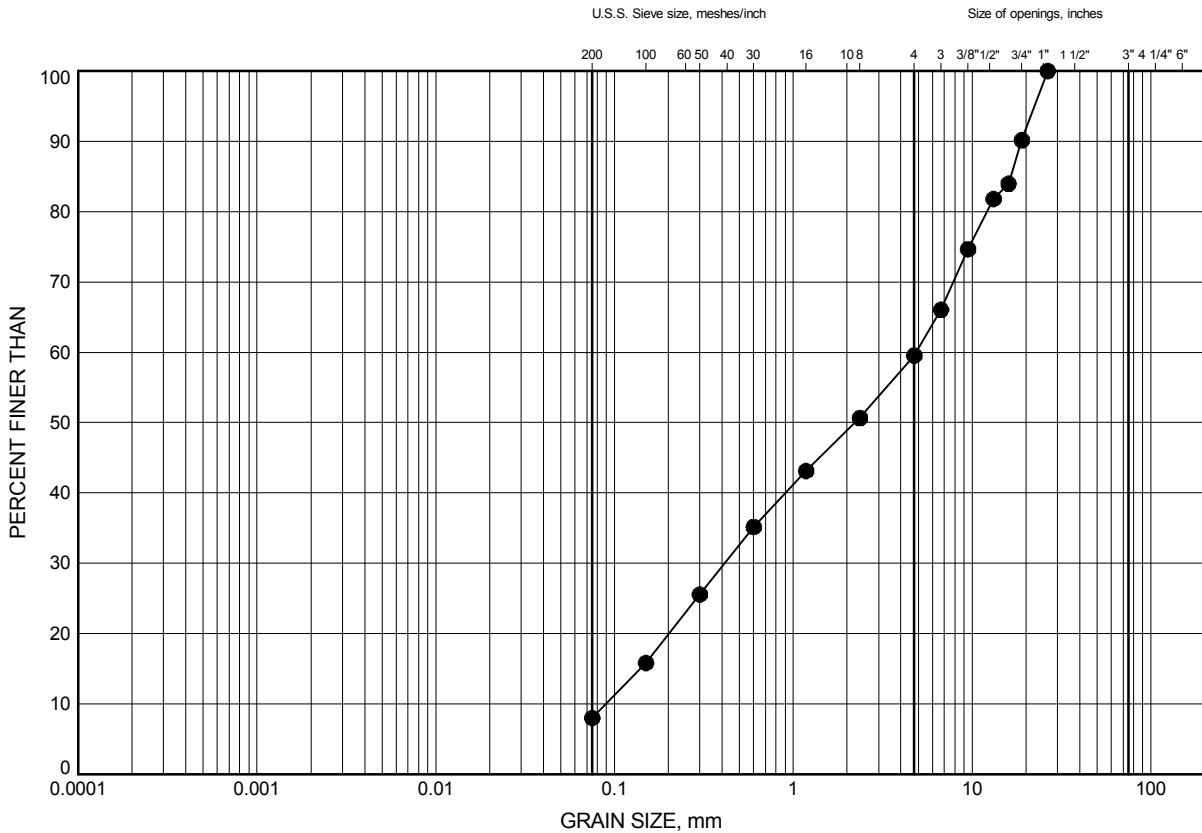
FIGURE C2

Sand with Silt and Gravel

SYMBOL	BOREHOLE	DEPTH (m)	ELEV. (m)
●	17-4	0.15	271.06

A gradation analysis was completed on a sample of the sand with gravel layer. The grain size distribution curve is included in Figure C2 of Appendix C. The results of the tests are summarized below and are presented on the corresponding Record of Borehole sheet in Appendix B.

Table 4-2: Gradation Results for Sand with Gravel

Soil Particle	Percentage (%)
Gravel	40
Sand	52
Silt and Clay	8

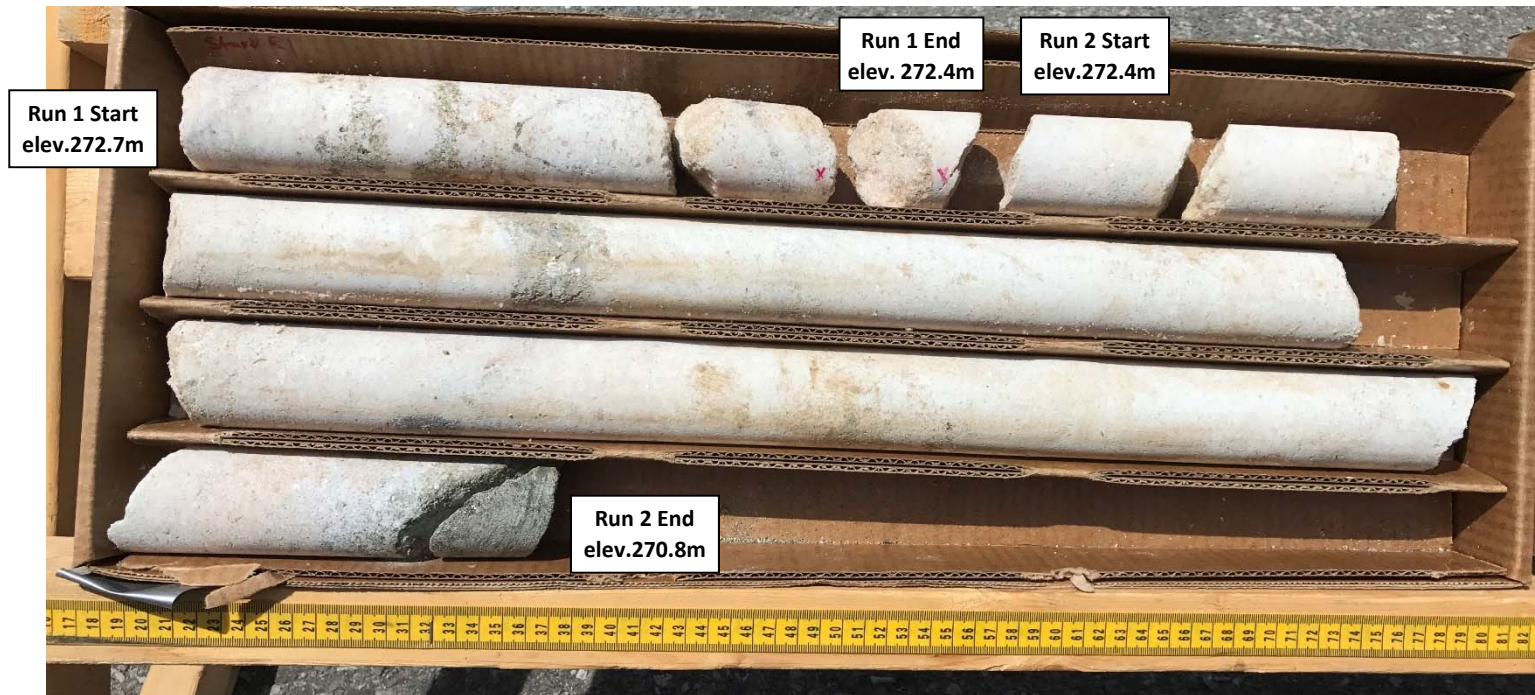
Borehole 17-1
Runs 1 and 2 (of 3)
Elevation 272.7 m to 270.8 m

The Total Core Recovery (TCR) was 100%, the Solid Core Recovery (SCR) ranged from 92 to 100% and the Rock Quality Designation (RQD) ranged from 75 to 100%. Based on the RQD values the bedrock is classified as good to excellent quality. The granite bedrock is estimated to be strong to very strong.

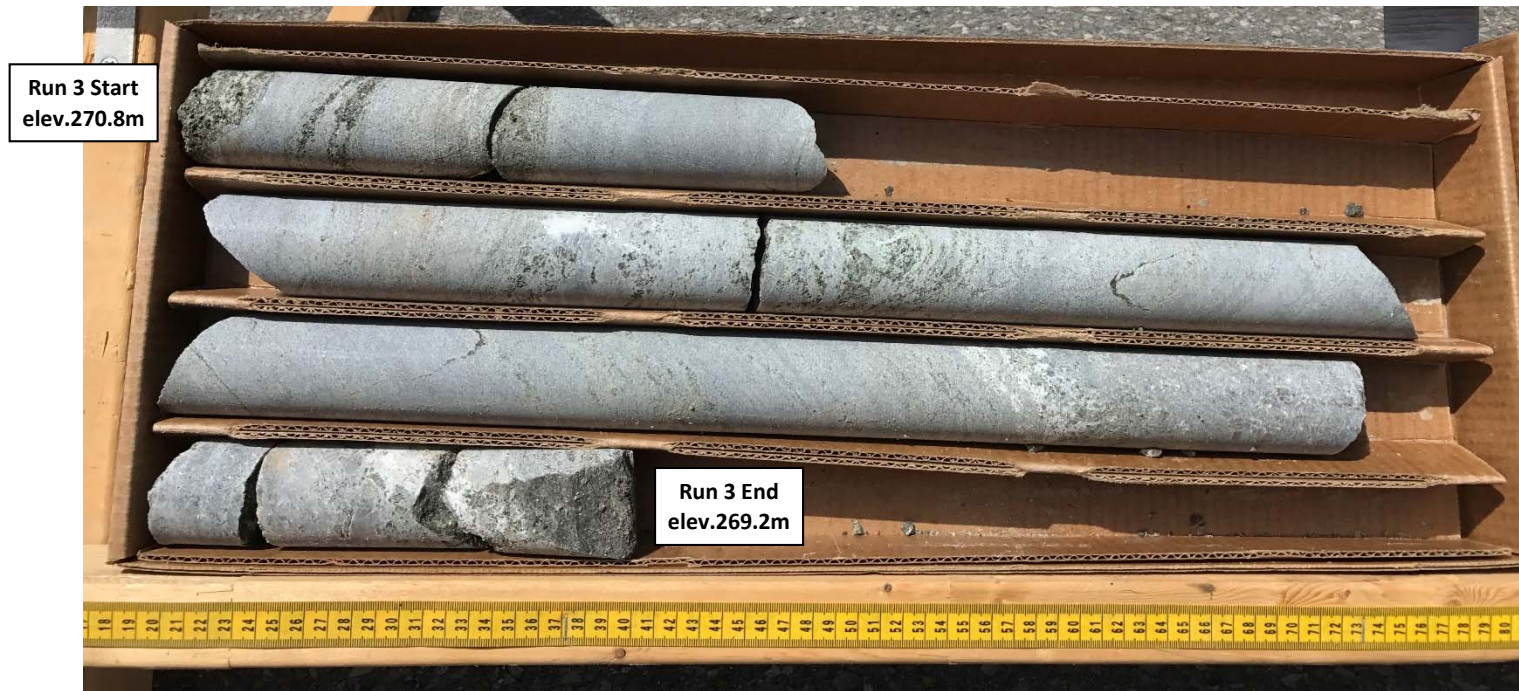
Borehole 17-1
Run 3 (of 3)
Elevation 270.8 m to 269.2 m

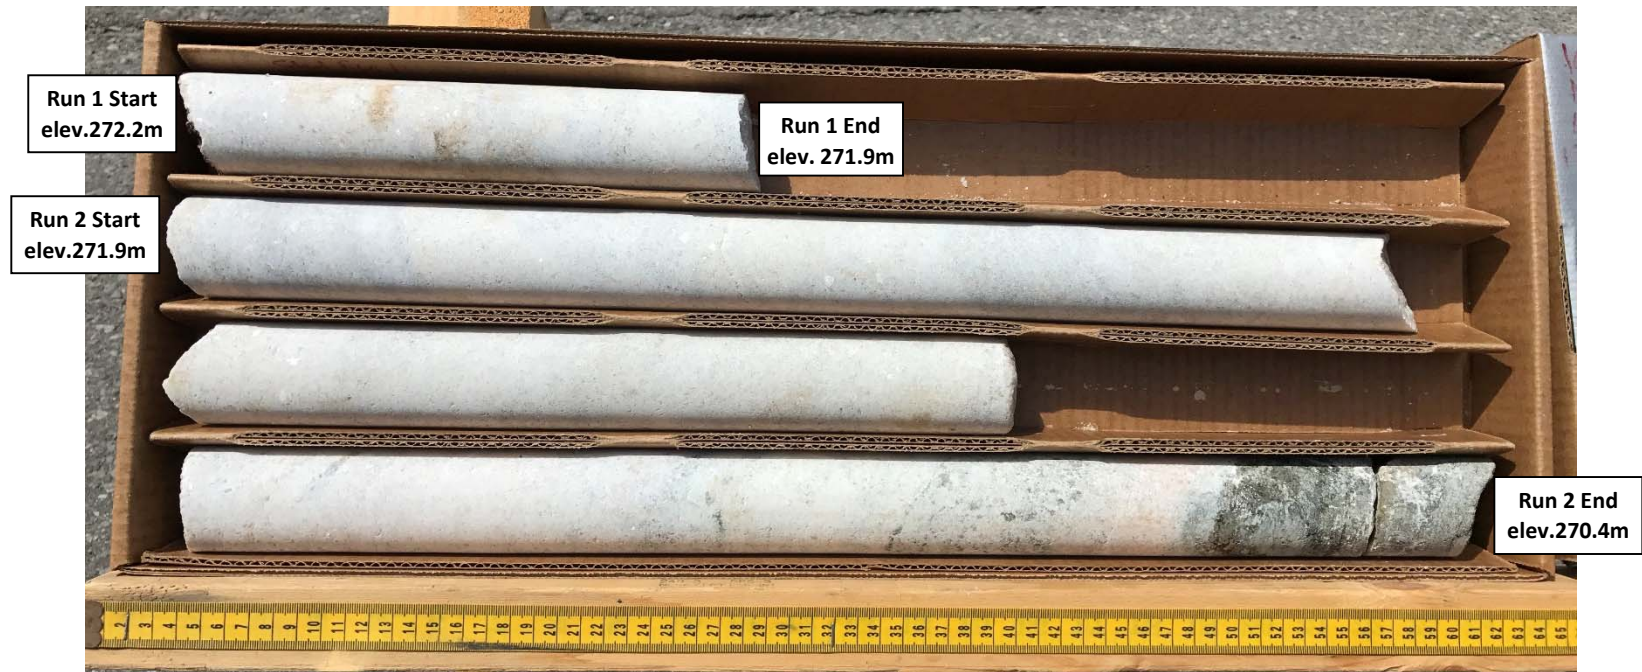
Borehole 17-2
Runs 1 and 2 (of 3)
Elevation 272.2 m to 270.4 m

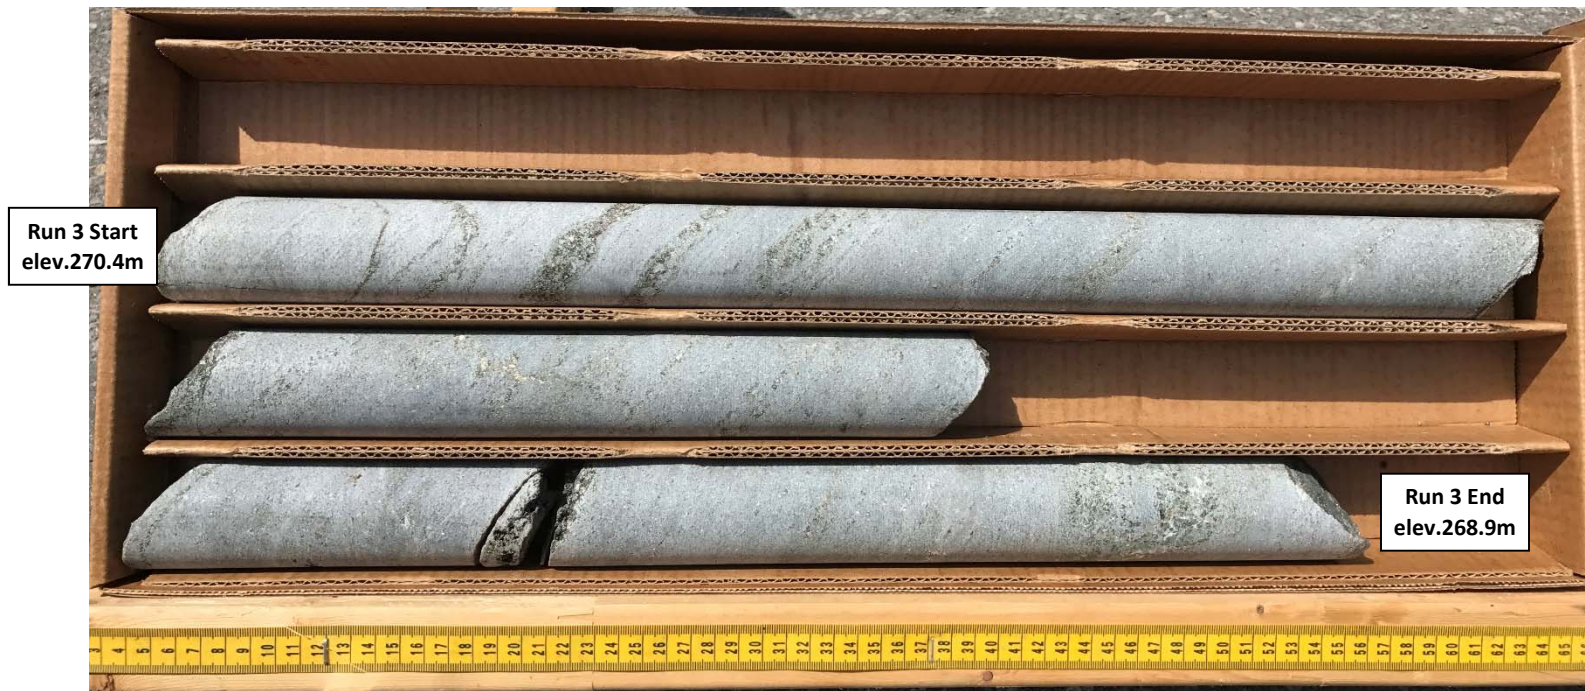
Borehole 17-2
Run 3 (of 3)
Elevation 270.4 m to 268.9 m

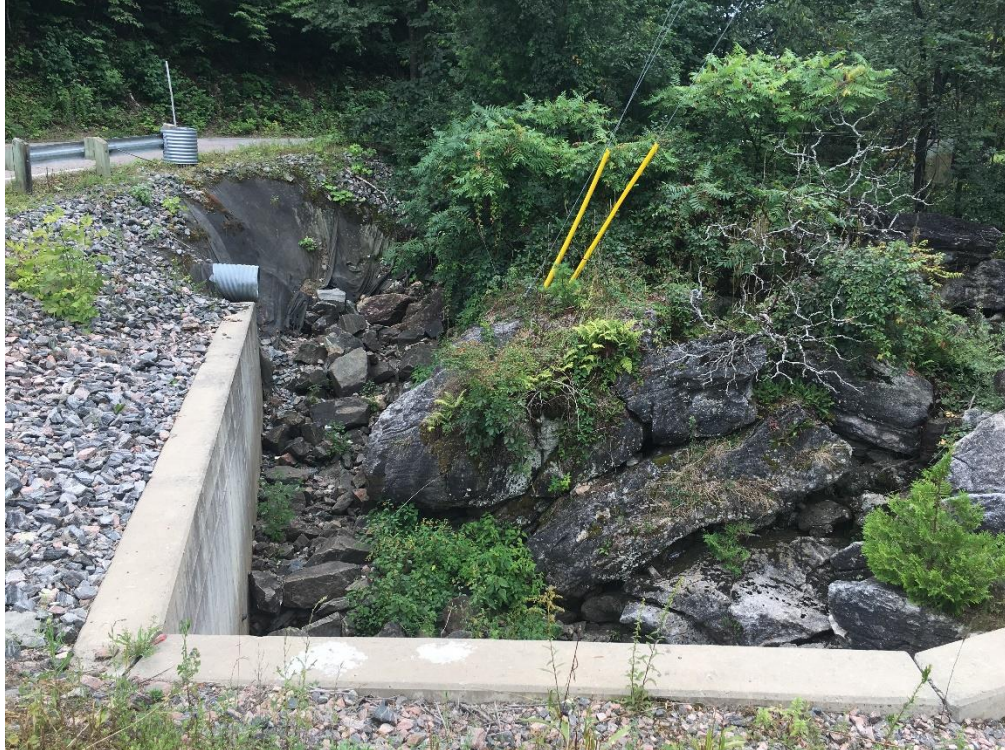
Photo 1. Looking upstream from culvert inlet, note erosion at north wingwall

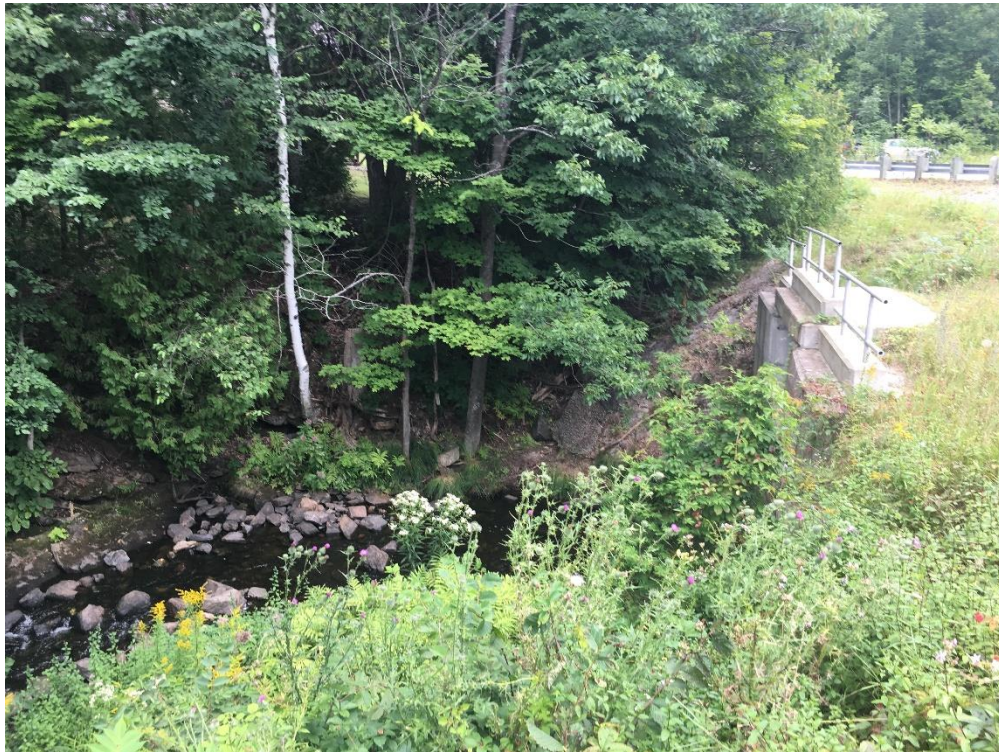
Photo 4. Looking northward at culvert outlet and wingwalls
