Foundation Investigation Report

*CCTV Camera Pole Installation along Highway 401 from
Gardiners Road (Sta. 17+950 Kingston Twp.) to Highway 15
(Sta. 11+500 Pittsburgh Twp.), Kingston, ON*

Agreement No. 4020-E-0008

Final Report

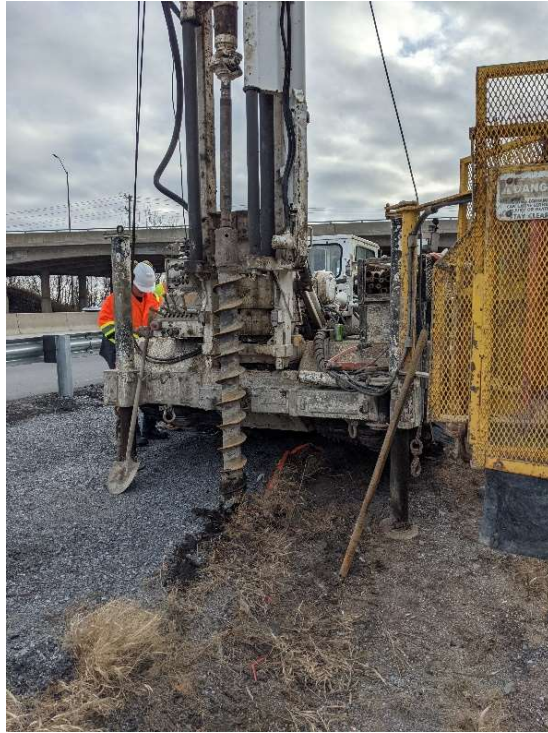
Photograph 1. Drilling of BH21-07 (facing east), December 7, 2021

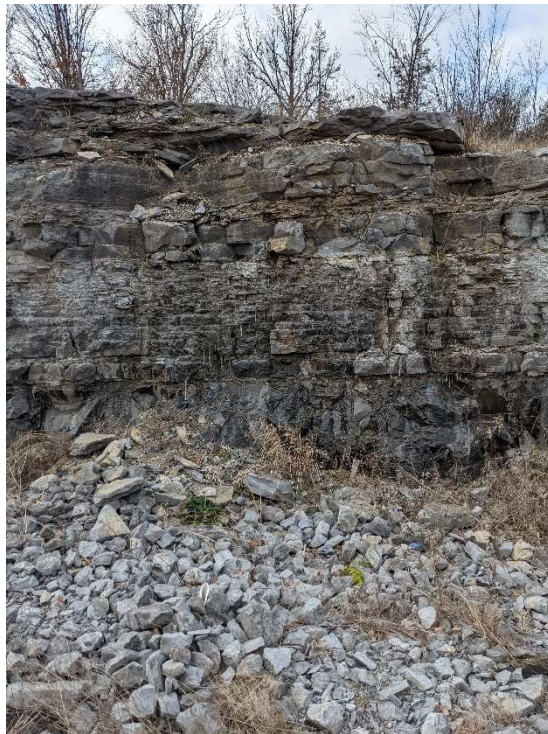
Photograph 2. Bedrock outcrop adjacent to BH21-07 (facing south), December 7, 2021

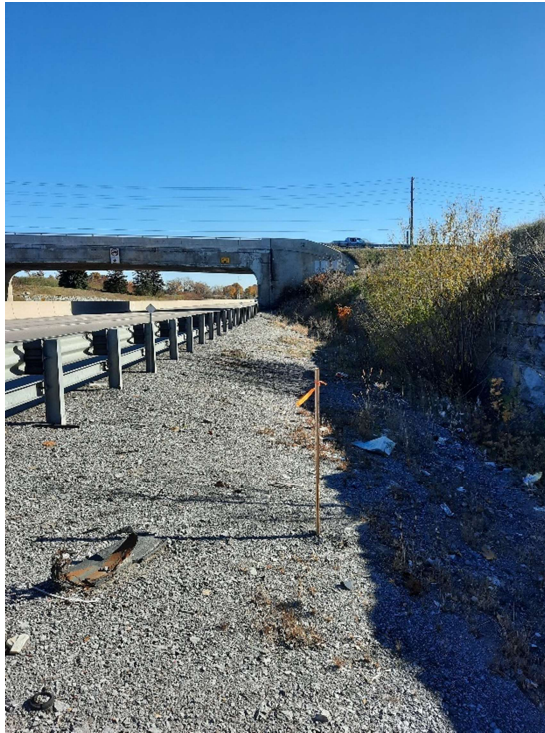
Photograph 3. CCTV 09 Location (facing east), November 10, 2021 (Note: BH21-09A was drilled on the other side of underpass shown on the photo, since there was no access behind the guardrail)

Table 1.4 below summarizes the encountered stratigraphy during the field investigation at BH21-09A. Due to machine access issues, BH21-09A was drilled approximately 150 m east of the proposed CCTV 09 location. A manual test pit was attempted at the stake location to confirm the depth to bedrock. However, due to the frozen ground and working time restrictions, bedrock was not encountered at the stake location through manual methods. Bedrock outcrops adjacent to the stake location were observed, suggesting that the bedrock is present at a shallow depth.

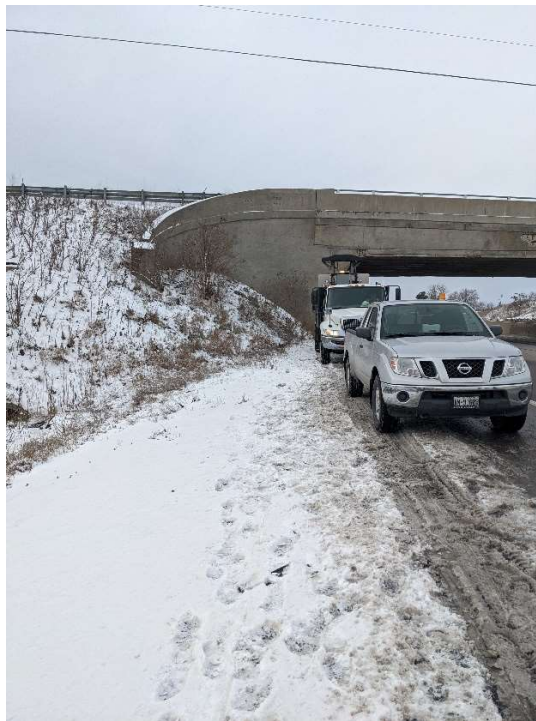
Photograph 4. Location of BH21-09A (facing west), December 9, 2021

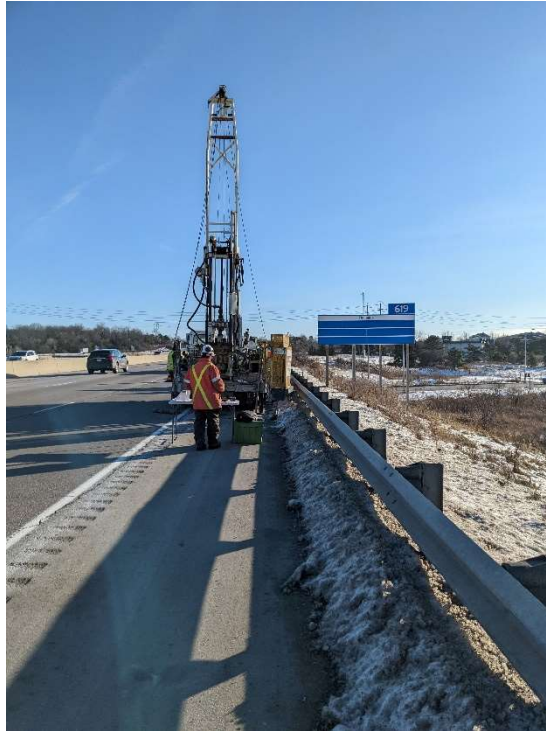
Photograph 5. Drilling of BH21-12 at the shoulder (facing east), December 21, 2021 (Note: The location of CCTV 12 is on the other side of guardrail on the embankment slope)

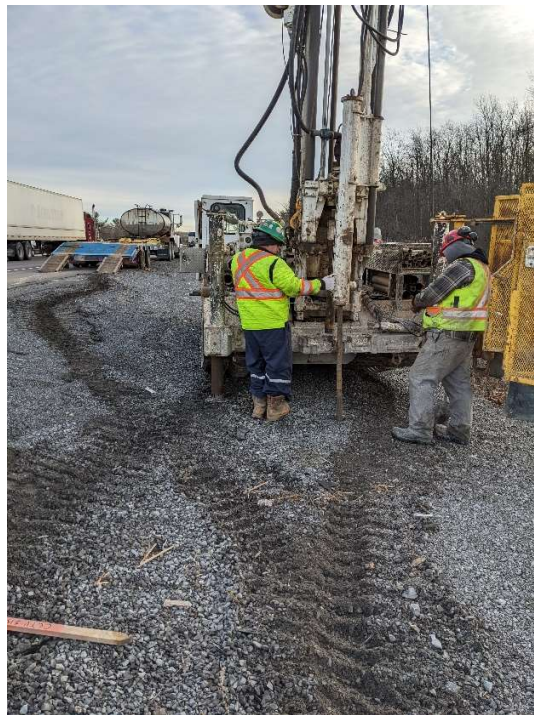
Photograph 6. Drilling of BH21-15 (facing east), December 14, 2021

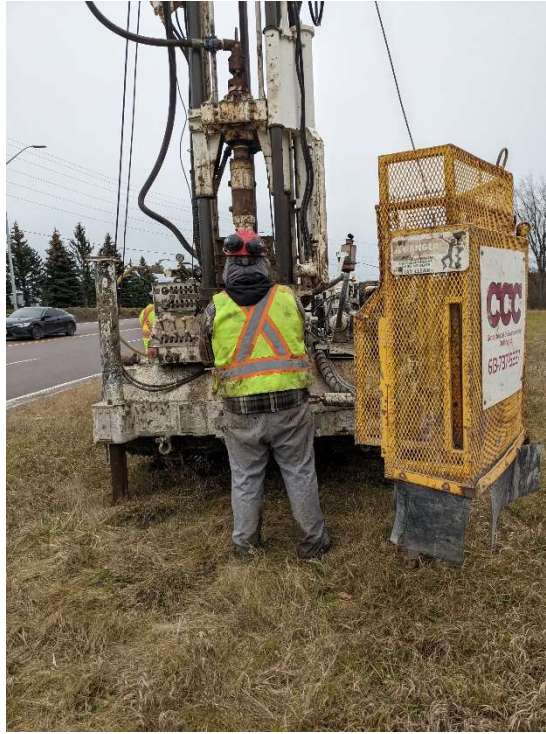
Photograph 7. Drilling of BH21-17, located off Hwy 15 (facing south), December 15, 2021

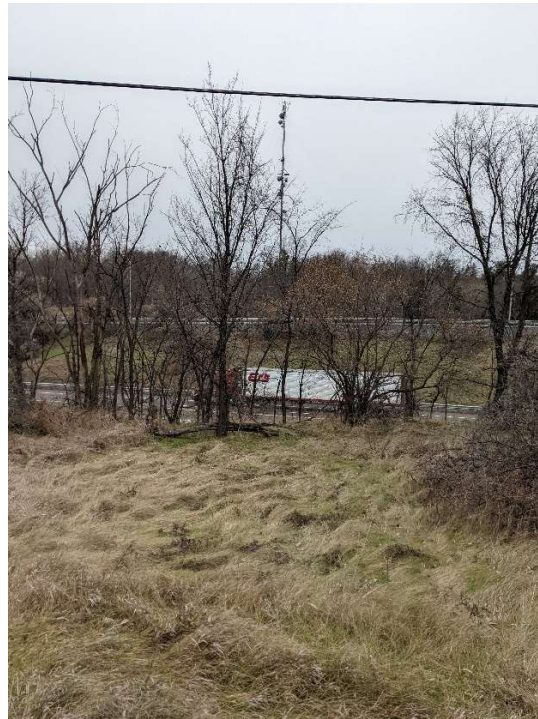
Photograph 8. Hwy 401 at location of BH21-17 (facing north), December 15, 2021

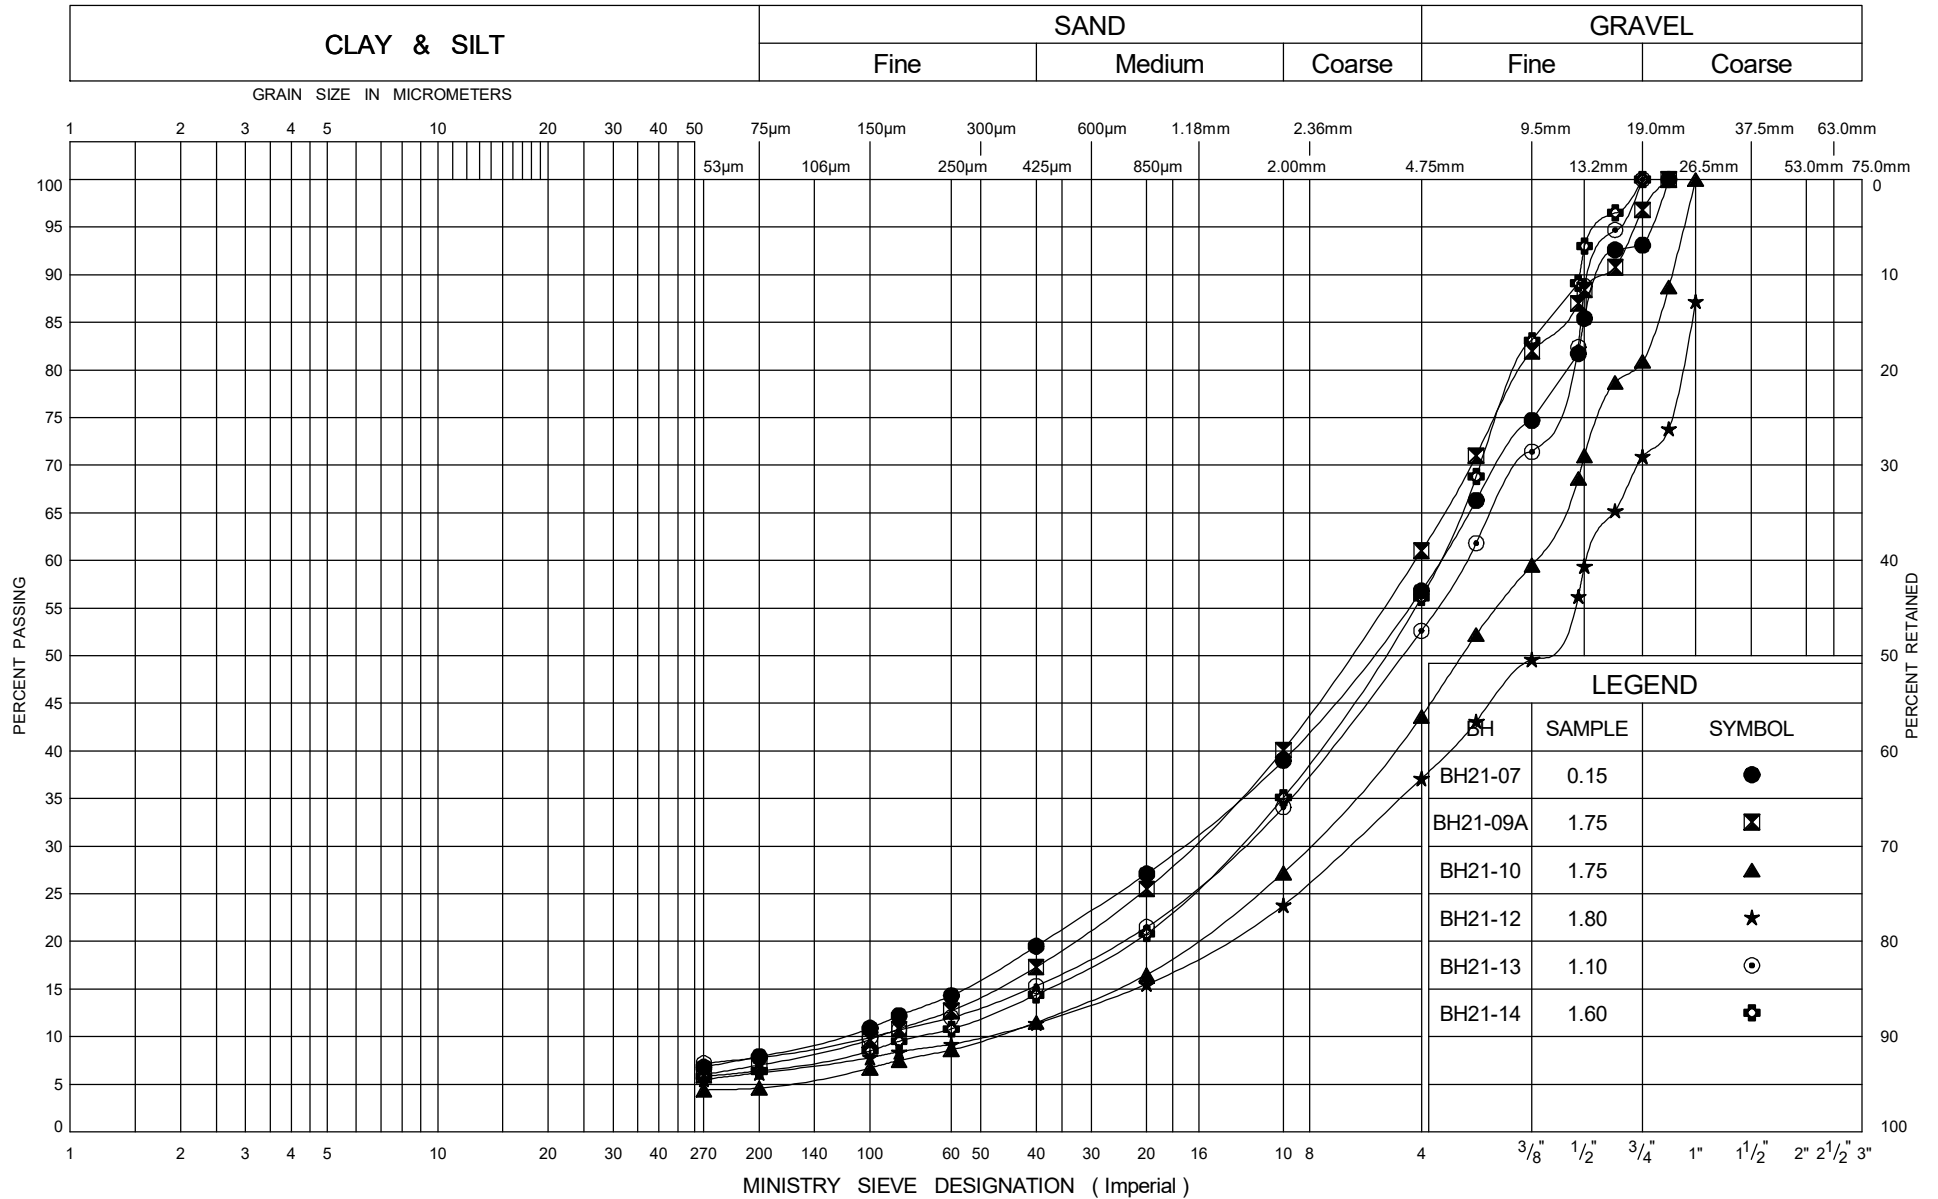
GRAIN SIZE DISTRIBUTION

Sand and Gravel to Sandy Gravel (FILL)

The results of the moisture content and grain size distribution tests performed by EXP are provided on the record of borehole sheets in Appendix C. The results of the grain size distribution test performed by EXP is also provided on Figure 1 in Appendix D.

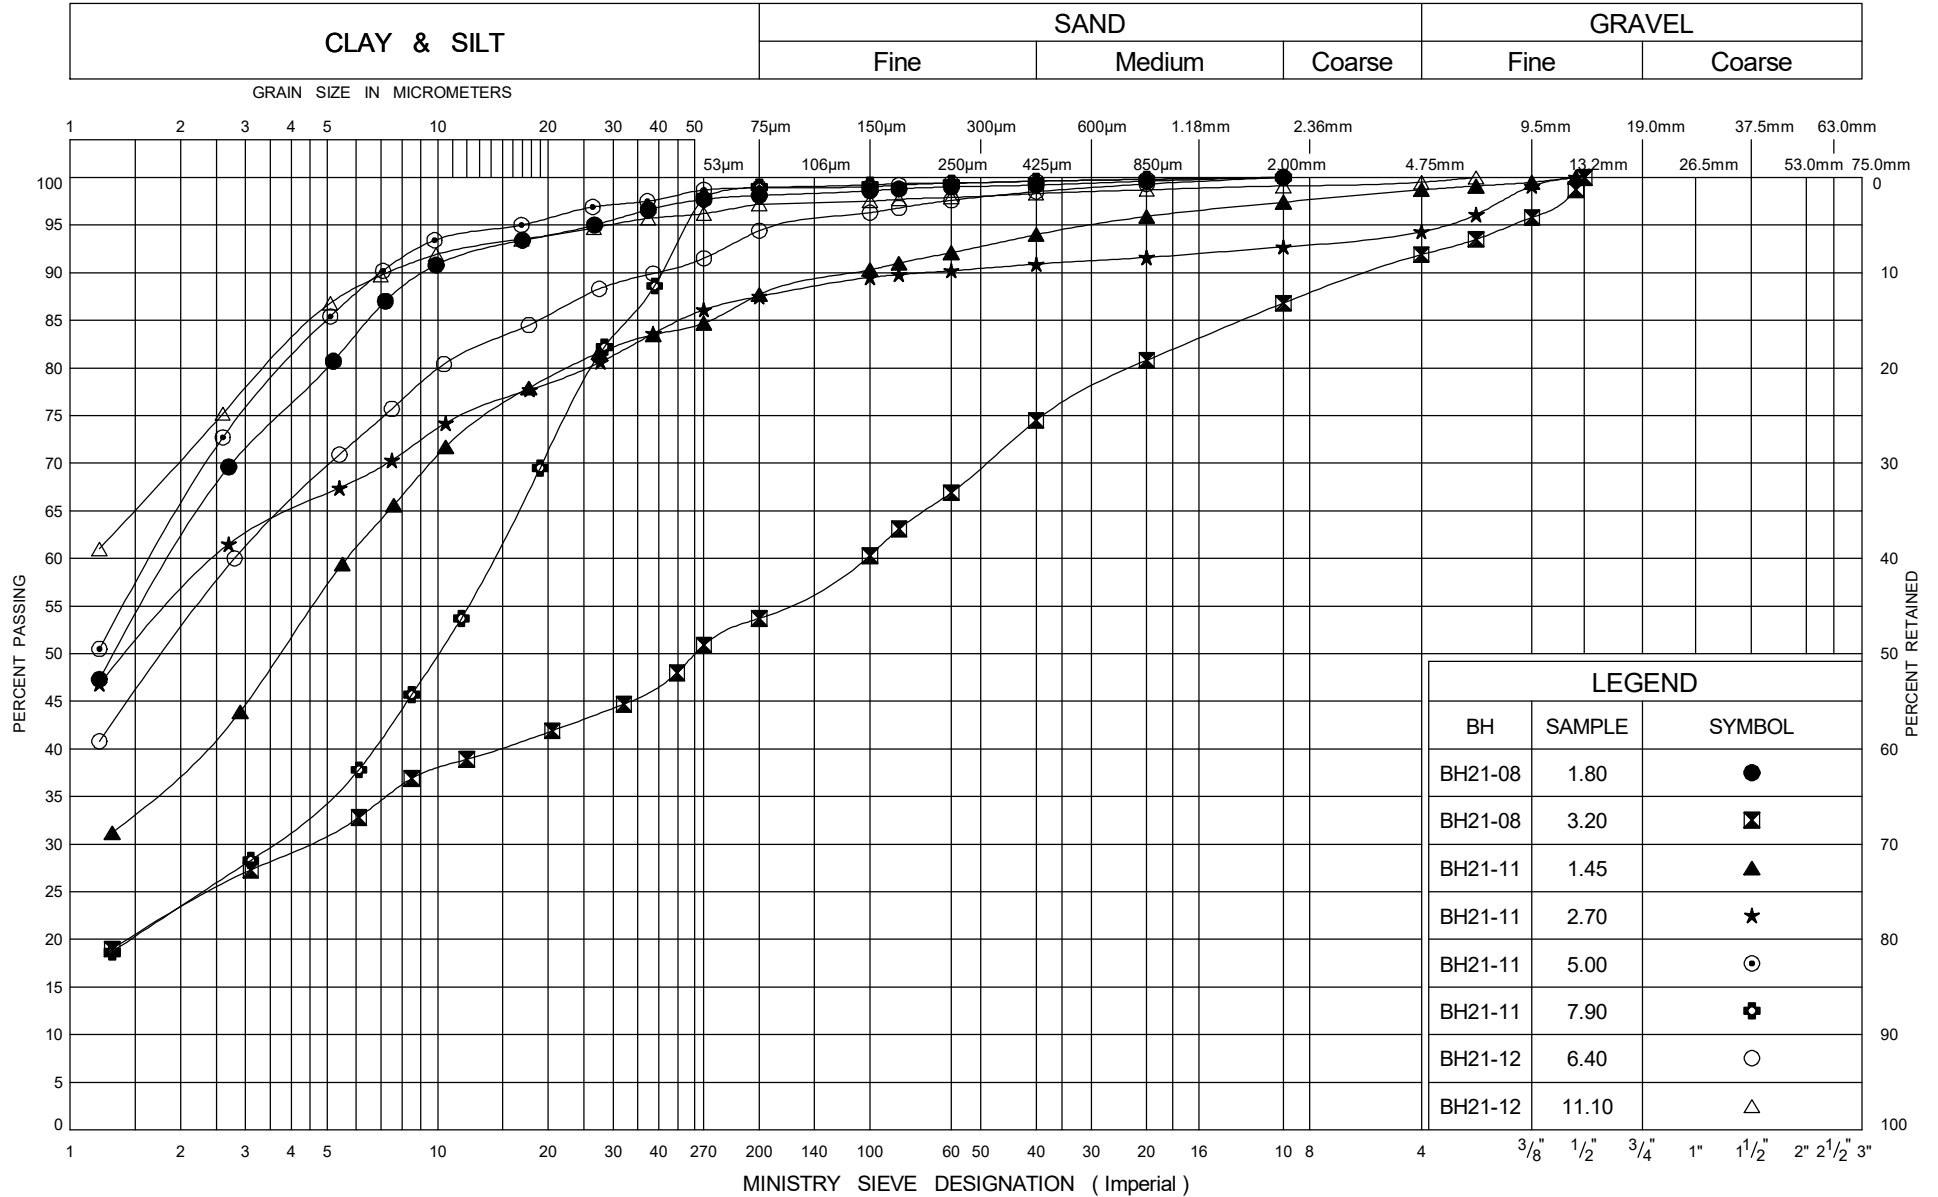
GRAIN SIZE DISTRIBUTION

Clayey Silt to Silty Clay

The results of the moisture content, grain size distribution, and Atterberg limits tests performed by EXP are provided on the record of borehole sheets in Appendix C. The results of the grain size distribution and Atterberg limits tests performed by EXP are also provided on Figure 2 and Figure 5, respectively, in Appendix D.

The results of the moisture content, grain size distribution, and Atterberg limit tests performed by EXP are provided on the record of borehole sheets in Appendix C. The results of the grain size distribution and Atterberg limits tests performed by EXP are also provided on Figure 2 and Figure 5, respectively, in Appendix D.

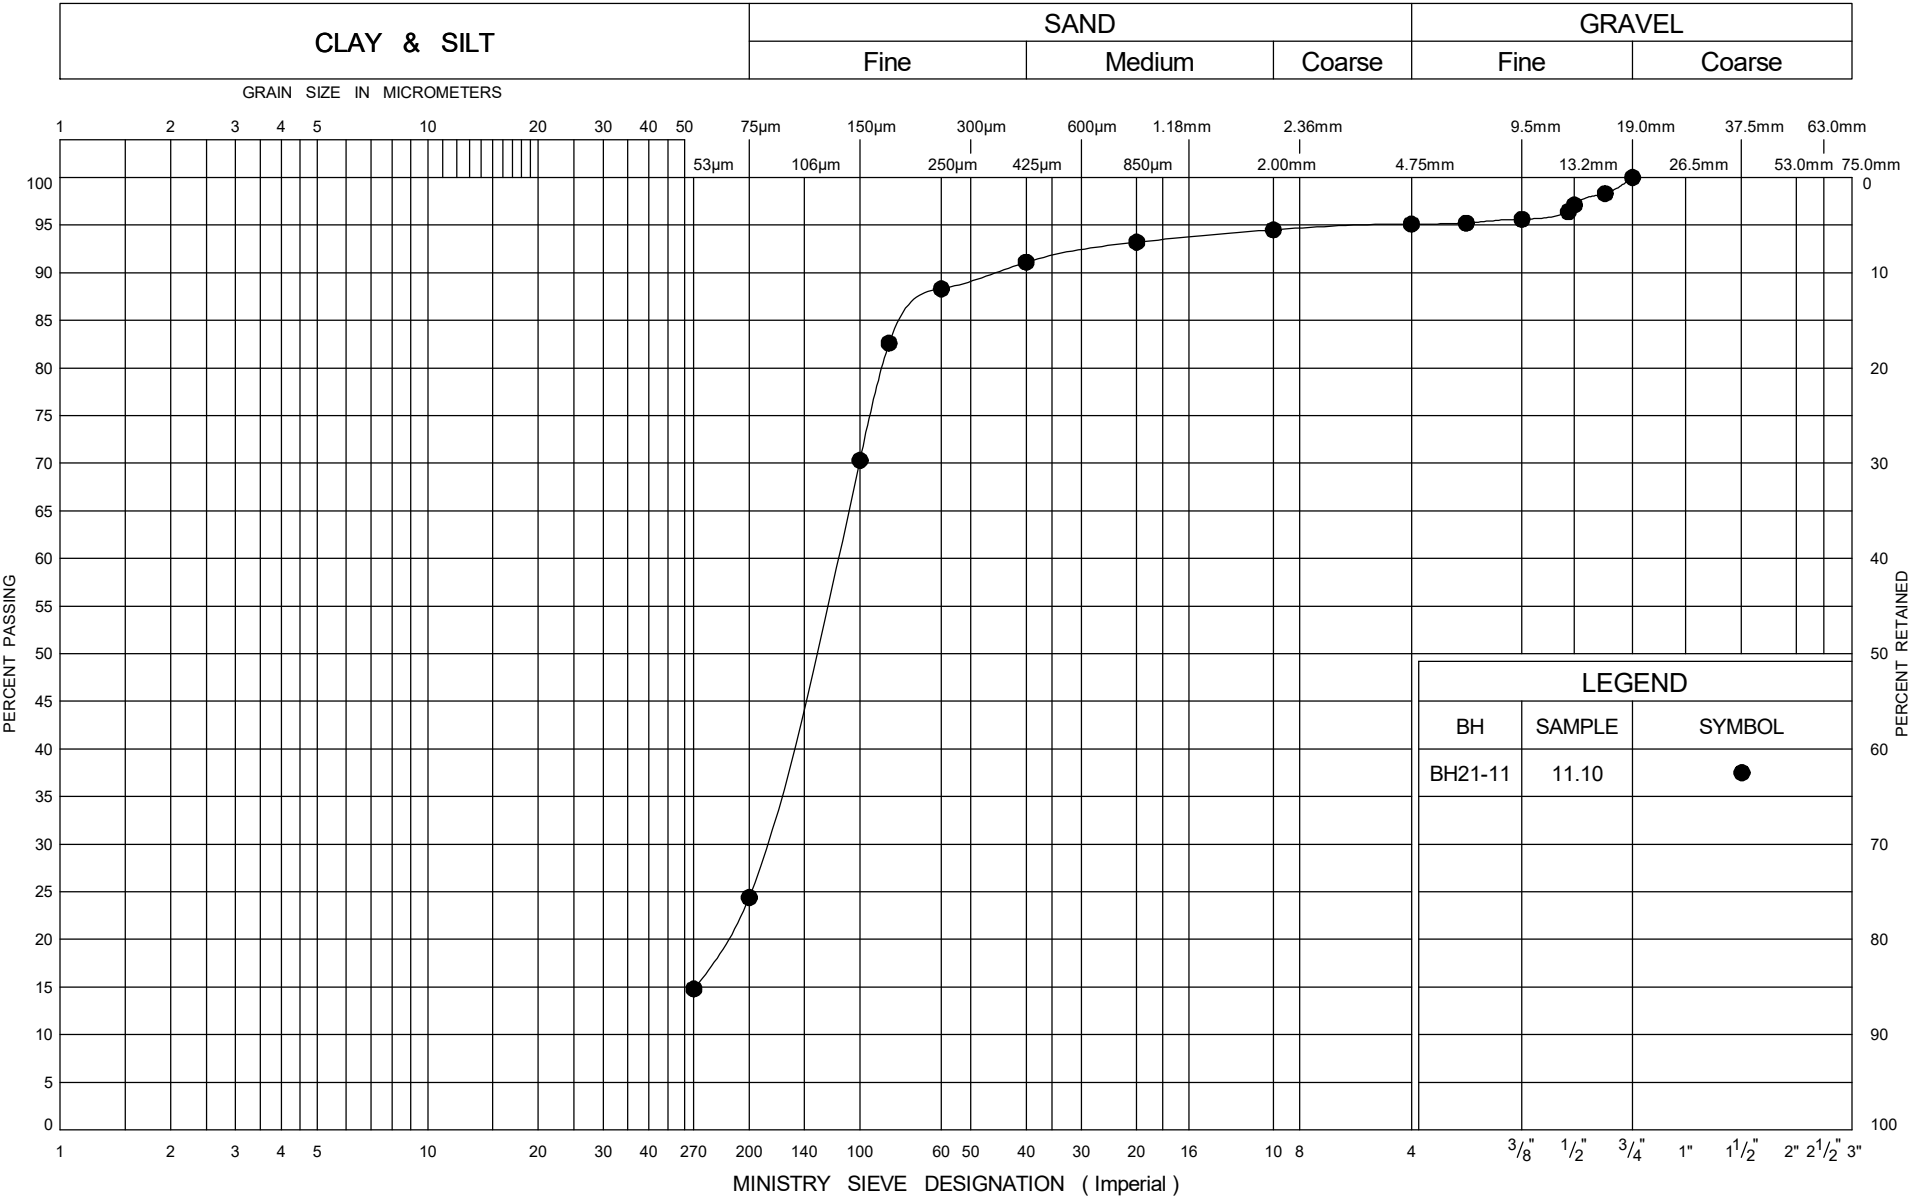
FIG No 4
W-P Agreement No. 4020-E-0008
CCTV Hwy. 401 Kingston

Sand

The results of the moisture content and grain size distribution tests performed by EXP are provided on the record of borehole sheets in Appendix C. The results of the grain size distribution test performed by EXP is also provided on Figure 4 in Appendix D.

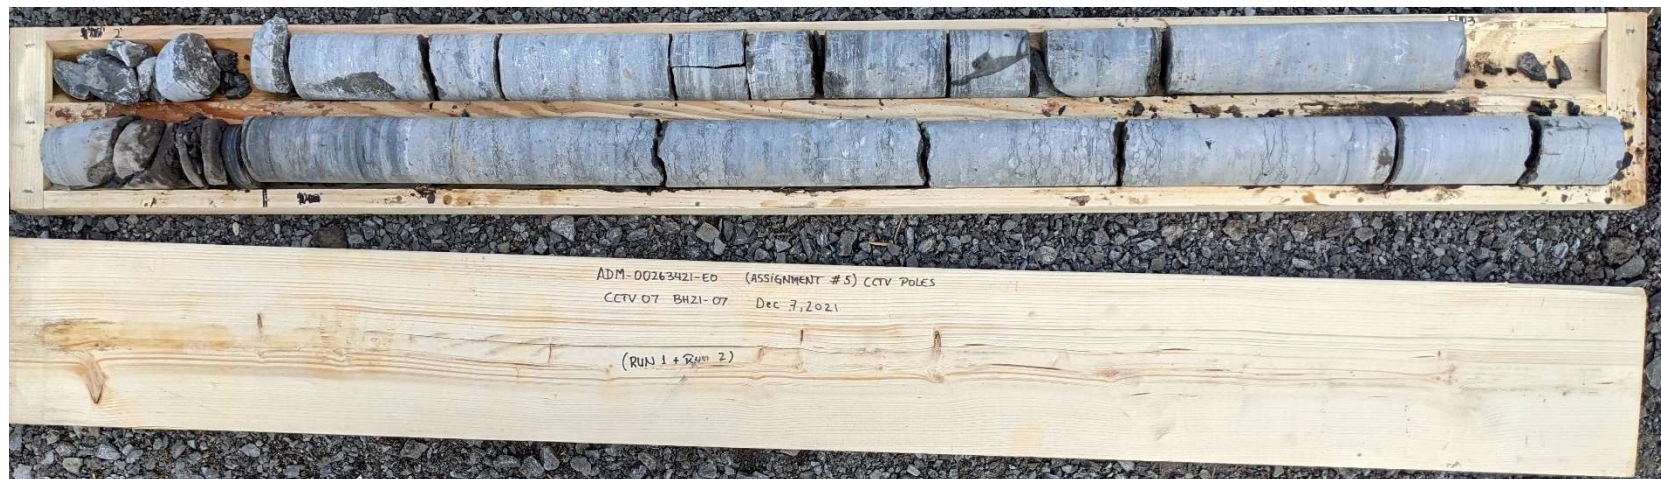
Photograph D1. Run 1 (Top) and Run 2 (Bottom), rock core from BH21-07

The shaly limestone/dolostone could generally be described as grey to dark grey in colour, intensely to slightly fractured, fine grained, moderately hard to hard, and slightly weathered to fresh. The Rock Quality Designation (RQD) measured on the core samples typically ranged from approximately 63% to 84%, indicating a rock mass of fair to good quality. The total core recovery (TCR) of shaly limestone/dolostone cores was 90% to 100%. The uniaxial compressive strength (UCS) of the shaly limestone/dolostone was measured to be 152.3 MPa, indicating very strong (R5) rock, according to the CFEM. A weathered zone was assessed to be approximately 0.5 m to 1.0 m from the top of the bedrock.

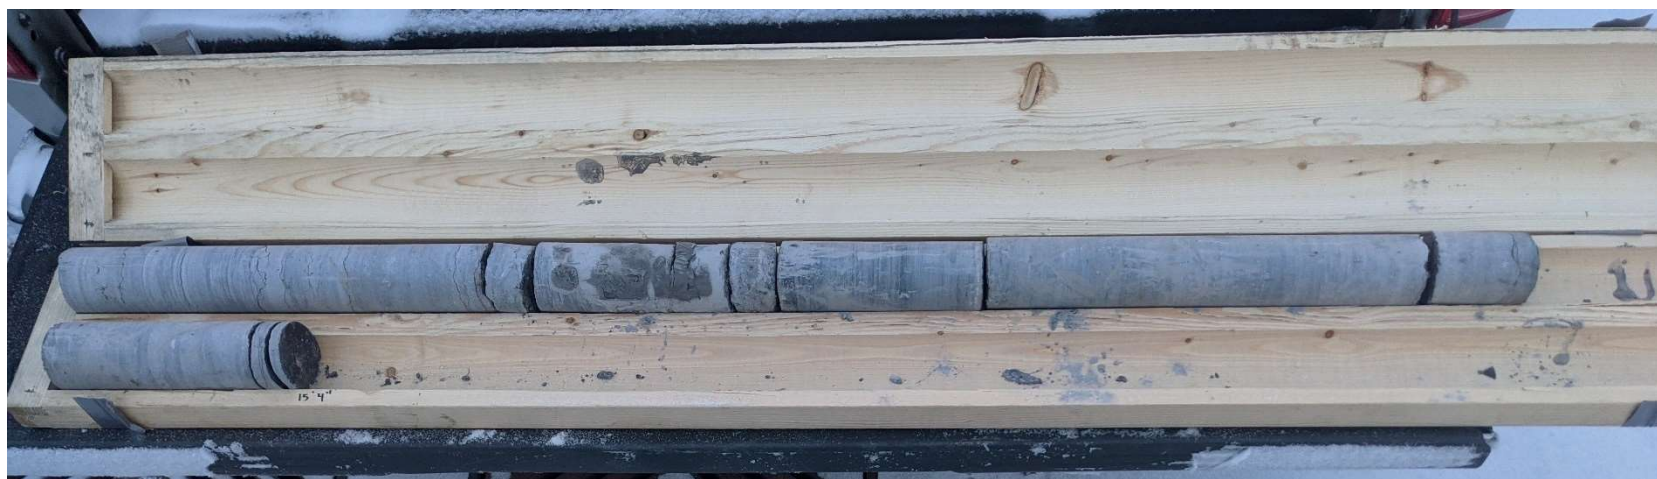
Photograph D2. Run 3, rock core from BH21-07

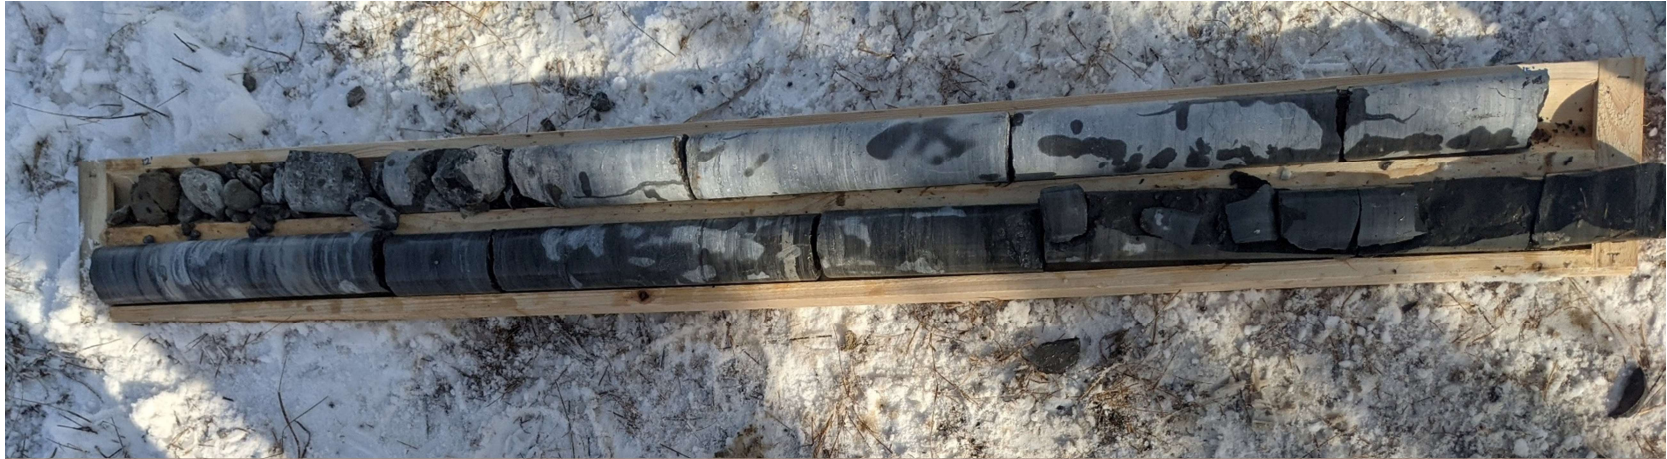
Photograph D3. Run 1 (Top) and Run 2 (Bottom), rock core from BH21-08

The shaly limestone/dolostone could generally be described as grey to dark grey in colour, intensely to slightly fractured, fine grained, moderately hard to hard, and slightly weathered to fresh. The RQD measured on the core samples typically ranged from approximately 68% to 78%, indicating a rock mass of fair to good quality. The TCR of shaly limestone/dolostone cores was 97% to 100%. The UCS of the shaly limestone/dolostone was measured to be 160.5 MPa, indicating very strong (R5) rock, according to the CFEM. A weathered zone was assessed to be approximately 0.5 m from the top of the bedrock.

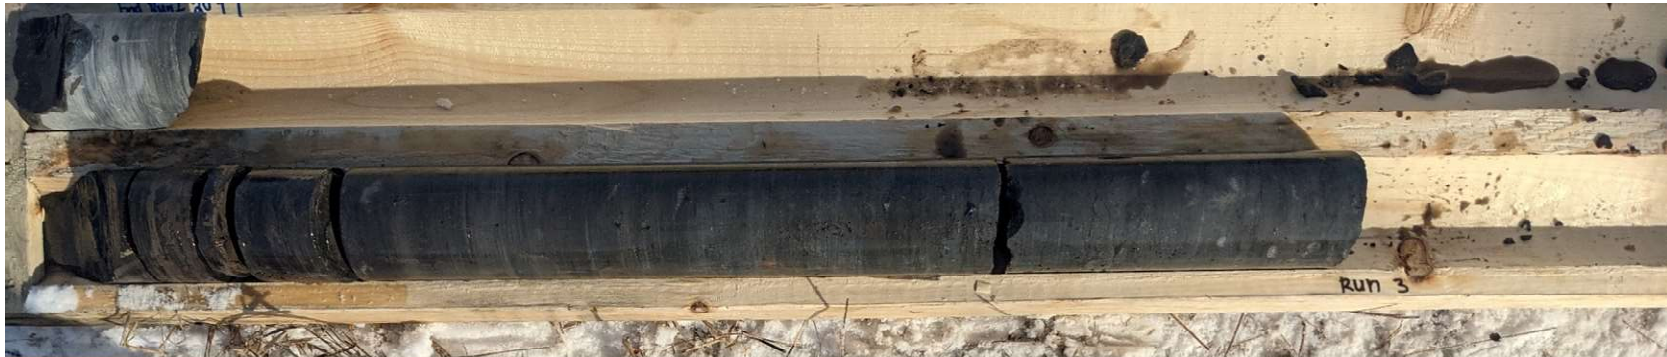
Photograph D4. Run 2 (Top) and Run 3 (Bottom), rock core from BH21-08

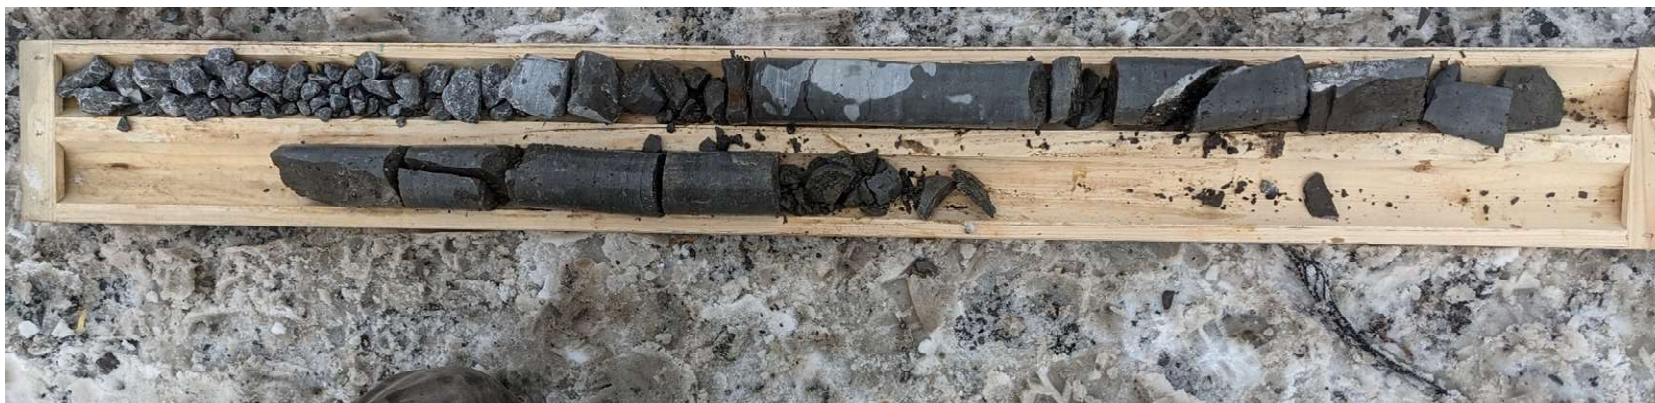
Photograph D5. Run 1, rock core from BH21-09A

The shaly limestone/dolostone could generally be described as grey to dark grey in colour, intensely to slightly fractured, fine grained, moderately hard to hard, and slightly weathered to fresh. The RQD measured on the core samples typically ranged from approximately 10% to 87%, indicating a rock mass of very poor to very good quality. The TCR of shaly limestone/dolostone cores was 100%. The UCS of the shaly limestone/dolostone was measured to be 202.4 MPa, indicating very strong (R5) rock, according to the CFEM. A weathered zone was assessed to be approximately 1.0 m to 1.5 m from the top of the bedrock.

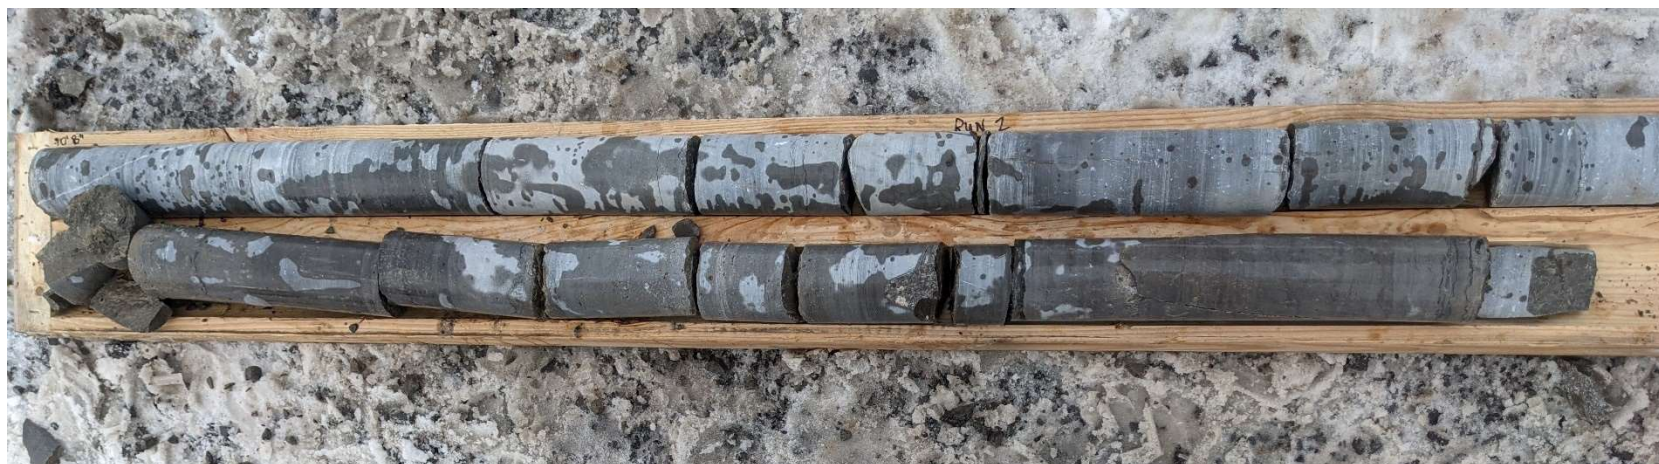
Photograph D6. Run 2 (Top) and Run 3 (Bottom), rock core from BH21-09A

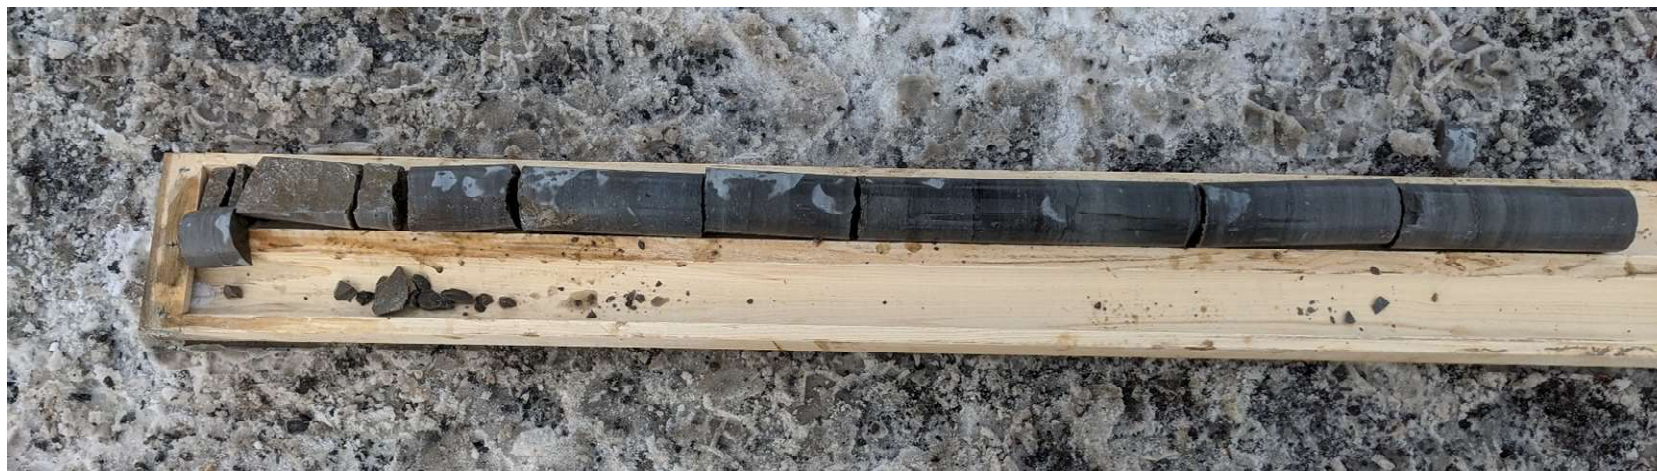
Photograph D7. Run 4, rock core from BH21-09A

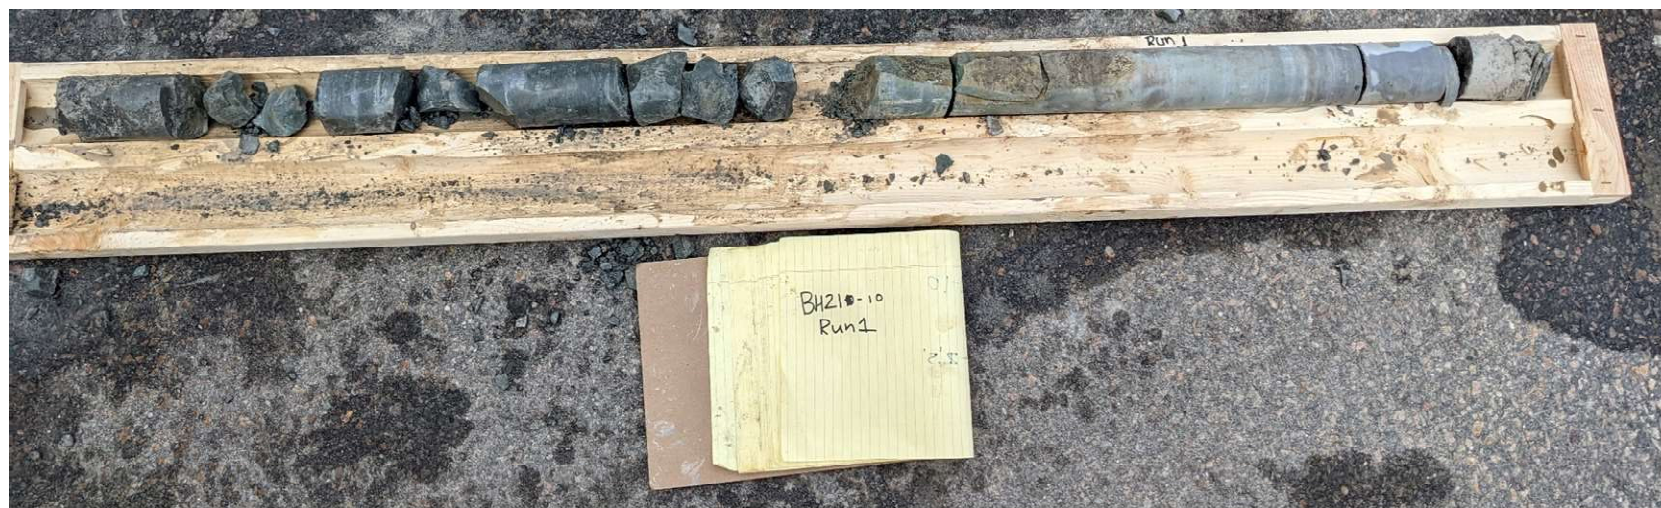
Photograph D8. Run 1 (Top), rock core from BH21-10

The shaly limestone/dolostone could generally be described as grey to dark grey in colour, intensely to slightly fractured, fine grained, moderately hard to hard, and slightly weathered to fresh. The RQD measured on the core samples typically ranged from approximately 52% to 100%, indicating a rock mass of fair to very good quality. The TCR of shaly limestone/dolostone cores ranged from 94% to 100%. The UCS of the shaly limestone/dolostone was measured to be 164.4 MPa, indicating very strong (R5) rock, according to the CFEM. A weathered zone was assessed to be approximately 0.5 m to 1.0 m from the top of the bedrock.

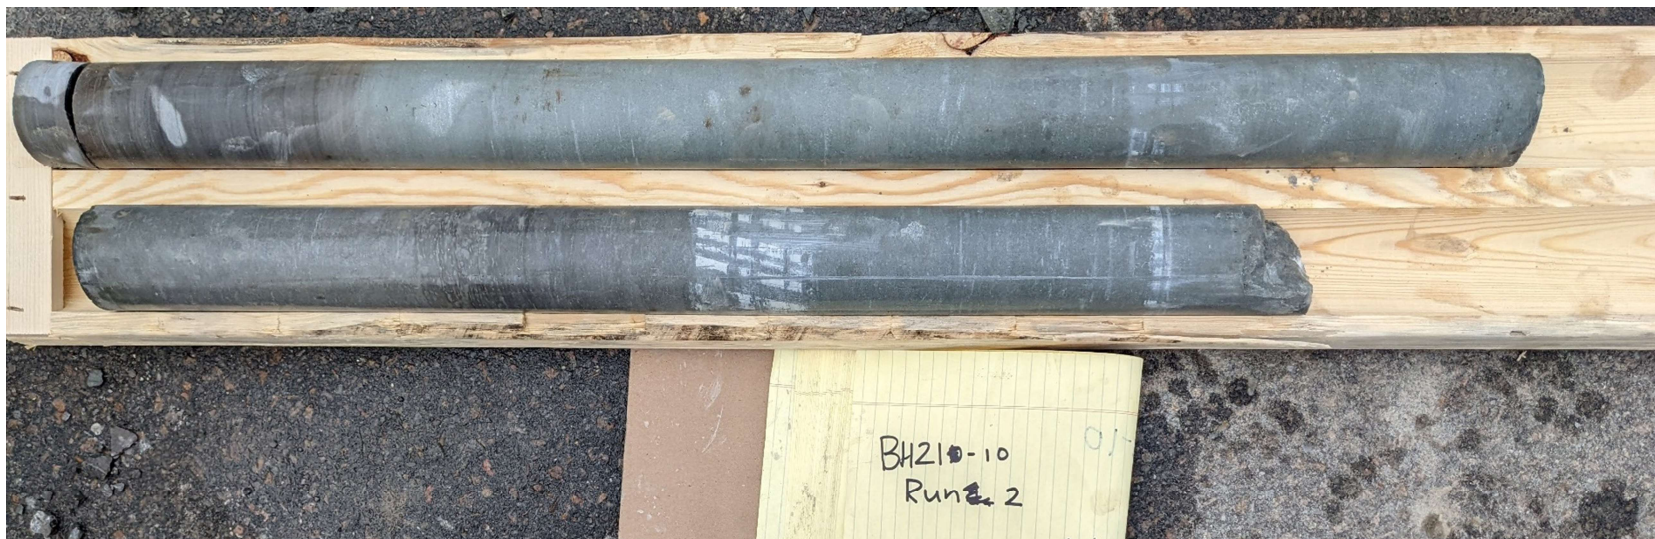
Photograph D9. Run 2, rock core from BH21-10

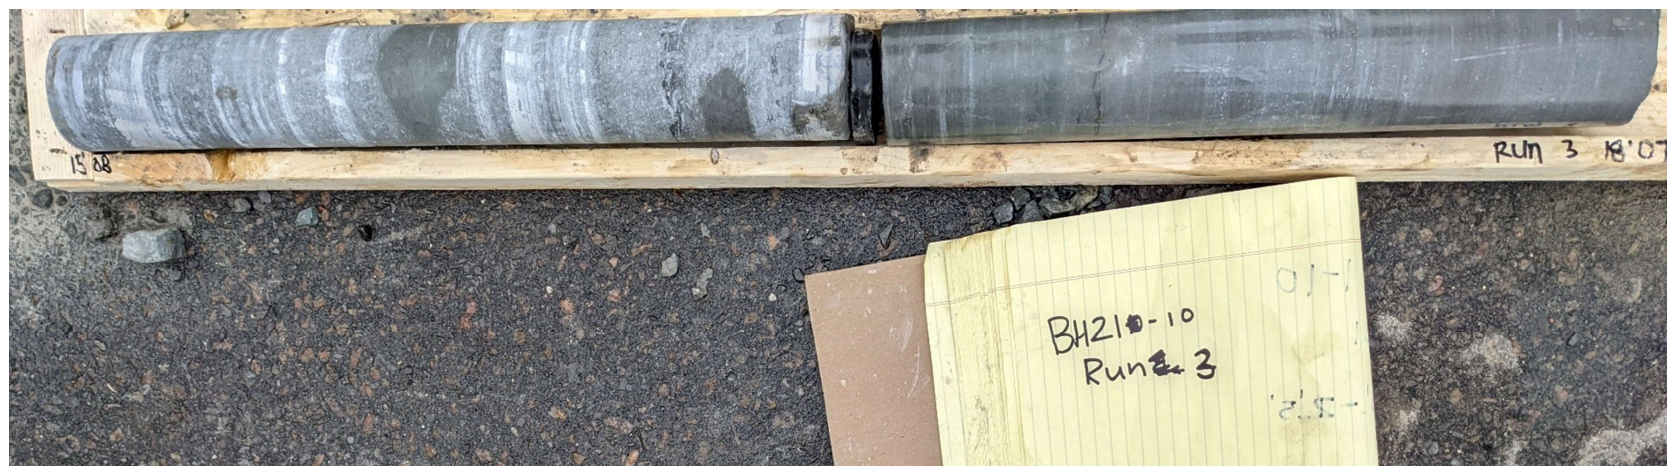
Photograph D10. Run 3, rock core from BH21-10

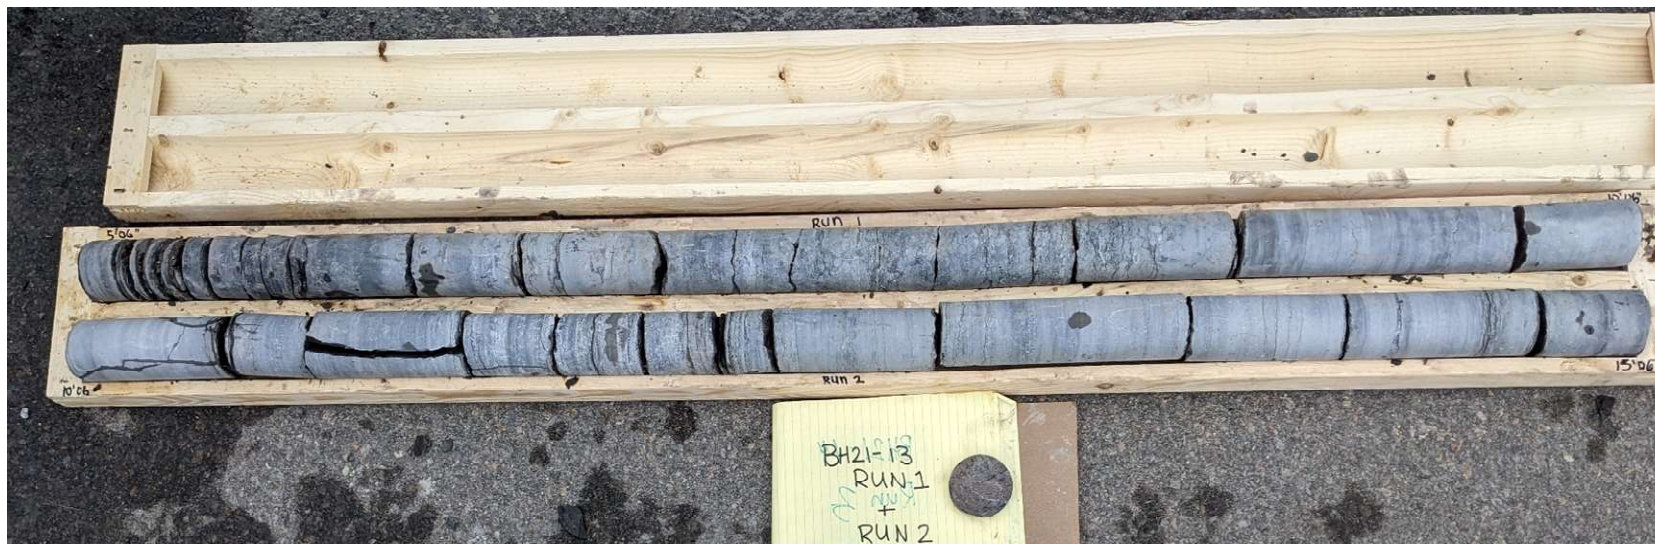
Photograph D11. Run 1 (Top) and Run 2 (Bottom), rock core from BH21-13

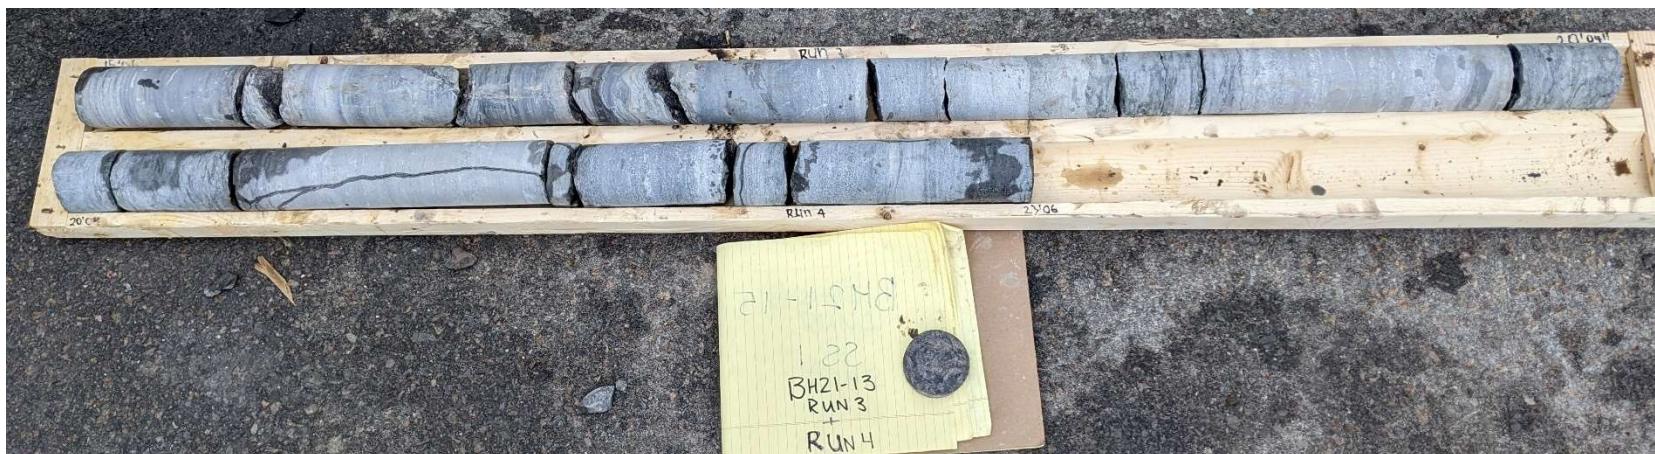
Photograph D12. Run 3 (Top) and Run 4 (Bottom), rock core from BH21-13

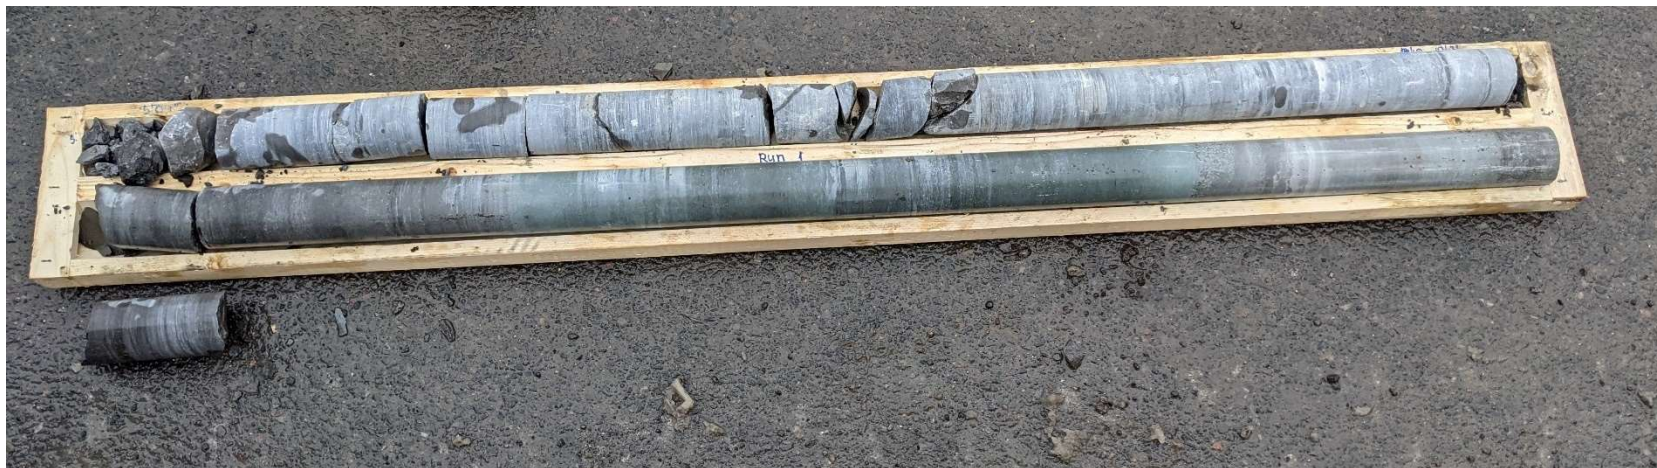
Photograph D13. Run 1 (Top) and Run 2 (Bottom), rock core from BH21-14

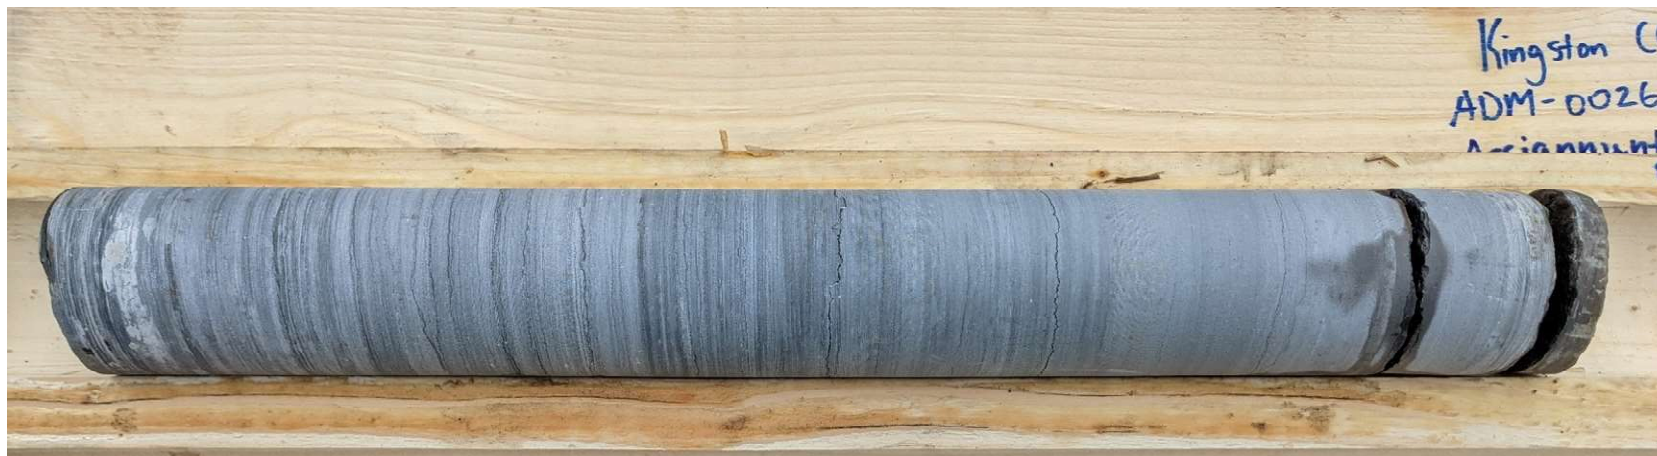
Photograph D14. Run 3, rock core from BH21-14
