Foundation Investigation Report

*CCTV Camera Pole Installation along Highway 401 from
Gardiners Road (Sta. 17+950 Kingston Twp.) to Highway 15
(Sta. 11+500 Pittsburgh Twp.), Kingston, ON*

Agreement No. 4020-E-0008

Final Report

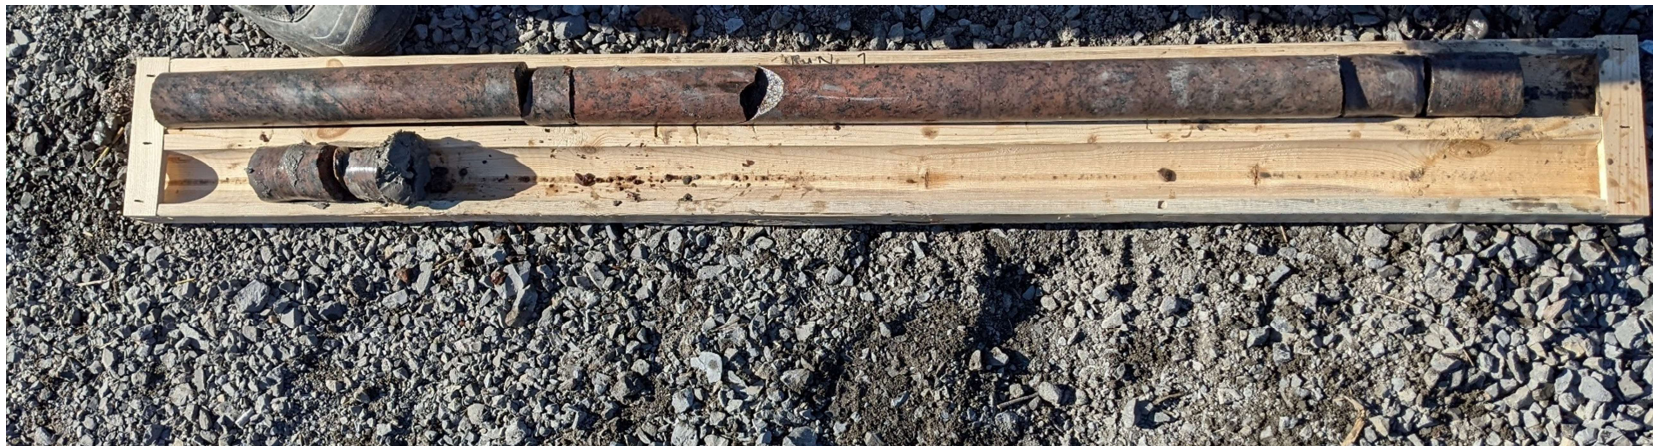
Photograph D15. Run 1, rock core from BH21-15

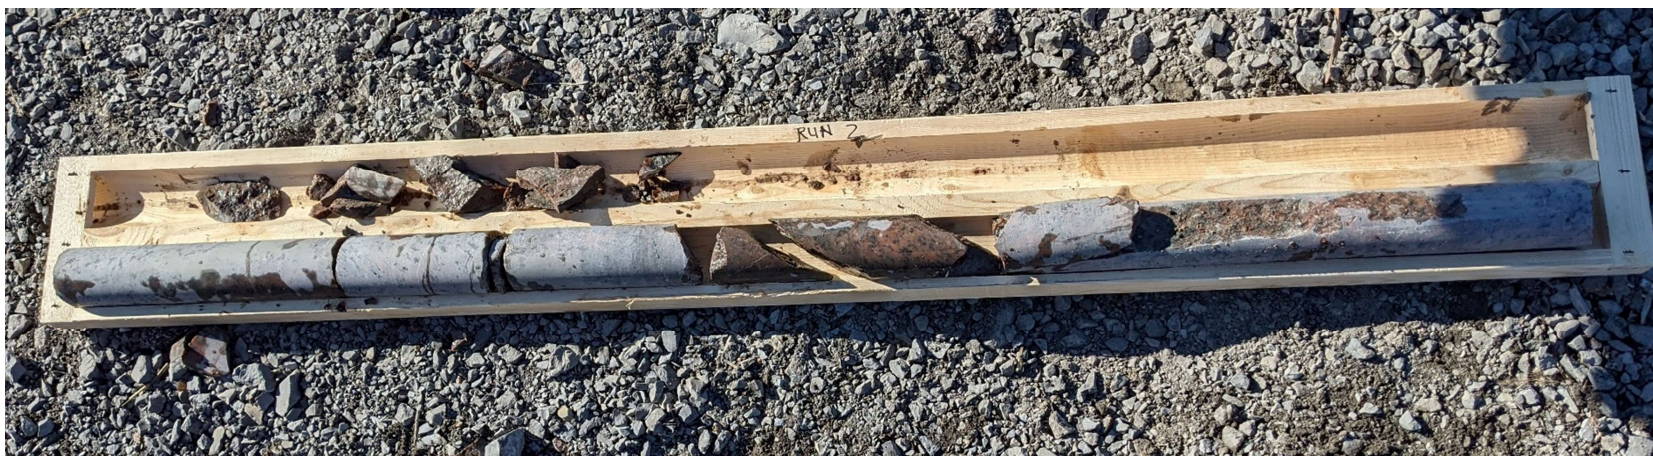
Photograph D16. Run 2, rock core from BH21-15

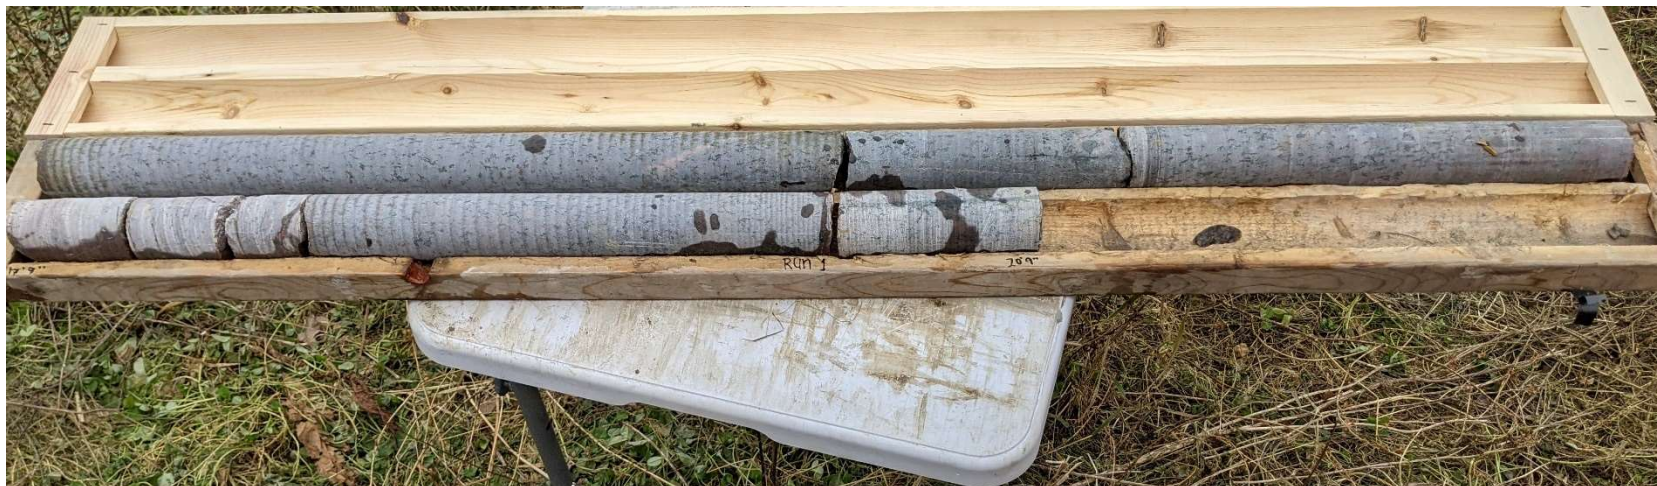
Photograph D17. Run 1 (Bottom) and Run 2 (Top), rock core from BH21-16

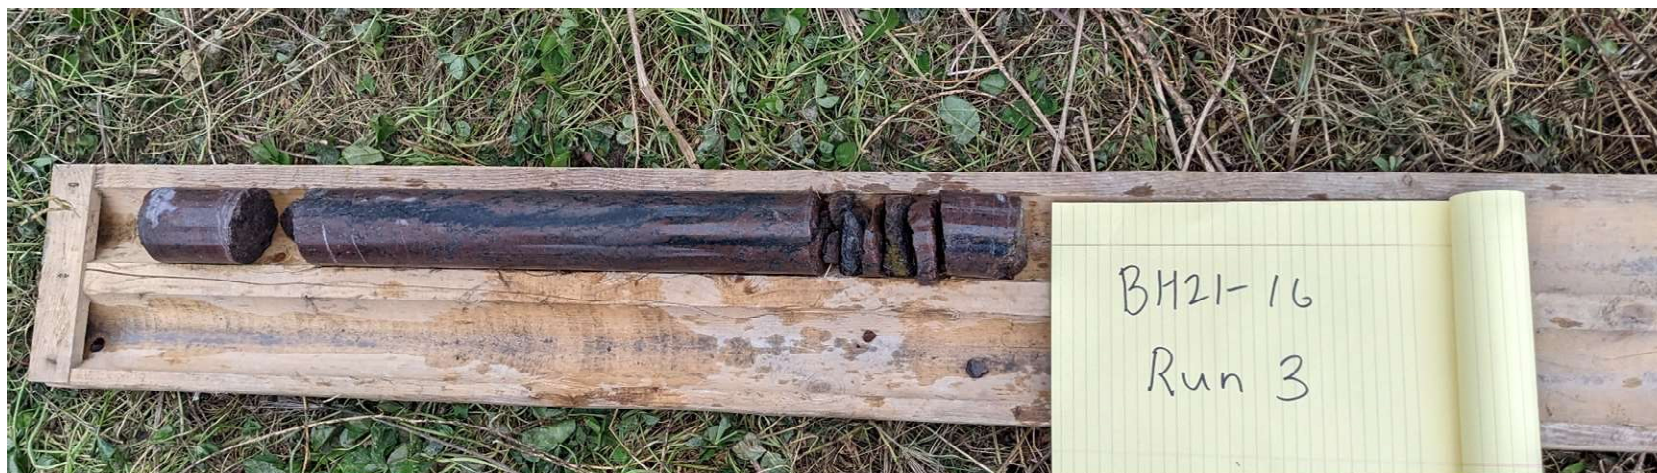
Photograph D18. Run 3, rock core from BH21-16

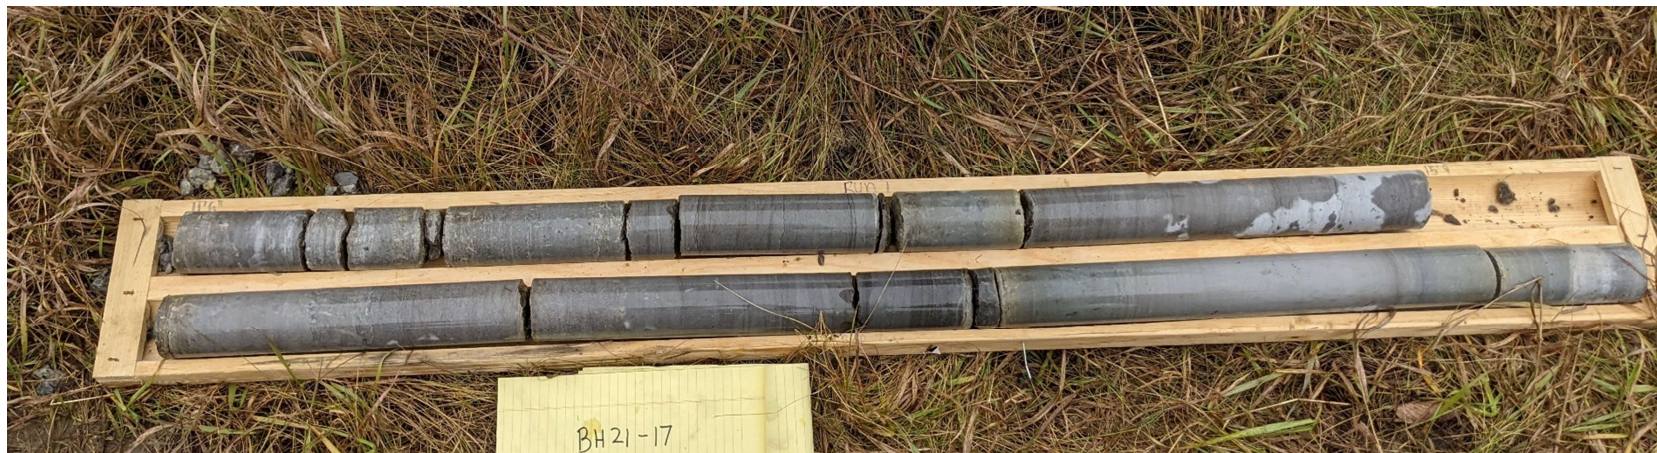
Photograph D19. Run 1 (Top) and Run 2 (Bottom), rock core from BH21-17

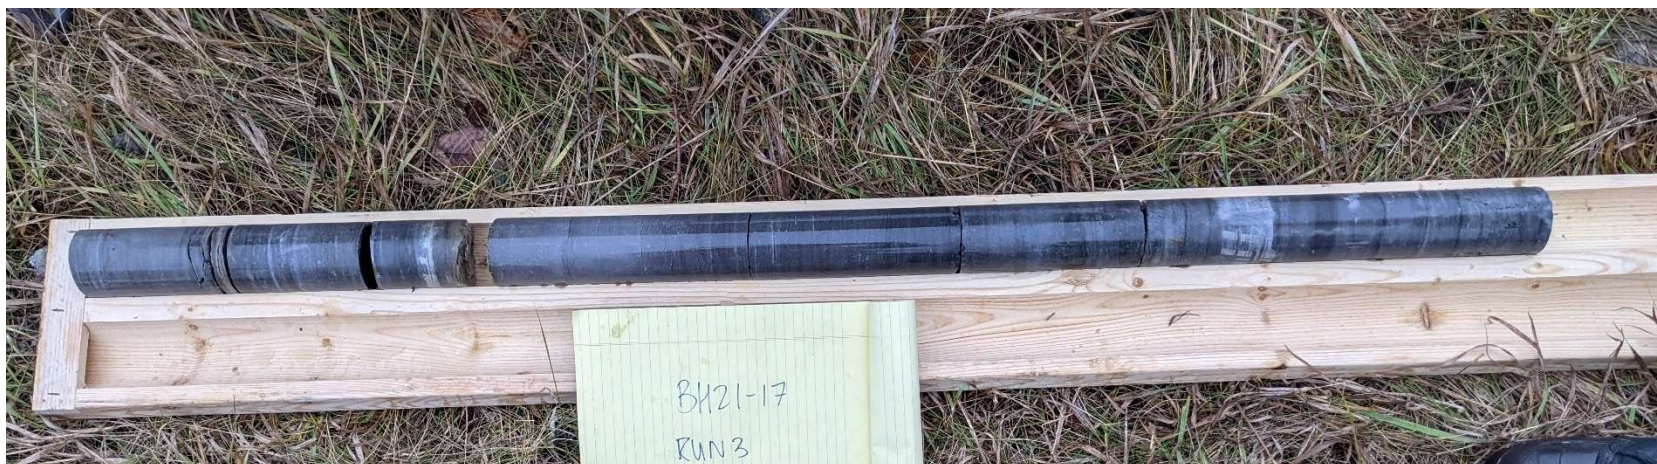
Photograph D20. Run 3, rock core from BH21-17
