BA 1323
WILLIAM A. TROW AND ASSOCIATES LTD.

Project: J750

Re: Foundation Conditions
Dargel Bridge
Township of Blenheim

We have completed an investigation of foundation conditions at the existing Dargel bridge crossing of the Nith River. The field work consisted of 3 borings taken to a maximum depth of 46 feet below the level of this stream.

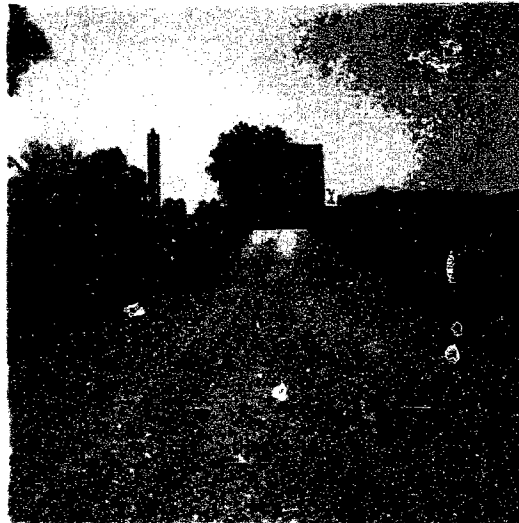
View of Bridge from South approach
Drill on Hole 1

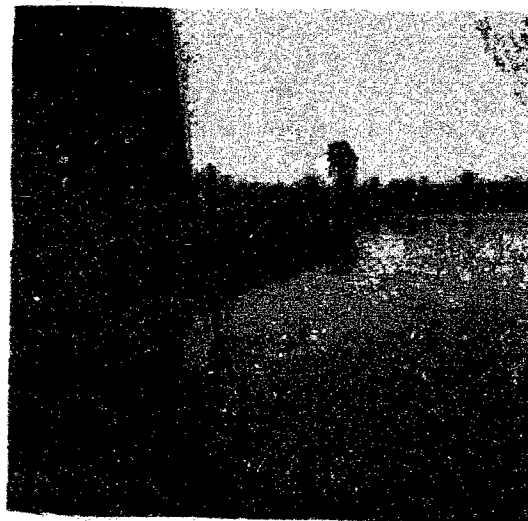
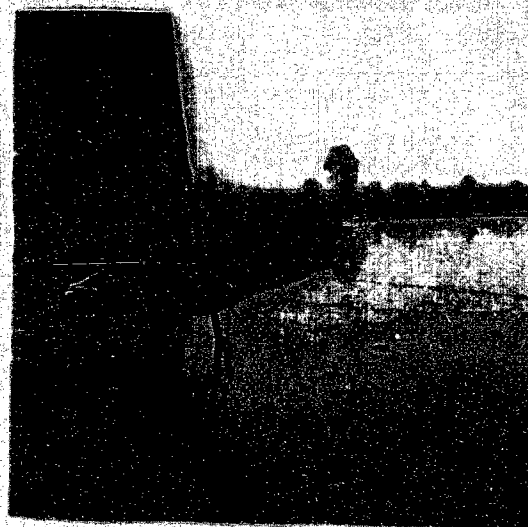
View looking East showing
erosion of North bank of the river

The piles should be cut off below low water level which has been given as El 86 feet. The river banks and bed adjacent to the piers and abutments should be protected with a layer of well graded rip rap about 18 inches thick. Alternatively sheet piling can be driven to protect the tops of the piles during periods of high scour activity in the river.

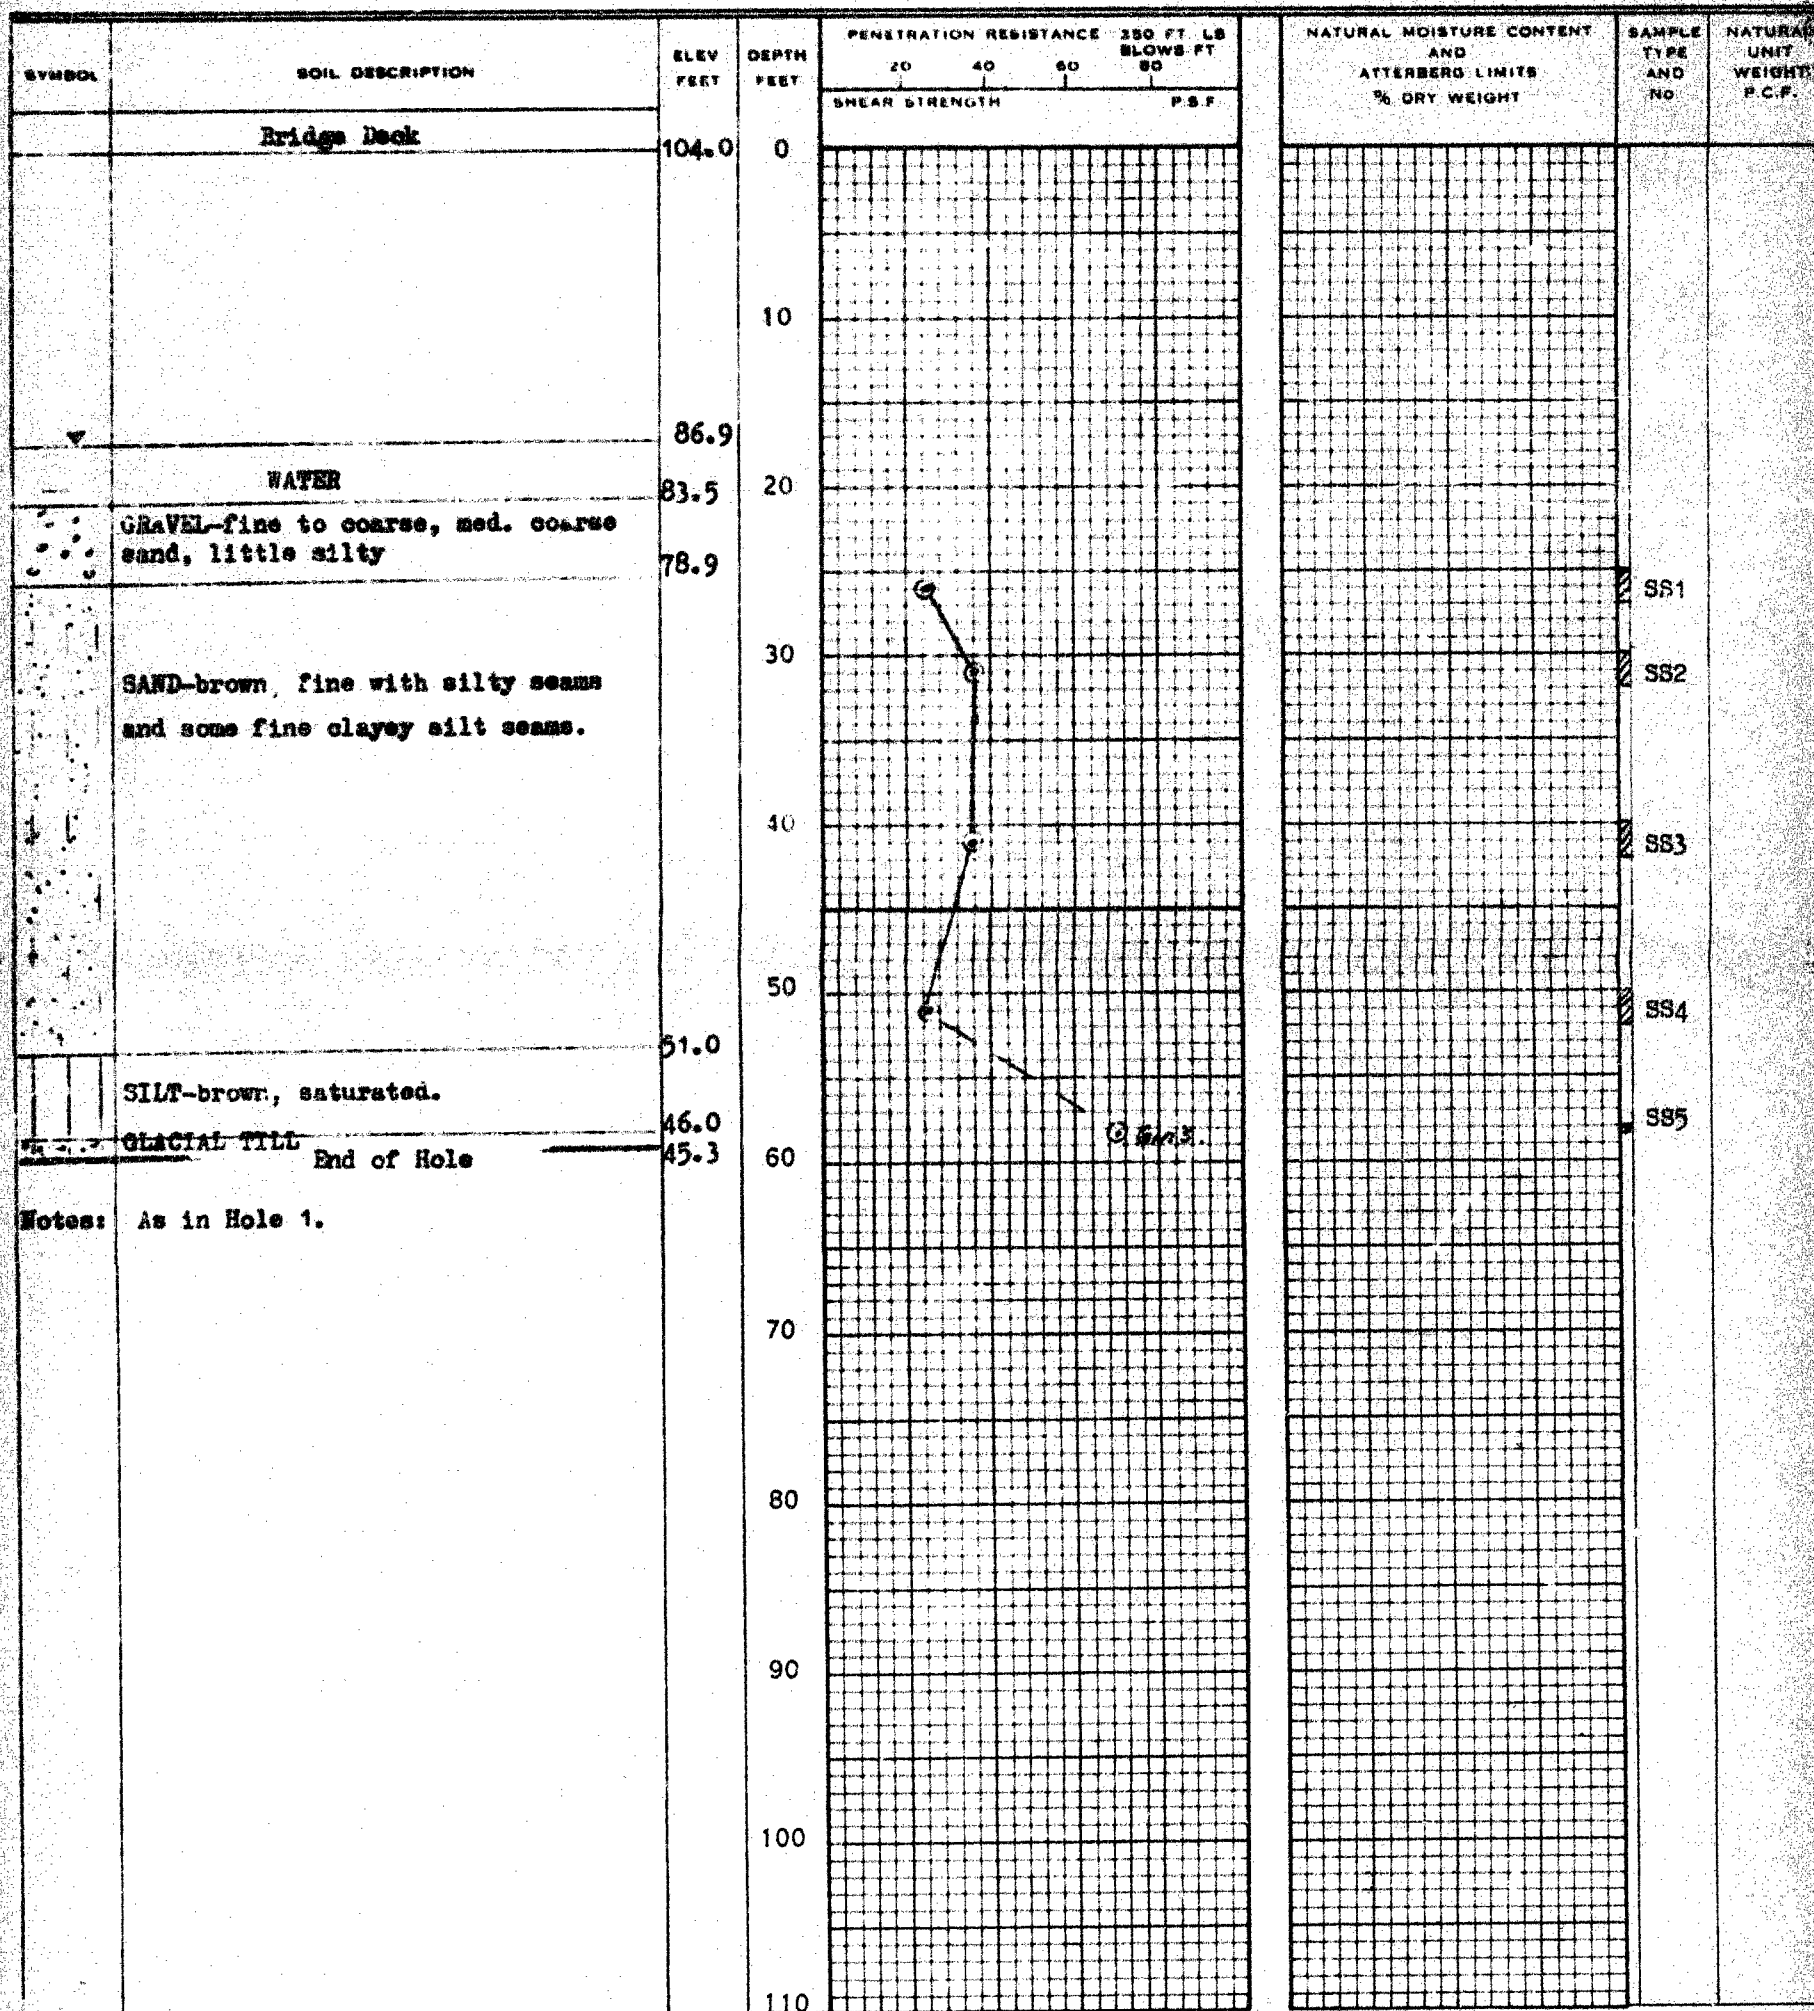
BORERHOLE NO. 3
 PROJECT Dargel Bridge, Twp. of Blenheim
 LOCATION East of Drumbo, Ont.
 HOLE LOCATION See Dwg. 1.
 HOLE ELEVATION 104 ft.
 DATUM See Dwg. 1.

Hole No. 3 was performed from the bridge deck. The elevations of all holes were referred to the bench mark established on the four foot stump located at the south end of the bridge.

In order to provide protection against scour, the abutment footings should be taken at least to the maximum indicated depth of river erosion which, from the results of hole 3, appears to be about 8 feet below the present river surface. The fine sand at this depth is sufficiently dense to support a net bearing pressure of 4000 psf safely. However, excavation work to this level will involve the usual dewatering problems encountered when digging well below the water table in fine sand.
