**FOUNDATION INVESTIGATION REPORT
REPLACEMENT OF STRUCTURAL CULVERT No. 38S-480
HIGHWAY 639, 12.5 KM NORTH OF HIGHWAY 108 JUNCTION
CHRISTIAN CREEK CROSSING STATION 12+330
DISTRICT OF ALGOMA
W.P. 5264-10-01
5013-E-0041**

GEOCRES NUMBER: 41J-97

**SUBMITTED TO
MMM GROUP LIMITED**

**January 2016
19-5161-233**

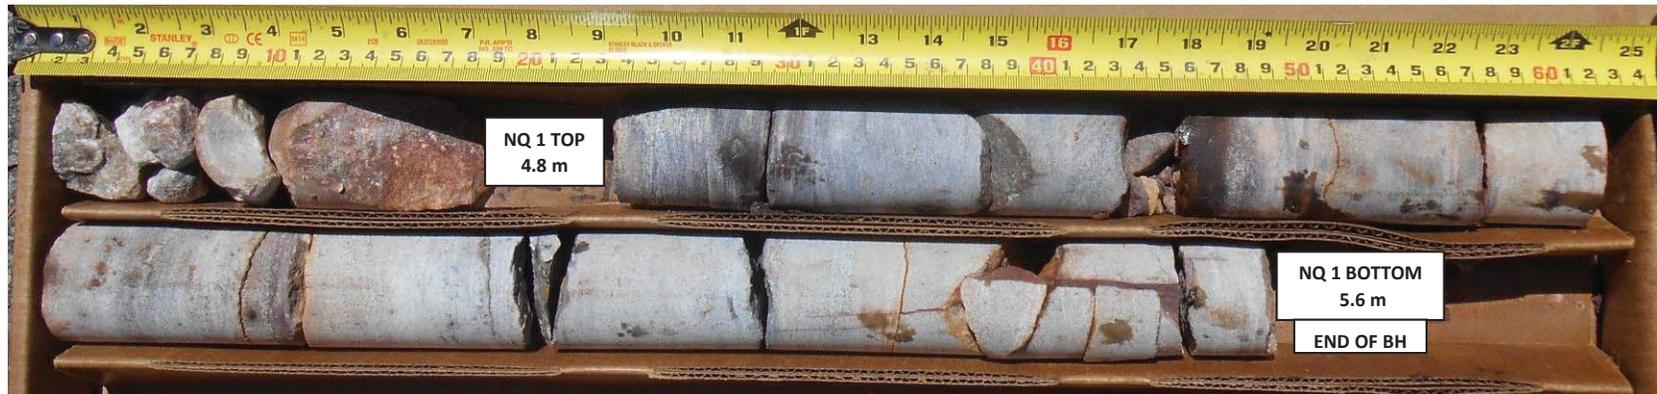
BH 15-1
Cored Length of 4.8 to 5.6 metres
Core Box 1 (of 1)

Granitic bedrock was encountered beneath the rockfill in both the embankment boreholes; as identified by visual inspection of NQ coring. Borehole 15-3 was terminated at refusal on inferred bedrock. Bedrock was exposed in Borehole 15-4. The bedrock surface ranged in elevation from 356.0 m to 356.4 m. Bedrock total core recovery was 100% in both cored boreholes, solid core recovery ranged from 85% to 87% and the RQD values ranged from 40% to 82%. Based on the RQD values the rock mass quality ranges from poor to good. The bedrock fractures had a flat orientation. The fracture index was 1 fracture per 0.3 m. A photograph of the bedrock cores is provided in Appendix B.

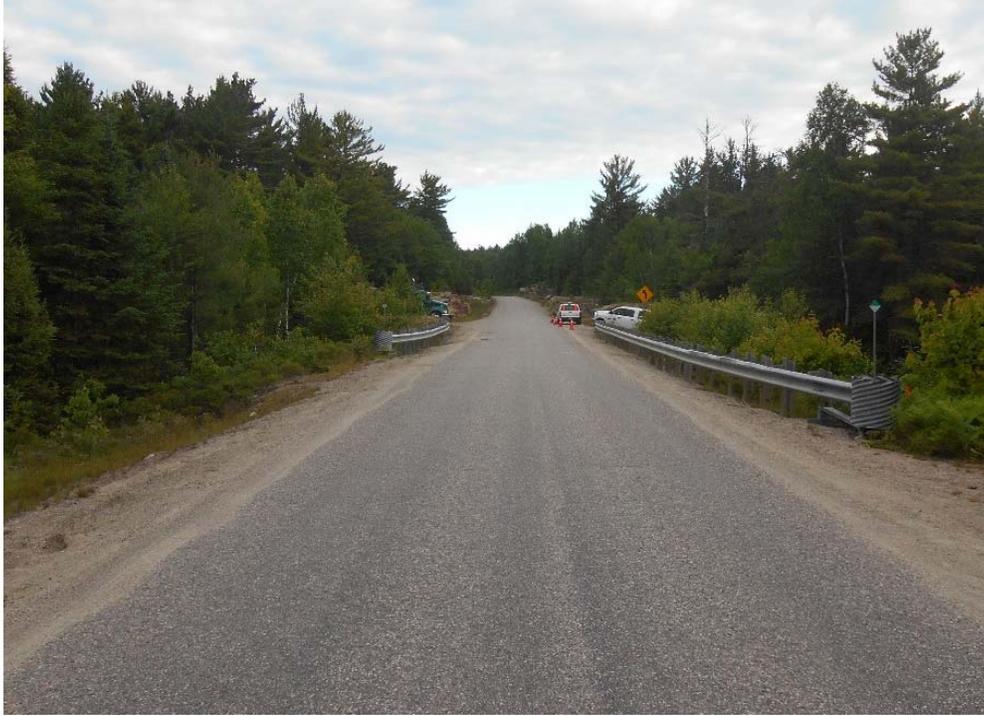
Figure 1: Roadway Platform at Culvert 38S-480 Looking North

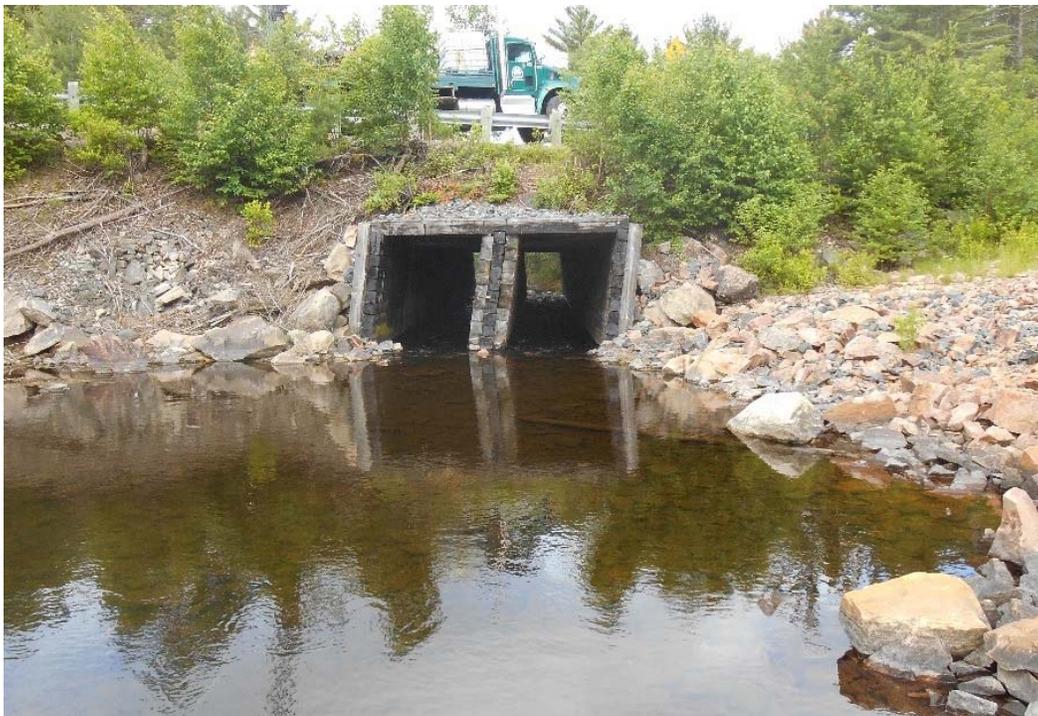
Figure 2: Culvert 38S-480 inlet looking west

The Design Report also indicates that the existing culvert is a twin cell, timber box culvert that was constructed in 1981. The total length of structure is reported to be 27 m. Each cell is noted as being constructed with a span of 1.8 m and an interior height of 2.1 m. The height of the fill over the culvert was reported to be approximately 1.5 m. A structure inspection was conducted by MTO in May 2012, for Culvert 38S-480 with the report issued March 2014. The report recommended the structure to be replaced within 1 to 5 years of the inspection.

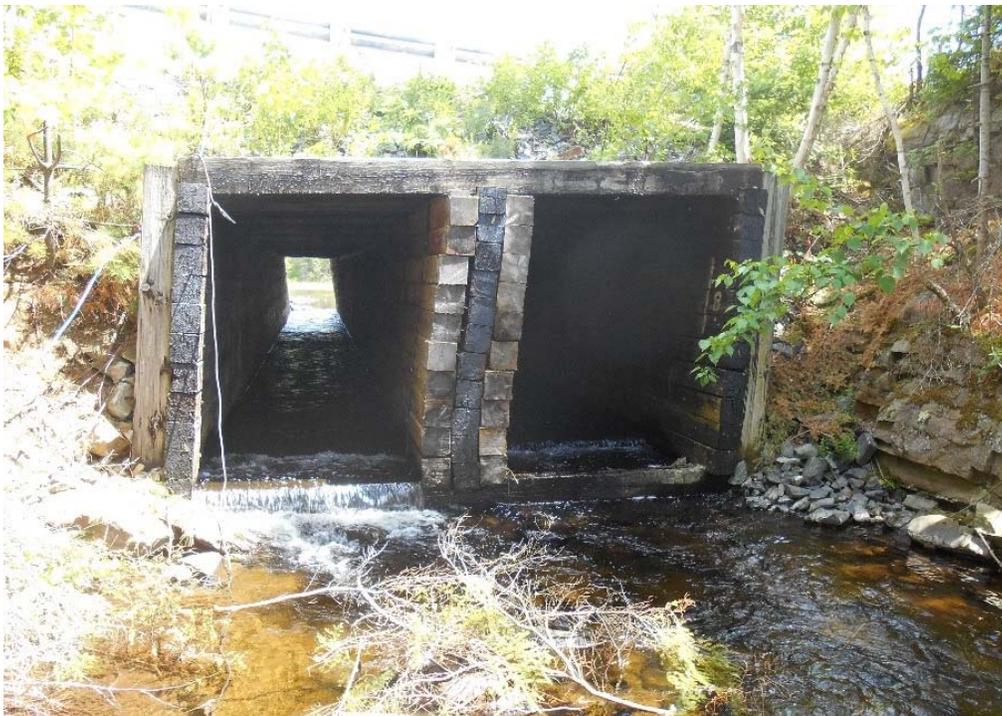
Figure 4: Culvert 38S-480 outlet looking east
