**FINAL
FOUNDATION INVESTIGATION AND DESIGN REPORT
TEMPORARY DETOUR BRIDGE
SIDEBURNED LAKE BRIDGE HIGHWAY 101
AGREEMENT NO.: 5015-E-0027**

G.W.P. 5144-10-00

Geocres No.: 41O-27

October 2018
Thurber File No.: 13624

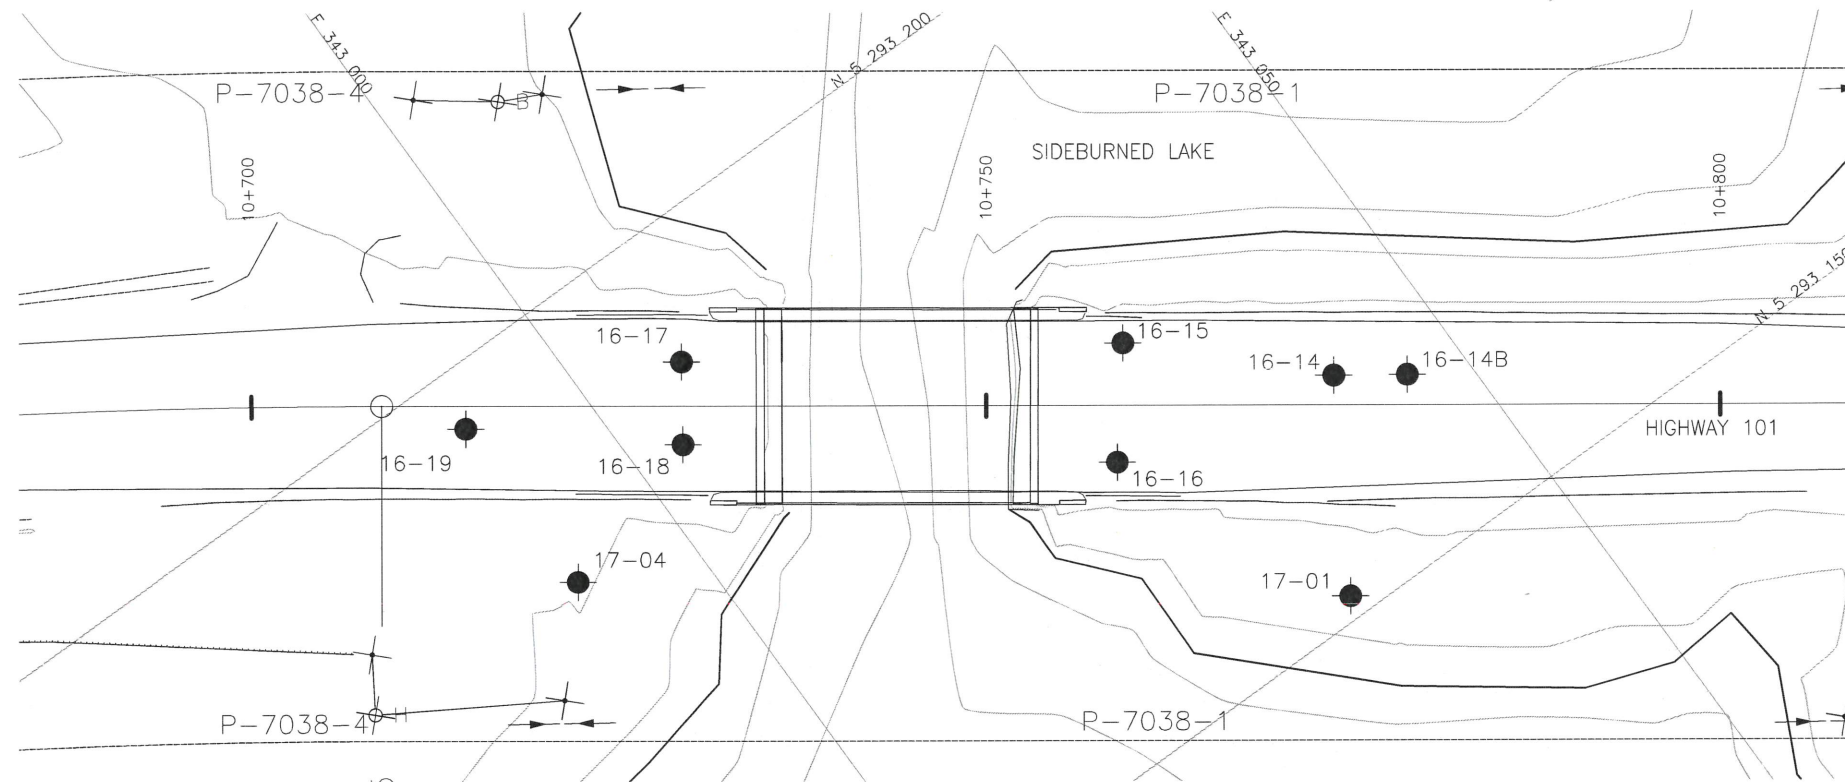
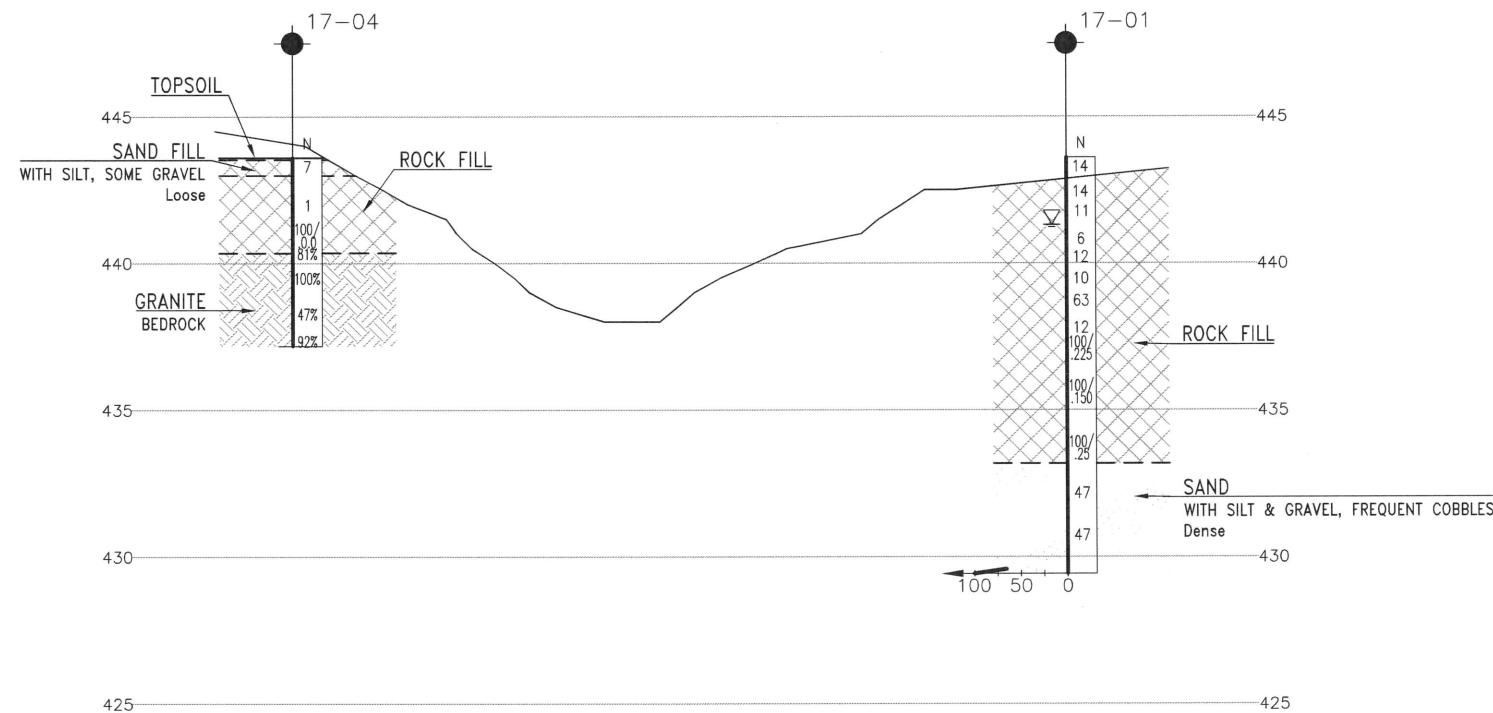
HIGHWAY 101
SIDEburned LAKE
TEMPORARY BRIDGE
BOREHOLE LOCATIONS AND SOIL STRATA

PLAN
SCALE 1:500

PROFILE
H 1:500
V 1:250

The approximate borehole locations are shown on the Borehole Locations and Soil Strata Drawing included in Appendix A. The coordinates and elevation of the boreholes are provided on this drawing and on the individual Record of Borehole sheets.

Details of the encountered soil stratigraphy are presented on the Record of Borehole sheets included in Appendix B and the Borehole Locations and Soil Strata drawing included in Appendix A. A general description of the stratigraphy, based on the conditions encountered in the boreholes, is given in the following paragraphs. However, the factual data presented on the Record of Borehole sheets takes precedence over this general description for interpretation of the site conditions. It must be recognized that the soil and groundwater conditions may vary between and beyond borehole locations.

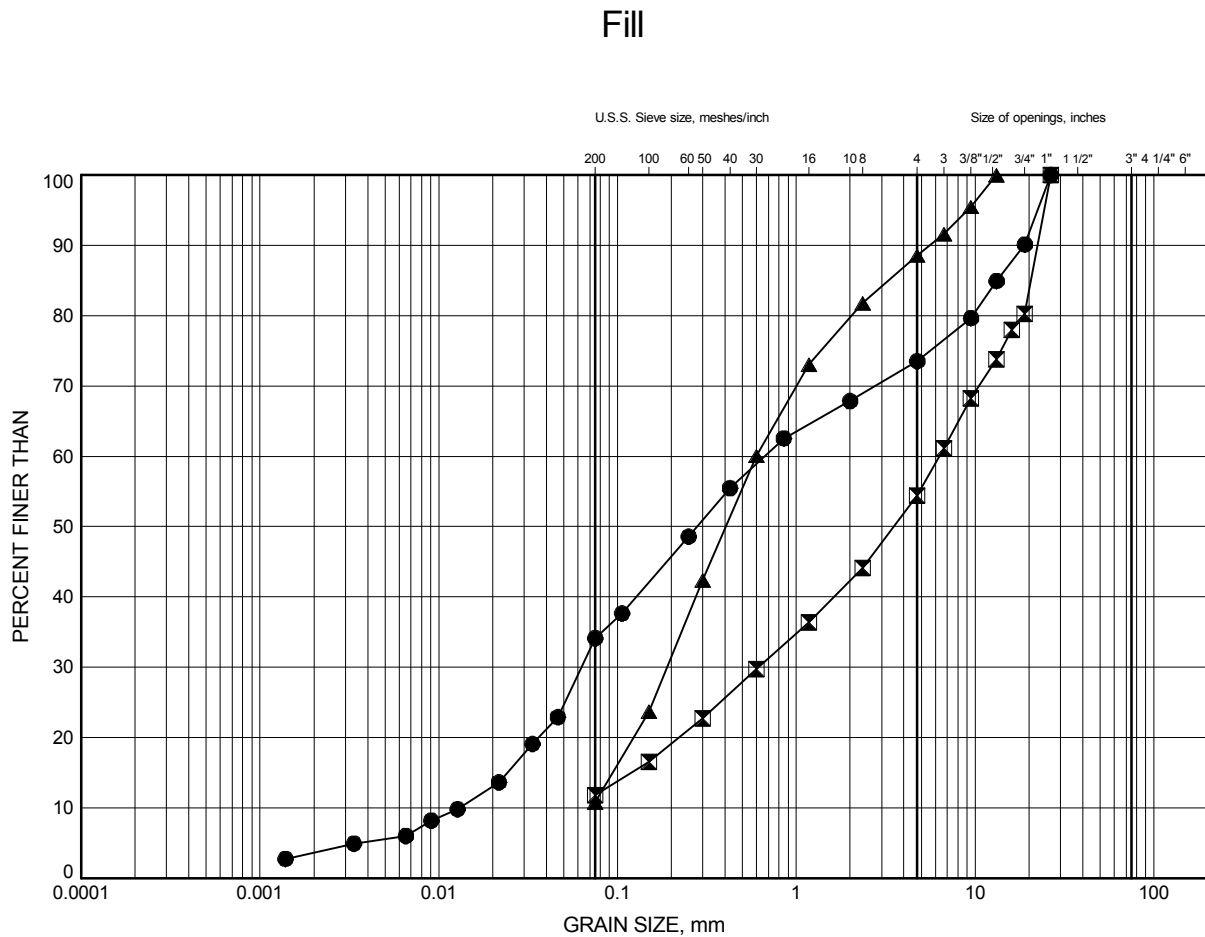
FIGURE C1

GRAIN SIZE DISTRIBUTION

Gradation analysis was completed on one sample of the sand fill. The grain size distribution curve is included in Figure C1 of Appendix C. The results of the test are summarized below and are presented on the corresponding Record of Borehole sheet in Appendix B.

Gradation analyses were completed on two samples of the infill material. The grain size distribution curves are included in Figure C1 of Appendix C. The results of the tests are summarized below and are presented on the corresponding Record of Borehole sheets in Appendix B.

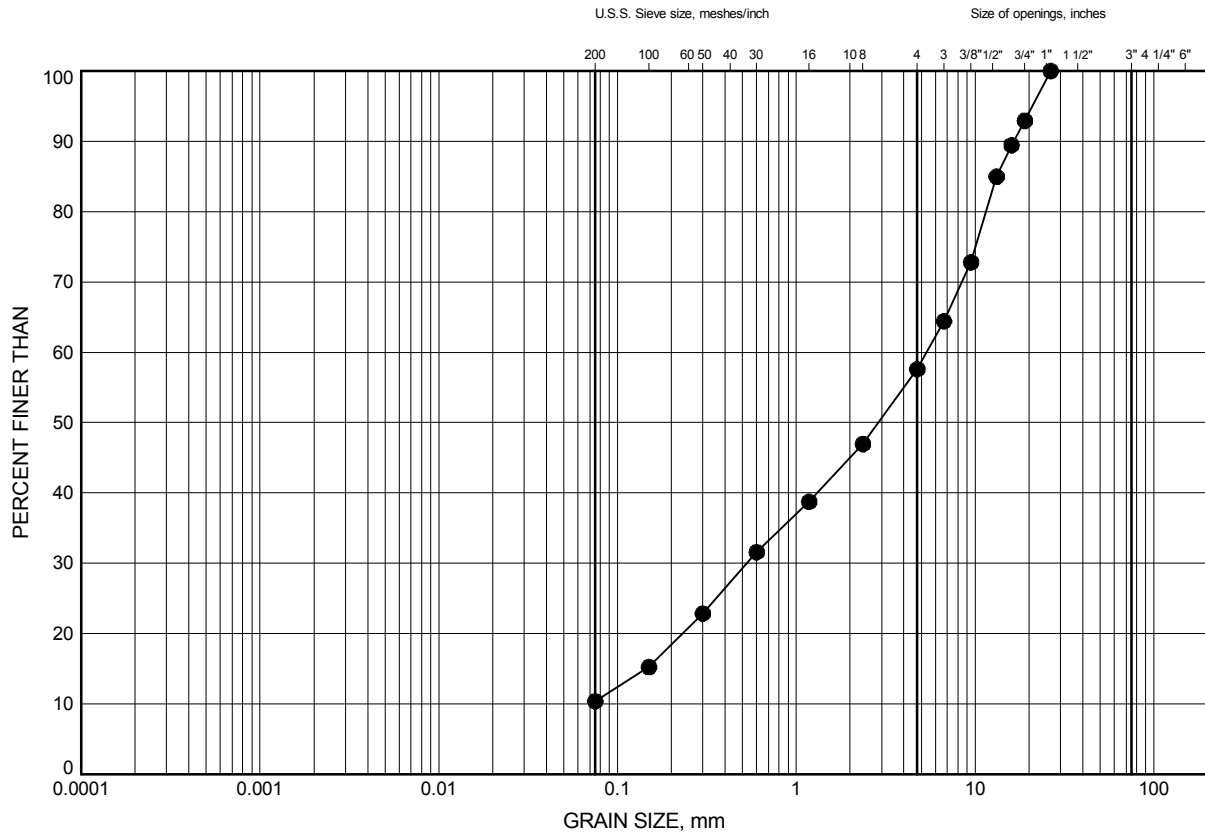
FIGURE C2

Sand with Silt and Gravel

Gradation analysis was completed on one sample of the sand. The grain size distribution curve is included in Figure C2 of Appendix C. The results of the test are summarized below and are presented on the corresponding Record of Borehole sheet in Appendix B and indicate a SP-SM material.

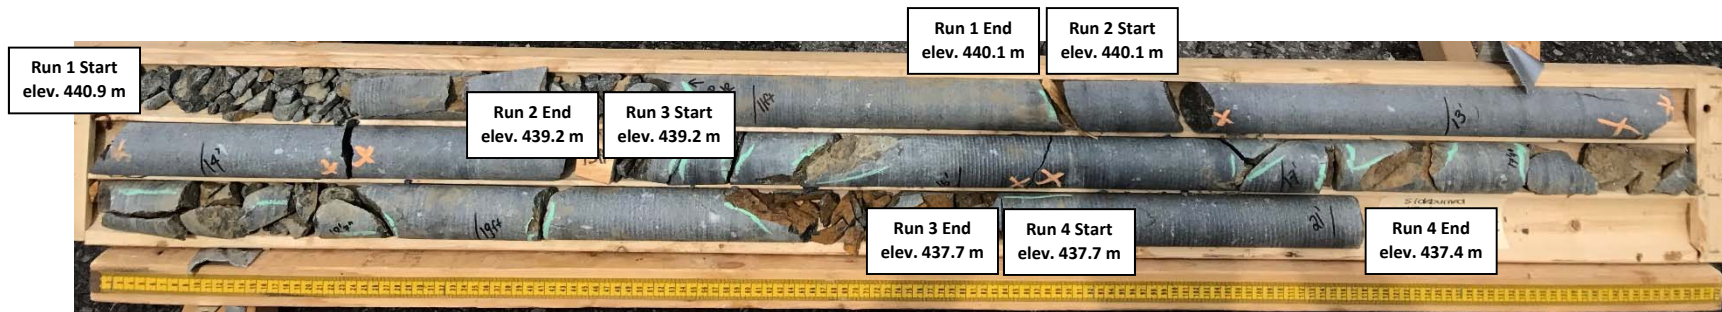
Appendix C.2
Rock Core Photographs

Borehole 17-4
Run 1 to 4 (of 4)
Elevation 440.9 m to 437.4 m

Bedrock was encountered below the overburden soils. Bedrock was proven with coring in Borehole 17-4 and was inferred at DCPT refusal in Borehole 17-1. The proven and inferred bedrock surface ranged from elevation 440.5 to 429.4 m. The Total Core Recovery (TCR) was 100%, the Solid Core Recovery (SCR) ranged from 47 to 100% and the Rock Quality Designation (RQD) ranged from 47 to 100% indicating a poor to excellent rock quality. Photographs of the recovered rock core are provided in Appendix C.

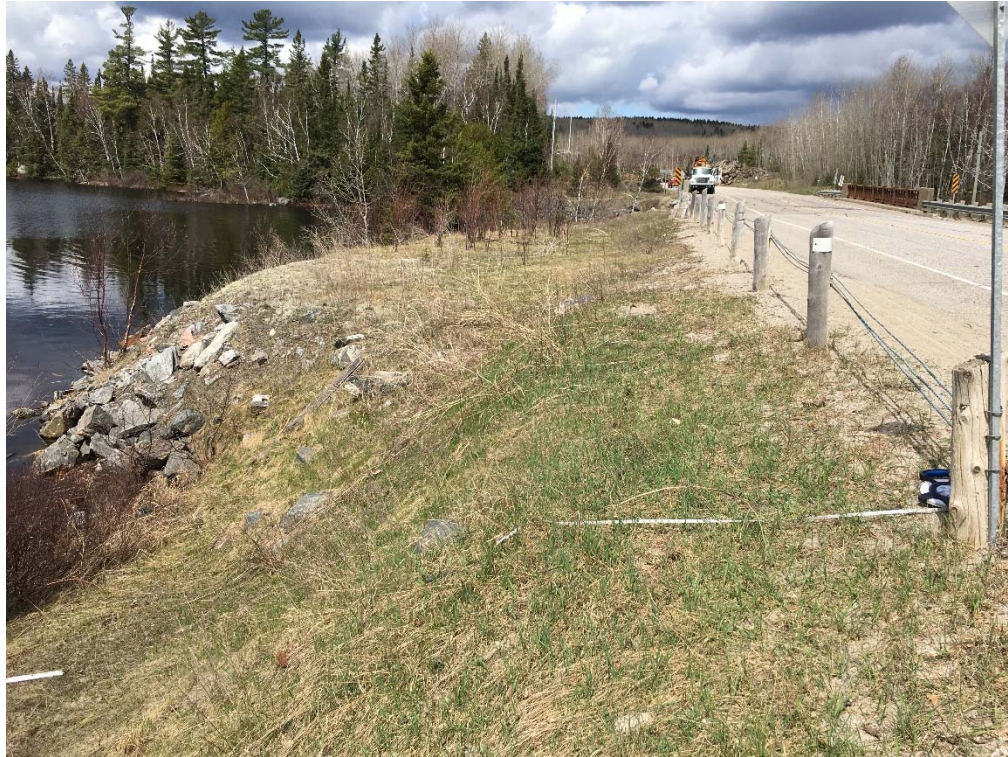
Photo 1. South side of highway looking west [taken June 2017].

Photographs showing the existing conditions in the area of the temporary detour bridge are included in Appendix D for reference.

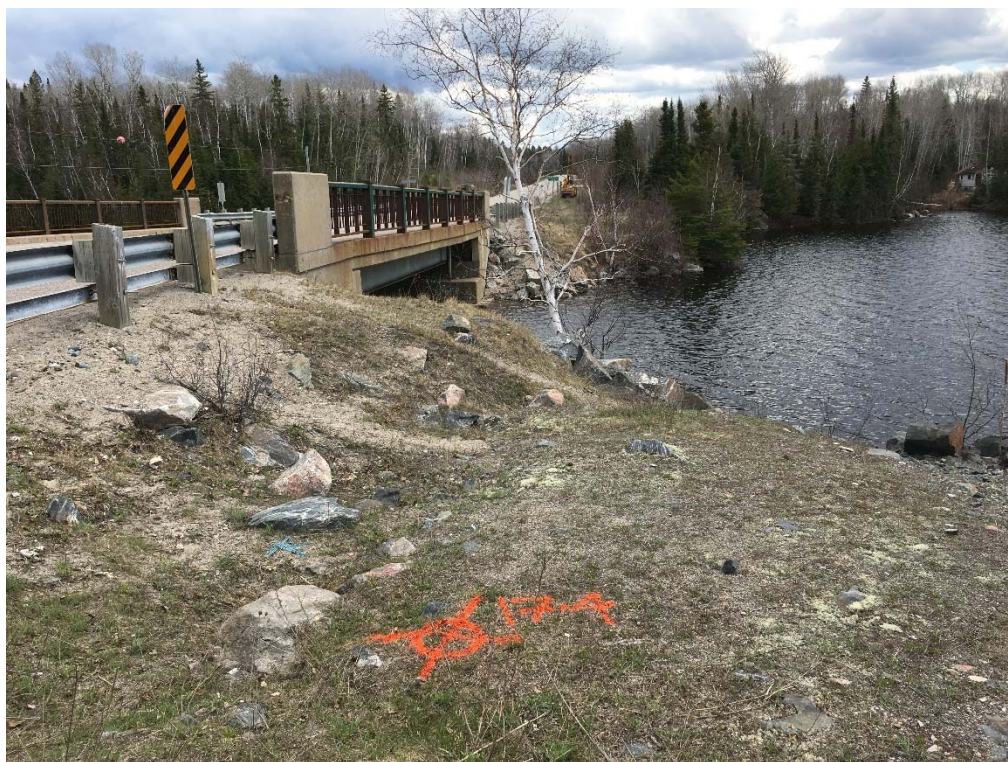
Photo 2. South side of highway looking east [taken June 2017].
