**FINAL  
FOUNDATION INVESTIGATION AND DESIGN REPORT  
TEMPORARY DETOUR BRIDGE  
NEMEGOSENDA RIVER BRIDGE HIGHWAY 101  
AGREEMENT NO.: 5015-E-0027**

**G.W.P. 5144-10-00**

**Geocres No.: 41O-30**

October 2018  
Thurber File No.: 13624

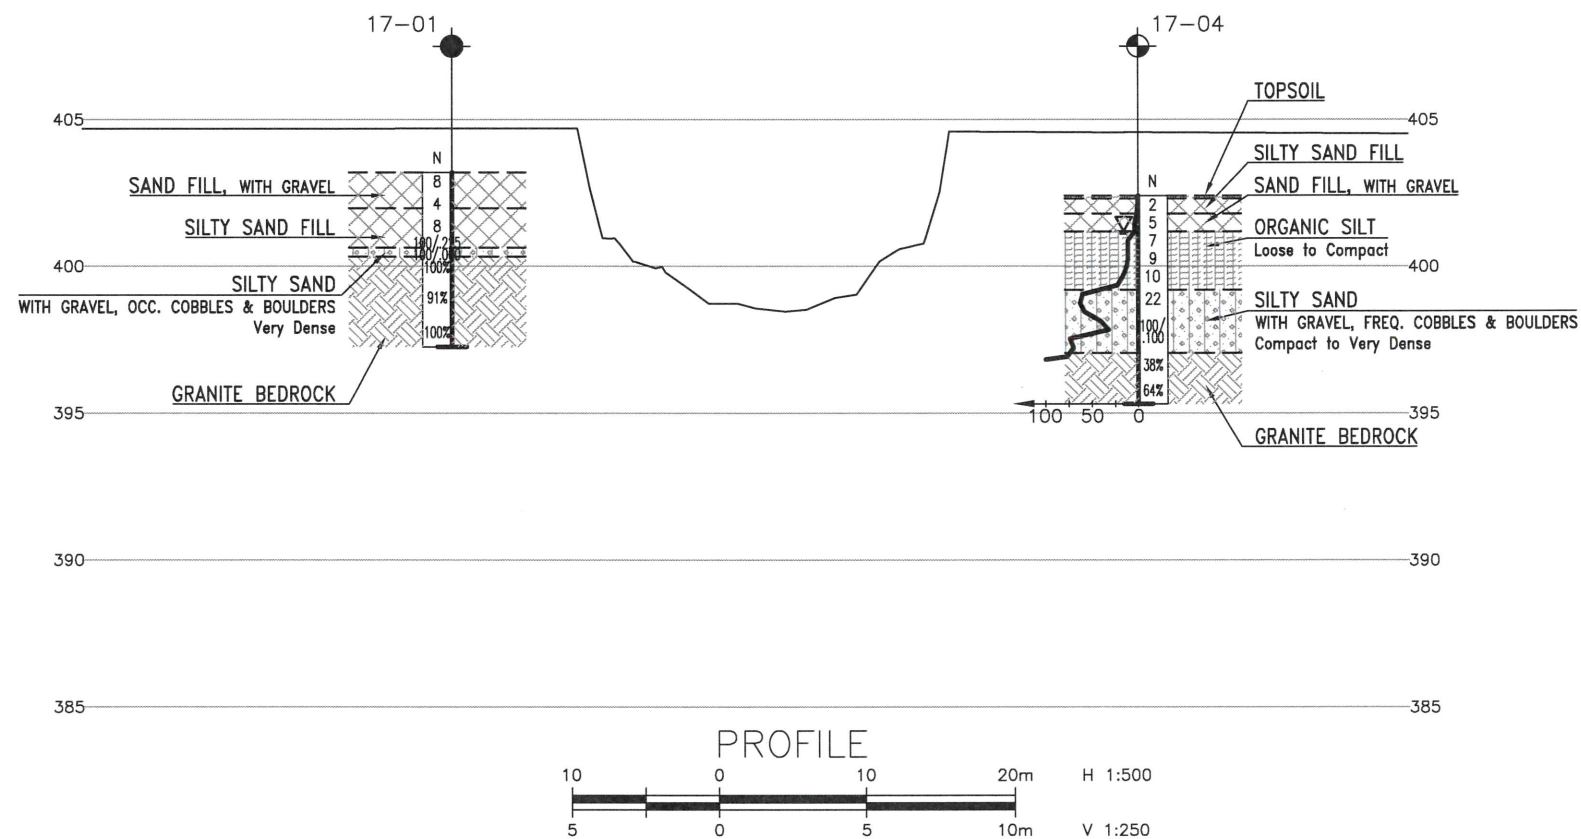
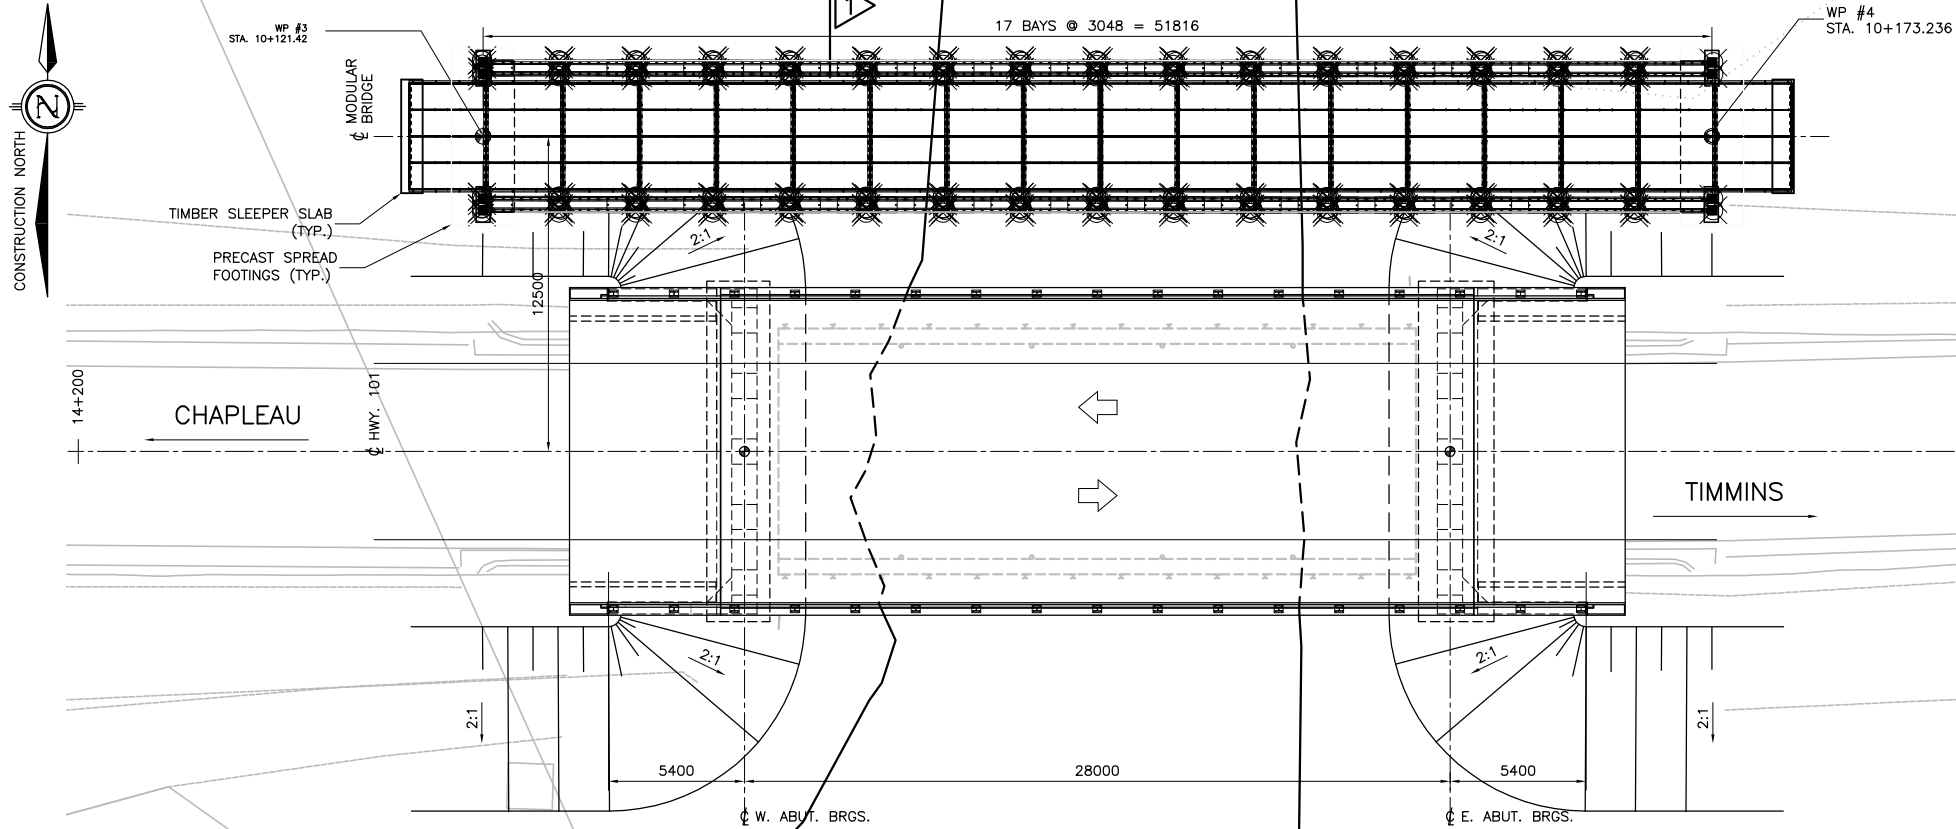
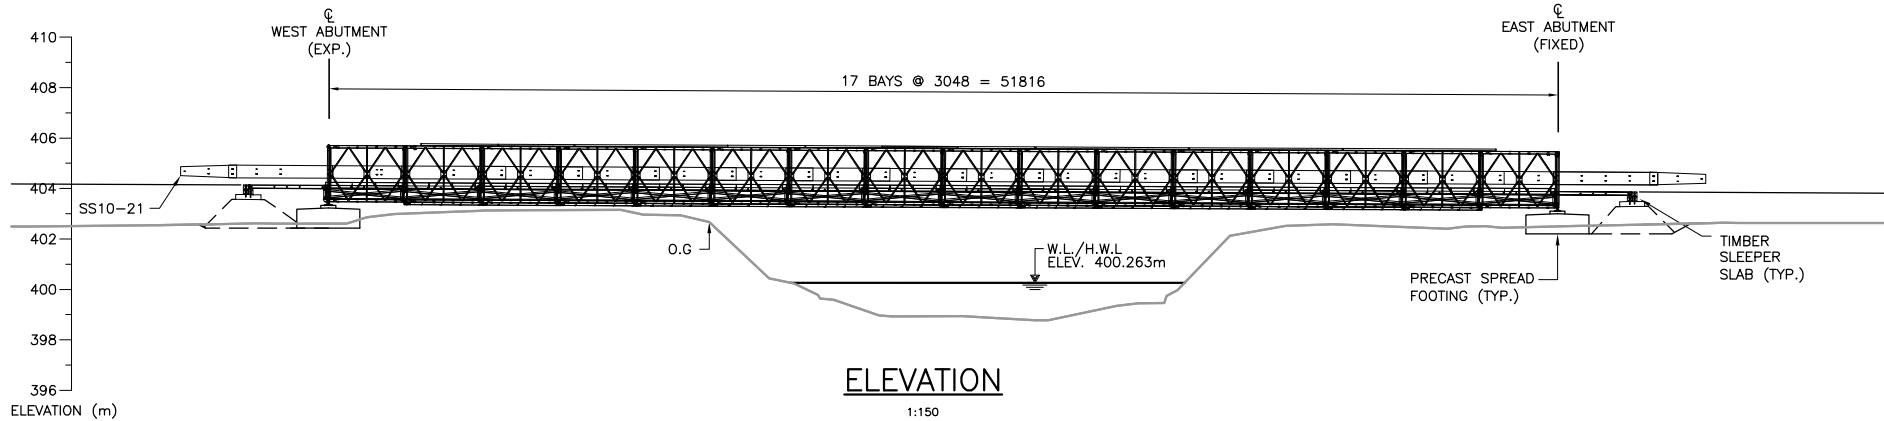
HIGHWAY 101  
NEMEGOSENDA RIVER  
TEMPORARY BRIDGE  
BOREHOLE LOCATIONS AND SOIL STRATA

The current field investigation for the detour bridge included advancing two foundation boreholes drilled on May 11, 2017 and May 24, 2017. The northing, easting and elevation of the boreholes are shown on the Borehole Location and Soil Strata Drawing No. 1 in Appendix A and are summarized in Table 3-1.

Reference is made to the Record of Borehole sheets in Appendix B for details of the soil stratigraphy encountered in the boreholes. A stratigraphic profile and cross section for the bridge area are presented on Drawing No. 1 in Appendix A for illustrative purposes. An overall description of the stratigraphy is given in the following paragraphs; however, the factual data presented in the Record of Boreholes governs any interpretation of the site conditions. It must be recognized that the soil and groundwater conditions may vary between and beyond borehole locations.

The boreholes were backfilled with a low-permeability mixture of bentonite pellets and auger cuttings in accordance with Ontario MOE Regulation 903. The coordinates and elevations were surveyed by Thurber following completion of drilling relative to site features and elevation benchmarks provided by MPCE. The coordinates are provided on the Borehole Locations and Stratigraphy Drawing included in Appendix A and on the individual Record of Borehole sheets.

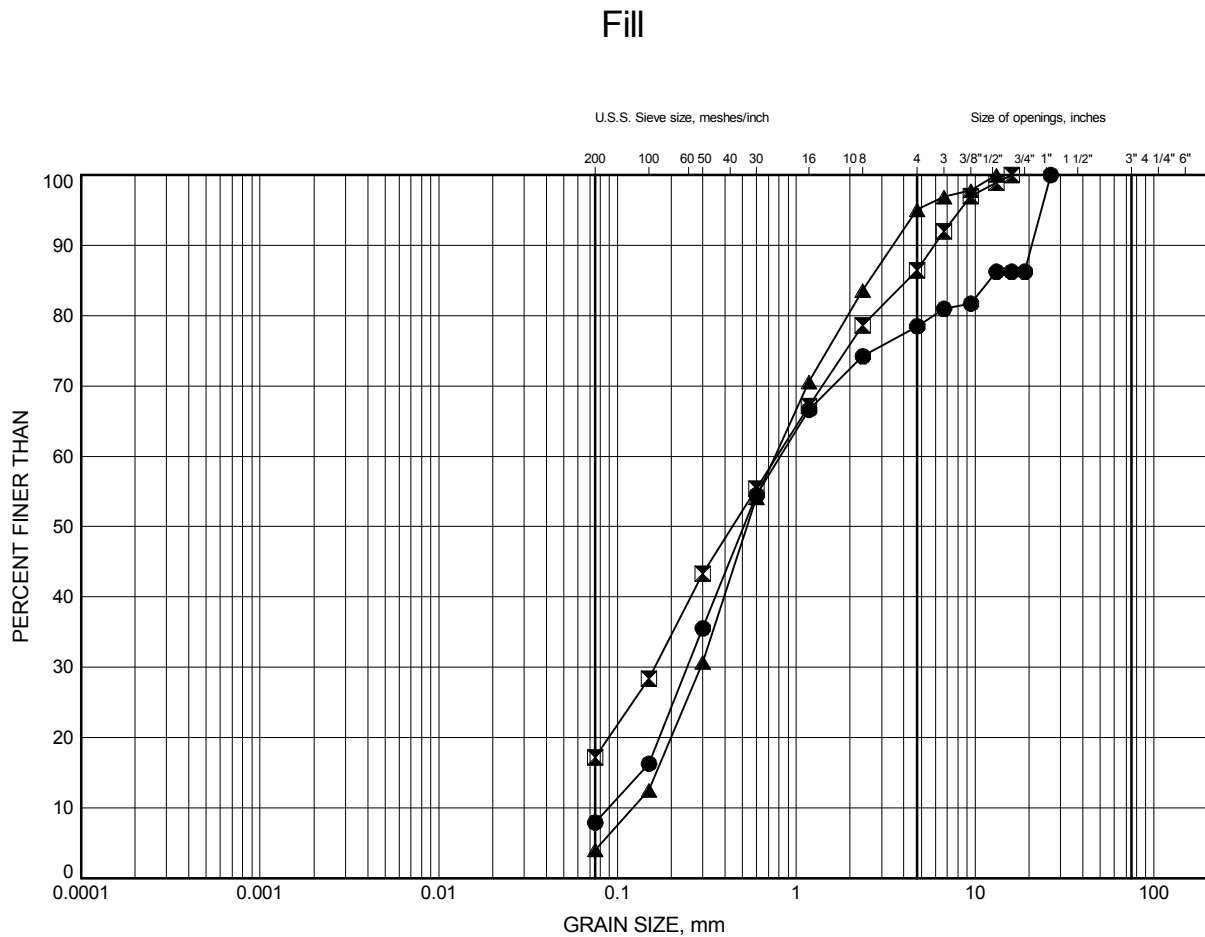
FIGURE C1

The moisture content of the samples tested ranged from 7% to 20%. The results of grain size analyses conducted on three samples of this material are summarized in Table 5-1 and are illustrated on Figure C1 in Appendix C.

Soil Particle	%
Gravel	5 to 22
Sand	69 to 91
Silt and Clay	4 to 17

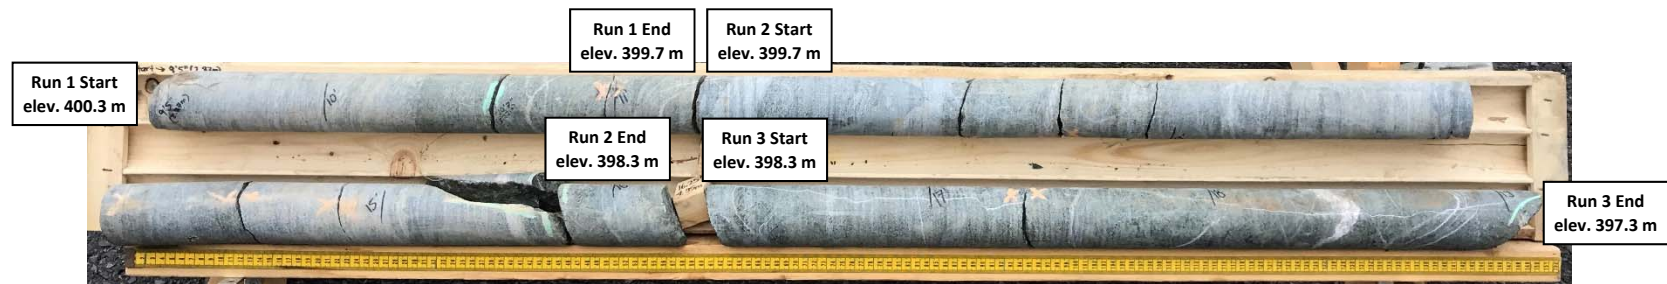
**Borehole 17-1**  
**Run 1 to 3 (of 3)**  
**Elevation 400.3 m to 397.3 m**

The Total Core Recovery (TCR) was 100% within the granite bedrock, the Solid Core Recovery (SCR) ranged from 64 to 100% and the Rock Quality Designation (RQD) ranged from 38 to 100%. Based on the RQD value the bedrock is classified to be of poor to excellent quality. Photographs of the recovered core are provided in Appendix C.

The overburden materials were underlain by granite bedrock. Both Boreholes 17-01 and 17-04 were advanced into the bedrock by coring. The inferred and cored bedrock surface ranges from elevation 396.7 to 400.3 m and is summarized in the table below:

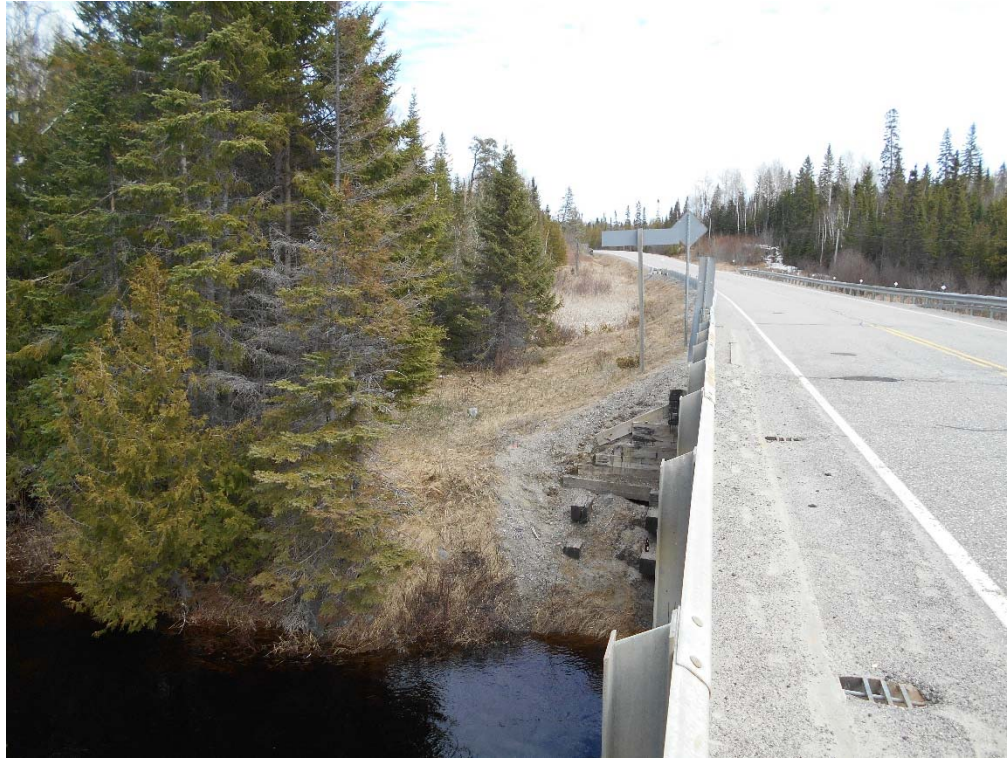
**Photo 1. Looking northeast at north side of the east abutment [taken May 2017].**

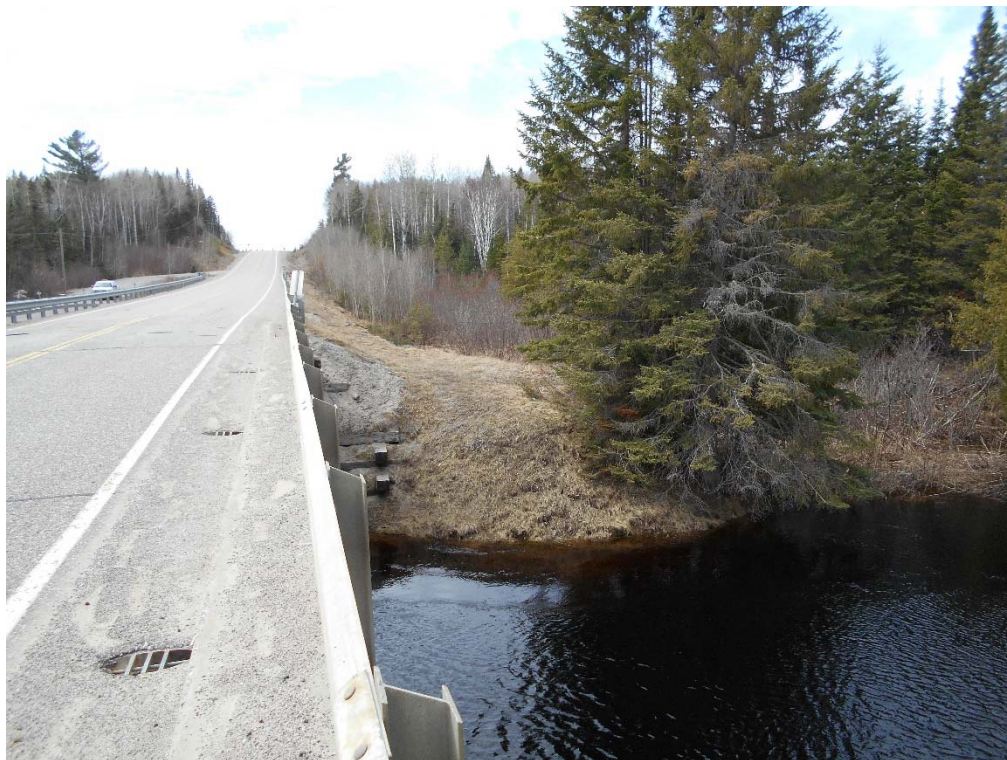
**Photo 2. Looking northwest at north side of the west abutment [taken  
\_May 2017].**
