**FINAL  
FOUNDATION INVESTIGATION REPORT  
TEMPORARY DETOUR BRIDGE  
NEMEGOSENDA RIVER BRIDGE HIGHWAY 101  
AGREEMENT NO.: 5015-E-0027**

**G.W.P. 5144-10-00**

**Geocres No.: 41O-30**

October 2018  
Thurber File No.: 13624

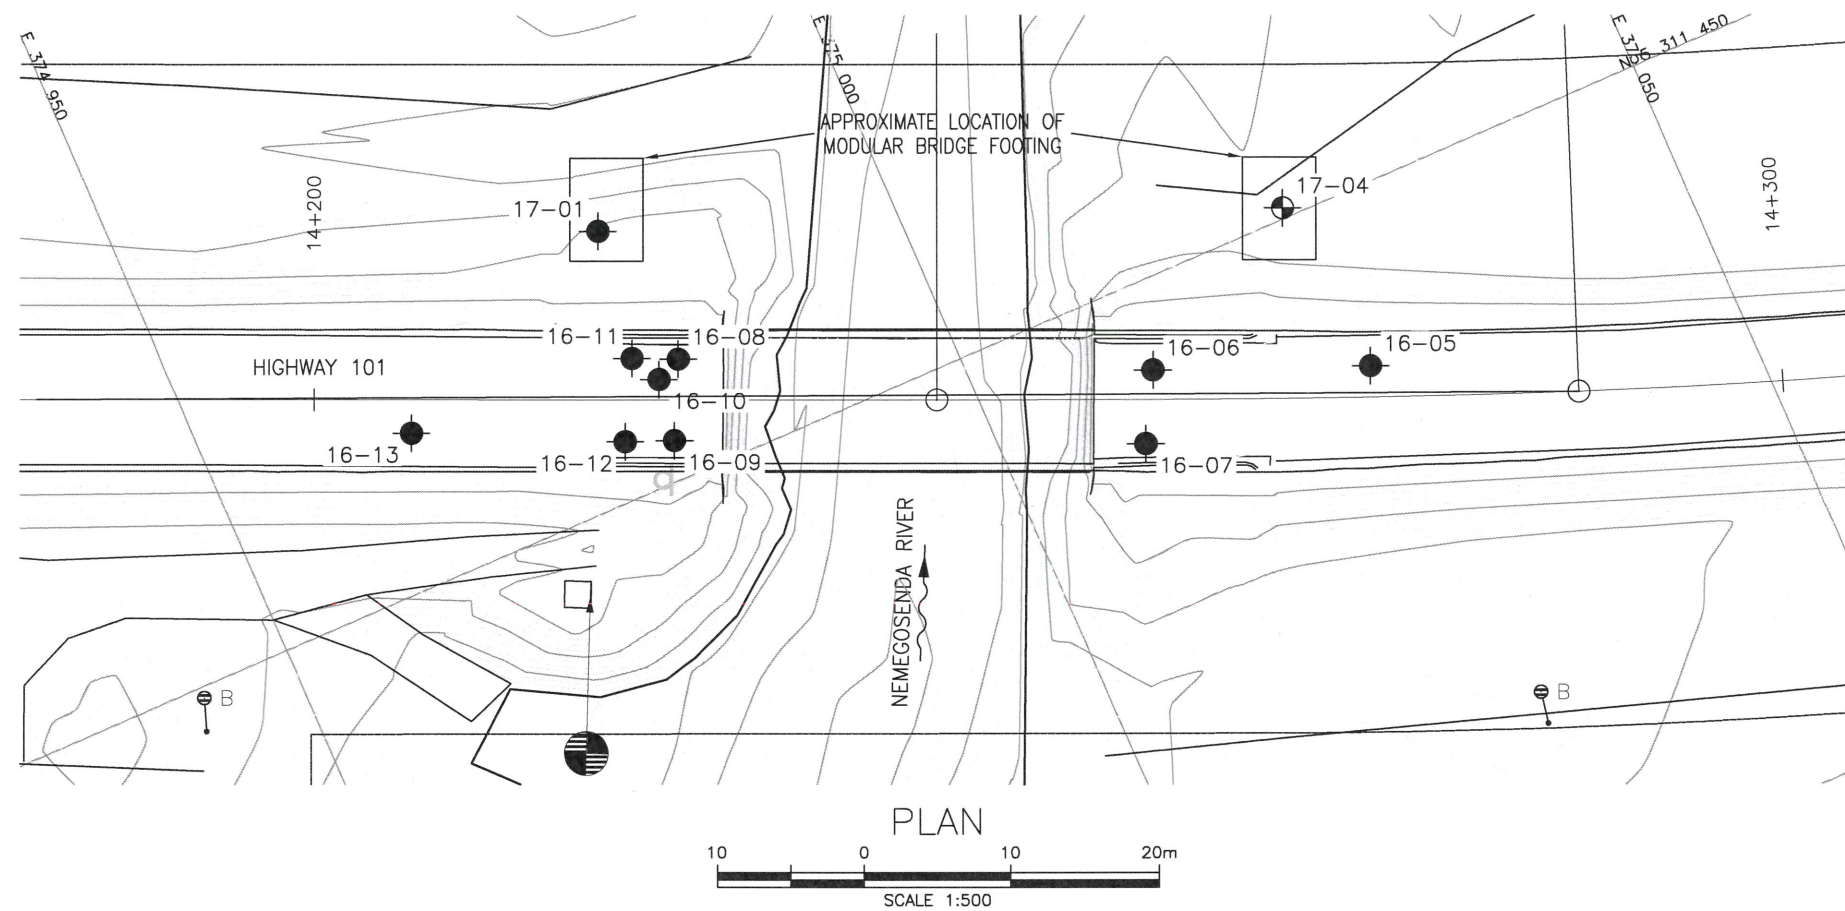
HIGHWAY 101  
NEMEGOSENDA RIVER  
TEMPORARY BRIDGE  
BOREHOLE LOCATIONS AND SOIL STRATA

The current field investigation for the detour bridge included advancing two foundation boreholes drilled on May 11, 2017 and May 24, 2017. The northing, easting and elevation of the boreholes are shown on the Borehole Location and Soil Strata Drawing No. 1 in Appendix A and are summarized in Table 3-1.

Reference is made to the Record of Borehole sheets in Appendix B for details of the soil stratigraphy encountered in the boreholes. A stratigraphic profile and cross section for the bridge area are presented on Drawing No. 1 in Appendix A for illustrative purposes. An overall description of the stratigraphy is given in the following paragraphs; however, the factual data presented in the Record of Boreholes governs any interpretation of the site conditions. It must be recognized that the soil and groundwater conditions may vary between and beyond borehole locations.

The stratigraphy in the boreholes along the alignment of the proposed temporary bridge structure is generally characterized by a sand fill overlying native organic silt, underlain by silty sand with gravel overlying bedrock.

The existing Nemegosenda River structure is located on Highway 101 within the township of Chewett (Linear Highway Referencing System Base Points: 40420, Offset: 0.0). The location of the bridge is shown on the inset Key Plan on Drawing No. 1 in Appendix A. At the bridge site, Highway 101 is a two-lane, undivided highway with a rural cross-section. Steel guide rails are present on both sides of the highway for a short distance from the bridge.

The boreholes were backfilled with a low-permeability mixture of bentonite pellets and auger cuttings in accordance with Ontario MOE Regulation 903. The coordinates and elevations were surveyed by Thurber following completion of drilling relative to site features and elevation benchmarks provided by MPCE. The coordinates are provided on the Borehole Locations and Stratigraphy Drawing included in Appendix A and on the individual Record of Borehole sheets.

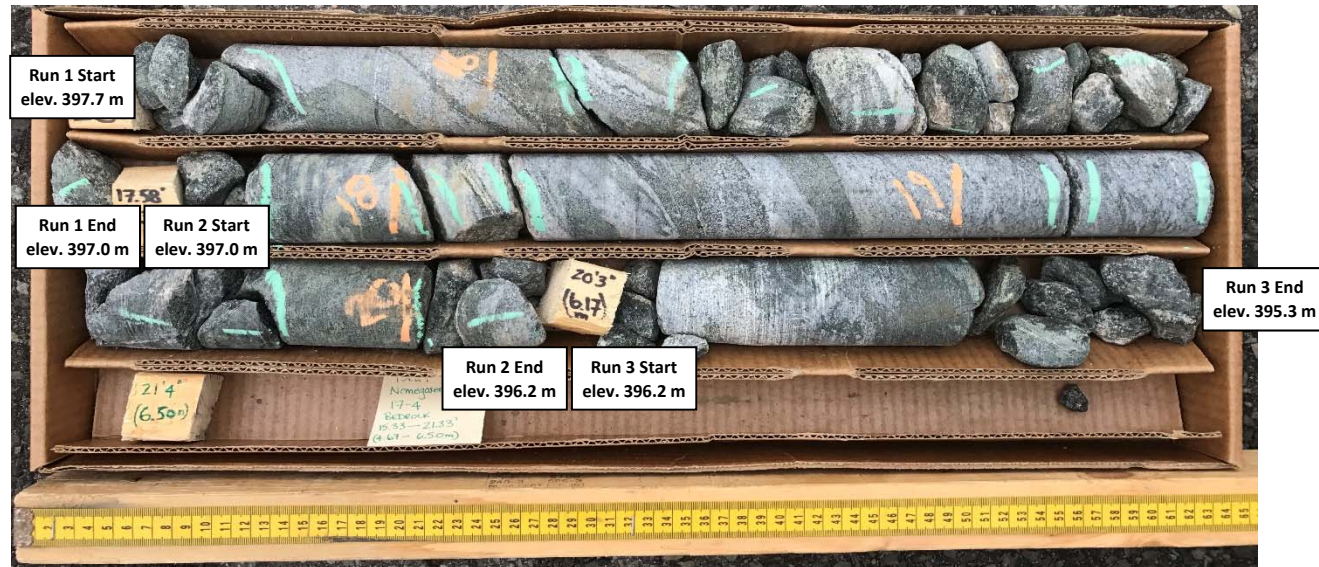
**Borehole 17-4**  
**Run 1 to 3 (of 3)**  
**Elevation 397.7 m to 395.3 m**

The Total Core Recovery (TCR) was 100% within the granite bedrock, the Solid Core Recovery (SCR) ranged from 64 to 100% and the Rock Quality Designation (RQD) ranged from 38 to 100%. Based on the RQD value the bedrock is classified to be of poor to excellent quality. Photographs of the recovered core are provided in Appendix C.

397.0													
5.4	GRANITE BEDROCK		2	RUN									RUN #2 TCR=100% SCR=66% RQD=38%
	Grey Medium Grained Fresh												
			3	RUN									RUN #3 TCR=100% SCR=64% RQD=64%
	-Core barrel jammed at 7.1 m, no core recovery in Run 3 below 6.5 m

The overburden materials were underlain by granite bedrock. Both Boreholes 17-01 and 17-04 were advanced into the bedrock by coring. The inferred and cored bedrock surface ranges from elevation 396.7 to 400.3 m and is summarized in the table below:

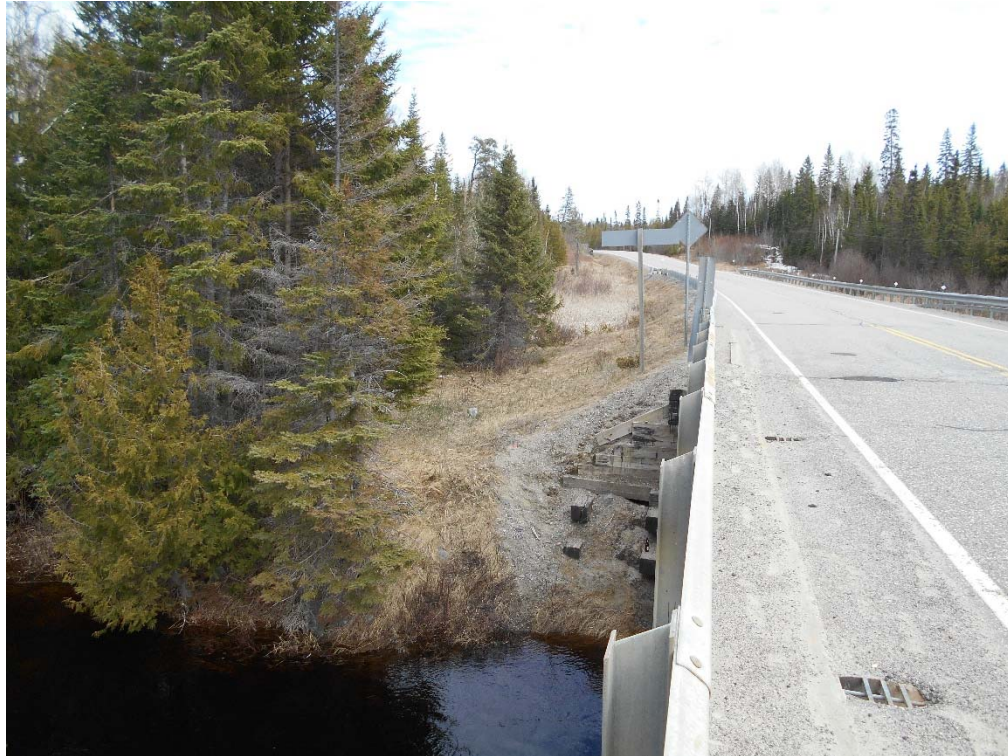
**Photo 1. Looking northeast at north side of the east abutment [taken May 2017].**

Site photographs showing the general conditions in the area of the temporary detour bridge during the time of the field investigation are presented in Appendix D.

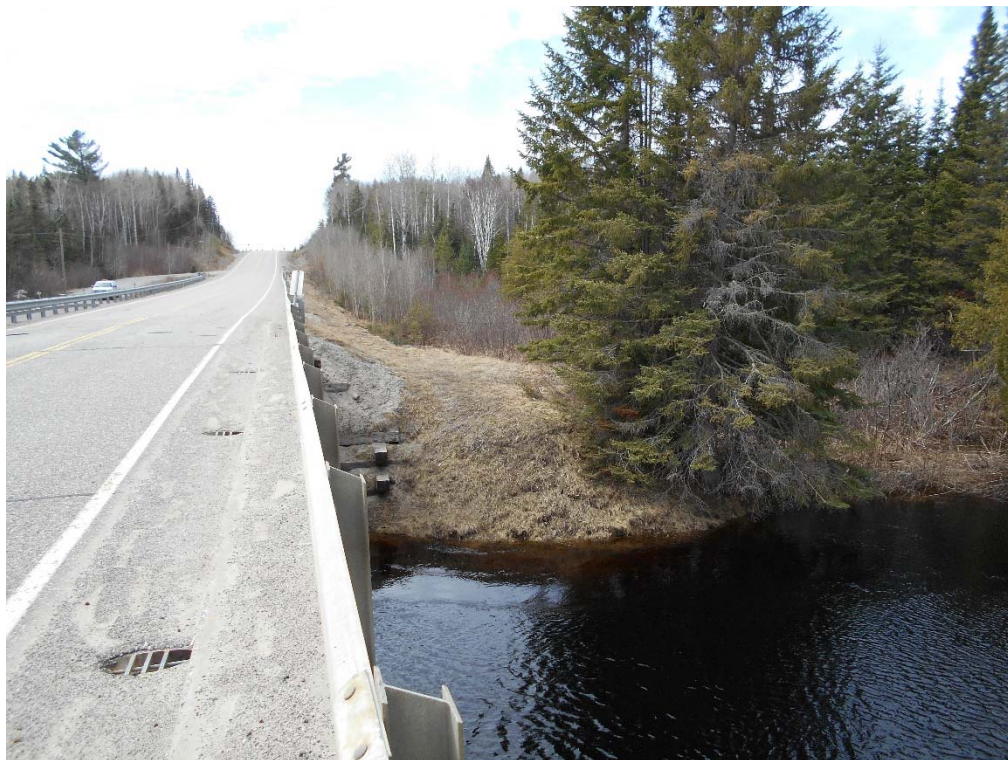
**Photo 2. Looking northwest at north side of the west abutment [taken  
\_May 2017].**
