**FINAL  
FOUNDATION INVESTIGATION REPORT  
REHABILITATION OF BRIDGE STRUCTURE No. 46-236  
NEBSKWASHI RIVER BRIDGE HIGHWAY 129  
CHAPLEAU TOWNSHIP  
G.W.P. 5144-10-00  
AGREEMENT NO.: 5015-E-0027**

**GEOCRES NUMBER: 41O-28**

**October 2018  
THURBER FILE NO.: 13624**

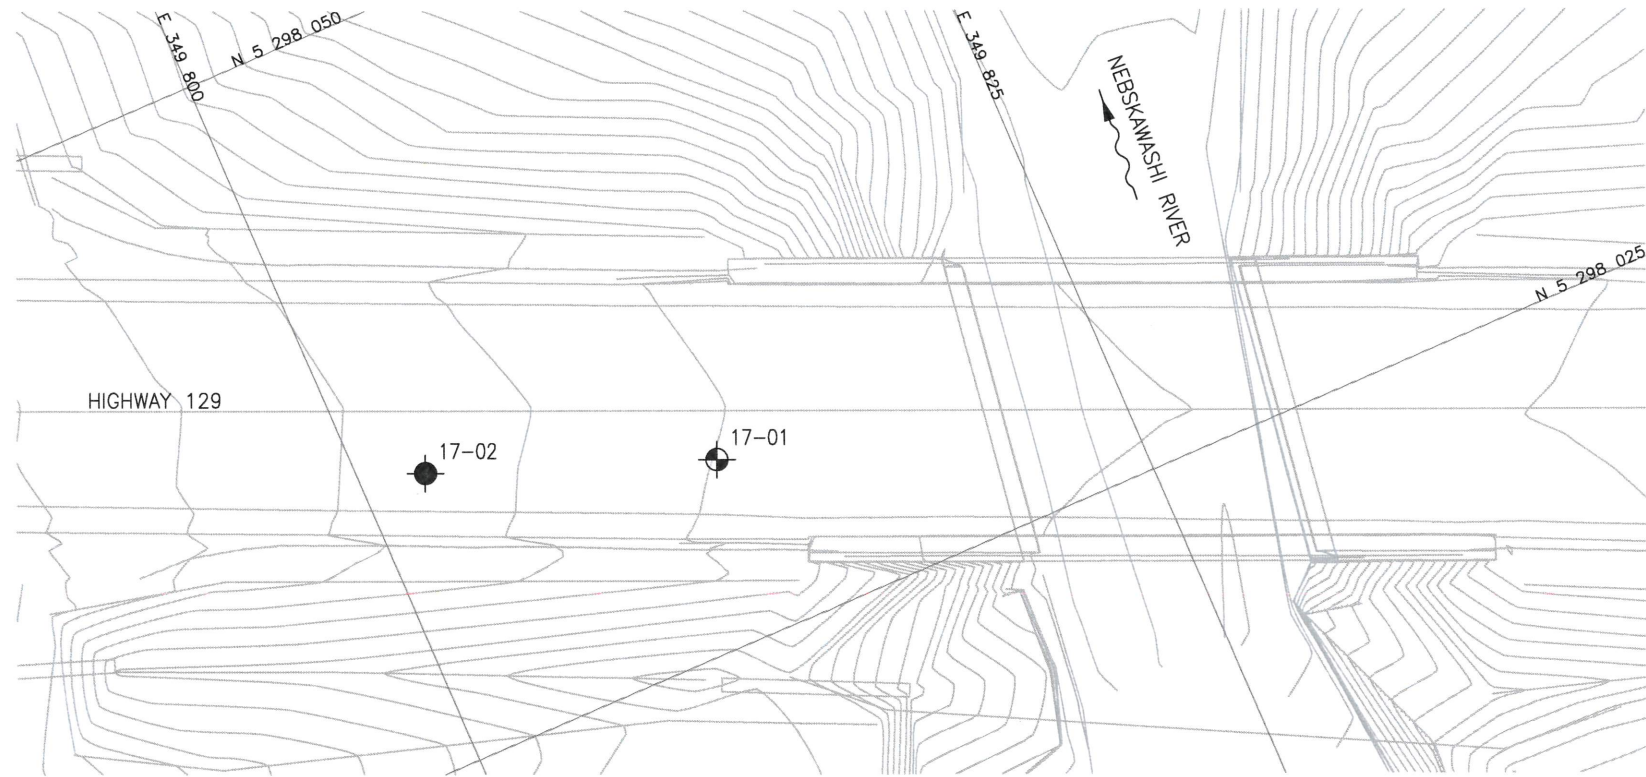
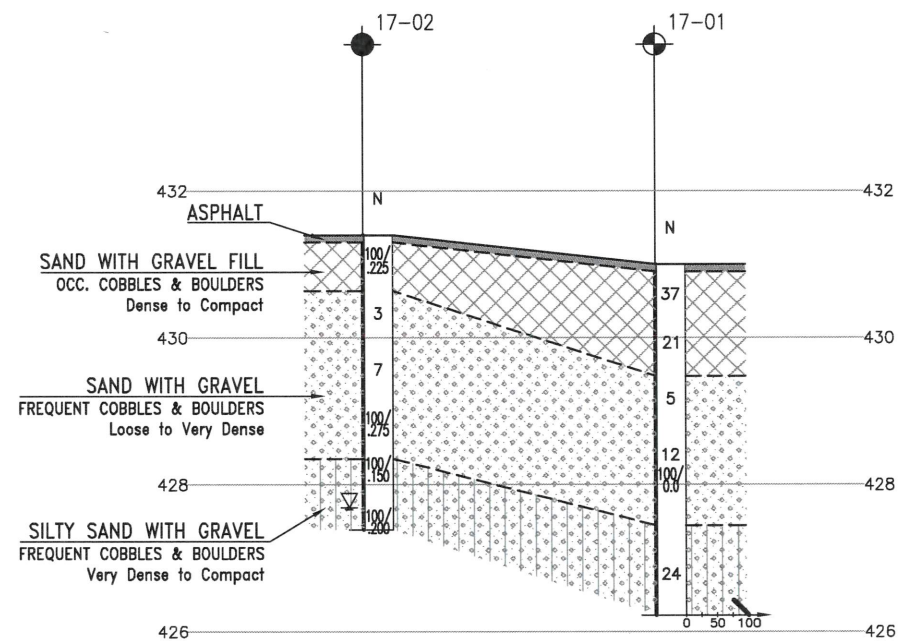
HIGHWAY 129  
NEBSKAWASHI RIVER  
BRIDGE REHABILITATION  
BOREHOLE LOCATIONS AND SOIL STRATA

Reference is made to the Record of Borehole sheets in Appendix B for details of the soil stratigraphy encountered at the investigated locations. A stratigraphic profile is presented on Drawing No. 1 in Appendix A for illustrative purposes. An overall description of the stratigraphy is given in the following paragraphs; however, the factual data presented in the Record of Boreholes governs any interpretation of the site conditions.

NO	ELEVATION	NORTHING	EASTING
17-01	431.0	5 298 031.2	349 811.5
17-02	431.4	5 298 034.7	349 802.2

The Nebskwashi River Bridge (Structure No. 46-236) is located on Highway 129, approximately 1.0 km north of the north junction of Highway 101 and Highway 129. It is noted that for orientation purposes, Highway 129 within the project limits, will be described with an east-west alignment. The location of the bridge is shown on the inset Key Plan on Drawing No. 1 in Appendix A.

The field investigation for this site included two boreholes drilled on May 12, 2017. The northing, easting and elevation of the boreholes are shown on the Borehole Location and Soil Strata Drawing No. 1 in Appendix A and are summarized in Table 3-1.

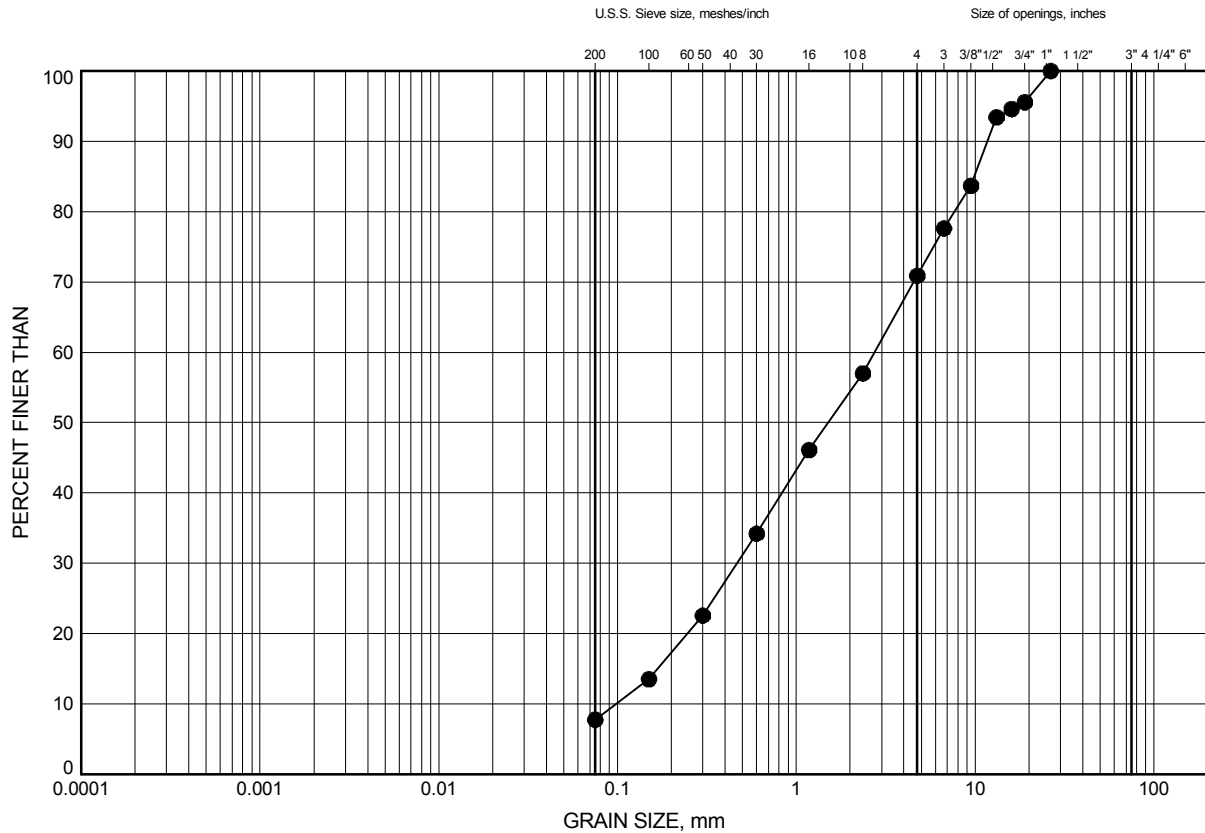
FIGURE C1

### Granular Fill

SYMBOL	BOREHOLE	DEPTH (m)	ELEV. (m)
●	17-01	0.41	430.61

The moisture content of the samples tested ranged from 1% to 2%. The results of grain size analysis conducted on one sample of this material are summarized in Table 4-1 and illustrated on Figure C1 in Appendix C.

<b>Soil Particle</b>	<b>%</b>
Gravel	29
Sand	63
Silt and Clay	8

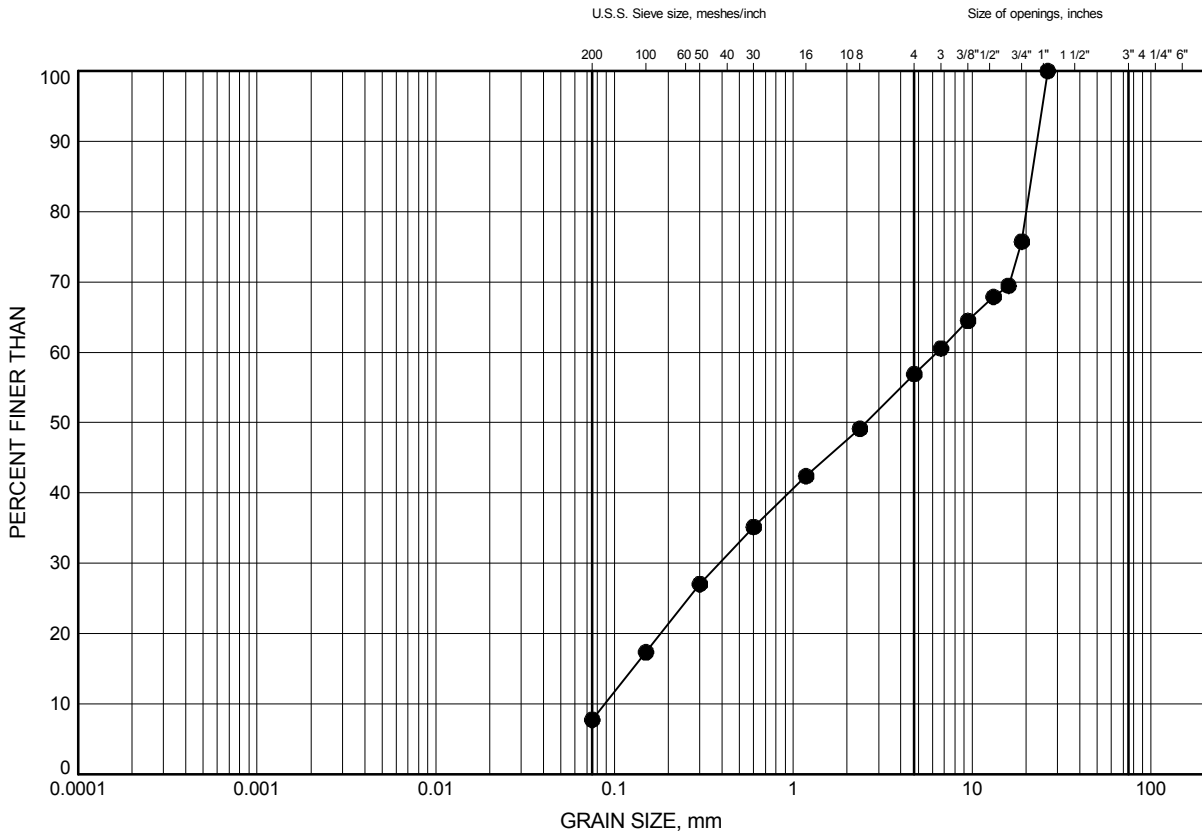
FIGURE C2

### Sand with Gravel

SYMBOL	BOREHOLE	DEPTH (m)	ELEV. (m)
●	17-02	1.07	430.36

The moisture content for the samples tested ranged from 1% to 11%. The results of grain size analysis conducted on one sample of this material are summarized in Table 4-2 and illustrated on Figure C2 in Appendix C.

Soil Particle	%
Gravel	43
Sand	49
Silt & Clay	8

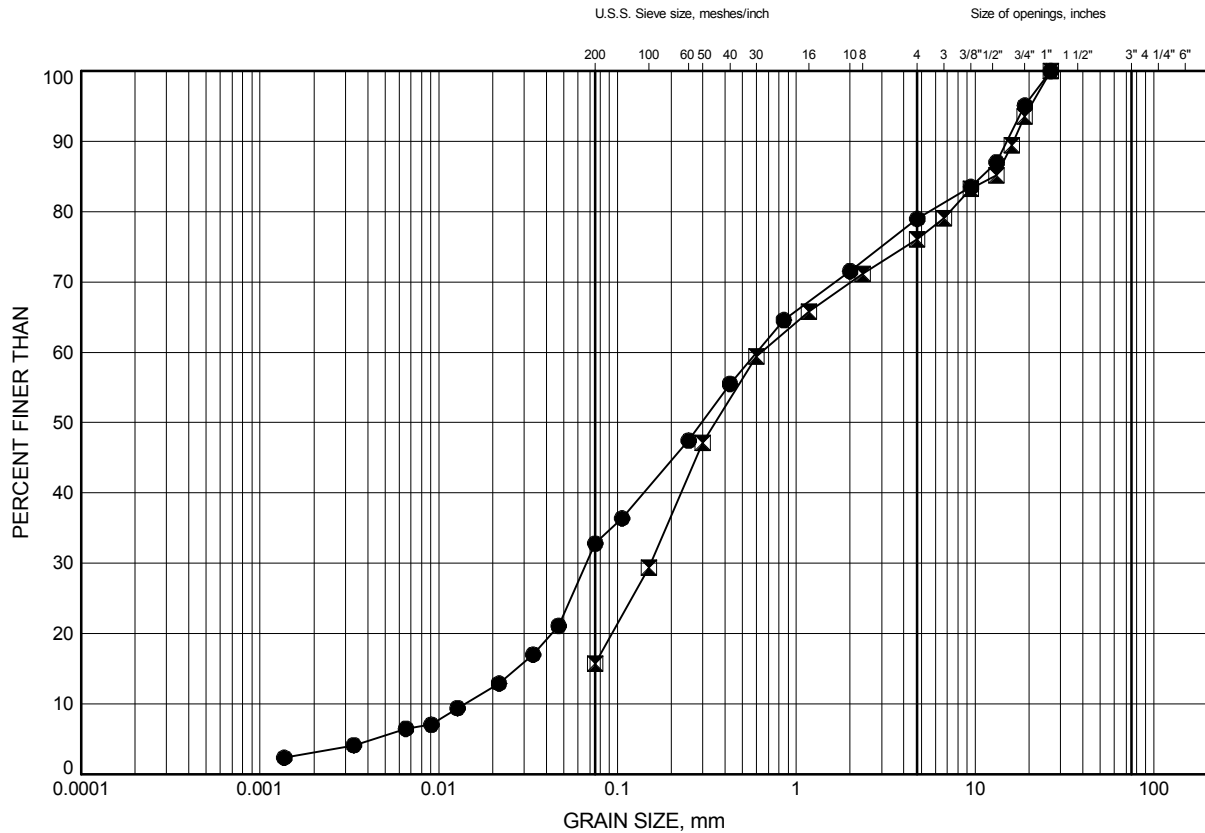
FIGURE C3

### Silty Sand with Gravel

SYMBOL	BOREHOLE	DEPTH (m)	ELEV. (m)
●	17-01	4.22	426.80
⊠	17-02	3.20	428.23

The moisture content for the samples tested ranged from 5% to 19%. The results of grain size analysis conducted on two samples of this material are summarized in Table 4-3 and illustrated on Figure C3 in Appendix C.

Soil Particle	%	
Gravel	21 to 24	
Sand	46 to 60	
Silt	30	16
Clay	3

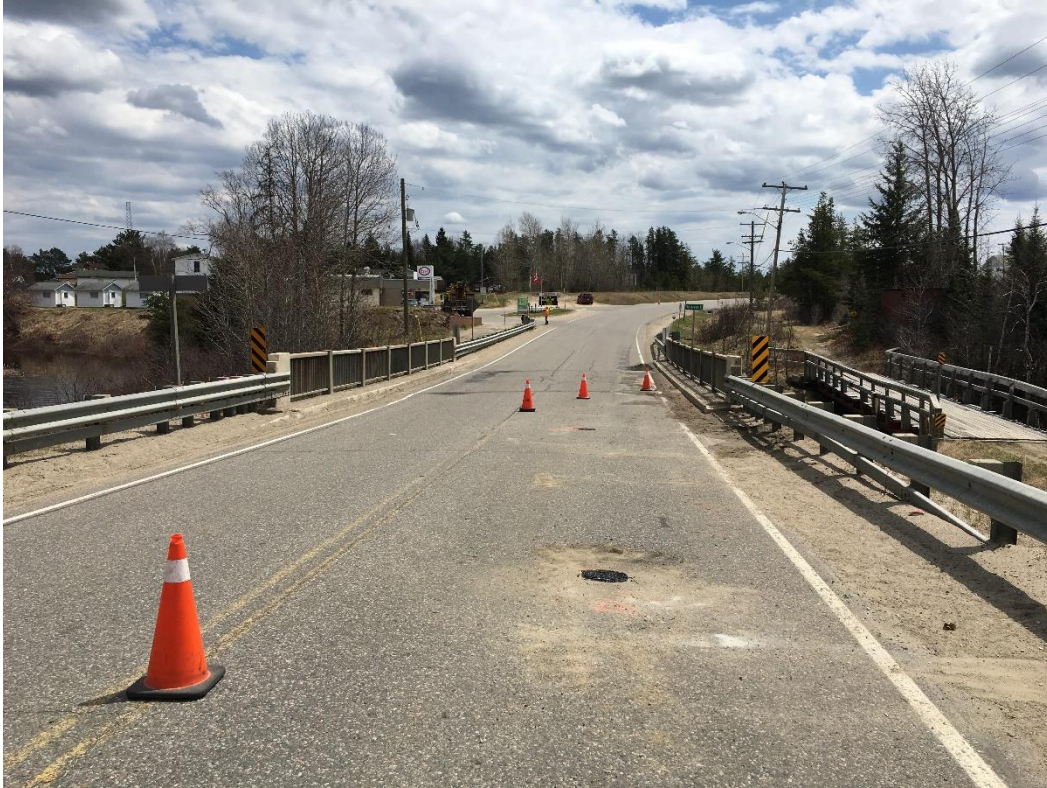
**Figure 1: As Drilled Boreholes at Bridge 46-236 looking East [taken May 5, 2017]**

Site photographs showing the general conditions at the site during the time of the field investigation are presented in Appendix D.

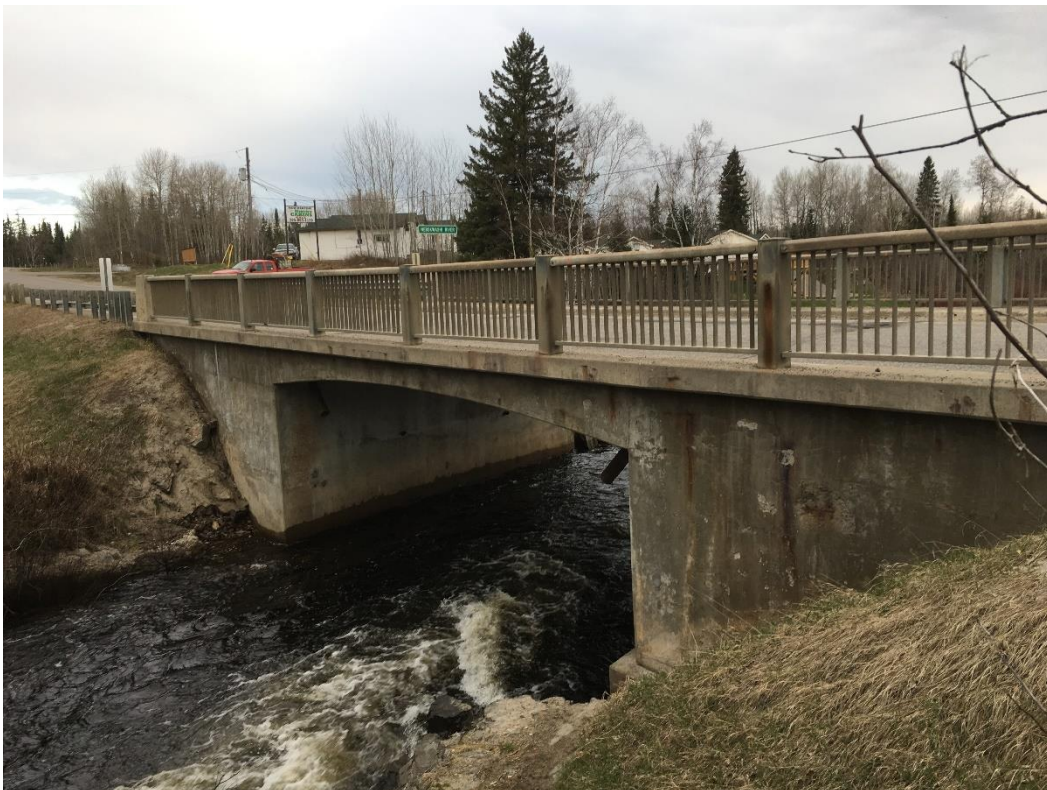
**Figure 2: Looking towards West Abutment [taken May 5, 2017]**
