FOUNDATION INVESTIGATION REPORT **Non-Structural Culvert Replacement, Highway 634, Township of Kendrey,** **District of Cochrane, Ontario**

Agreement No. 5015-E-0007
Assignment No. 4
WO. 2016-11040
Geocres No. 42H-68

Foundation Investigation Report

Non-Structural Culvert Replacement, Highway 634

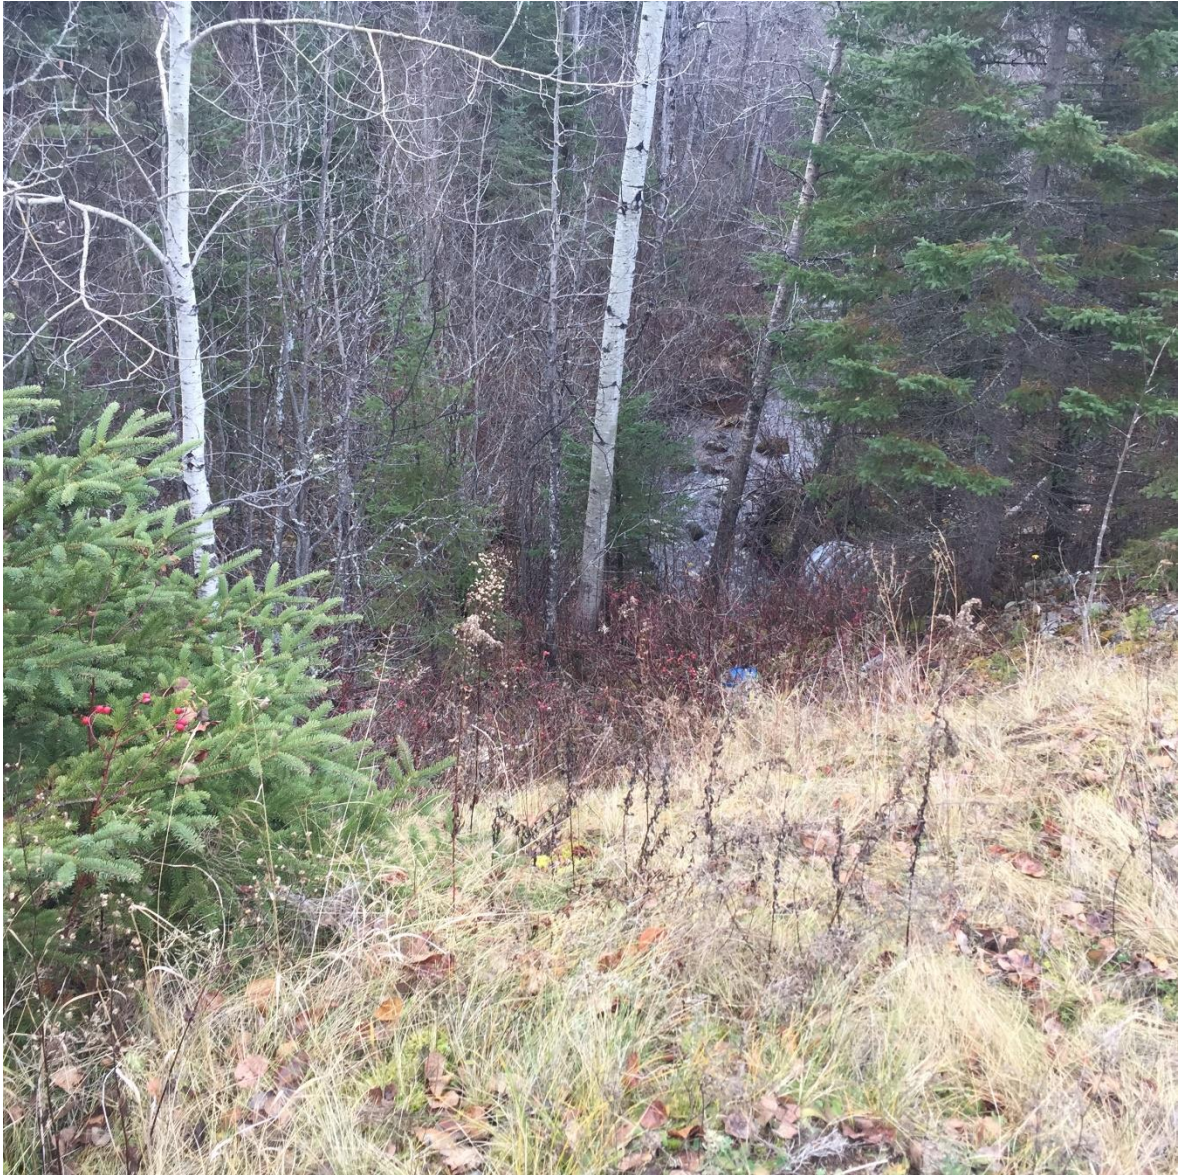
Photo 1. Inlet side of Non-Structural Culvert (facing east) on November 8, 2016

During the site reconnaissance on November 8, 2016, the general site conditions were assessed. The existing creek flows from east to west. Vegetation at the site consists of large deciduous and coniferous trees and wild bushes. The inlet and outlet of the culvert are generally surrounded by low lying grasses, small shrubs and trees. The photos of inlet and outlet are included in Appendix A.

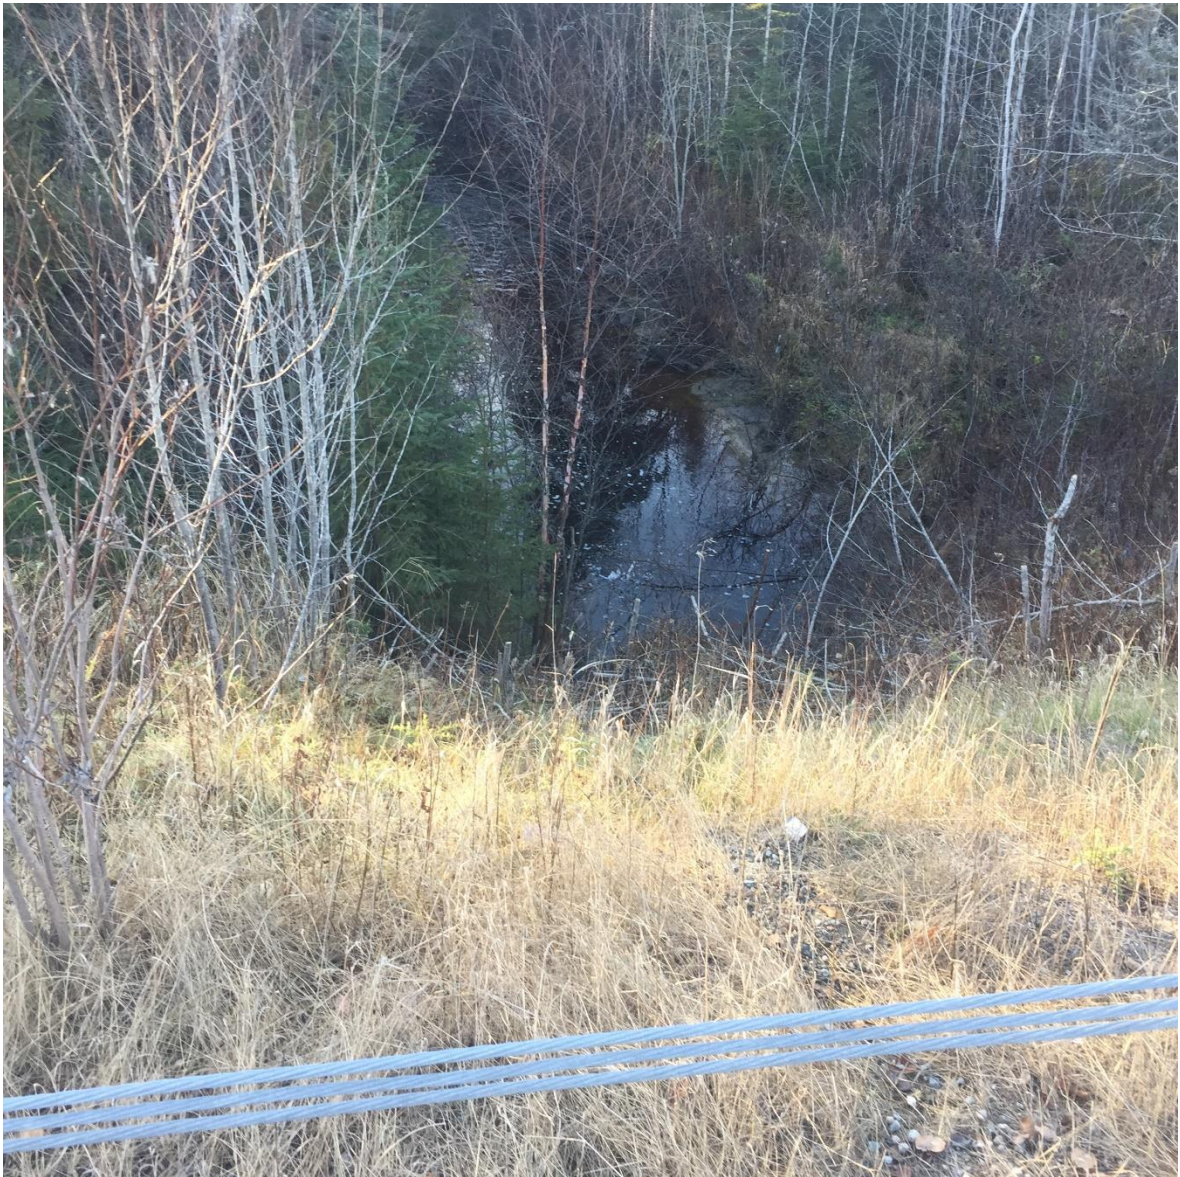
Photo 2. Outlet side of Non-Structural Culvert (facing north-west) on November 8, 2016

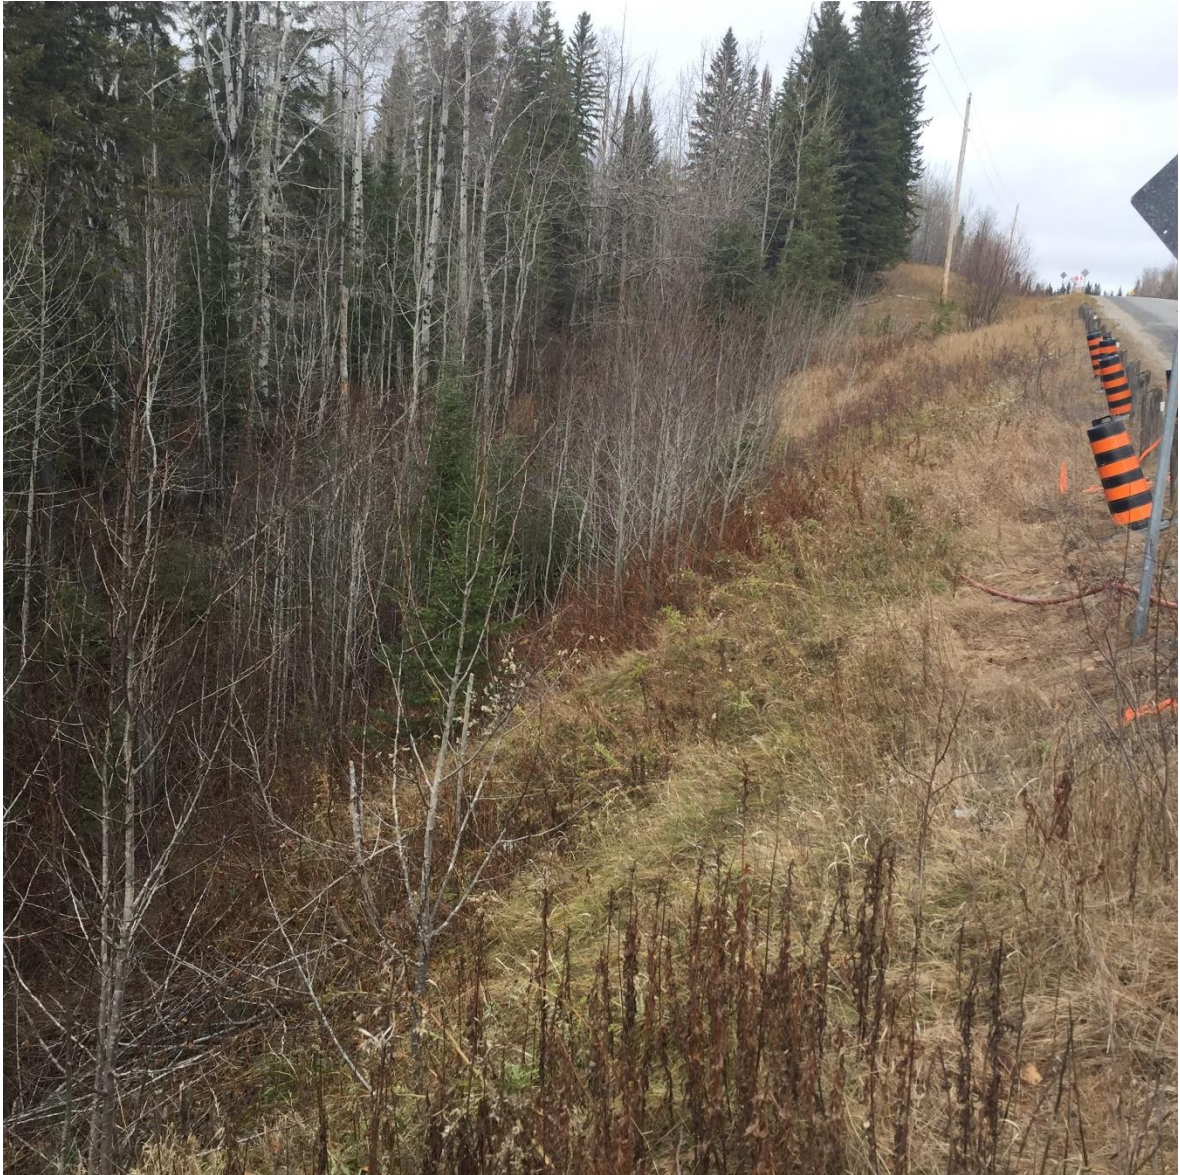
Photo 3. West Embankment (facing north) on November 8, 2016

In general, the slopes of highway embankment are covered with grass and light vegetation, with trees and larger vegetation towards the embankment toes. Bedrock outcrops were not observed at the site. The riding surface of Hwy 634 comprises of asphalt surface treatment. The surface of Hwy 634 near the culvert location was in fair shape with a number of localized cracks on the asphalt. Based on the MTO provided information, at the culvert location, a sinkhole developed in late September 2016 on the west side of the roadway and it was repaired by excavating undermined pavement layers and backfilling the void with granular material.

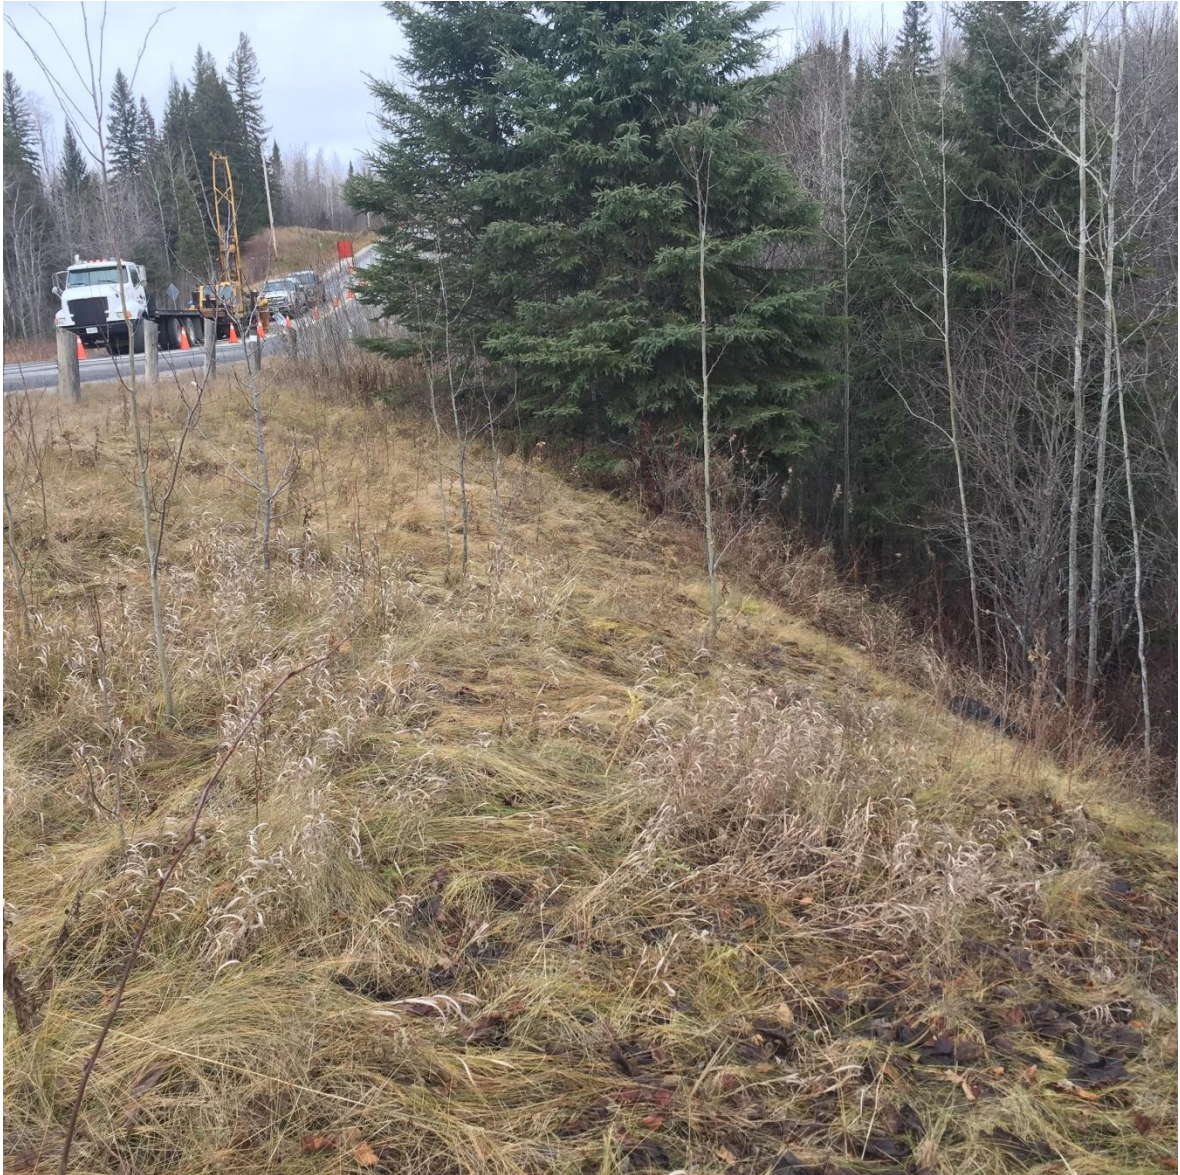
Photo 4. East Embankment (facing north) on November 8, 2016

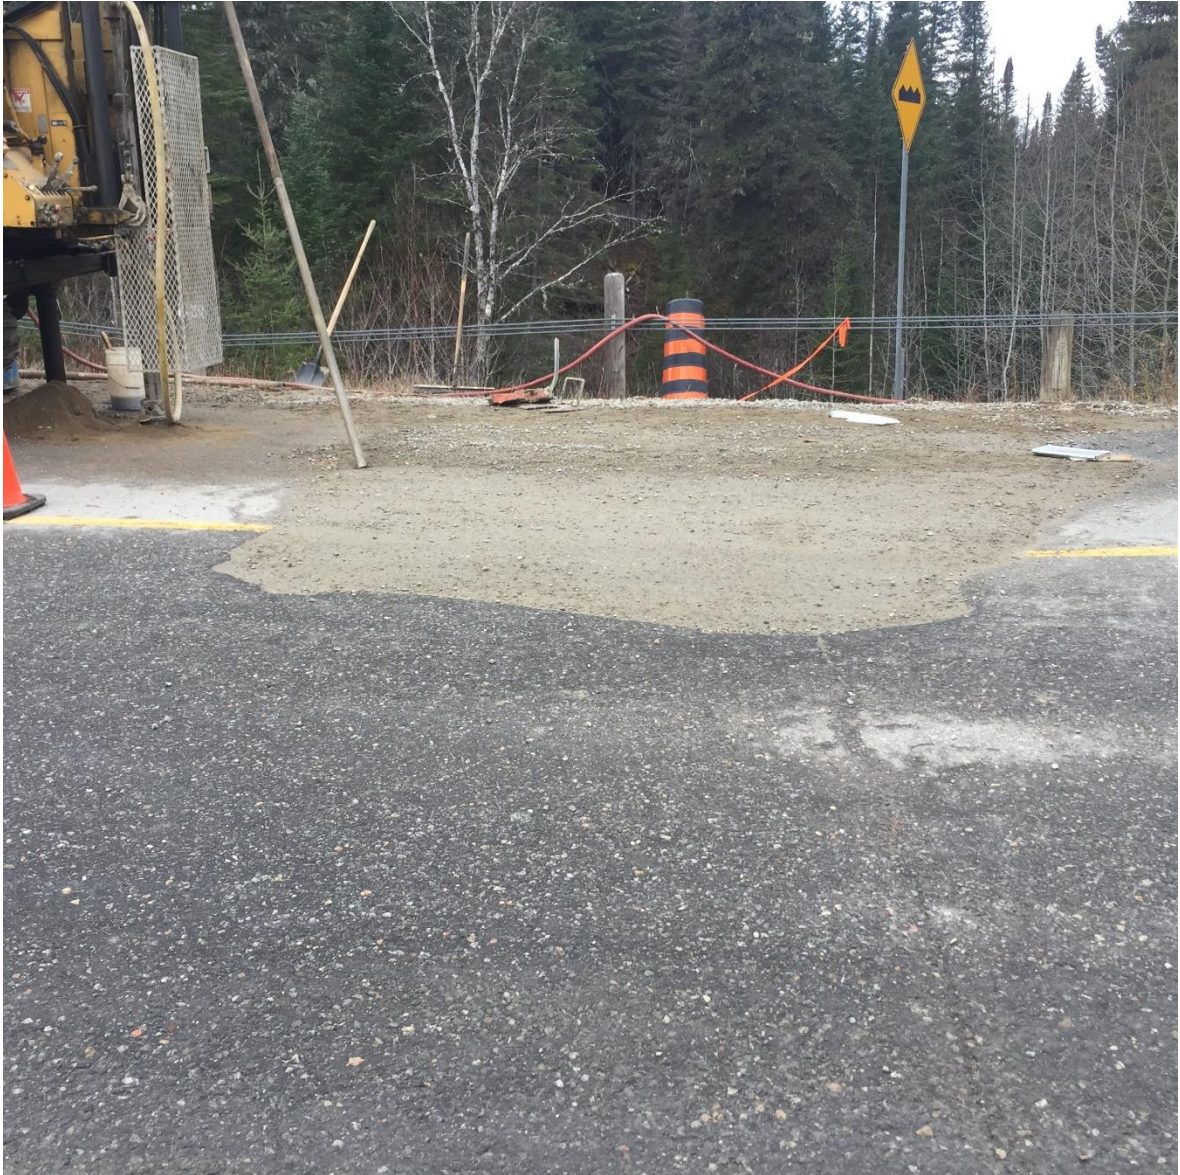
Photo 5. Temporarily Repaired Sinkhole on Western Side of Roadway (facing west) on November 8, 2016

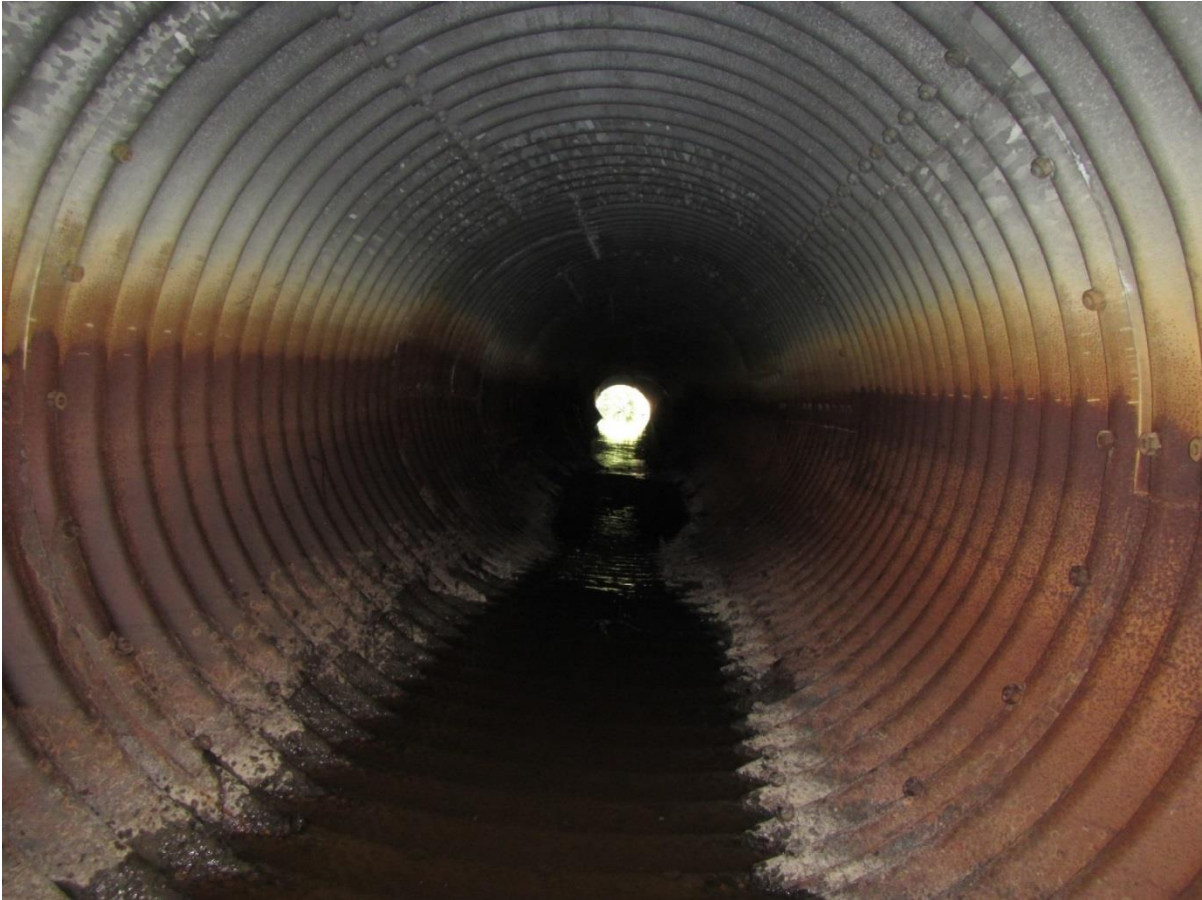
Photo 6. Non-structural culvert November 8, 2016
