SUPPLEMENTARY FOUNDATION INVESTIGATION AND DESIGN REPORT

**Proposed Replacement of Culvert on Highway 118,
Township of Stanhope, Ontario**

**Agreement No. 5015-E-0007
Assignment No. 5
Geocres No. 31E-382**

exp Services Inc.
August 31, 2017

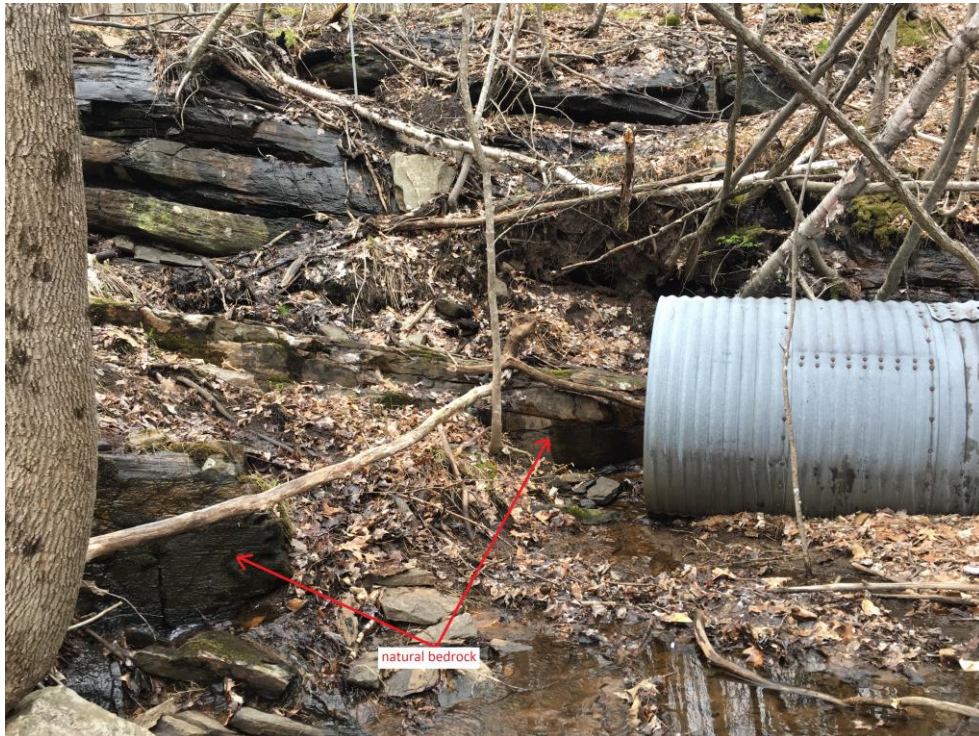
Photo 11: Inlet side, bedrock outcrops

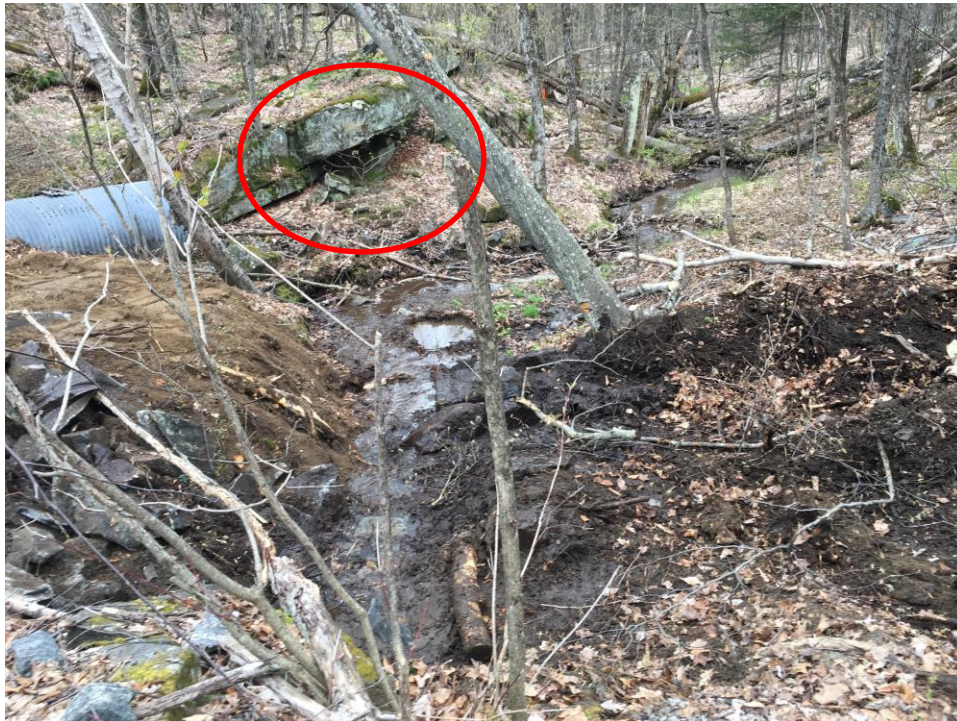
Photo 12: Outlet side, bedrock outcrops

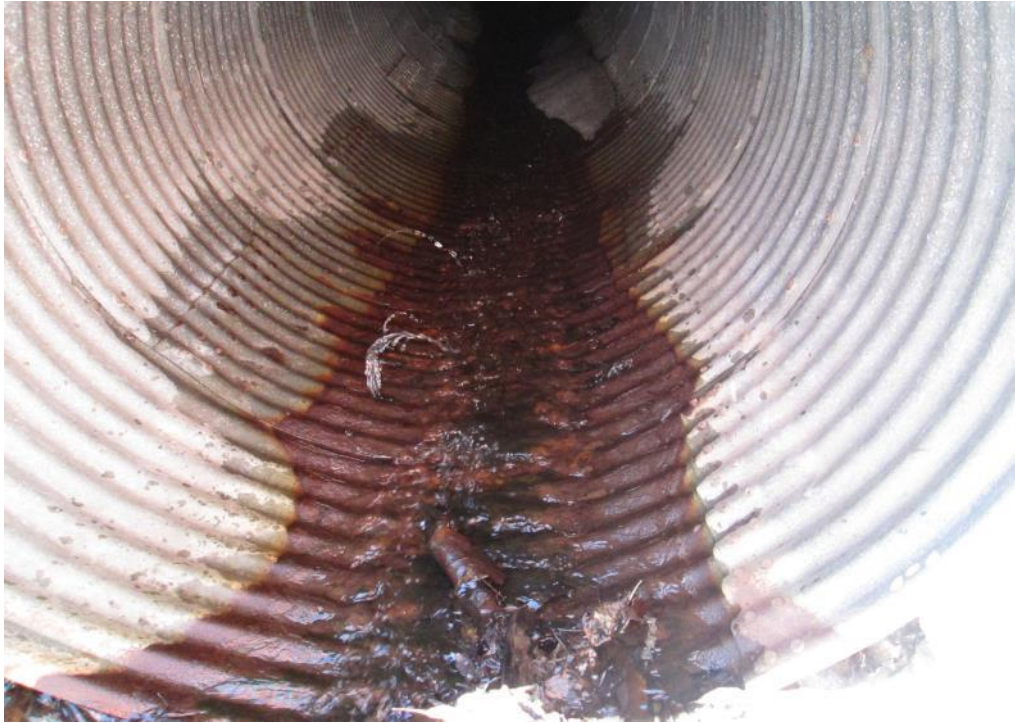
Photo 13: Deterioration of culvert at inlet

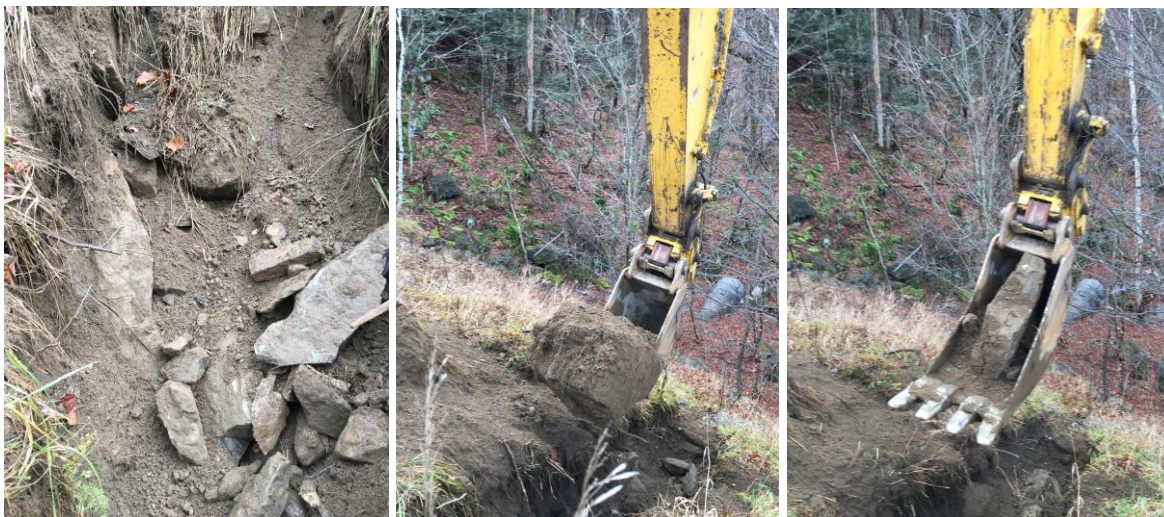
Photo 16: Test pit TP1 at the west embankment slope, various sized rock fragments in soil matrix

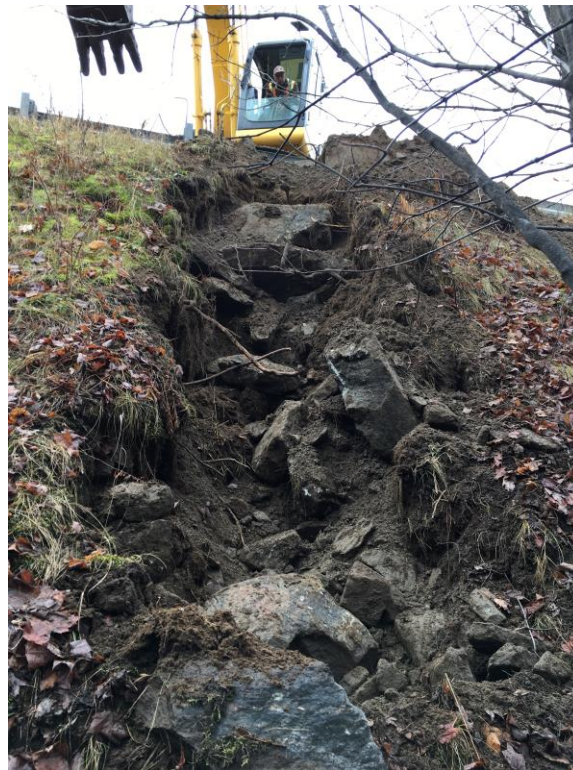
Photo 18: Test pit TP2 at the east embankment slope, various sized rock fragments in soil matrix

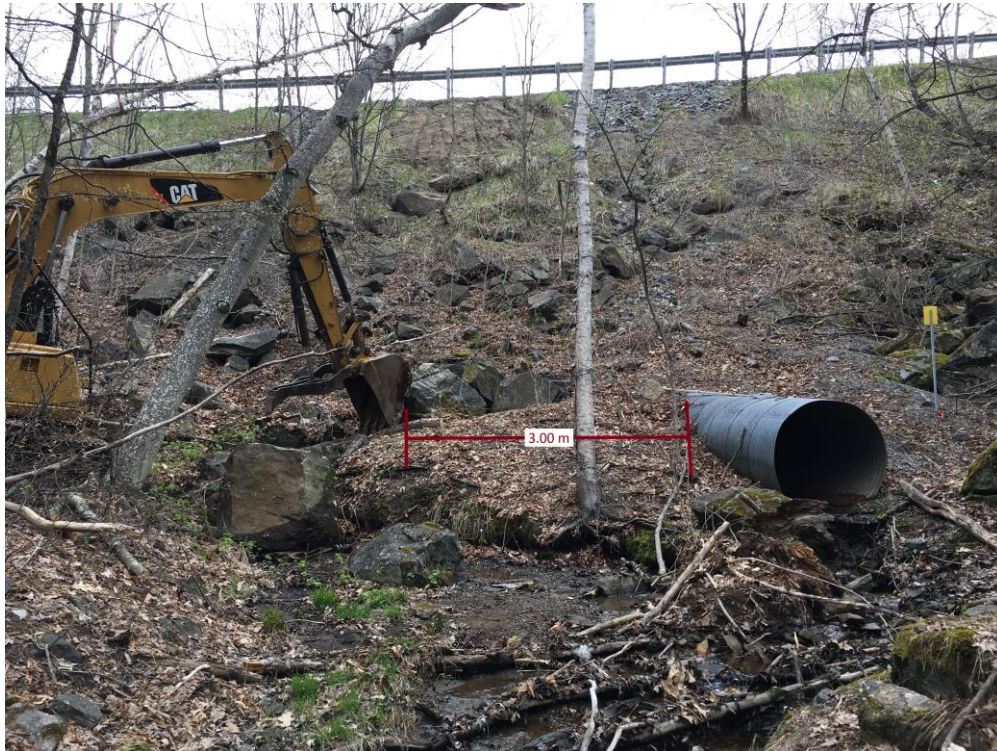
Photo 19: Test pit TP3 at the toe of west embankment slope facing west, outlet side

Rock fill was encountered in the test pits excavated above toes of each side of the embankment slope (TP2 and TP4). These excavated test pits are shown through Photos 19 to 26 in Appendix A. The rock fill pieces had mostly cobble and boulder size and angular to round shape. Some rock fill pieces were 1.65 m in size as shown on Photo 24. An infill between rock grains was mostly silty, sandy, gravelly and organic soil, but voids were also observed. The shallow bedrock was encountered at the inlet side (Photo 26).

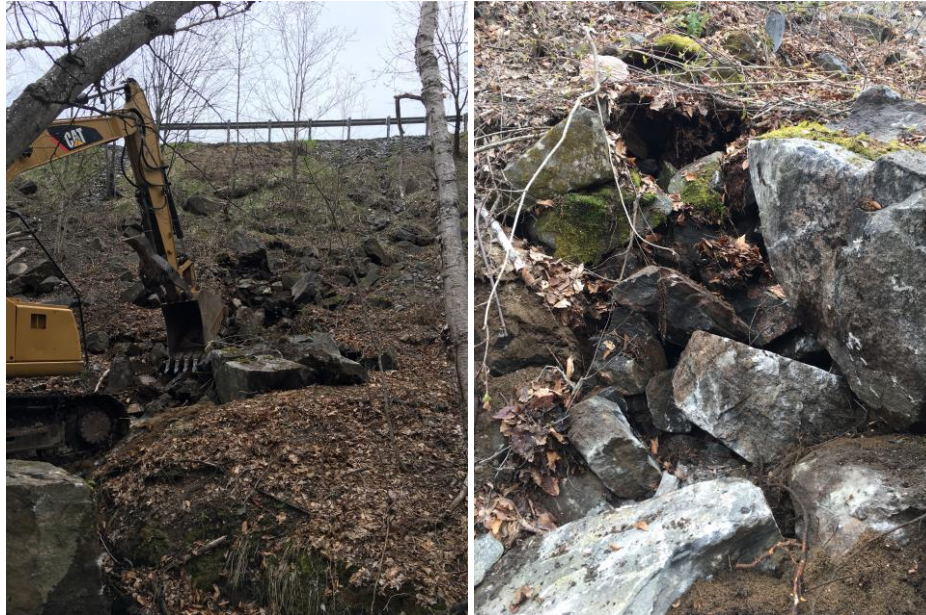
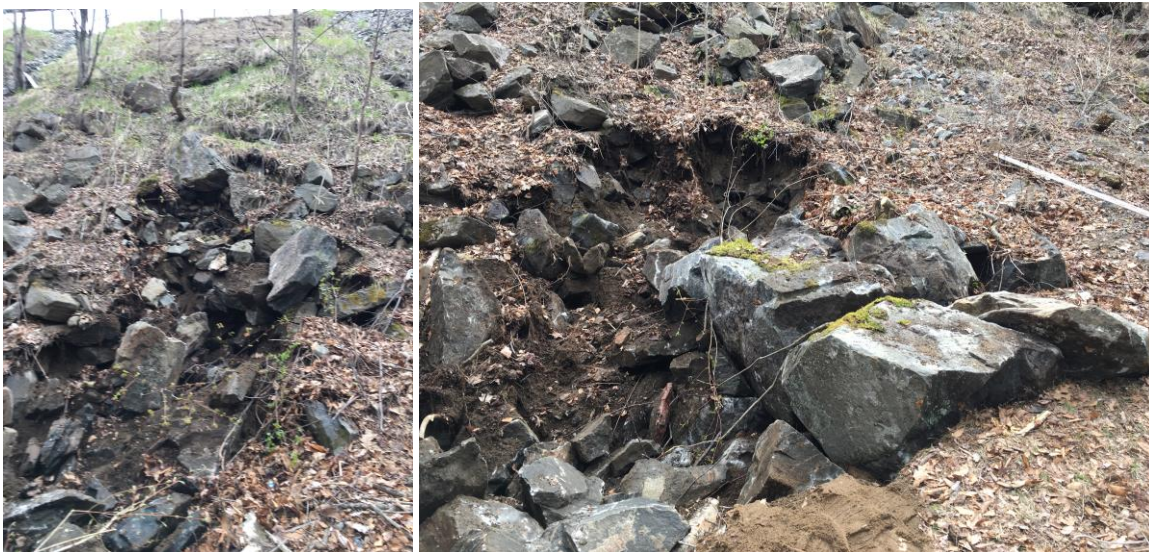
Photo 21: Test pit TP3 at the toe of the west embankment side, cobble and boulder sized rock fill

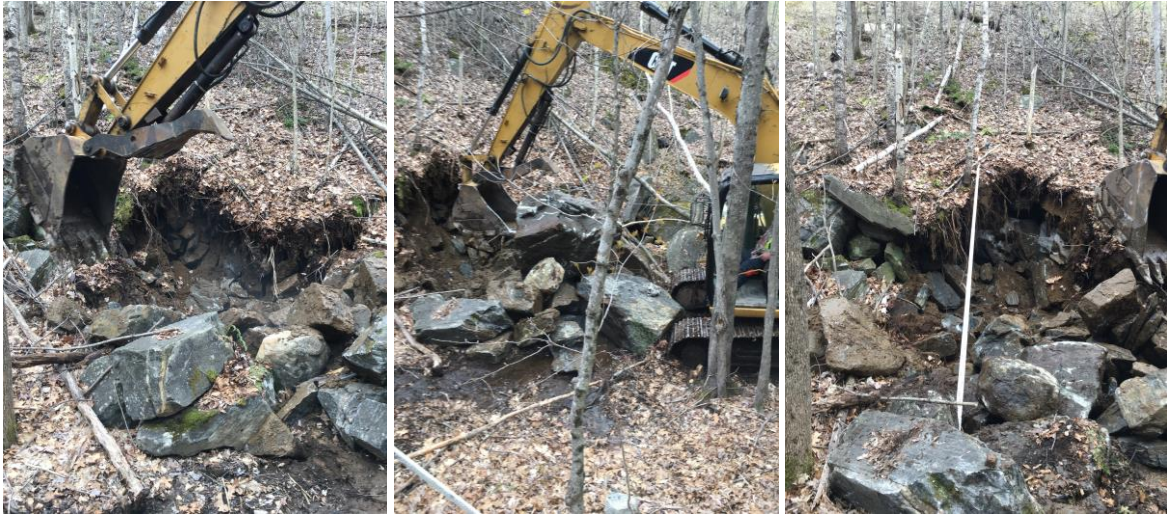
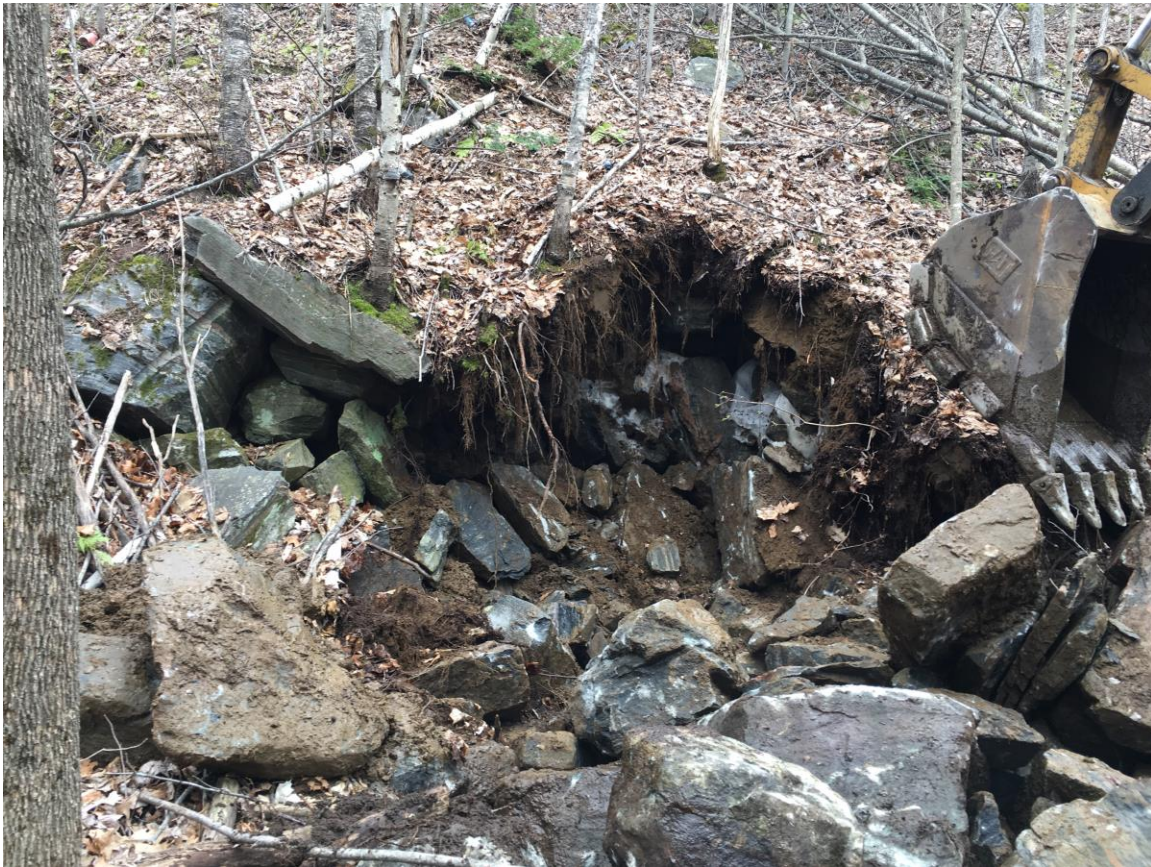
Photo 24: Test pit TP4 at the toe of the east embankment side, cobbles and boulder sized rock fill

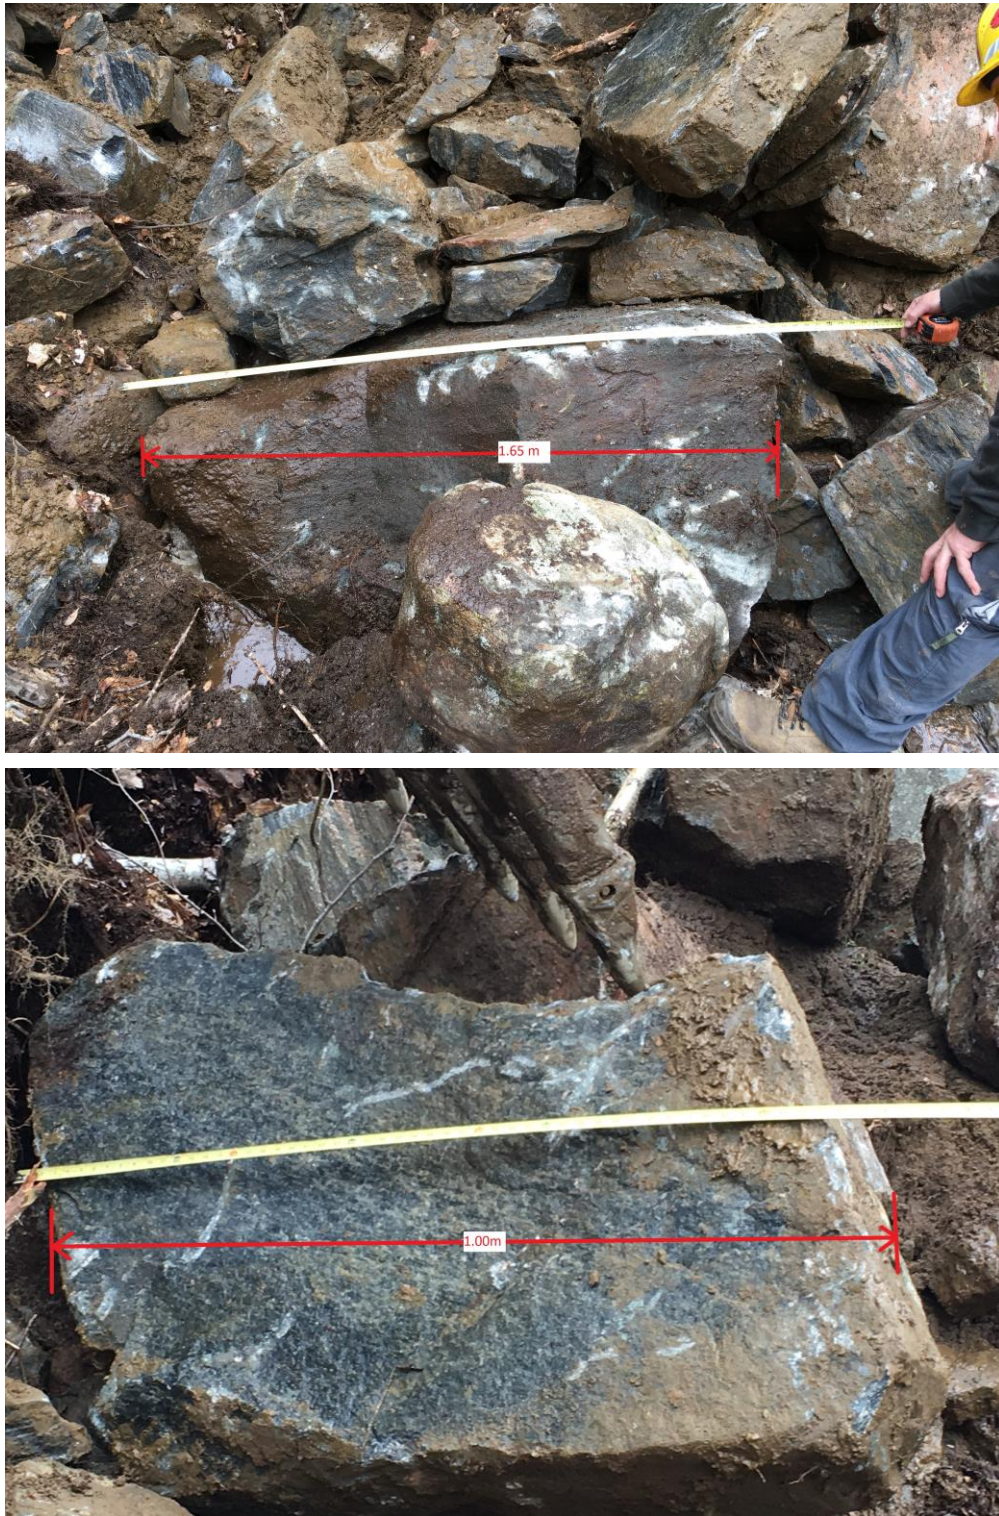
Photo 25: Test pit TP4 at the toe of the east embankment side, boulder sized rock fill

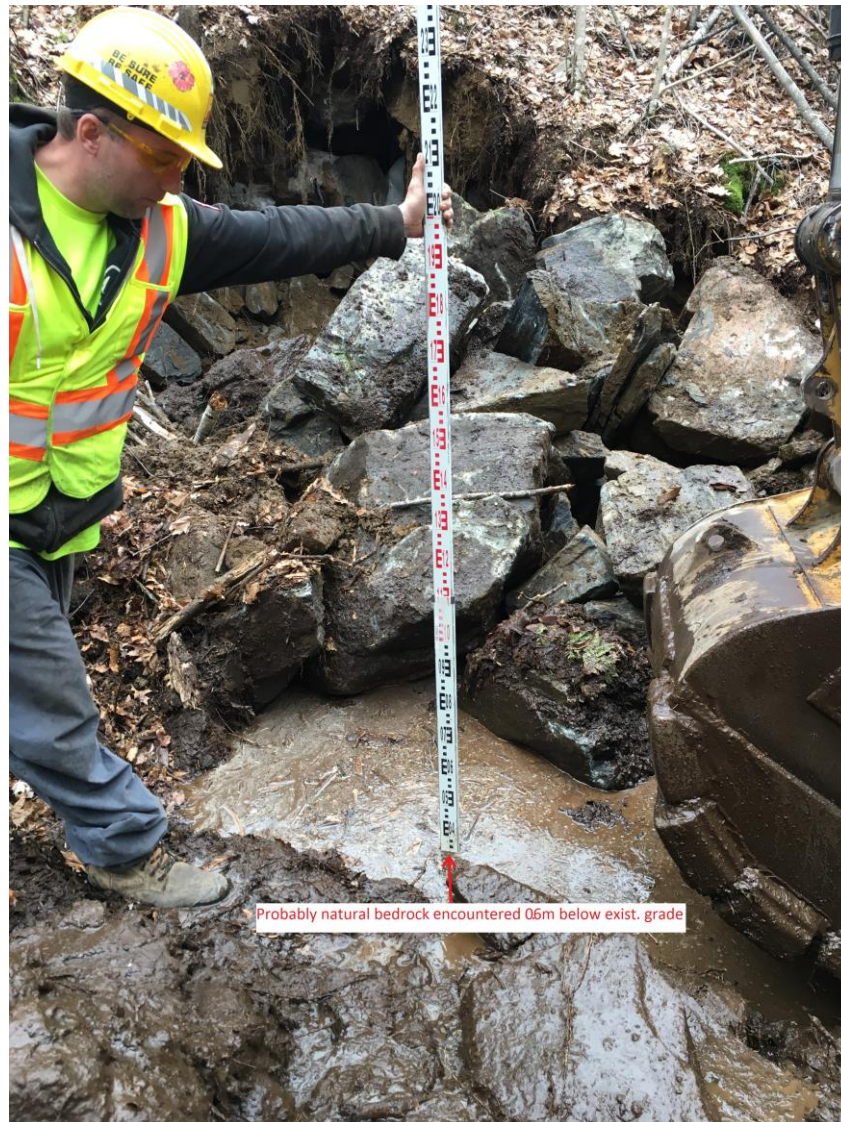
Photo 26: Test pit TP4 at the toe of the east embankment side, bedrock elevation

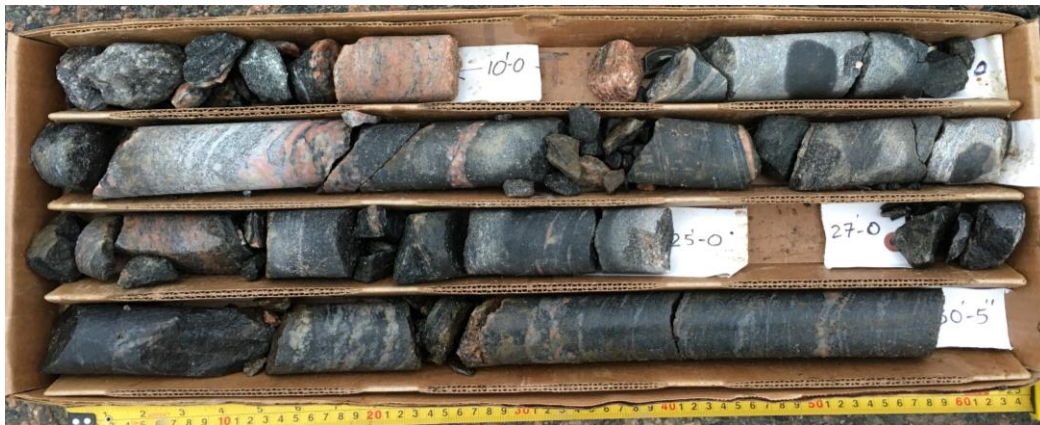
Project NO: ADM 0002331875-F0
BH NO: 201
Run NO: 1,2,3,4 & 5 (**Rockfill**)
Sample Depth: 2.67 m to 9.27 m
Elevation: 348.4 m to 341.83 m
Date: December 6 & 7, 2016

Photo 1. Rockfill Core Sample for BH201 from Elevation 348.4 m to 341.83 m

The composition of this rock fill layer is mainly of cobbles and boulders size grains. The coring was attempted to obtain their samples. As noted on the borehole logs, the size of cored rock samples was upto 1.0 m. Between the rock pieces some silty and sandy soil infills and/or voids were observed during the coring.

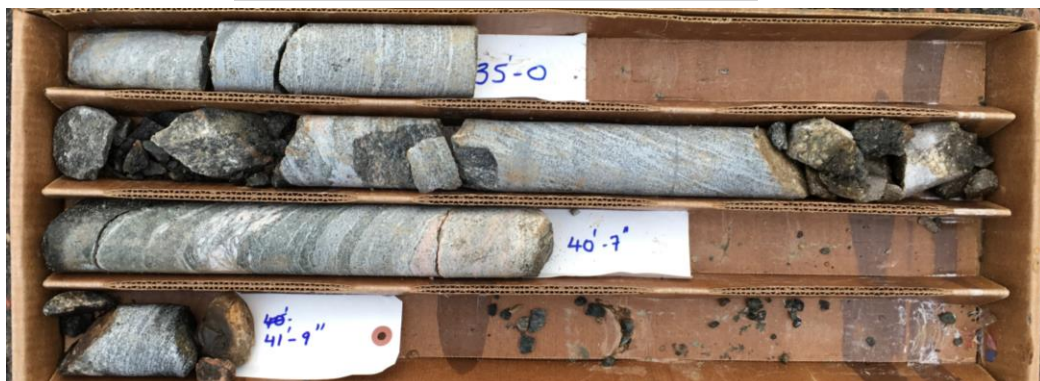
Project NO: ADM 0002331875-F0
BH NO: 201
Run NO: 6,7 & 8 (**Rockfill**)
Sample Depth: 9.27 m to 12.73
Elevation: 341.83 m to 338.4 m
Date: December 6 & 7, 2016

Photo 2. Rockfill Core Sample for BH201 from Elevation 341.83 m to 338.4 m

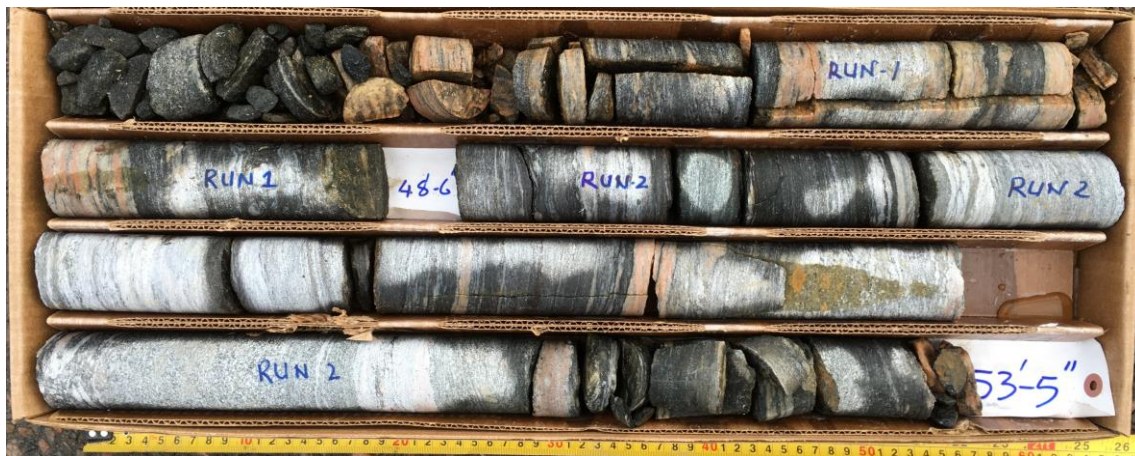
Project NO: ADM 0002331875-F0
BH NO: 201
Run NO: 1 & 2 (**Bedrock**)
Sample Depth: 13.5 m to 16.3 m
Elevation: 337.6 m to 334.8 m
Date: December 7, 2016

Photo 3. Bedrock Core Sample for BH201 from Elevation 337.6 m to 334.8 m

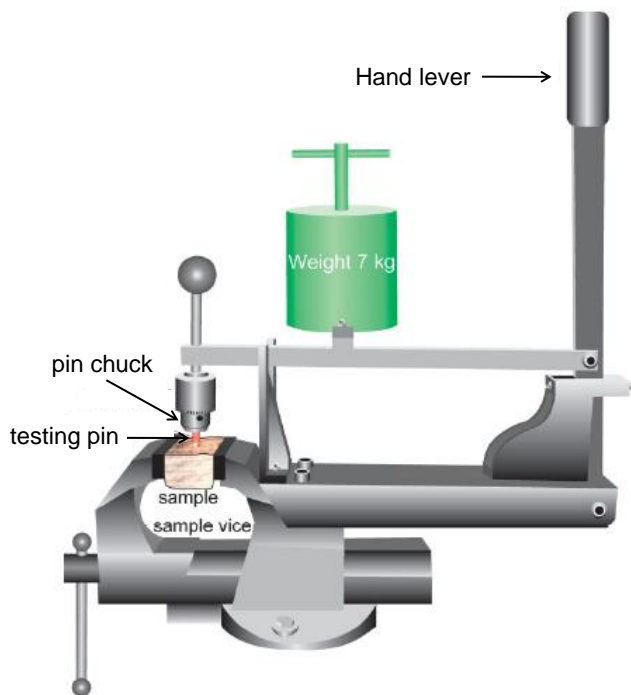
Figure 1 - CERCHAR test apparatus (after Plinninger and Restner, 2008)

Rock abrasivity is a characteristic of significance in estimating wear on mechanical excavation equipment such as core bits and disc cutters. While a number of tests have been proposed, the most widely accepted remains the CERCHAR scratch test (West 1989; Plinninger et al., 2003). In this test, a conical steel point of cone angle 90° is slowly drawn 10 mm across the rock surface under a normal, static force of 70 N. A drawing of the test device is presented in Figure 1. The abrasivity is then determined by the wear flat of the steel cone; units of measurement correspond to the diameter of the wear flat in tenths of a millimeter (e.g., a 0.3 mm diameter wear flat yields a measurement of 3). It is generally recommended that more than one measurement be made and the CERCHAR Abrasivity Index, *CAI*, be taken as the mean value.

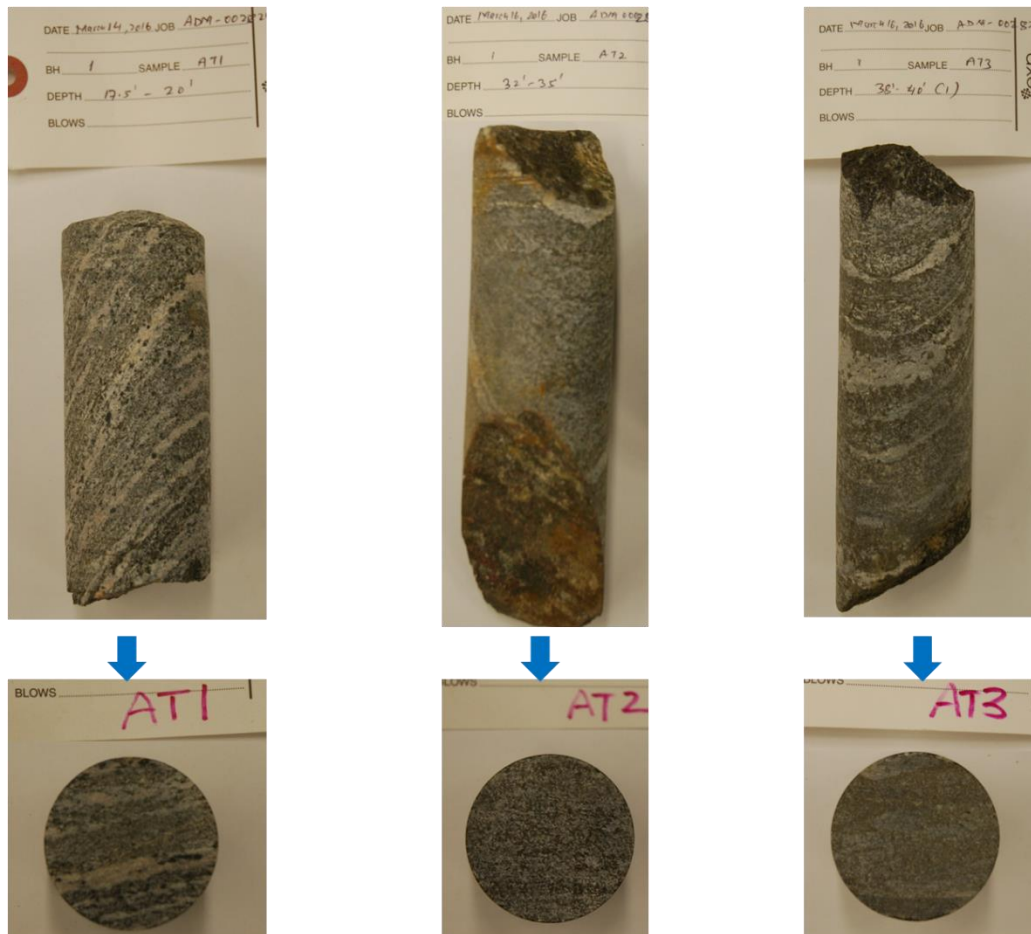
Figure 2- The supplied core and three test specimens after cutting

All the testing processes were undertaken sequentially on each individual specimen to minimize the time of exposure prior to testing. In order to obtain a suitable fresh surface for testing, the samples were wet cut using a diamond saw in MIRARCO'S Laboratory. As shown in [Figure 2](#), three specimens (marked as AT1, AT2, and AT3) were prepared from the supplied core.

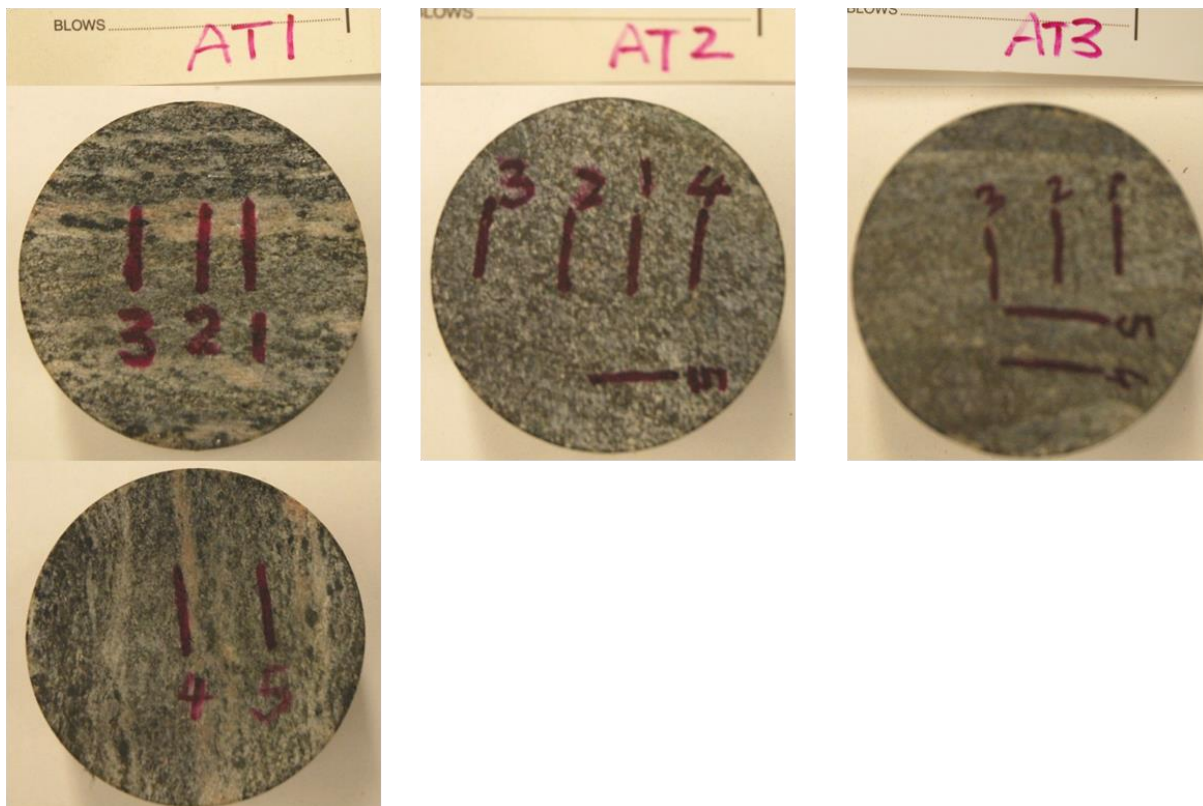
Figure 3-Specimens AT1, AT2, and AT3 after testing (scratches have been highlighted by marker pen)

According to the ASTM Standard D7265-10, each specimen was clamped in position with the test surface horizontal. A new pin was placed in the chuck and carefully brought to bear against the surface under the prescribed load of 70N. Because there is a pronounced fabric existing in the specimens, most of the scratches were made with the fabric oriented perpendicular to draw direction. The pin was then drawn across the surface for a distance of 10 mm. It was then removed for inspection. Then, the specimen was repositioned and the test was repeated two more times for each specimen (the pins were examined after each test). If the first three scratches on a sample yielded relatively consistent results, the following two scratches were performed perpendicular to the first three to investigate the possibility of a directional variability in the abrasiveness. Photographs of the three specimens following testing are presented in [Figure 3](#).

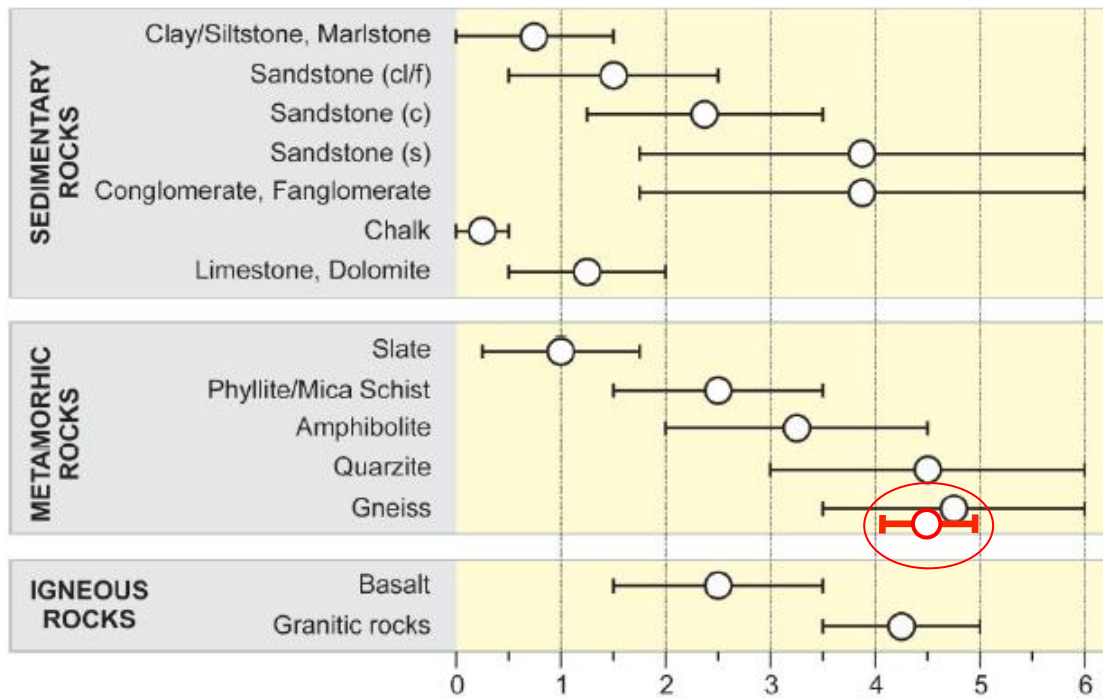
Figure 4- Comparison of test results (red) with compilation of typical CAI values (Plinninger and Restner, 2008)

The results obtained are consistent with published data for similar rock types as demonstrated in [Figure 4](#). According to the criteria established by [CERCHAR \(1986\)](#) (see [Table 2](#)), the three specimens would be classified as extremely abrasive. Using the more recent classification proposed by [Restner \(2007\)](#) (see [Table 3](#)) the rock would be considered as highly abrasive for the average *CAI* value (4.46) whereas Specimen AT2 itself would be classified as extremely abrasive.
