THURBER ENGINEERING LTD.

MEMORANDUM

**TECHNICAL MEMORANDUM
STEEP COBBLE SLOPE, EROSION MITIGATION
HIGHWAY 129, 37.4 KM NORTH OF HIGHWAY 554
AGREEMENT NO. 5020-E-0012, WORK ITEM #6
GWP 5161-18-00**

GEOCRES NO: 41J-144

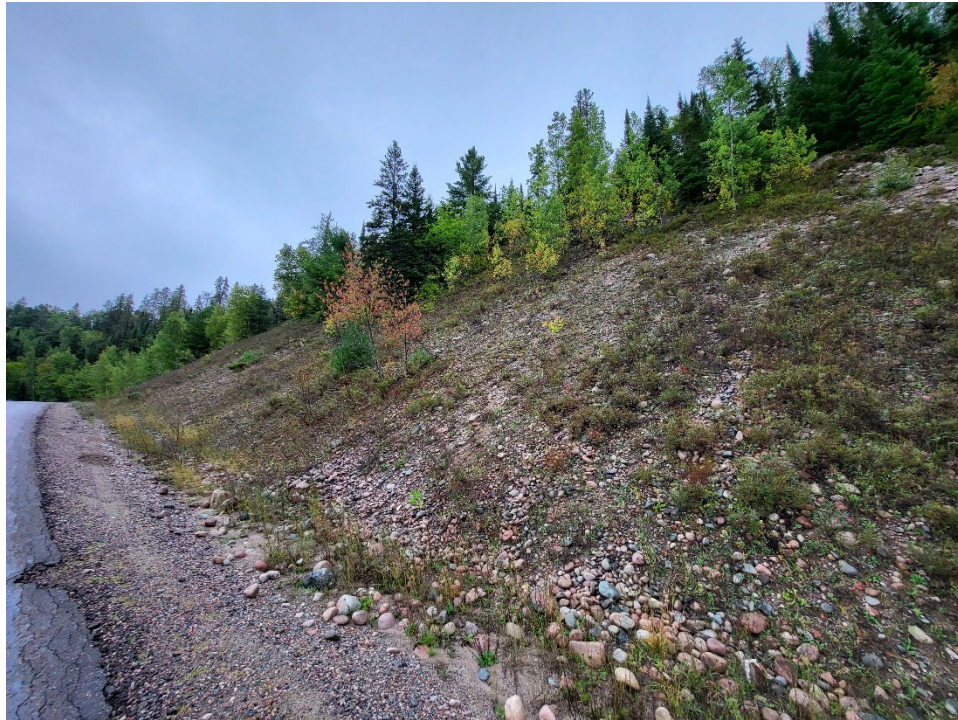
Photo 1. Toe of earth slope (looking north) *[taken Sept. 2022]*

It is understood that ongoing erosion with cobbles rolling down the slope and onto the travelled portion of the highway have occurred at this site. In addition, it is noted that the existing ditch at this location is very shallow. A proposed toe wall will widen the east ditch and clear zone adjacent to Highway 129. A drawing showing the existing slope and typical toe wall sections was provided by MPLJV and is attached to this memo. A review of the slope inclination in the project length was completed and the cut slope was found to range from 33 to 39 degrees from horizontal (1.5H:1V to 1.2H:1V) with a median value of 36 degrees. The toe of slope elevation ranges from approximately 307.2 to 303.8 m and crest of cut elevation ranges from approximately 328.1 to 323.4 m within the project area. The length along the slope measured from the existing crest to existing toe ranges from 35 to 40 m. Visible signs of global slope instabilities were not observed, but active surficial erosion with exposed cobbles was noted along the project area, especially near Sta. 19+350. Sand and cobbles, some trees, grass, and shrubs are present on the face of the slope.

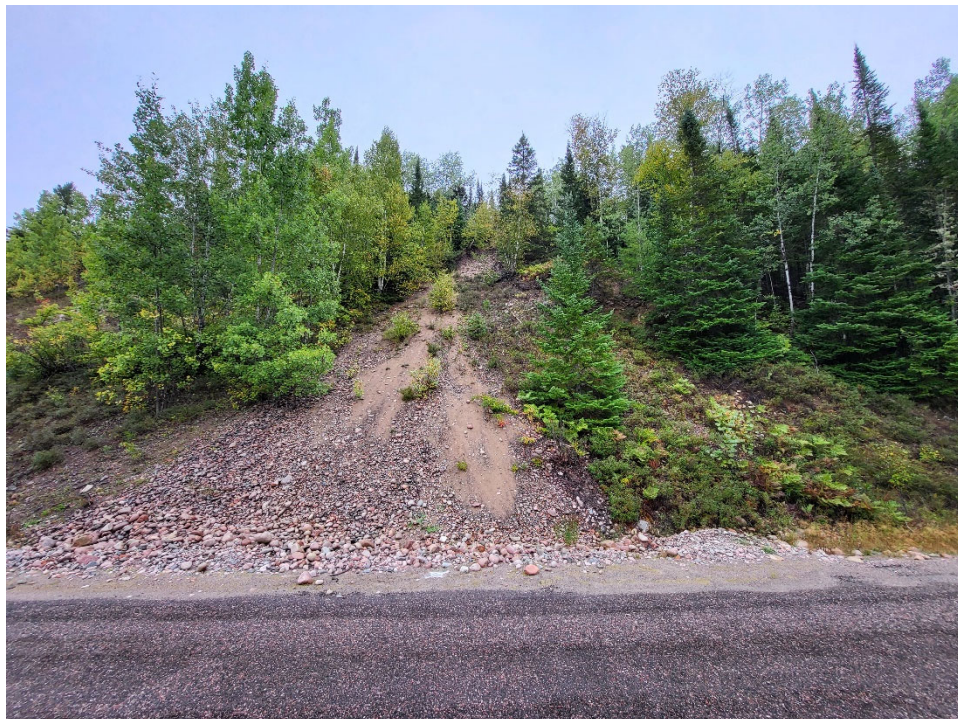
Photo 2. Active erosion near Sta. 19+350 (looking east) *[taken Sept. 2022]*

- The presence of cobbles within the cut slope soils is an inherent hazard with cobbles rolling down the slope and into the near driving lane. The cobbles are released from the slope as the surrounding soil matrix is eroded away by flowing water.
- The vegetation cover on the existing slope is minimal.
- Property constraints will limit the available property to allow for slope flattening above the existing cut slope crest as well as access to the crest of slope.

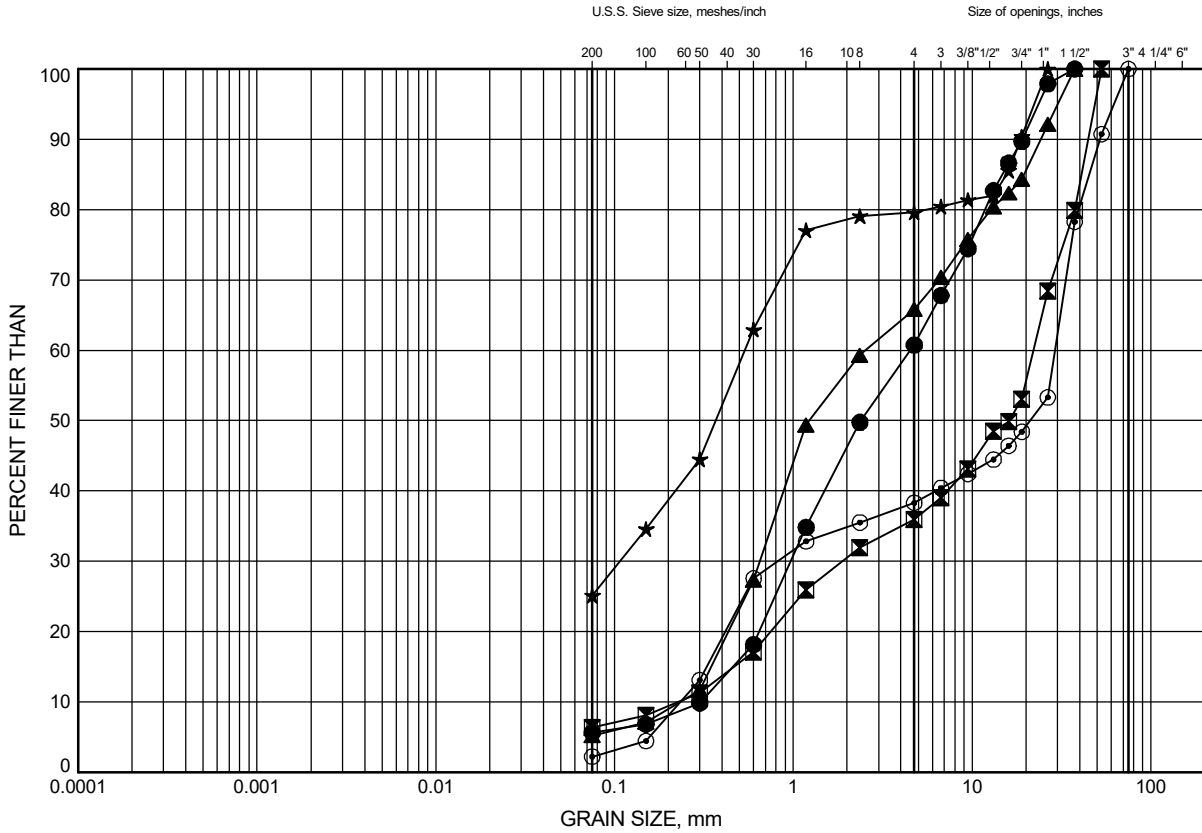
FIGURE C1

Sand with Silt and Gravel to Gravel with Silt and Sand

The recorded moisture content ranged from 1 to 19% but was typically less than 8%. The results of gradation analyses completed on five samples of the layer are illustrated on Figure C1. The results of the tests are summarized below and on the Record of Borehole sheets.

Soil Particle	Percentage (%)
Gravel	20 to 64
Sand	30 to 61
Silt & Clay	2 to 26
