## Foundation Investigation Report

*New Material Storage Facility at Dunchurch Patrol Yard,  
Highway 124, Dunchurch, ON*

Final Report

ADM-22006096-A9

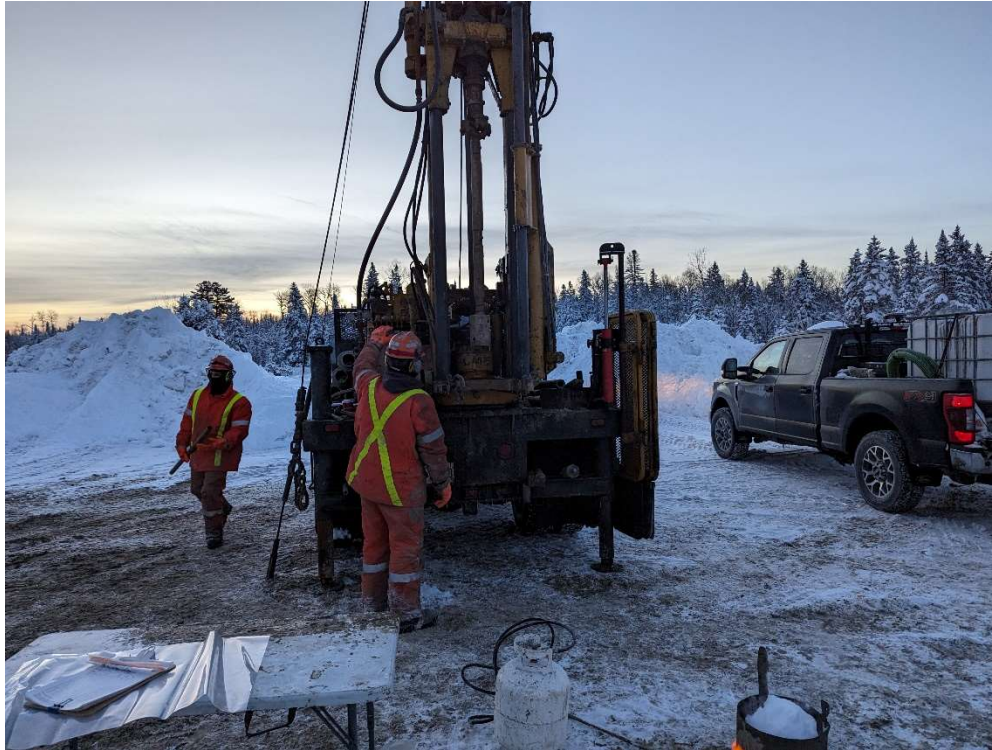
Photo 1. Dunchurch Patrol Yard – Drilling borehole BH23-D-1, facing southeast (January 19, 2024)

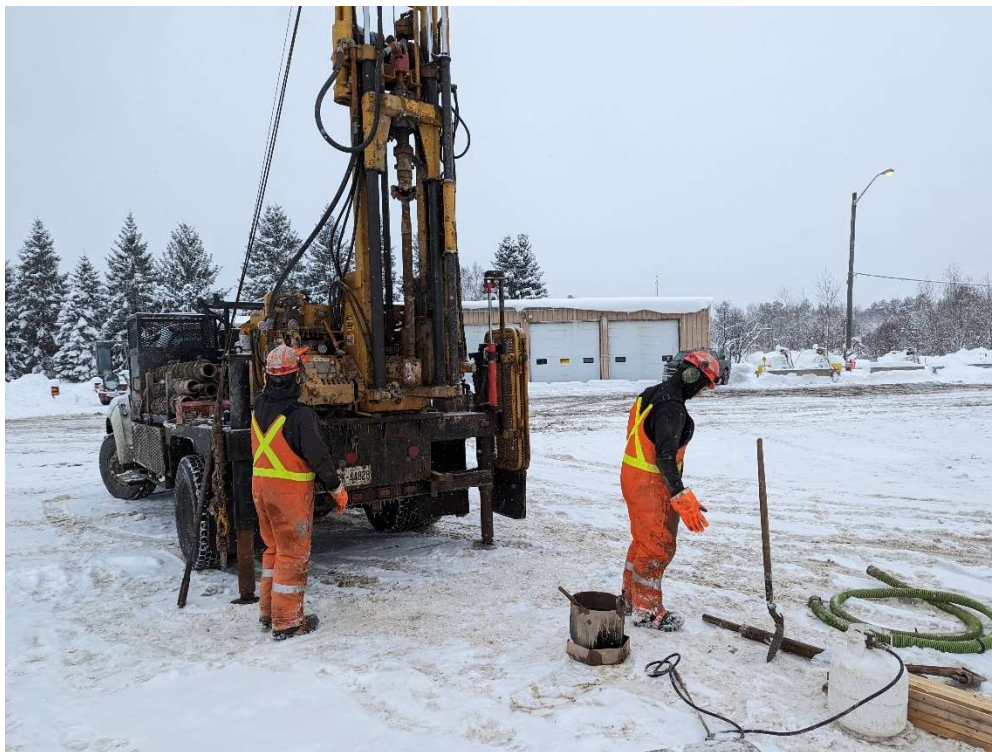
Photo 2. Dunchurch Patrol Yard – Drilling borehole BH23-D-2, facing west (January 18, 2024)

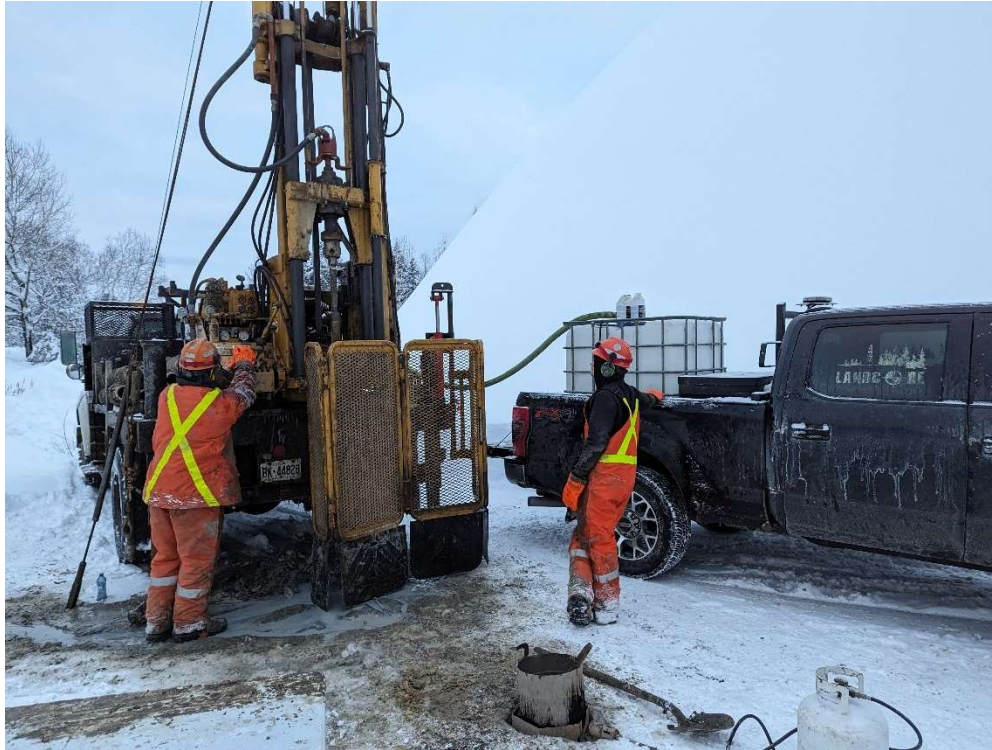
Photo 3. Dunchurch Patrol Yard – Drilling borehole BH23-D-3, facing southeast (January 18, 2024)

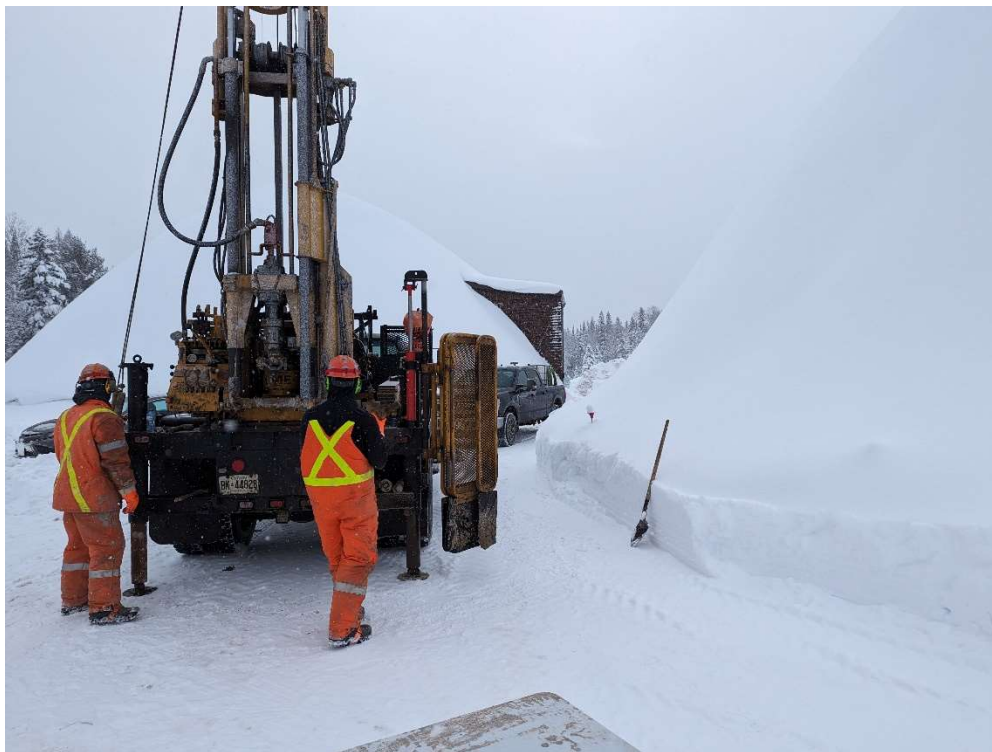
Photo 4. Dunchurch Patrol Yard – Drilling borehole BH23-D-4, facing south (January 18, 2024)

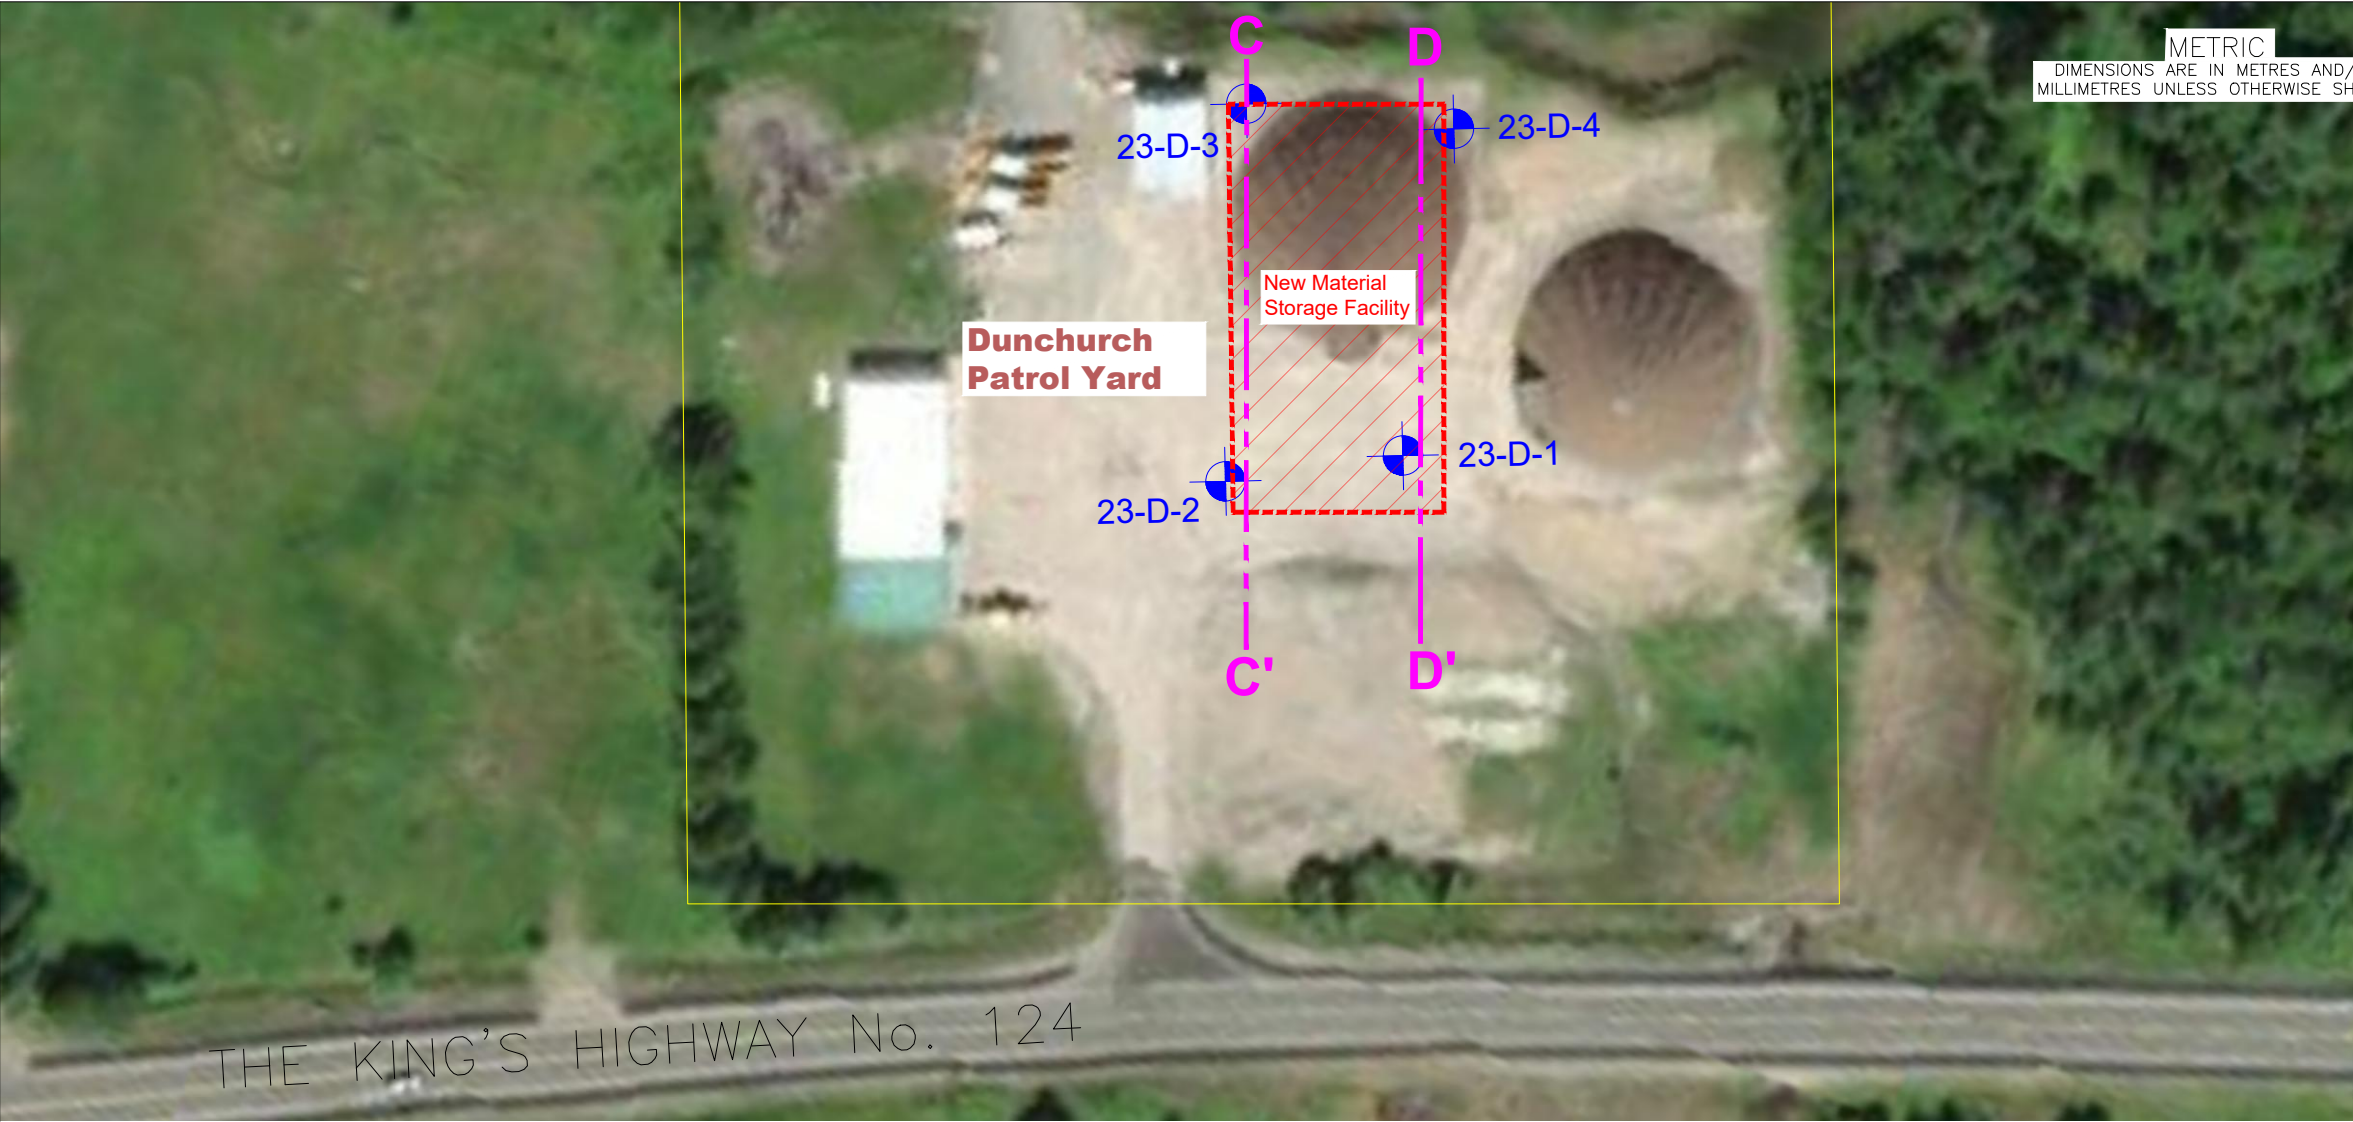
PLAN

SECTION  
C-C'

SECTION  
D-D'

A borehole location plan and cross section subsurface profiles are provided in Appendix B. It should be noted that the stratigraphic boundaries indicated on the borehole log and cross section stratigraphic profiles are inferred from semi-continuous sampling, observations of drilling progress and results of Standard Penetration Tests. These boundaries typically represent transitions from one soil type to another and should not be regarded as exact planes of geological change. Furthermore, subsurface conditions may vary between and beyond the borehole locations.

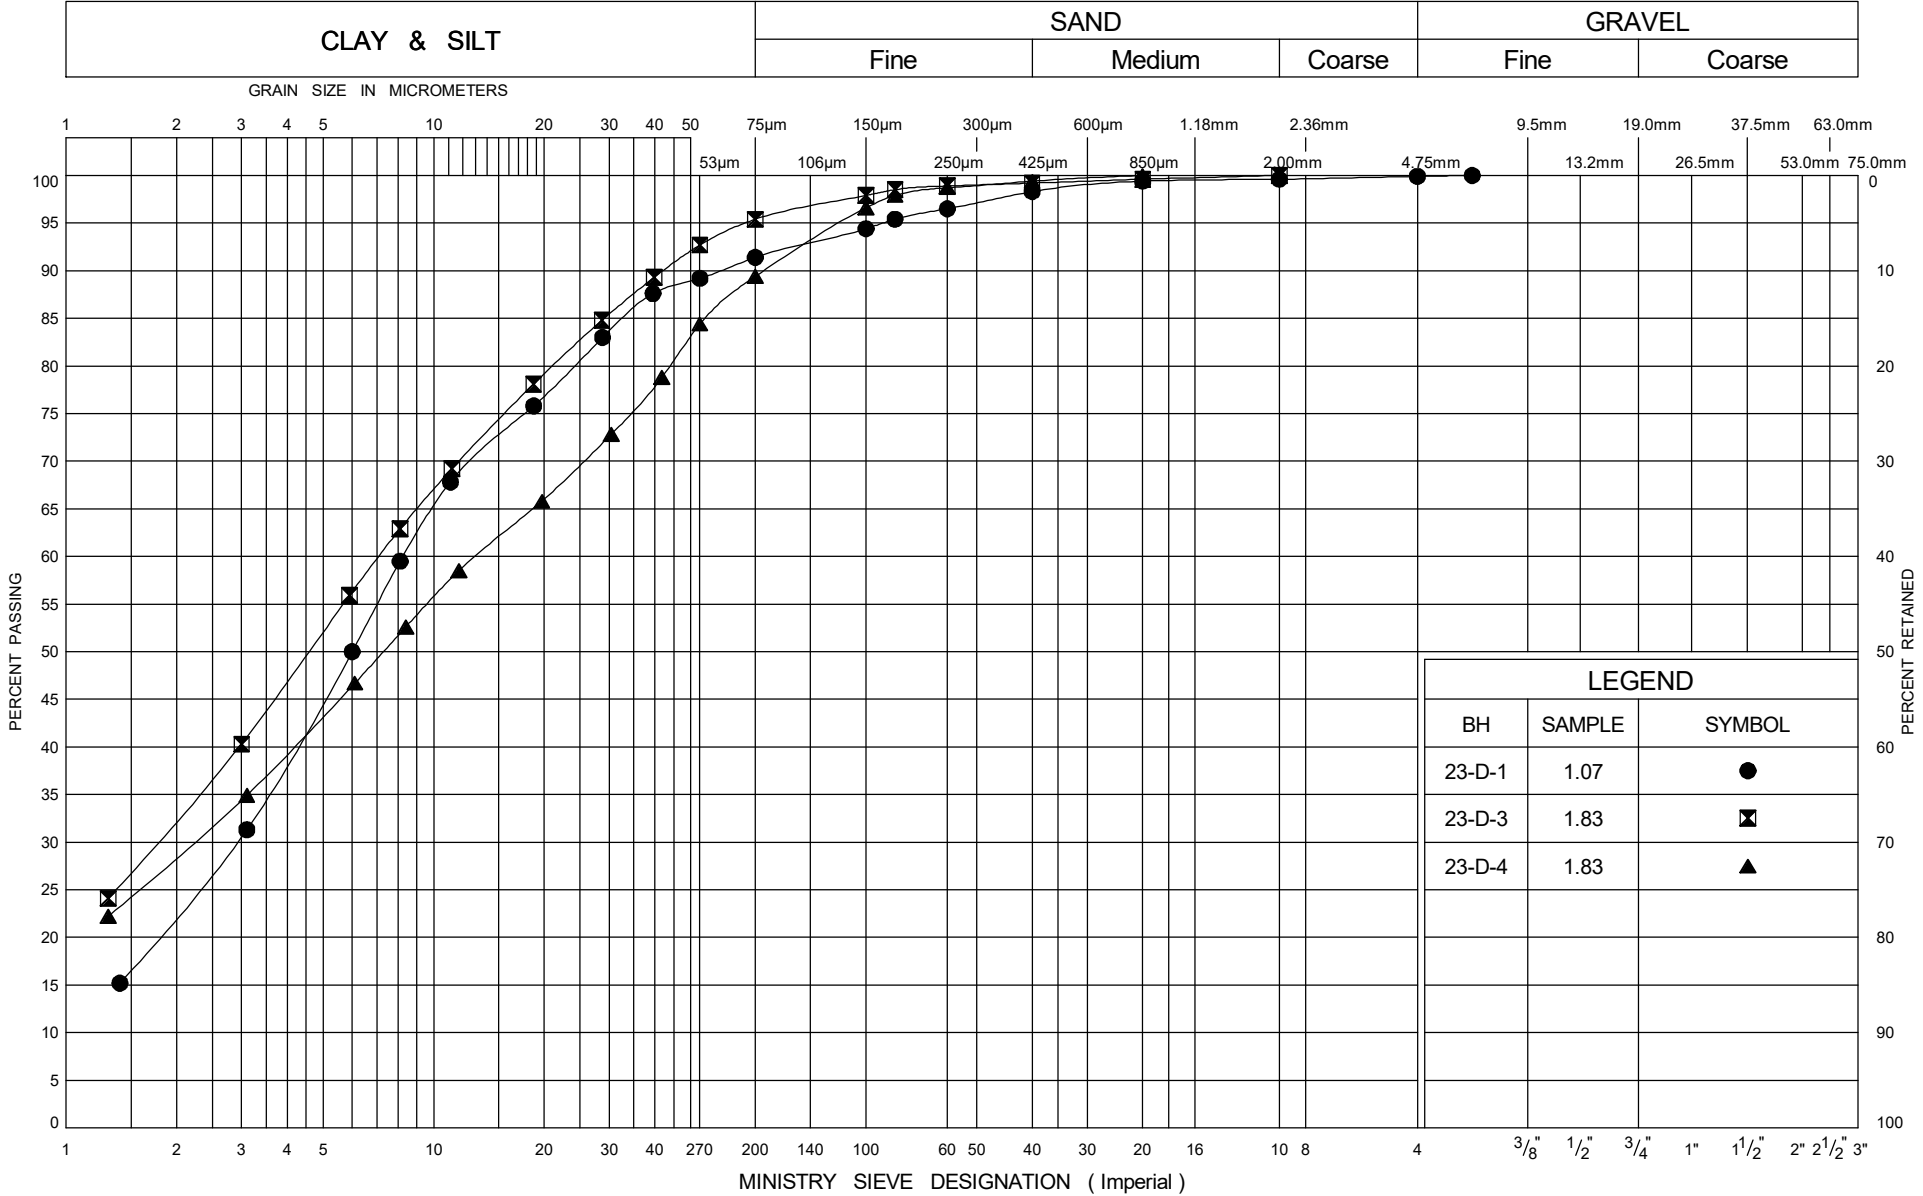
FIG No 1  
W P 5021-E-0020 Assign. #10  
Dunchurch Patrol Yard

GRAIN SIZE DISTRIBUTION  
Silty Clay / Clayey Silt

The results of the moisture content, grain size distribution, and Atterberg limits tests are provided on the record of borehole sheets in Appendix C. The results of the grain size distribution, and Atterberg limits tests are also provided on Figure 1, and Figure 3, respectively, in Appendix D.

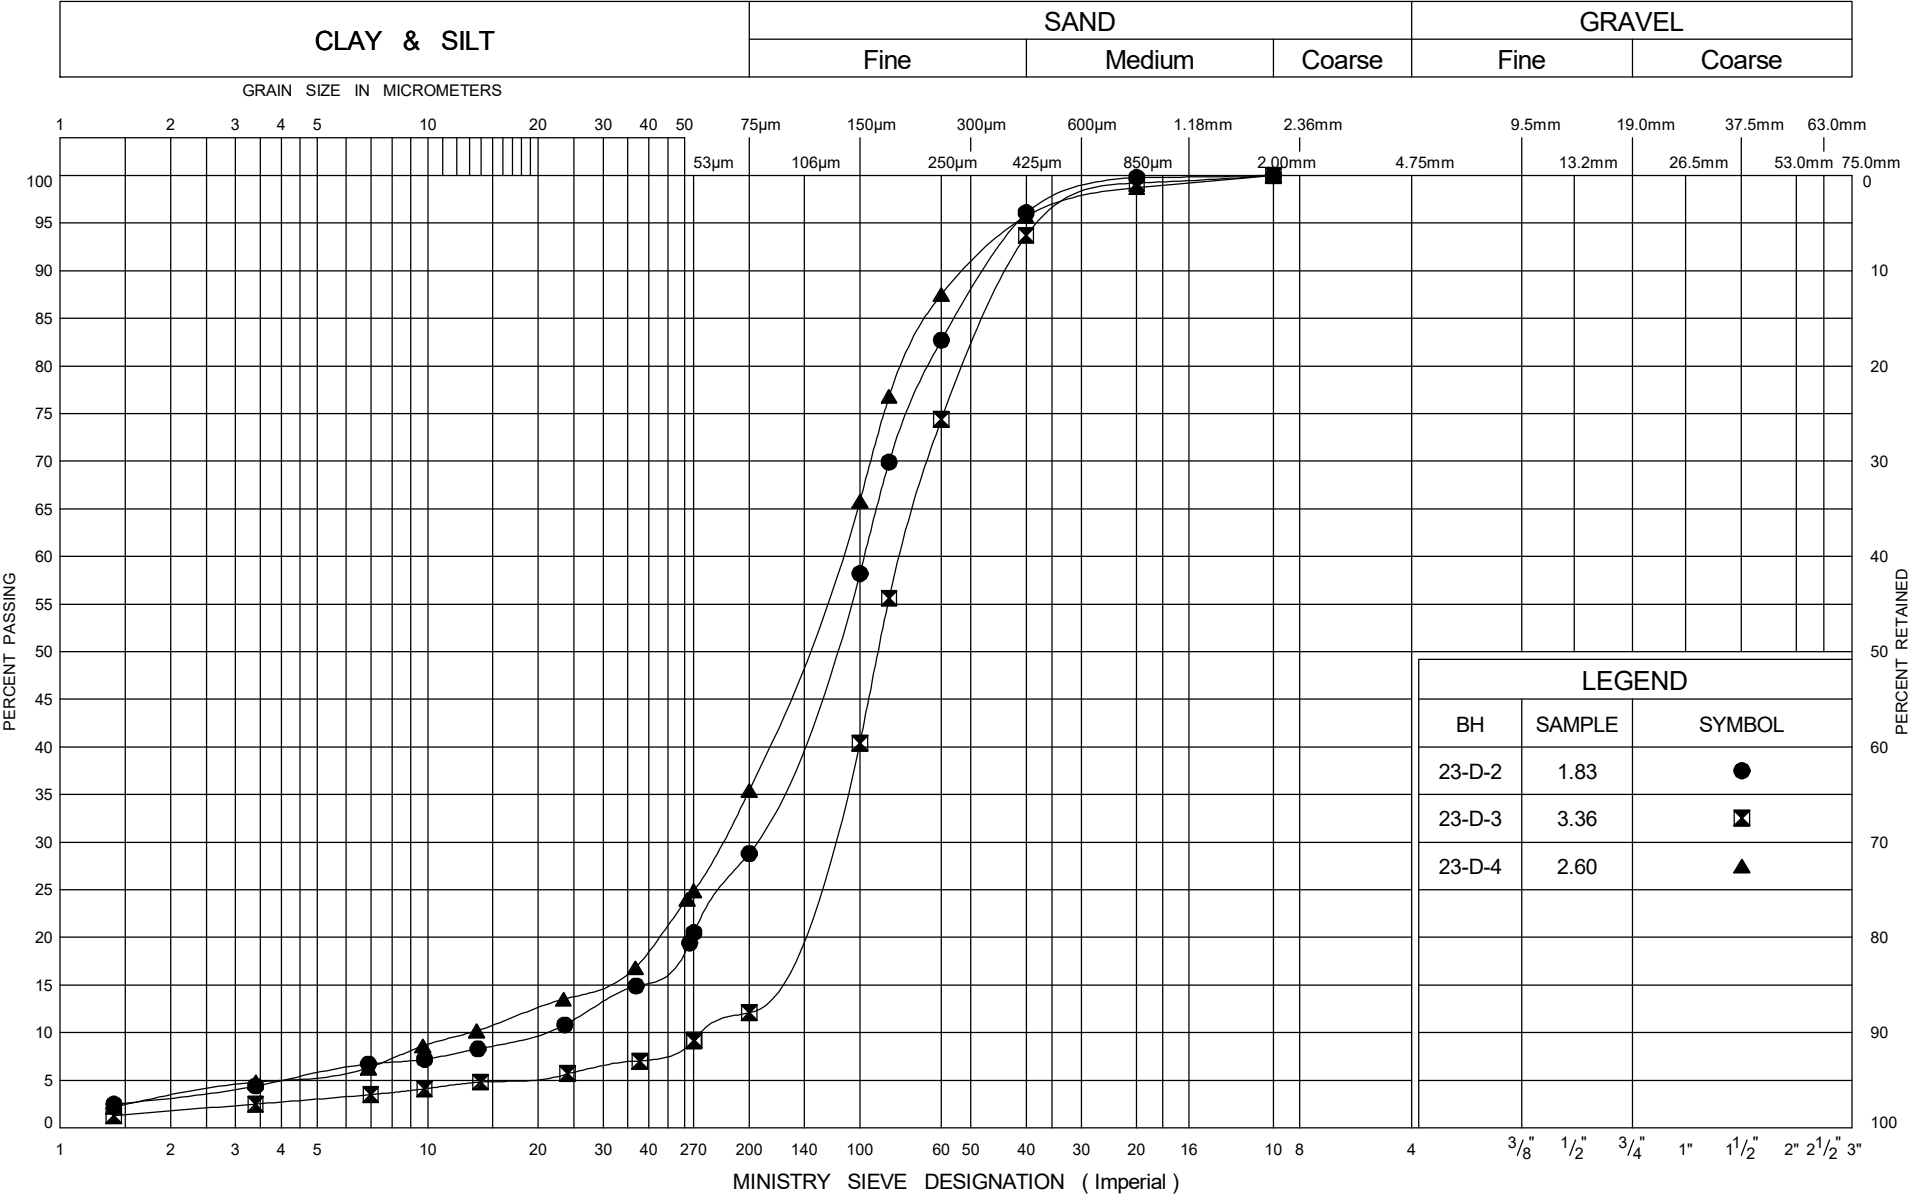
GRAIN SIZE DISTRIBUTION

The results of the moisture content and grain size distribution tests are provided on the record of borehole sheets in Appendix C. The results of the grain size distribution tests are also provided on Figure 2 in Appendix D.

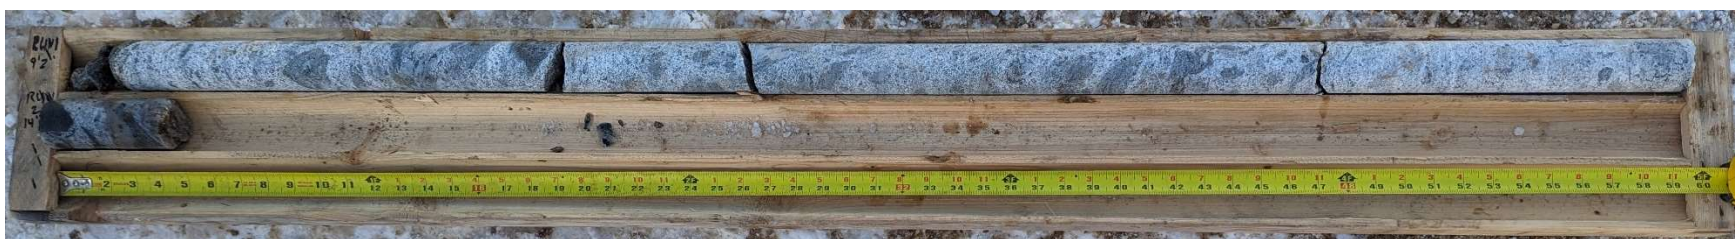
Figure E1. Bedrock core samples, BH23-D-1, Run 1 (top), Run 2 (middle), January 19, 2024

280.2	1.5	SAND, some silt, brown, wet, loose to compact	SS3	SS	9		279													
278.9	2.8	BEDROCK, dark grey to grey with quartz veining  Run 1: Start/End: 2.8 to 4.3 m Recovery: 100% RQD: 95%  Run 2: Start/End: 4.3 to 4.5 m Recovery: 83% RQD: 83%	RUN 1	NQ			278

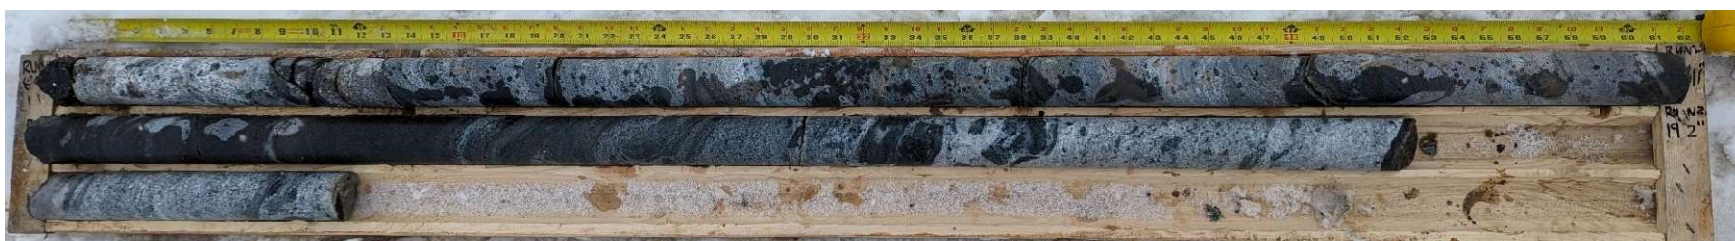
Figure E2. Bedrock core samples, BH23-D-2, Run 1 (top), Run 2 (middle), January 18, 2024

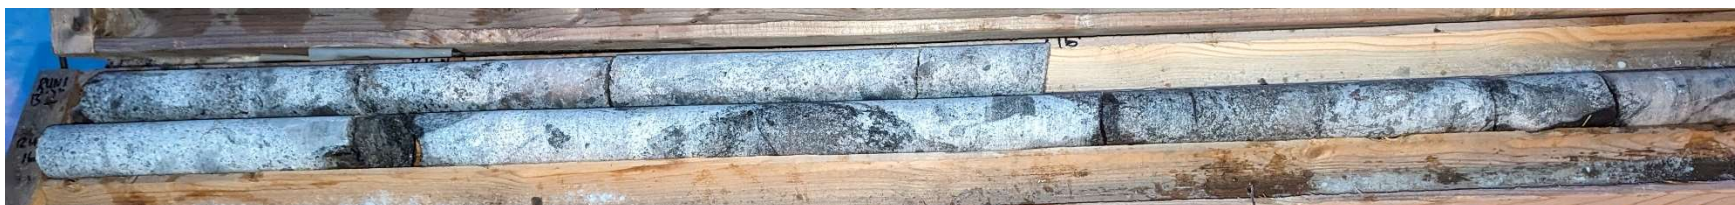
Figure E3. Bedrock core samples, BH23-D-3, Run 1 (top), Run 2 (middle), January 18, 2024

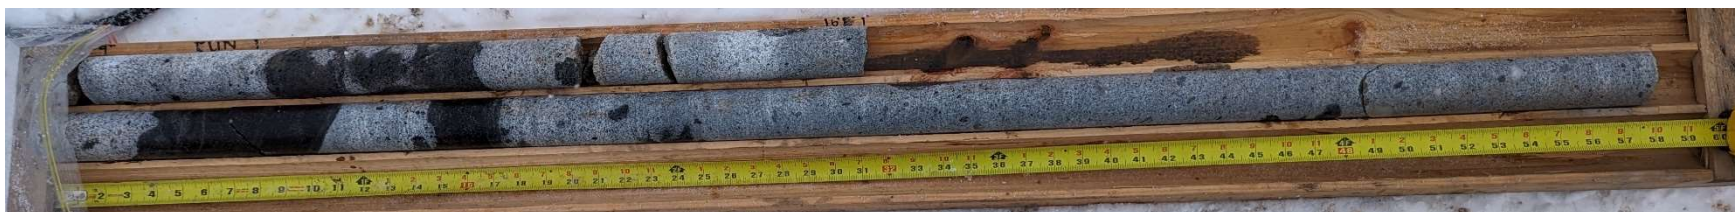
Figure E4. Bedrock core samples, BH23-D-4, Run 1 (top), Run 2 (middle), January 18, 2024
