Foundation Investigation Report

*Highway 11 – 2+1 Roadway Model Project: **Site SW12***

Assignment No. 5021-E-0038
GWP 5033-22-00
Geocres No. 31L13-008
(Latitude: 46.834600; Longitude: -79.797120)

Final Report

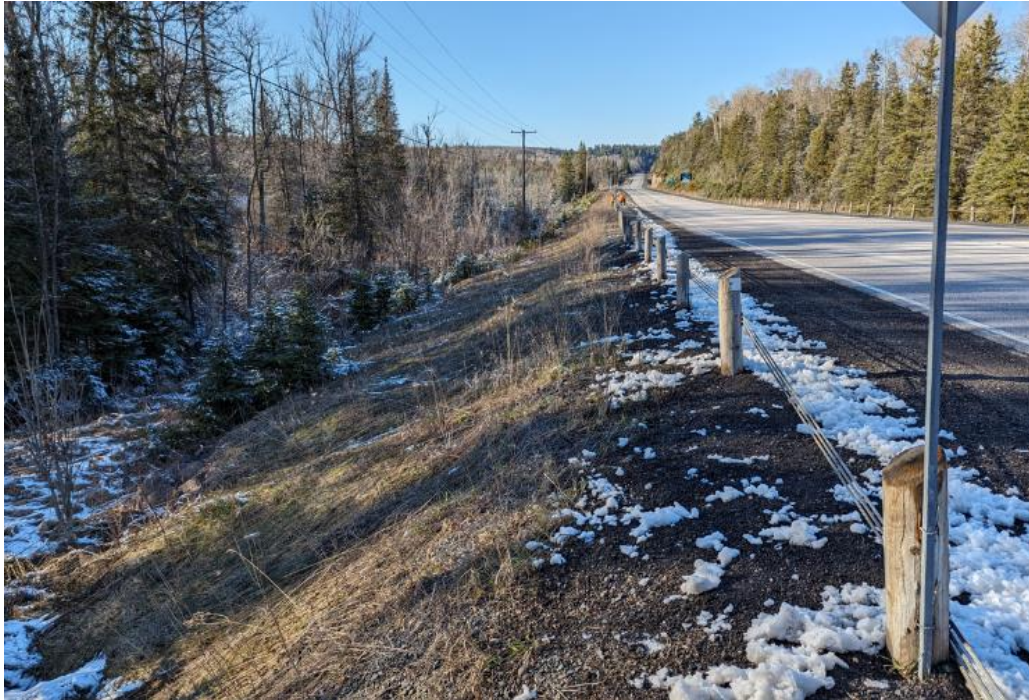
Photograph 1. Roadway surface and shoulder, embankment side slope, and ground conditions beyond embankment toe along SBL (west) side, looking north (April 24, 2024)

Photographs 1 to 12 in Appendix A depict the site, culvert, road, and activities during drilling, taken by EXP between May and July 2024. Photographs 1 and 2 show the existing roadway surface shoulder, embankment side slope, and ground conditions/vegetation beyond embankment toe along the SBL side as well as the overhead power lines running adjacent to the SBL. Photographs 3 and 4 show the existing roadway surface and shoulder, cut side slope, bedrock outcrops and ground conditions/vegetation beyond the embankment toe along the NBL side. Photograph 5 shows the drilling of borehole BH12-3 which required the use of mats for access, while Photograph 6 shows the drilling of borehole BH12-11 with the Explo portable rig which was placed on a platform constructed on the swampy ground surface. Photograph 7 shows the locations of boreholes BH12-5, BH12-11, and BH-13, which needed to be accessed using an Argo ATV via the marshy and watery terrain. Photographs 8 and 9 show the inlet and outlet of the existing culvert and the surrounding area of the west and east side of the highway embankment, including the existing rip rap and vegetation. Photograph 10 was taken in May and shows the creek on the east side of the highway. Photographs 11 and 12 show the inlet and outlet of the existing CSP culvert, respectively.

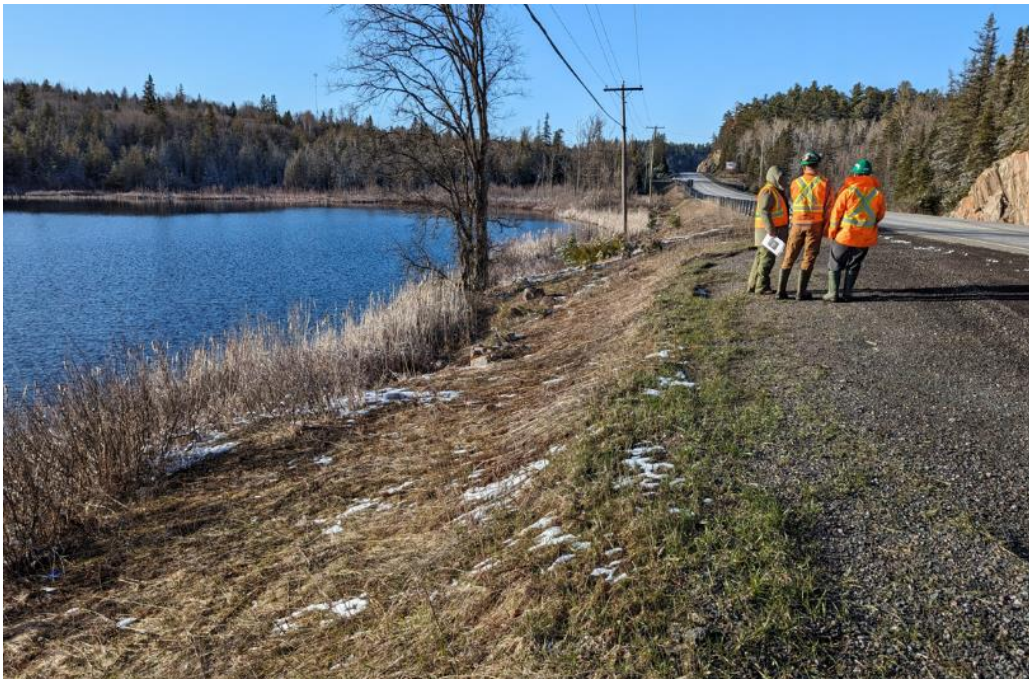
Photograph 2. Roadway surface and shoulder, embankment side slope, and ground conditions beyond embankment toe along SBL (west) side, looking north (April 24, 2024)

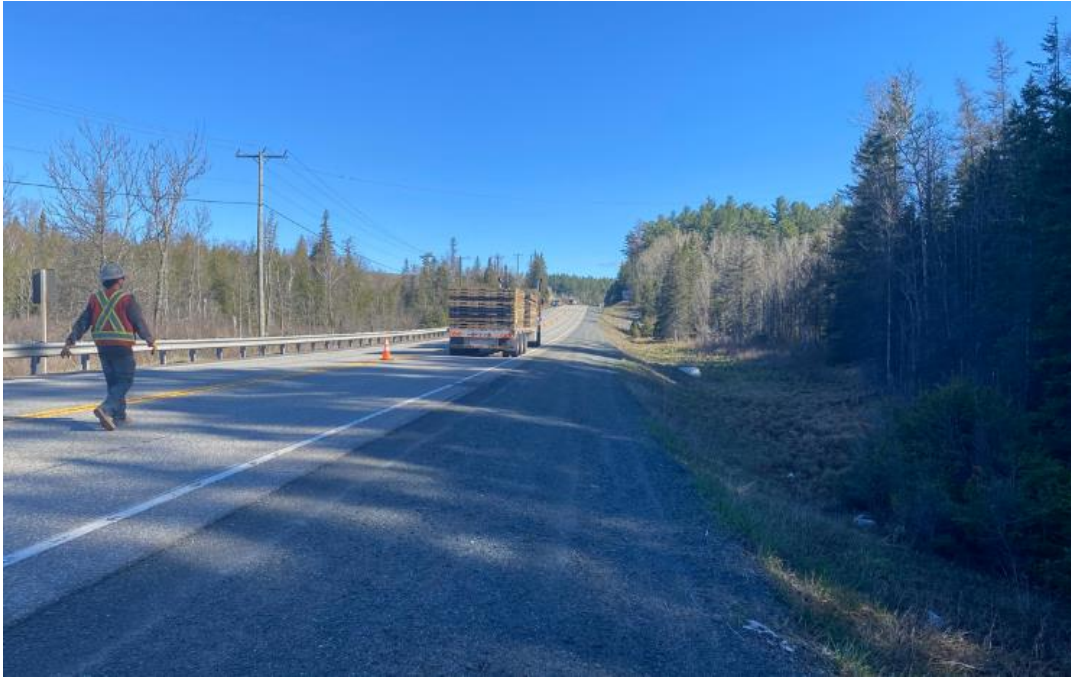
Photograph 3. Roadway surface and shoulder, embankment side slope, and ground conditions beyond embankment toe along NBL (east) side, looking north (May 6, 2024)

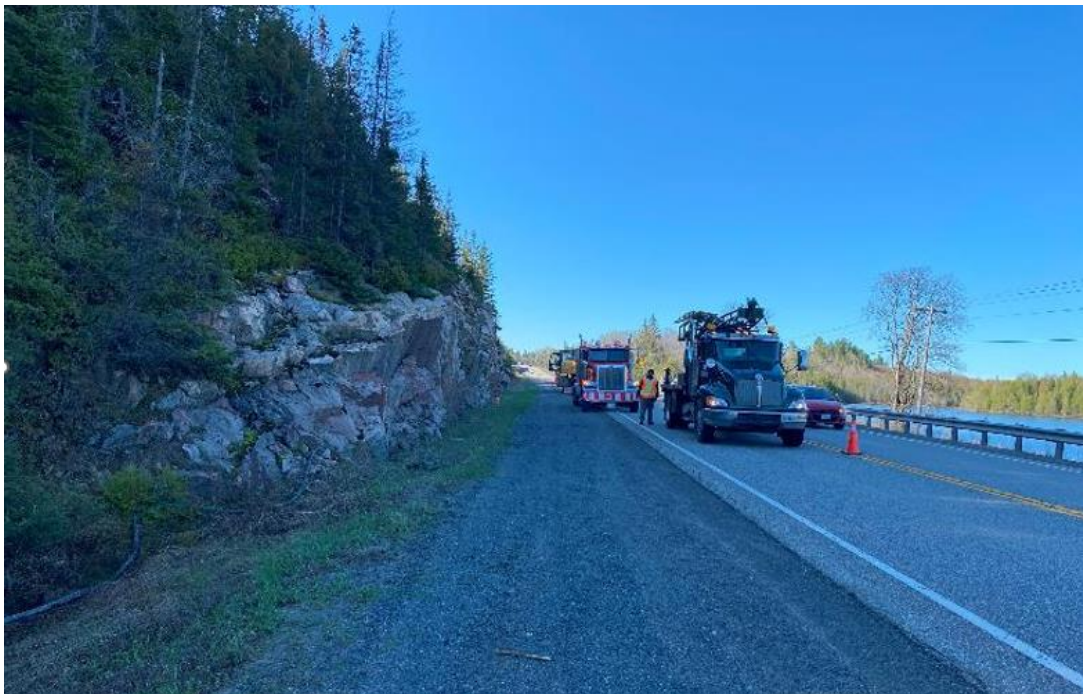
Photograph 4. Roadway surface and shoulder SBL (west) side, looking south (May 8, 2024)

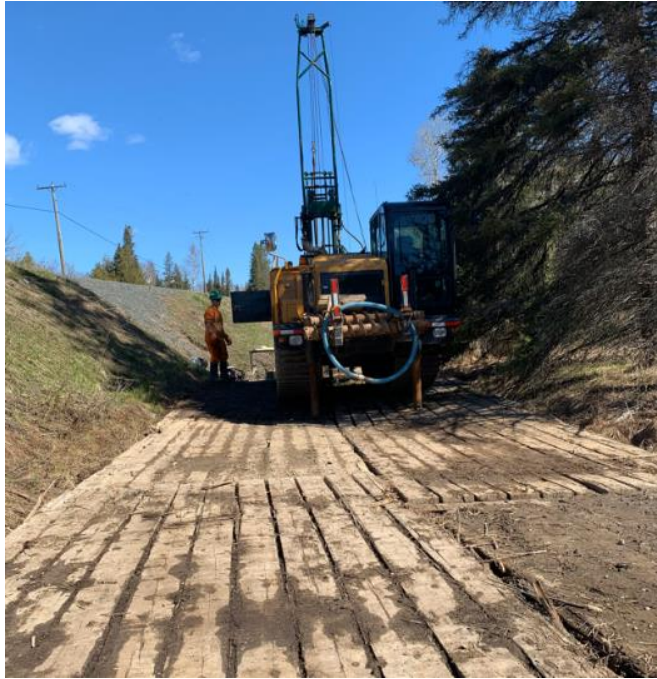
Photograph 5. East side of embankment at Borehole BH12-3 Location facing north (May 7, 2024)

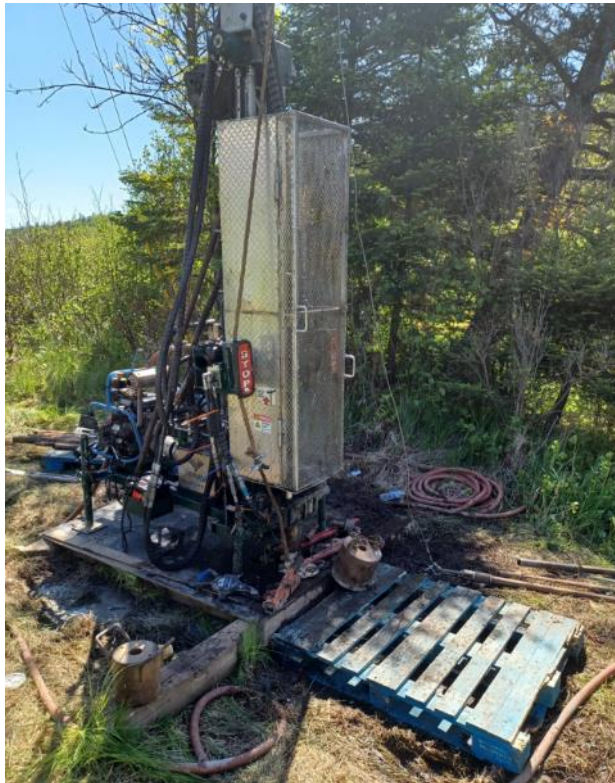
Photograph 6. West side of embankment at Borehole BH12-5 Location facing west (June 5, 2024)

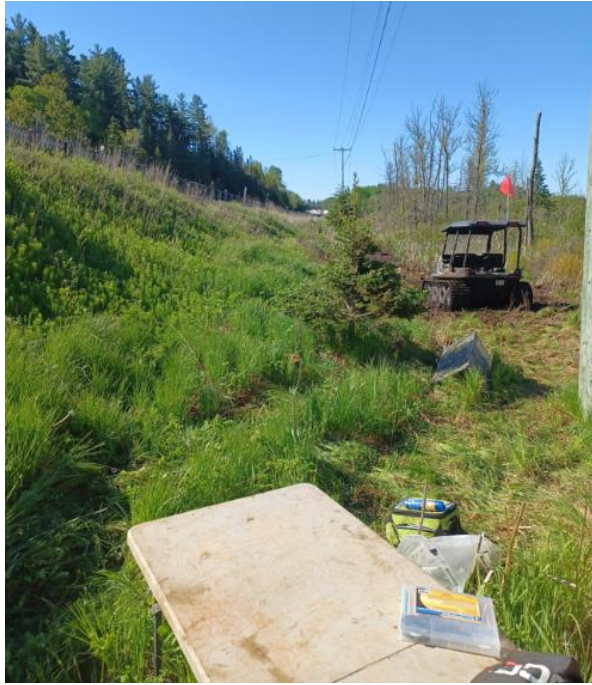
Photograph 7. West side of embankment at Borehole BH12-5 Location facing south (June 5, 2024)

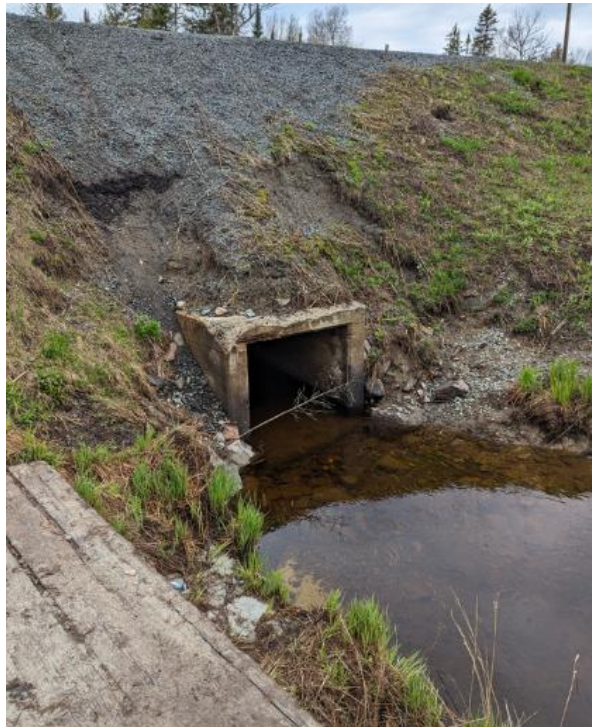
Photograph 8. Concrete box culvert inlet and east side of embankment, facing west (May 7, 2024)

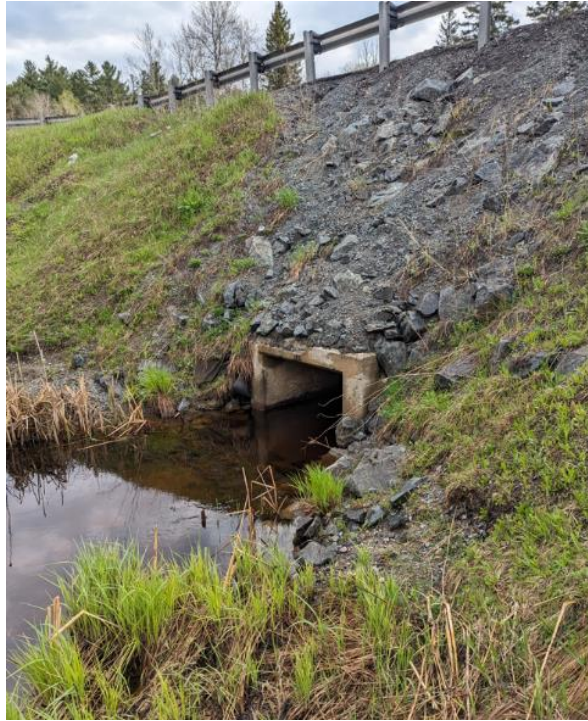
Photograph 9. Culvert outlet and west side of embankment, facing northeast (May 7, 2024)

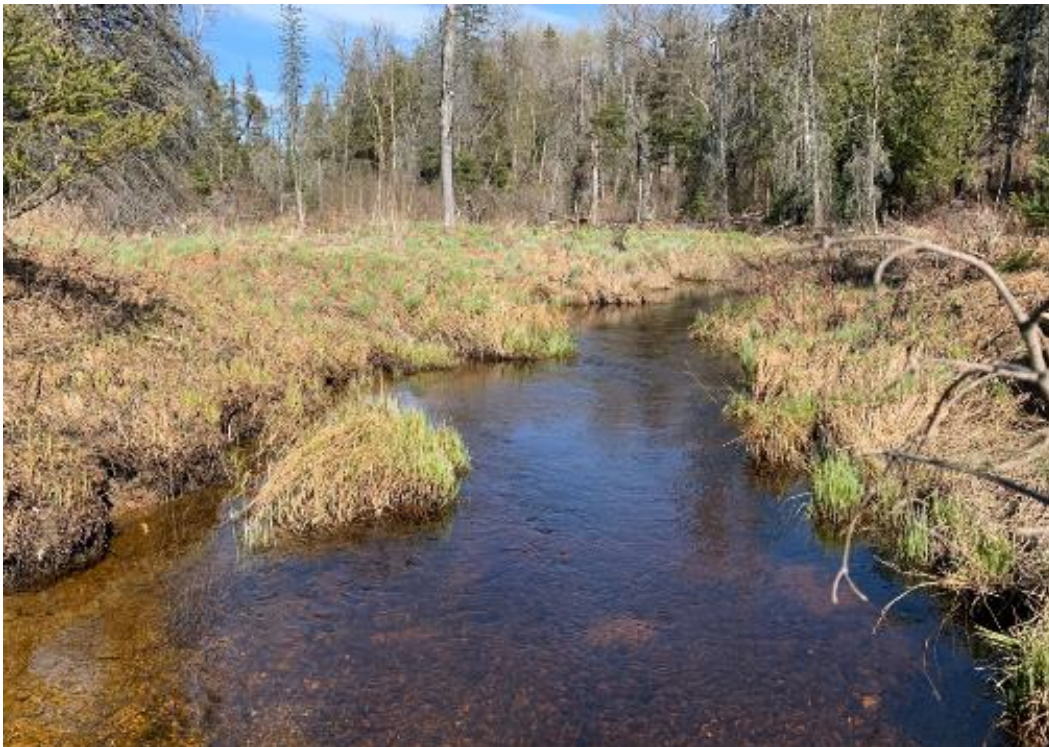
Photograph 10. Concrete box culvert outlet and west side of embankment, facing east (May 7, 2024)

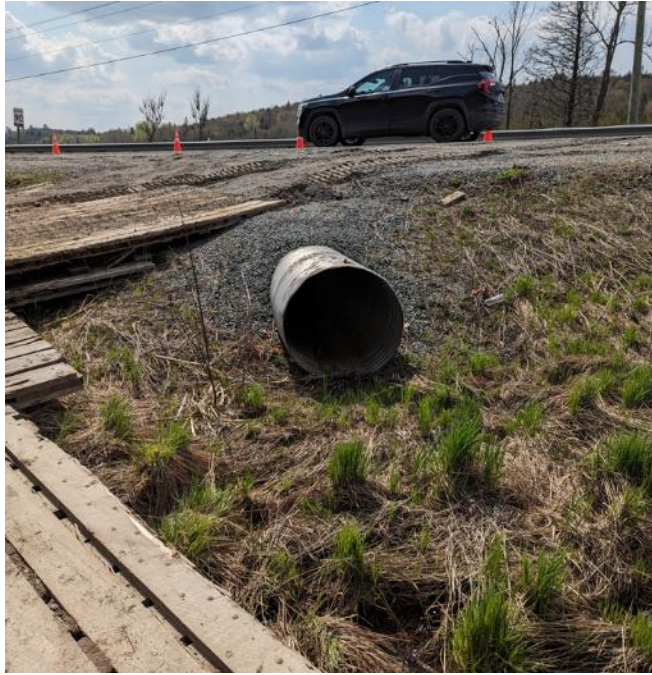
Photograph 11. Corrugated steel pipe culvert inlet and east side of embankment, facing west (May 7, 2024)

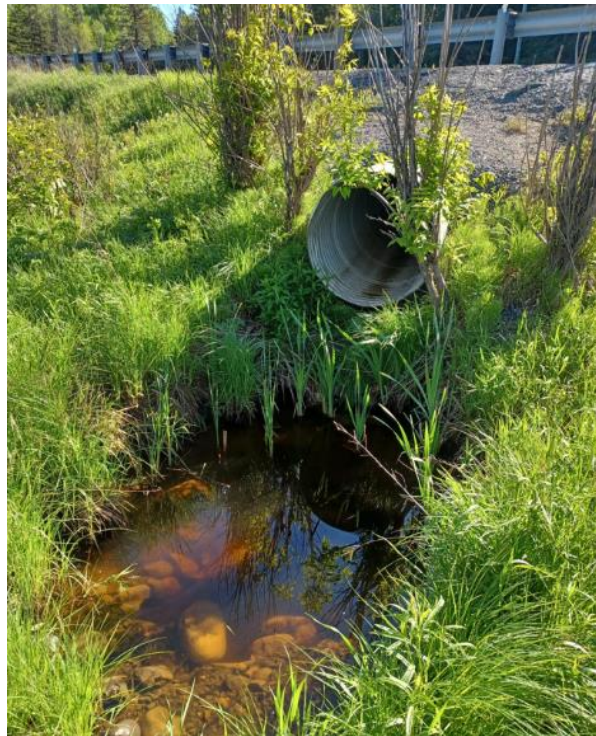
Photograph 12. Corrugated steel pipe culvert outlet and west side of embankment, facing east (May 7, 2024)

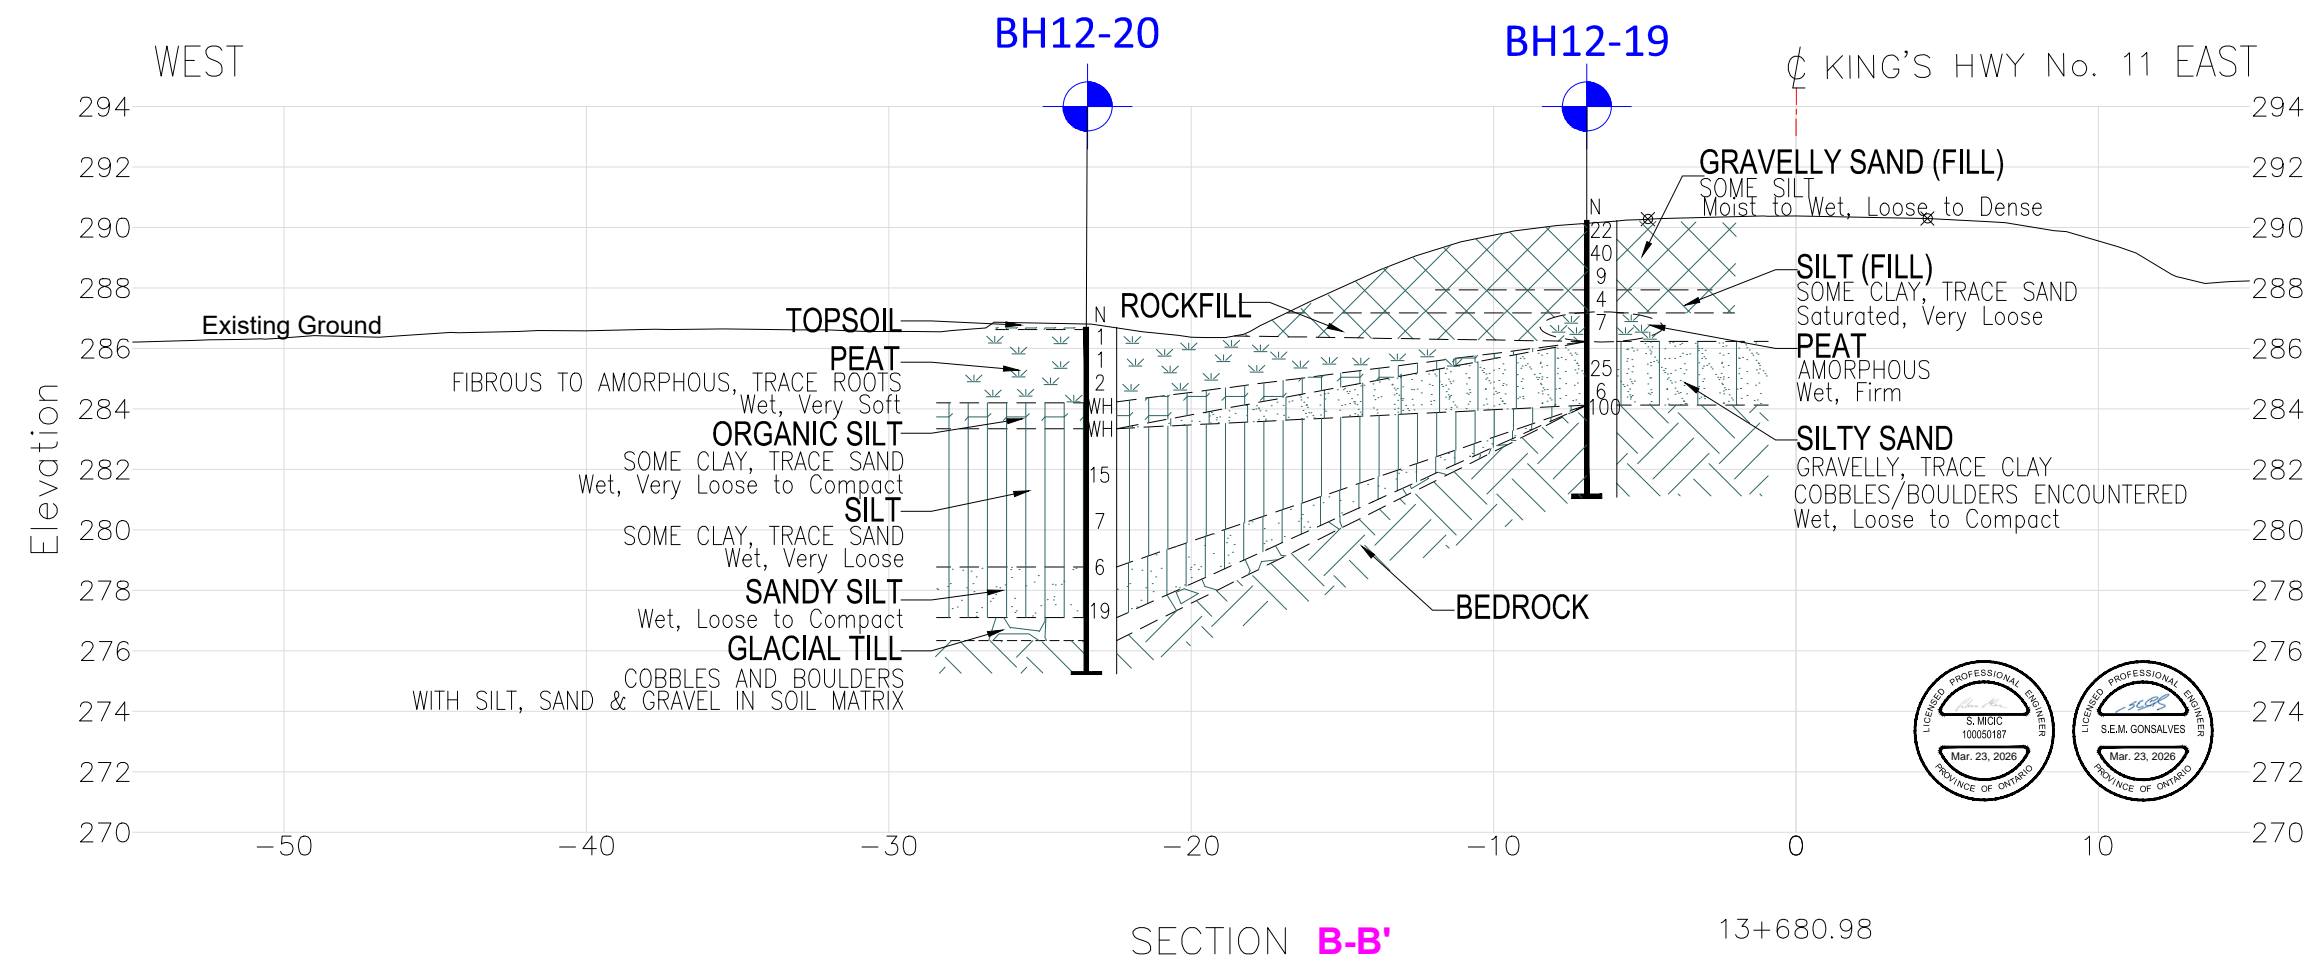
SHEET
2

PLAN

SECTION B-B'

A borehole location plan and cross section subsurface profiles are provided in Appendix B. It should be noted that the stratigraphic boundaries indicated on the borehole log and cross section stratigraphic profiles are inferred from semi-continuous sampling, observations of drilling progress and results of Standard Penetration Tests (SPT). These boundaries typically represent transitions from one soil type to another and should not be regarded as exact planes of geological change. Furthermore, subsurface conditions may vary between and beyond the borehole locations.

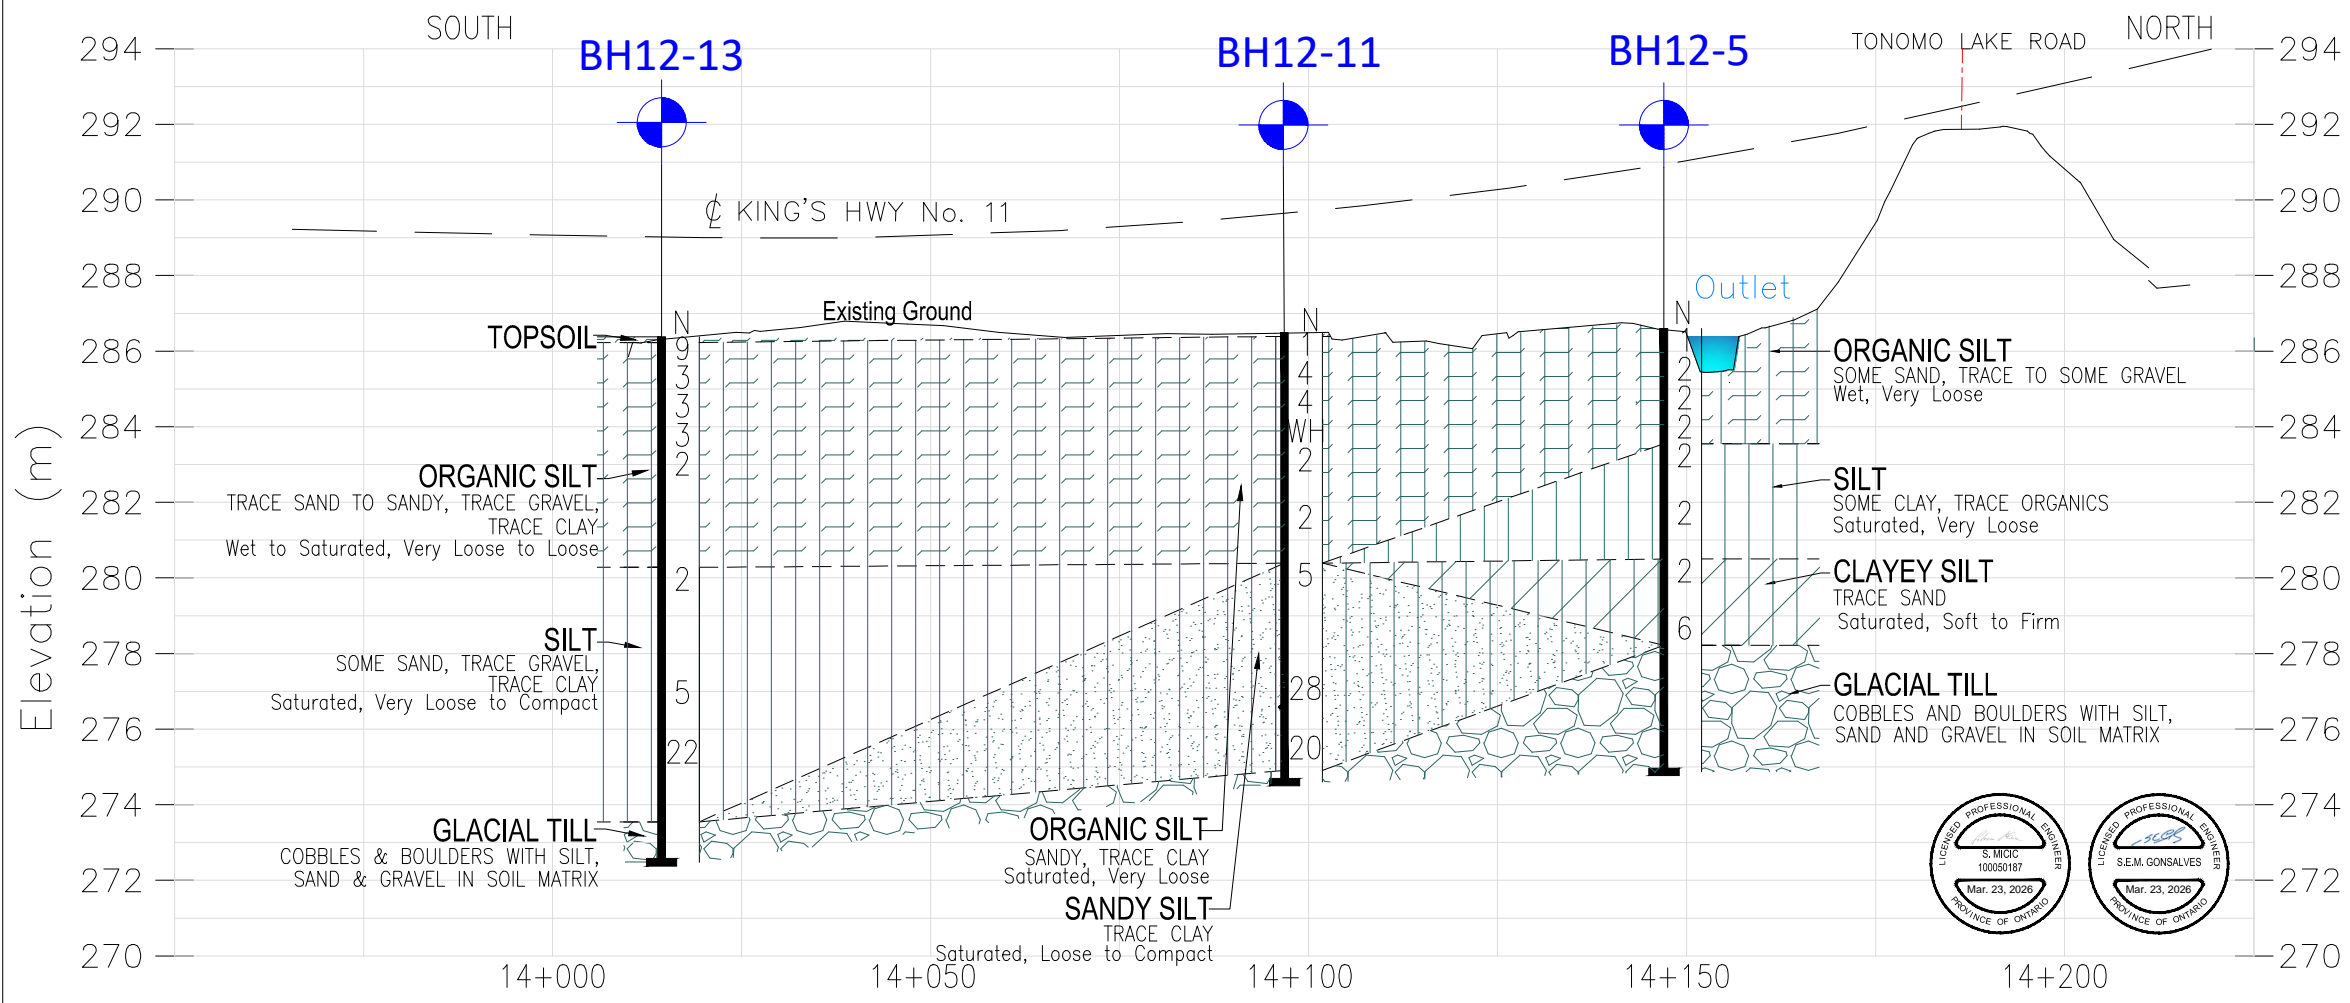
PLAN

SECTION C-C'

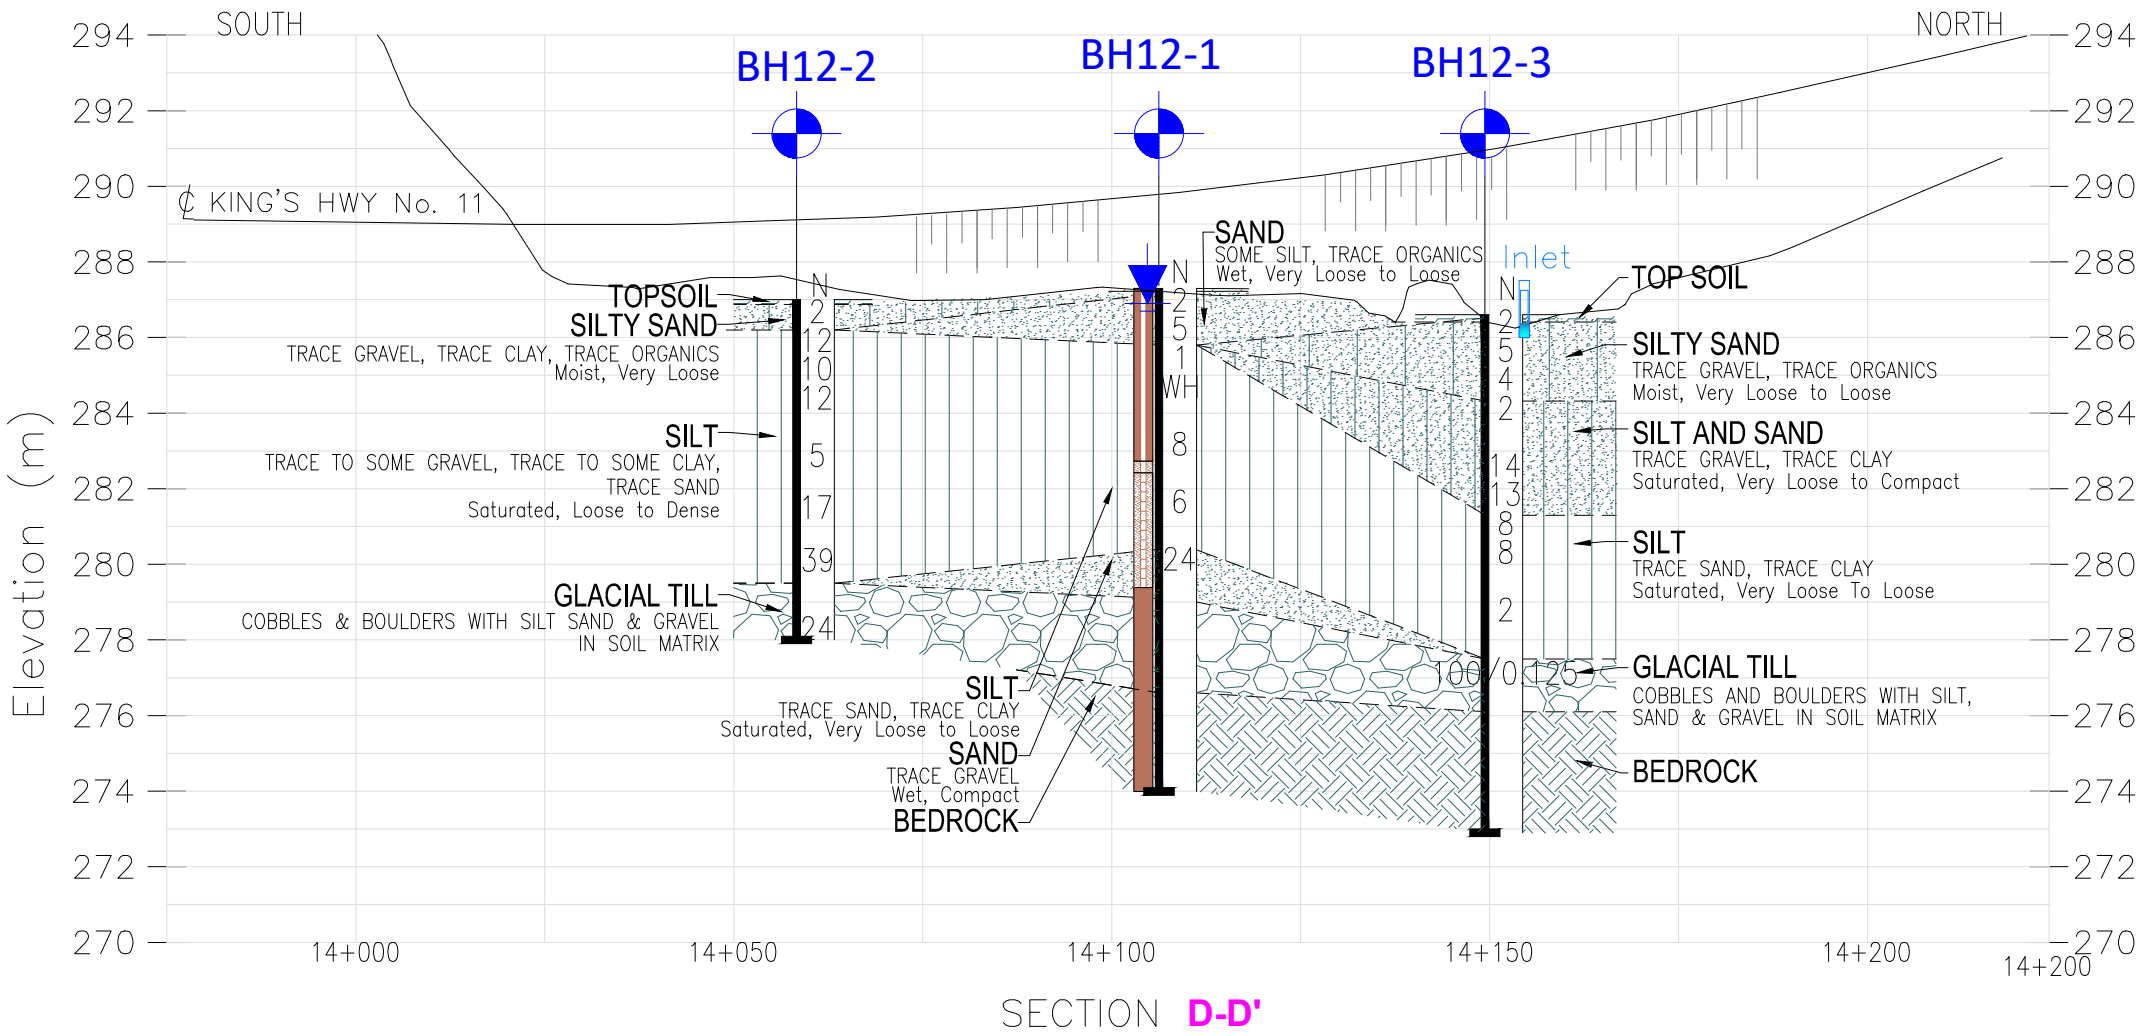
PLAN

SECTION D-D'

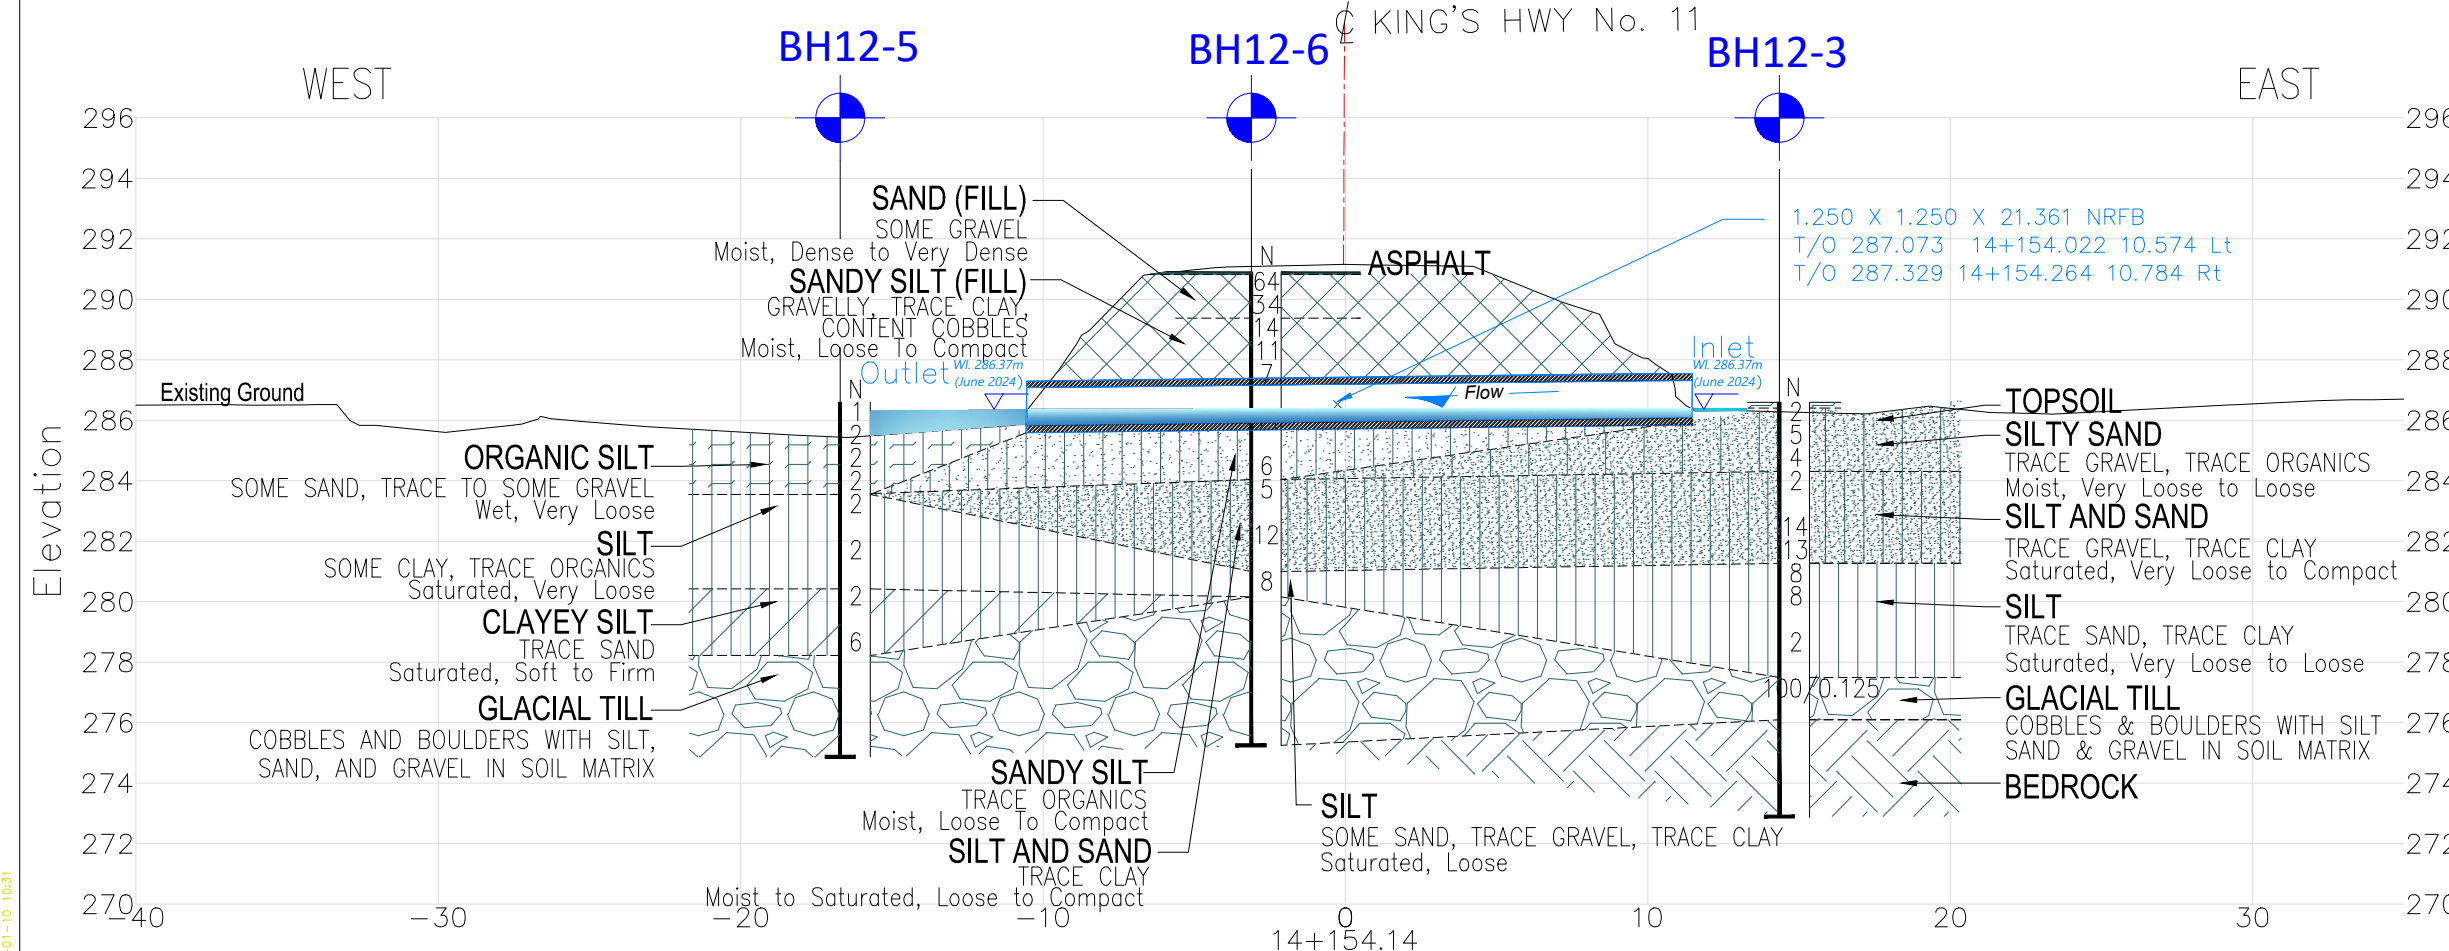
PLAN

SECTION E-E'

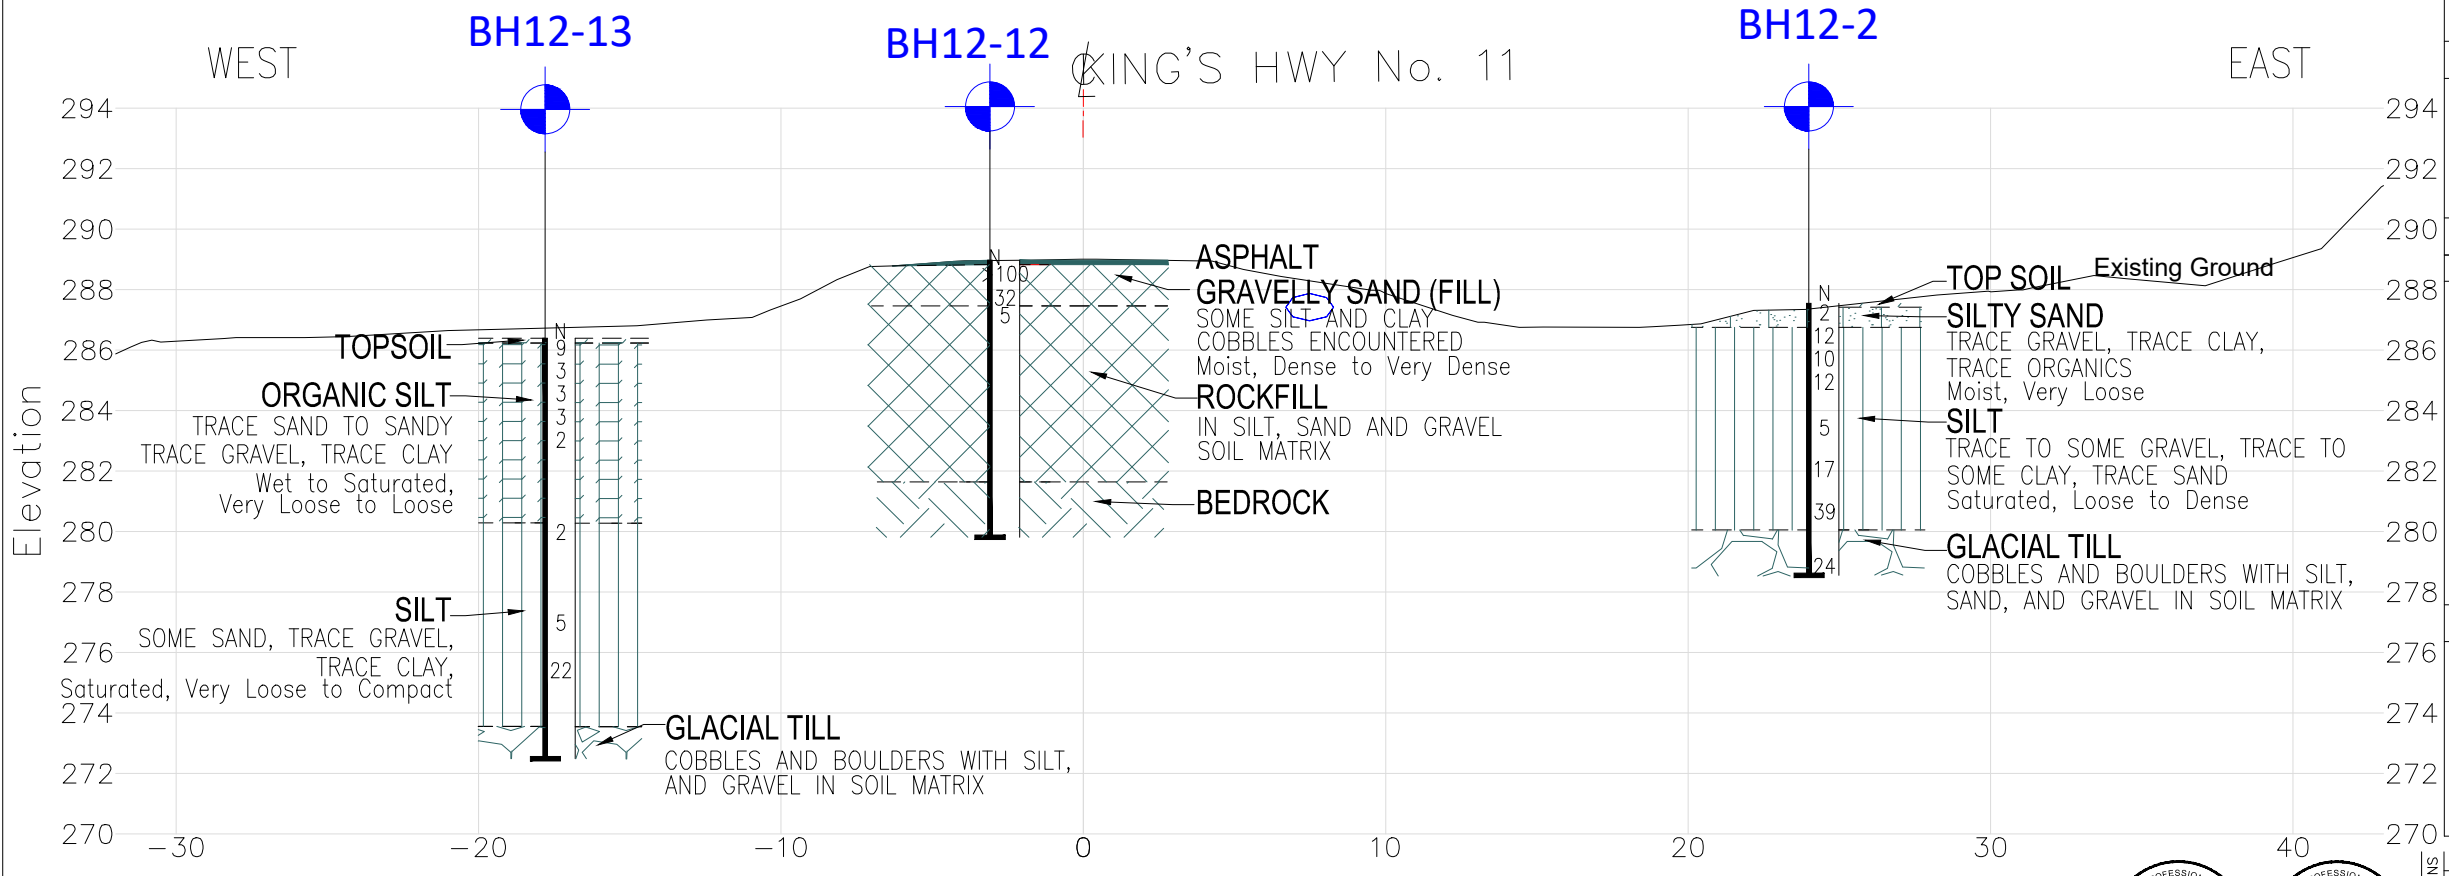
PLAN

SECTION F-F'

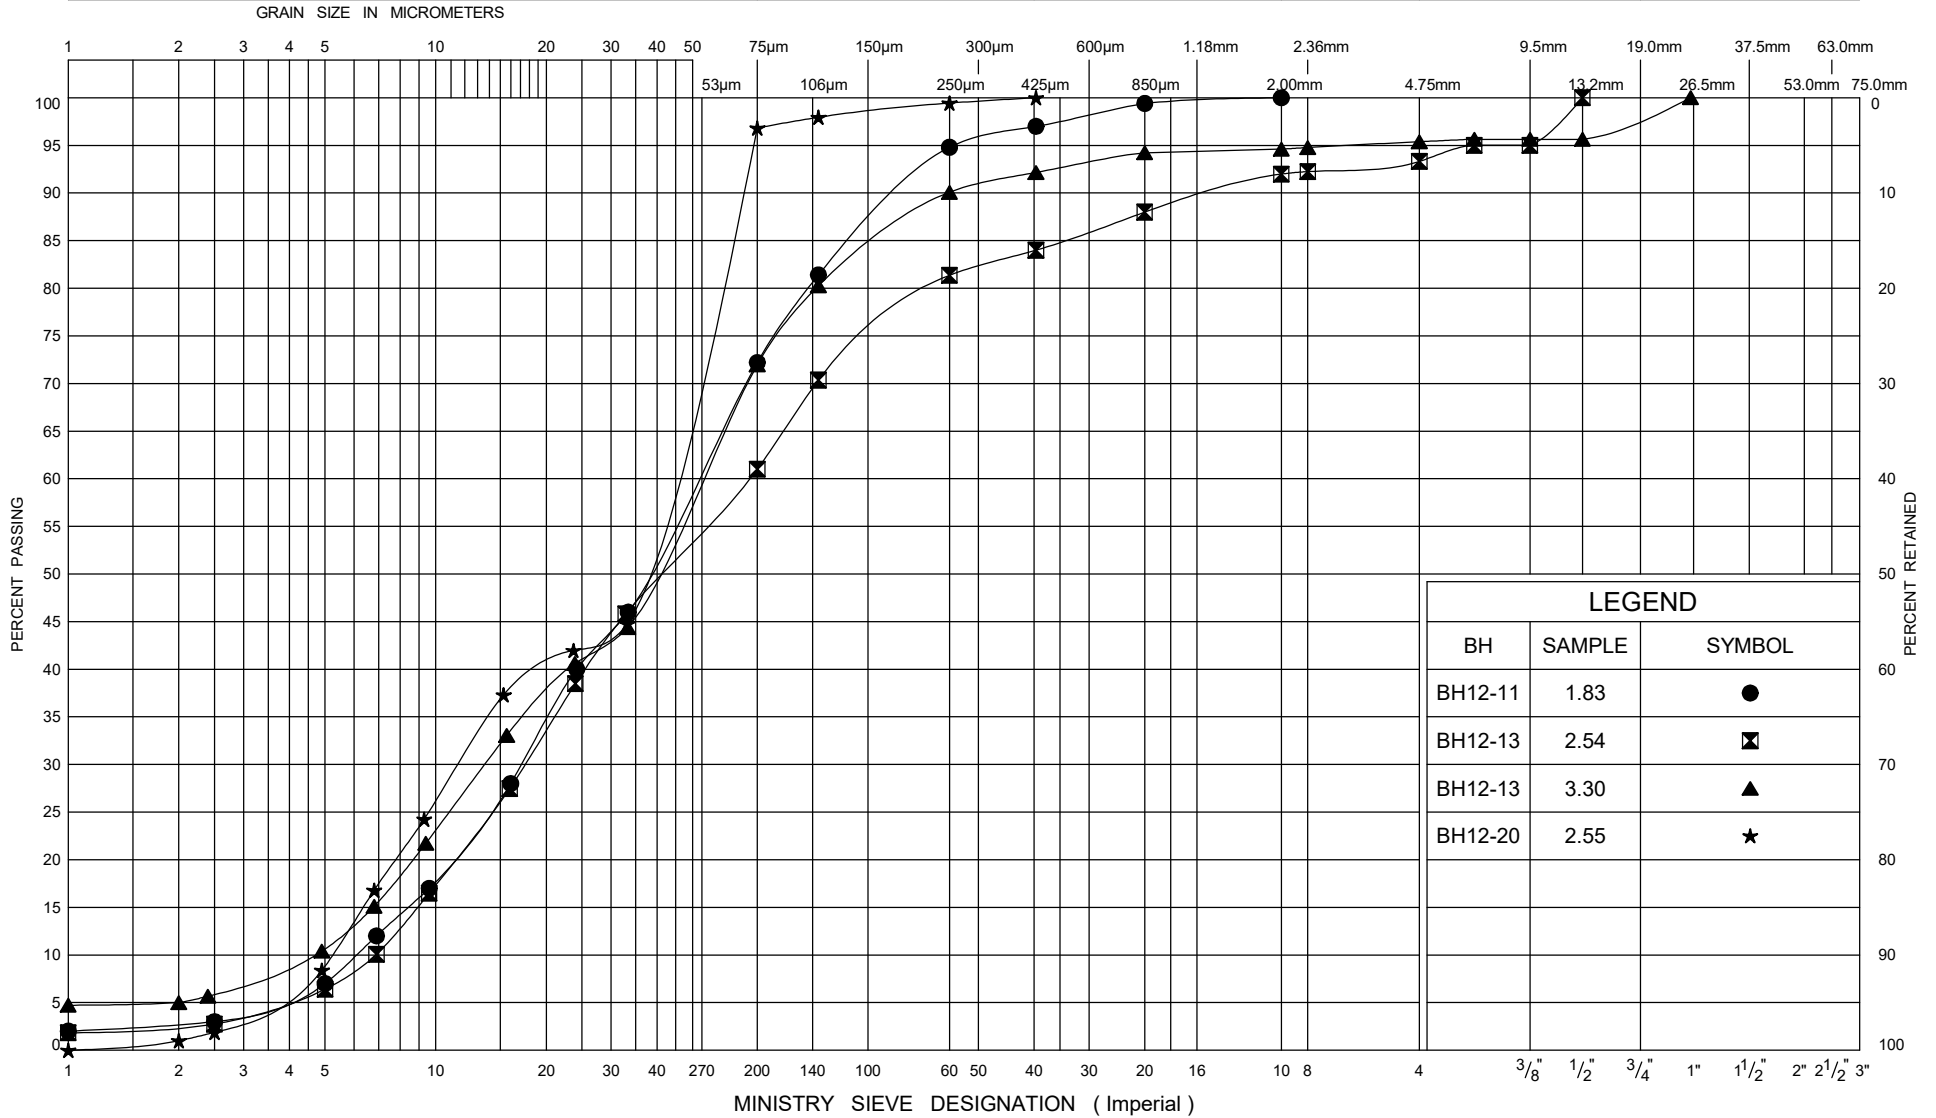
FIG No 1
 GWP 5033-22-00
 Highway 11 2+1, SW12

LEGEND		
BH	SAMPLE	SYMBOL
BH12-11	1.83	●
BH12-13	2.54	⊠
BH12-13	3.30	▲
BH12-20	2.55	★

The results of the moisture content, organic content, grain size distribution, and Atterberg limit tests are provided on the record of borehole sheets in Appendix C. The results of the grain size distribution tests are also provided on Figure 1 in Appendix D.
