Foundation Investigation Report

*Highway 11 – 2+1 Roadway Model Project: **Site SW12***

Assignment No. 5021-E-0038
GWP 5033-22-00
Geocres No. 31L13-008
(Latitude: 46.834600; Longitude: -79.797120)

Final Report

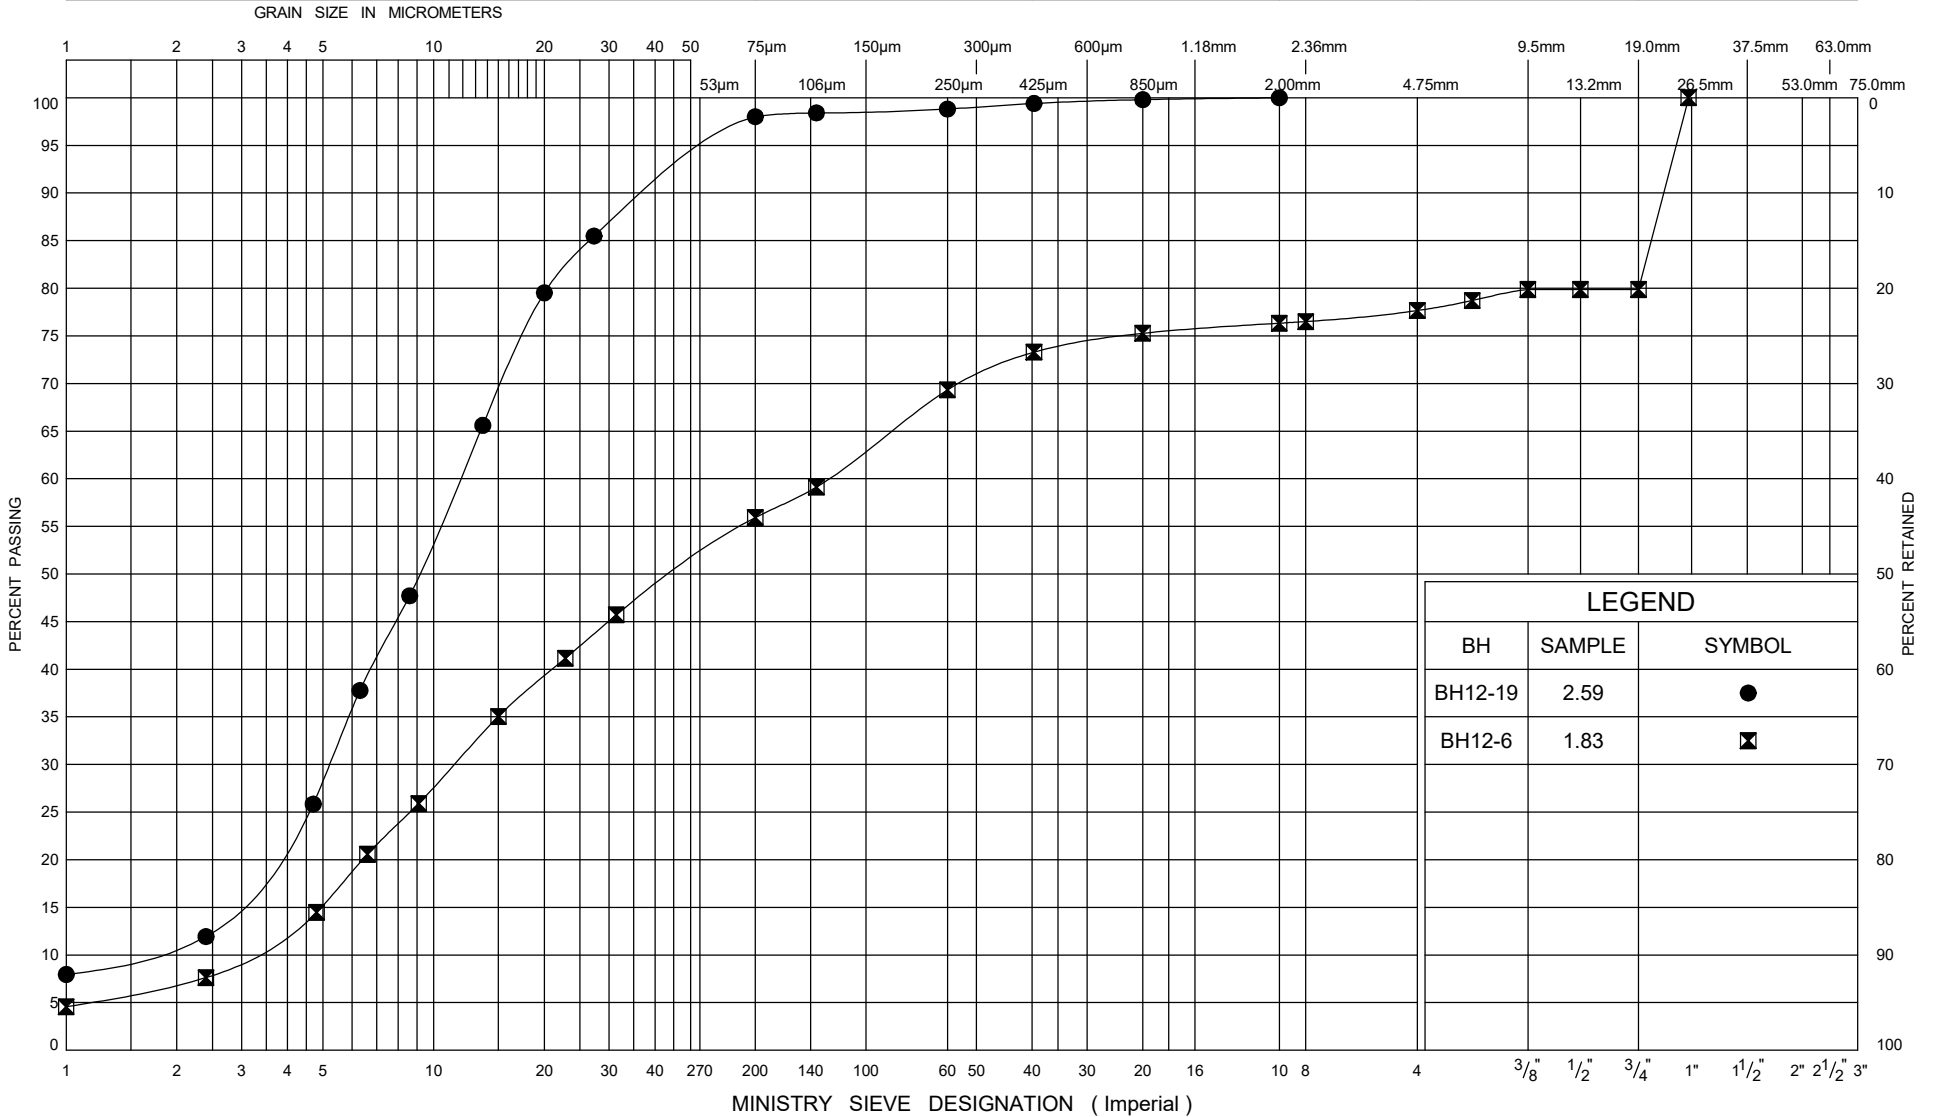
LEGEND		
BH	SAMPLE	SYMBOL
BH12-19	2.59	●
BH12-6	1.83	⊠

The results of the moisture content and grain size distribution tests are provided on the record of borehole sheets in Appendix C. The results of the grain size distribution test are also provided on Figure 3 in Appendix D.

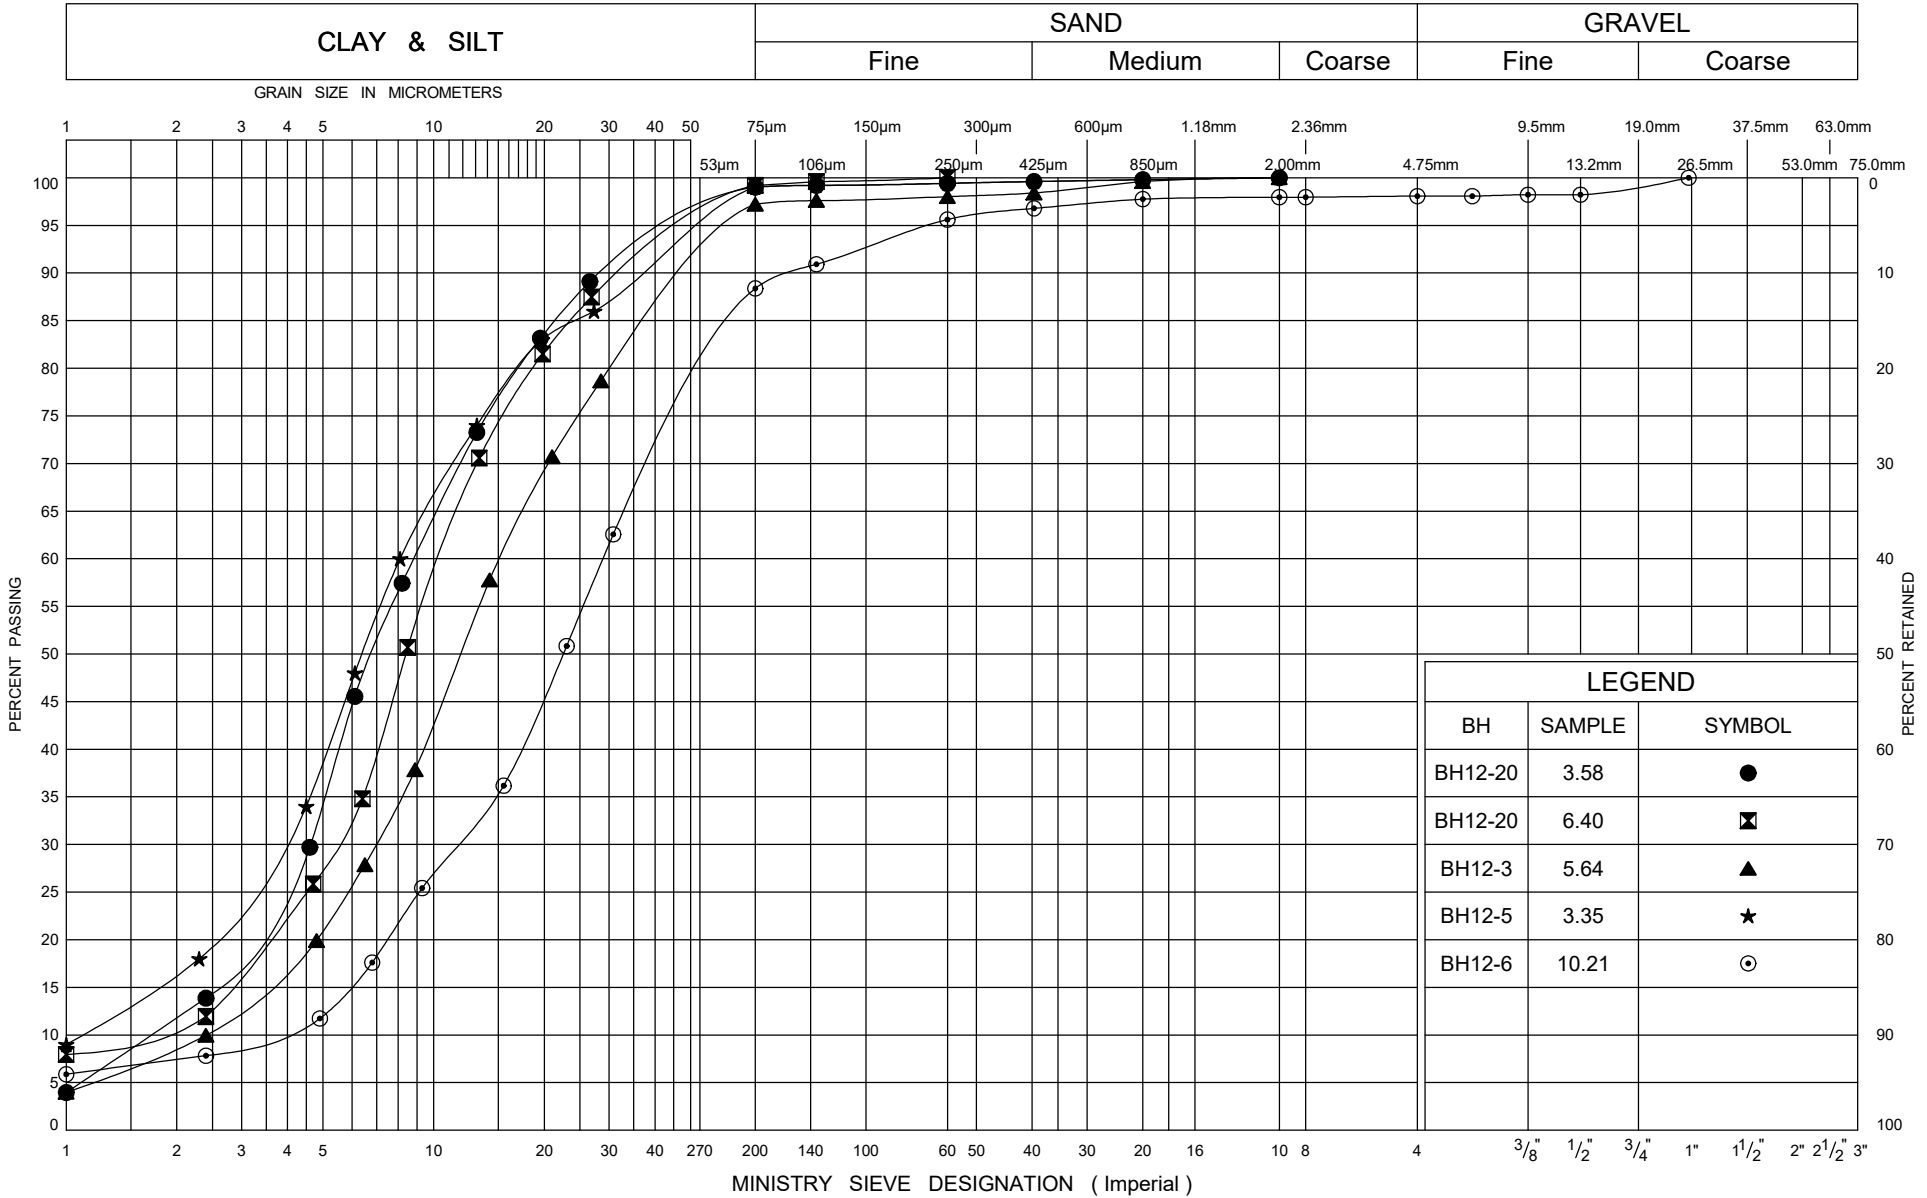
LEGEND		
BH	SAMPLE	SYMBOL
BH12-20	3.58	●
BH12-20	6.40	⊠
BH12-3	5.64	▲
BH12-5	3.35	★
BH12-6	10.21	⊙

The results of the moisture content, grain size distribution, Atterberg limit, and unit weight tests are provided on the record of borehole sheets in Appendix C. The results of the grain size distribution tests are also provided on Figure 5 and Figure 6 in Appendix D.

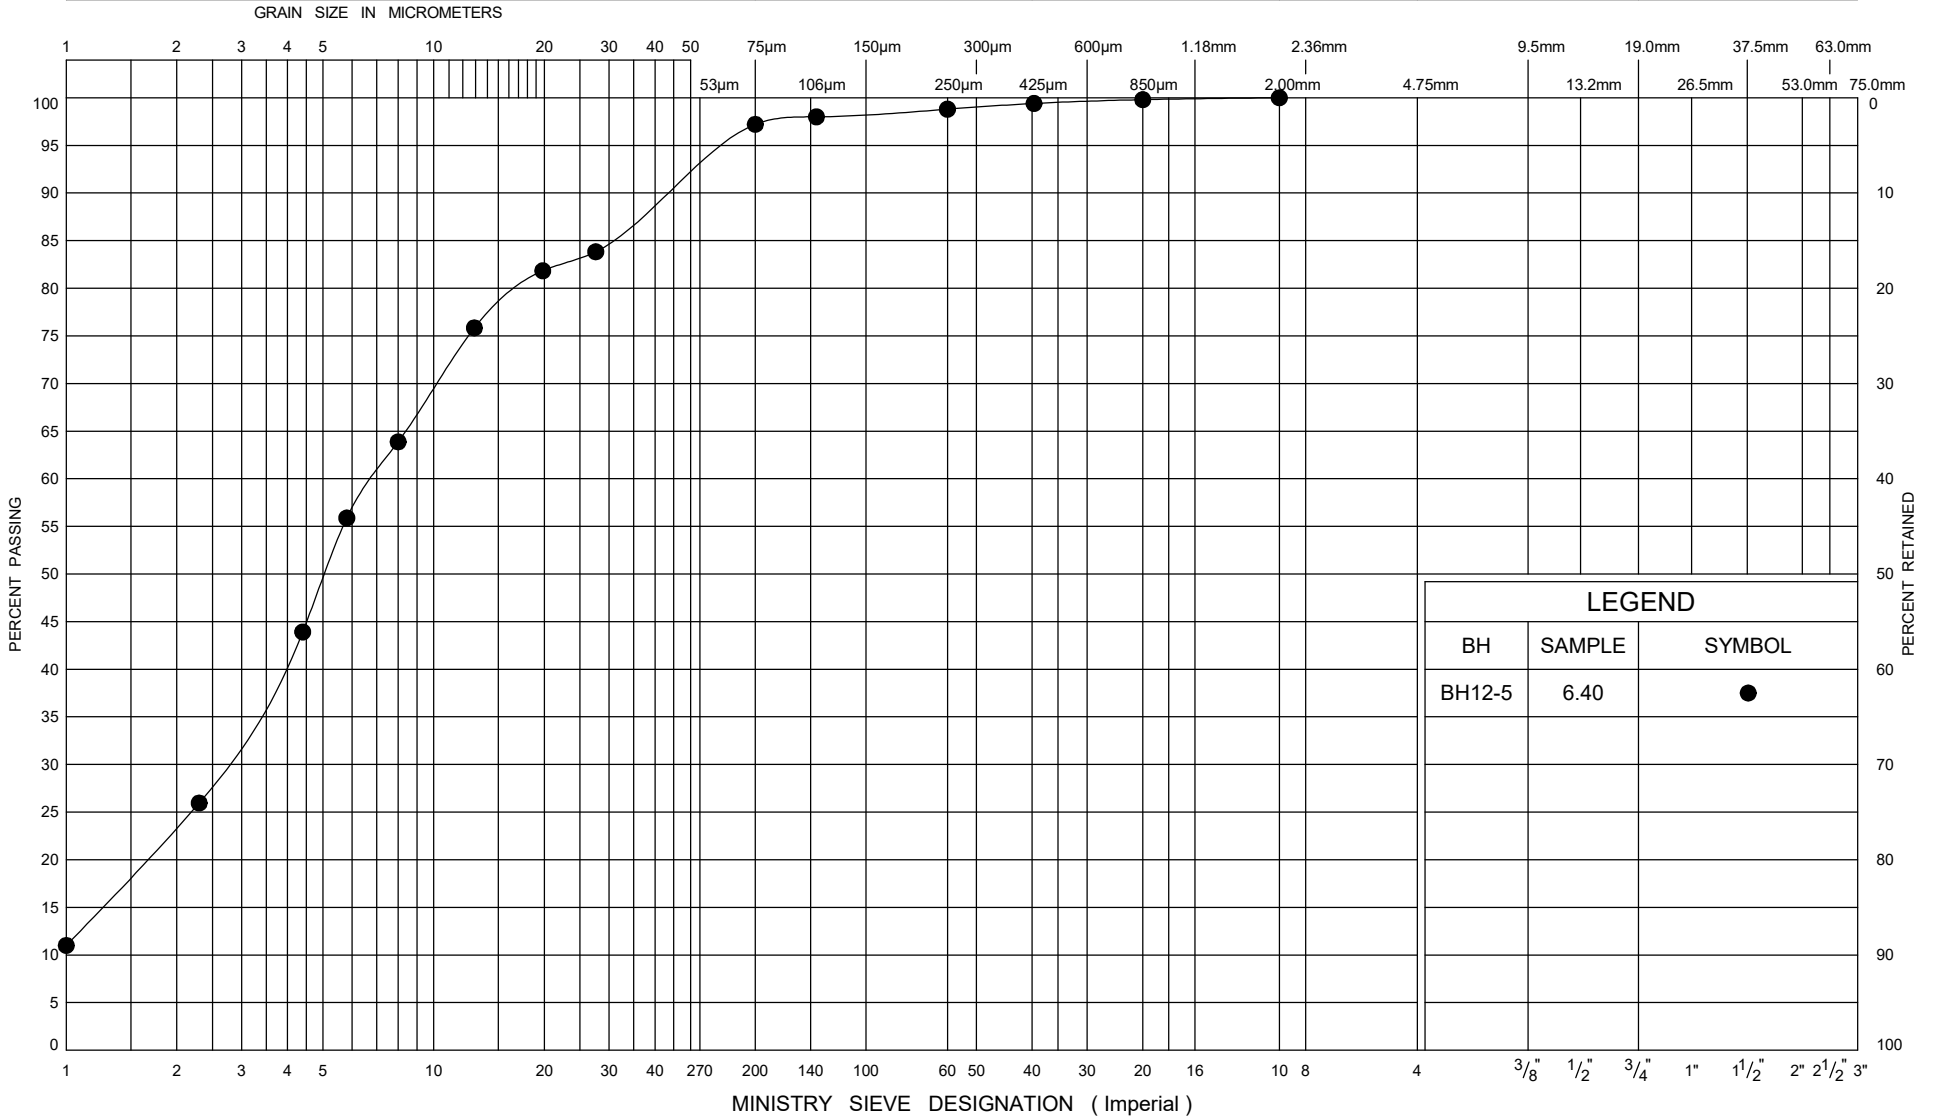
LEGEND		
BH	SAMPLE	SYMBOL
BH12-5	6.40	●

The results of the moisture content, grain size distribution, and unit weight tests are provided on the record of borehole sheets in Appendix C. The results of the grain size distribution test are also provided on Figures 7 in Appendix D.

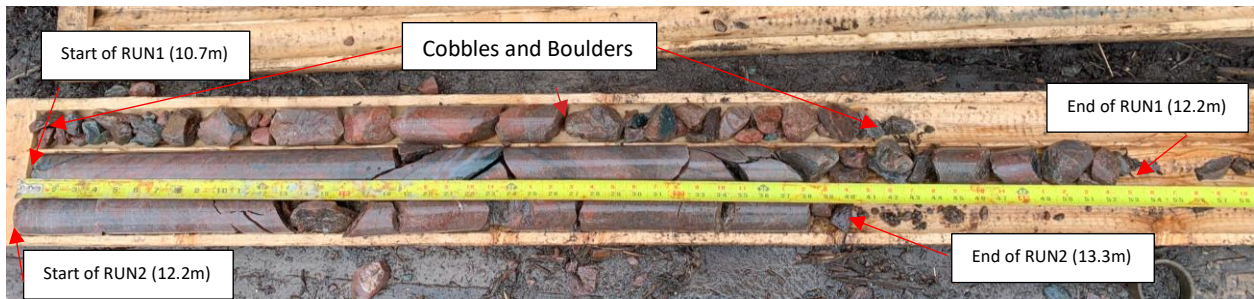
Photograph E1. Rock cores from BH12-1. Middle: Run 1, Bottom: Run 2.

All recovered soil samples were placed in labelled moisture-proof bags and returned to EXP's laboratory for additional visual, textual, and olfactory examination, and selective testing. The rock cores were placed in wooden core boxes and photographed as shown in Appendix E.

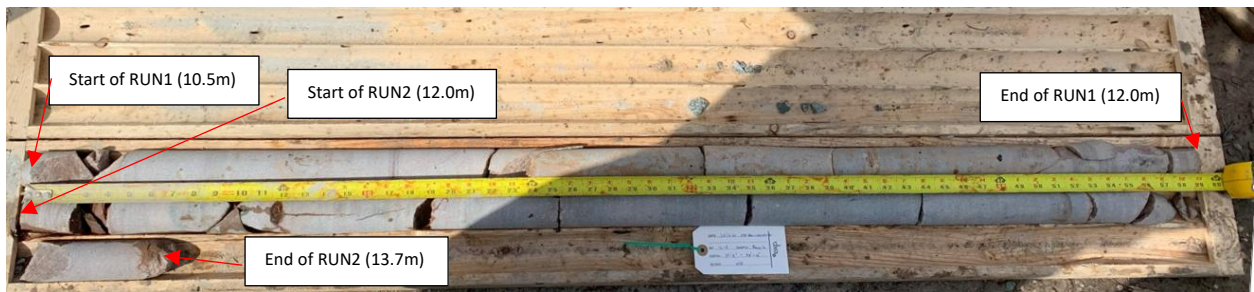
Photograph E2. Rock cores from BH12-3. Top: Run 1, Middle/Bottom: Run 2.

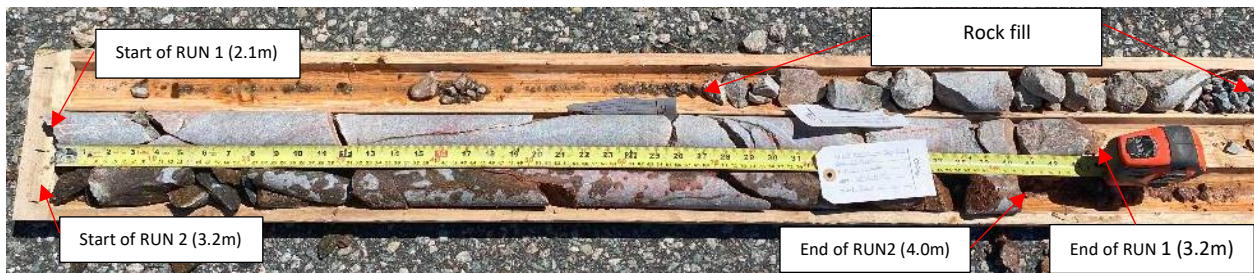
Photograph E3. Rock cores from BH12-4. Middle: Run 1, Bottom: Run 2.

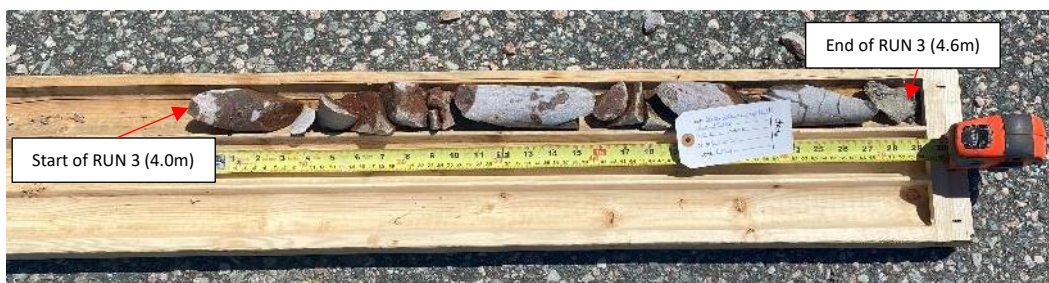
Photograph E4. Rock cores from BH12-4. Top: Run 3.

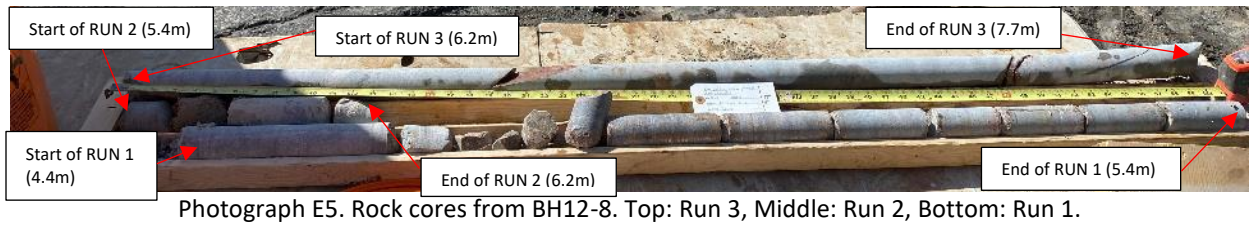
Photograph E5. Rock cores from BH12-8. Top: Run 3, Middle: Run 2, Bottom: Run 1.

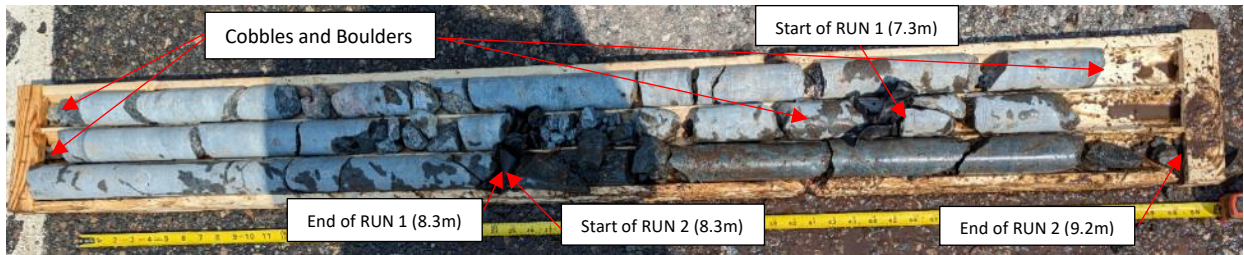
Photograph E6. Rock cores from BH12-12. Middle: Run 1, Bottom: Run 1&2.

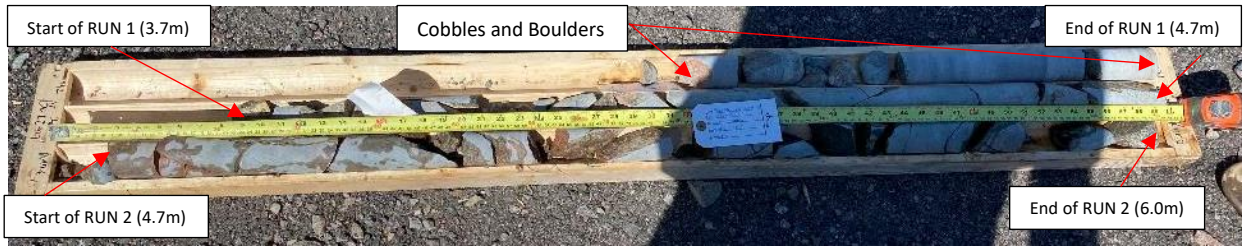
Photograph E7. Rock cores from BH12-15. Middle: Run 1, Bottom: Run 2.

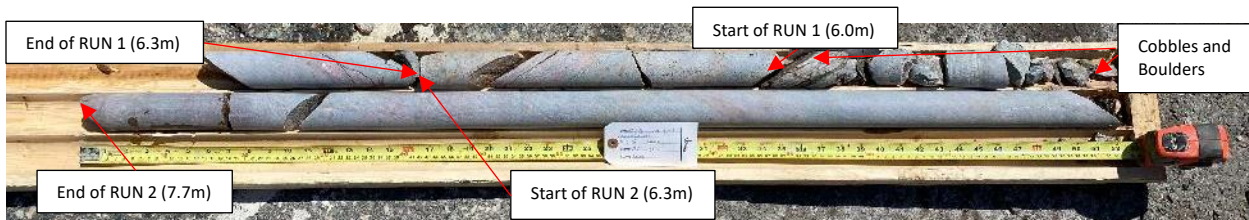
Photograph E8. Rock cores from BH12-16. Top: Run 1/Run 2, Bottom: Run 2.

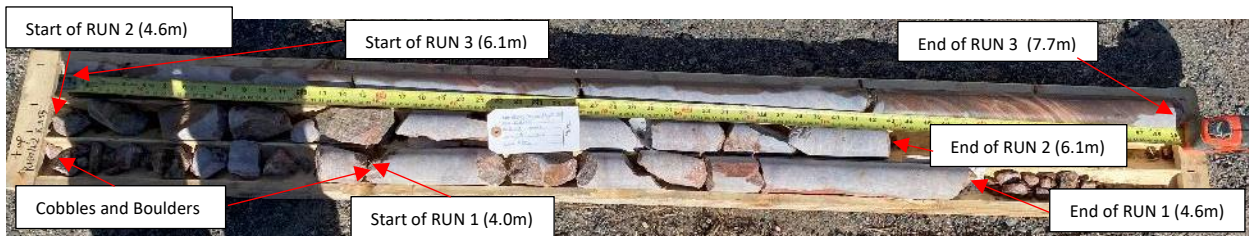
Photograph E9. Rock cores from BH12-17. Top: Run 3, Middle: Run 2, Bottom: Run 1.

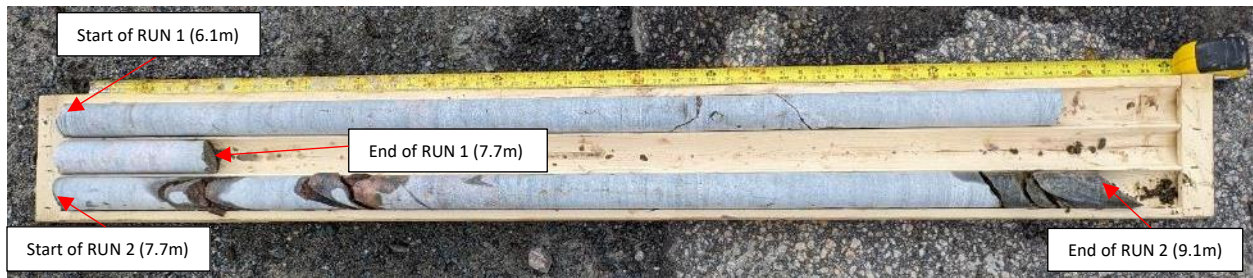
Photograph E10. Rock cores from BH12-19. Top: Run 1, Middle: Run 1, Bottom: Run 2.
