Foundation Investigation and Design Report

*Highway 11 – 2+1 Roadway Model Project: **Site SW2***

Assignment No. 5021-E-0038
GWP 5151-21-00
Geocres No. 31L12-004
(Latitude: 46.575311; Longitude: -79.629389)

Final Report

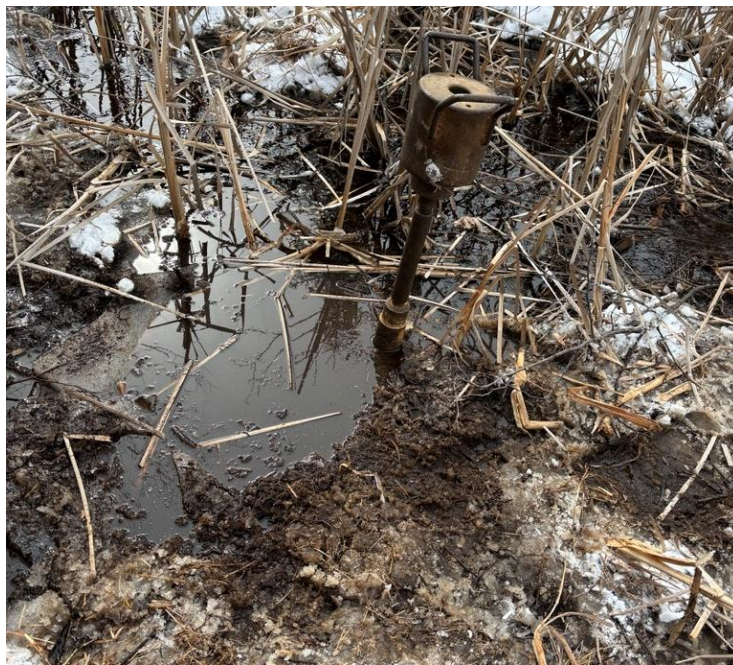
Photograph 4. Surface spoon in swamp at SW2 at borehole BH2-7 (March 25, 2024)

Photographs 1 to 6 in Appendix A shows the site and activities during drilling photographed between November 2023 and April 2024 by EXP. Photograph 1 shows the surrounding area of the east side of the highway embankment, including the existing rockfill and vegetation. Photograph 2 shows the field investigation being carried out on the south bound lane at borehole BH2-5. Photograph 3 shows the field investigation being carried out at borehole BH2-6 in a swamp location using a tripod setup. Photograph 4 shows a surface spoon during sampling and highlights the condition of the swamped area at borehole BH2-7. Photograph 5 shows the accumulated water on the east side of the embankment. Photograph 6 shows the hand-held Honda GX35 Portable Soil Sampler used for advancing probeholes on the east side of the embankment.

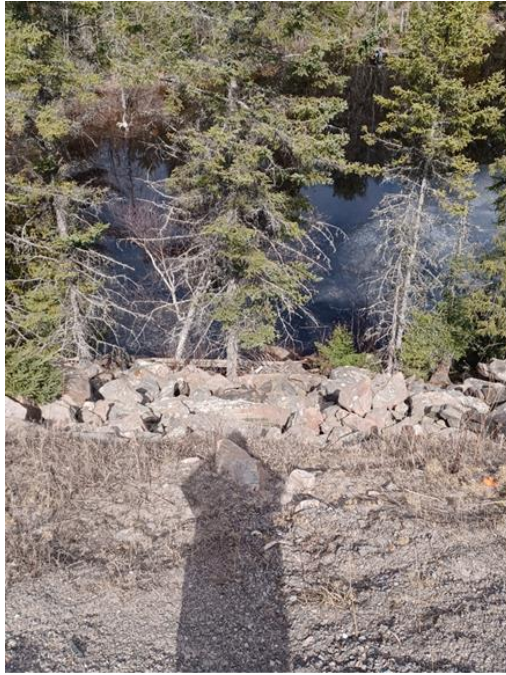
Photograph 5. East side of embankment near proposed location of BH2-1 (April 8, 2024)

Access for a standard track-mounted drill rig or mobile tripod system was not feasible on the east side of the embankment because of its steep elevation and the presence of dense, mature trees and an open water body at its base. As a result, a hand-held Honda GX35 portable soil sampler was used to determine the depth to refusal and to collect samples from the loose to soft overburden soils. Probeholes (PH2-1 to PH2-8), replacing the originally planned BH2-1, were advanced at eight (8) locations along the east embankment toe. These probeholes were situated at the bottom of the steep embankment and extended northward from an area of accumulated water toward the SW2 north boundary.

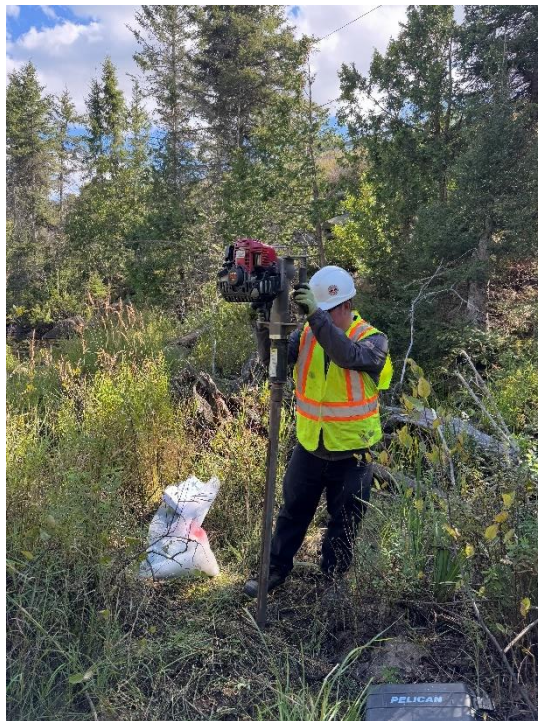
Photograph 6. Honda GX35 Portable Soil Sampler used for the probeholes on the east side of the embankment

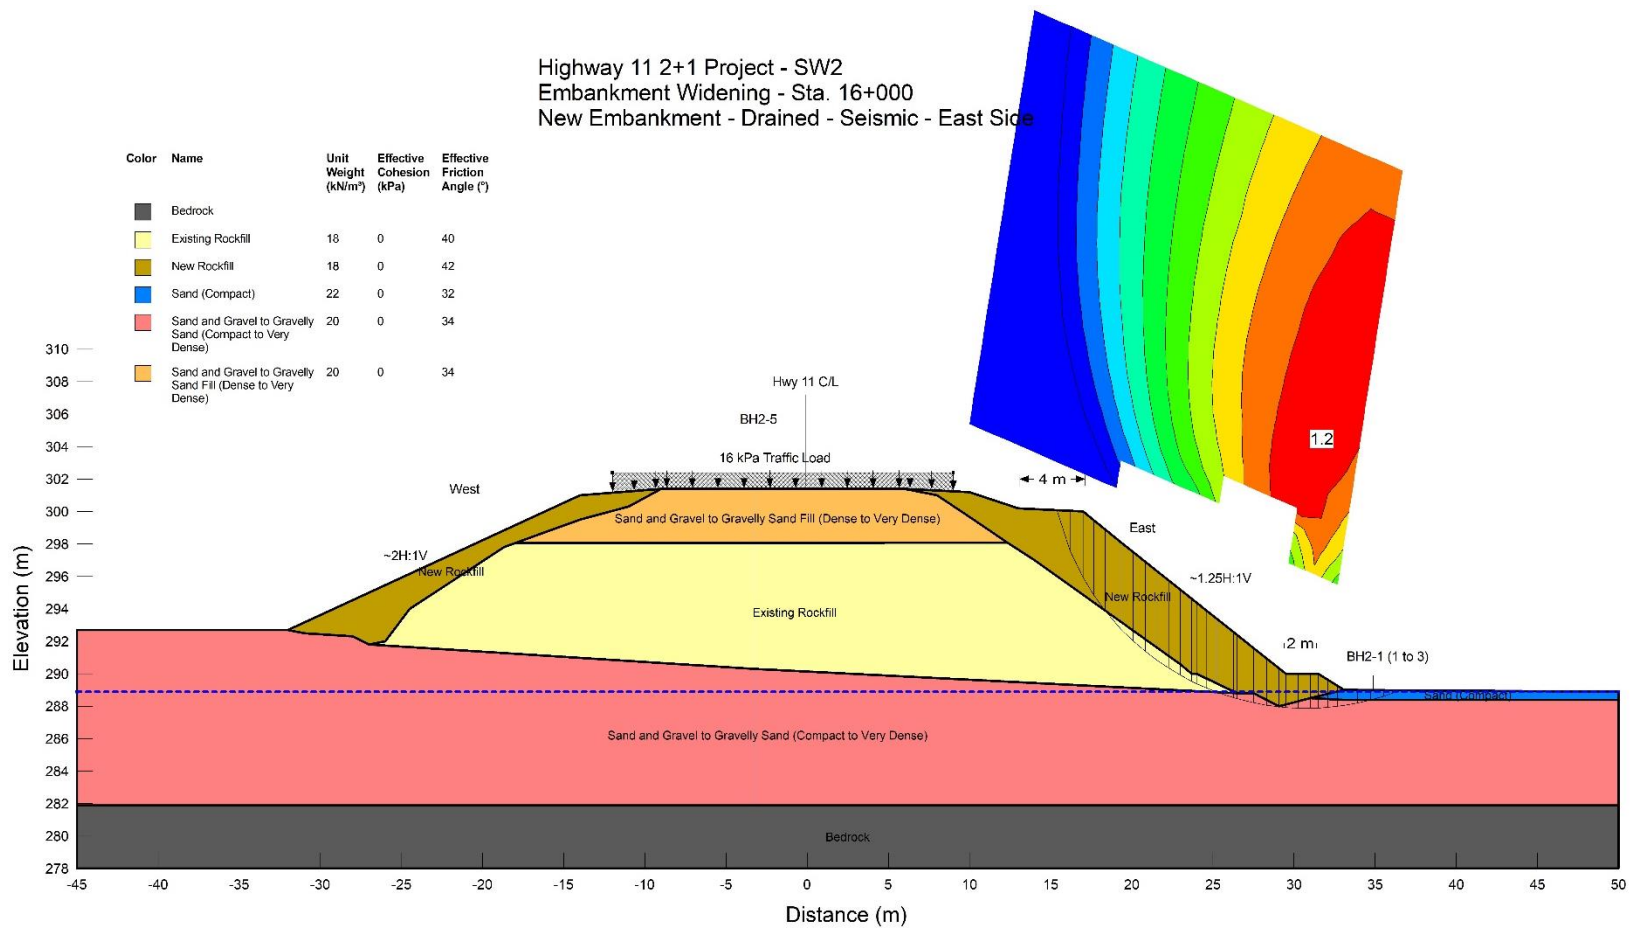
Figure F2: Slope stability analysis for Sta. 16+000 east side of embankment (1.25H:1V) – drained, seismic condition

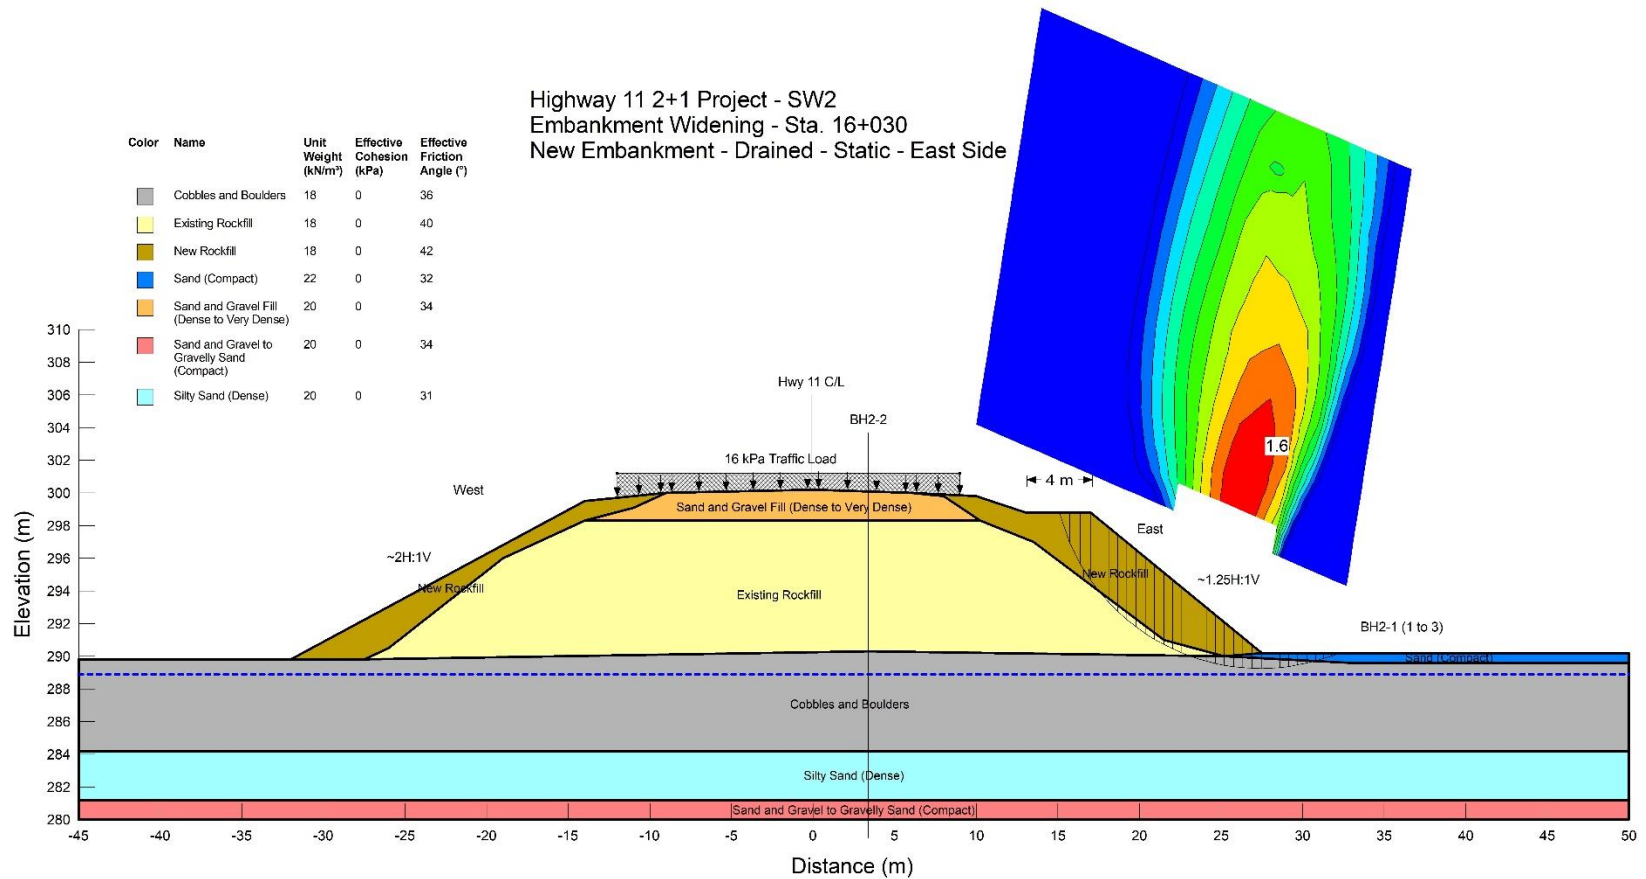
Figure F3: Slope stability analysis for Sta. 16+030 east side of embankment (1.25H:1V) – drained, static condition

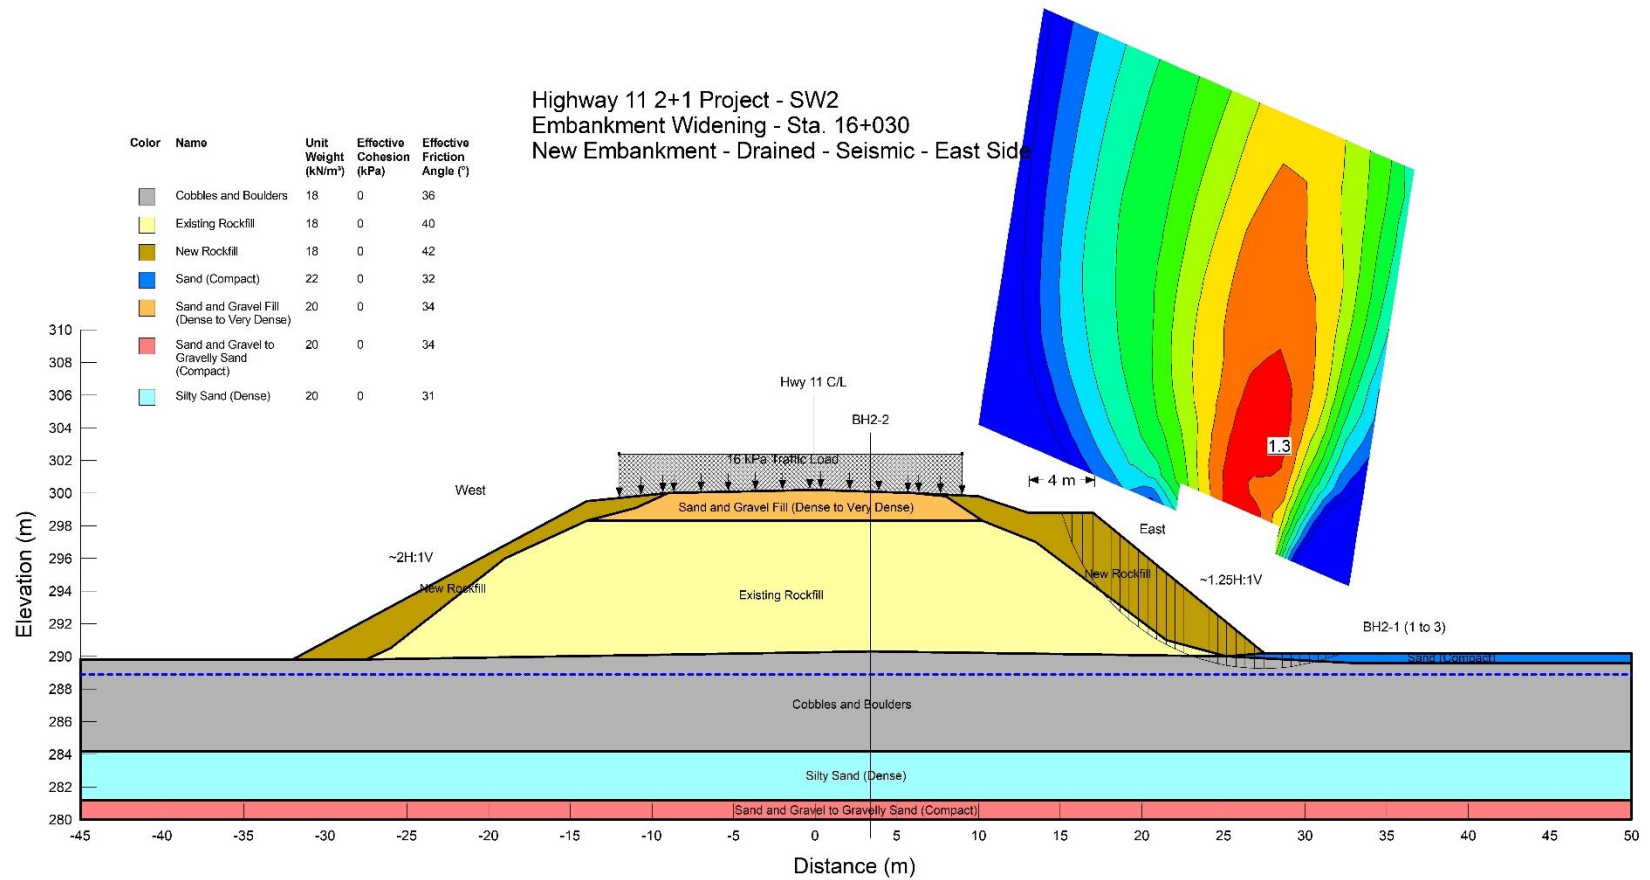
Figure F4: Slope stability analysis for Sta. 16+030 east side of embankment (1.25H:1V) – drained, seismic condition

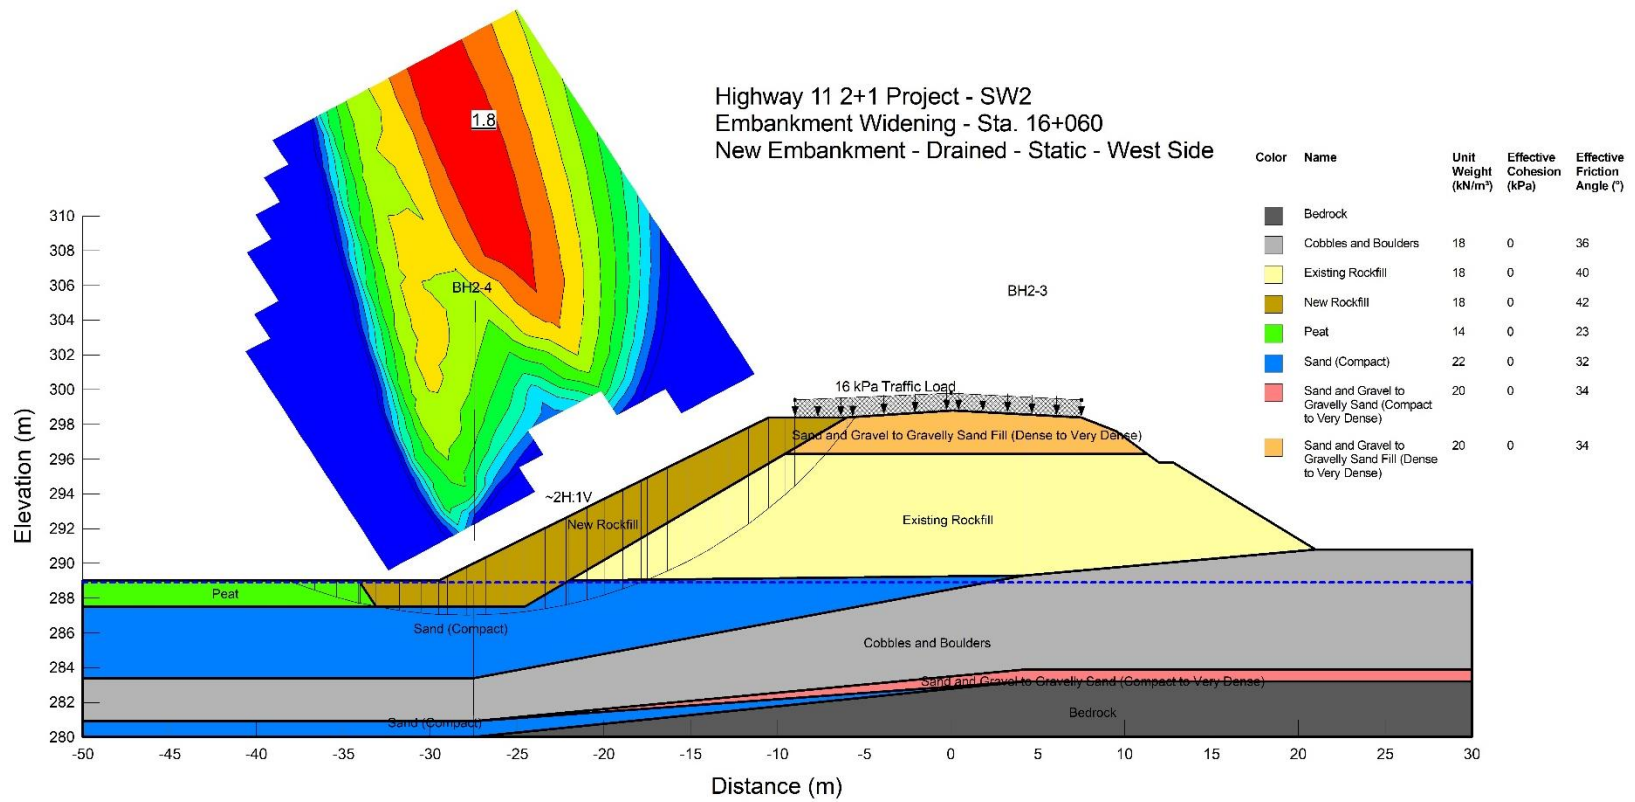
Figure F5: Slope stability analysis for Sta. 16+060 west side of embankment (2H:1V) – drained, static condition

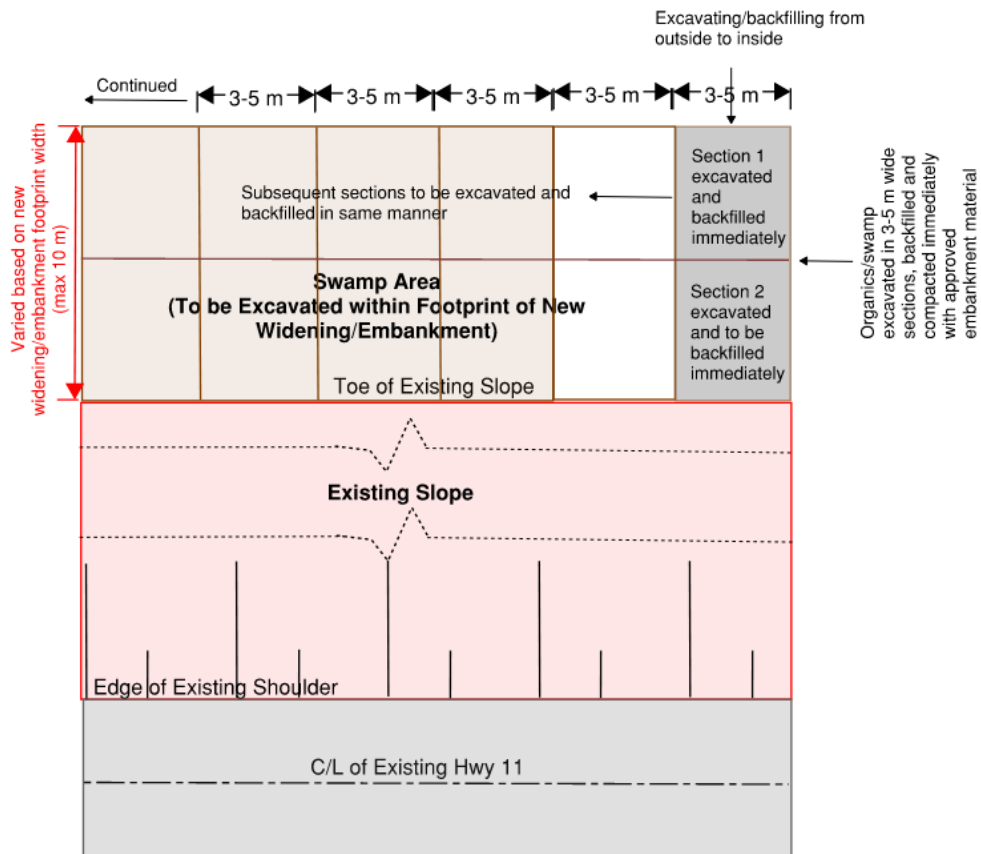
The top peat/organic material shall be excavated along the whole footprint of the new embankment fill for widening. The excavation shall be in accordance with OPSD 203.020 and OPSD 203.030 following the slope of the existing rock fill embankment, and then, backfilled with rock fill immediately after excavation. Do not keep the excavation open under any circumstances.

These simultaneous excavation and backfilling operations shall be done from outside to inside in sections parallel to the existing highway as shown below. The sections shall be approximately 3 m to 5 m wide.
