Foundation Investigation Report

*Highway 11 – 2+1 Roadway Model Project: **Site SW2***

Assignment No. 5021-E-0038
GWP 5151-21-00
Geocres No. 31L12-004
(Latitude: 46.575311; Longitude: -79.629389)

Final Report

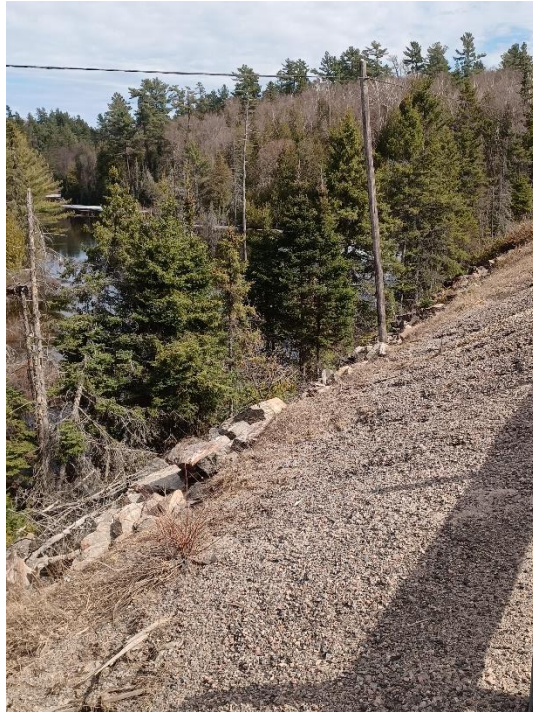
Photograph 1. Embankment slope facing southeast (April 08, 2024)

Photographs 1 to 6 in Appendix A shows the site and activities during drilling photographed between November 2023 and April 2024 by EXP. Photograph 1 shows the surrounding area of the east side of the highway embankment, including the existing rockfill and vegetation. Photograph 2 shows the field investigation being carried out on the south bound lane at borehole BH2-5. Photograph 3 shows the field investigation being carried out at borehole BH2-6 in a swamp location using a tripod setup. Photograph 4 shows a surface spoon during sampling and highlights the condition of the swamped area at borehole BH2-7. Photograph 5 shows the accumulated water on the east side of the embankment. Photograph 6 shows the hand-held Honda GX35 Portable Soil Sampler used for advancing probeholes on the east side of the embankment.

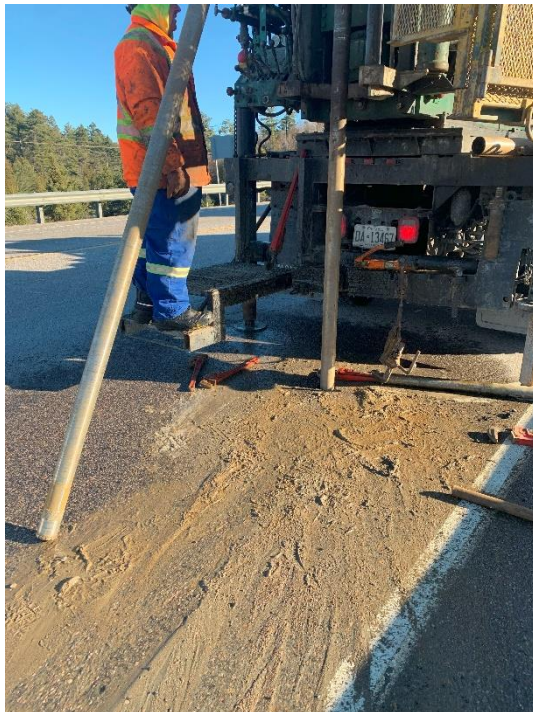
Photograph 2. SPT sampling in the southbound lane (November 20, 2023)

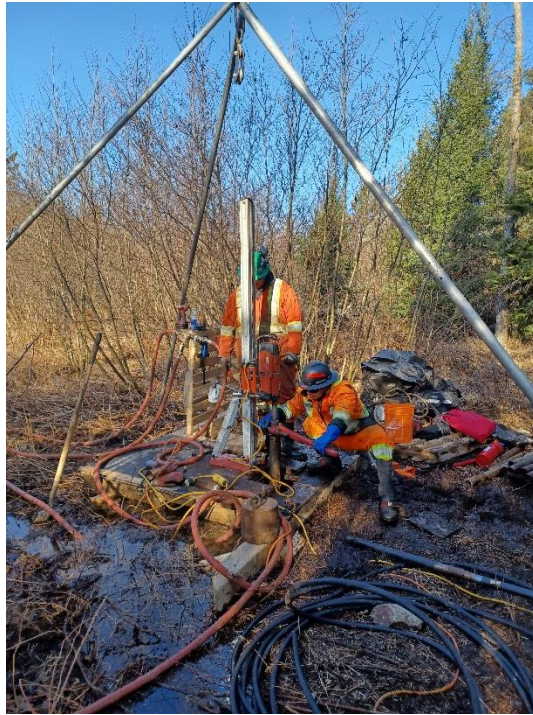
Photograph 3. SPT sampling at SW2 at borehole BH2-6 using tripod setup in swamp (April 09, 2024)

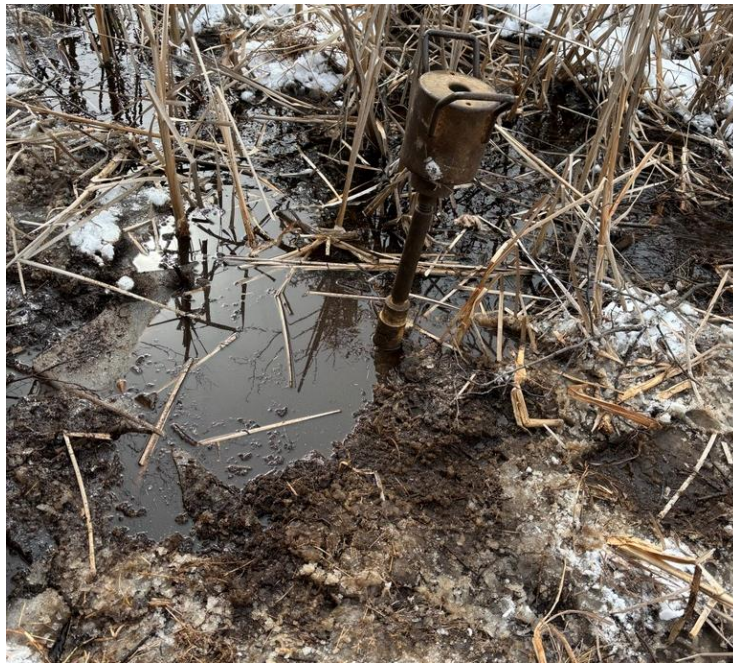
Photograph 4. Surface spoon in swamp at SW2 at borehole BH2-7 (March 25, 2024)

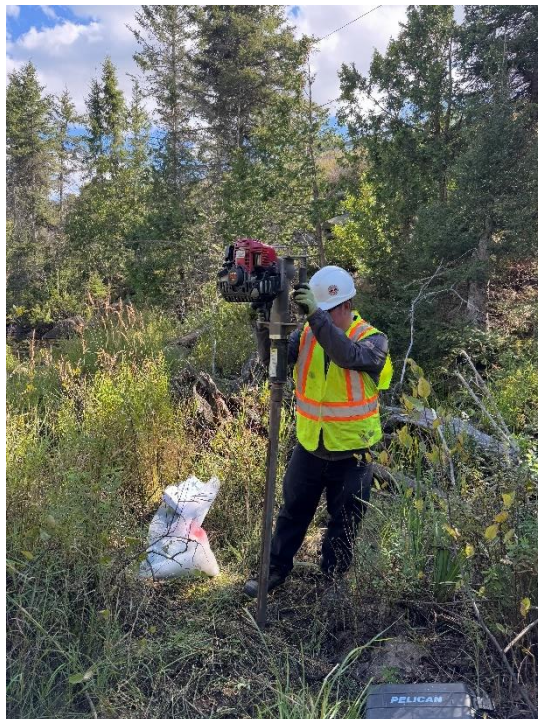
Photograph 6. Honda GX35 Portable Soil Sampler used for the probeholes on the east side of the embankment

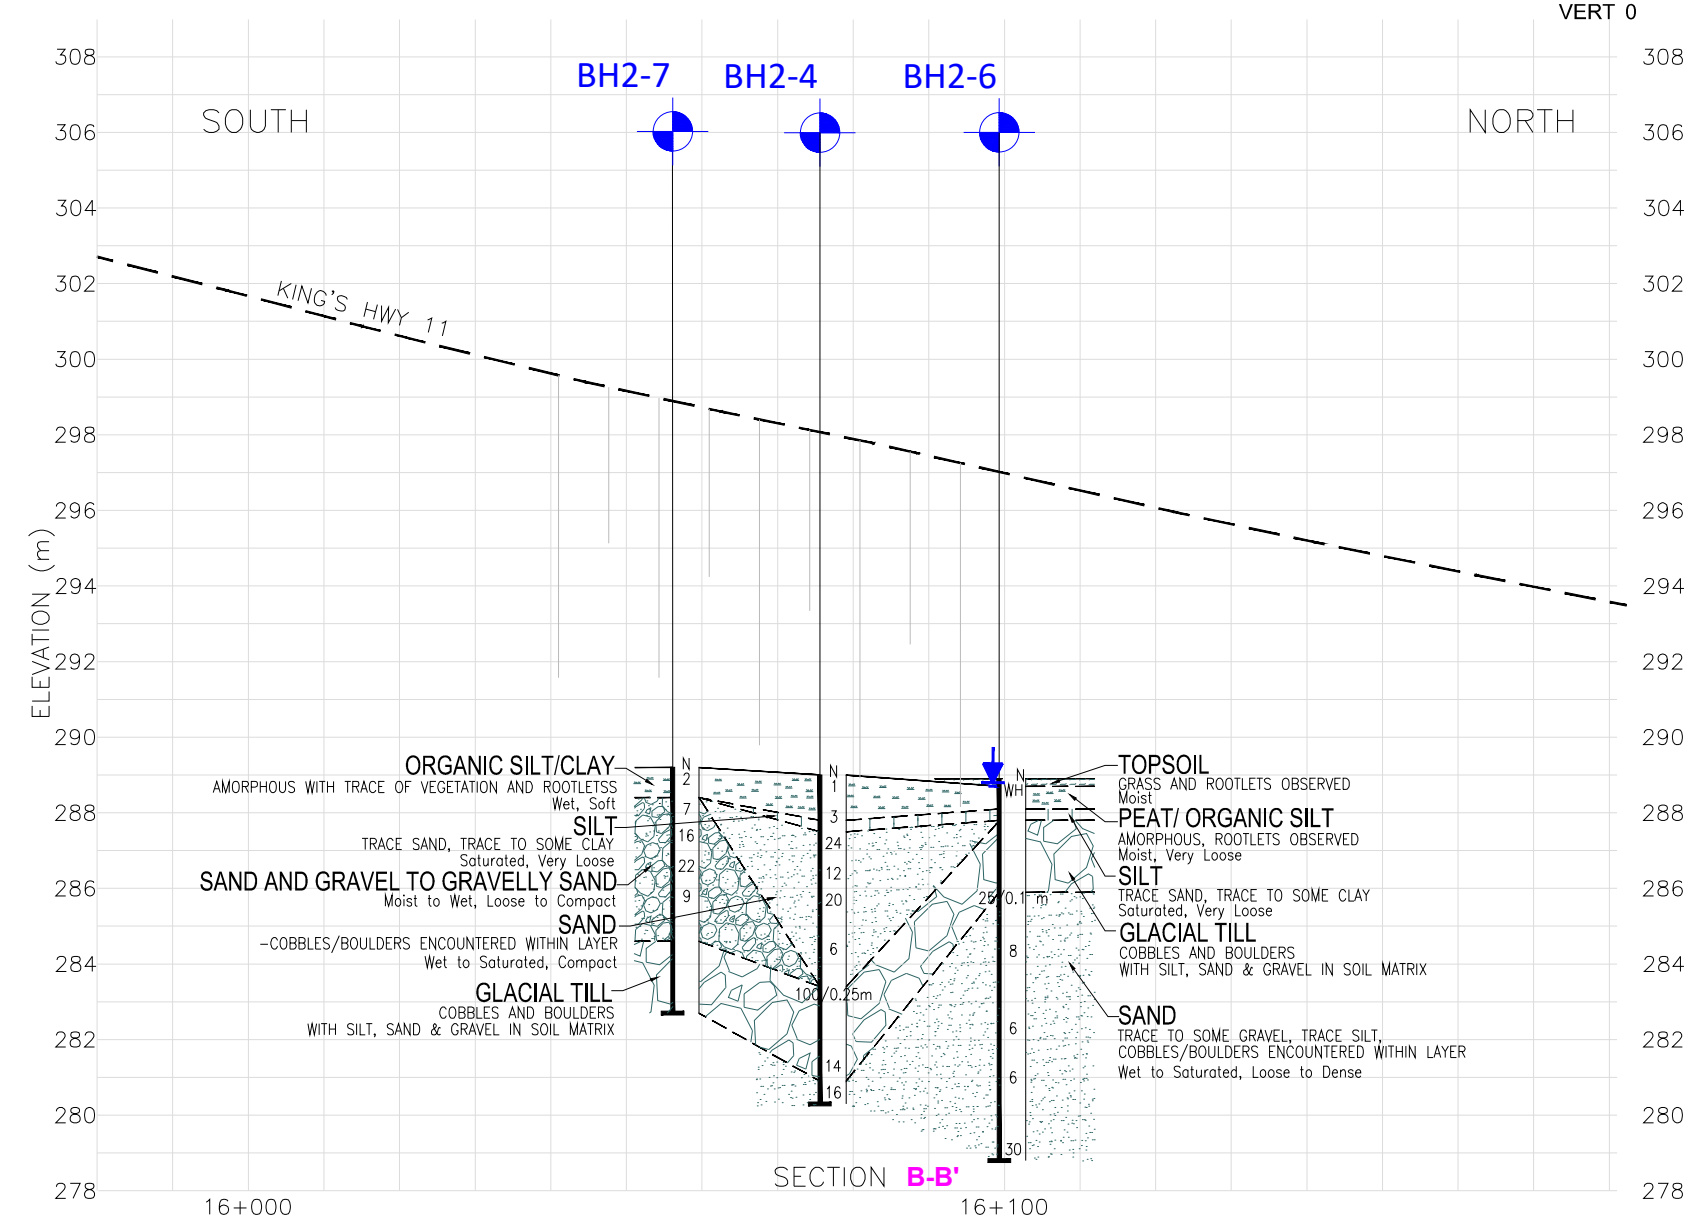
SHEET
2

PLAN

SECTION B-B'

A borehole location plan and cross section subsurface profiles are provided in Appendix B. It should be noted that the stratigraphic boundaries indicated on the borehole log and cross section stratigraphic profiles are inferred from semi-continuous sampling, observations of drilling progress and results of Standard Penetration Tests (SPT). These boundaries typically represent transitions from one soil type to another and should not be regarded as exact planes of geological change. Furthermore, subsurface conditions may vary between and beyond the borehole locations.

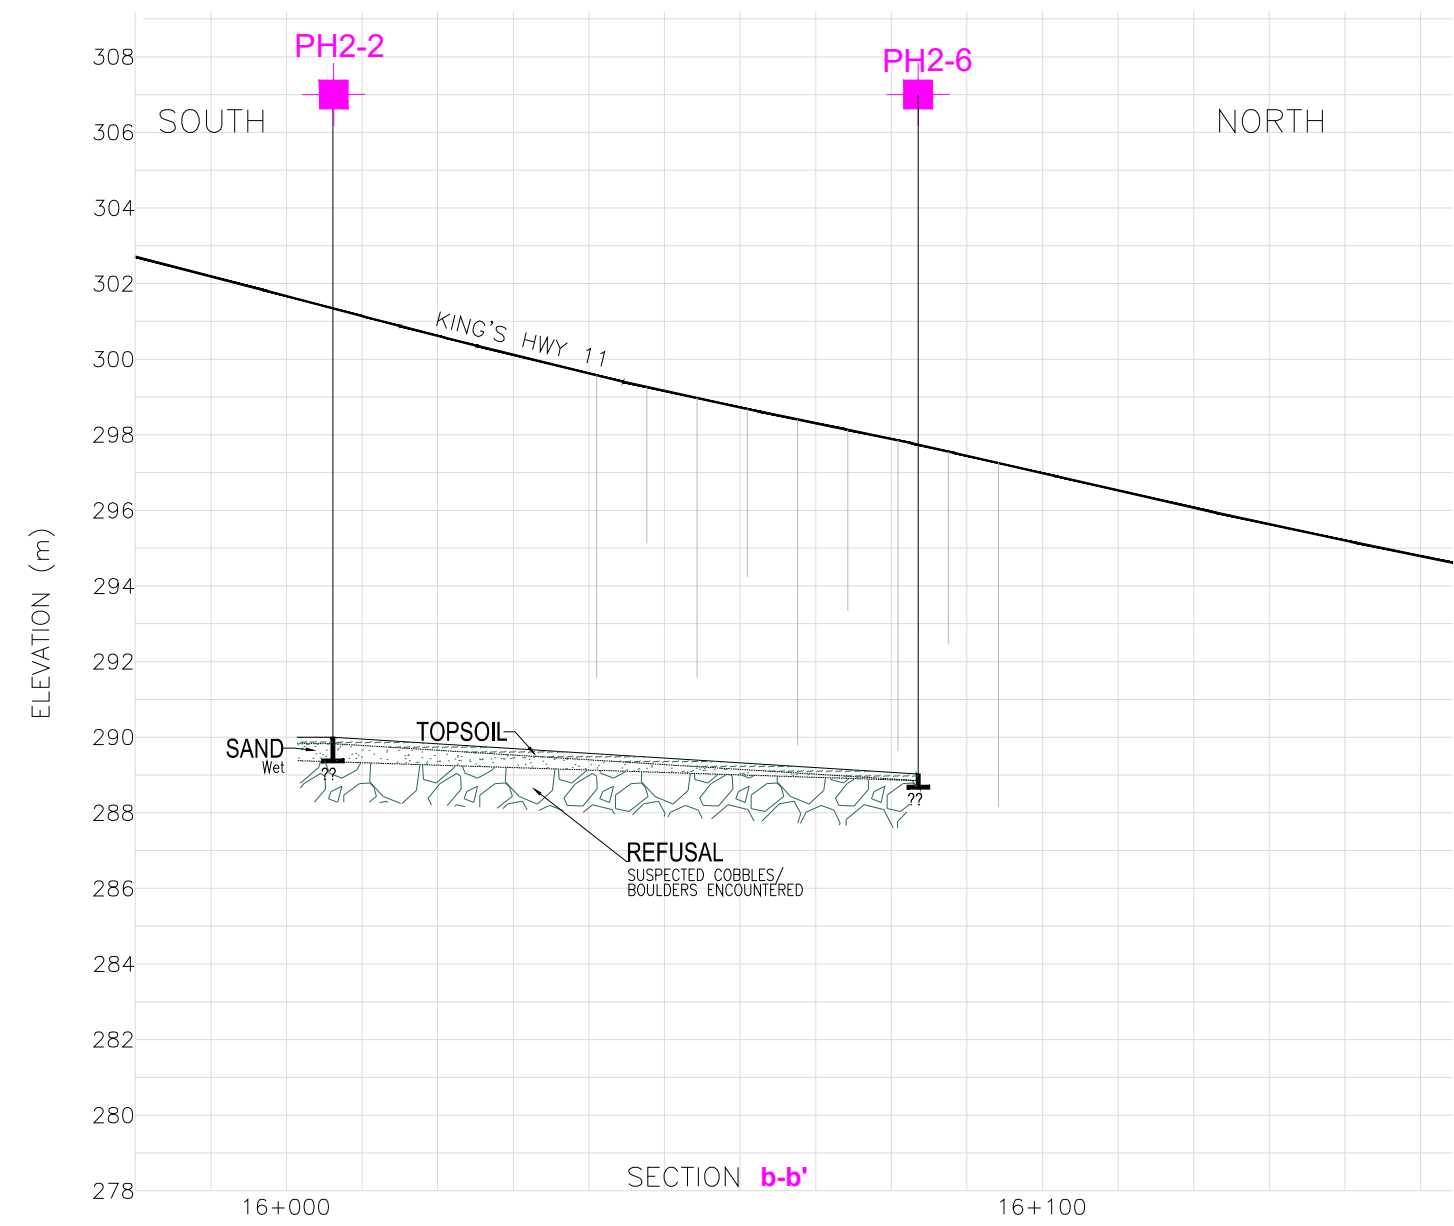
SHEET
3

PLAN

SECTION b-b'

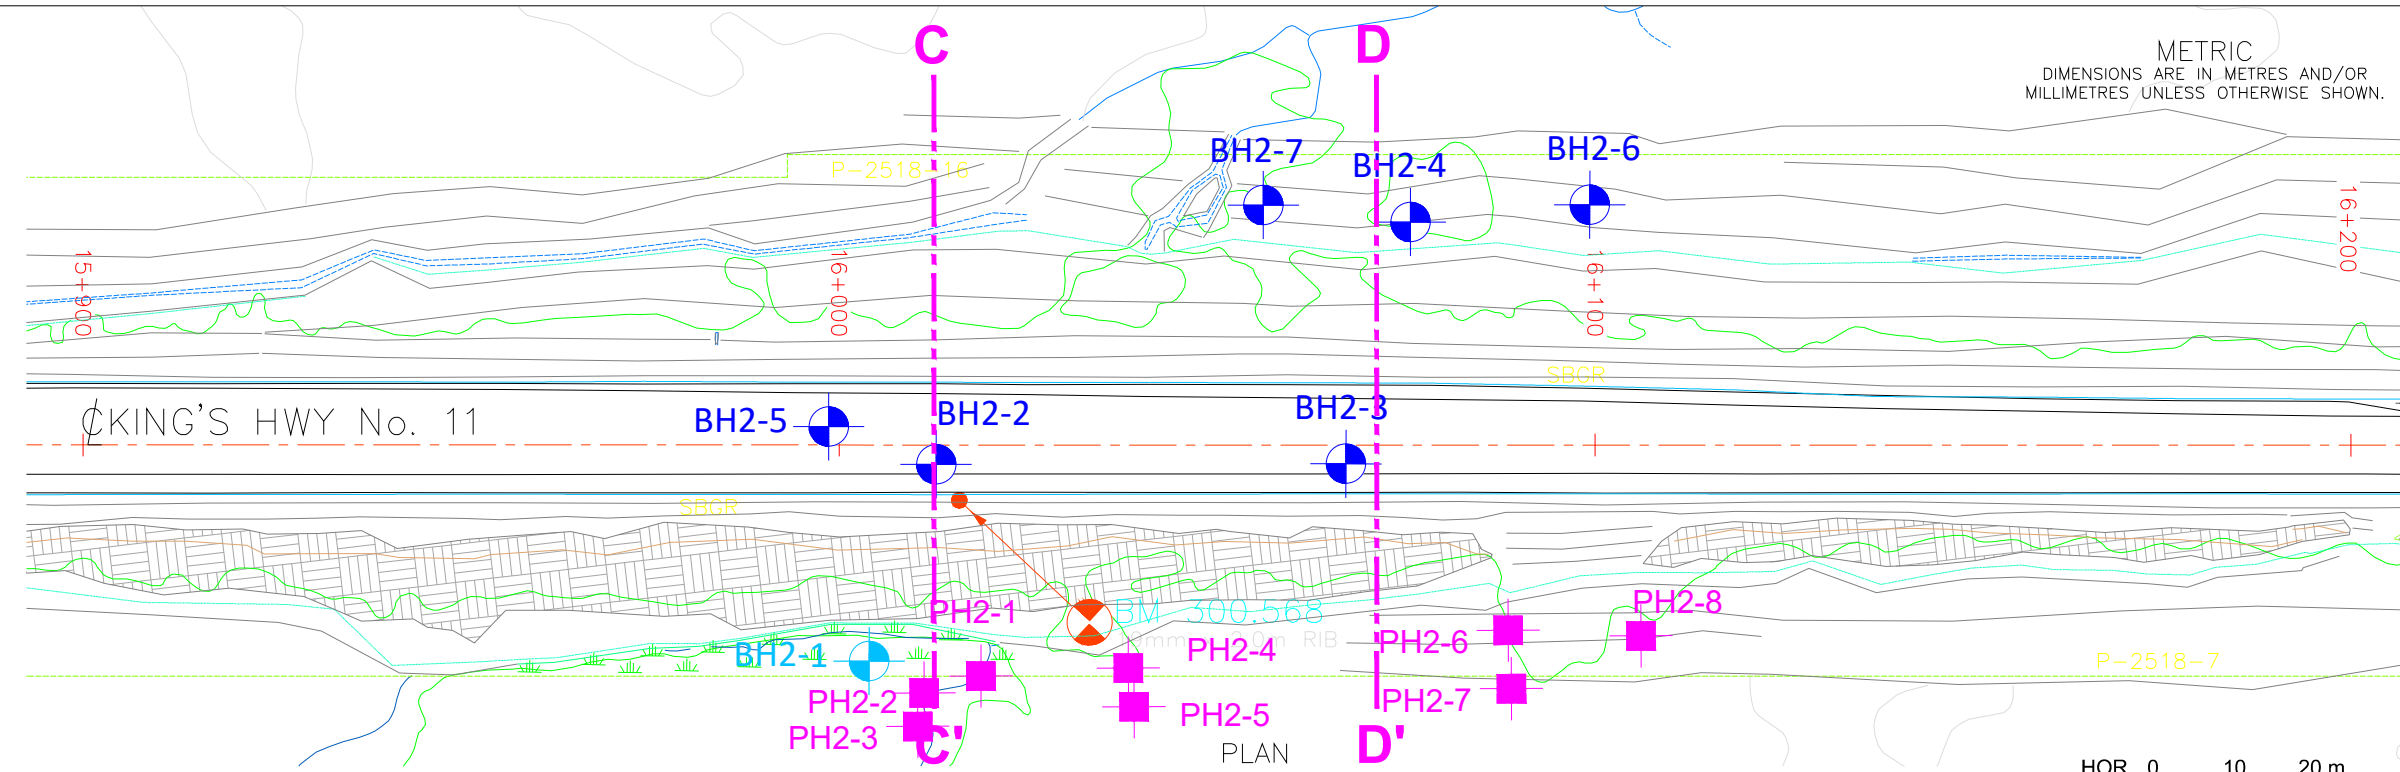
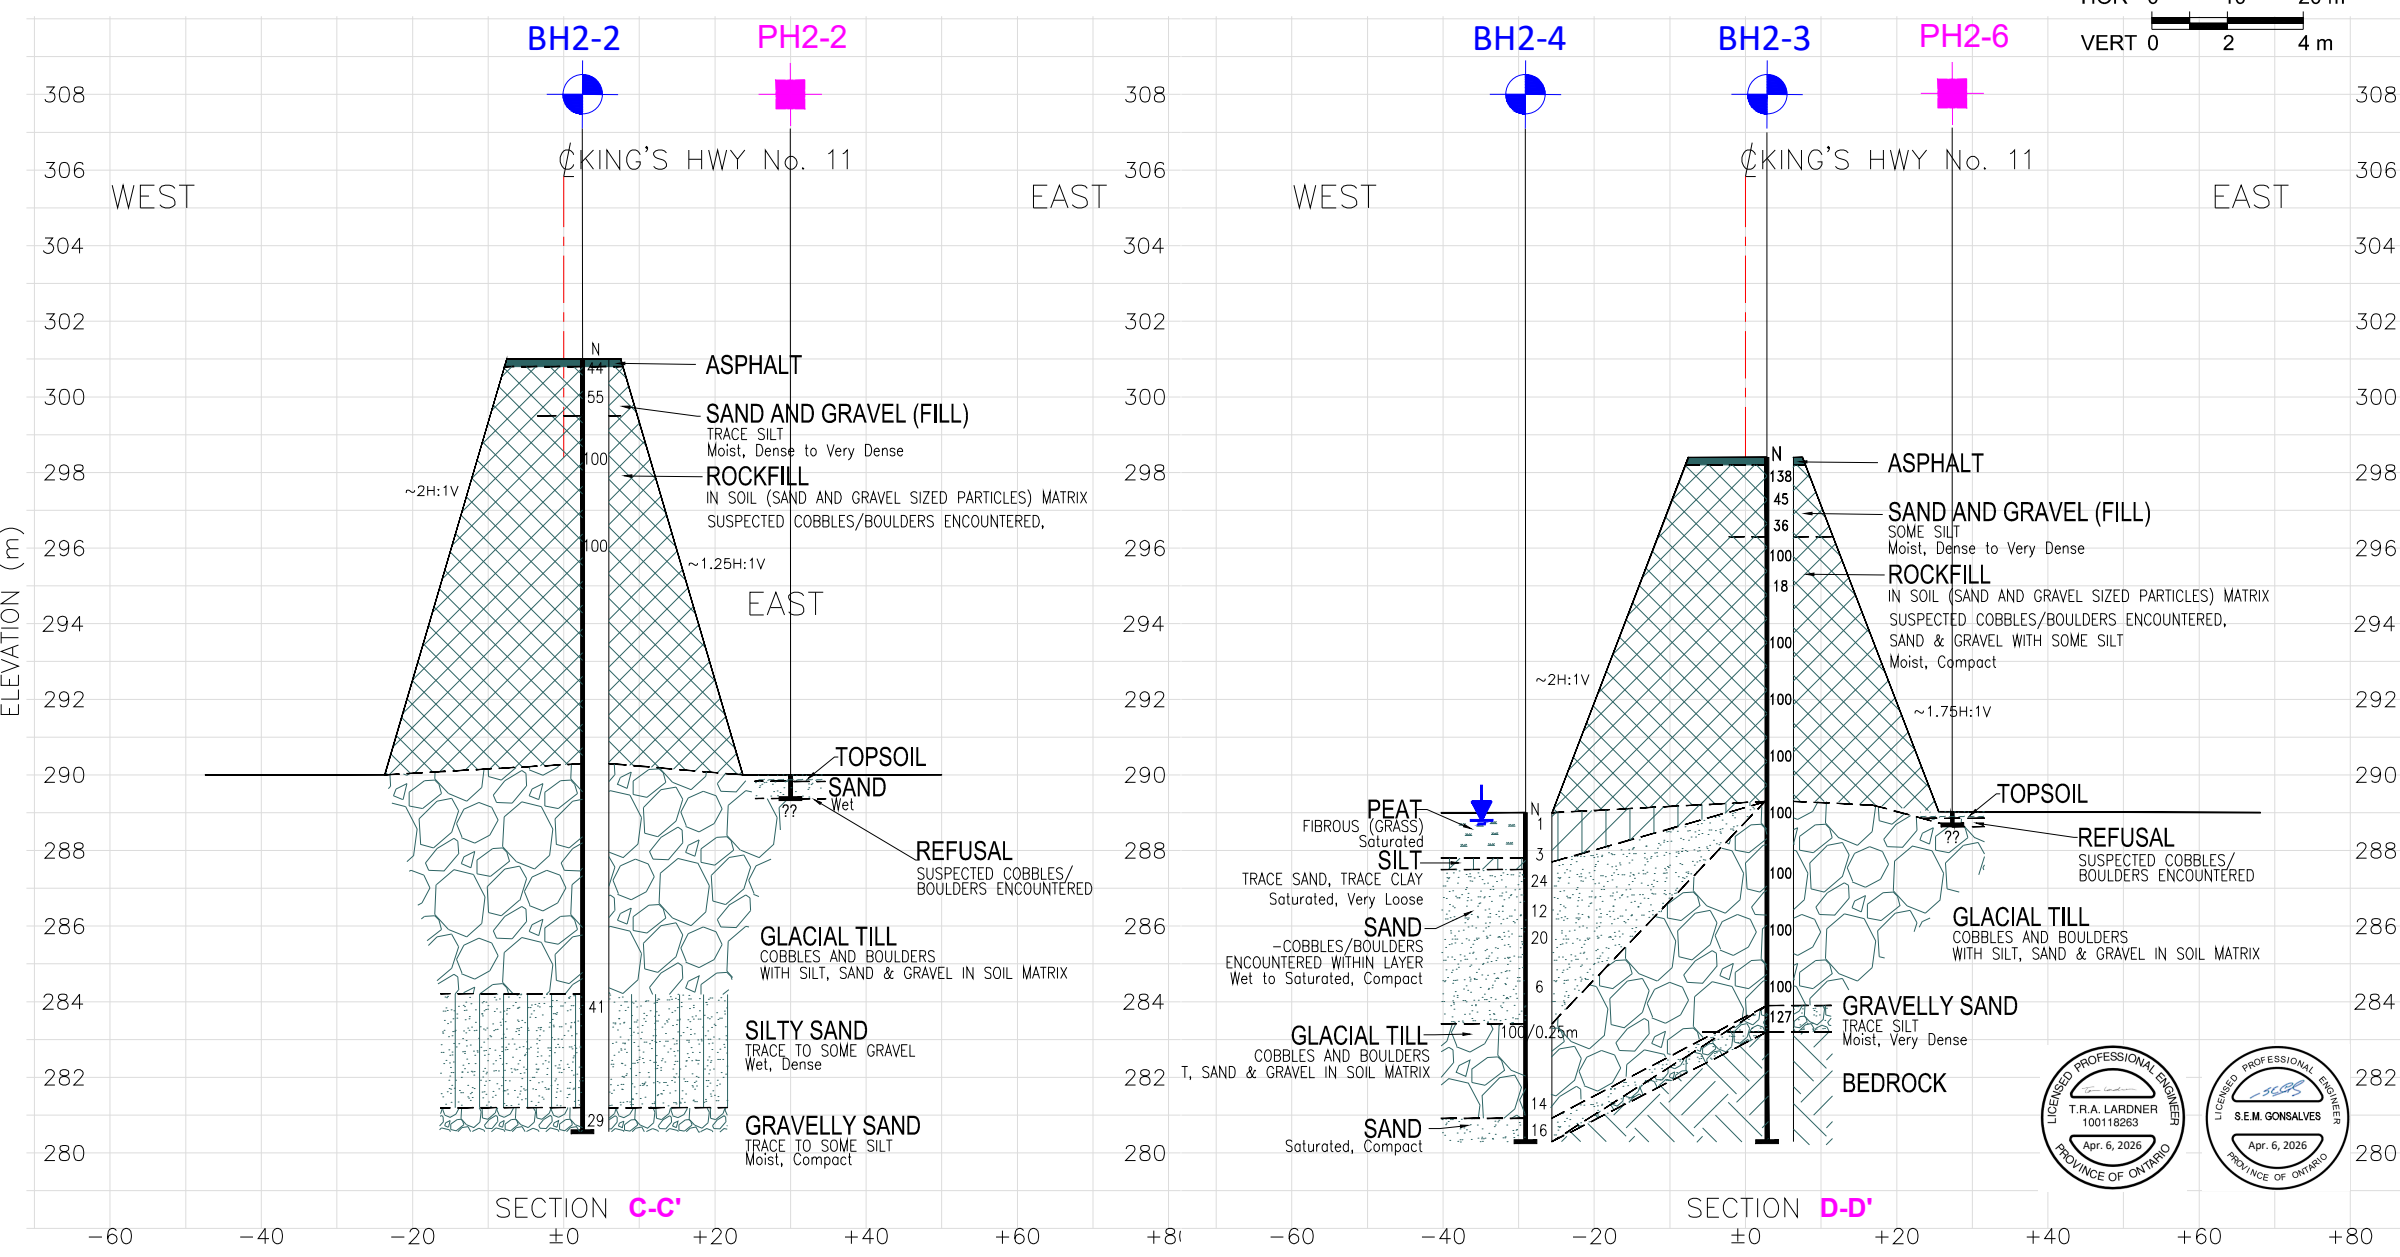
SHEET 4

- SOIL STRATA SYMBOLS
- TOPSOIL
 - ASPHALT
 - FILL
 - SILTY SAND
 - PEAT/ ORGANIC SILT
 - SAND
 - SAND & GRAVEL TO GRAVELLY SAND
 - COBBLES & BOULDERS
 - BEDROCK

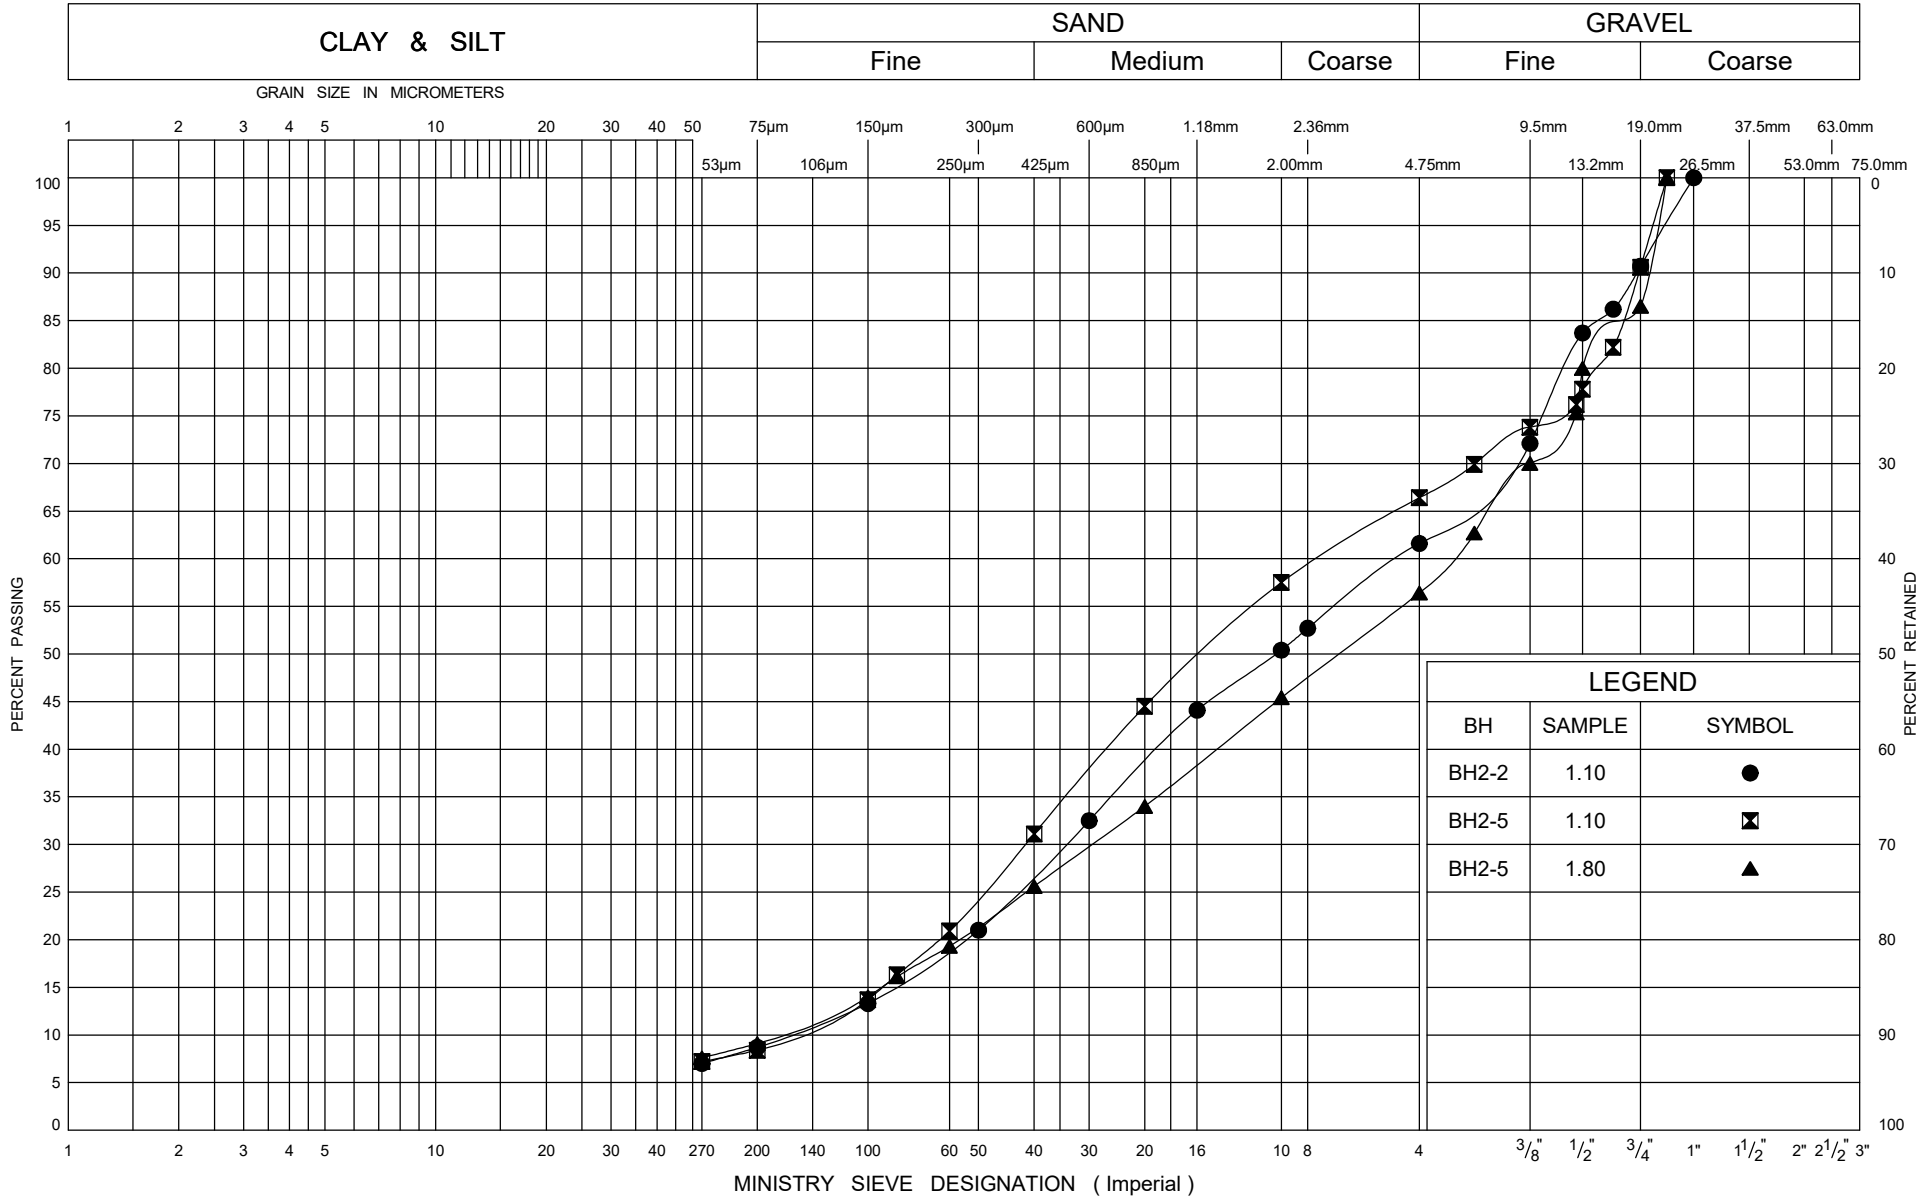
FIG No 1
W PGWP 5151-21-00
Highway 11 2+1 - SW2

GRAIN SIZE DISTRIBUTION
Cohesionless Fill: Sand and Gravel/Gravelly Sand

The results of the moisture content, and grain size distribution tests are provided on the record of borehole sheets in Appendix C. The results of the grain size distribution test are also provided on Figure 1 in Appendix D.

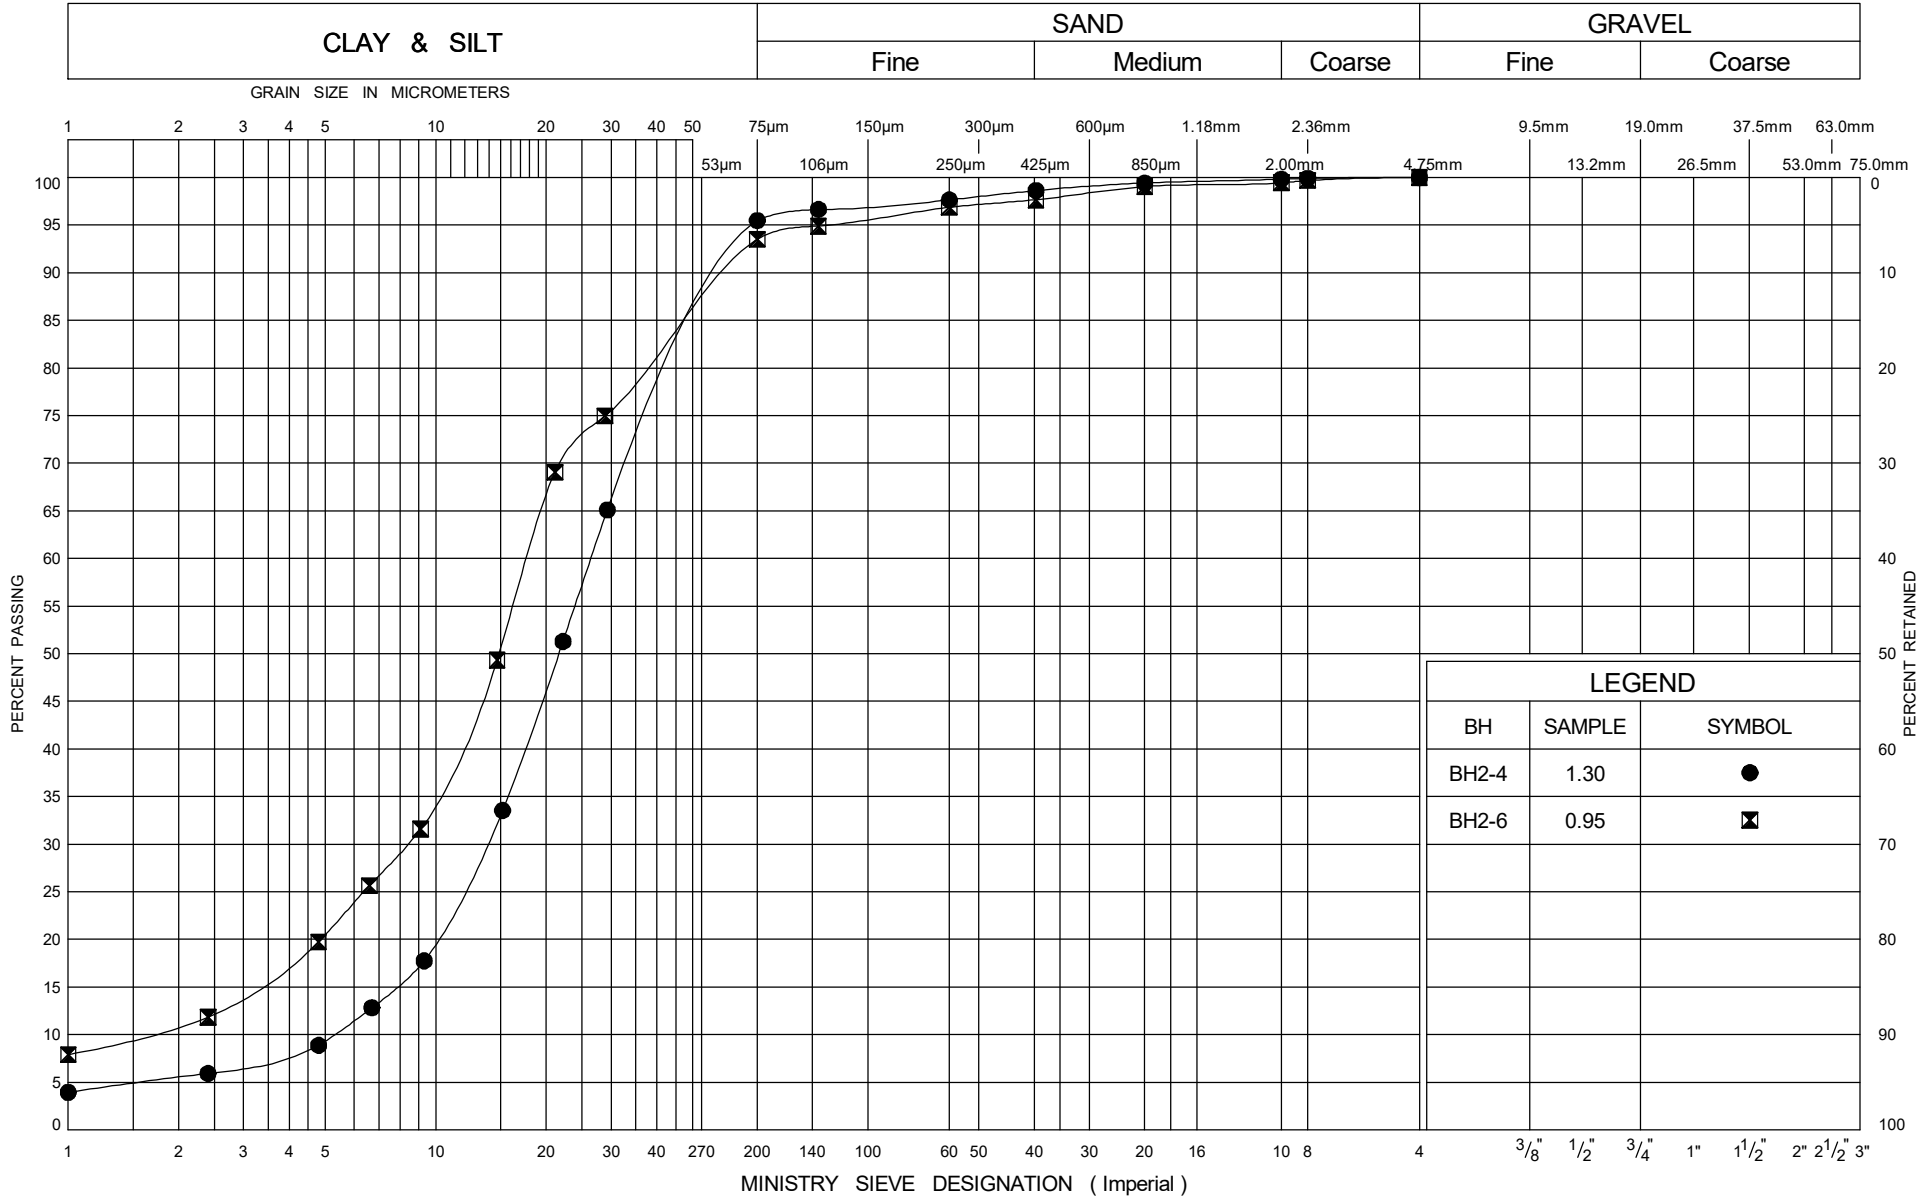
LEGEND		
BH	SAMPLE	SYMBOL
BH2-4	1.30	●
BH2-6	0.95	⊠

The results of the moisture content and grain size distribution tests are provided on the record of borehole sheets in Appendix C. The results of the grain size distribution tests are also provided on Figure 2 in Appendix D.

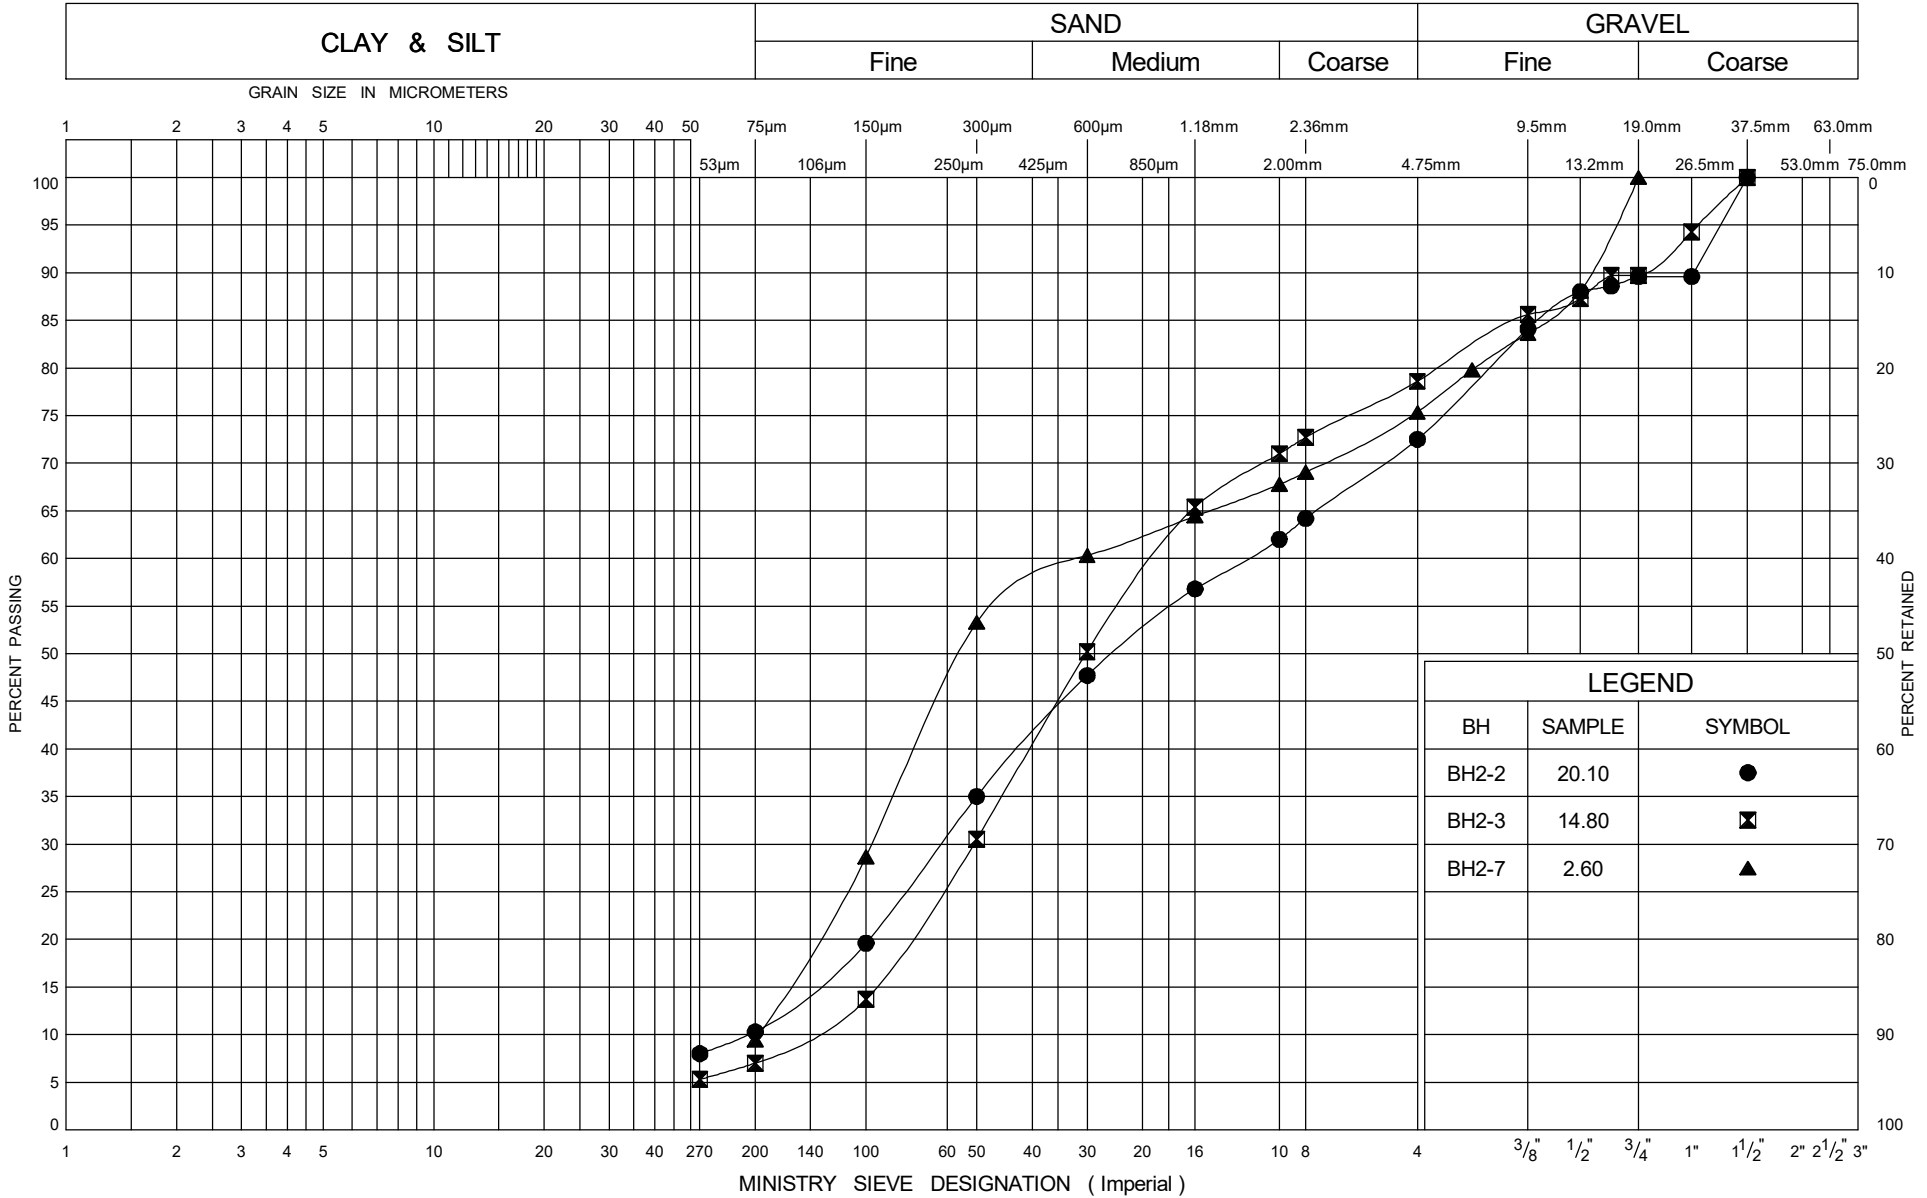
FIG No 3
W P GWP 5151-21-00
Highway 11 2+1 - SW2

GRAIN SIZE DISTRIBUTION
Sand and Gravel to Gravelly Sand

The results of the moisture content and grain size distribution tests are provided on the record of borehole sheets in Appendix C. The results of the grain size distribution tests are also provided on Figure 3 in Appendix D.

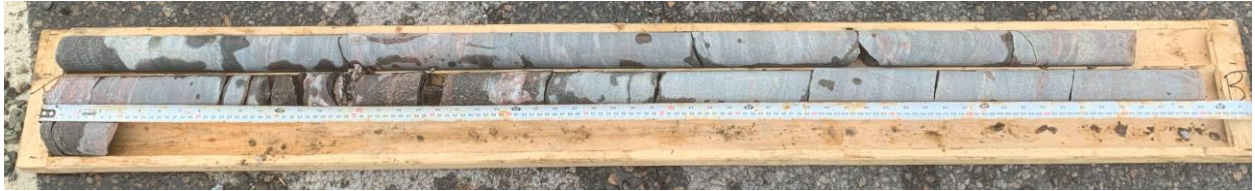
Photograph E1. Rock cores from BH2-5. Top: Run 1, Middle: Run 2, Bottom: Run 2 continued.

All recovered soil samples were placed in labelled moisture-proof bags and returned to EXP’s laboratory for additional visual, textual, and olfactory examination, and selective testing. The rock cores were placed in wooden core boxes and photographed as shown in Appendix E.
