**Foundation Investigation and Design
Proposed MTO Garage and Terminal Building
Sachigo Lake Airport
Agreement No.: 6005-A-000250**

FINAL REPORT

Geocres No.: 53D-01
MTO Ref.: GWP 2012-03-00
Trow Ref.: F-03183-A/G
Date: February 3, 2004

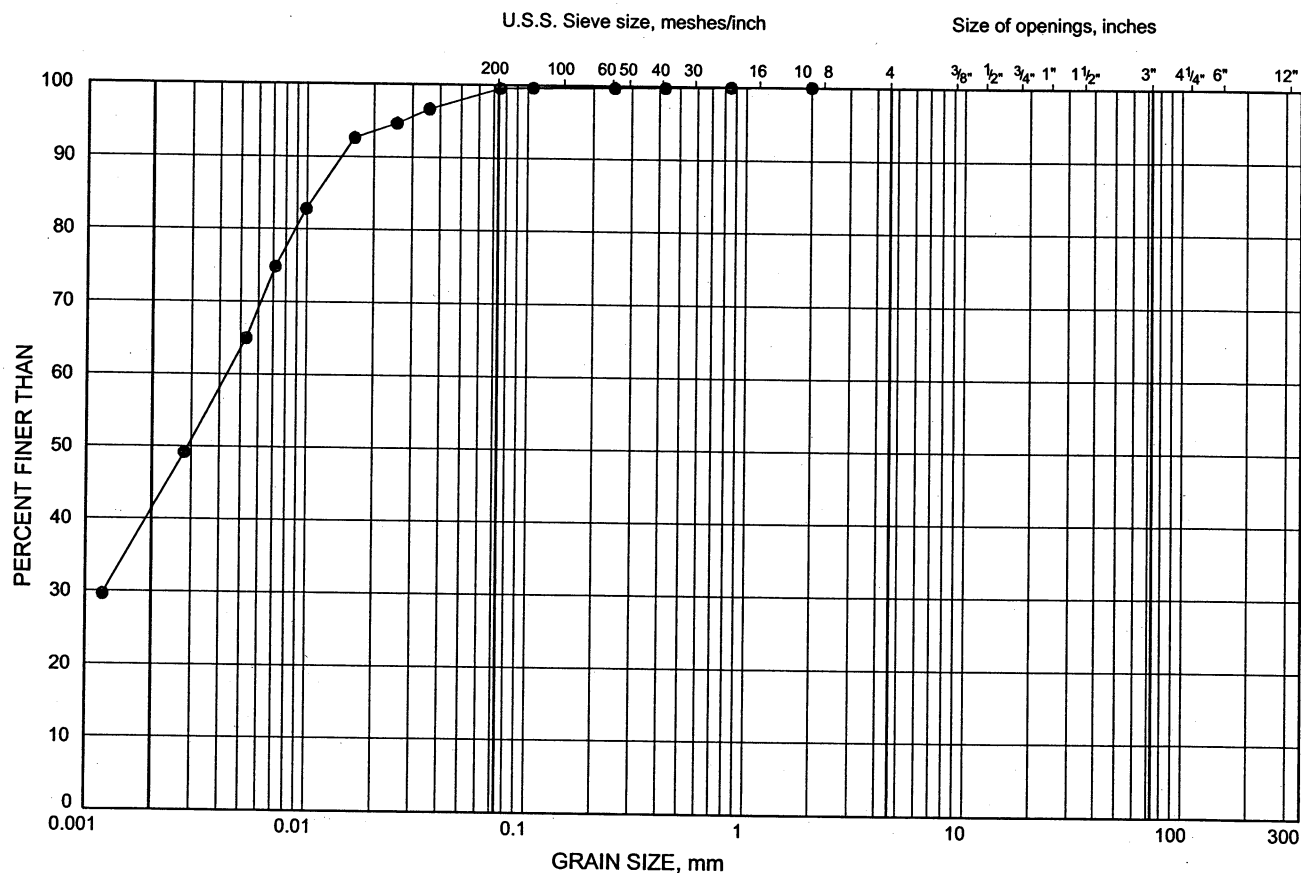
Figure 4

Grain Size Distribution

Unified Soil Classification System

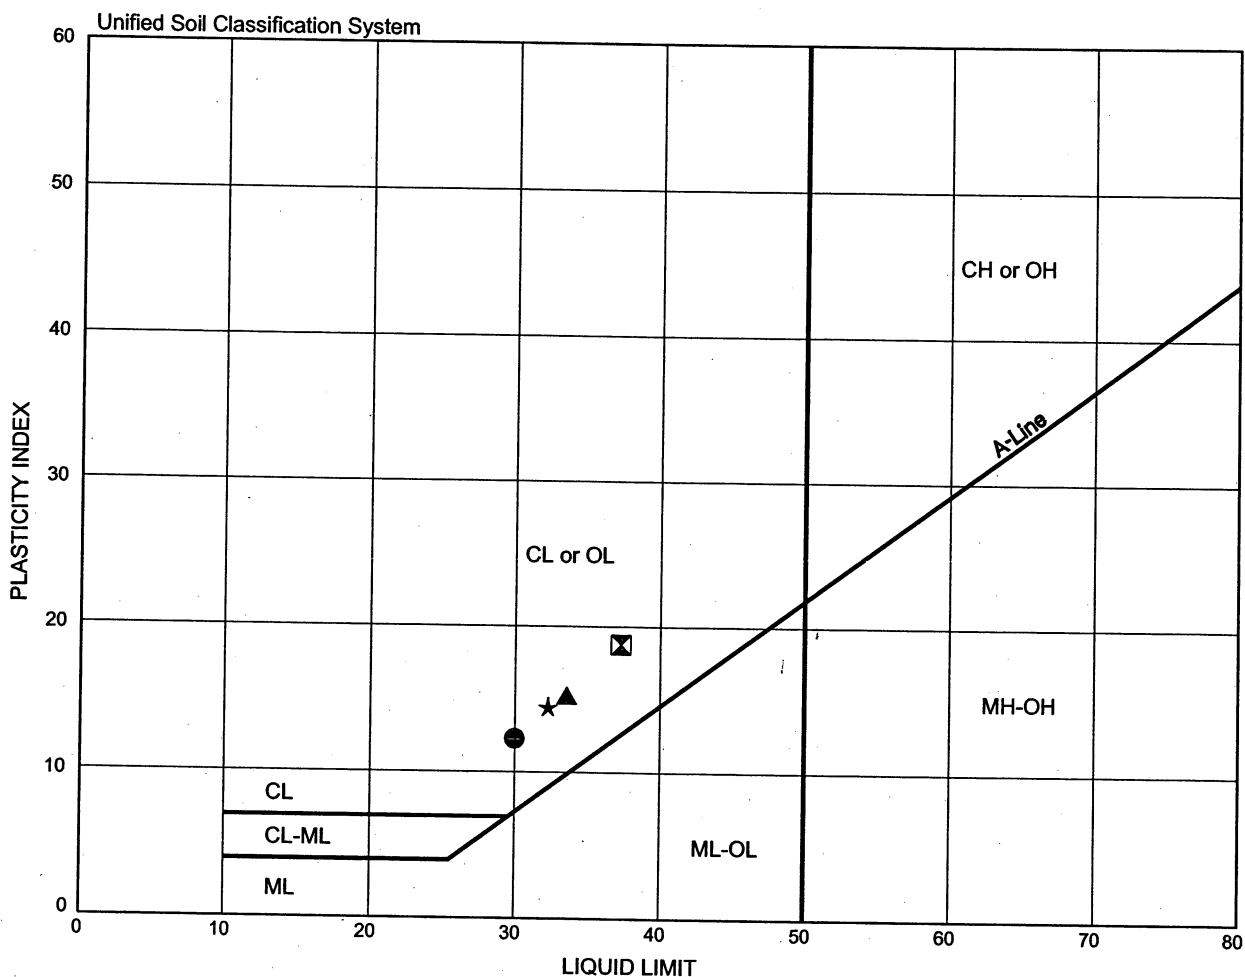
Figure 5

Symbol	Location	Sample No.	Depth (m)	Elevation (m)	W	W _p	W _L	PI
●	TP2	3	1.52		19.0	18	30	12
⊠	TP6	3	1.22		26.9	19	37	19
▲	TP7	3	1.07		22.6	18	34	15
★	TP9	3	1.22		21.0	18	32	15

Atterberg limits testing conducted on four samples of silty clay indicated that the silty clay is generally of medium plasticity. The natural moisture contents of these specimens were between the plastic and liquid limits. This data are presented on the Plasticity Chart, Figure 5, and summarized in the following Table 1.

Table 1: Summary of Atterberg Limits Testing				
Test Pit/Sample	TP2-3	TP6-3	TP7-3	TP8-3
Liquid Limit, w_L	30	37	34	32
Plastic Limit, w_P	18	19	18	18
Plasticity Index, I_P	12	19	15	15
Moisture Content, w	19.0%	26.9%	22.6%	21.0%

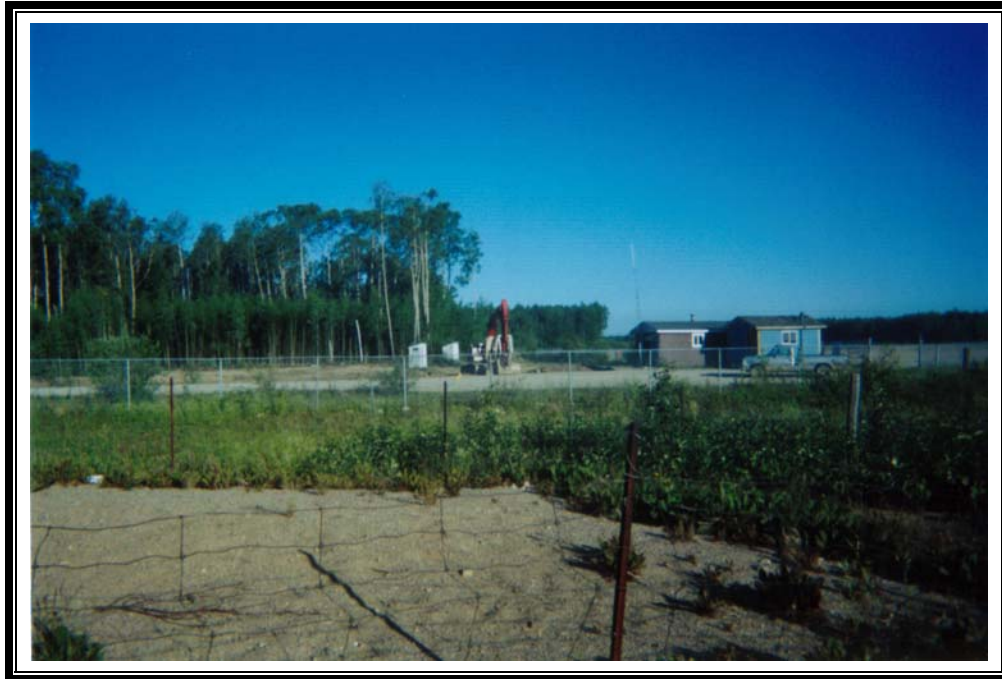
Photo 1: Looking west at the investigation area. Note existing security building (blue) and existing terminal building (brown).

The key features of the immediate investigation area are detailed on Figure 2, Test Pit Location Plan, which is based on a survey plan of the site by Delta Survey Inc, and illustrated on Photographs 1 to 5 included in Appendix B of this report. As shown on the plan, the current study area is located near the south side of the apron, adjacent to the existing terminal building. As illustrated on the photographs, the investigation area was generally surfaced with minor grass and minor sand and gravel fill. In preparation for the project, trees and other brush had been removed from the southwest portion of the investigation area. A temporary brush pile was observed near the southeast corner of the investigation area.

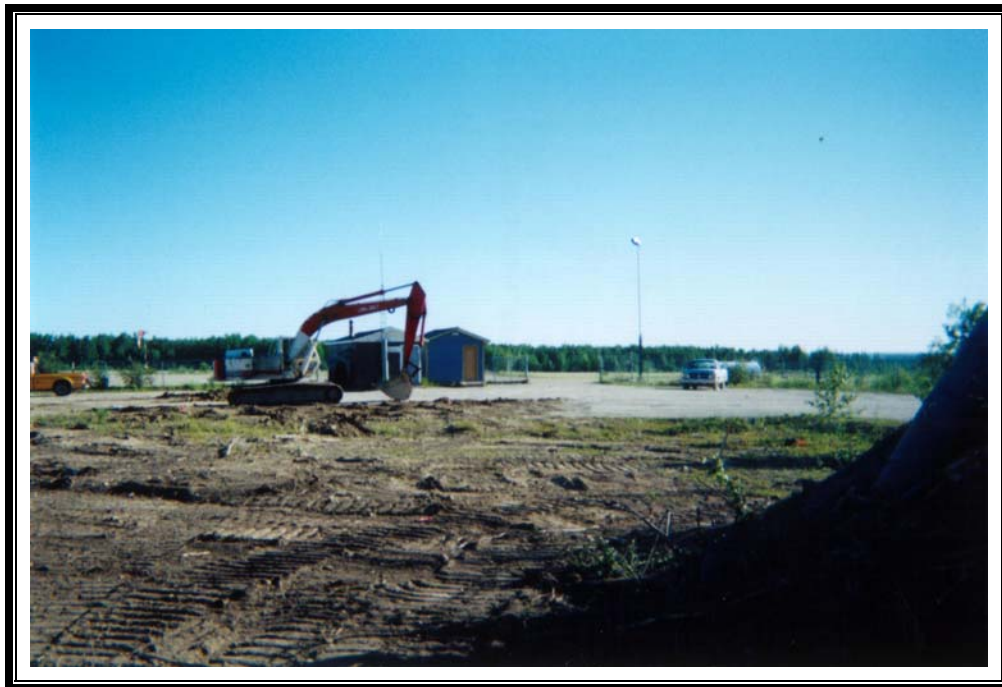
Photo 2: Looking north at the investigation area. Gravel surfaced apron in background. Note temporary brush pile at immediate right.

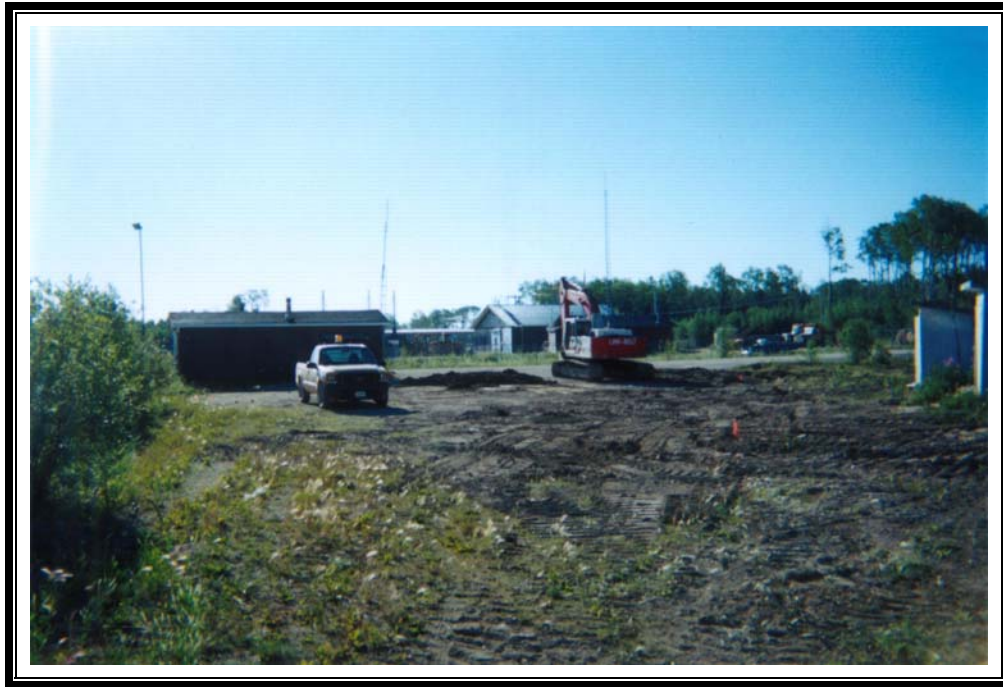
Photo 3: Looking east at the investigation area.

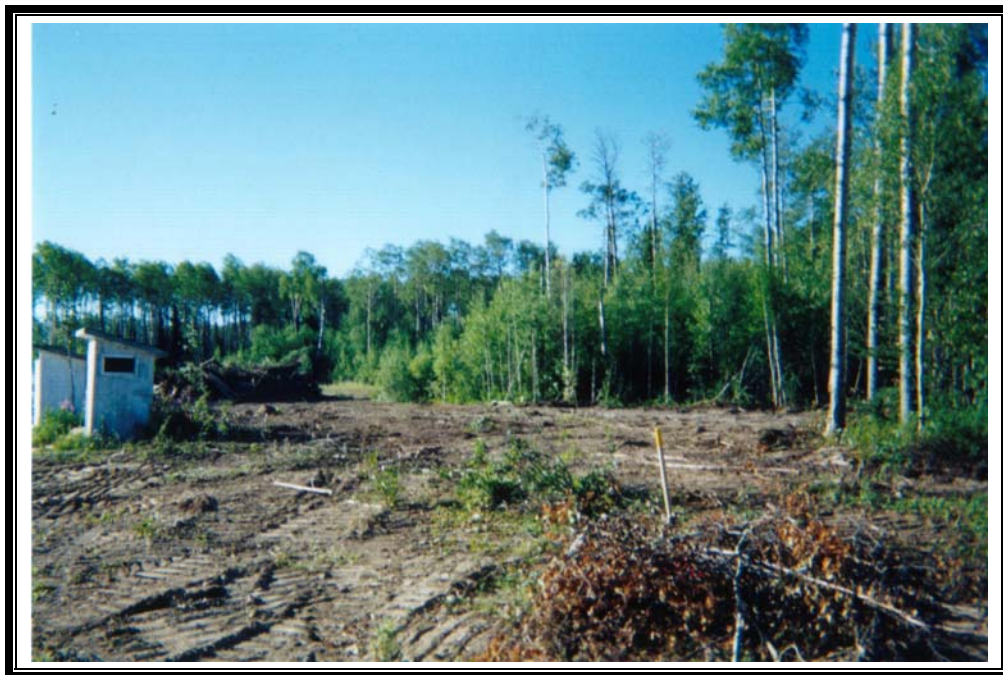
Photo 4: Looking southeast at the investigation area.

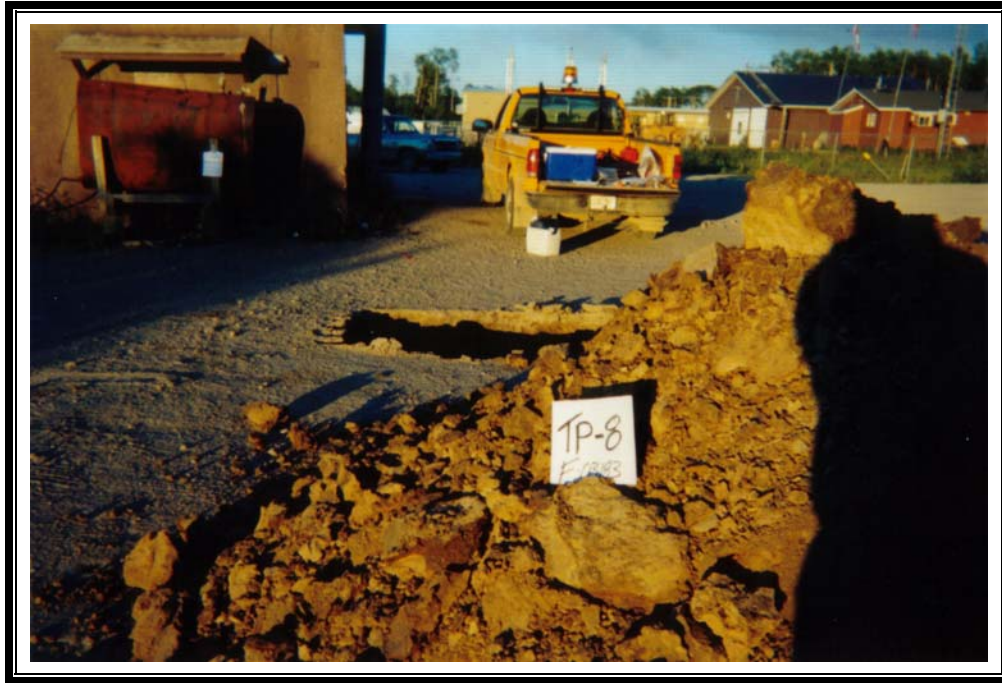
Photo 5: Looking at TP8. Note the heating oil tank alongside the terminal building. Note also the maintenance complex in background.

Frozen soil was also encountered within the silty clay stratum at TP6 to TP8 and TP10, from depths ranging between about 1.7 m and 3.65 m. It is noted that these four test pit locations were noted to be relatively unprotected (i.e., parking area) relative to the other test pits. Based on the time of year of the investigation (summer), this is probably an area of discontinuous permafrost.

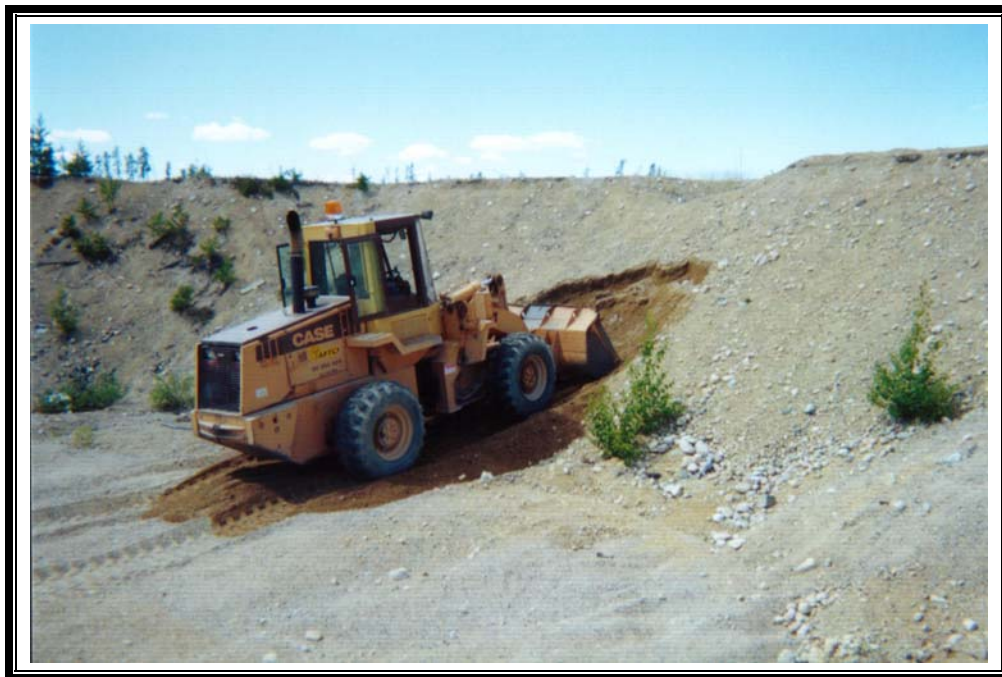
Photo 6: Sampling of the gravel source from large esker deposit.

The proposed gravel source consisted of a natural deposit of sand and gravel located some 17 km from the airport site (UTM 54,5293E, 5,975,255N, NAD 83, Zone 15). Based on the results of the grain size analyses, the proposed sand and gravel source appears to meet the gradation specifications for OPSS Granular B. A moisture-density relationship (i.e., Proctor test) conducted on the sand and gravel fill indicated a Standard Proctor Maximum Dry Density (SPMDD) of 1931 kg/m³ at an optimum water content of 8.3% by dry weight. Laboratory test results are presented in Appendix C of this report.

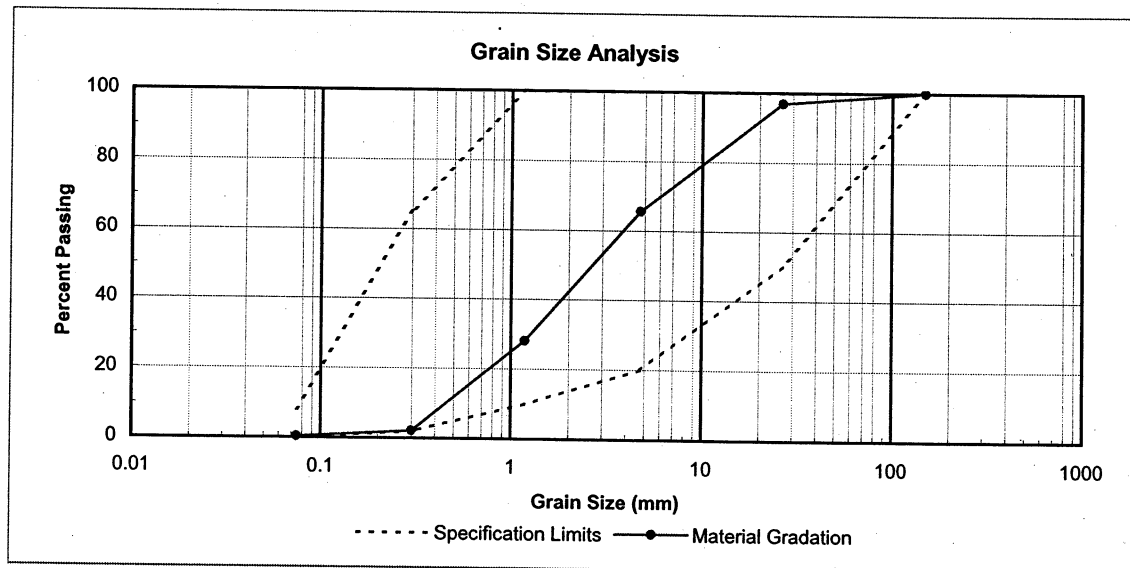
MTO Sieve Designation LS 602 - Figure 1	Cumulative Mass Retained	Percent Passing	Specifications: OPSS: 1010 Table 2
150 mm	0	100	100
106 mm			
75 mm			
53 mm			
37.5 mm			
26.5 mm	343.4	96.9	50 - 100
19 mm	877.3	92.1	
13.2 mm	1413.2	87.2	
9.5 mm	2123.9	80.8	
6.7 mm			
4.75 mm	3826.2	65.5	20 - 100
1.18 mm	117.9	28.1	10 - 100
0.3 mm	199.9	2.1	2 - 65
0.075 mm	205.2	0.4	0 - 8

In addition, a grain size analyses and moisture density relationship (standard Proctor) test was conducted on the sample of the proposed gravel source. Results of the testing are provided in Appendix C.

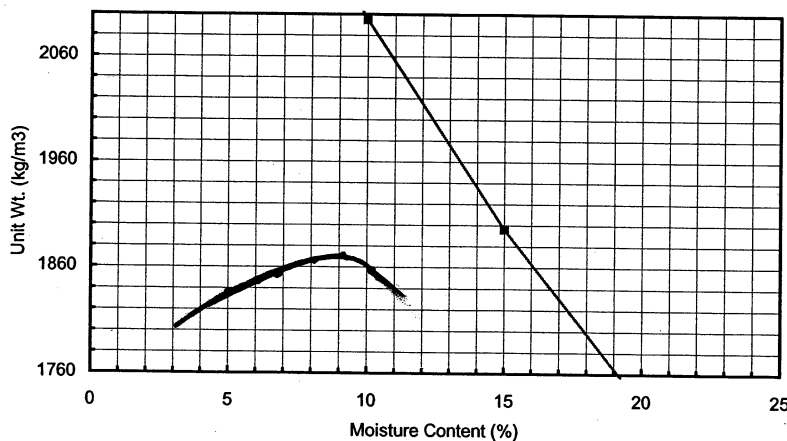
Max. Wet Density g/cm³ 2039 Oversize Sieve 19 mm (% Ret'd) 7.9%
Ma. Dry Density g/cm³ 1870 MDD Corrected for Oversize: 1931
Optimum Moisture 9.0% Moisture Corrected for Oversize: 8.3%

Zero Air Voids
