### **FOUNDATION INVESTIGATION REPORT**

**Murky Creek Bridge Replacement, Highway 584, Site No. 48E-004, District of  
Thunder Bay, Ontario**

**Agreement No. 6014-E-0017  
Assignment No. 10 & 11  
GWP 6054-08-00  
Geocres No. 42L-002**

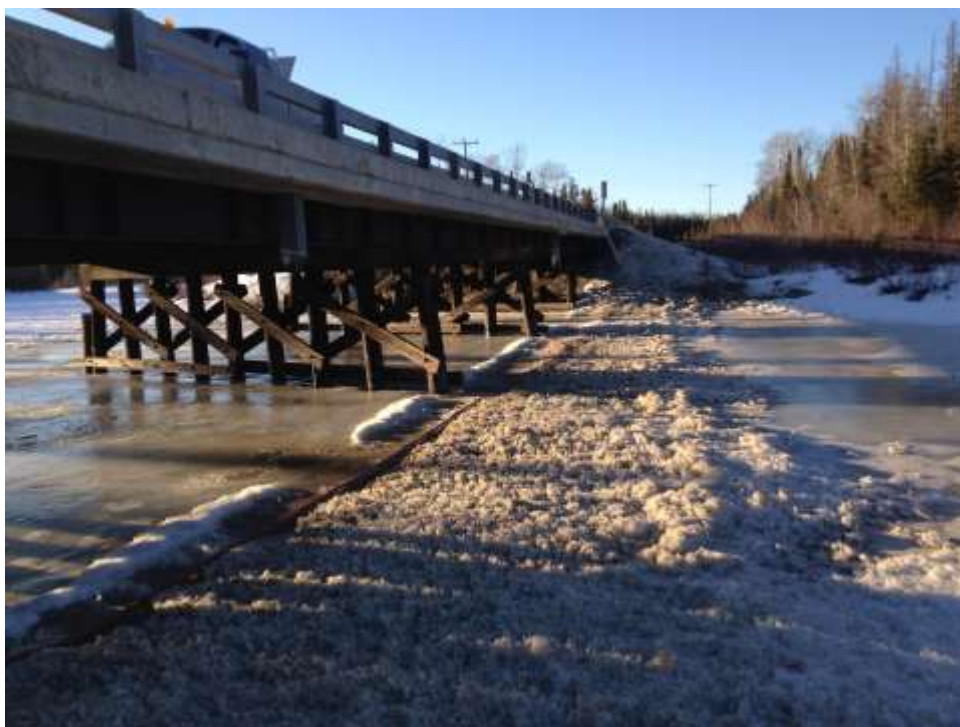
Photo 1. Looking north at downstream side of existing bridge, east side of highway

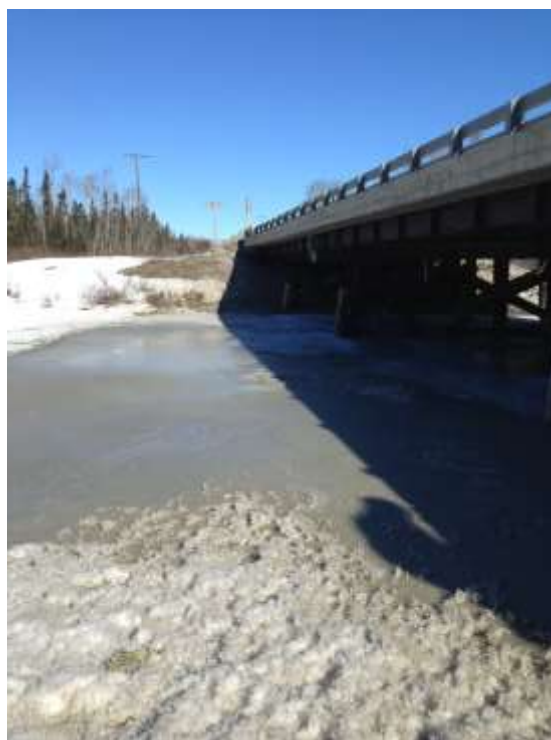
Photo 2. Looking north at upstream side of existing bridge, west side of highway

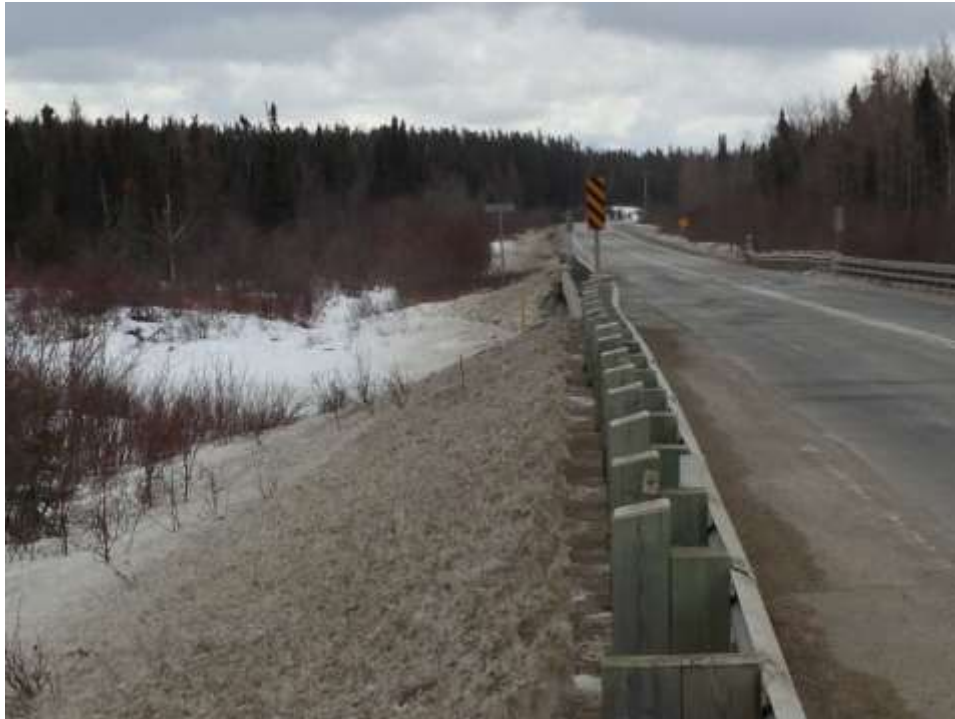
Photo 5. Embankment slope on east side facing south

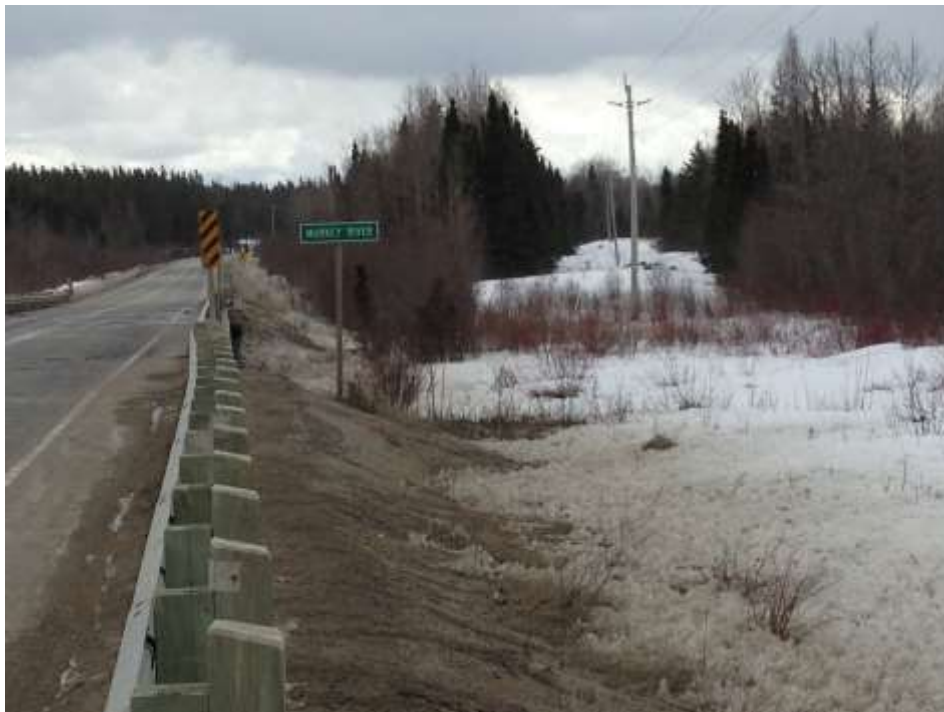
Photo 6. Embankment slope on west side facing south

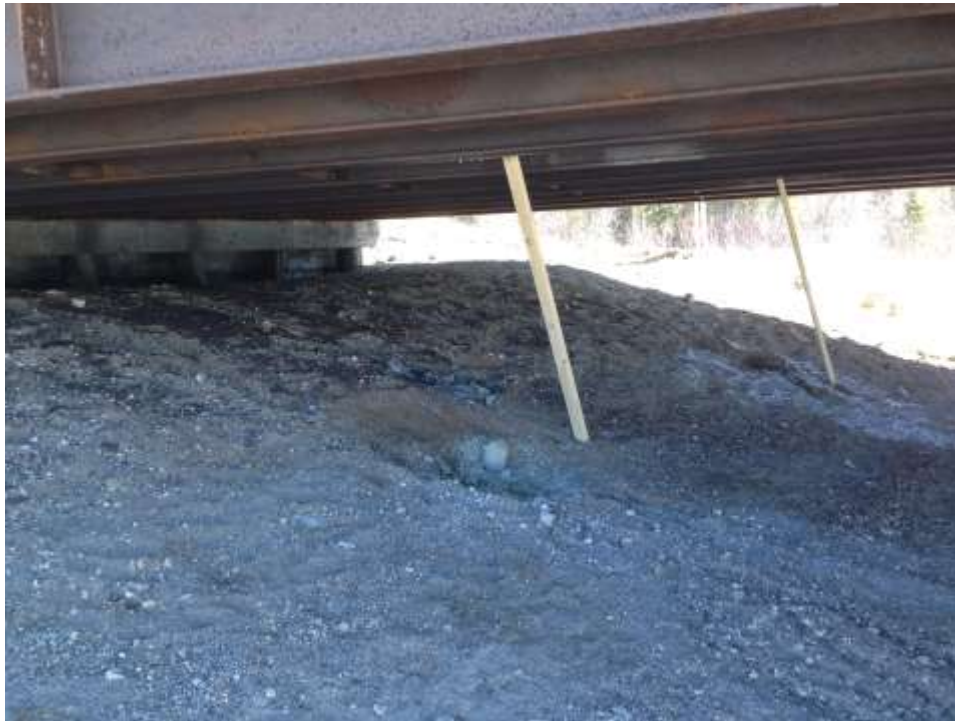
Photo 7. Existing north abutment slope facing northeast

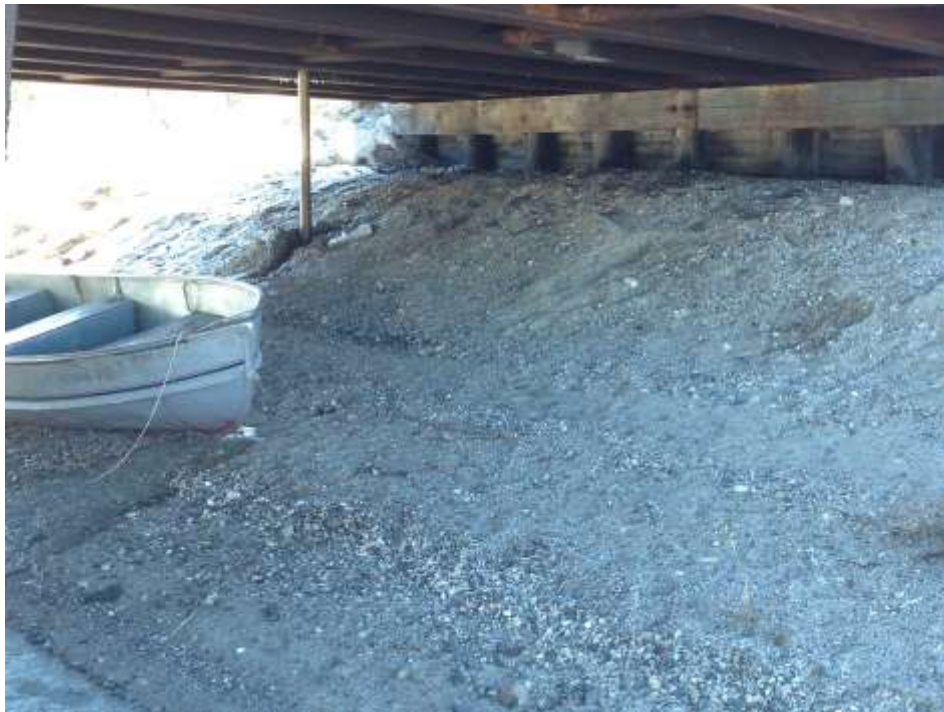
Photo 8. Existing south abutment slope facing southeast

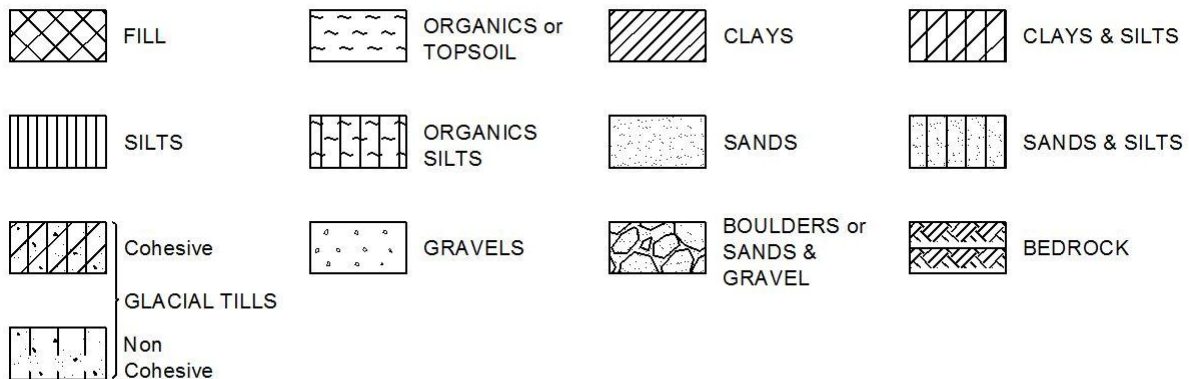
Strata plots symbolize the soil or bedrock description. They are combinations of the following basic symbols:

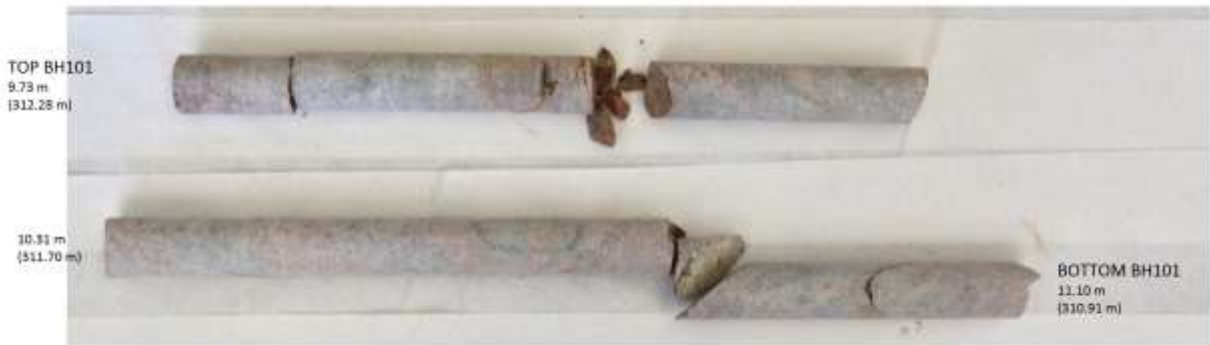
BH101 - Bedrock Core Samples with Depths and Elevations

312.3																	
9.7	- refusal to SPT at about 9.6 m depth BEDROCK - medium strong, white, black, red to pink, fractured, medium grained, granite			SS	100												
			S8	CORE												Recovery=98% RQD=60%

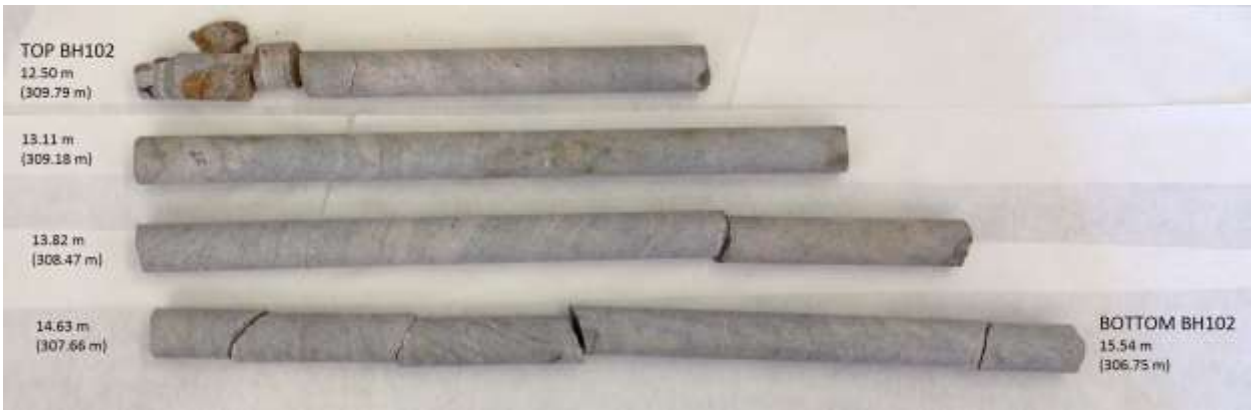
BH102 - Bedrock Core Samples with Depths and Elevations

309.8																			
12.5	<b>BEDROCK</b> - medium strong, white, black, red to pink, fractured to very sound, medium grained, granite						309												
			S15	CORE															
							308

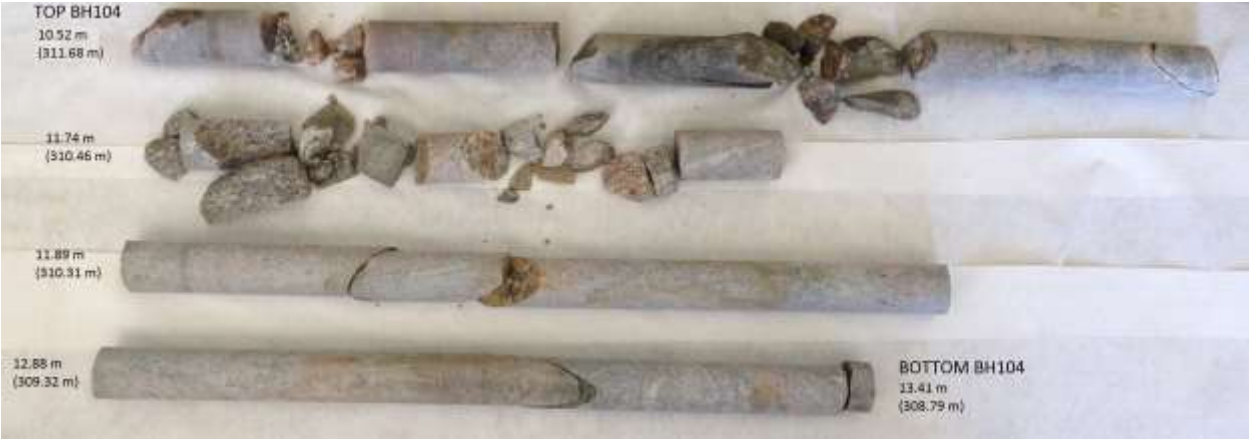
BH104 - Bedrock Core Samples with Depths and Elevations

10.5	<b>BEDROCK</b> - medium strong, white, black, red to pink, severely fractured to sound, medium grained, granite		S8	CORE			311											Recovery=100% RQD=35%		
								310												
				S9	CORE													Recovery=95% RQD=80%

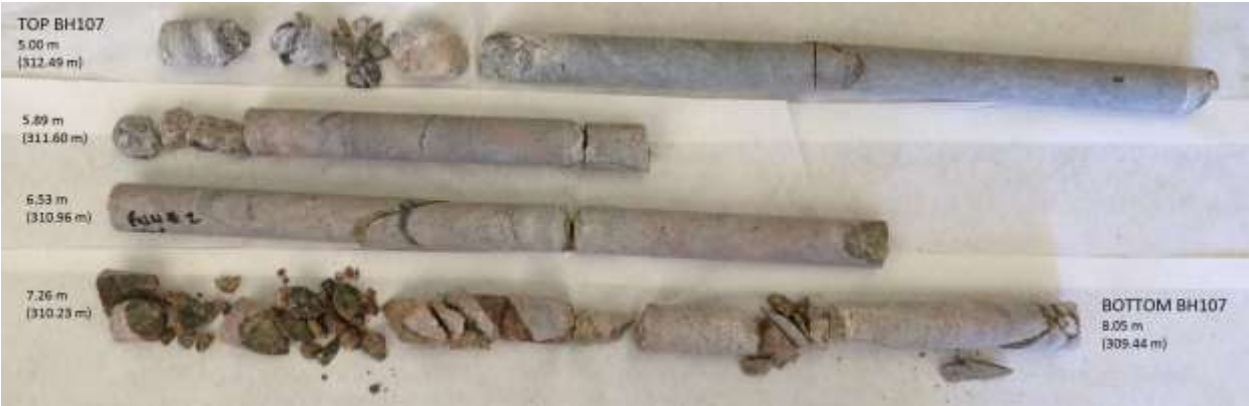
BH107 - Bedrock Core Samples with Depths and Elevations

ranging between 309.8 m and 312.5 m. The bedrock was generally described as medium strong (25 MPa to 50 MPa compressive strength), white, black and red to pink in colour, severely fractured to very sound and medium grained, granite. The boreholes were extended by rock coring to depths ranging between about 1.4 m to 3.4 m into bedrock, and to depths ranging between about 8.1 m and 15.5 m below ground surface. The boreholes were terminated at elevations ranging between about 306.8 m and 310.9 m. Photographs of the bedrock core samples are presented in Appendix C, after the Borehole Logs.

Gross recoveries ranged between about 80% and 100%. The Rock Quality Designation (RQD), which is a modified core recovery, ranged between 35% and 100% (severely fractured to very sound).

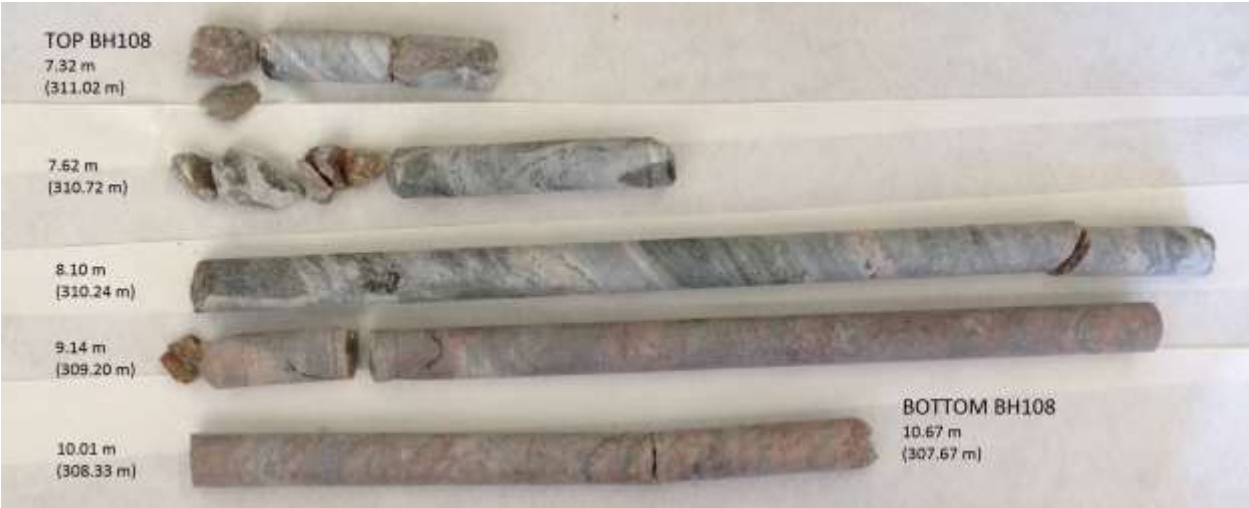
BH108 - Bedrock Core Samples with Depths and Elevations
