FOUNDATION INVESTIGATION REPORT

Caribus Lake Tributary Timber Culvert Replacement, Highway 11, Site No. 45-269/C, District of Rainy River

**Agreement No. 6014-E-0017
Assignment No. 6
GWP 6320-14-00
Geocres No. 52B-024**

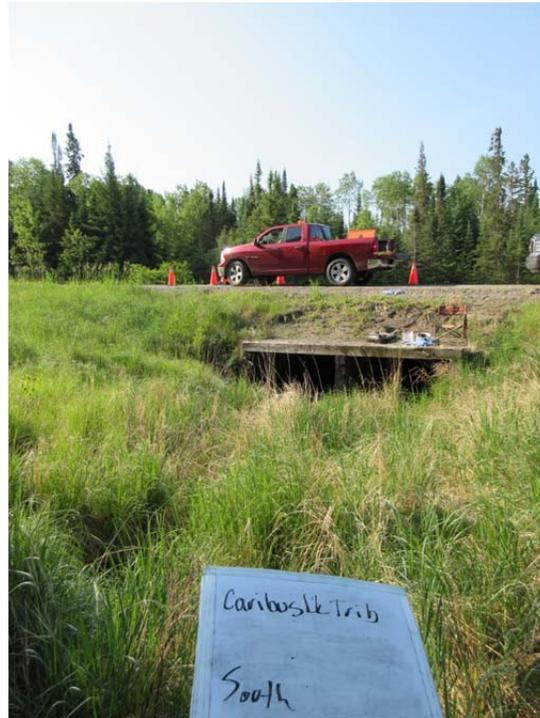
Photo 1. Existing culvert inlet on north side of highway

At the vicinity of the inlet and outlet of the culvert some tall grass was noted at both culvert ends. The surrounding area of the culvert also contained tall grass. The inlet and outlet appeared to be

generally clear of debris and excess vegetation, and as such the flow does not appear to be restricted.

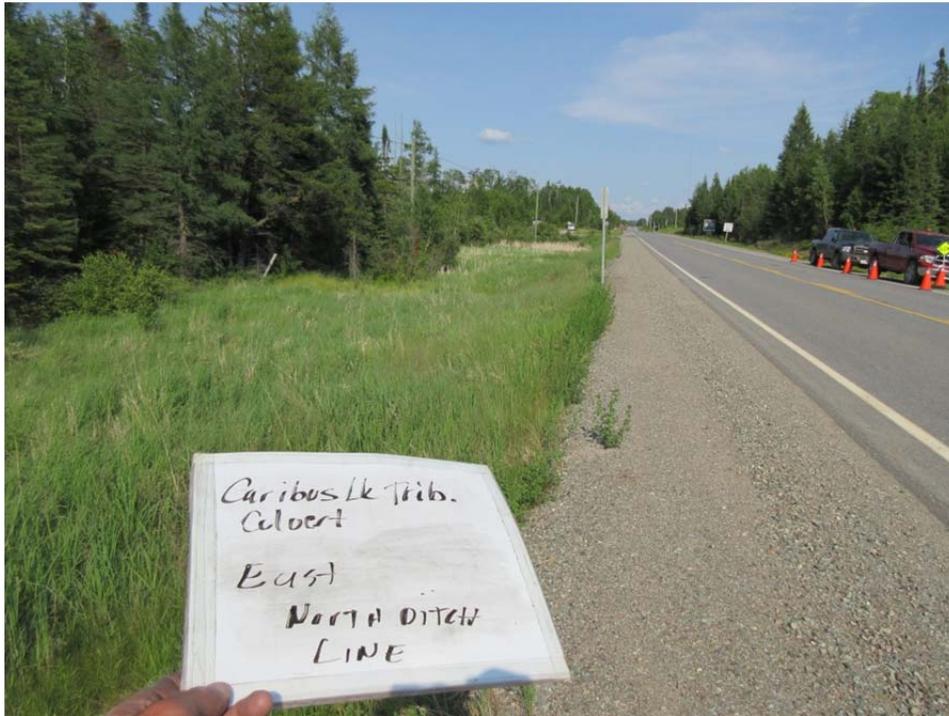
Photo 5. Embankment slope on north side facing east

As shown on Drawing 1 (Appendix B), the Caribus Lake Tributary Timber Culvert is located on Highway 11, about 3.1 km west of the junction of Hwy 11 and Hwy 11B, in the District of Rainy River, south of Atikokan, Ontario. At the site, Hwy 11 is a two lane roadway, with a speed limit of 90 km/h and is about 7.1 m wide from edge of pavement to edge of pavement, with sand and gravel shoulders about 2 m wide. Based on drawings provided, the roadway embankment is about 3.5 m high with side slopes of about 2H:1V.

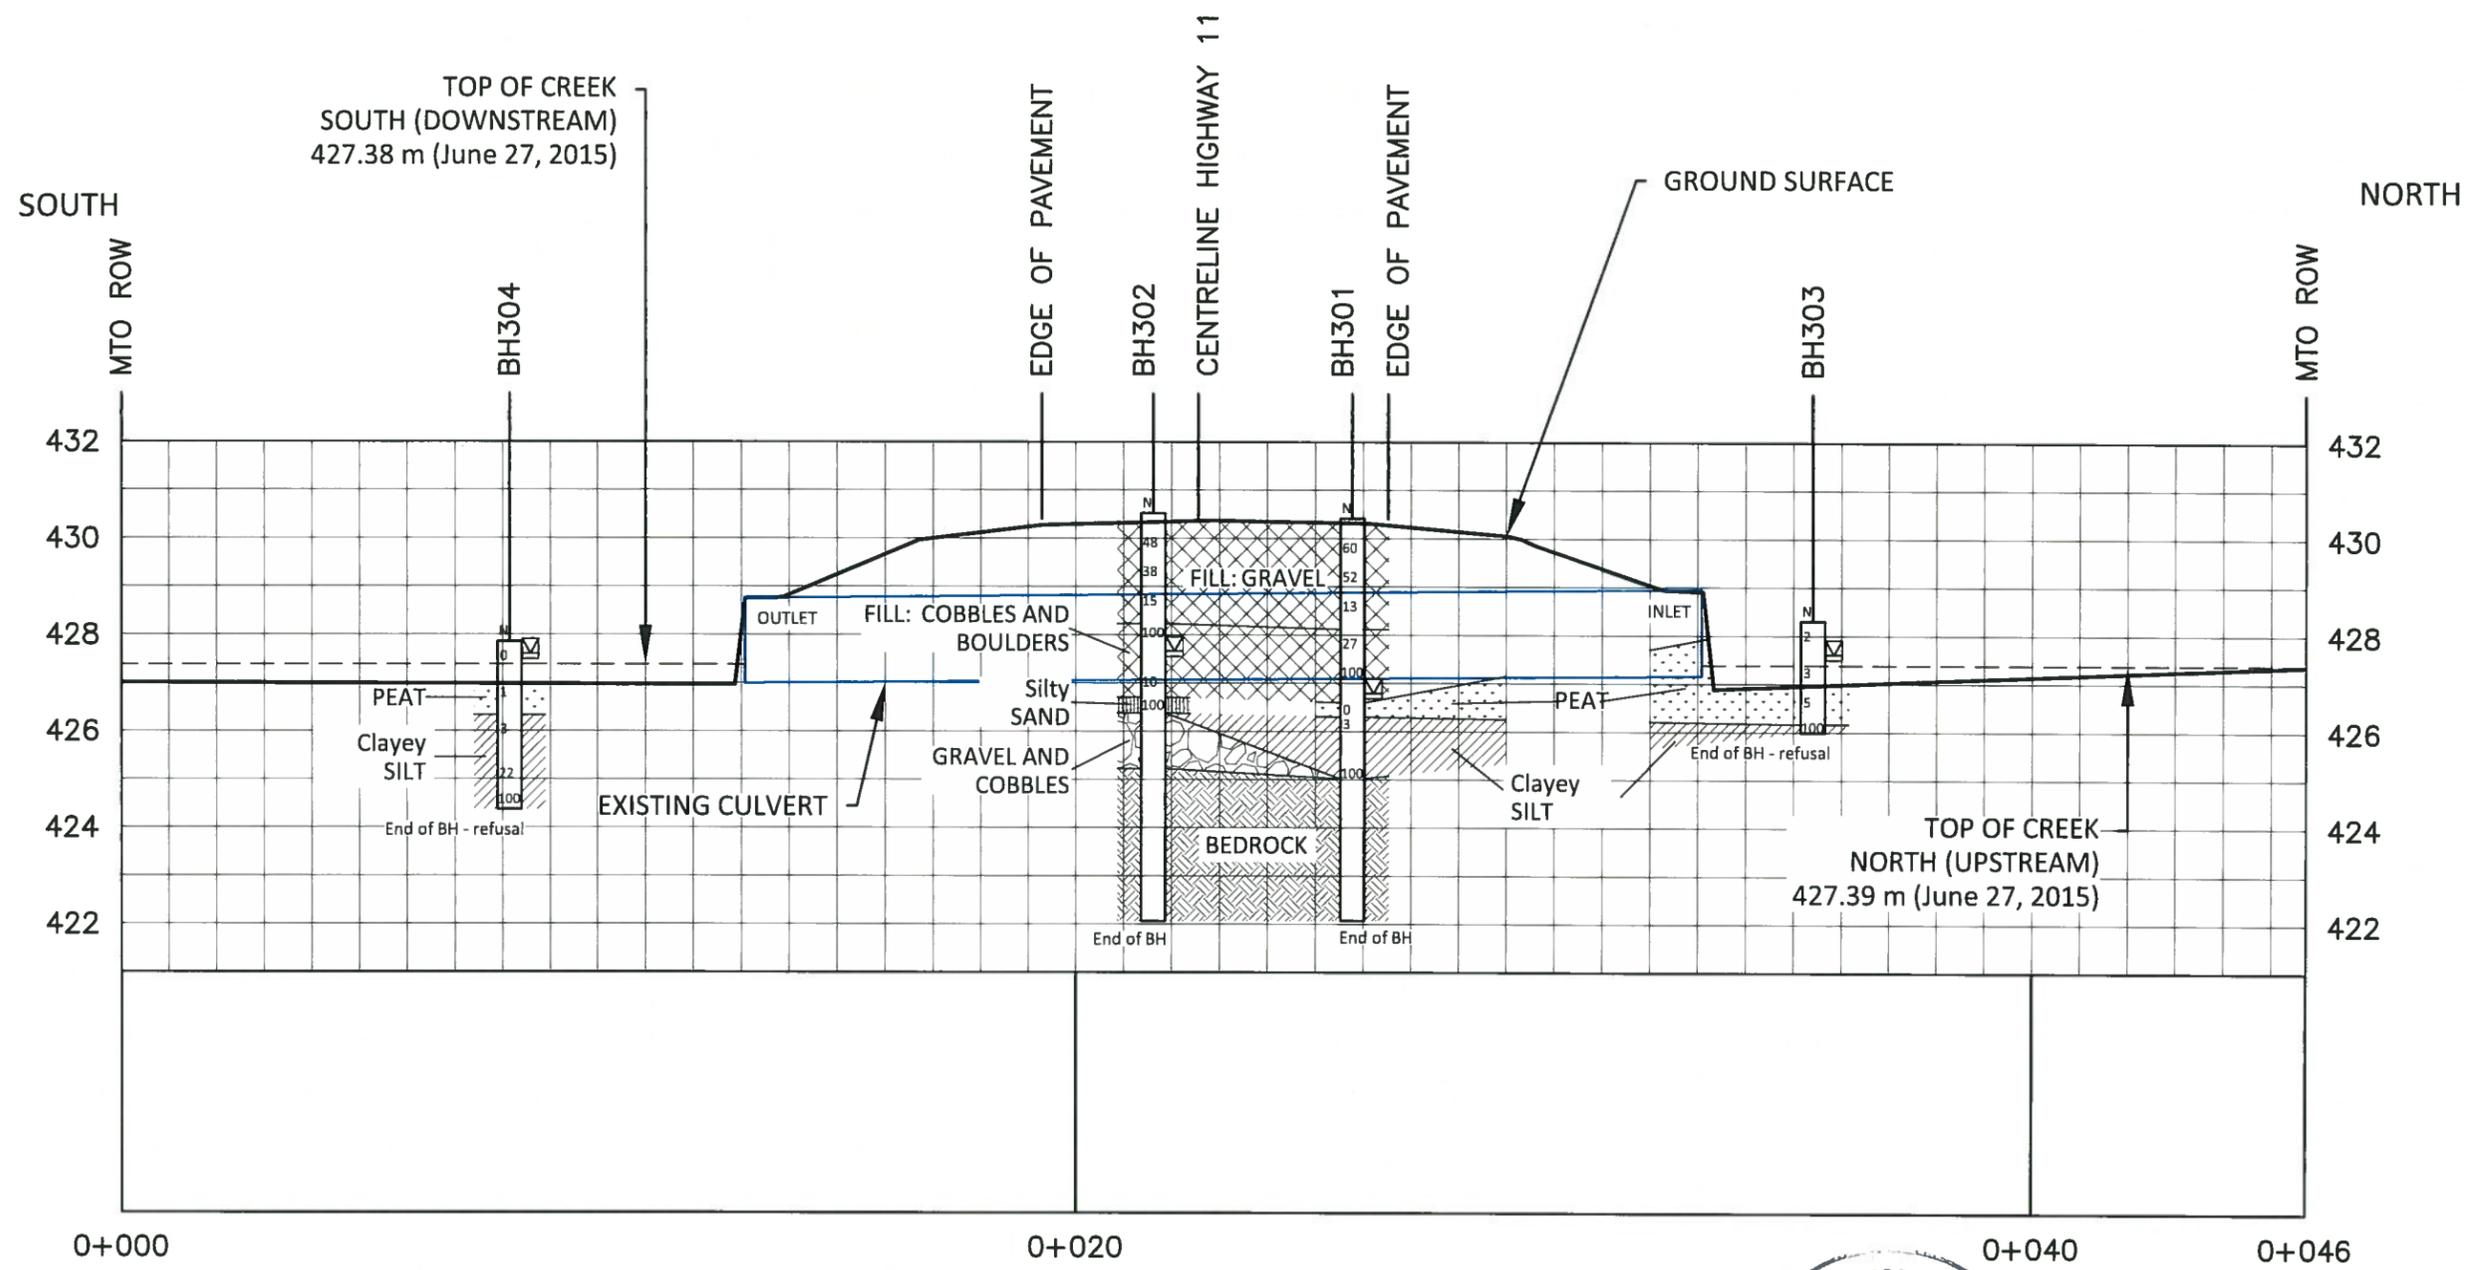
A - A'
PROFILE OF CARIBUS LAKE CULVERT

A borehole location plan and stratigraphic sections are provided in Appendix B. It should be noted that the stratigraphic boundaries indicated on the borehole log and stratigraphic sections are inferred from semi-continuous sampling, observations of drilling progress and results of Standard Penetration Tests. These boundaries typically represent transitions from one soil type to another and should not be interpreted as exact planes of geological change. Furthermore, subsurface conditions may vary between and beyond the borehole locations.

In general, the subsurface conditions along the proposed culvert alignment consist of a layer of fill material composed of silty gravel with sand, and cobbles and boulders. In general, the fill was overlying peat, overlying clayey silt and overlying bedrock. A more detailed summary of the subsurface conditions encountered in the boreholes is provided in the following sections.

The field investigation was performed on June 19 to 21, and 26 to 28, 2015. The field program consisted of drilling four (4) sampled boreholes (BH301 to BH304). Two (2) boreholes were located within the highway, BH301, and BH302. BH301 was located about 5 m west of the culvert centerline and about 3 m north of the highway centerline. BH302 was located about 5 m east of the culvert centerline and about 1.2 m south of the highway centerline. An additional two (2) boreholes (BH303 and BH304) were advanced off of the highway. BH303 was located about 5.5 m west of the culvert centerline and about 13 m north of the highway centerline (inlet/upstream side). BH304 was located about 3.2 m west of the culvert centerline and about 15 m south of the highway centerline (outlet/downstream side). The borehole locations are shown on Drawing 1 in Appendix B.

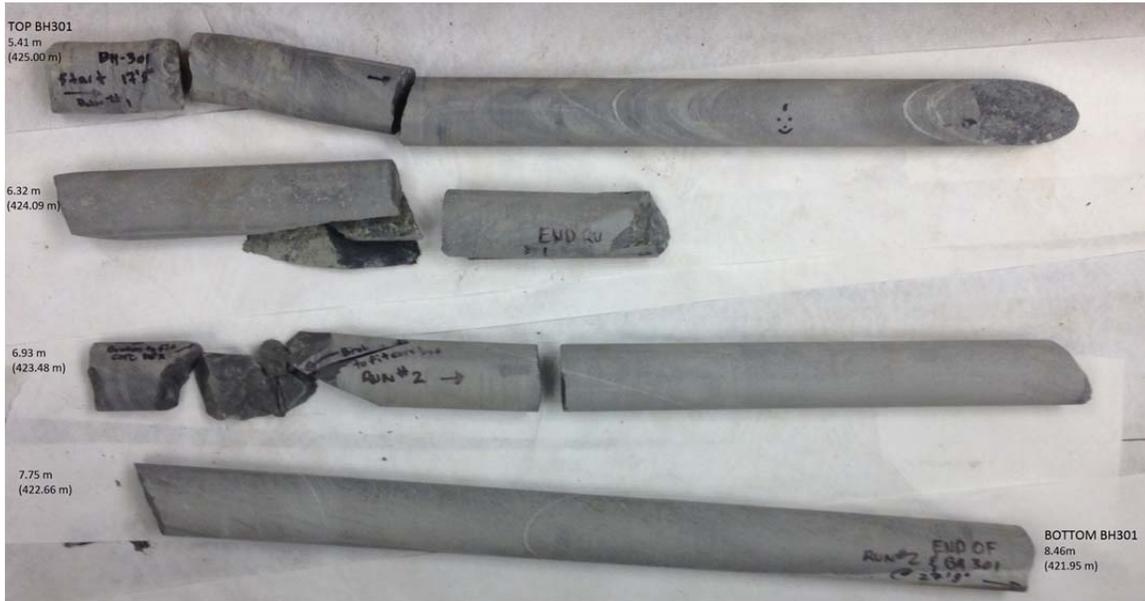
BH301 - Bedrock Core Samples with Depths and Elevations

Bedrock was encountered underlying the clayey silt at BH301, and beneath the cobbles and boulders at BH302, at depths of about 5.4 m (425.0 m elevation) and 5.3 m (425.2 m elevation), respectively. The bedrock was generally described as a medium strong (25 MPa to 50 MPa compressive strength), fractured to very sound, green to grey, and fine grained. The boreholes were extended by rock coring about 3.0 m to 3.1 m into bedrock, and to depths ranging about 8.3 m and 8.5 m below ground surface. The boreholes were terminated at elevations ranging between about 422.0 m and 422.2 m. Photographs of the bedrock core samples are presented in Appendix C, after the Borehole Logs.

Gross recoveries ranged between about 93% and 100%. The Rock Quality Designation (RQD), which is a modified core recovery, ranged from 53% to 100% (fractured to very sound).

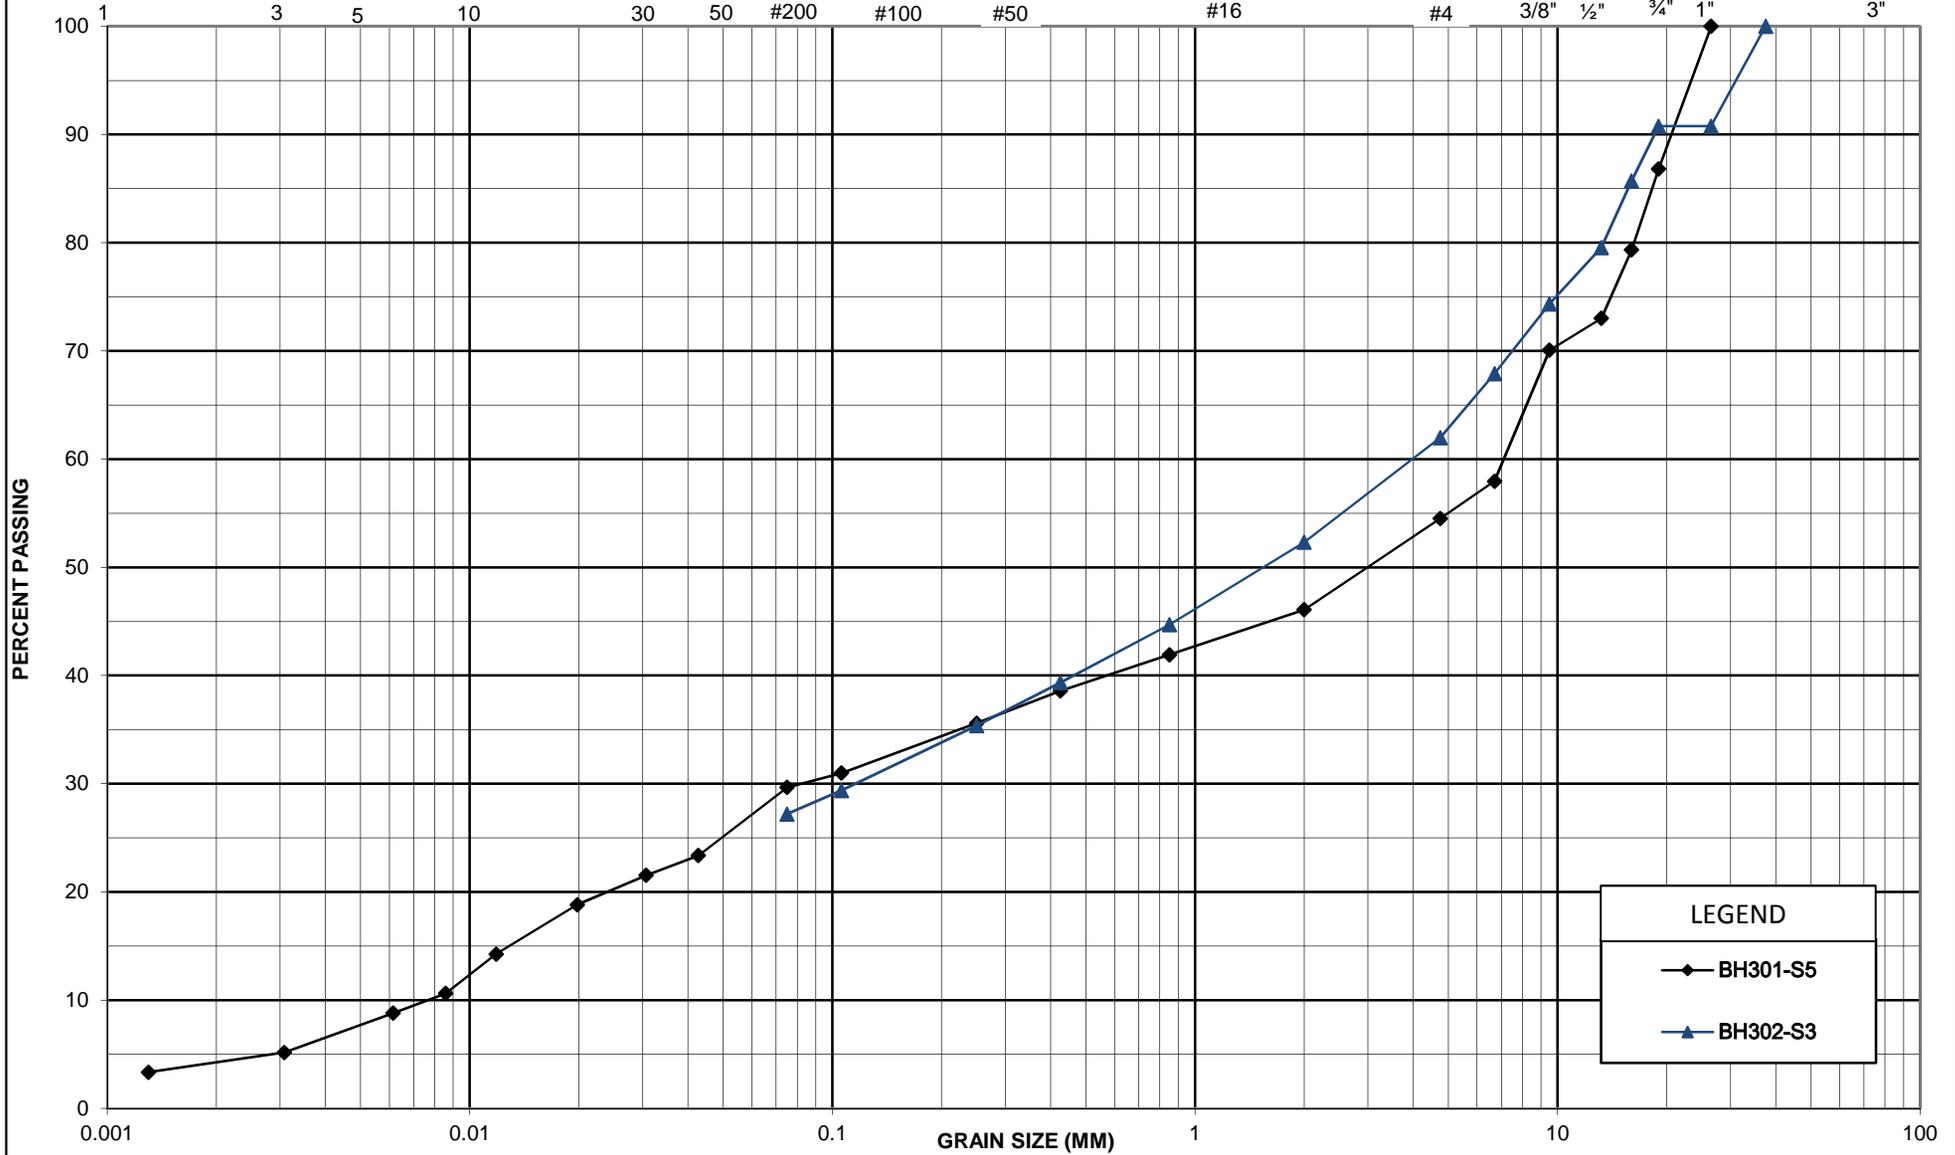
GRAIN SIZE DISTRIBUTION

- 38% to 45% gravel;
- 25% to 35% sand;
- 26% to <27% silt ; and
- 4% to <27% clay size.

The results of the moisture content and grain size distribution tests are provided on the record of borehole sheets in Appendix C. The results of the grain size distribution tests are also provided on Figure 1, in Appendix D.

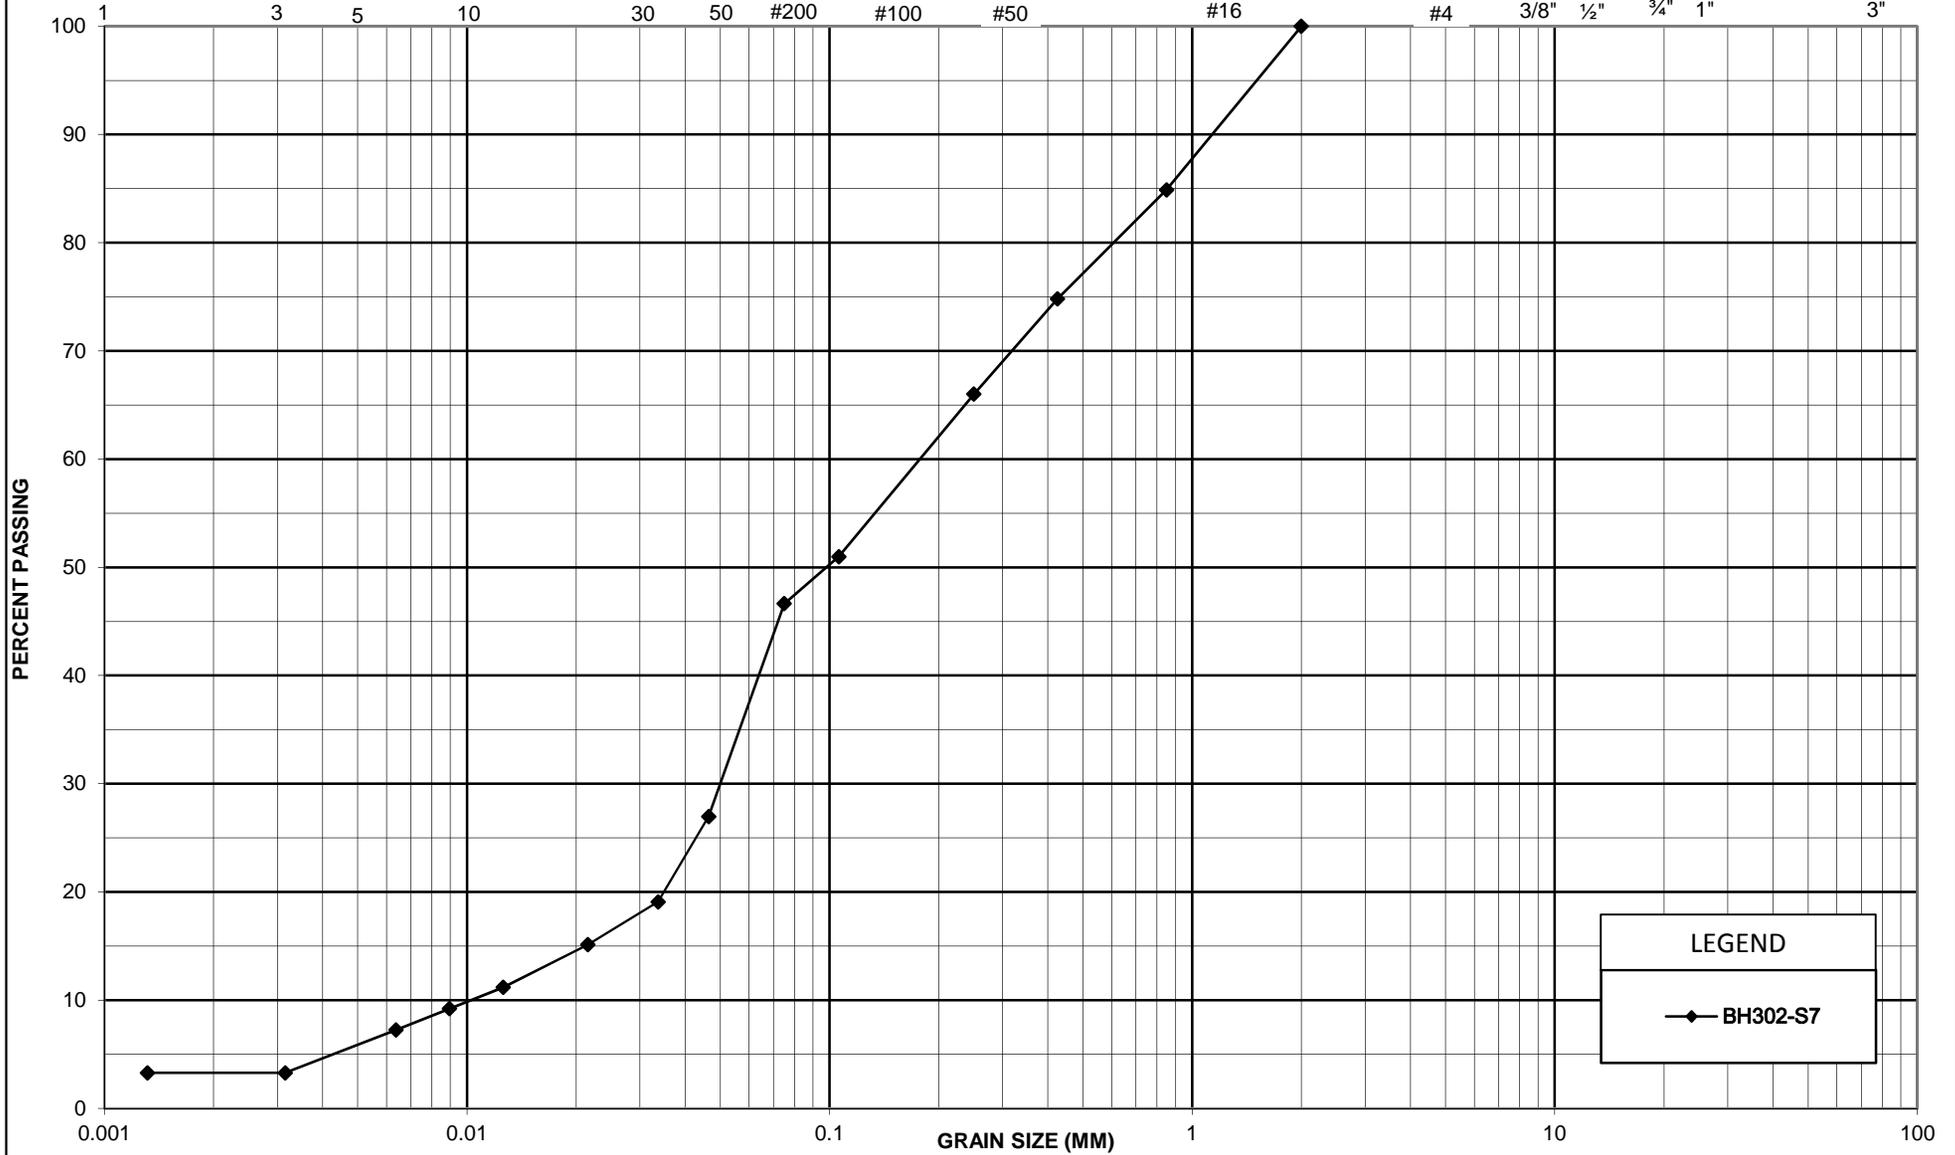
- 54% sand;
- 43% silt; and
- 3% clay size.

The results of the moisture content, grain size distribution and Atterberg Limits tests are provided on the record of borehole sheets in Appendix C. The results of the grain size distribution are also provided on Figure 2 in Appendix D, and Atterberg Limits tests are provided on Figure 5 in Appendix D.

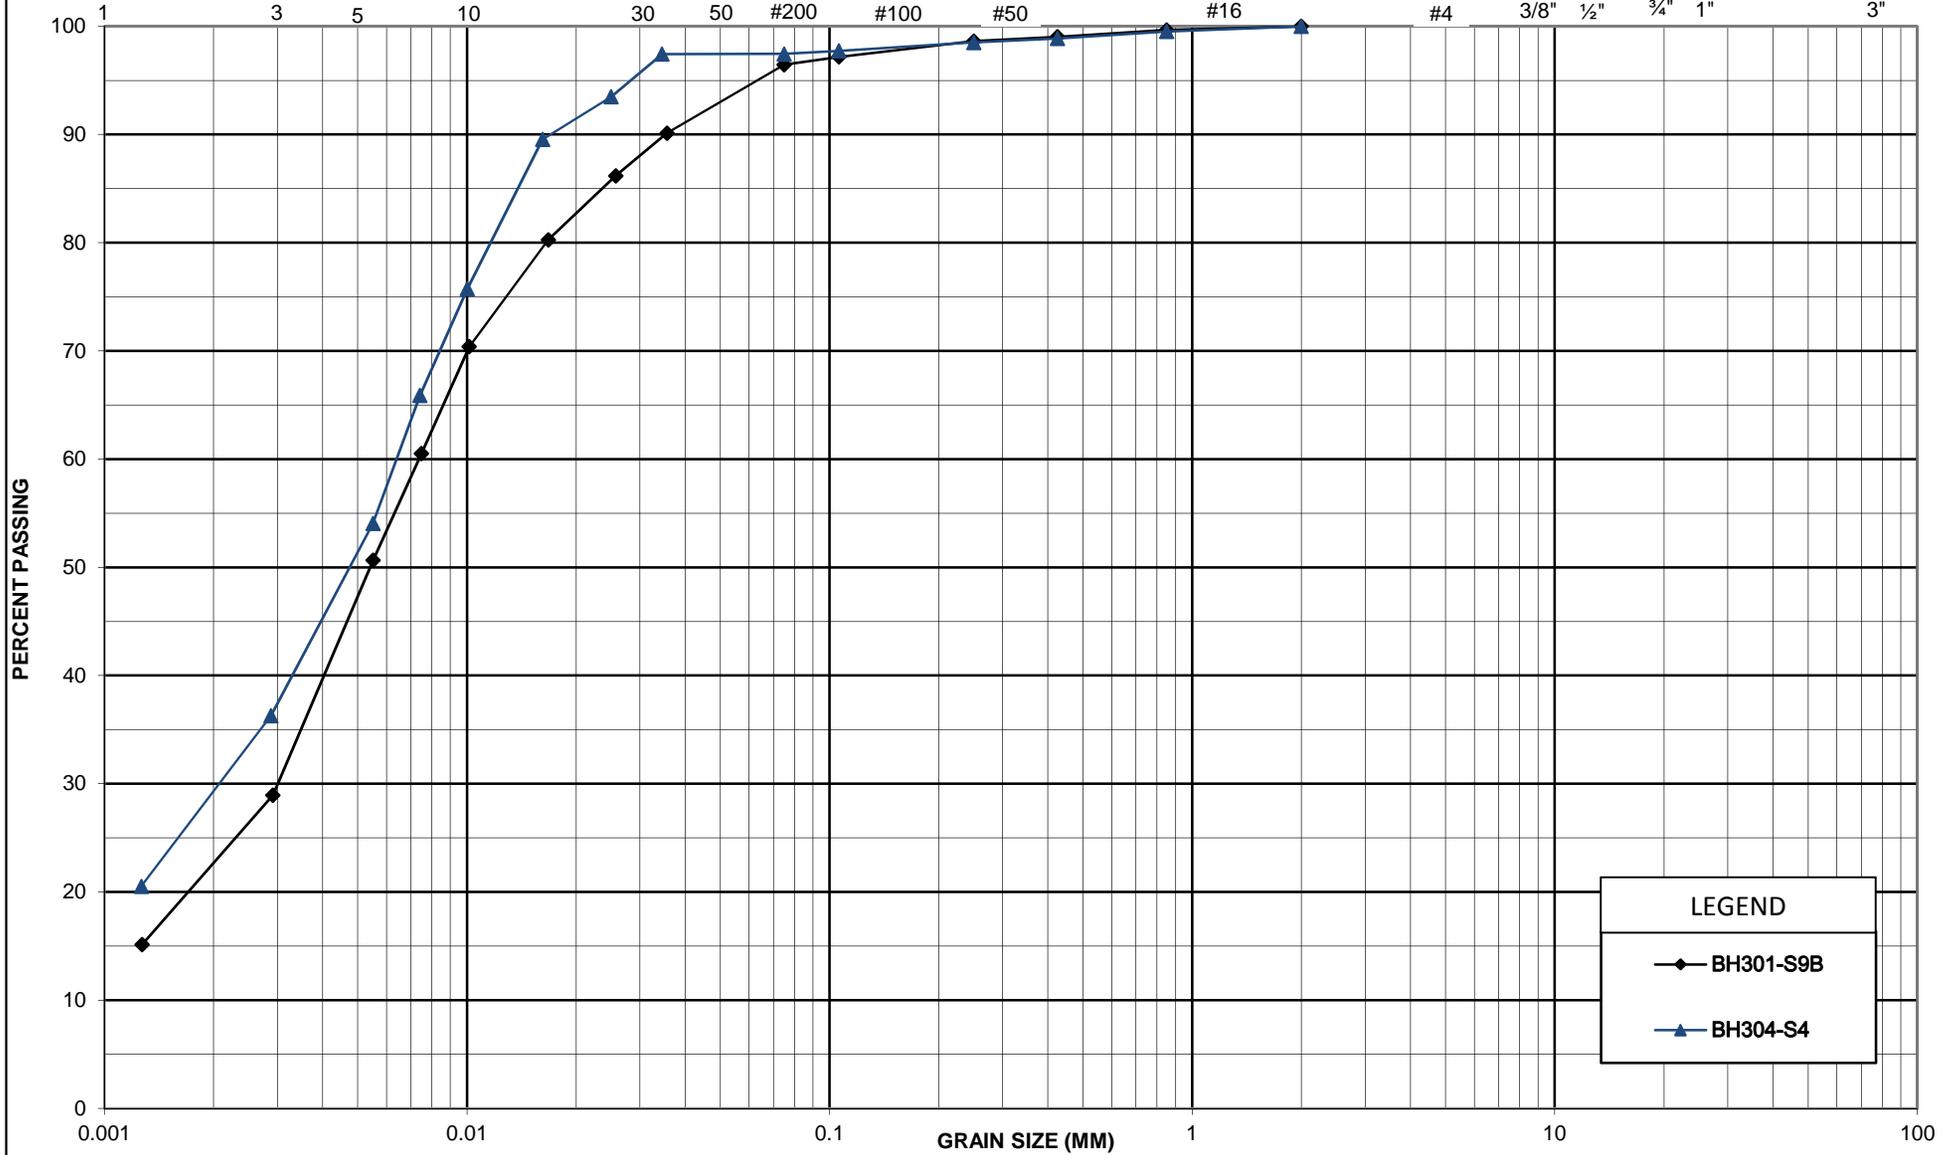
- 0% gravel;
- 2% to 3% sand;
- 70% to 75% silt; and
- 22% to 28% clay size.

The results of the moisture content, grain size distribution and Atterberg Limits tests are provided on the record of borehole sheets in Appendix C. The results of the grain size distribution are also provided on Figure 3 in Appendix D, and Atterberg Limits tests are provided on Figure 4 in Appendix D.

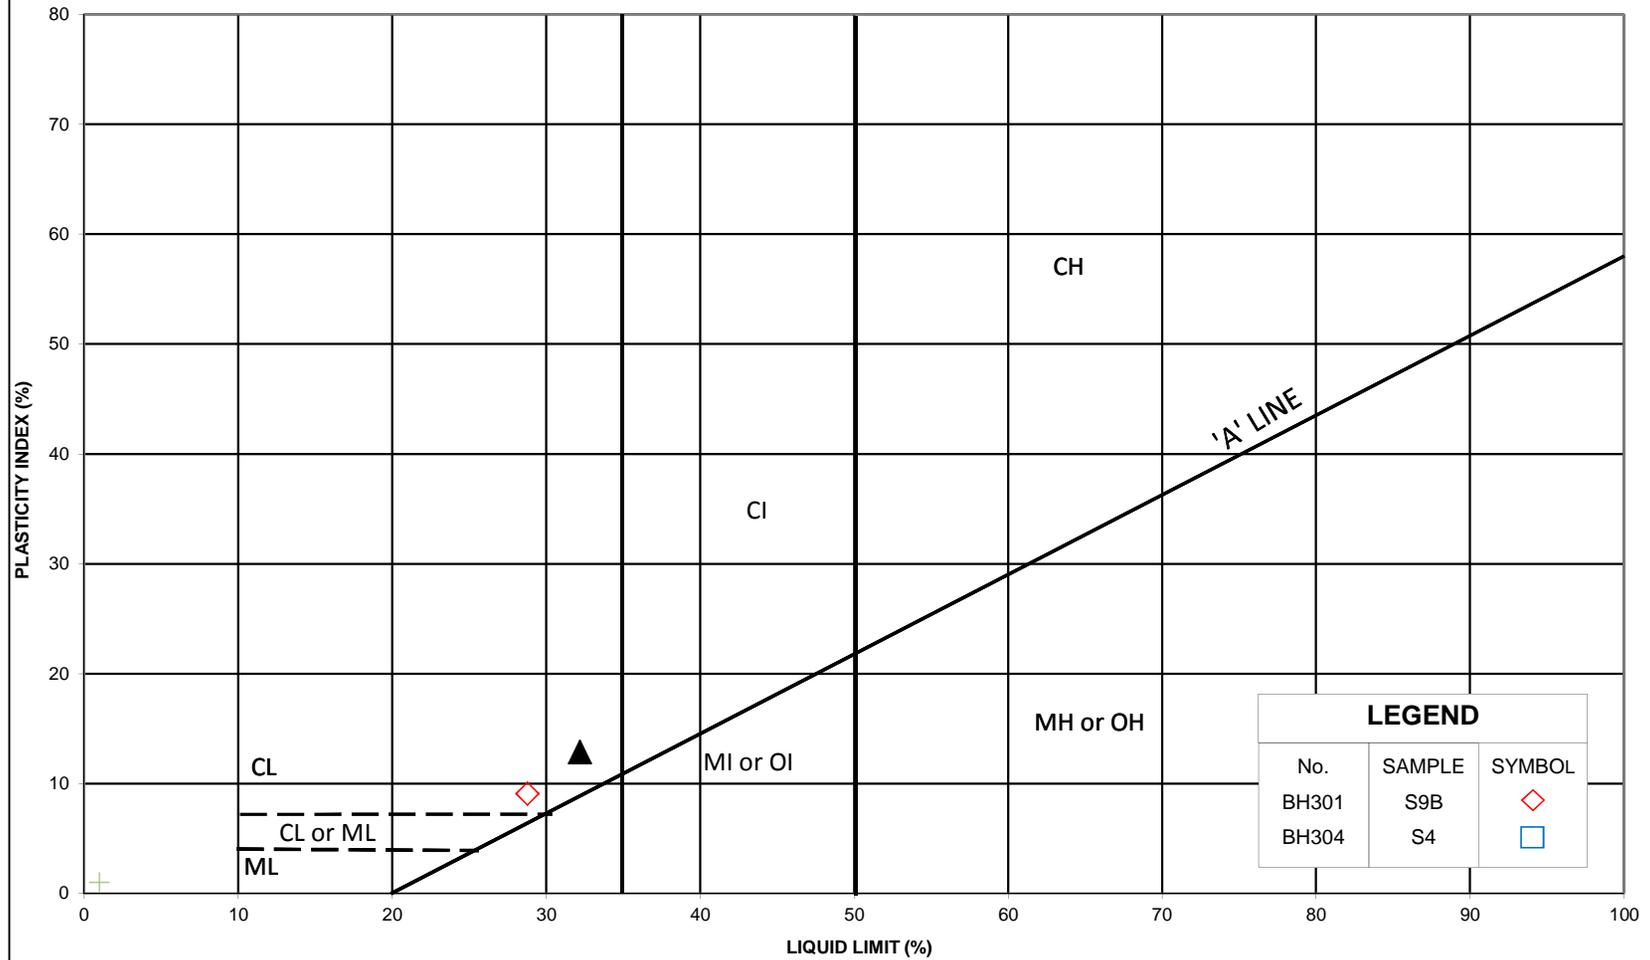
FIGURE No. 4
 ADM-00223648-E0
 July 22, 2015

Total saturated unit weights have been calculated based on the moisture contents and are estimated to range from about 18.4 to 21.0 kN/m³. Two (2) Atterberg Limits tests were performed on representative samples of the clayey silt (BH301-S9B and BH304-S4). The results indicated that the soil is of low to medium plasticity. The data is shown on the plasticity chart, Figure 4. The liquid limit, plastic limit and plasticity index ranged between about 29 and 32, 19 and 20, and 9 and 13 respectively.

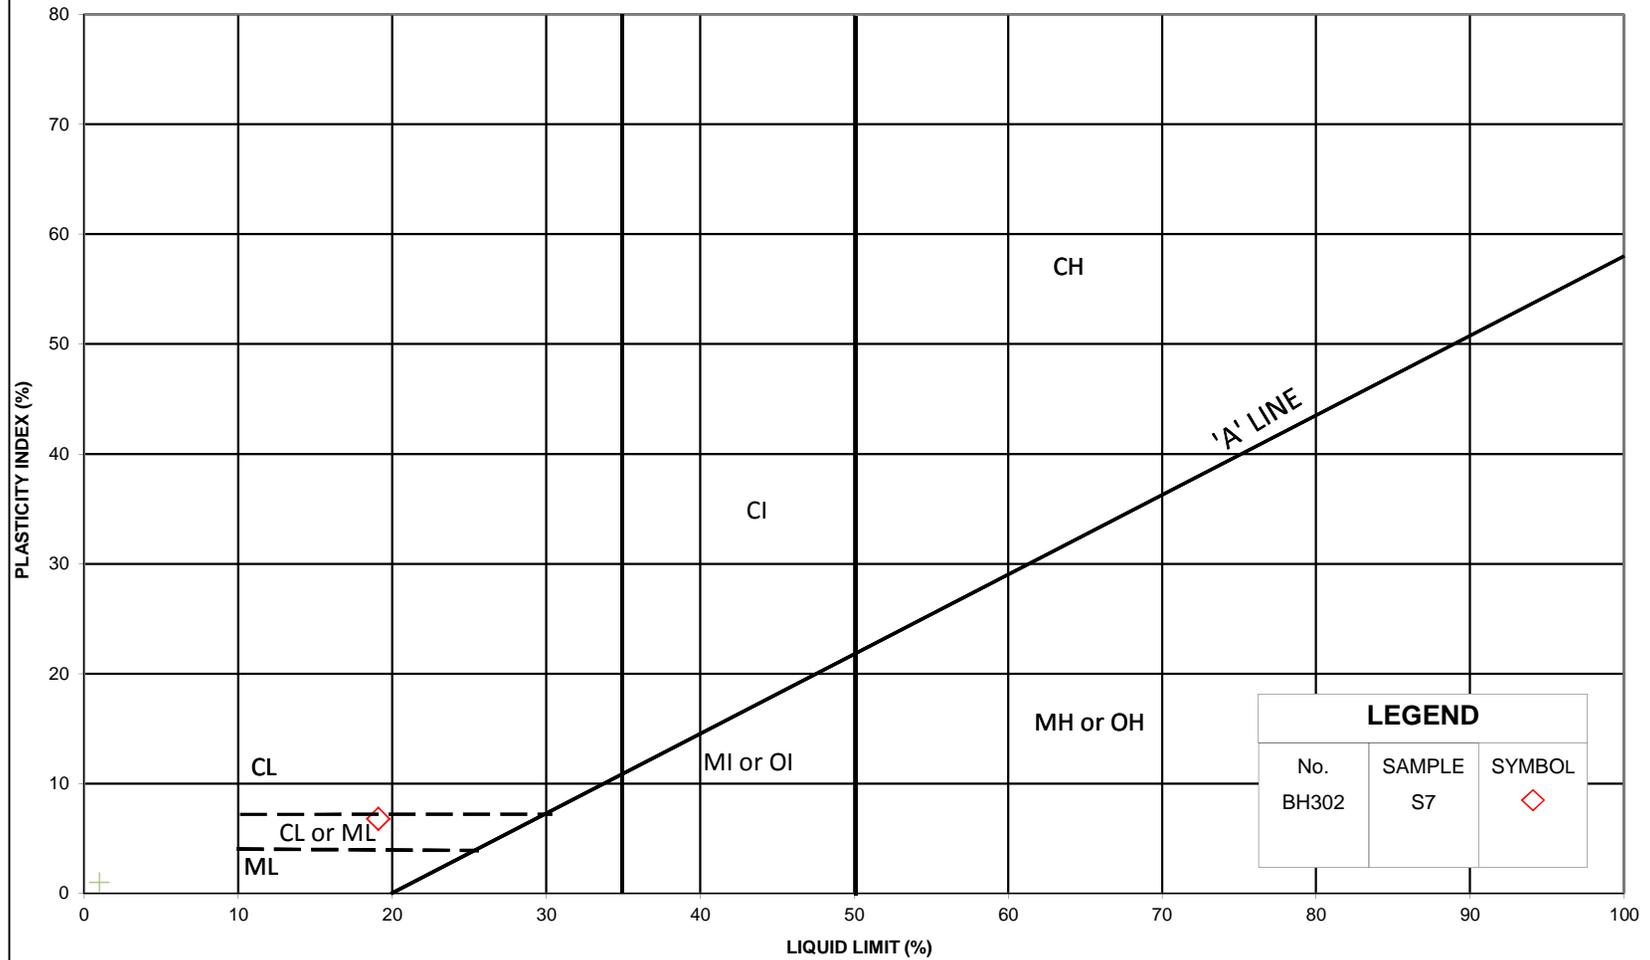
FIGURE No. 5
ADM-00223648-E0
July 22, 2015

Total saturated unit weight has been calculated based on the moisture contents and is estimated to be about 22.3 kN/m³. One (1) Atterberg Limits tests was performed on representative sample of the silty sand (BH302-S7), as some cohesive properties were noted. The results indicated that the soil is of low plasticity and the soil contained more cohesionless properties than cohesive properties. The data is shown on the plasticity chart, Figure 5. The liquid limit, plastic limit and plasticity results were 19, 12 and 7, respectively.
