FOUNDATION INVESTIGATION REPORT

**Flood Creek West Timber Culvert Replacement, Highway 11, 48W-261/C, District
of Rainy River**

Agreement No. 6014-E-0017

GWP 6319-14-00

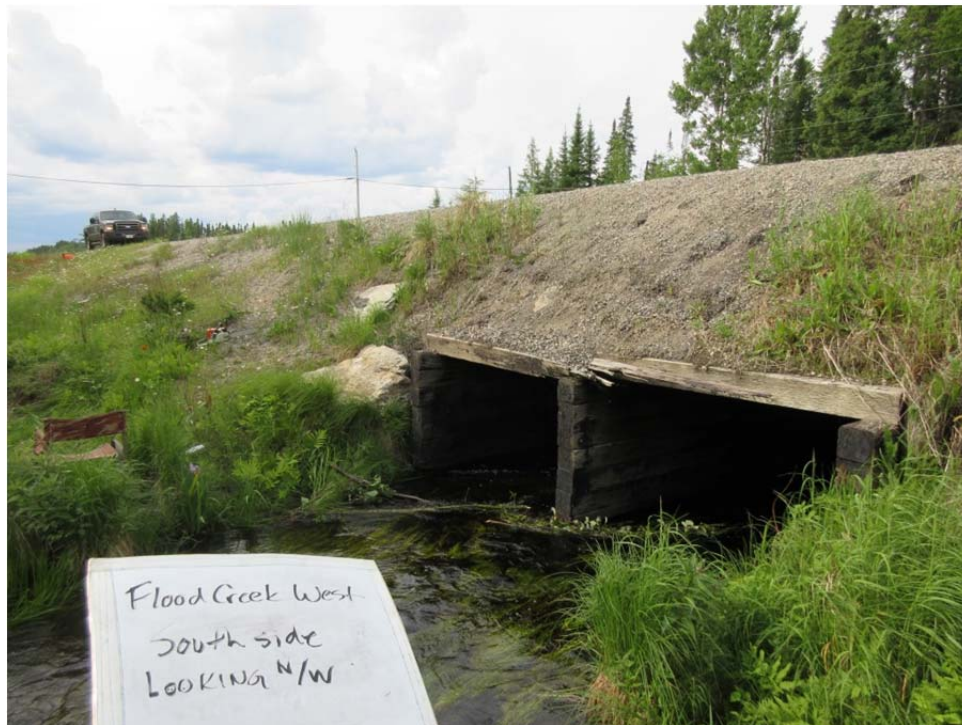
Photo 1. Existing culvert inlet on south side of highway

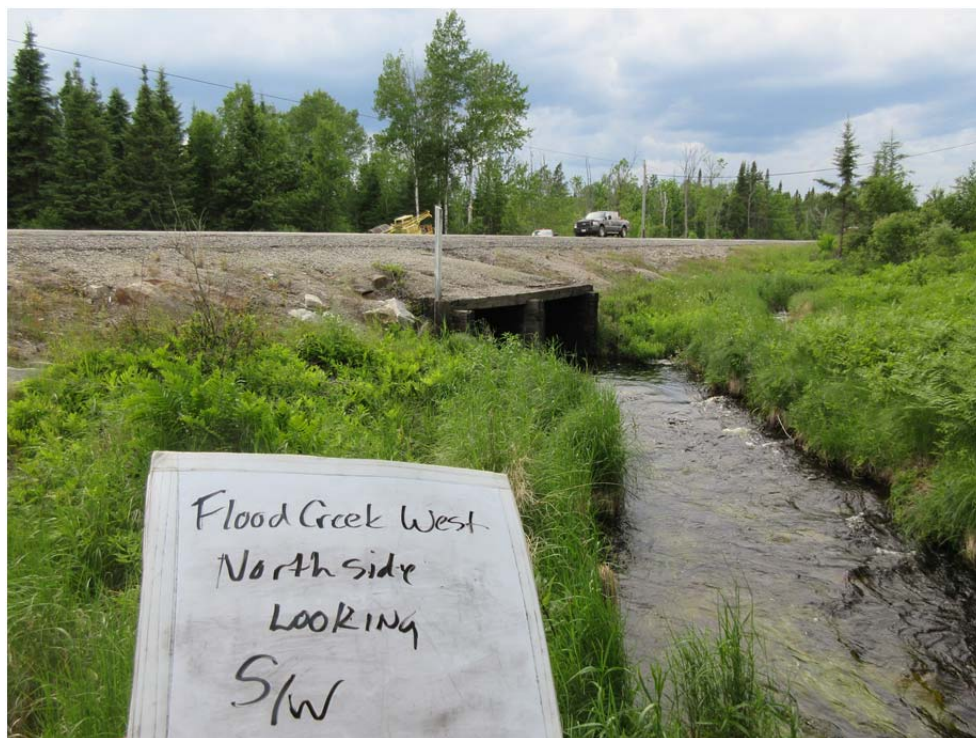
Photo 2. Existing culvert outlet on north side of highway

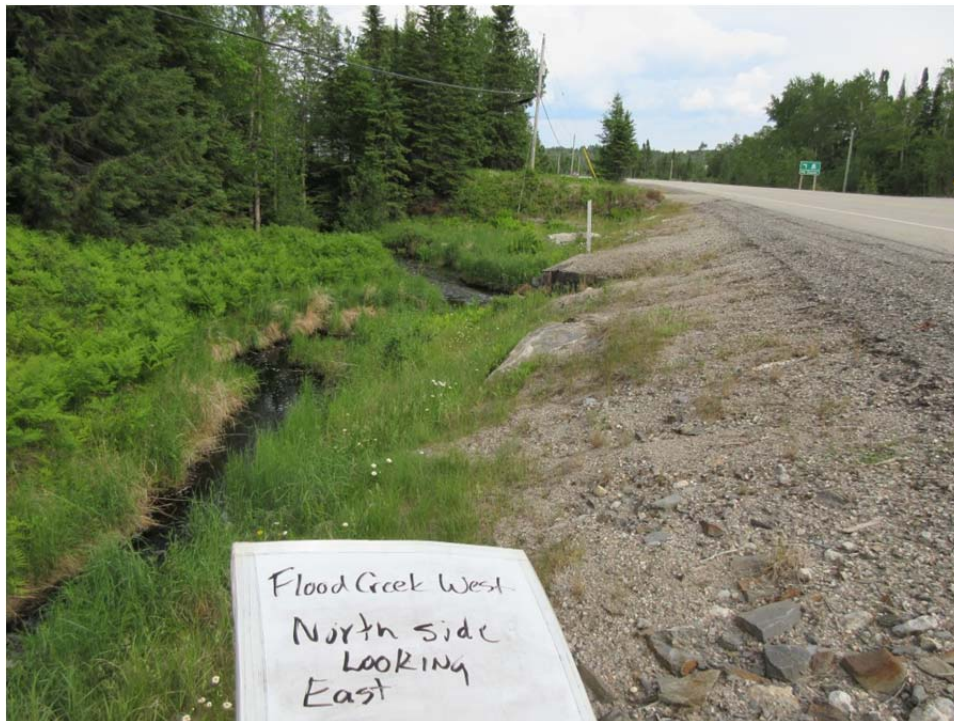
Photo 5. Embankment slope on north side facing east

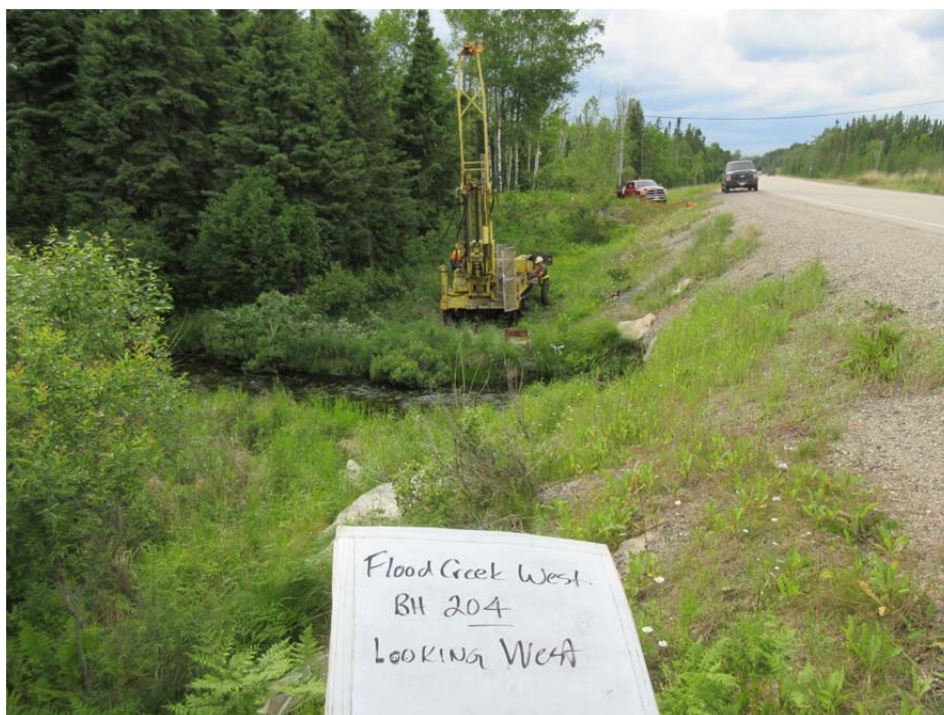
Photo 6. Embankment slope on south side facing west

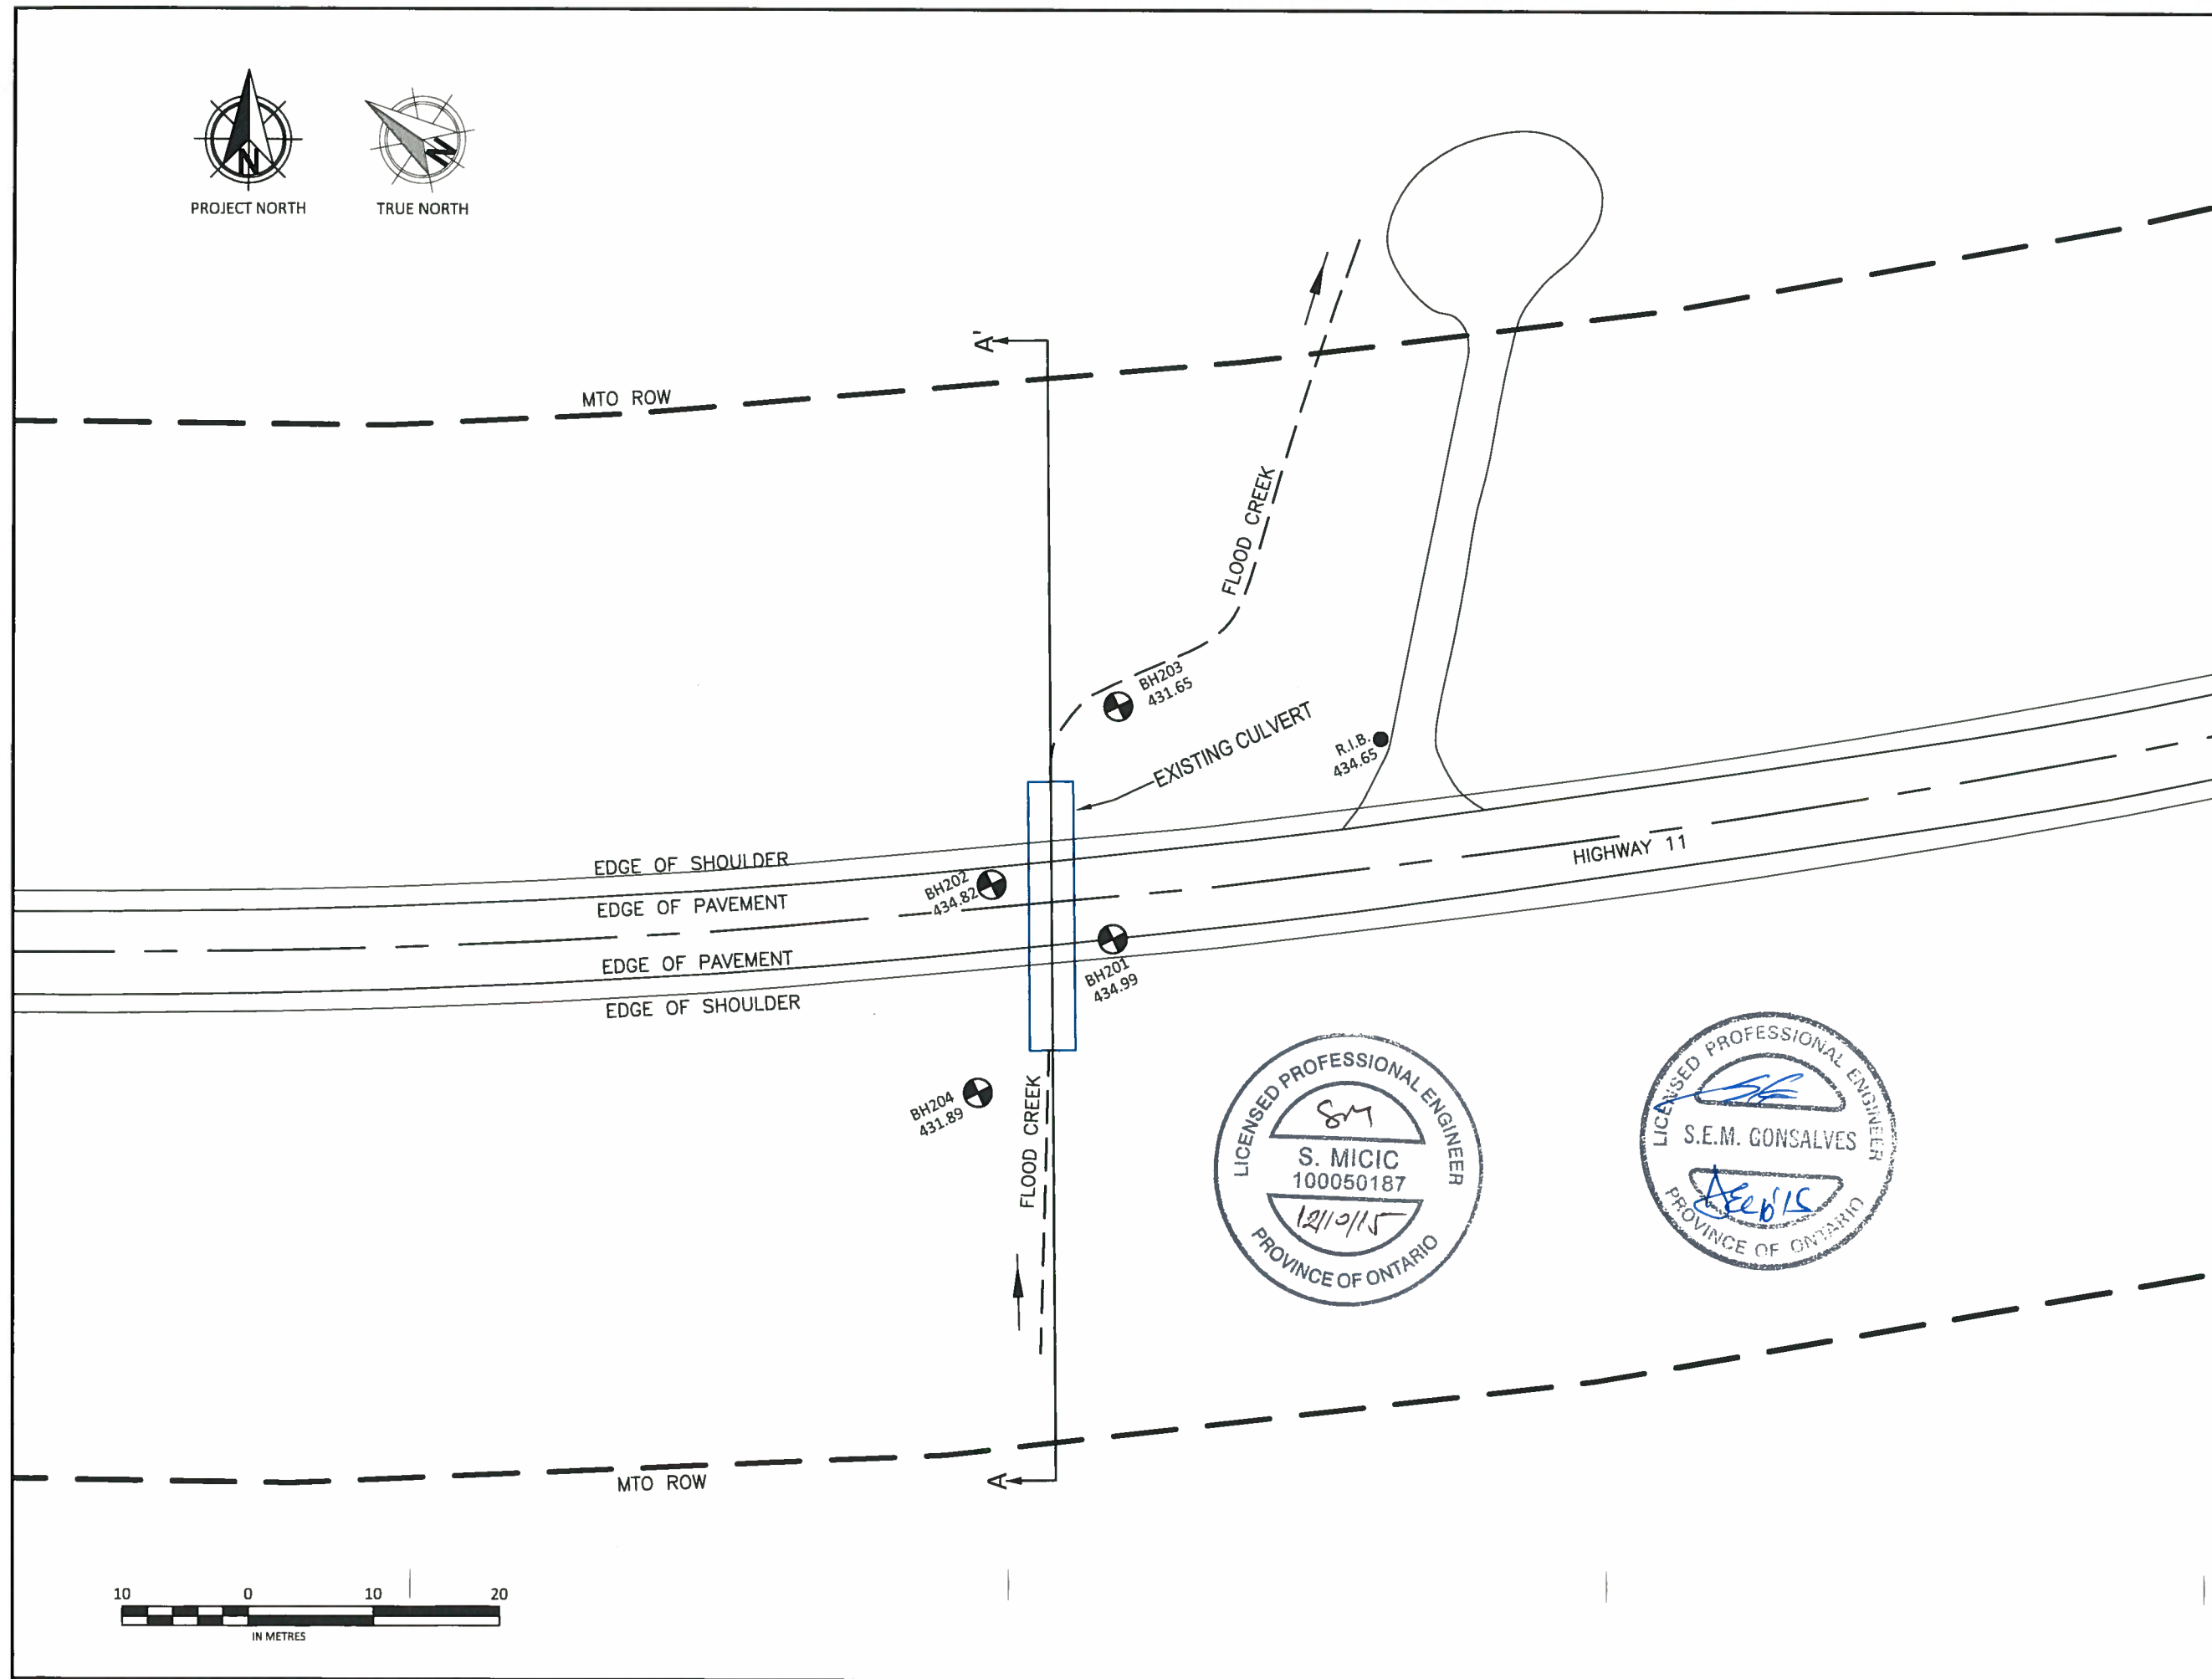
DWG
1

As shown on Drawing 1 (Appendix B), the Flood Creek West Timber Culvert is located on Highway 11, about 650 m west of the junction of Hwy 11 and Hwy 623, in the District of Rainy River, south of Sapawe, Ontario. At the site, Hwy 11 is a two lane roadway, with a speed limit of 90 km/h and is about 9.6 m wide from edge of pavement to edge of pavement (includes asphalt paved shoulders, about 1.9 m and 0.5 m wide on the north and south sides, respectively).

The field investigation was performed on June 27 and 28, 2015. The field program consisted of advancing four (4) sampled boreholes (BH201 to BH204). Two (2) boreholes were located within the highway, BH201, and BH202. BH201 was located about 5 m east of the culvert centerline and about 3.7 m south of the highway centerline. BH202 was located about 5 m west of the culvert centerline and about 1.8 m north of the highway centerline. An additional two (2) boreholes (BH203 and BH204) were advanced off of the highway. BH203 was located about 5.6 m east of the culvert centerline and about 15 m north of the highway centerline (outlet/downstream side). BH204 was located about 6.3 m west of the culvert centerline and about 15 m south of the highway centerline (inlet/upstream side). The borehole locations are shown on Drawing 1 in Appendix B.

The borehole locations were referenced to the MTM ON-16 NAD83 coordinate system and their ground surface elevations were surveyed by **exp** personnel. The ground surface elevations, including top of water in the creek, were referenced to a geodetic elevation located at the highway centerline at the culvert centerline. The elevation at the centerline is 434.83 m. The centerline elevation was tied into a round iron bar [RIB] in rock east of the site and north of the highway. The RIB elevation is 434.65 m. The location of the RIB is shown on Drawing 1, in Appendix B.

PLAN

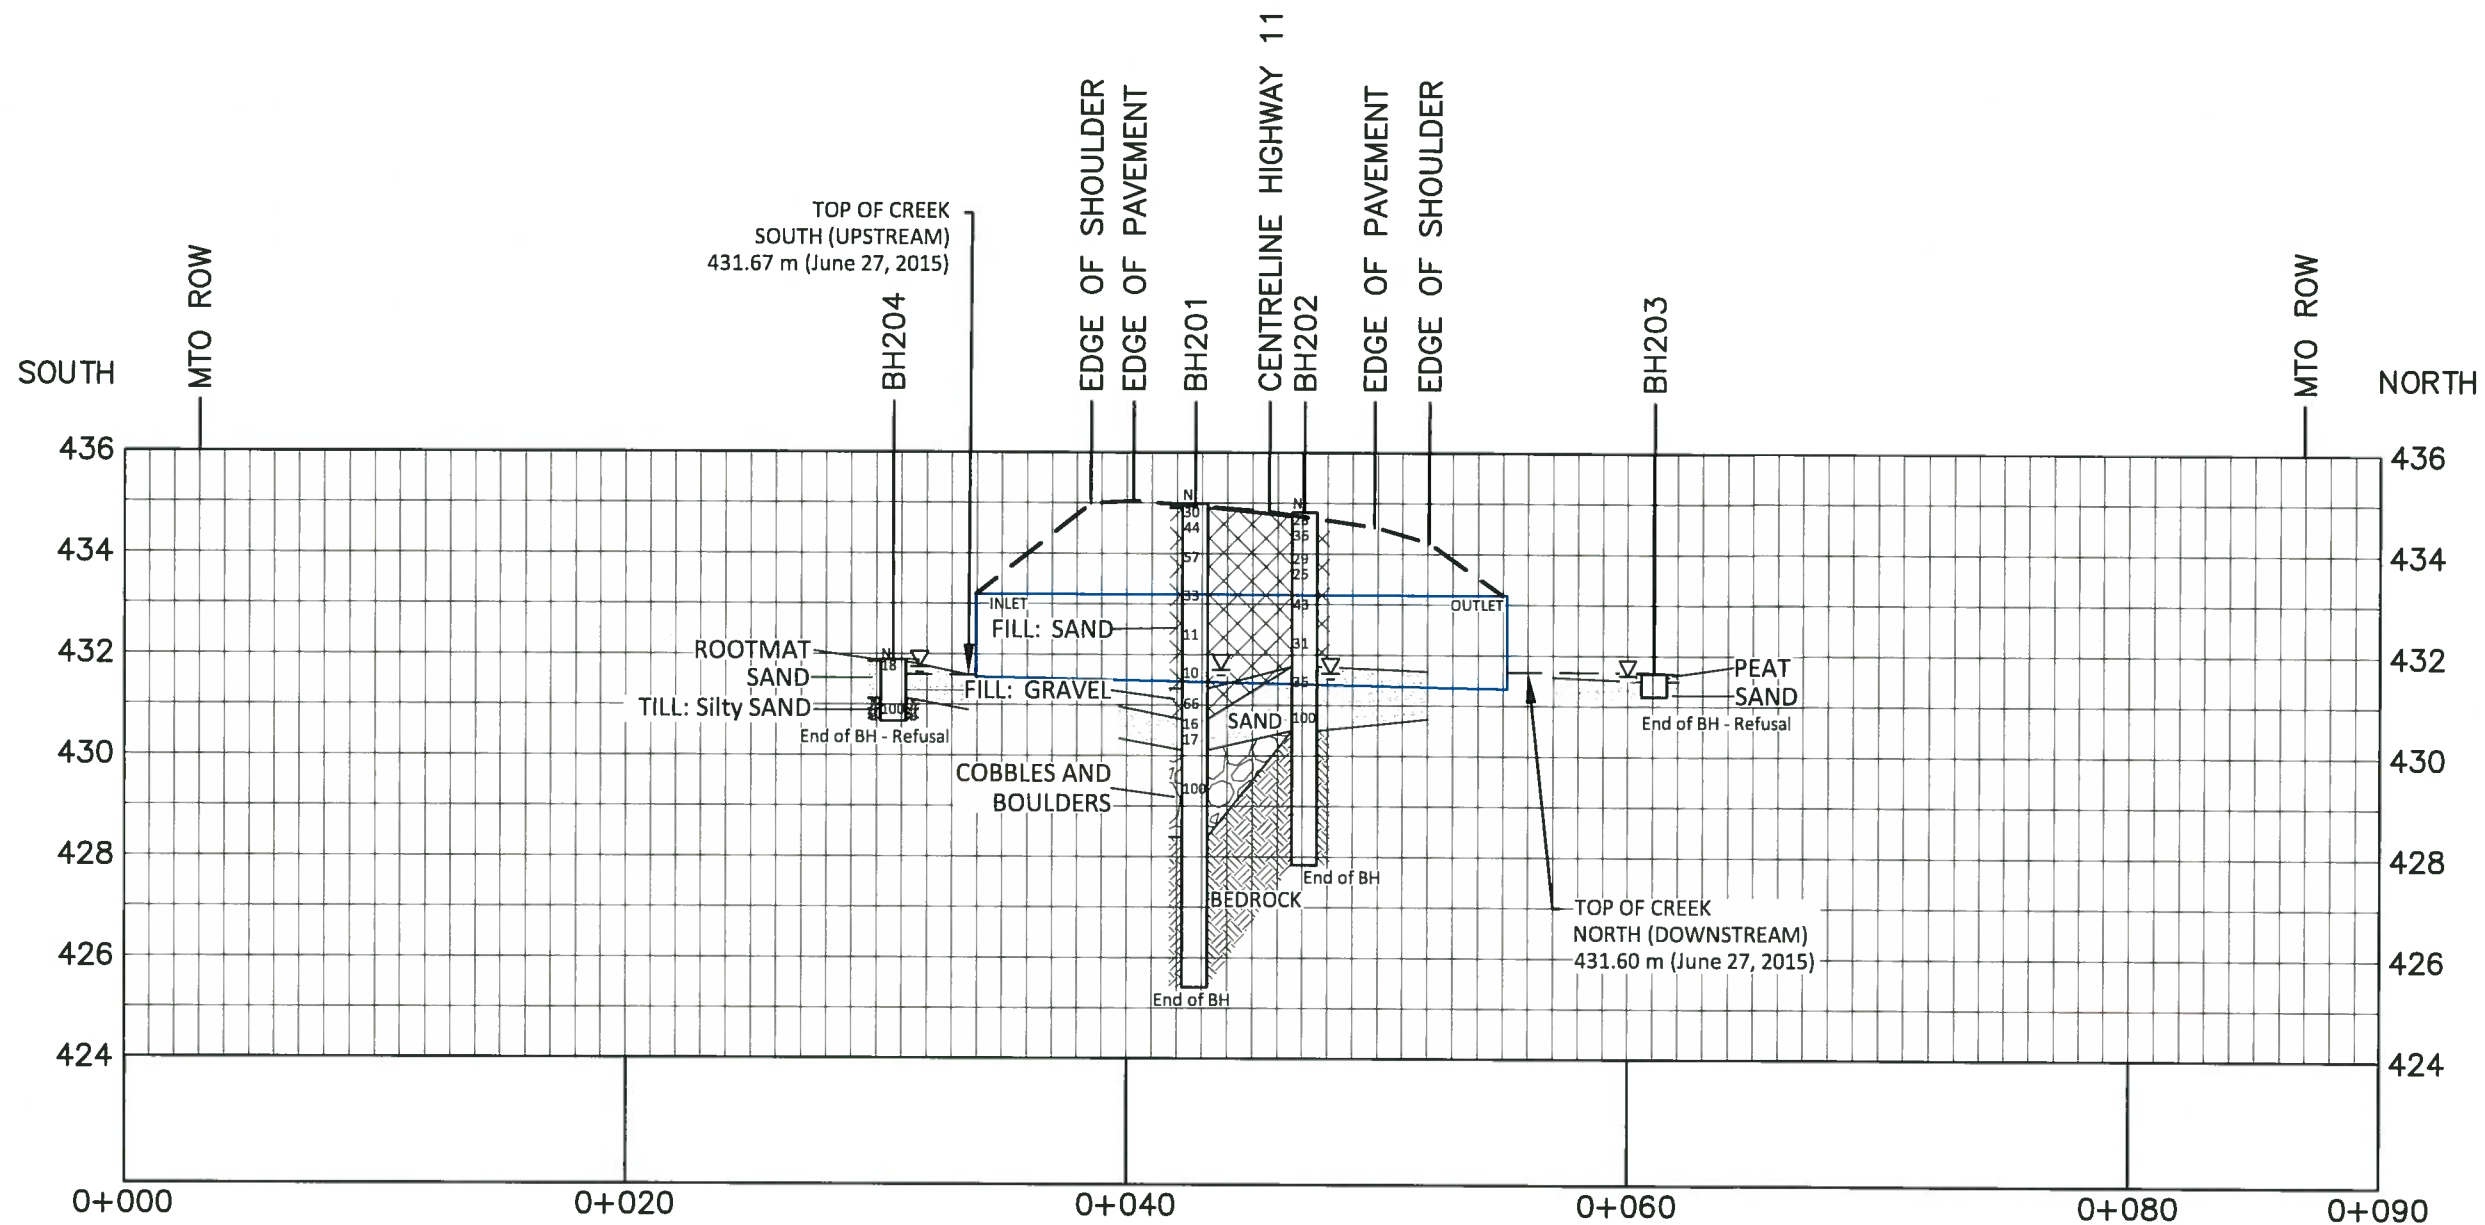
A - A'
PROFILE OF FLOOD CREEK WEST CULVERT

A borehole location plan and stratigraphic sections are provided in Appendix B. It should be noted that the stratigraphic boundaries indicated on the borehole log and stratigraphic sections are inferred from semi-continuous sampling, observations of drilling progress and results of Standard Penetration Tests. These boundaries typically represent transitions from one soil type to another and should not be interpreted as exact planes of geological change. Furthermore, subsurface conditions may vary between and beyond the borehole locations.

In general, the subsurface conditions along the proposed culvert alignment consist of a layer of sand fill, overlying native sand, overlying cobbles and boulders and sand till, and overlying bedrock. A more detailed summary of the subsurface conditions encountered in the boreholes is provided in the following sections.

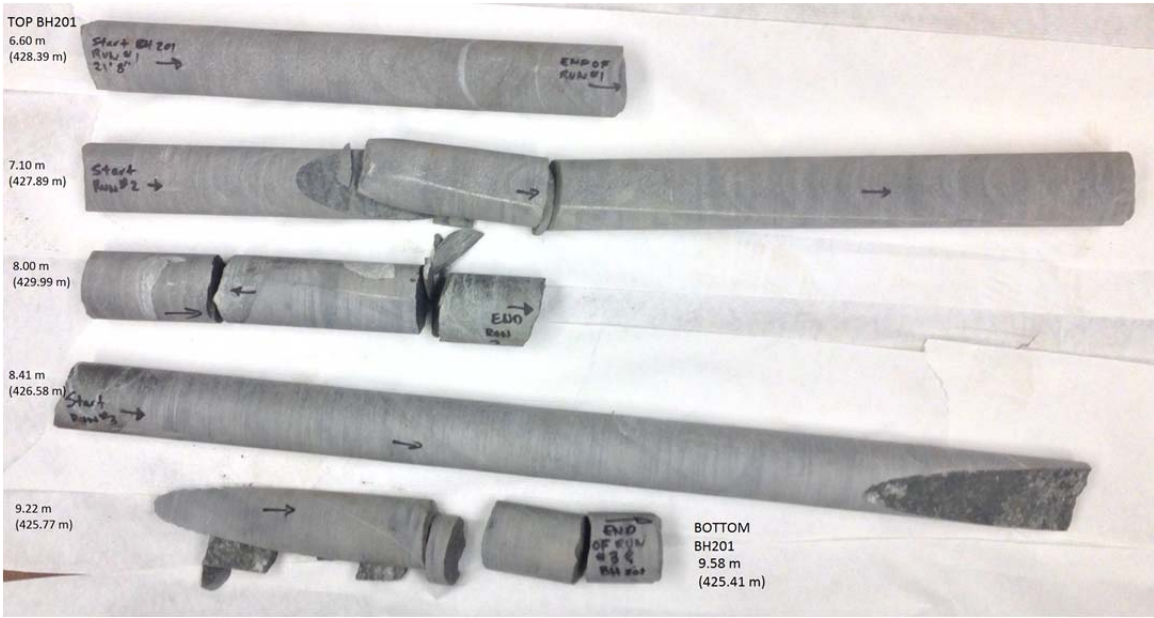
Bedrock was encountered beneath the cobbles and boulders at BH201 and beneath the sand at BH102, at depths of about 6.6 m (428.4 m elevation) and 4.3 m (430.5 m elevation) below ground surface, respectively. The bedrock was generally described as a medium strong (25 MPa to 50 MPa compressive strength), fractured to very sound, greenish dark grey, and fine grained. The boreholes were extended by rock coring between about 2.7 m and 3.0 m into bedrock, and to depths ranging between about 7.0 m and 9.6 m below ground surface. The boreholes were terminated at elevations ranging between about 425.4 m and 427.8 m. Photographs of the bedrock core samples are presented in Appendix C, after the Borehole Logs.

Gross recoveries ranged between about 99% and 100%. The Rock Quality Designation (RQD), which is a modified core recovery, ranged from 59% to 100% (fractured to very sound).

BH201 - Bedrock Core Samples with Depths and Elevations

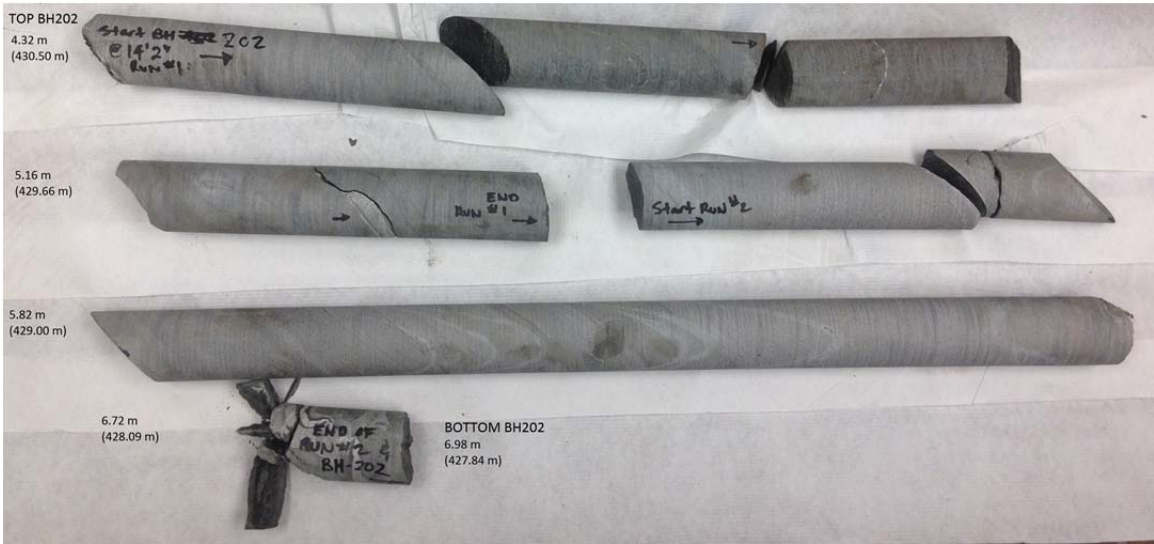
BH202 - Bedrock Core Samples with Depths and Elevations

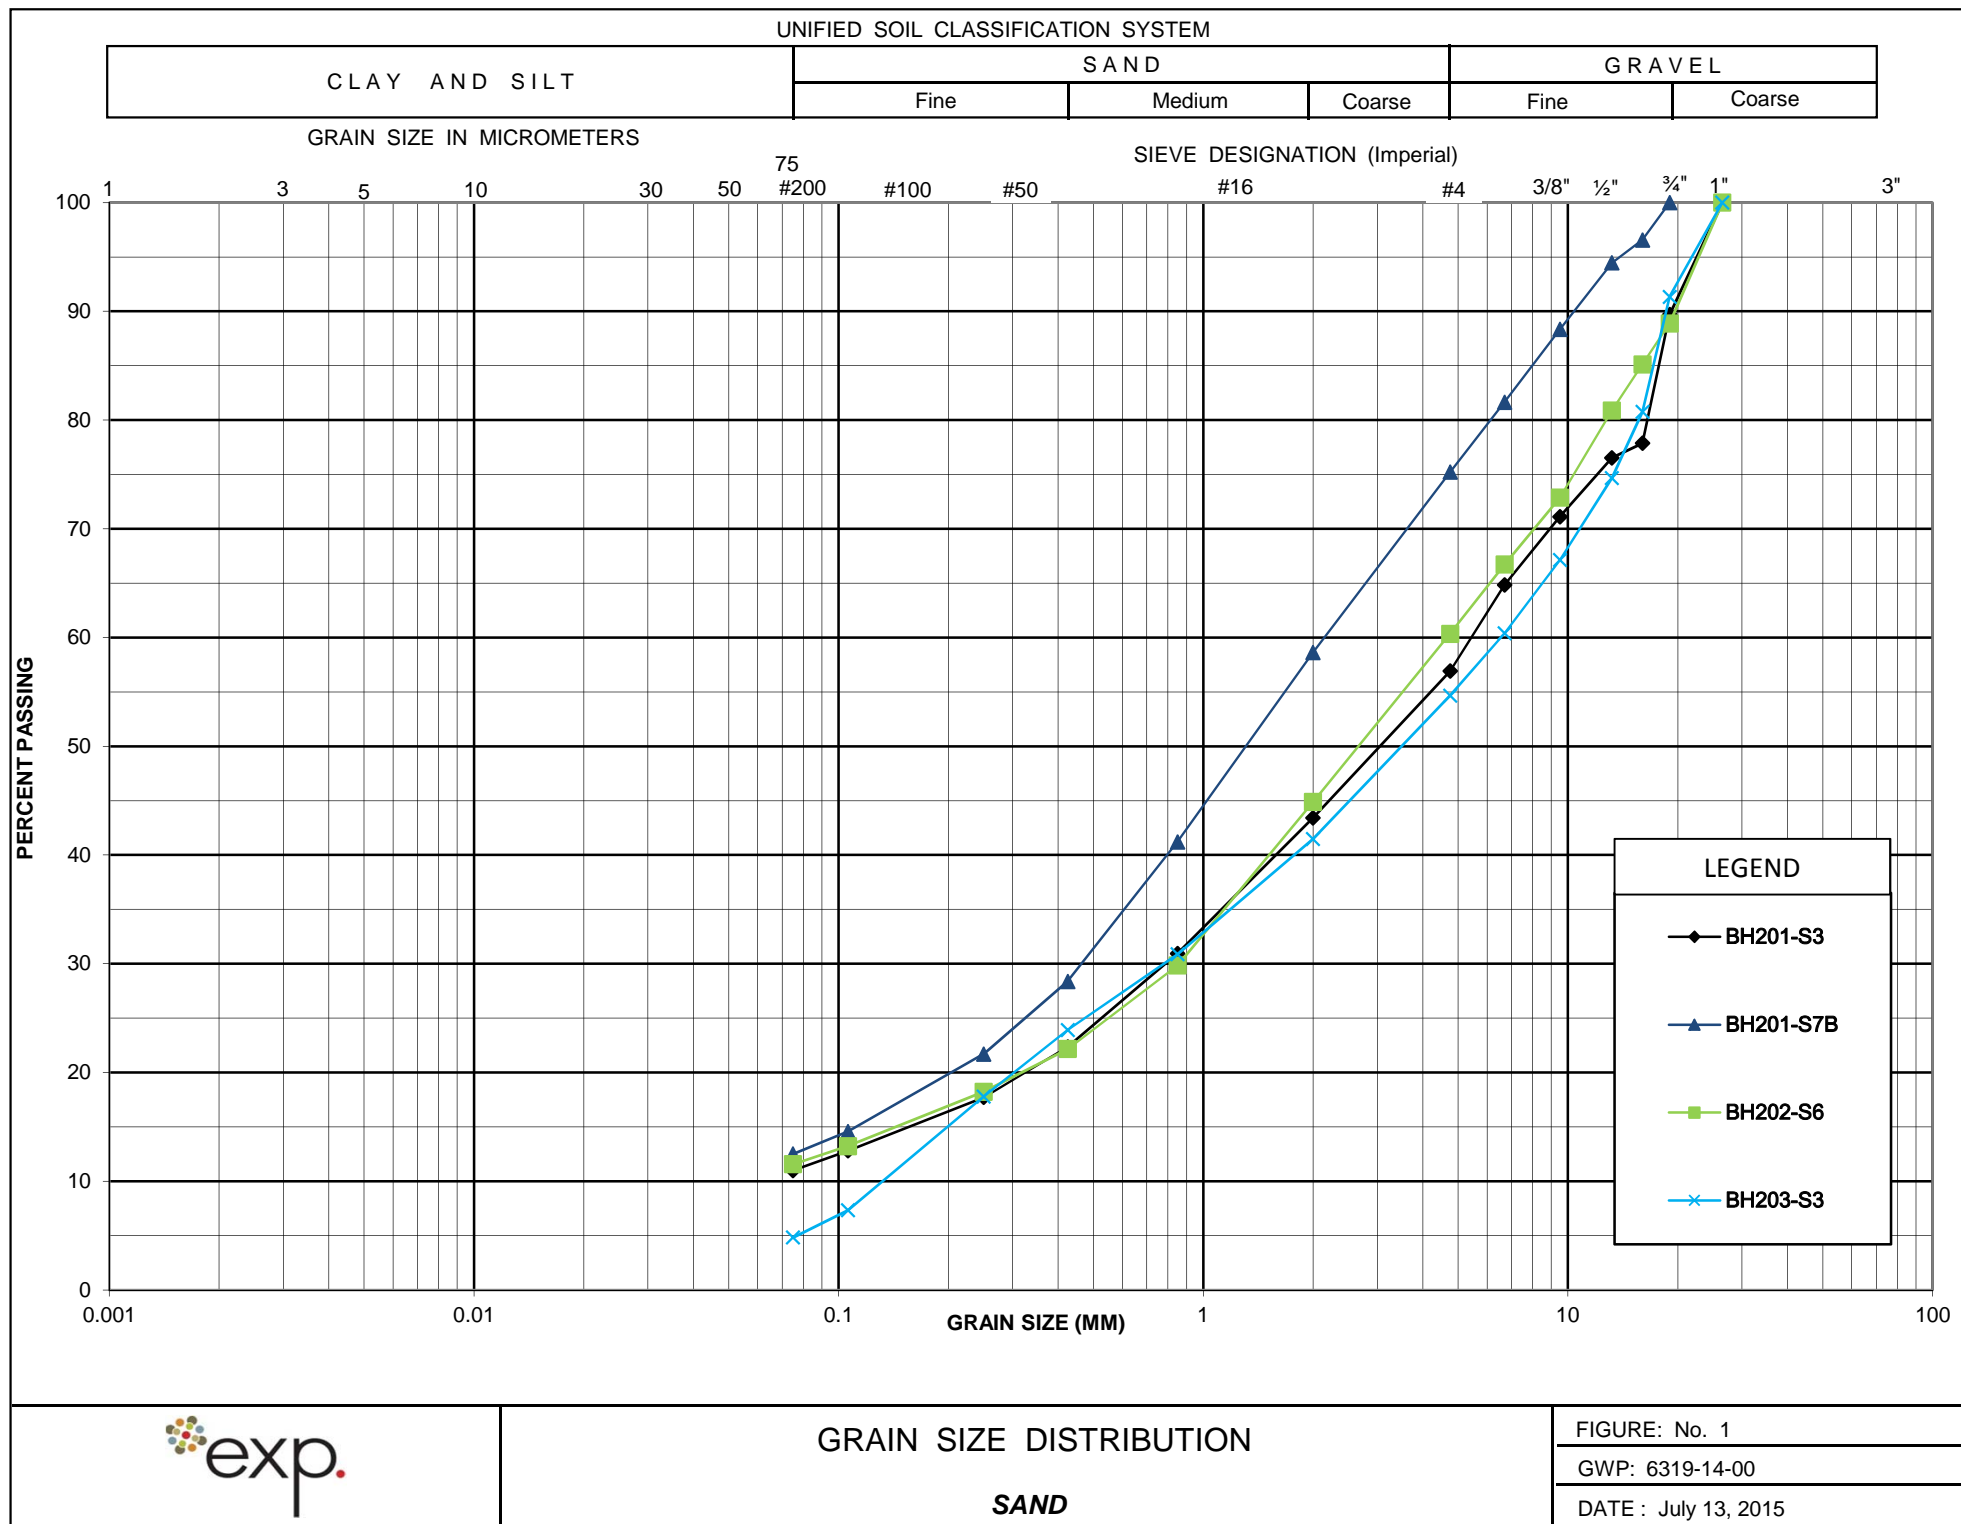
The results of the moisture content and grain size distribution test are provided on the record of borehole sheets in Appendix C. The results of the grain size distribution tests are also provided on Figure 1, in Appendix D.

UNIFIED SOIL CLASSIFICATION SYSTEM

The results of the moisture content and grain size distribution tests are provided on the record of borehole sheets in Appendix C. The results of the grain size distribution are also provided on Figures 1 and 2 in Appendix D.

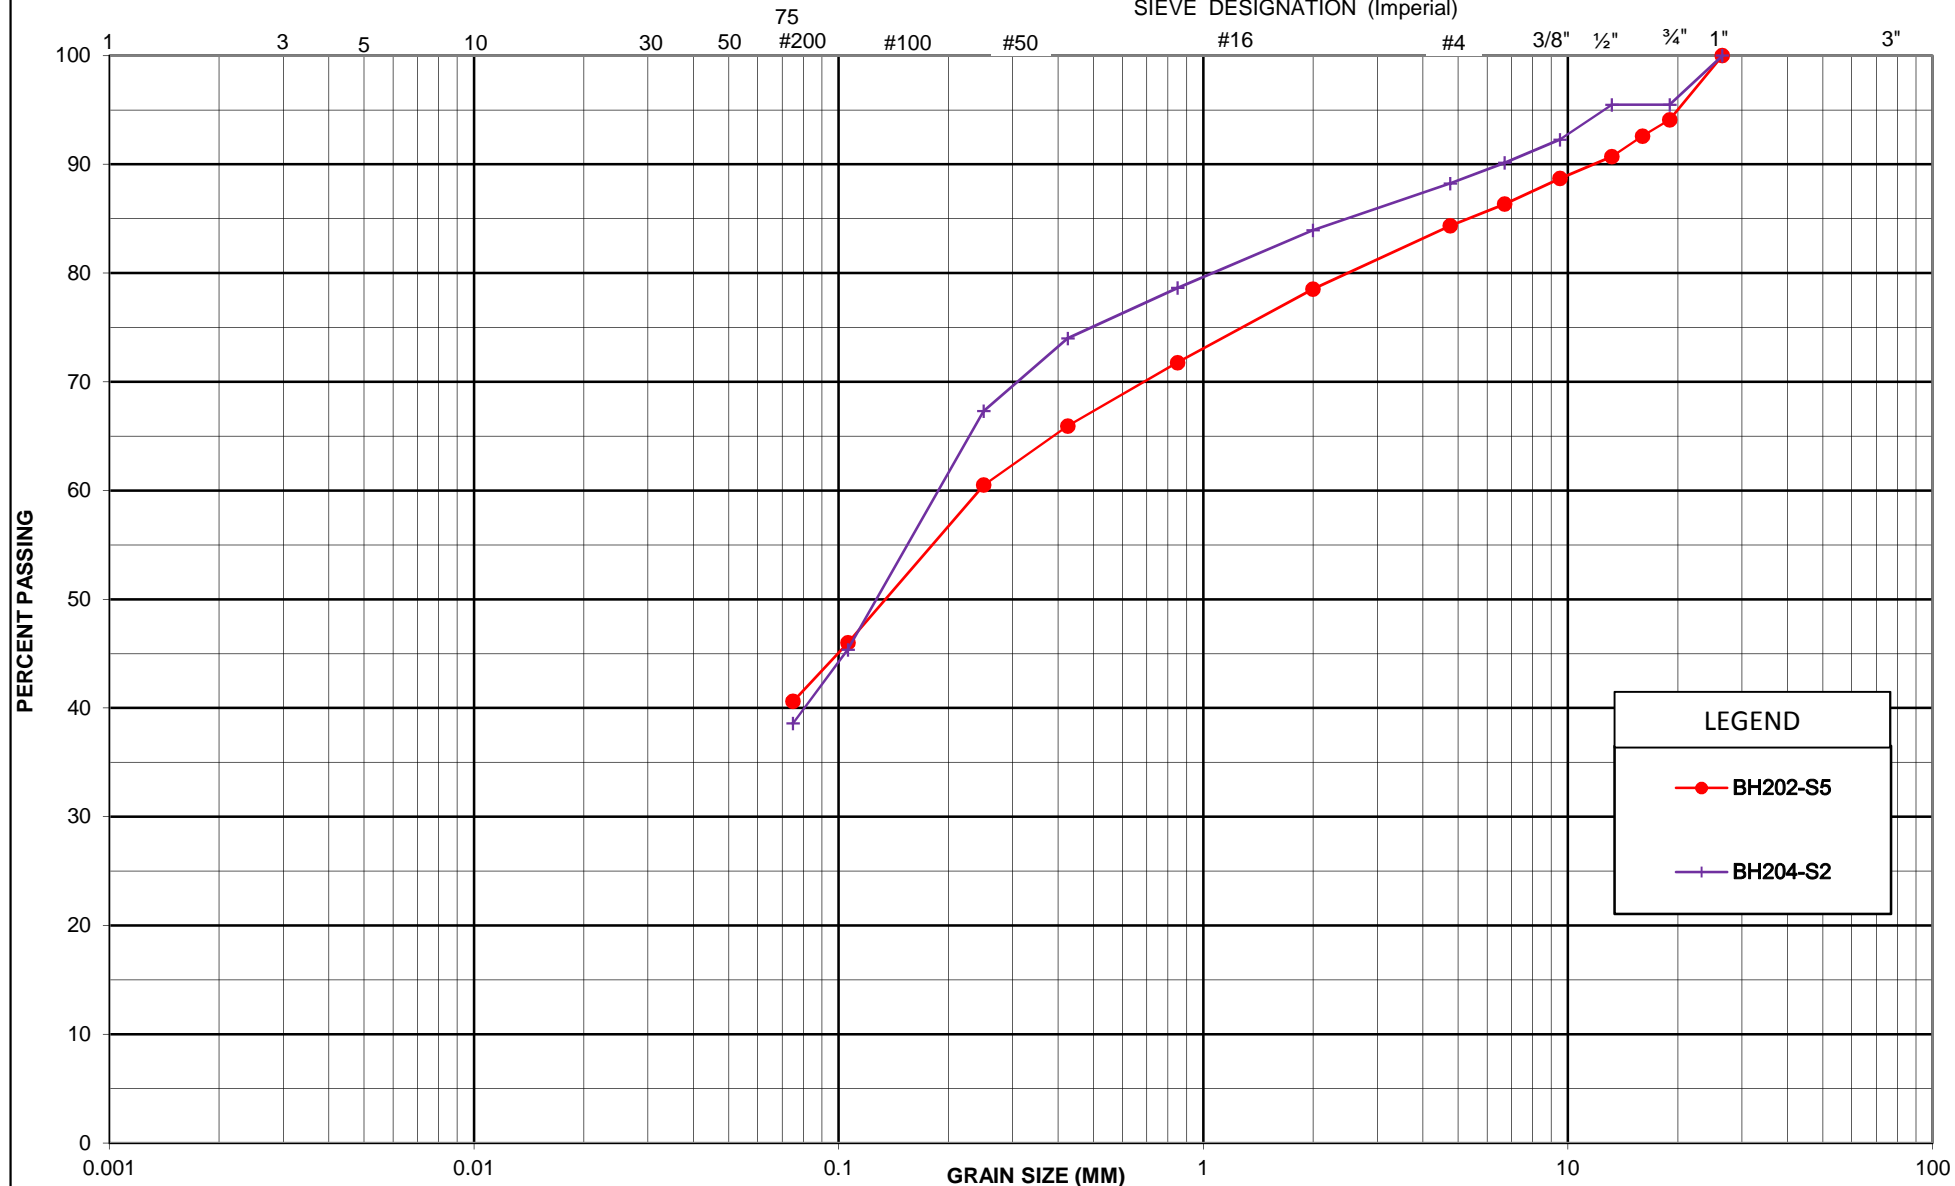
The results of the moisture content and grain size distribution tests are provided on the record of borehole sheets in Appendix C. The results of the grain size distribution are also provided on Figure 2 in Appendix D.

GRAIN SIZE DISTRIBUTION

SILTY SAND
