FOUNDATION INVESTIGATION REPORT

**Kawawia Creek Culvert Replacement, Highway 502, Site No. 41S-244/C, District
of Kenora**

Agreement No. 6014-E-0017

exp Services Inc.
December 11, 2015

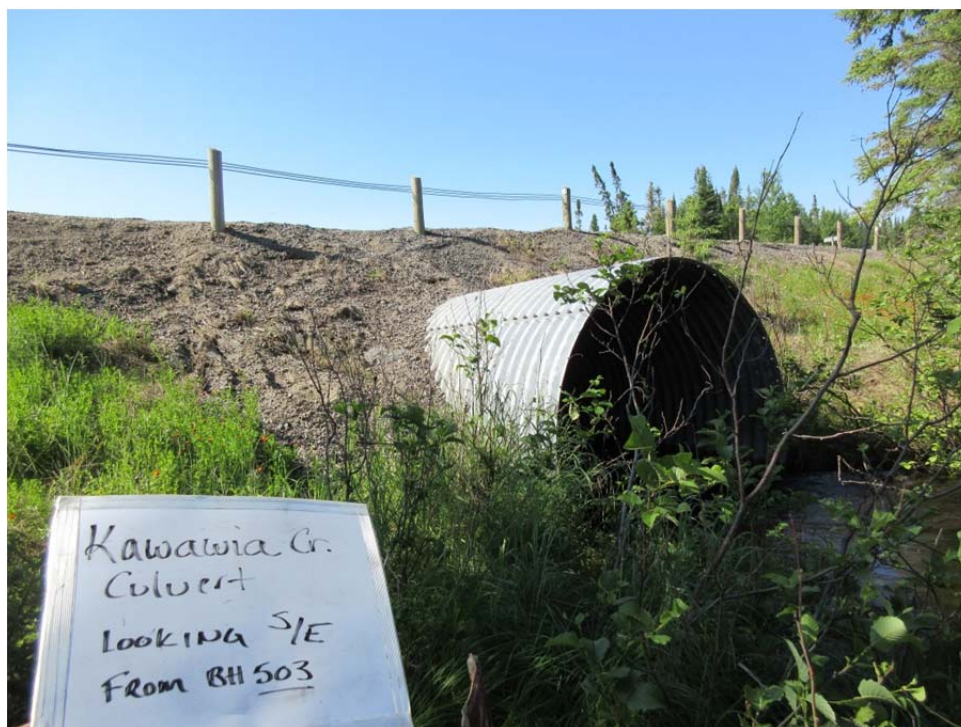
Photo 1. Existing culvert inlet on west side of highway

At the vicinity of the inlet and outlet of the culvert some minor vegetation was noted at both culvert ends. The surrounding area of the culvert at the west side of Hwy 502 was generally forested and at the east side was generally a low lying area with tall grass. The inlet and outlet appeared to be generally clear of debris and excess vegetation, and as such the flow does not appear to be restricted.

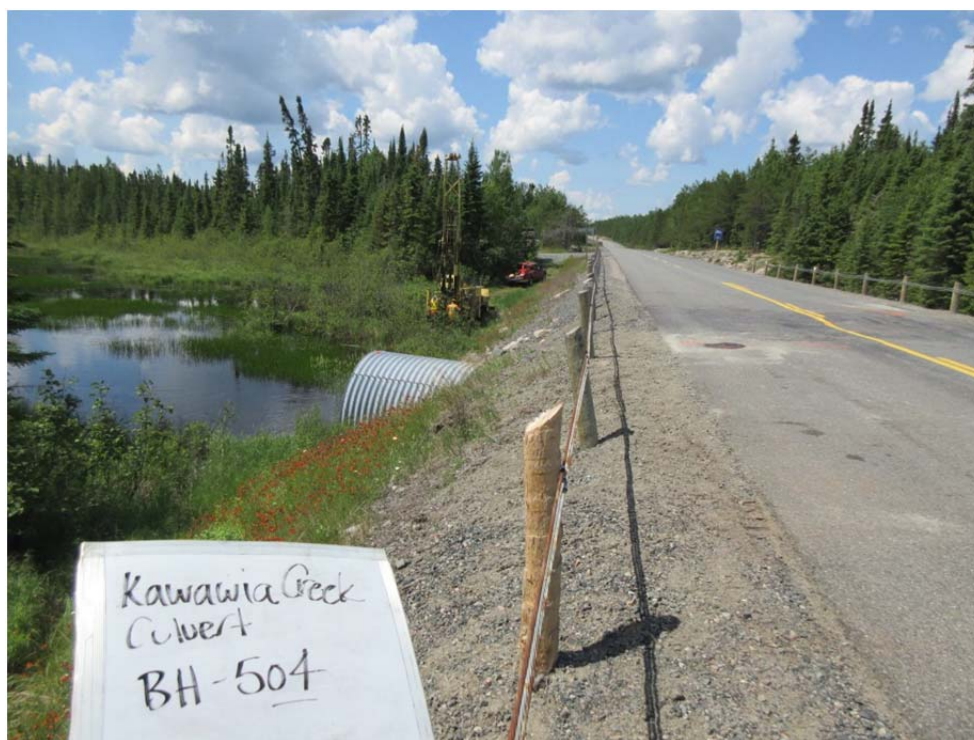
Photo 2. Existing culvert outlet on east side of highway facing south

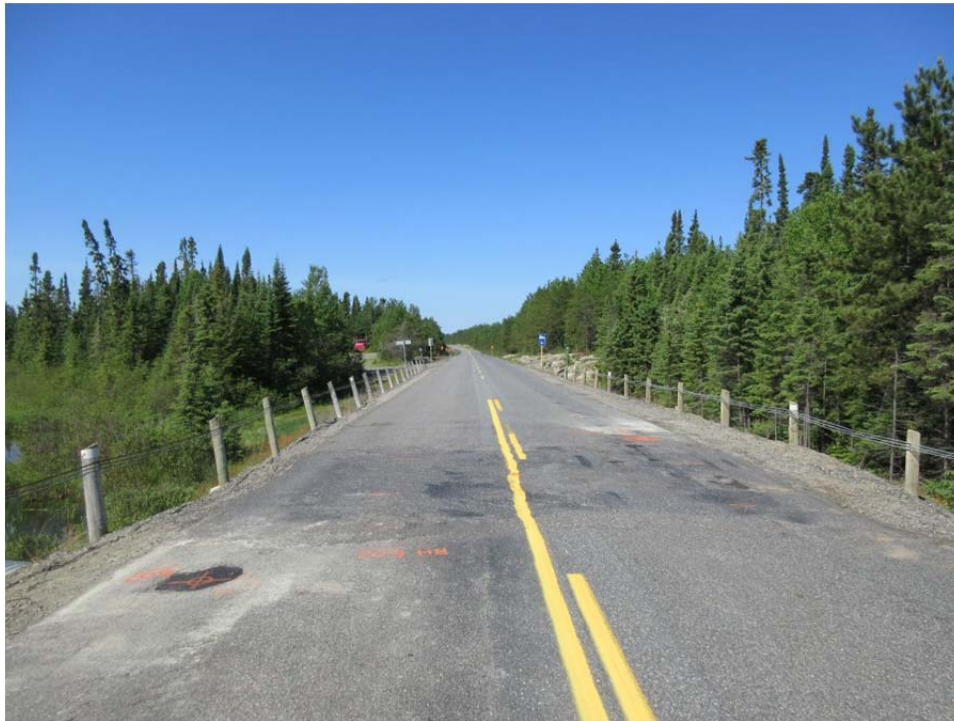
Photo 3. Facing south on Highway 502 before the existing culvert

and outlet were about 396.00 m and 395.99 m, respectively. The elevation of highway pavement centerline at the culvert centerline is about 399.3 m. Guard rails were observed on both sides of the highway and frost heave/settlement of the roadway structure was noted at the culvert location.

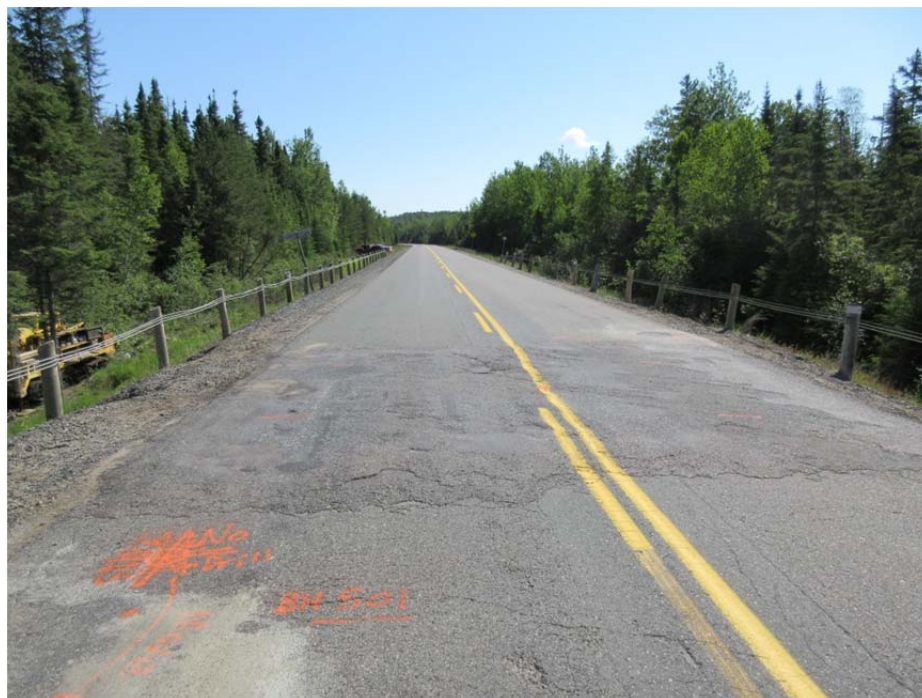
Photo 4. Facing north on Highway 502 before the existing culvert

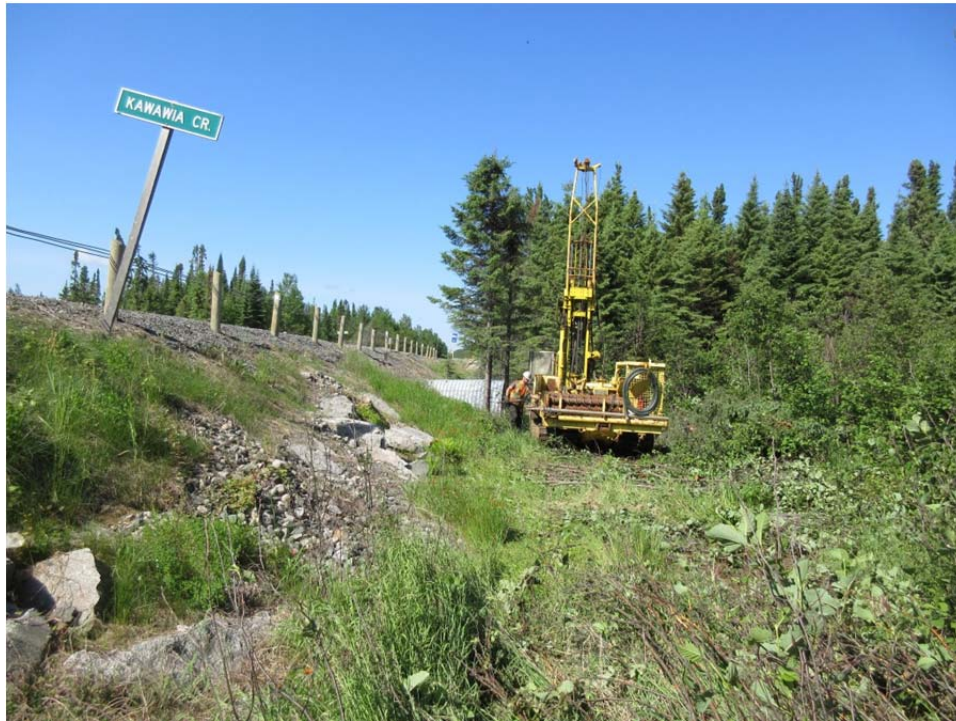
Photo 5. Embankment slope on west side facing south

As shown on Drawing 1 (Appendix B), the Kawawia Creek Culvert is located on Highway 502, about 64.6 km north of the junction of Hwy 11 and Hwy 502, in the District of Kenora, Ontario. At the site, Hwy 502 is a two lane roadway, with a speed limit of 80 km/h and is about 7.0 m wide from edge of pavement to edge of pavement, with narrow sand and gravel shoulders. Based on drawings provided, the roadway embankment is about 4.3 m high with side slopes of about 2V:1H and 1.5V:1H at the culvert inlet and outlet, respectively.

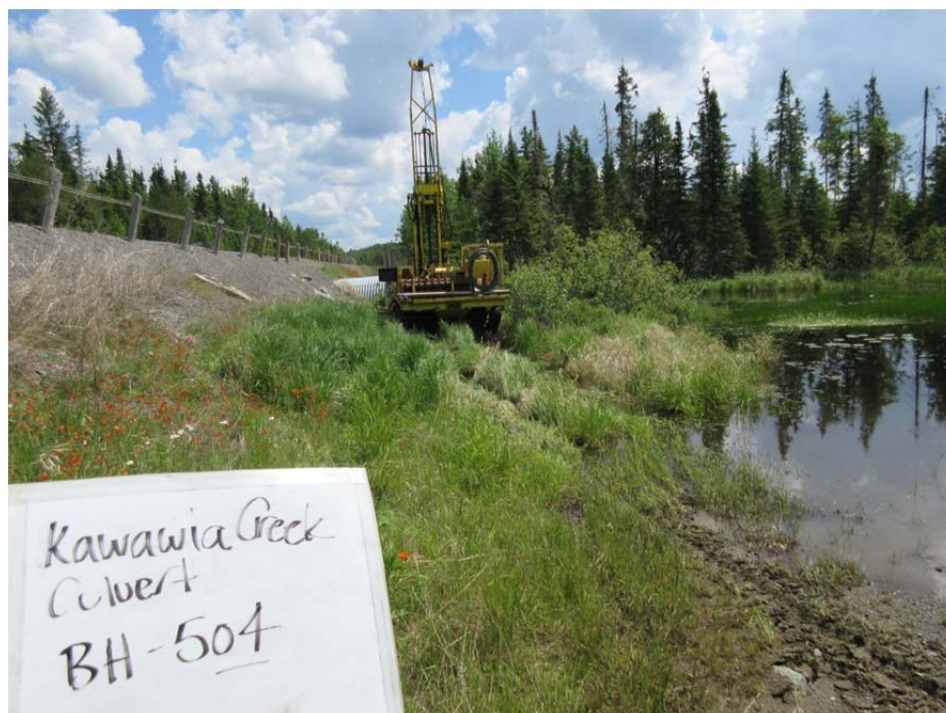
Photo 6. Embankment slope on east side facing north

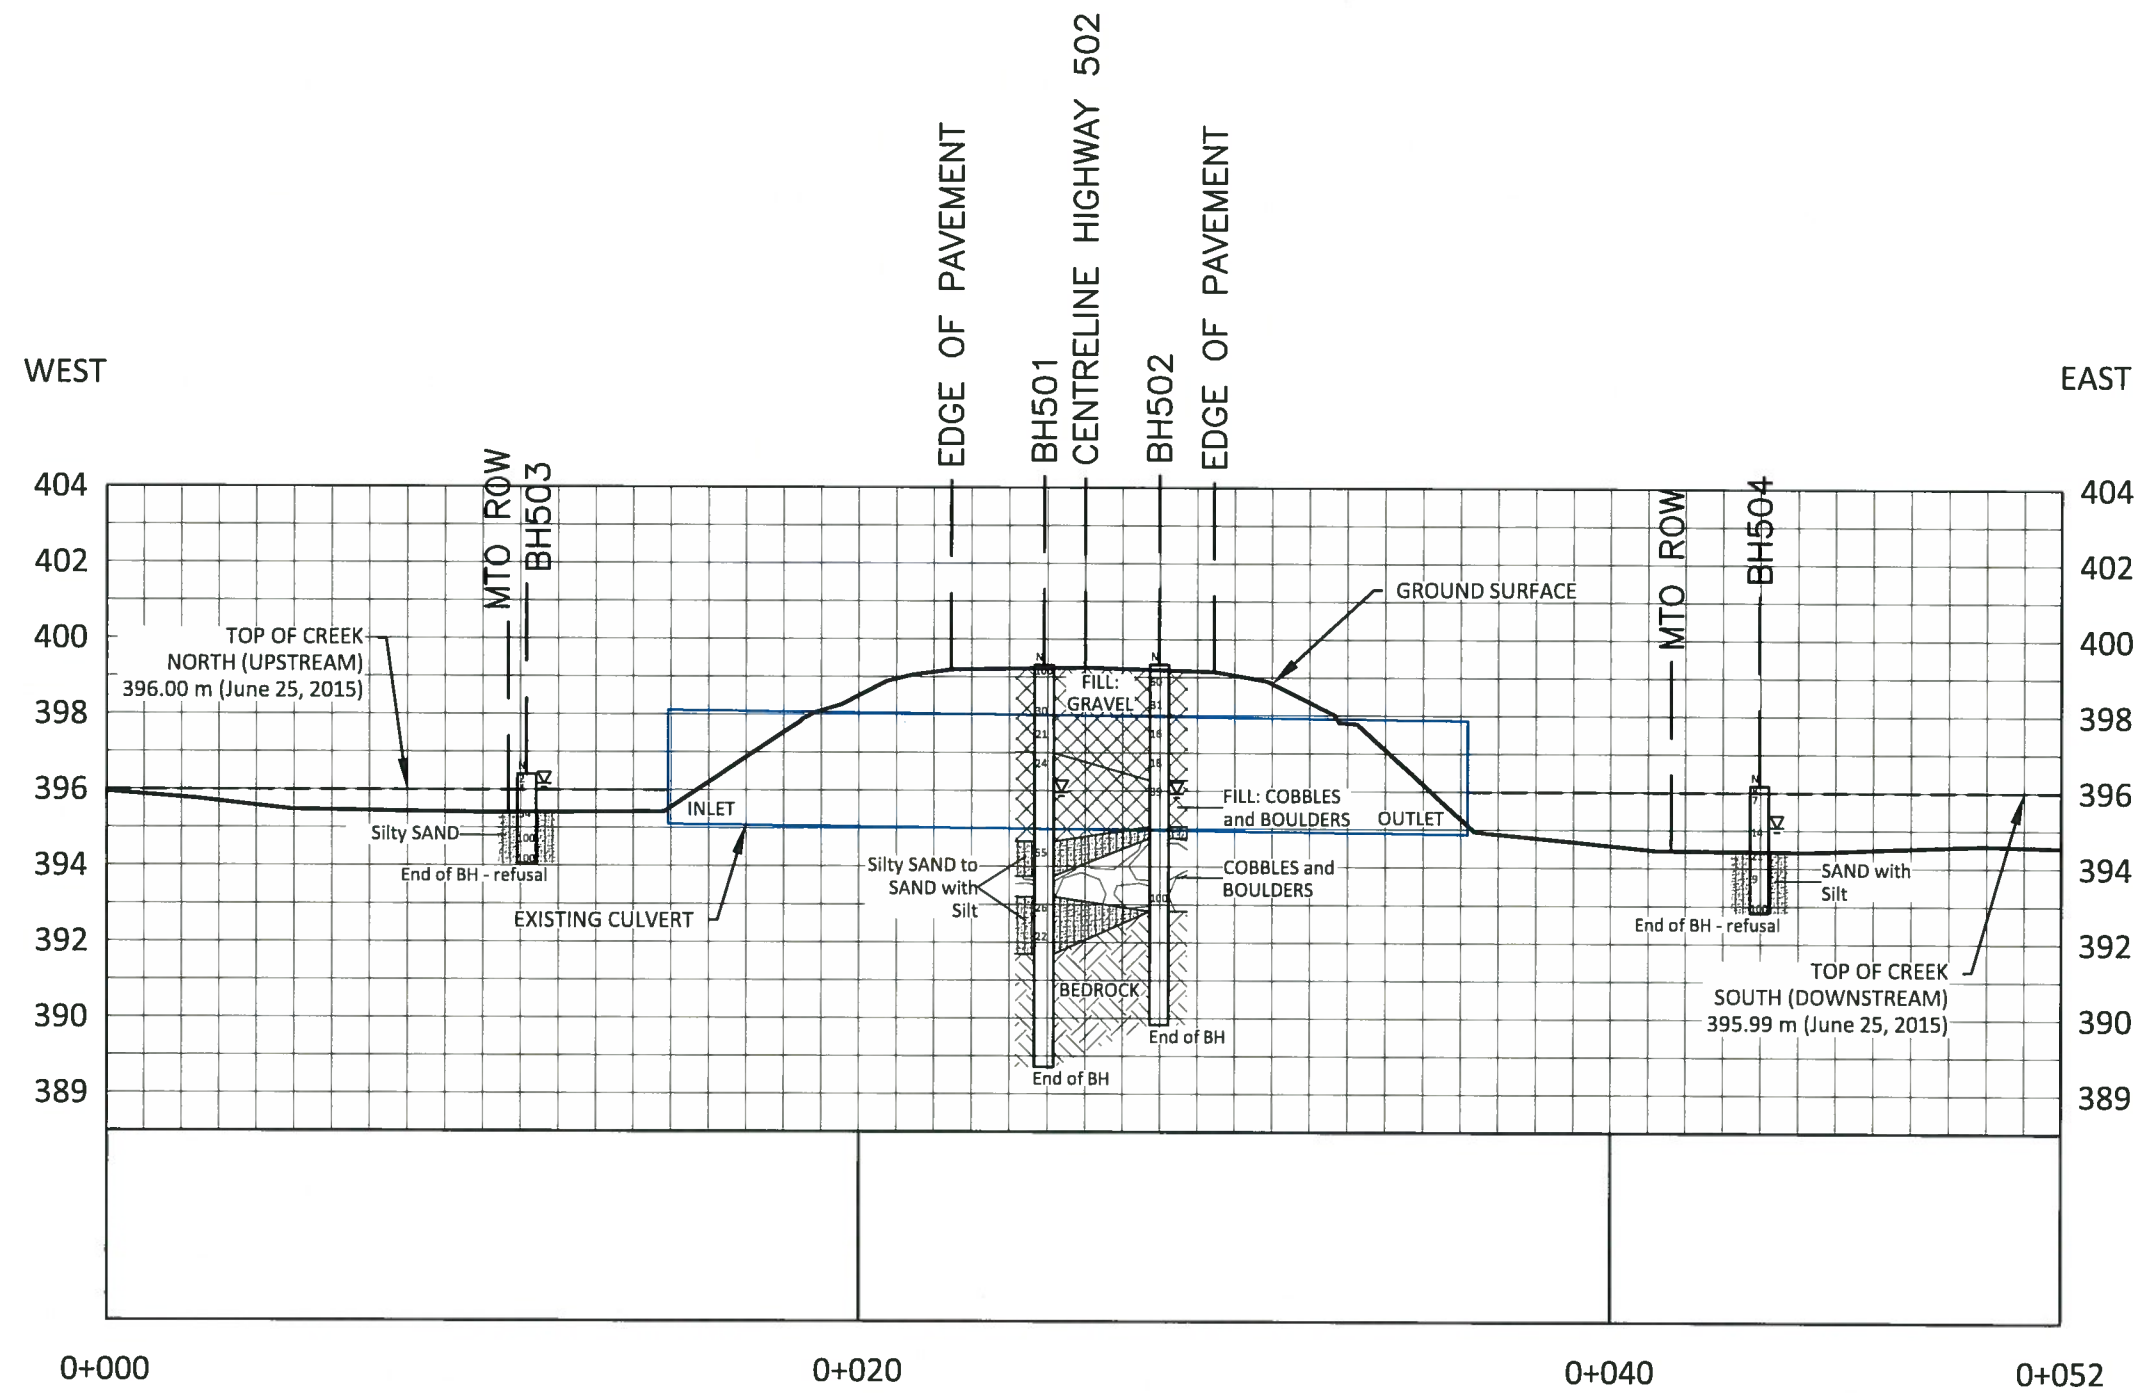
DWG
2

A - A'
PROFILE OF KAWAWIA CREEK CULVERT

A borehole location plan and stratigraphic sections are provided in Appendix B. It should be noted that the stratigraphic boundaries indicated on the borehole log and stratigraphic sections are inferred from semi-continuous sampling, observations of drilling progress and results of Standard Penetration Tests. These boundaries typically represent transitions from one soil type to another and should not be interpreted as exact planes of geological change. Furthermore, subsurface conditions may vary between and beyond the borehole locations.

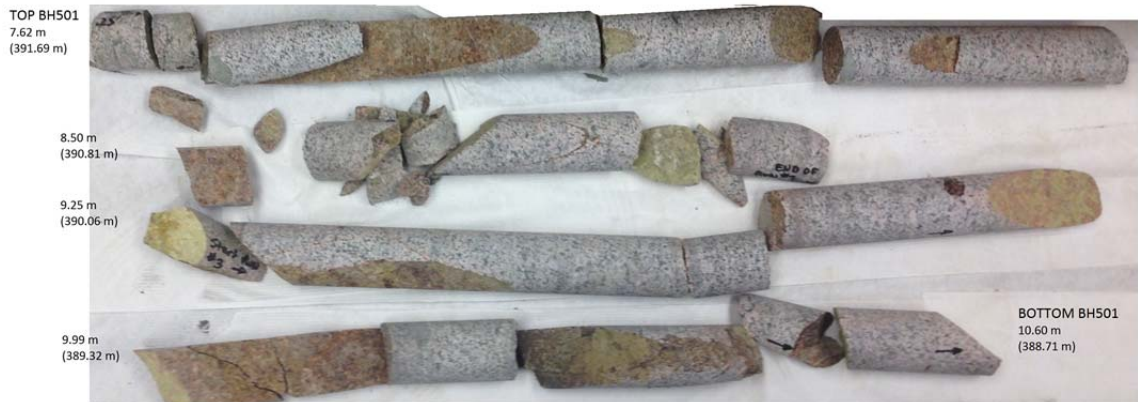
BH501 - Bedrock Core Samples with Depths and Elevations

Bedrock was encountered underlying the silty sand with gravel, and the cobbles and boulders at BH501 and BH502, at depths of about 7.6 m (391.7 m elevation) and 6.5 m (392.8 m elevation), respectively. The bedrock was generally described as a medium strong (25 MPa to 50 MPa compressive strength), very severely fractured, pink to white, and medium to coarse grained. The boreholes were extended by rock coring about 3.0 m into bedrock, and to depths ranging about 9.5 m and 10.6 m below ground surface. The boreholes were terminated at elevations ranging between about 388.7 m and 389.8 m. Photographs of the bedrock core samples are presented in Appendix C, after the Borehole Logs.

Gross recoveries ranged between about 97% and 100%. The Rock Quality Designation (RQD), which is a modified core recovery, was 0% for all core run samples (very severely fractured).

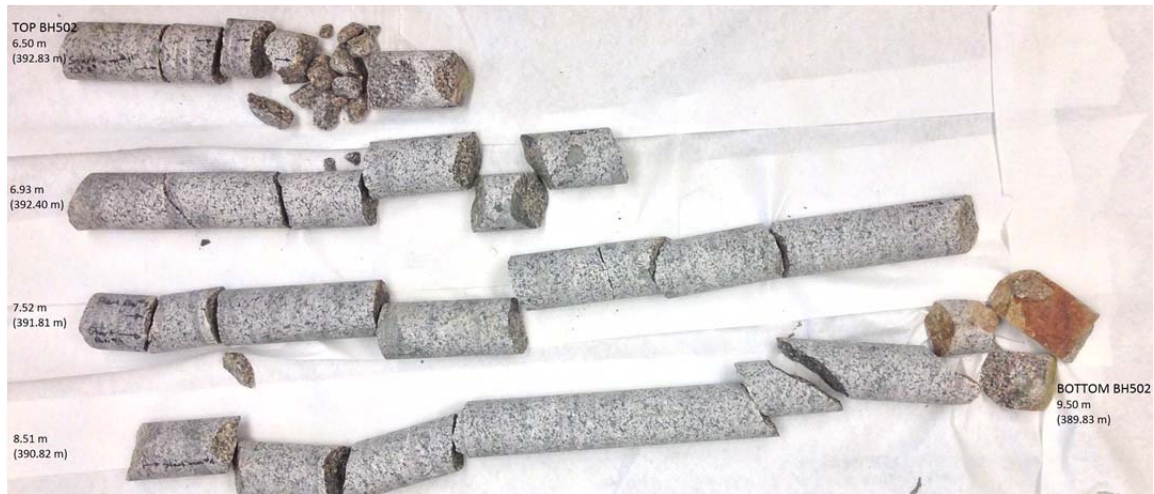
BH502 - Bedrock Core Samples with Depths and Elevations

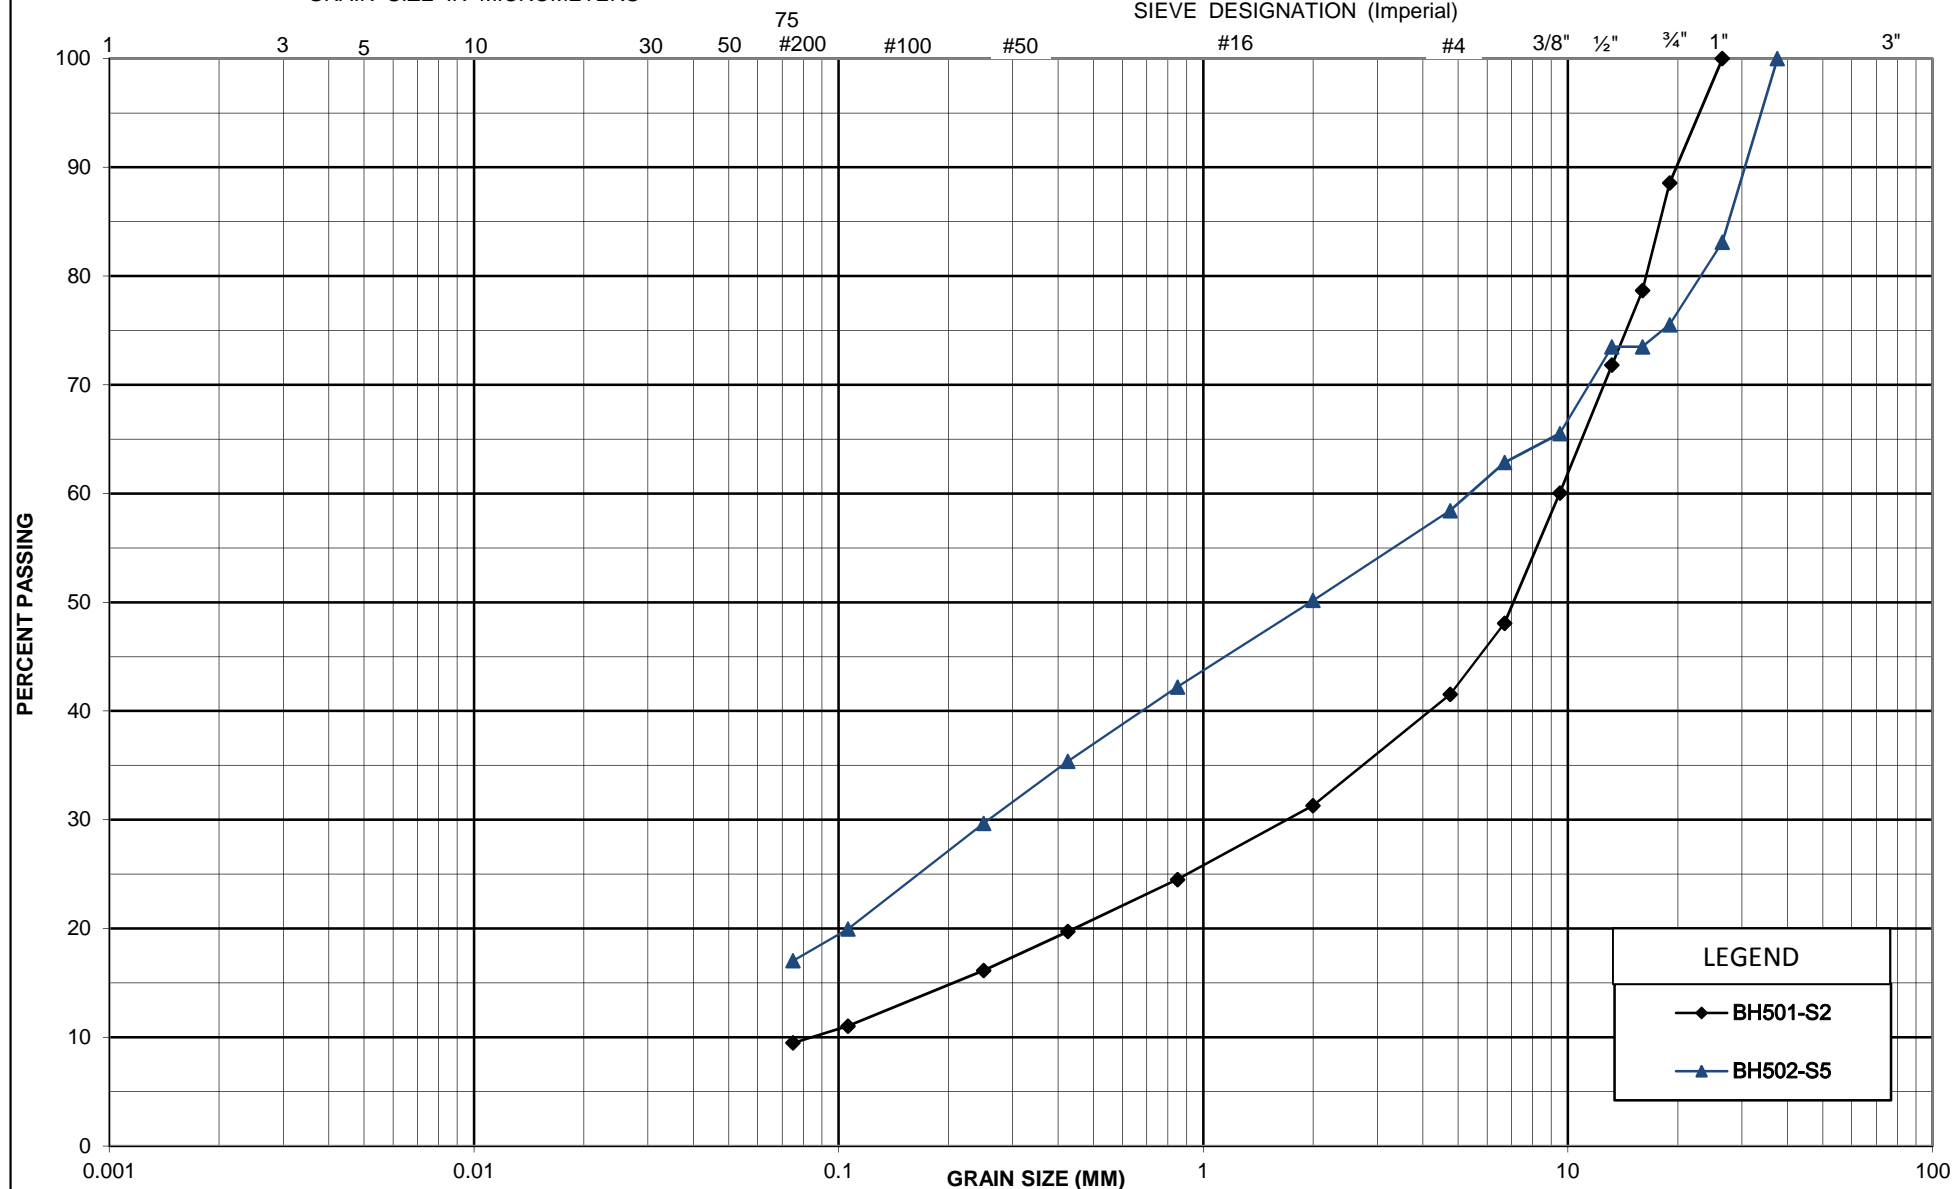
GRAIN SIZE DISTRIBUTION

The results of the moisture content and grain size distribution tests are provided on the record of borehole sheets in Appendix C. The results of the grain size distribution tests are also provided on Figure 1, in Appendix D.
