### **FOUNDATION INVESTIGATION REPORT**

**Minnikau River Culverts Replacement, Highway 642, Site No. 41S-255/C, District  
of Kenora**

**Agreement No. 6014-E-0017**

**exp Services Inc.**  
December 23, 2015

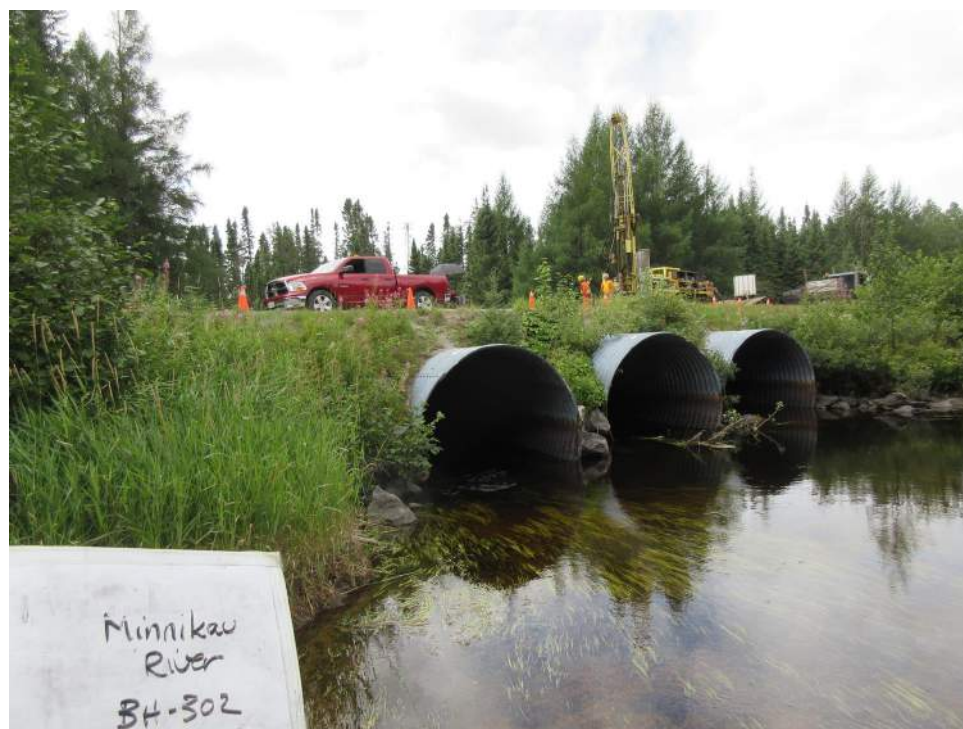
Photo 1. Existing culvert inlet on north side of highway

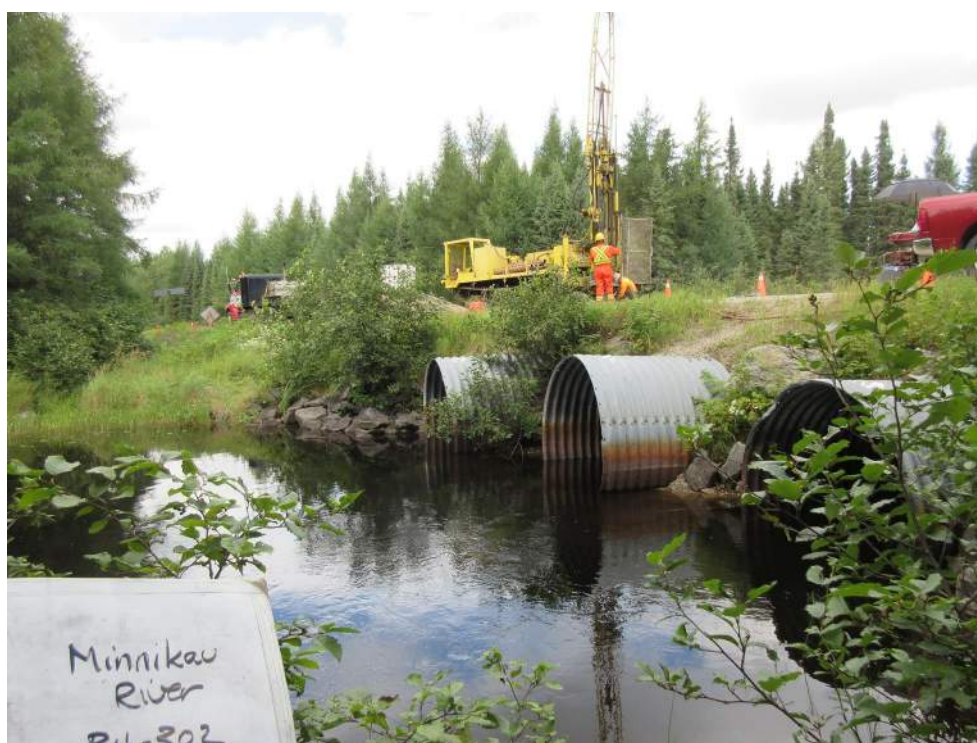
Photo 2. Existing culvert outlet on south side of highway

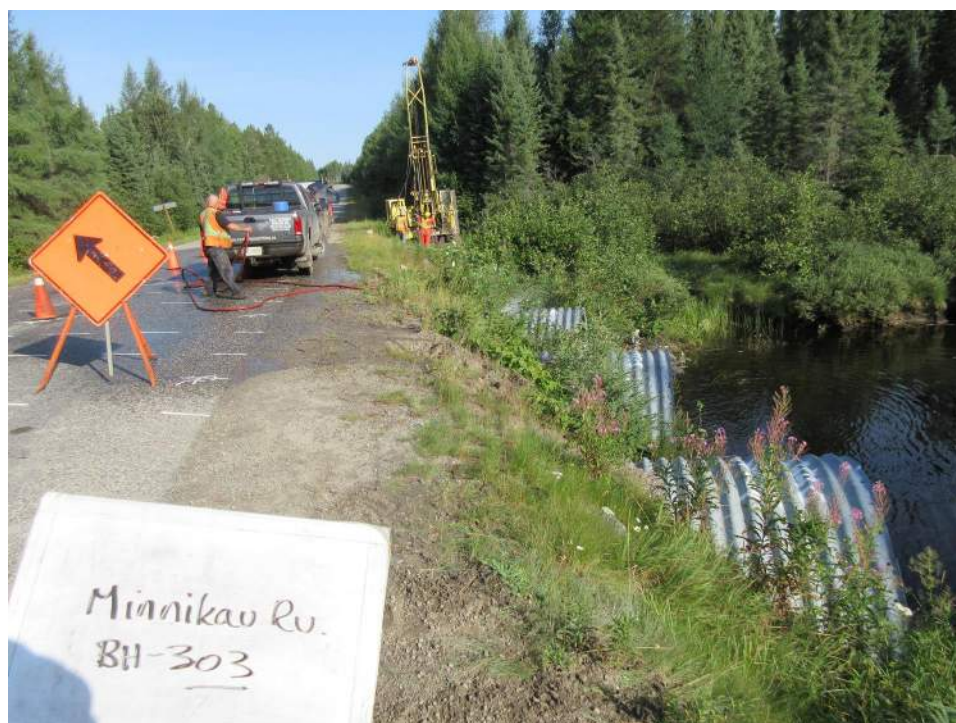
Photo 5. Embankment slope on north side facing west

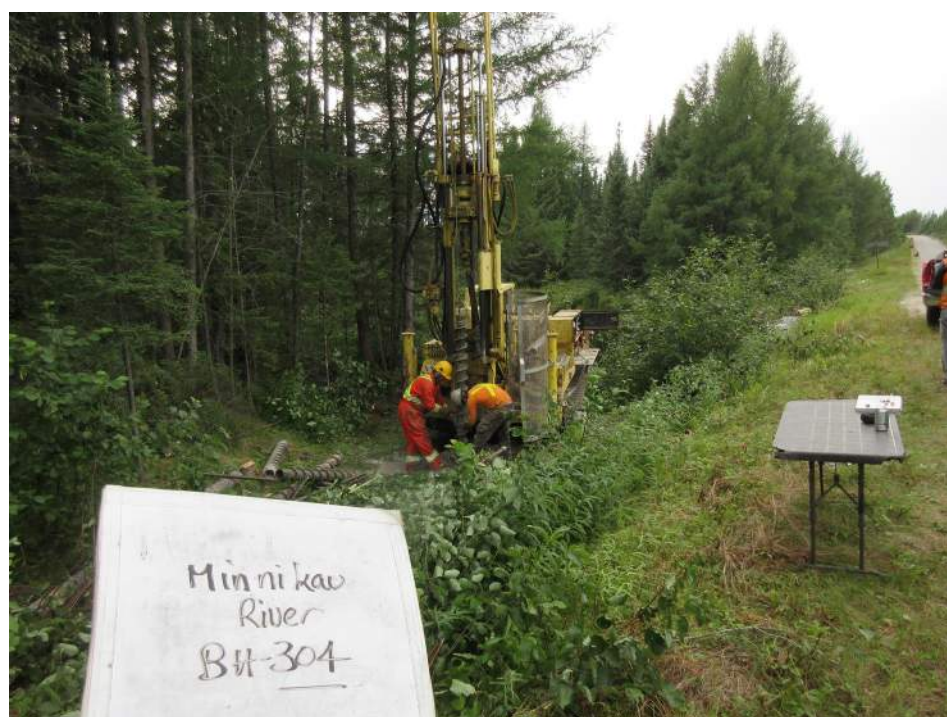
Photo 6. Embankment slope on south side facing west

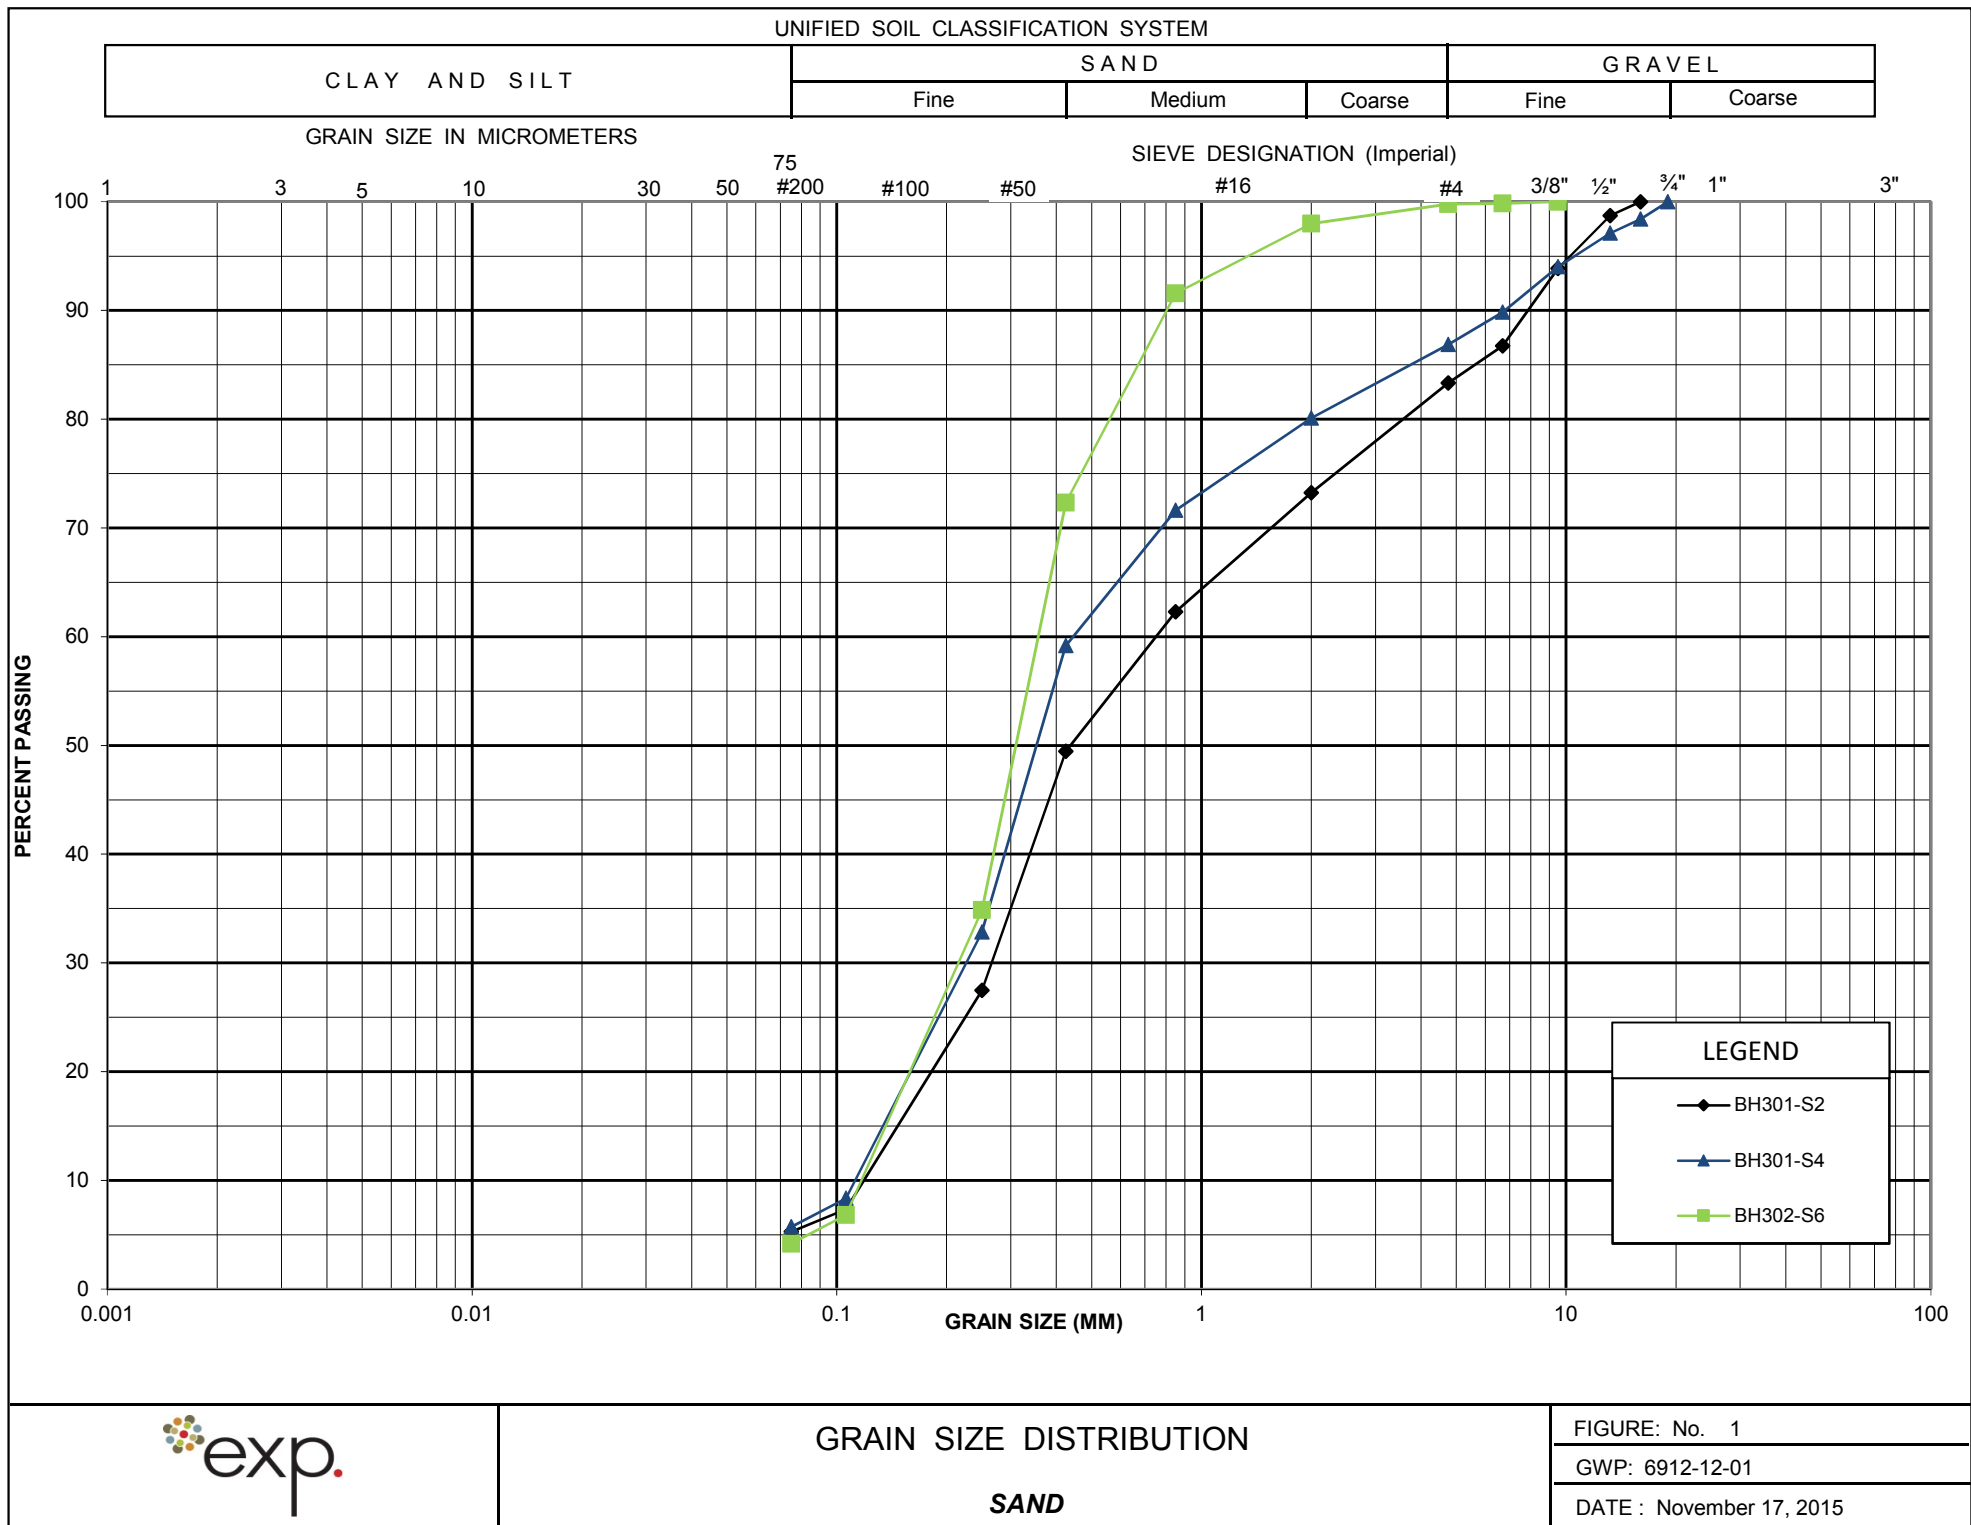
The results of the moisture content and grain size distribution tests are provided on the record of borehole sheets in Appendix C. The results of the grain size distribution tests are also provided on Figure 1, in Appendix D.

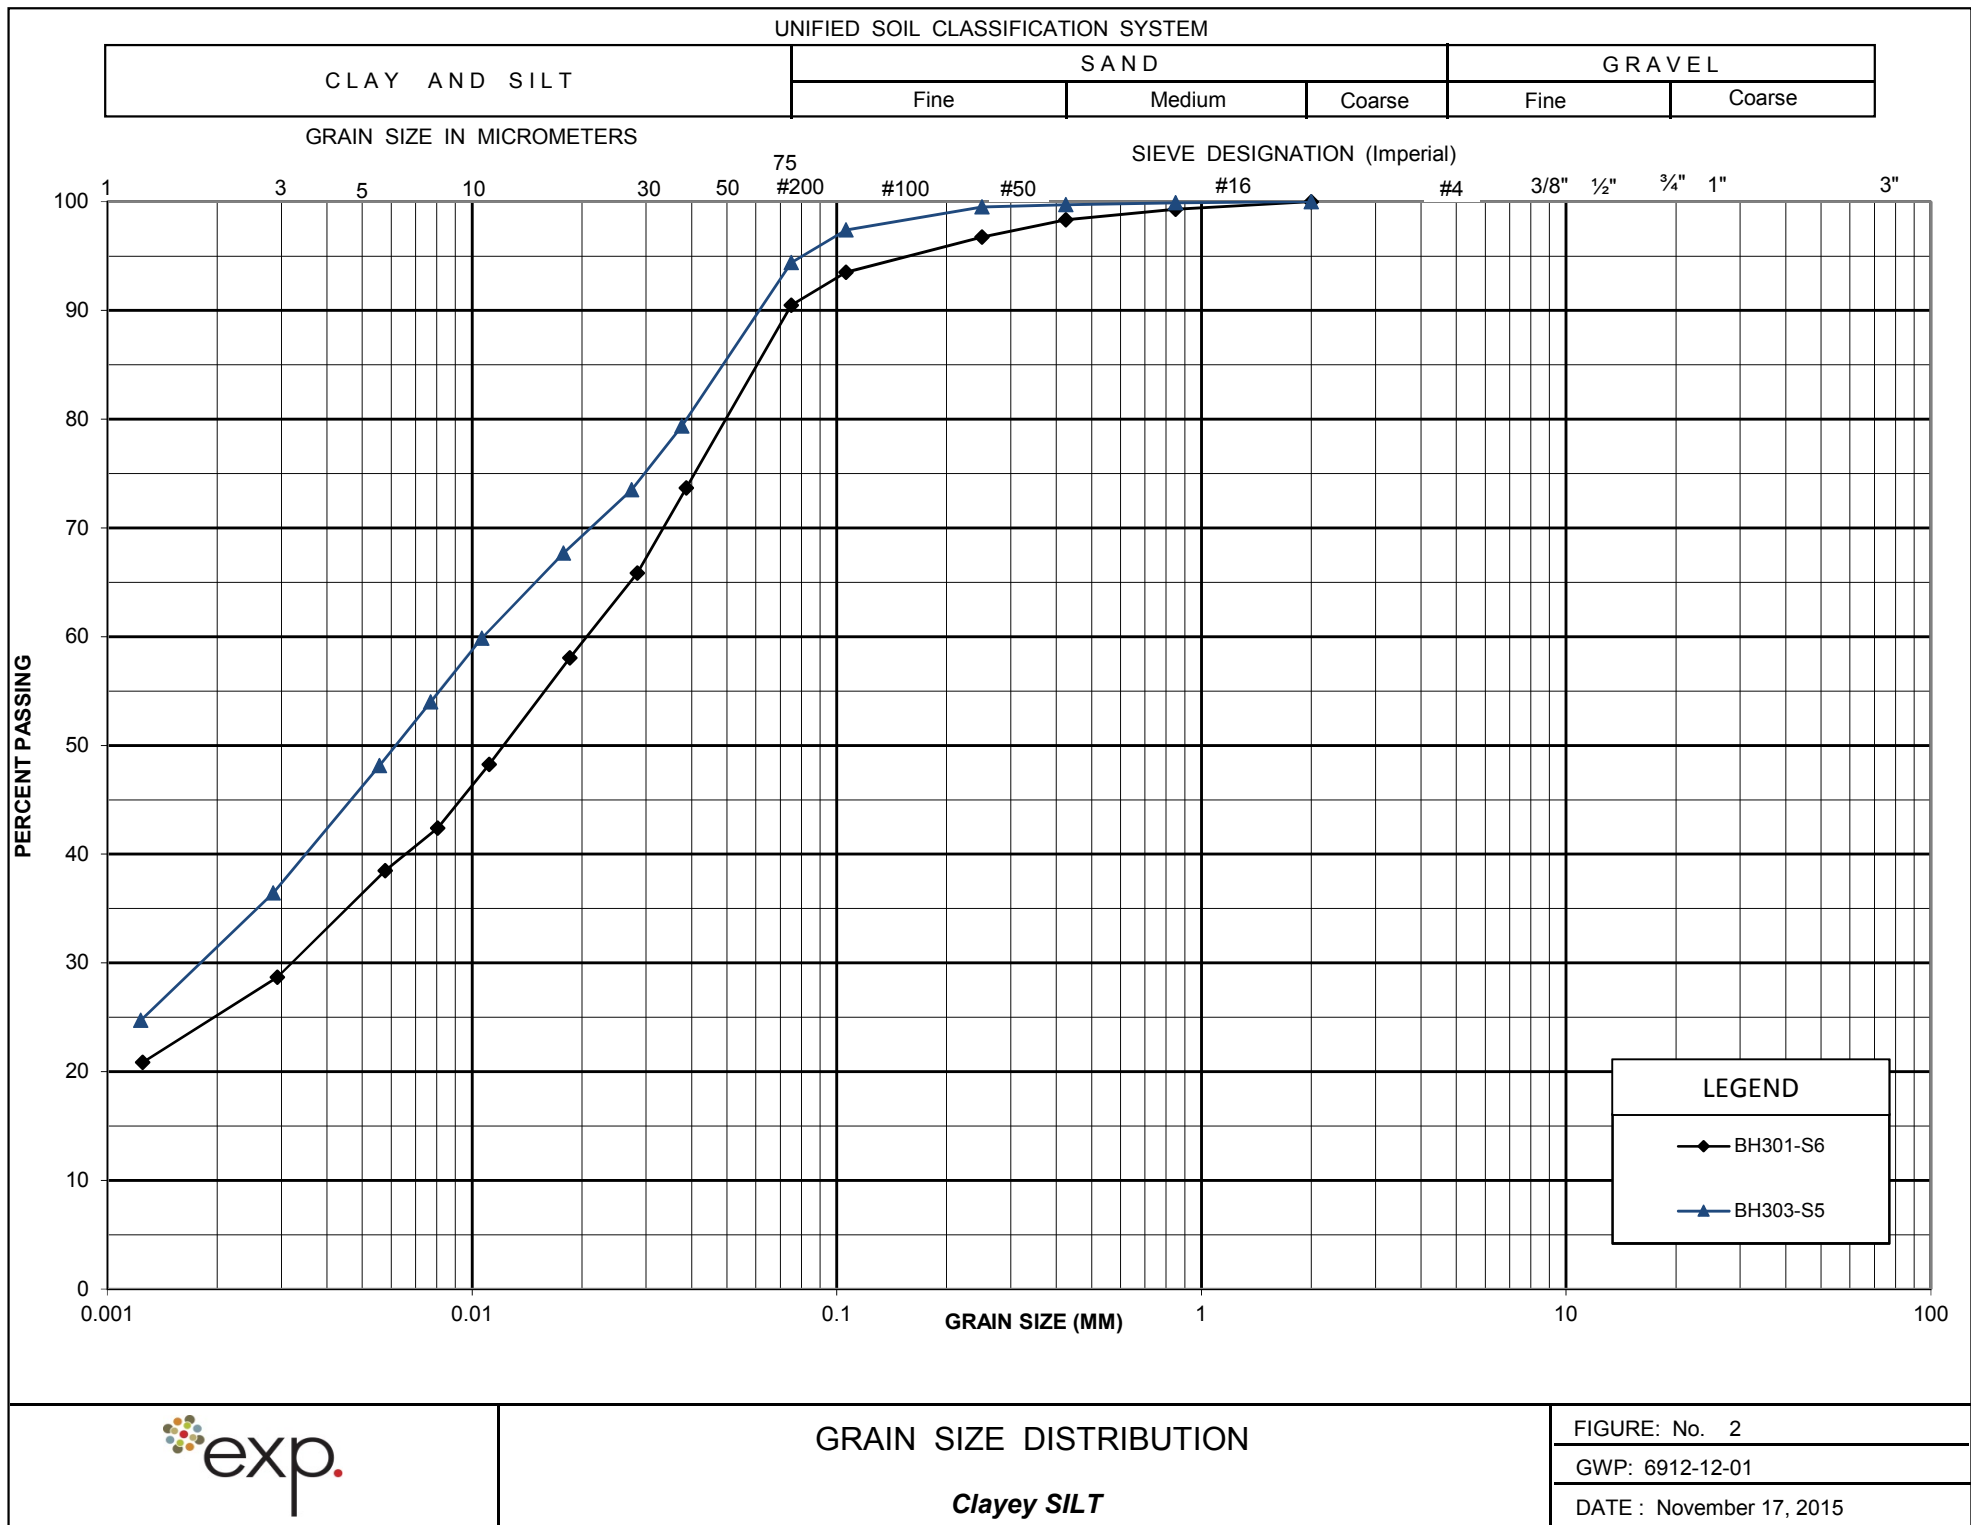
The results of the moisture content, grain size distribution and Atterberg Limits tests are provided on the record of borehole sheets in Appendix C. The results of the grain size distribution are also provided on Figure 2 in Appendix D, and Atterberg Limits tests are provided on Figure 5 in Appendix D.

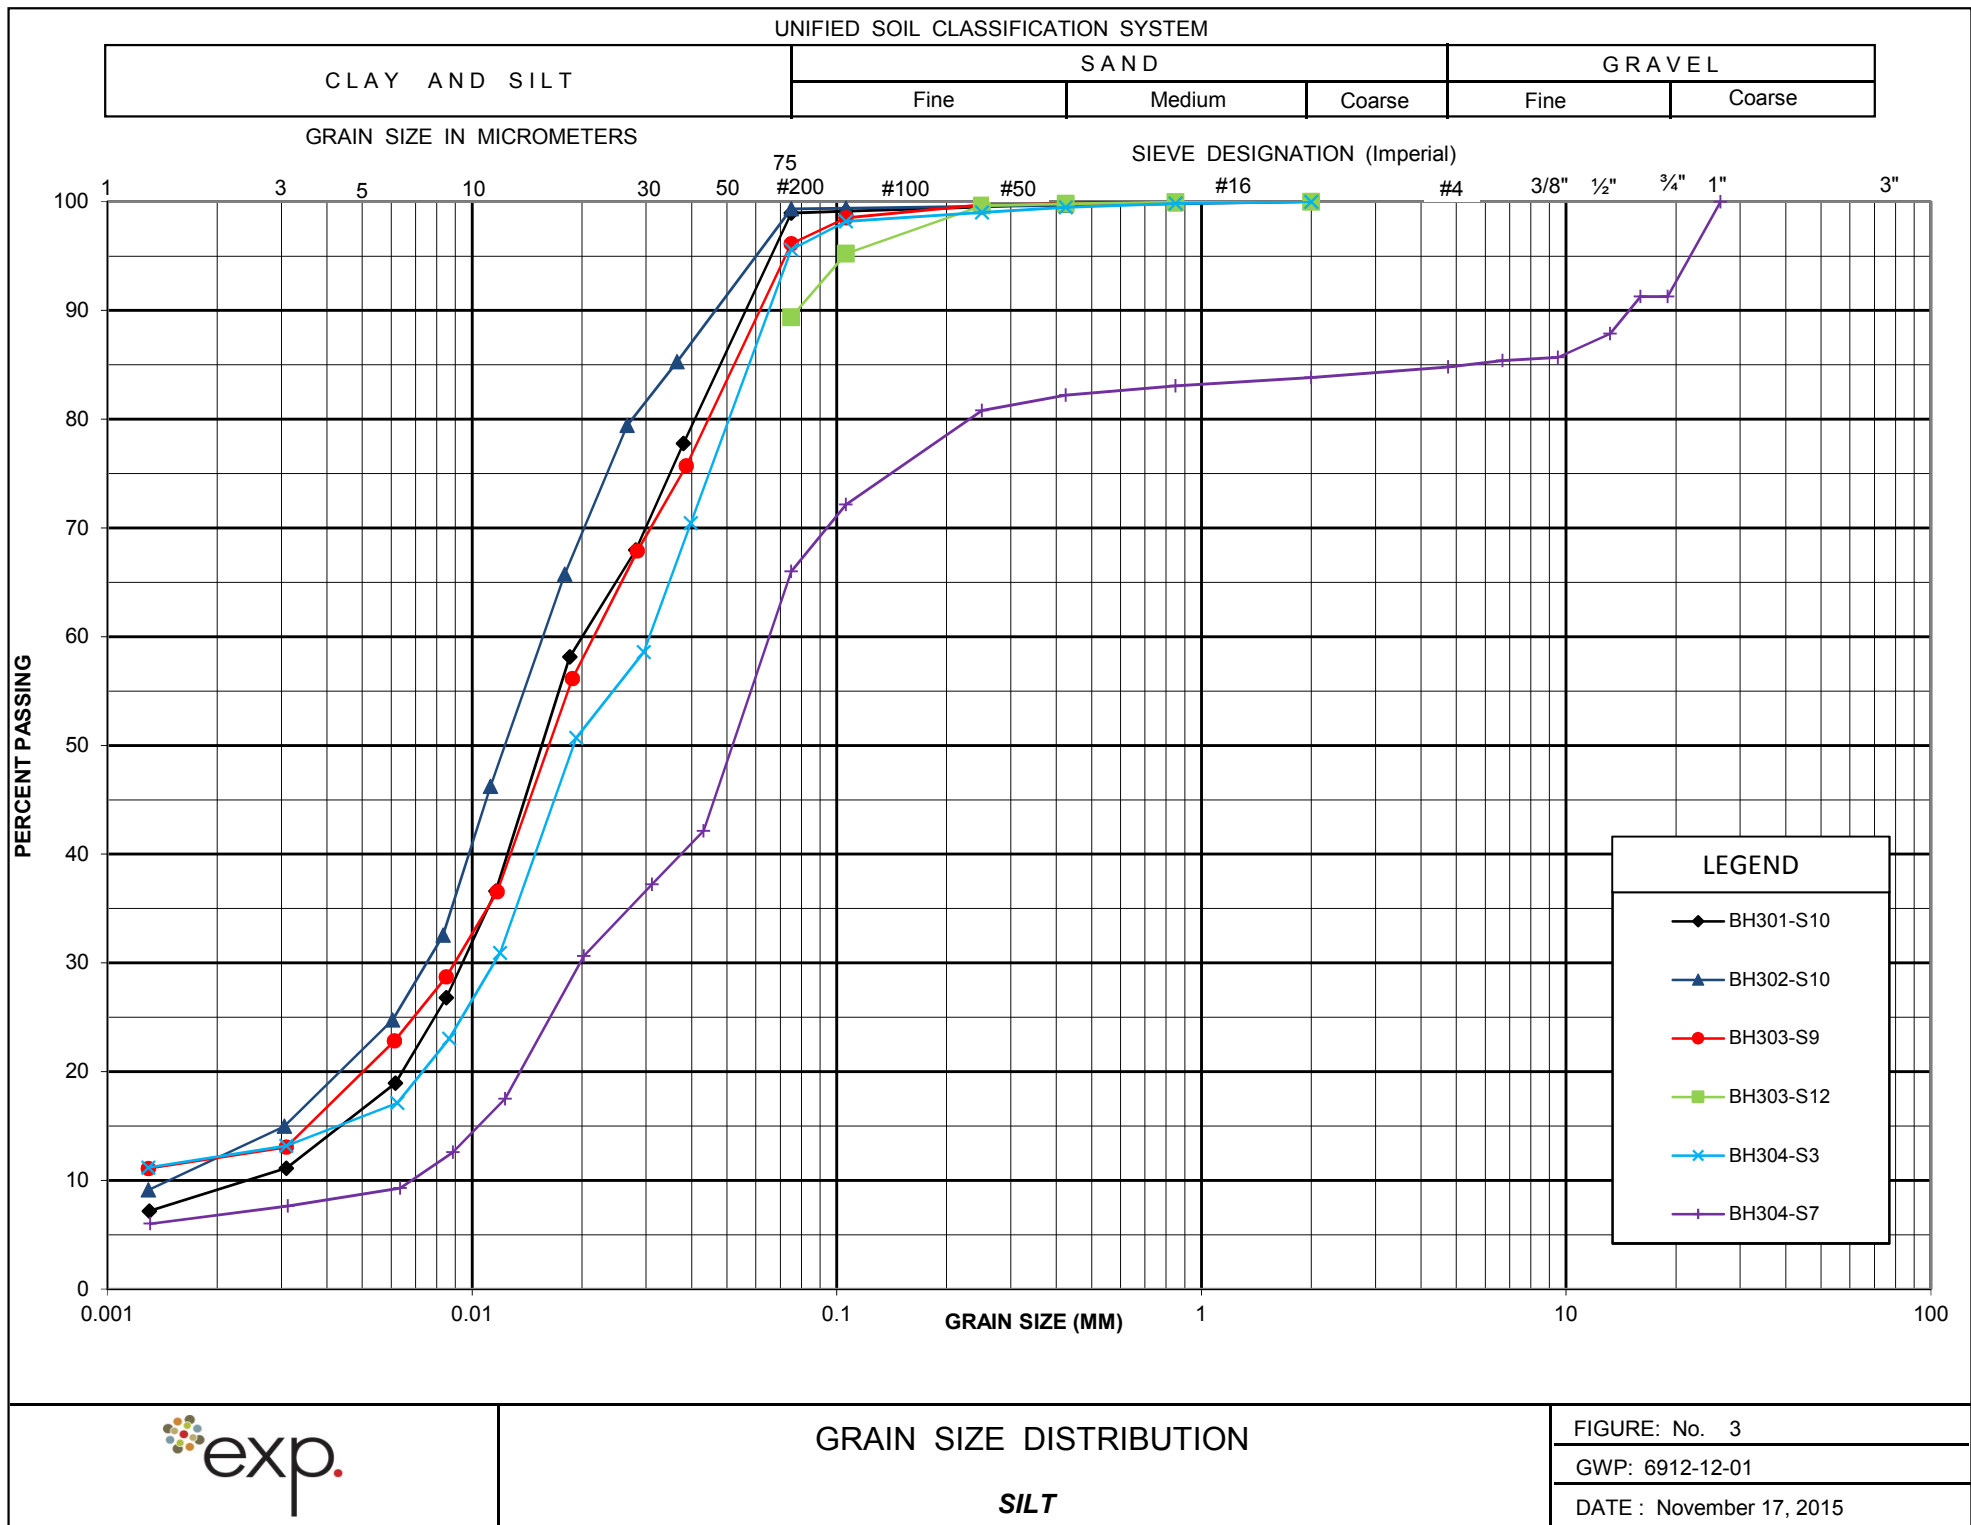
The results of the moisture content, grain size distribution and Atterberg Limits tests are provided on the record of borehole sheets in Appendix C. The results of the grain size distribution are also provided on Figure 3 in Appendix D, and Atterberg Limits tests are provided on Figure 6 in Appendix D.

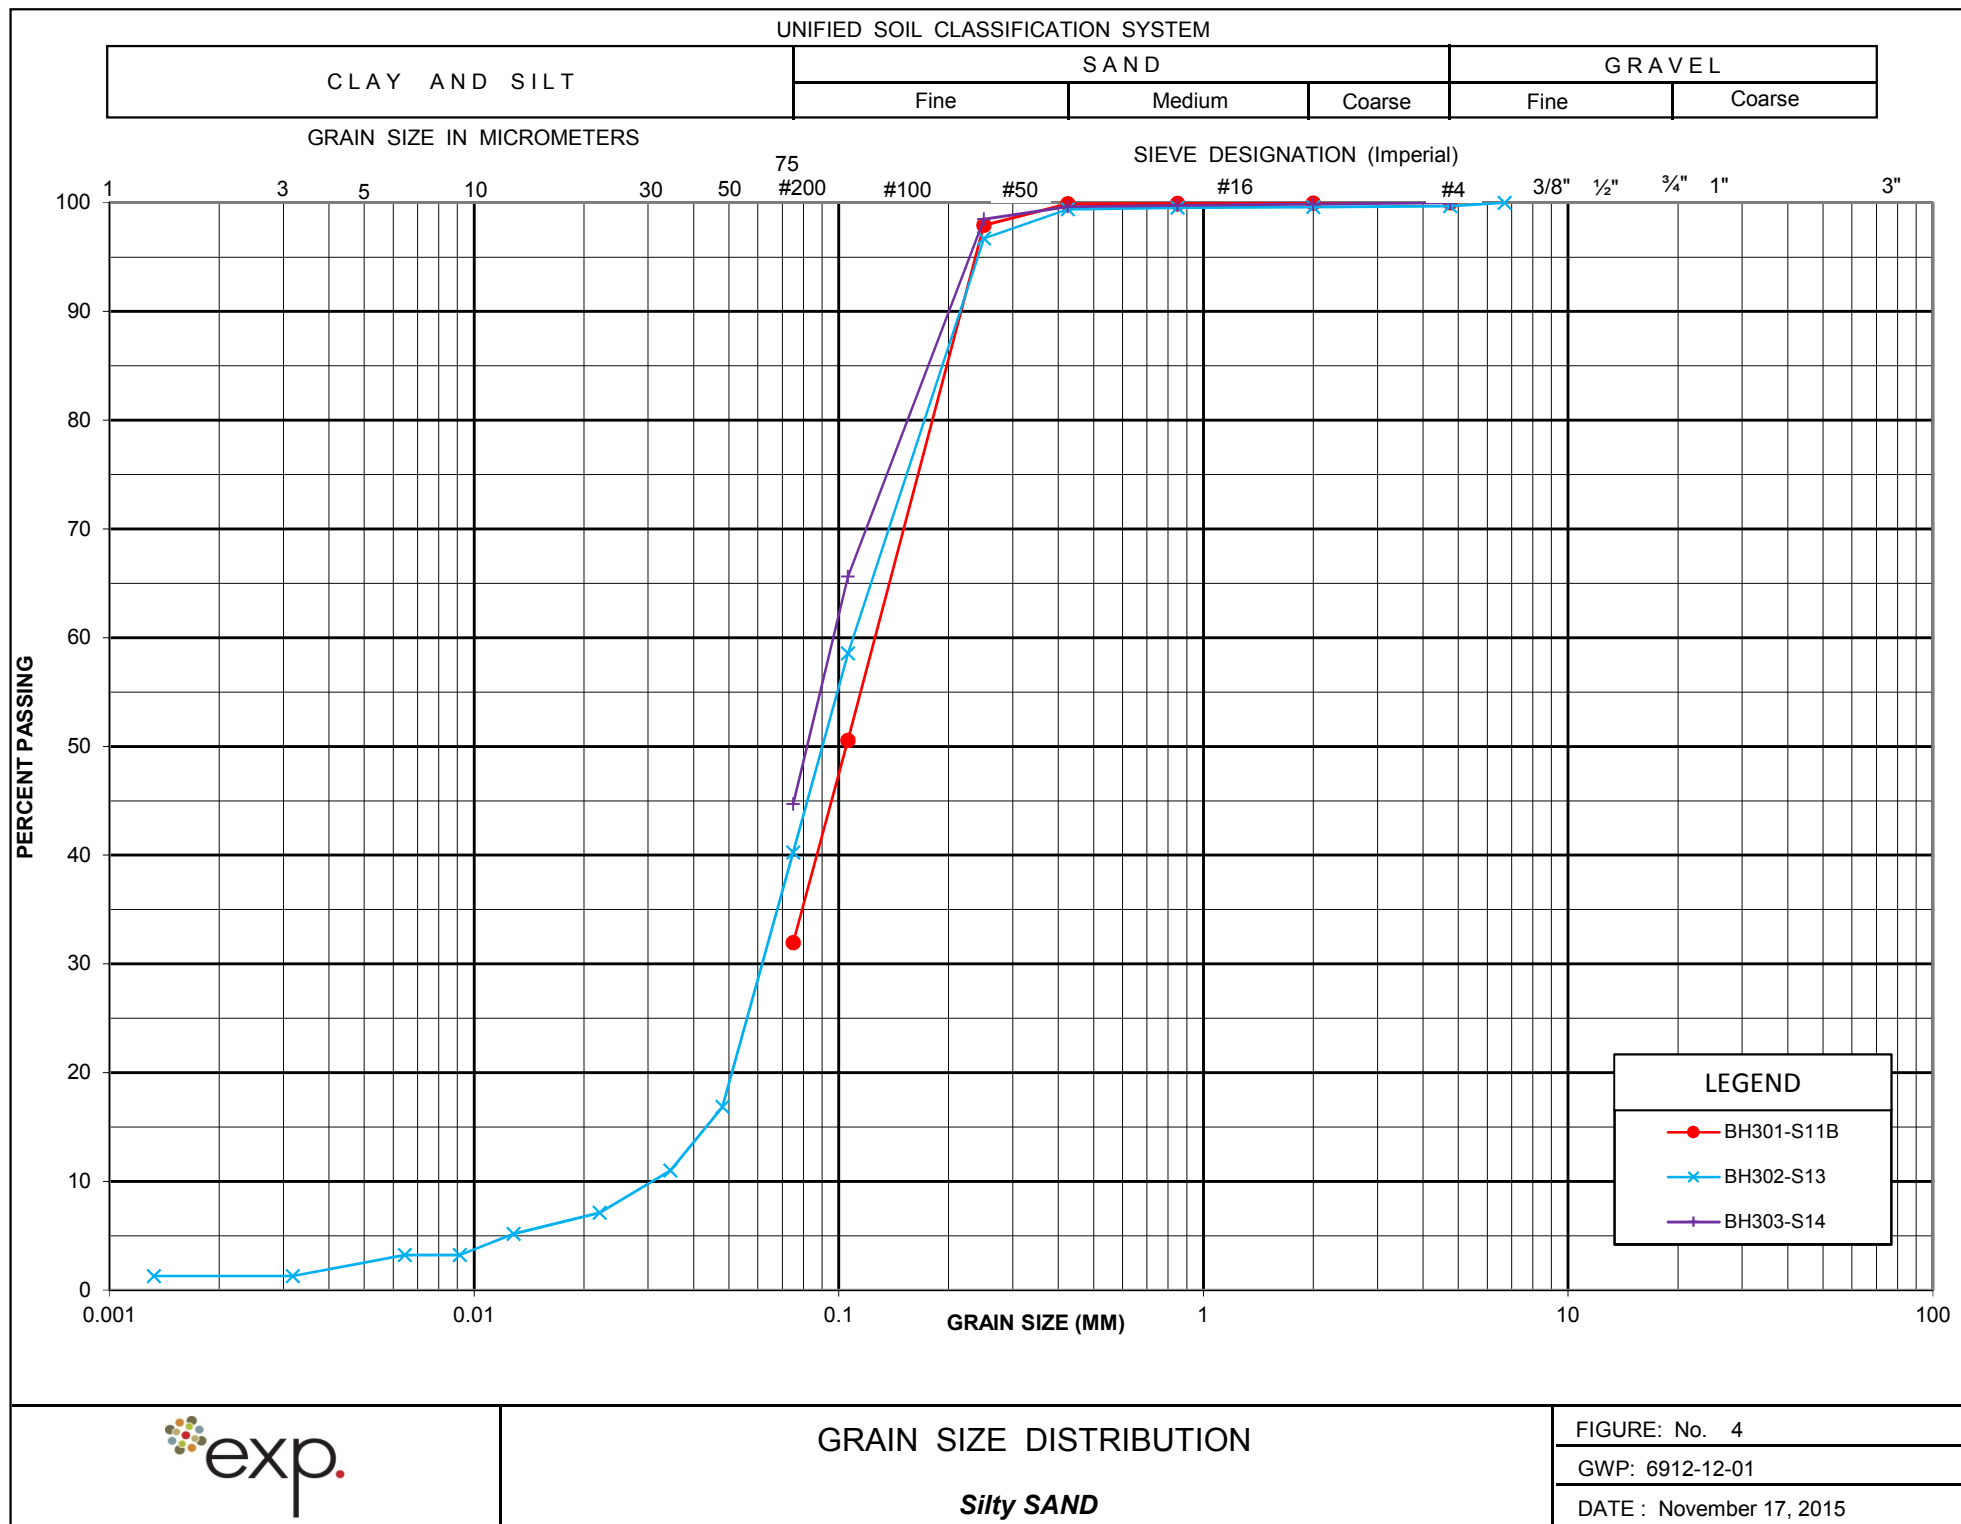
The results of the moisture content and grain size distribution tests are provided on the record of borehole sheets in Appendix C. The results of the grain size distribution tests are also provided on Figures 3 and 4, in Appendix D.
