FOUNDATION INVESTIGATION REPORT

**Additional Foundation Engineering Retainer Services for Detail Design for
New Eastbound and Westbound Truck Climbing lanes on Highway 17
from Pays Plat River Easterly for 7.2 km, Thunder Bay Area, Ontario**

Agreement No. 6017-E-0066

August 29, 2019

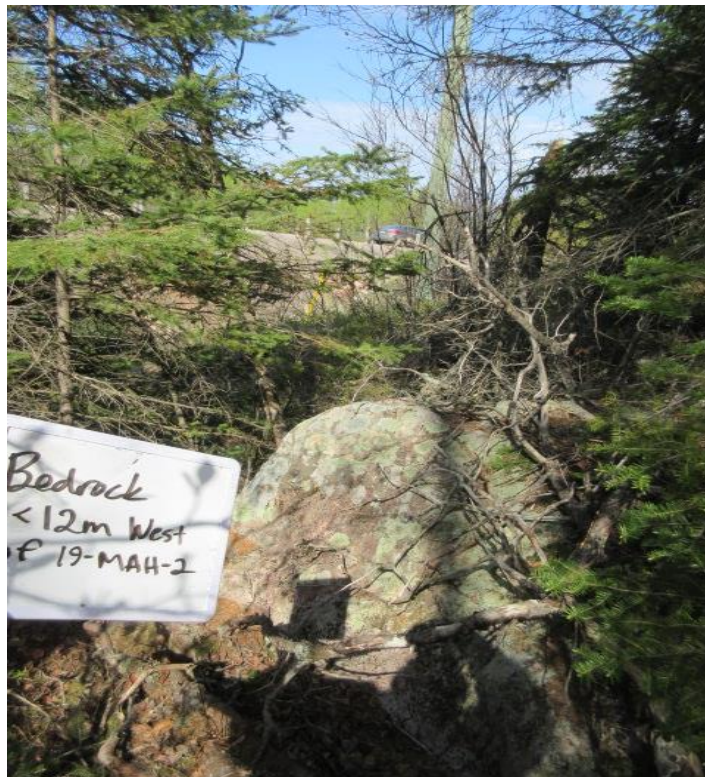
Photo 2. Section A- Bedrock close to 19-MAH-2, west bottom of Hwy 17 existing embankment close to Station 17+025, looking west

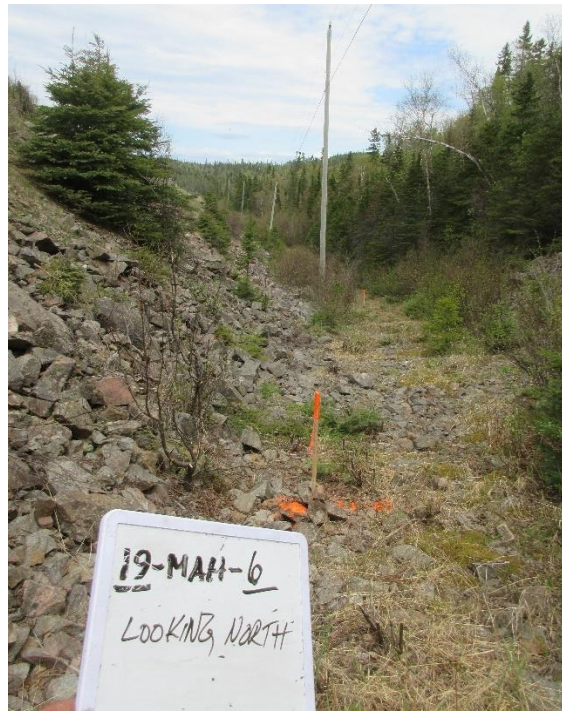
Photo 5. Section B - Toe of Hwy 17 existing embankment, rocky steep slopes close to Station 18+675, looking north

Section B from Station 18+600 to 18+675 is the area located east of existing Hwy 17, which is investigated for widening the WBL. In this area the highway embankment is approximately 7 m to 13 m high, with rocky steep slopes (Photo 5). The base of the embankment where the boreholes were located is also covered by rockfill. East of the embankment base the terrain raises into the steep natural rocky slope (Photos 5 and 6). The area is vegetated by bushes and trees (Photos 7 and 8). A small creek was observed in the middle portion of this section as shown on Photo 8. This area also has overhead powerlines, Hydro and Fiber Optics Telephone System (Photo 5).

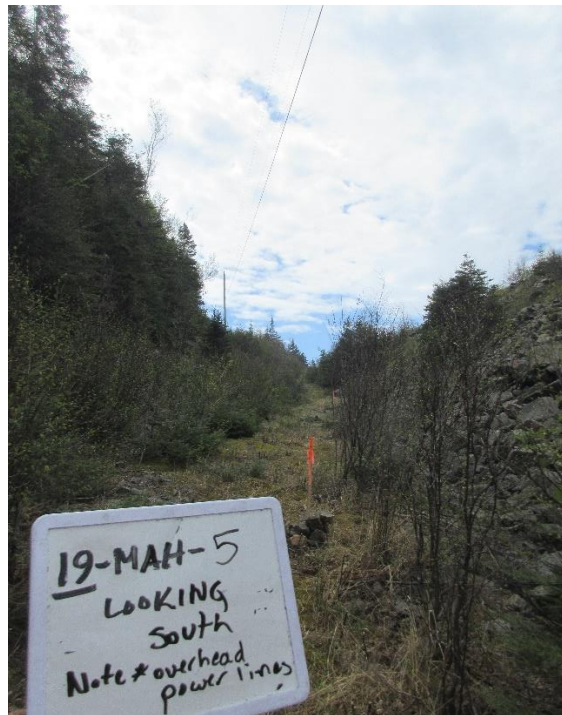
Photo 6. Section B – Overhead powerlines at toe of Hwy 17 existing embankment close to Station 18+650, looking south

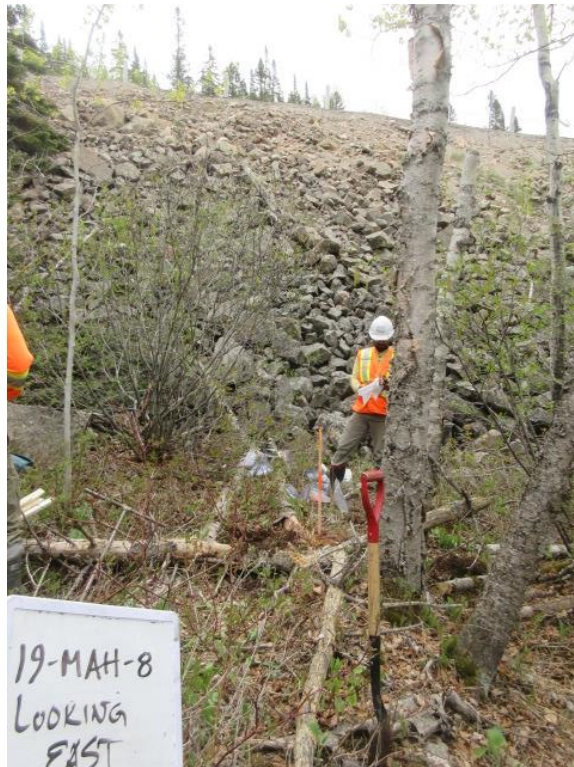
Photo 9. Section C - Toe of Hwy 17 existing embankment, rocky steep slopes close to Station 19+400, looking east

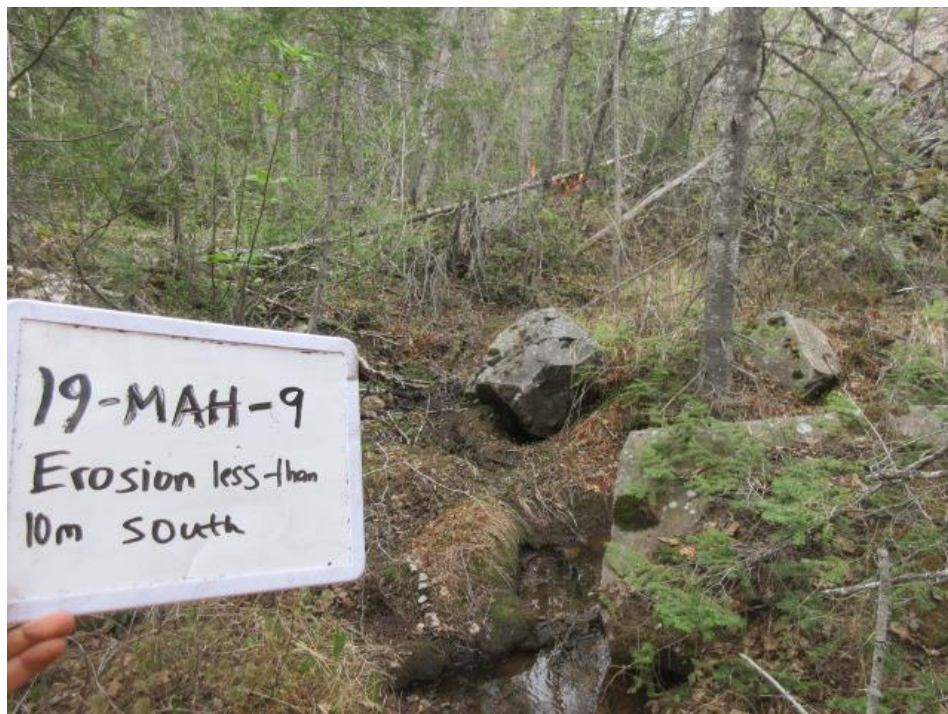
Photo 10. Section C - Hwy 17, erosion near 19-MAH-9, facing south

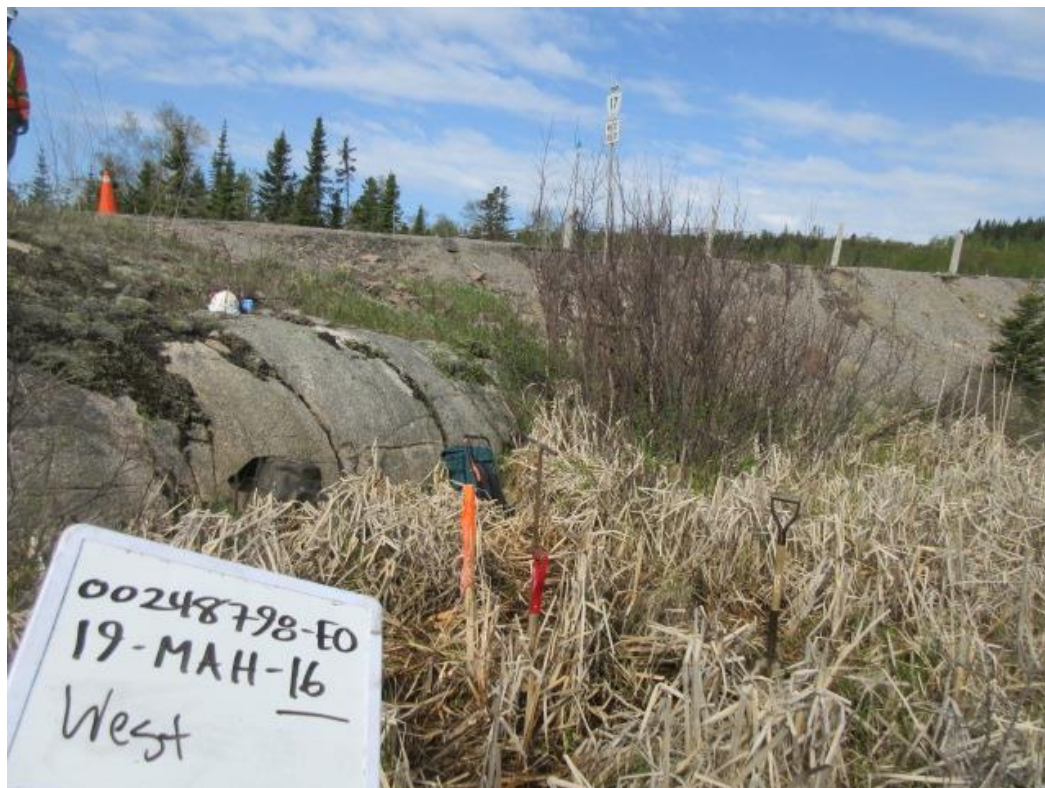
Photo 16. Section D – Bedrock outcrop close to 19-MAH-16, near Station 20+335, looking west

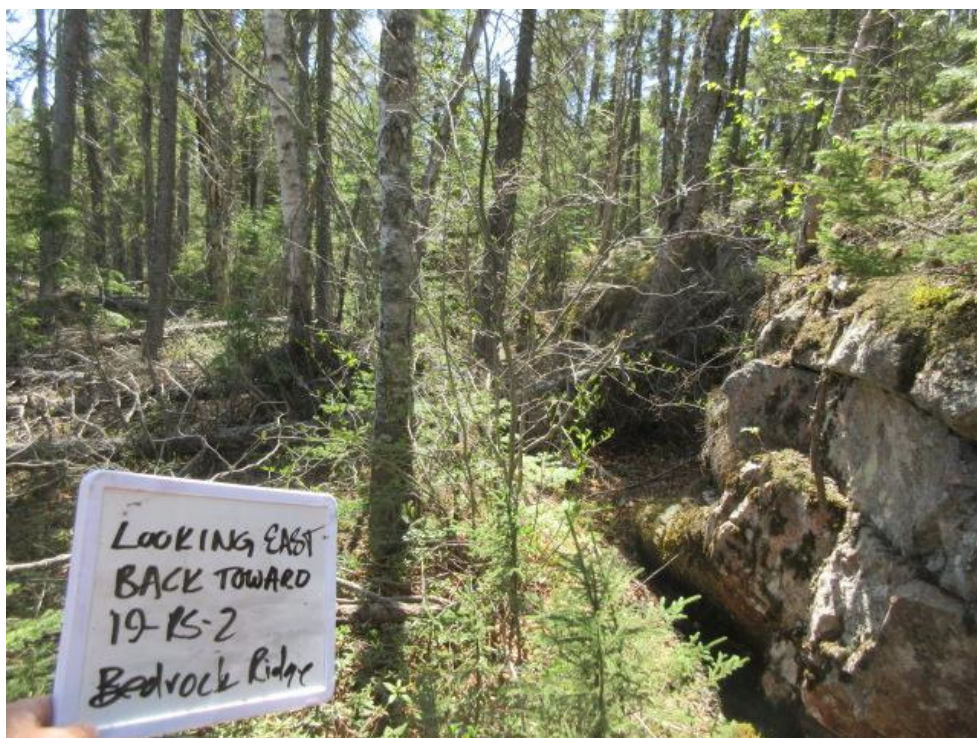
Photo 18. Section E – East boundary of the proposed rock surplus management area, bedrock ridge

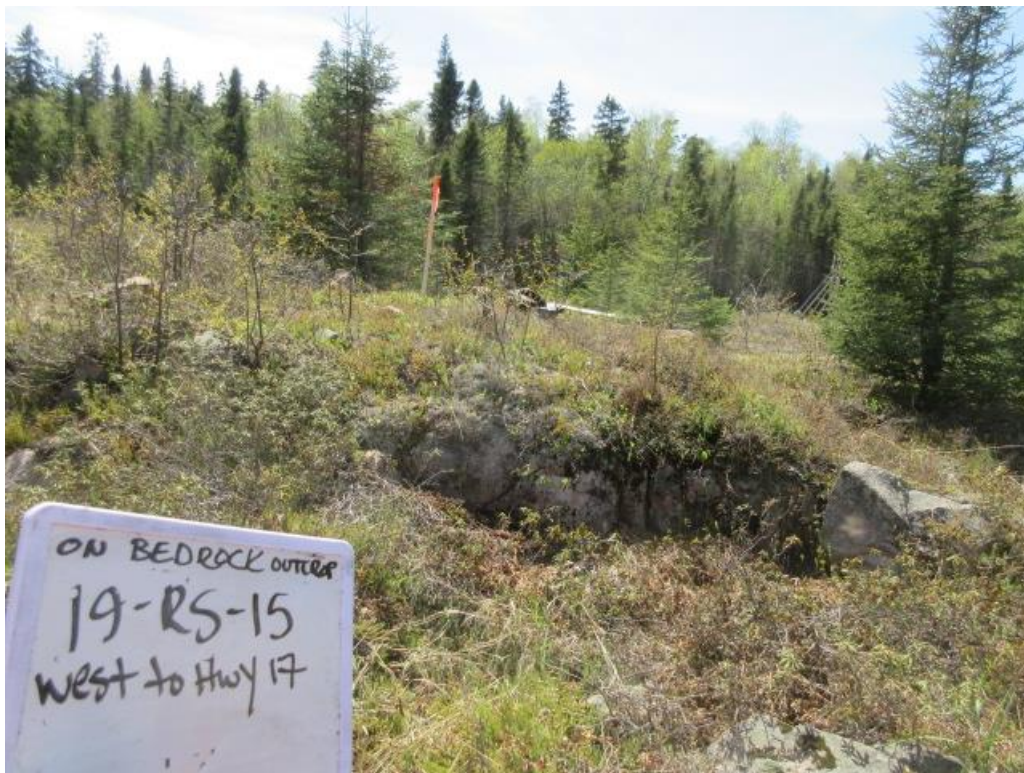
Photo 20. Section E – South-west corner of the proposed rock surplus management area, bedrock outcrop

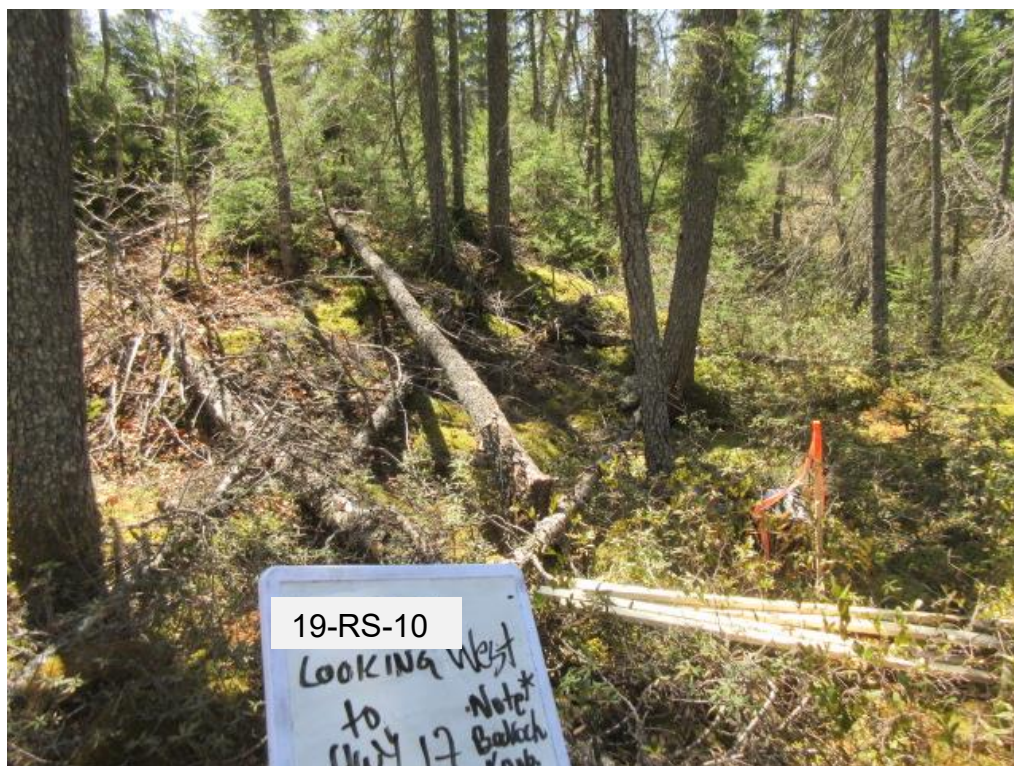
Photo 21. Section E – South boundary of the proposed rock surplus management area, bedrock knob

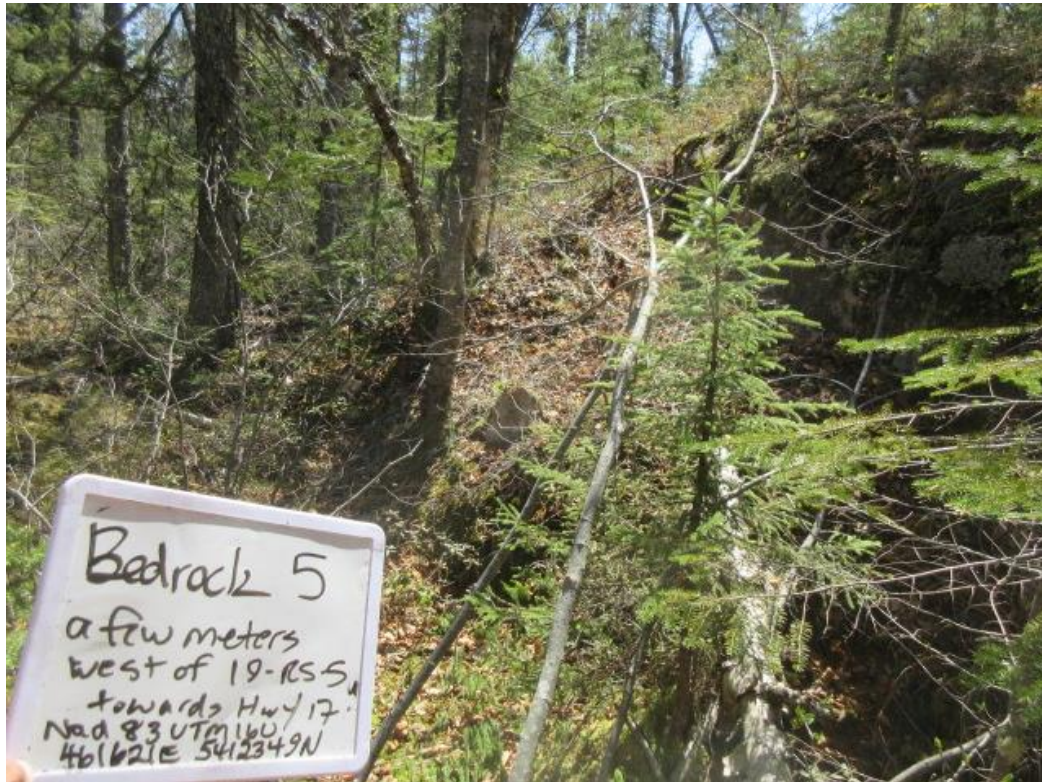
Photo 23. Section E – South-east corner of the proposed rock surplus management area, bedrock near 19-RS-5

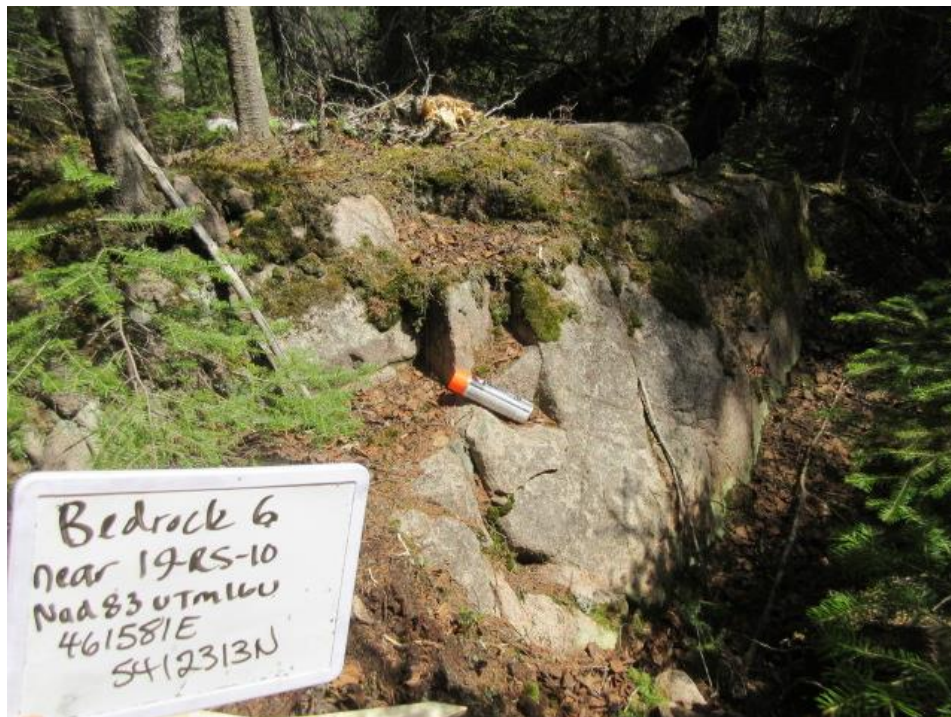
Photo 24. Section E – South boundary of the proposed rock surplus management area, bedrock near 19-RS-10

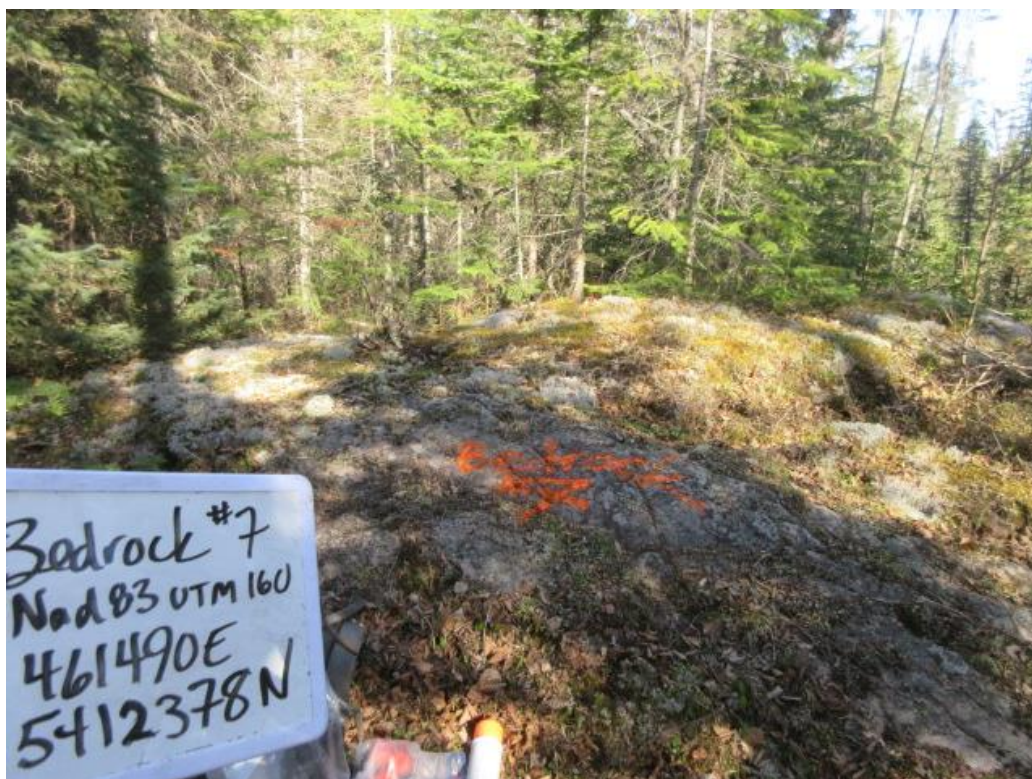
Photo 25. Section E – In the center of the proposed rock surplus management area, bedrock near 19-RS-7
