**FINAL
FOUNDATION INVESTIGATION REPORT
HIGHWAY 17 NON-STRUCTURAL CULVERT AT STATION 14+055
STABILITY ASSESSMENT OF TEMPORARY STAGING FILLS AND CUTS
UPSALA TOWNSHIP, ONTARIO
AGREEMENT NO.: 6022-E-0038, ASSIGNMENT NO.: 5**

GEOCRES NO.: 52G02-001

Date: April 12, 2024

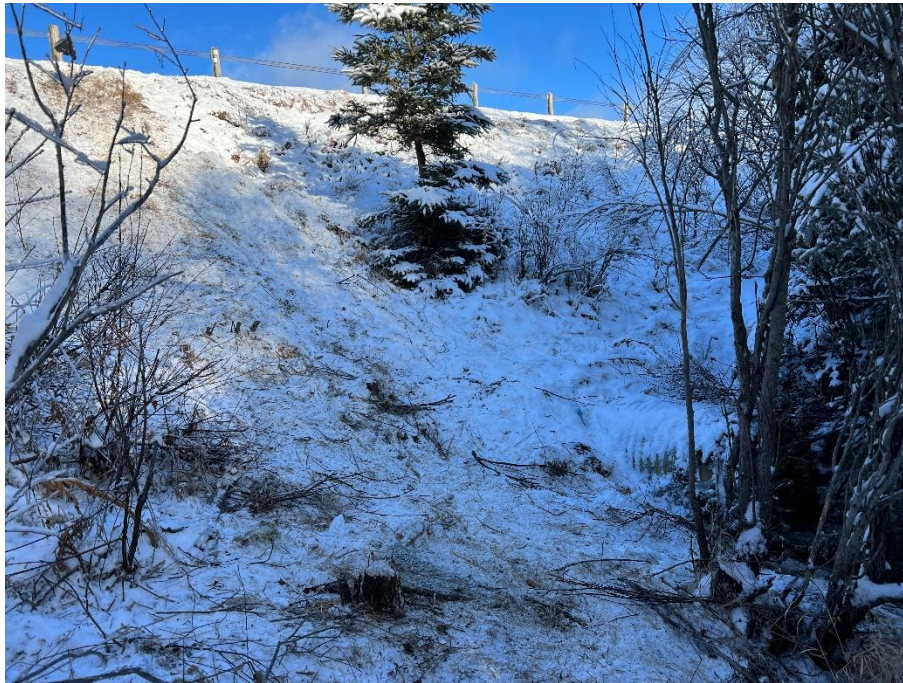
Photo 1: Culvert inlet *(taken on January 3, 2024)*

The cover above the existing culvert is approximately 6 m at the highway centreline. The embankment side slope at the culvert inlet (south side) is inclined at approximately 2.1H:1V. The embankment side slope at the culvert outlet (north side) is inclined at approximately 2.4H:1V. The existing highway embankment side slopes at the culvert did not show any visible signs of global instability at the time of the investigation.

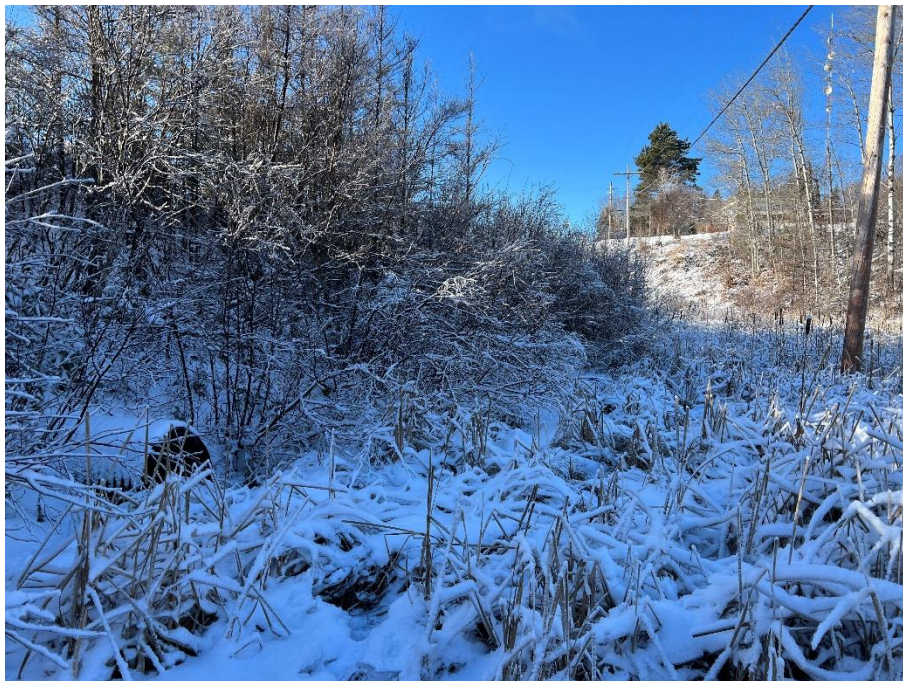
Photo 2: Culvert outlet *(taken on January 3, 2024)*

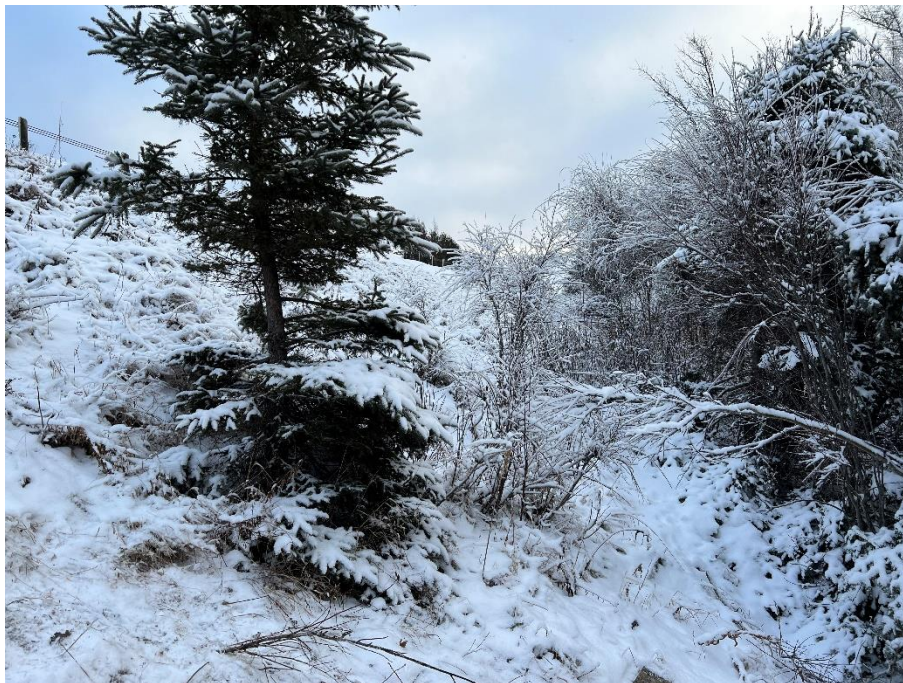
Photo 5: Looking east at the eastbound embankment (*taken on January 3, 2024*)

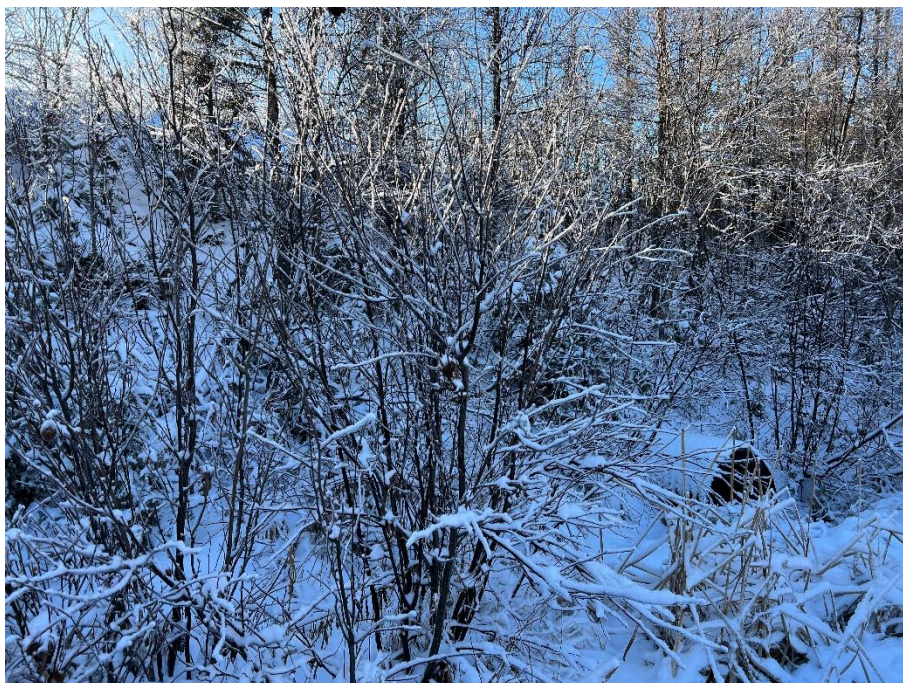
Photo 6: Looking west at the westbound embankment (*taken on January 3, 2024*)
