**HIGHWAY 72 NON-STRUCTURAL HIGH FILL CULVERT AT STATION 12+270  
LAVAL TOWNSHIP, ONTARIO  
AGREEMENT # 6022-E-0038, ASSIGNMENT # 7  
GEOCRES NO. 52F16-009**

This technical memorandum focuses on a slope stability analysis for the proposed temporary detour embankment staging including temporary cut slopes and embankment widening.

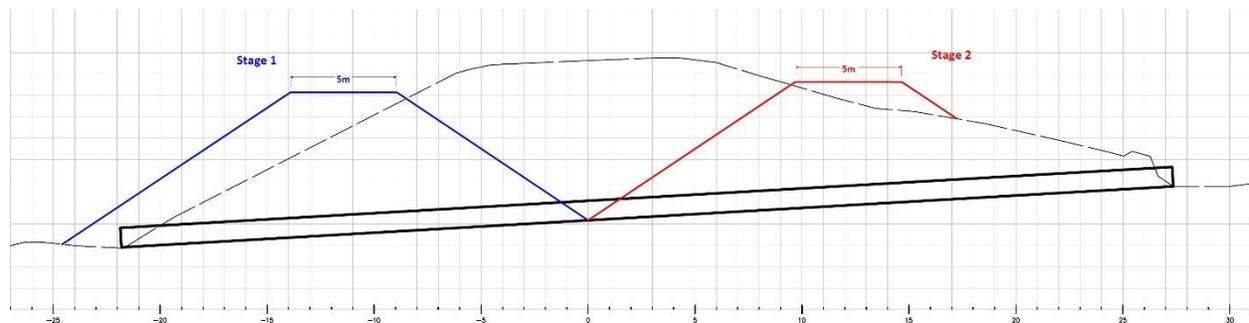
**Figure 3.1: Culvert construction staging sequence at Station 12+270 (provided by MTO).**

- **Stage 1:** Construct temporary embankment widening to the west of the existing highway alignment to facilitate one lane of traffic flow (i.e., platform width of 5 m) around the excavation for the construction of the new culvert east of the centreline. The temporary embankment will have a temporary cut slope at 2H:1V to the east (inside) and a widened slope to the west (outside) at 1.25H:1V or flatter. The temporary embankment will be widened to the west using OPSS Granular B Type II or rock fill. The maximum height of the new fill is on the order of 3 m.

- **Stage 2:** Construct temporary embankment to the east of the existing highway alignment to facilitate one lane of traffic flow (i.e., platform width of 5 m) around the excavation for the construction of the new culvert west of the centreline. The temporary embankment will have 1.25H:1V or flatter side slopes to the east (outside) and west (inside). The temporary embankment will be constructed using OPSS Granular B Type II or rock fill. The height of the temporary embankment is approximately 6 m.

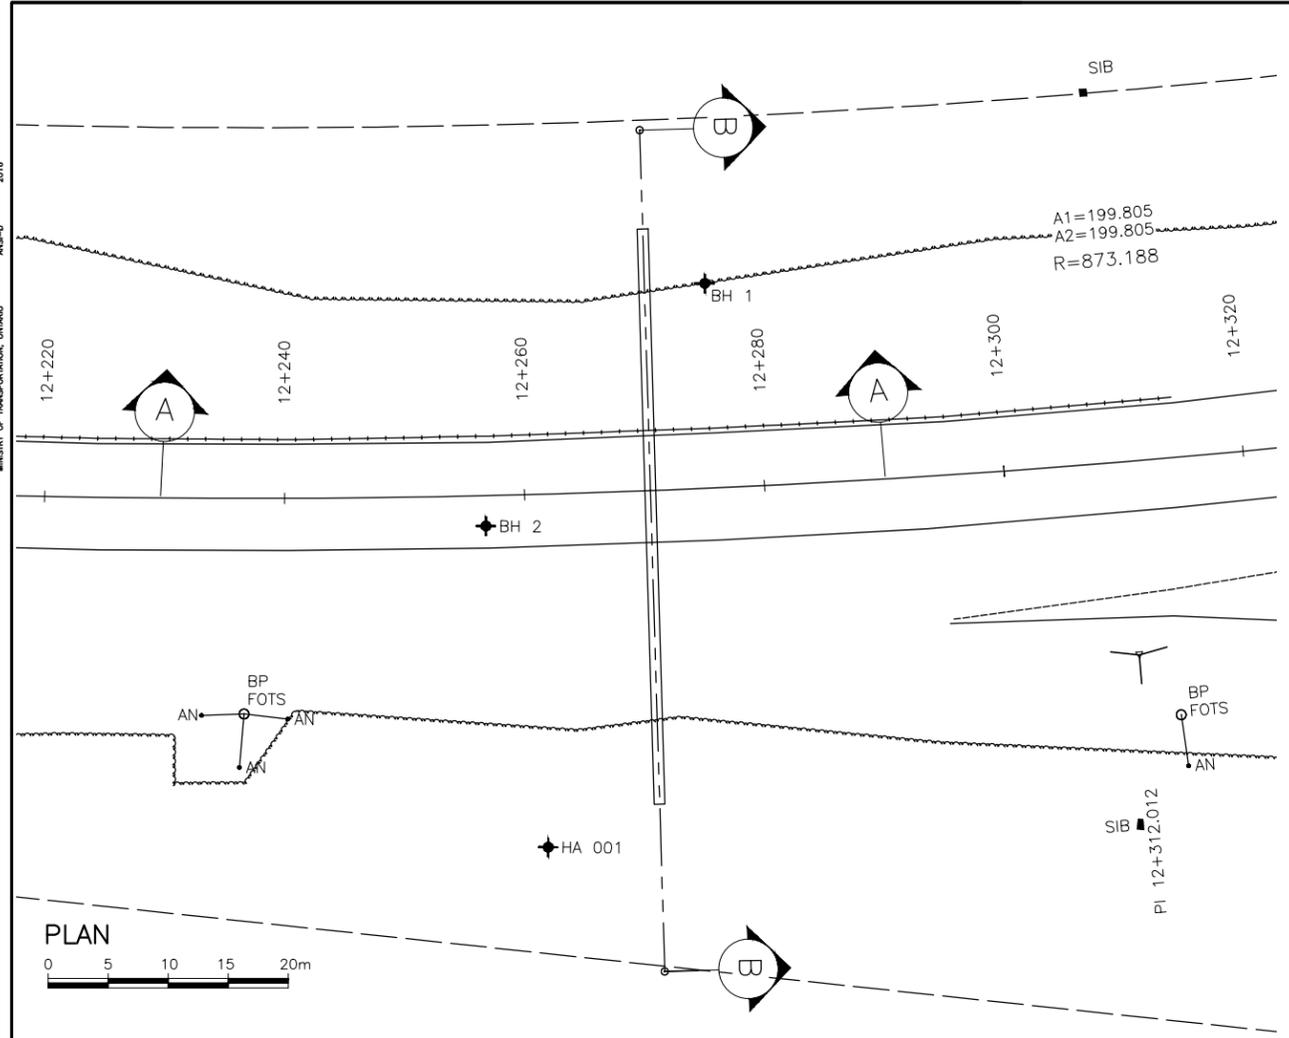
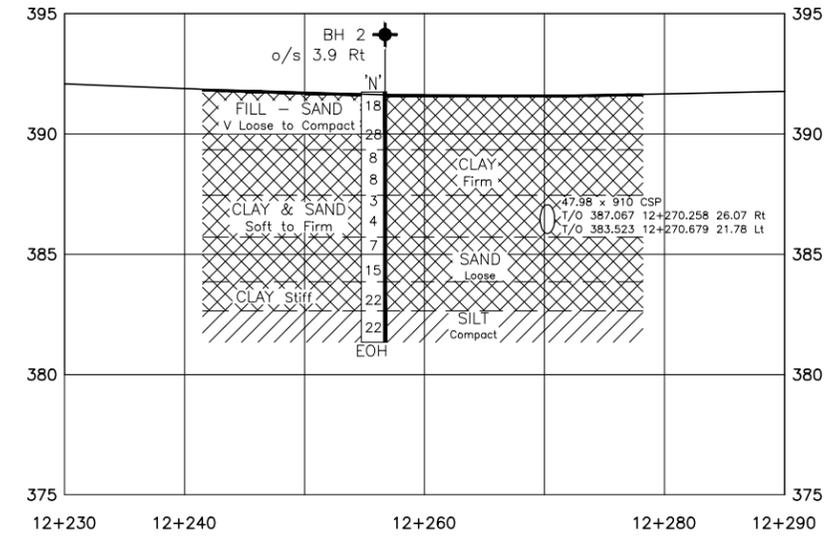
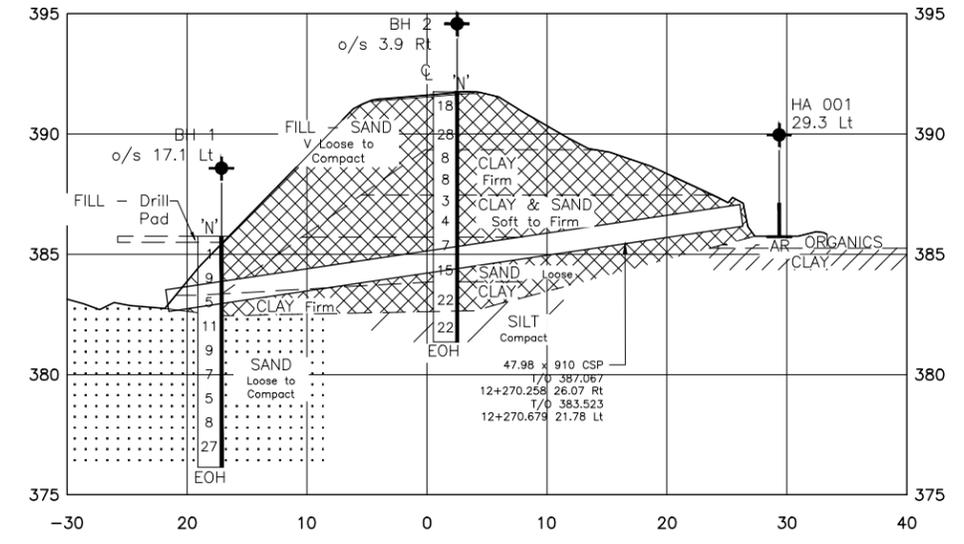
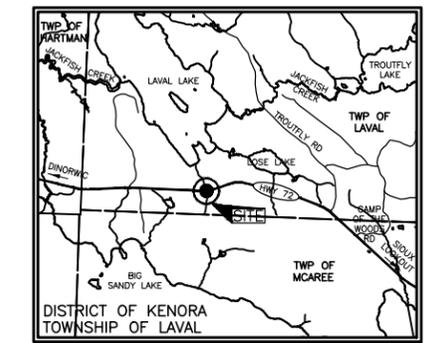
SOIL STRATA  
STA 12+270 CULVERT 20  
HIGHWAY 72 TOWNSHIP OF LAVAL

NOTE  
The boundaries between soil strata have been established only at Borehole locations. Between Boreholes the boundaries are assumed from geological evidence.

The subsurface conditions encountered in Boreholes BH 1 and BH 2 advanced by TBTE generally consisted of embankment fill material comprising very loose to compact sand, soft to firm clay and sand, and stiff clay overlying native loose to compact sand and compact silt. Both boreholes were noted to be dry upon completion and no monitoring wells or standpipe piezometers were installed.

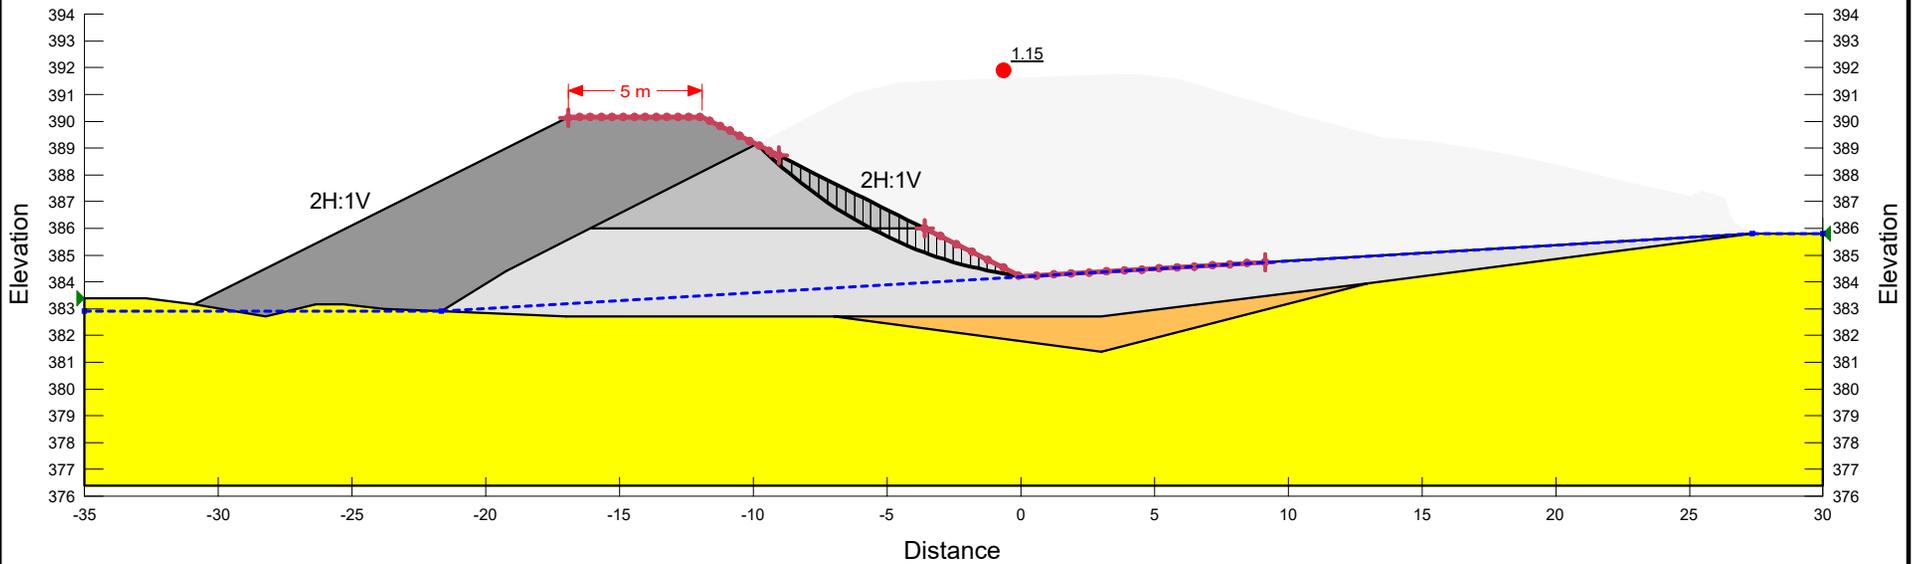
**Figure 1**

Color	Name	Unit Weight (kN/m <sup>3</sup> )	Effective Cohesion (kPa)	Effective Friction Angle (°)
Light Gray	Existing Fill - Lower	19	0	28
Medium Gray	Existing Fill - Upper	20.5	0	30
Dark Gray	OPSS Gran. B Type II	22	0	35
Yellow	Sand	21	0	30
Orange	Silt	20	0	33

Project		Hwy 72 Non-Structural High Fill Culvert (Laval)	
Analysis		Stage 1 East Side Temp. Cut Slope at 2H:1V with Gran. B Type II (Drained)	
Seismic Coefficient	Last Run	Scale	
H: 0g, V: 0g	2024-03-08, 04:17:55 PM	1:281

Additional Details	
Name: Stage 1 East Side Temp. Cut Slope at 2H:1V with Gran. B Type II	
Comments: Sta. 12+270	
Method: Morgenstern-Price, Half-Sine	
Min. Drainage Surface Depth: 1 m	
Entry: (-9.7834195, 389.08941) m, Exit: (-0.016876289, 384.20843) m	
Center: (2.2929966, 401.04198) m, Radius: 16.991289 m

For the Stage 1 temporary embankment to the west, the factor of safety is less than 1.3 for a temporary cut slope at 2H:1V (Figures 1 and 3). A factor of safety of greater than 1.3 is achieved for embankment widening with Granular B Type II at 2H:1V (Figure 2).

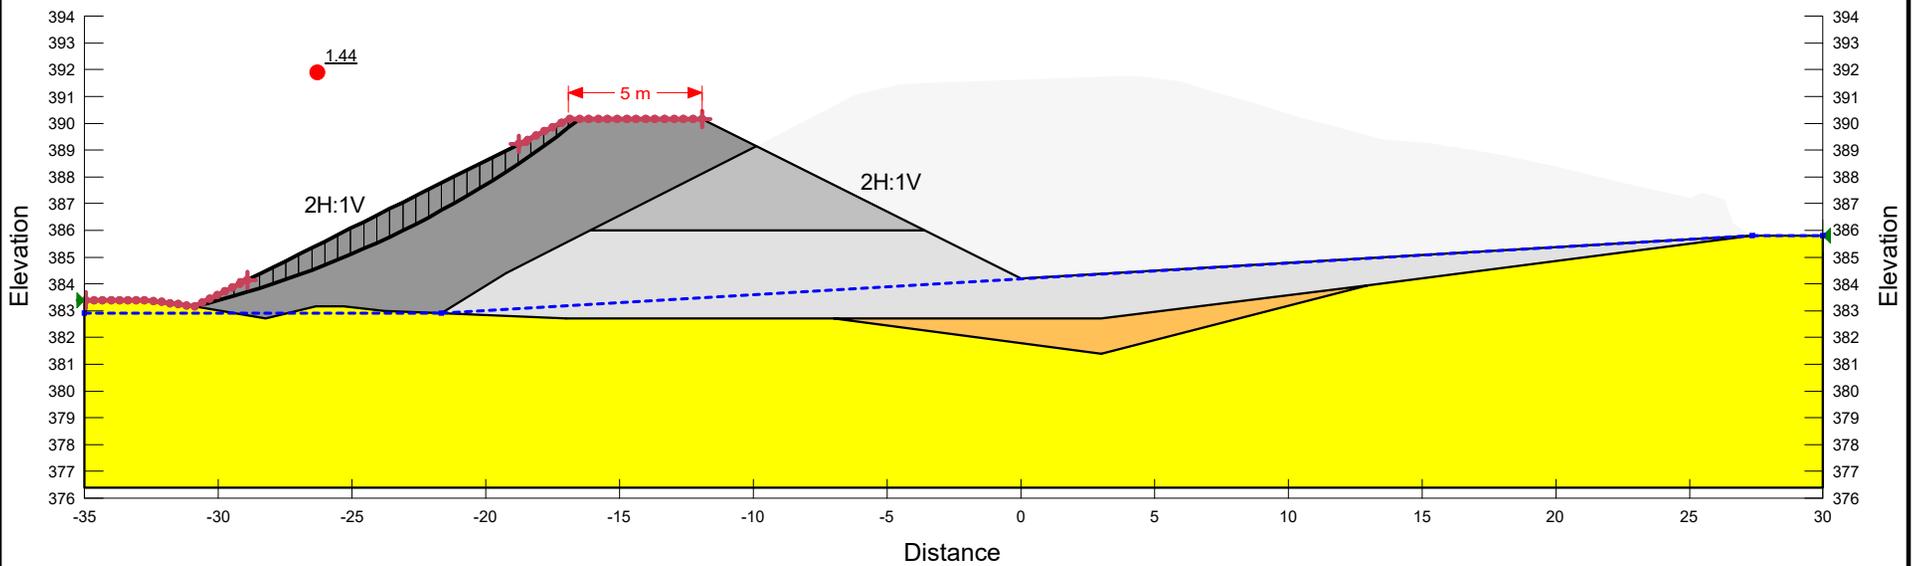
**Figure 2**

Color	Name	Unit Weight (kN/m <sup>3</sup> )	Effective Cohesion (kPa)	Effective Friction Angle (°)
Light Gray	Existing Fill - Lower	19	0	28
Medium Gray	Existing Fill - Upper	20.5	0	30
Dark Gray	OPSS Gran. B Type II	22	0	35
Yellow	Sand	21	0	30
Orange	Silt	20	0	33

Project <b>Hwy 72 Non-Structural High Fill Culvert (Laval)</b>	
Analysis <b>Stage 1 West Side Embank. Widening at 2H:1V with Gran. B Type II (Dr. Sinec)</b>	
Seismic Coefficient H: 0g, V: 0g	Last Run 2024-03-08, 04:17:57 PM
Scale 1:281

Additional Details  
 Name: Stage 1 West Side Embank. Widening at 2H:1V with Gran. B Type II  
 Comments: Sta. 12+270  
 Method: Morgenstern-Price, Half-Sine  
 Minimum Dr. Sinec Depth: 1 m  
 Entry: (-30.880008, 383.16) m, Exit: (-16.499565, 390.15) m  
 Center: (-39.929916, 420.0656) m, Radius: 37.999008 m

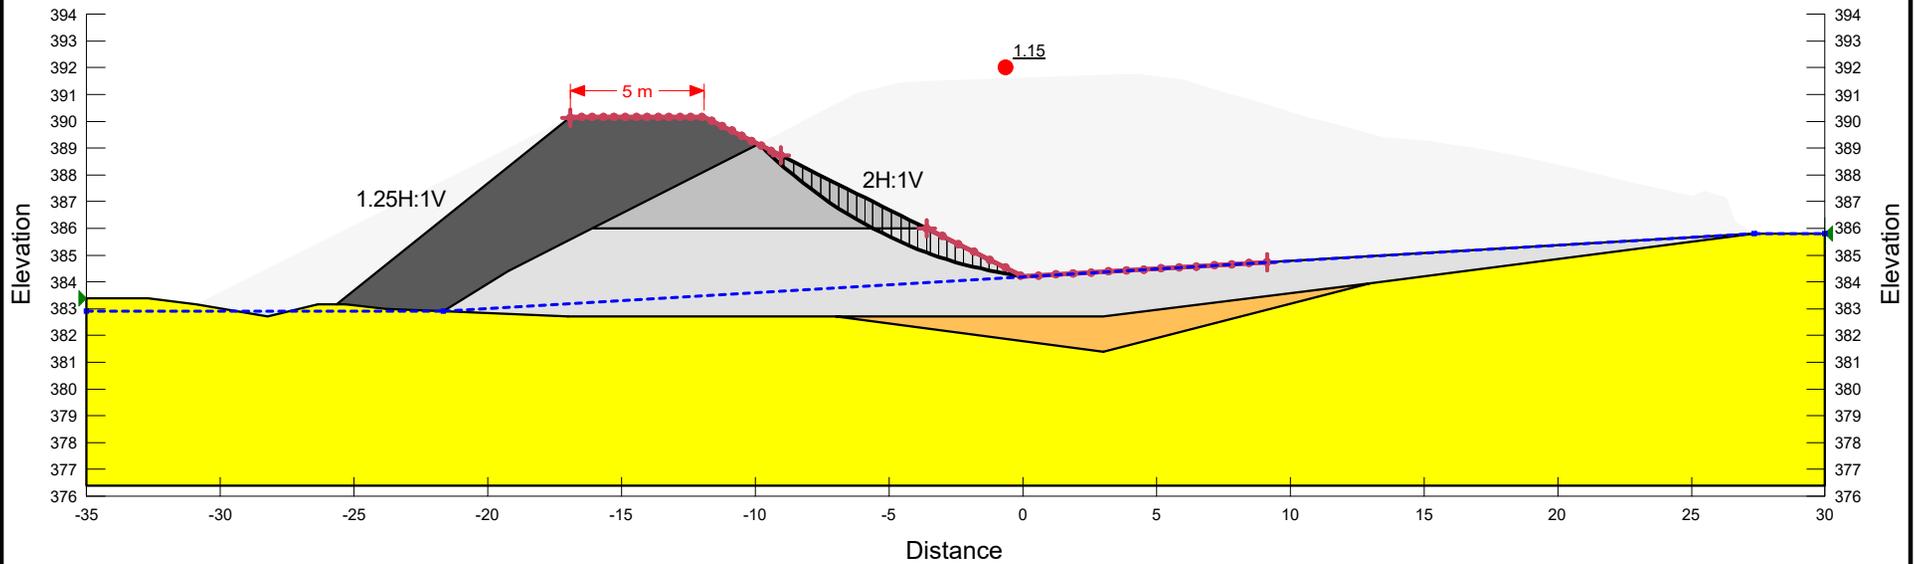
**Figure 3**

Color	Name	Unit Weight (kN/m <sup>3</sup> )	Effective Cohesion (kPa)	Effective Friction Angle (°)
Light Gray	Existing Fill - Lower	19	0	28
Medium Gray	Existing Fill - Upper	20.5	0	30
Dark Gray	Rock Fill	19	0	42
Yellow	Sand	21	0	30
Orange	Silt	20	0	33

Project <b>Hwy 72 Non-Structural High Fill Culvert (Laval)</b>	
Analysis <b>Stage 1 East Side Temp. Cut Slope at 2H:1V with Rock Fill (Drained)</b>	
Seismic Coefficient H: 0g, V: 0g	Last Run 2024-03-08, 04:18:00 PM
Scale 1:281

Additional Details Name: Stage 1 East Side Temp. Cut Slope at 2H:1V with Rock Fill Comments: Sta. 12+270 Method: Morgenstern-Price, Half-Sine Slip Surface Depth: 1 m Entry: (-9.7833958, 389.0894) m, Exit: (-0.016874459, 384.20843) m Center: (2.2929967, 401.04195) m, Radius: 16.991258 m
--

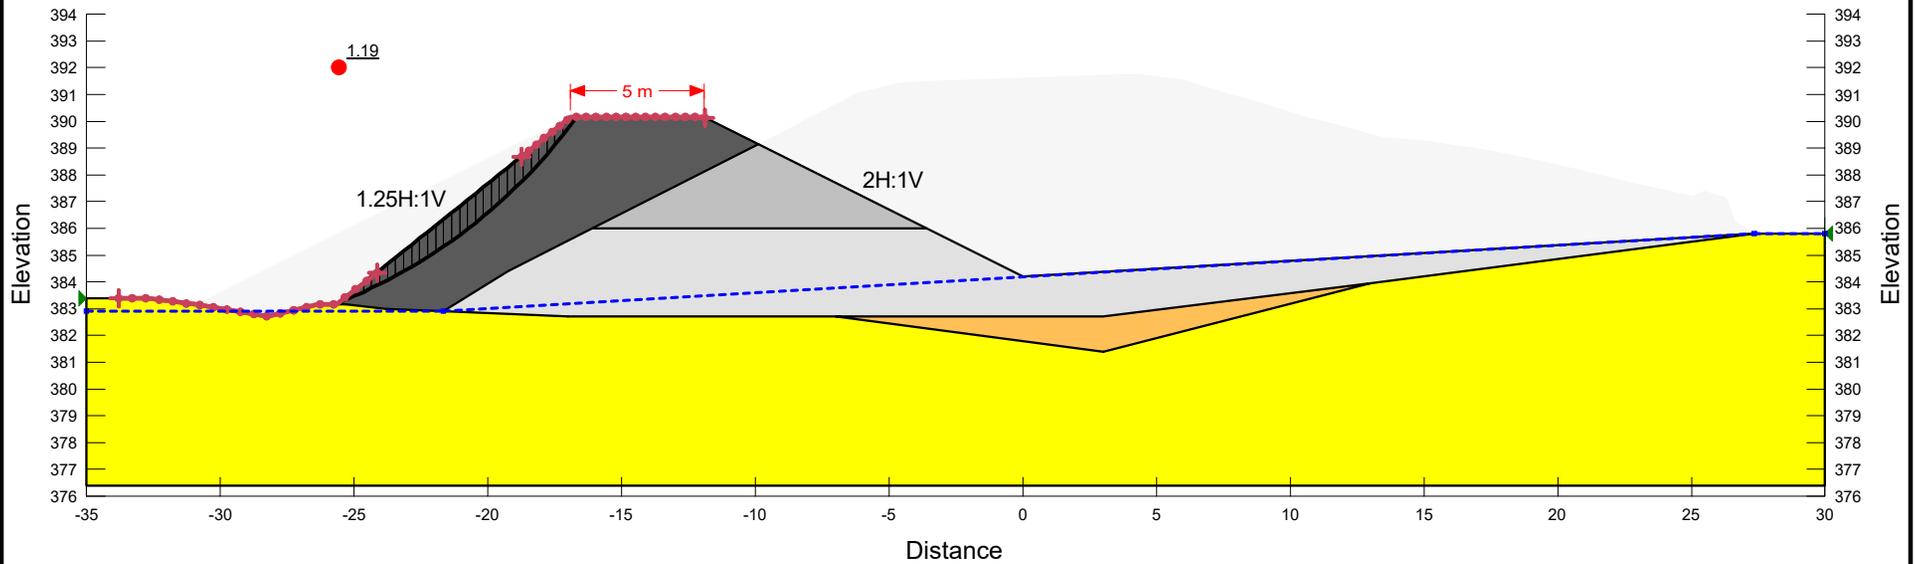
**Figure 4**

Color	Name	Unit Weight (kN/m <sup>3</sup> )	Effective Cohesion (kPa)	Effective Friction Angle (°)
Light Gray	Existing Fill - Lower	19	0	28
Medium Gray	Existing Fill - Upper	20.5	0	30
Dark Gray	Rock Fill	19	0	42
Yellow	Sand	21	0	30
Orange	Silt	20	0	33

Project <b>Hwy 72 Non-Structural High Fill Culvert (Laval)</b>	
Analysis <b>Stage 1 West Side Embank. Widening at 1.25H:1V with Rock Fill (Drained)</b>	
Seismic Coefficient H: Og, V: Og	Last Run 2024-03-08, 04:18:02 PM
Scale 1:281

Additional Details Name: Stage 1 West Side Embank. Widening at 1.25H:1V with Rock Fill Comments: Sta. 12+270 Method: Morgenstern-Price, Half-Sine Mill Surface Depth: 1 m Entry: (-25.543228, 383.23542) m, Exit: (-16.682789, 390.15) m Center: (-33.246741, 402.24104) m, Radius: 20.507504 m
---

Location	Cut or Fill	Side	Side Slope	Embank. Fill	Condition	Factor of Safety	Figure
Stage 1 West Temp. Embank.	Cut	East	2H:1V	Gran. B Type II	Drained	1.15	1
	Fill	West			Drained	1.44	2
	Cut	East	2H:1V	Rock Fill	Drained	1.15	3
	Fill	West	1.25H:1V		Drained	1.19	4
Stage 2 East Temp. Embank.	Fill	East	2H:1V	Gran. B Type II	Drained	1.48	5
		West			Drained	1.43	6
		East	1.25H:1V	Rock Fill	Drained	1.23	7
		West			Drained	1.20	8

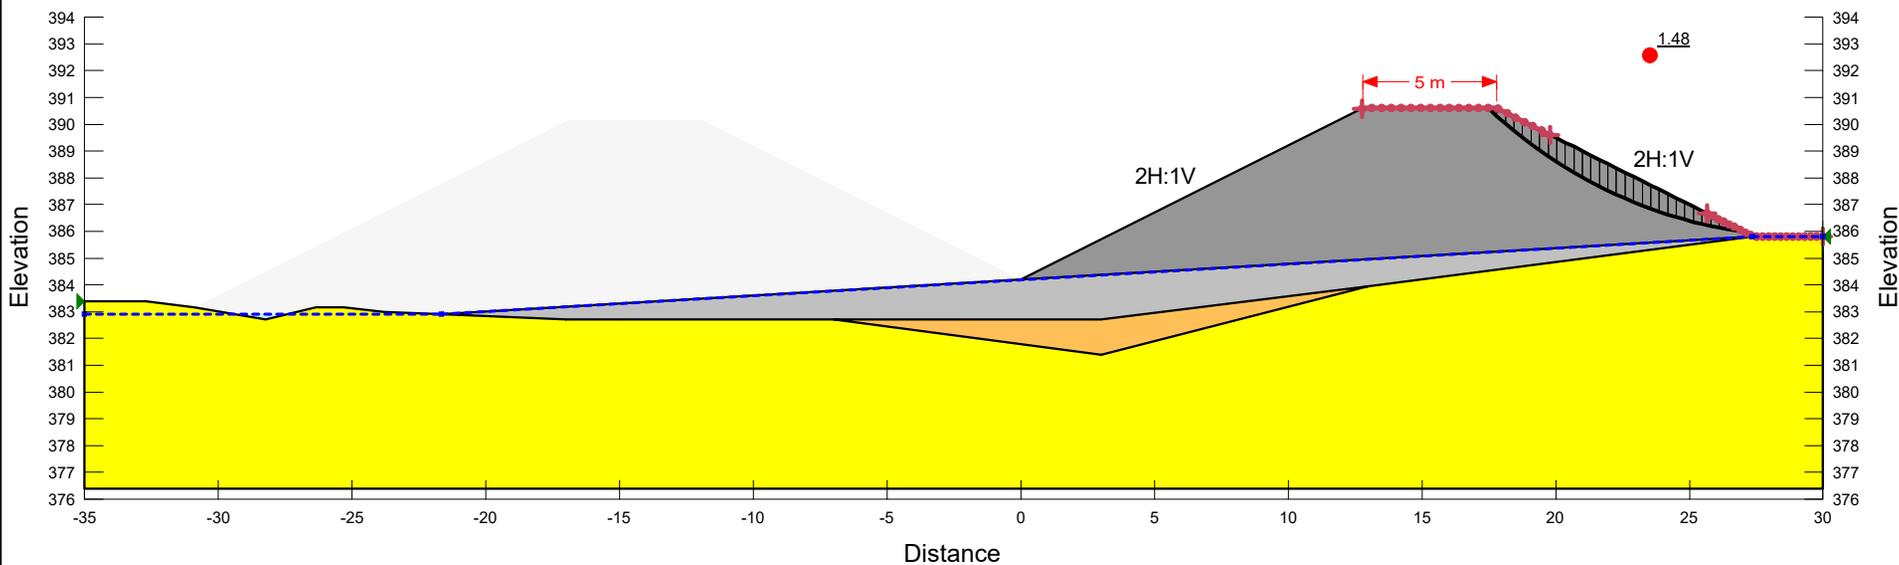
**Figure 5**

Color	Name	Unit Weight (kN/m <sup>3</sup> )	Effective Cohesion (kPa)	Effective Friction Angle (°)
Light Gray	Existing Fill - Upper	20.5	0	30
Dark Gray	OPSS Gran. B Type II	22	0	35
Yellow	Sand	21	0	30
Orange	Silt	20	0	33

Project		Hwy 72 Non-Structural High Fill Culvert (Laval)	
Analysis		Stage 2 East Side New Embank. at 2H:1V with Gran. B Type II (Drained)	
Seismic Coefficient	Last Run	Scale	
H: 0g, V: 0g	2024-03-08, 04:18:07 PM	1:281

Additional Details  
 Name: Stage 2 East Side New Embank. at 2H:1V with Gran. B Type II  
 Comments: Sta. 12+270  
 Method: Morgenstern-Price, Half-Sine  
 Min. Drainage Surface Depth: 1 m  
 Entry: (17.490117, 390.6) m, Exit: (27.06445, 385.96778) m  
 Center: (29.525633, 403.26548) m, Radius: 17.471924 m

For the Stage 2 temporary embankment to the east, embankment construction with Granular B Type II at 2H:1V achieves a factor of safety of greater than 1.3 (Figures 5 and 6).

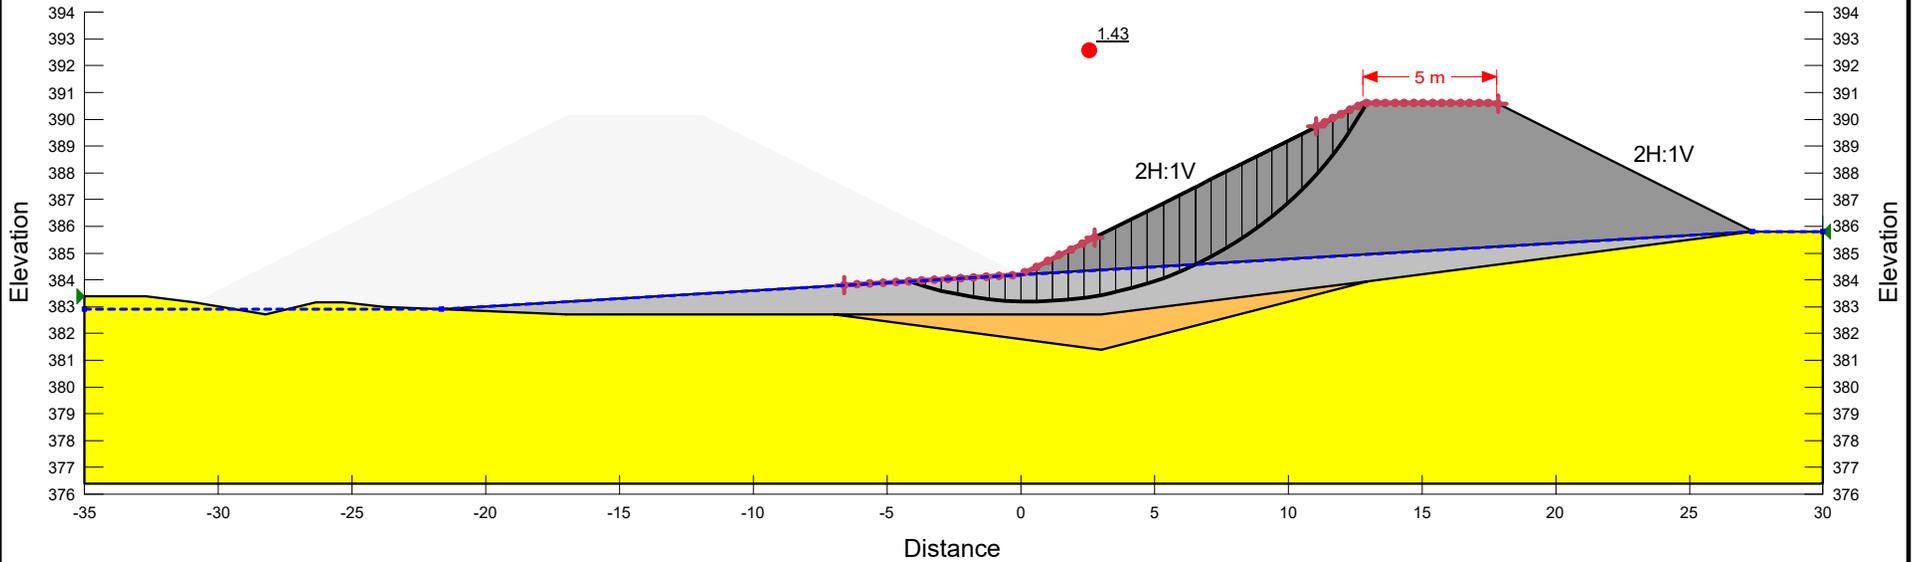
**Figure 6**

Color	Name	Unit Weight (kN/m <sup>3</sup> )	Effective Cohesion (kPa)	Effective Friction Angle (°)
Light Gray	Existing Fill - Upper	20.5	0	30
Dark Gray	OPSS Gran. B Type II	22	0	35
Yellow	Sand	21	0	30
Orange	Silt	20	0	33

Project		Hwy 72 Non-Structural High Fill Culvert (Laval)	
Analysis		Stage 2 West Side New Embank. at 2H:1V with Gran. B Type II (Drained)	
Seismic Coefficient	Last Run	Scale	
H: 0g, V: 0g	2024-03-08, 04:18:05 PM	1:281

Additional Details	
Name: Stage 2 West Side New Embank. at 2H:1V with Gran. B Type II	
Comments: Sta. 12+270	
Method: Morgenstern-Price, Half-Sine	
Minimum Drainage Surface Depth: 1 m	
Entry: (-4.1840228, 383.94877) m, Exit: (12.94255, 390.6) m	
Center: (0.39833786, 397.52505) m, Radius: 14.328768 m

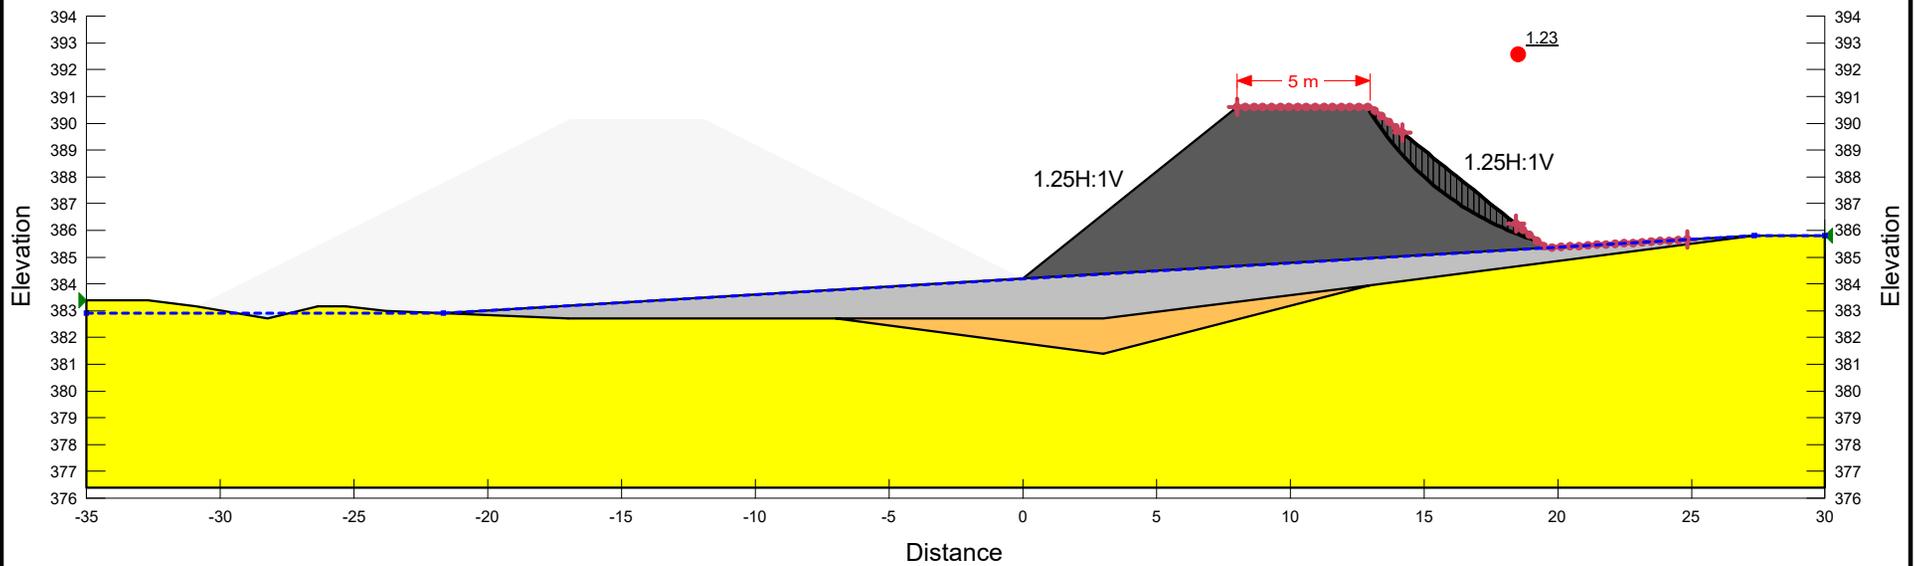
**Figure 7**

Color	Name	Unit Weight (kN/m <sup>3</sup> )	Effective Cohesion (kPa)	Effective Friction Angle (°)
Light Gray	Existing Fill - Upper	20.5	0	30
Dark Gray	Rock Fill	19	0	42
Yellow	Sand	21	0	30
Orange	Silt	20	0	33

Project <b>Hwy 72 Non-Structural High Fill Culvert (Laval)</b>	
Analysis <b>Stage 2 East Side New Embank. at 1.25H:1V with Rock Fill (Drained)</b>	
Seismic Coefficient H: 0g, V: 0g	Last Run 2024-03-08, 04:18:11 PM
Scale 1:281

Additional Details  
 Name: Stage 2 East Side New Embank. at 1.25H:1V with Rock Fill  
 Comments: Sta. 12+270  
 Method: Morgenstern-Price, Half-Sine  
 (Drained) Slip Surface Depth: 1 m  
 Entry: (12.8884, 390.6) m, Exit: (19.208626, 385.61764) m  
 Center: (22.45737, 396.23859) m, Radius: 11.106702 m

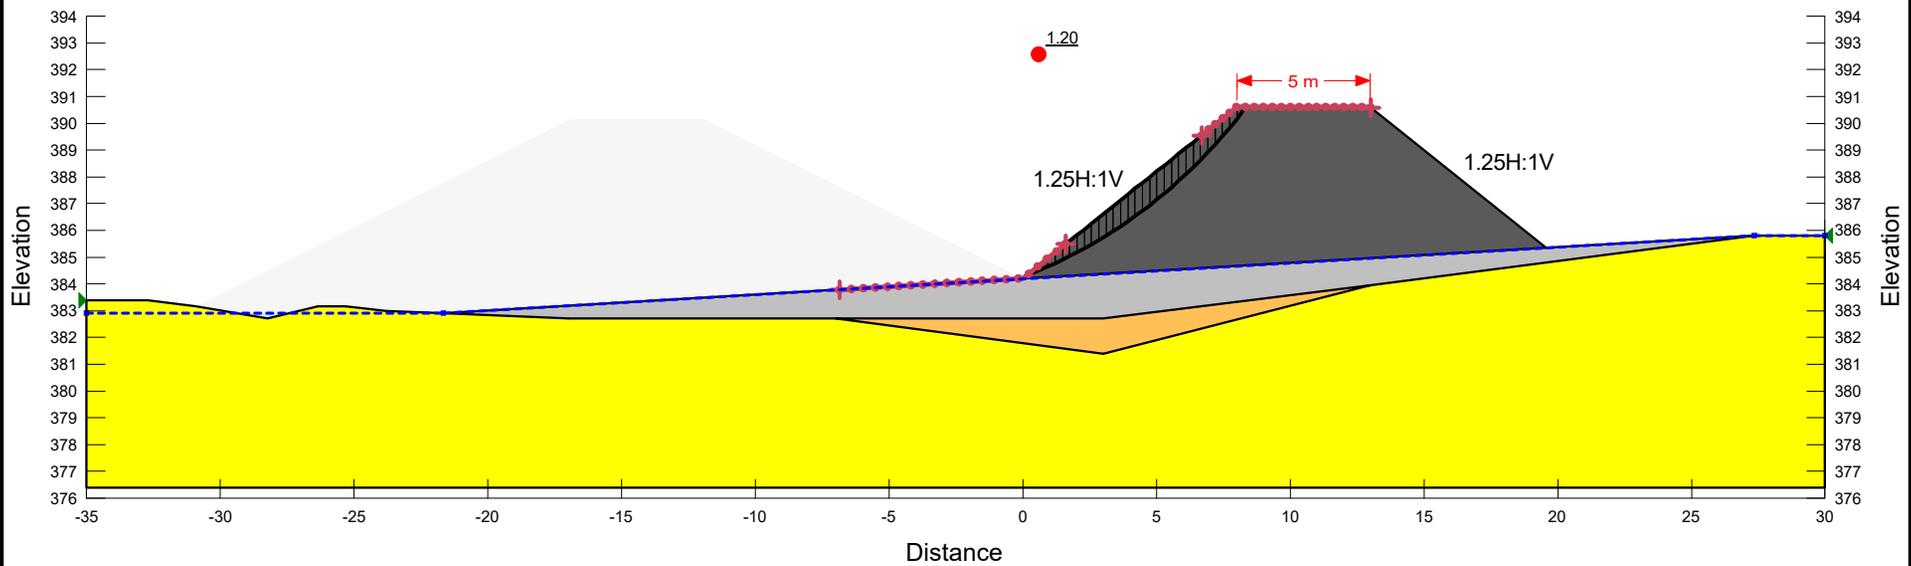
**Figure 8**

Color	Name	Unit Weight (kN/m <sup>3</sup> )	Effective Cohesion (kPa)	Effective Friction Angle (°)
Grey	Existing Fill - Upper	20.5	0	30
Dark Grey	Rock Fill	19	0	42
Yellow	Sand	21	0	30
Orange	Silt	20	0	33

Project <b>Hwy 72 Non-Structural High Fill Culvert (Laval)</b>	Additional Details Name: Stage 2 West Side New Embank. at 1.25H:1V with Rock Fill Comments: Sta. 12+270 Method: Morgenstern-Price, Half-Sine (Drained) Slip Surface Depth: 1 m Entry: (0.12933613, 384.30347) m, Exit: (8.3266803, 390.6) m Center: (-6.7821998, 401.78573) m, Radius: 18.798906 m	
	Analysis <b>Stage 2 West Side New Embank. at 1.25H:1V with Rock Fill</b>	Seismic Coefficient H: 0g, V: 0g	Last Run 2024-03-08, 04:18:10 PM
			Scale 1:281
