### **FOUNDATION INVESTIGATION AND DESIGN REPORT** **Crow River Bridge Replacement, Nort Road, District of Kenora**

**Agreement No. 6014-E-0017**  
**Assignment No. 5**  
**GWP 6322-11-00**  
**Geocres No. 52P-03**

**exp Services Inc.**  
August 28, 2015

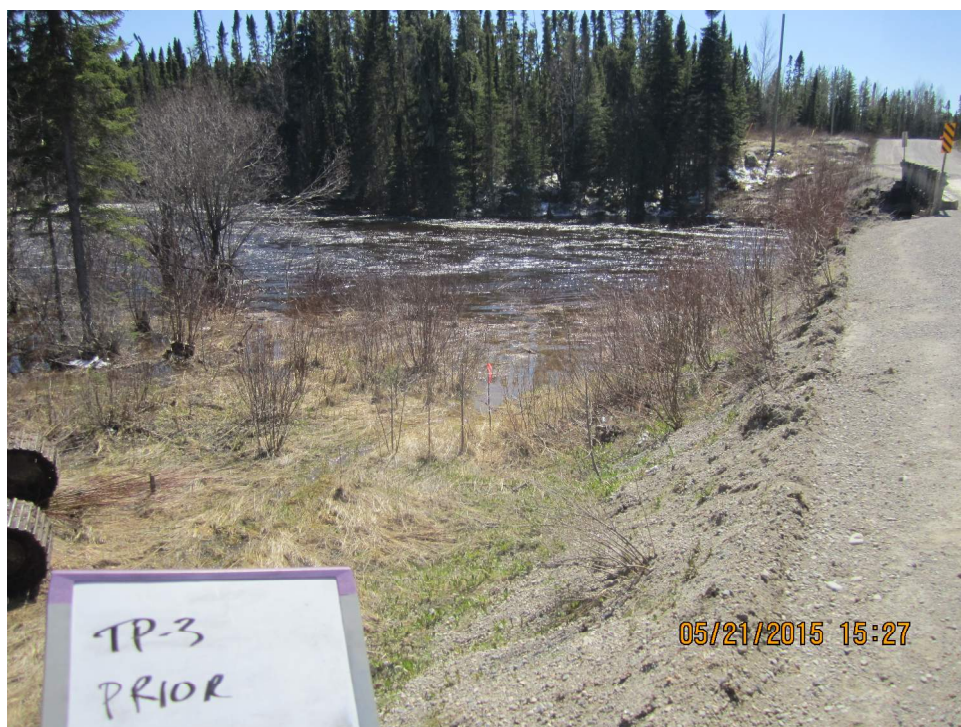
Photo 1. Looking south from the north bank, east of bridge

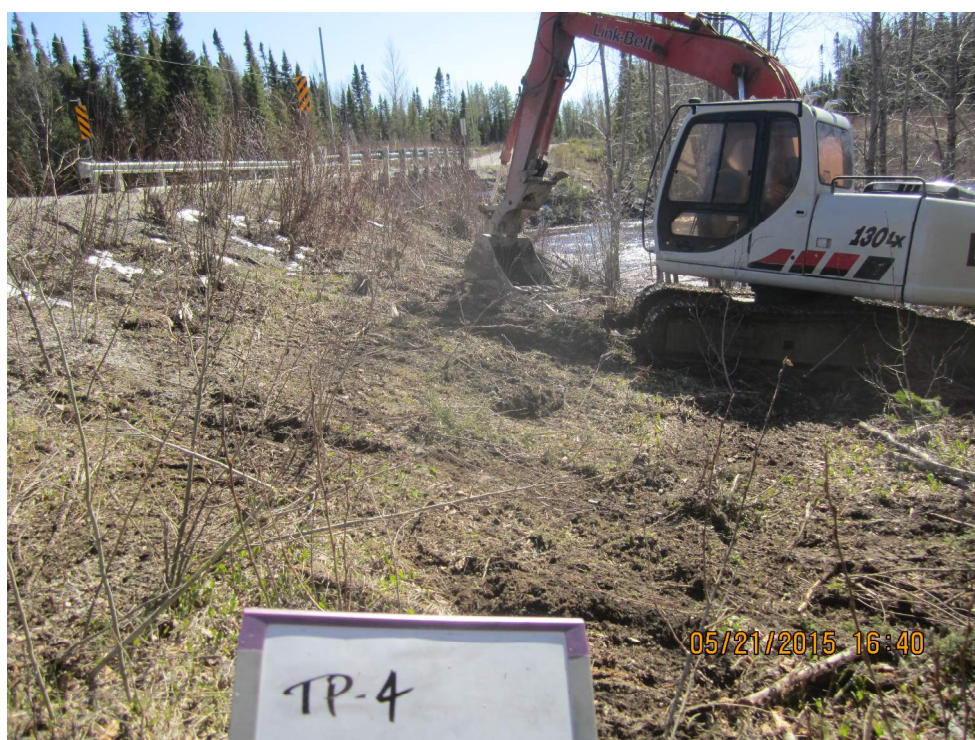
Photo 2. Looking south from the north bank, west of bridge

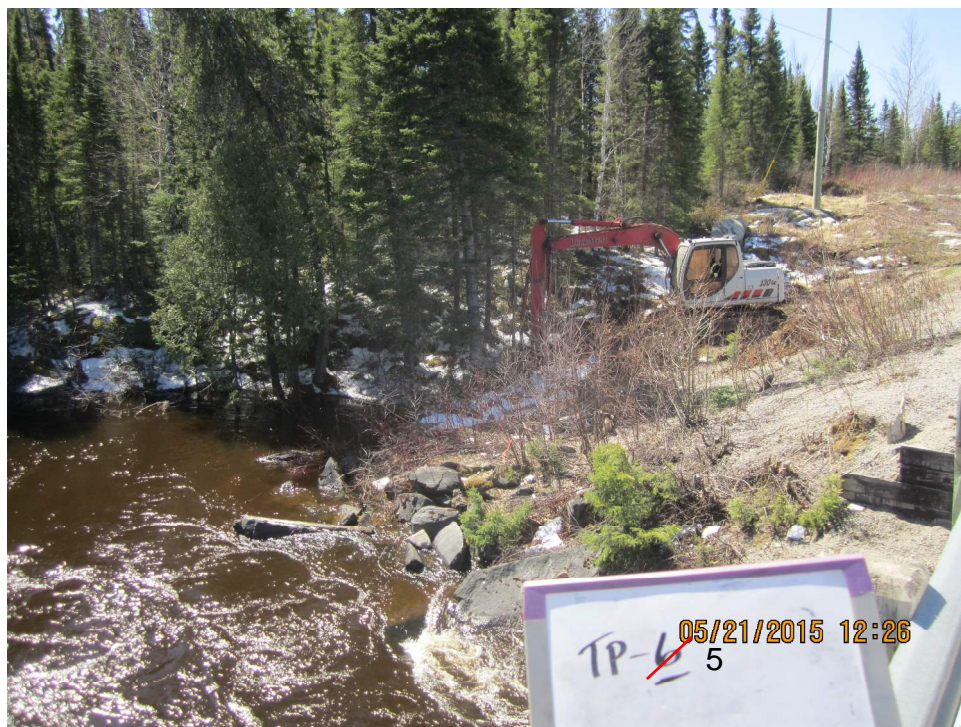
Photo 3. Looking southeast at the south bank, from the bridge deck

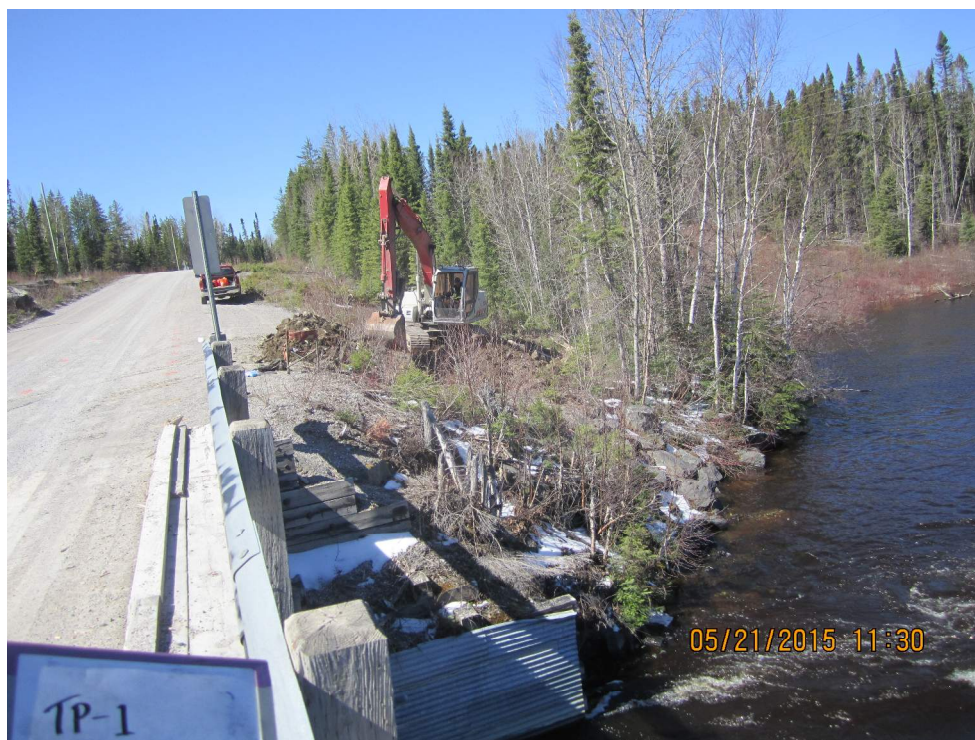
Photo 4. Looking south at the south bank, from the bridge deck

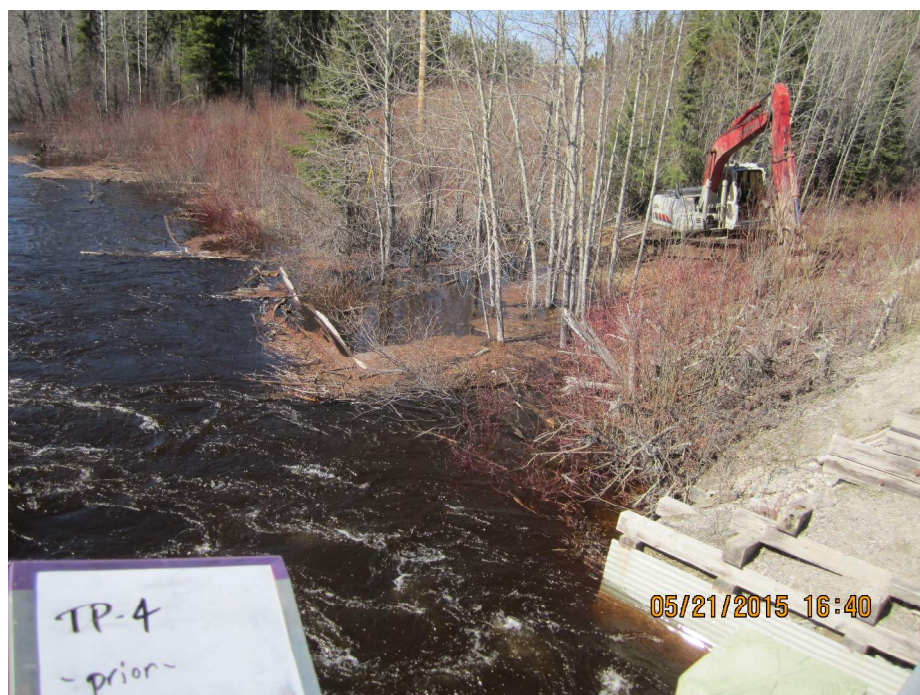
Photo 7. Water level at north shore and west of bridge

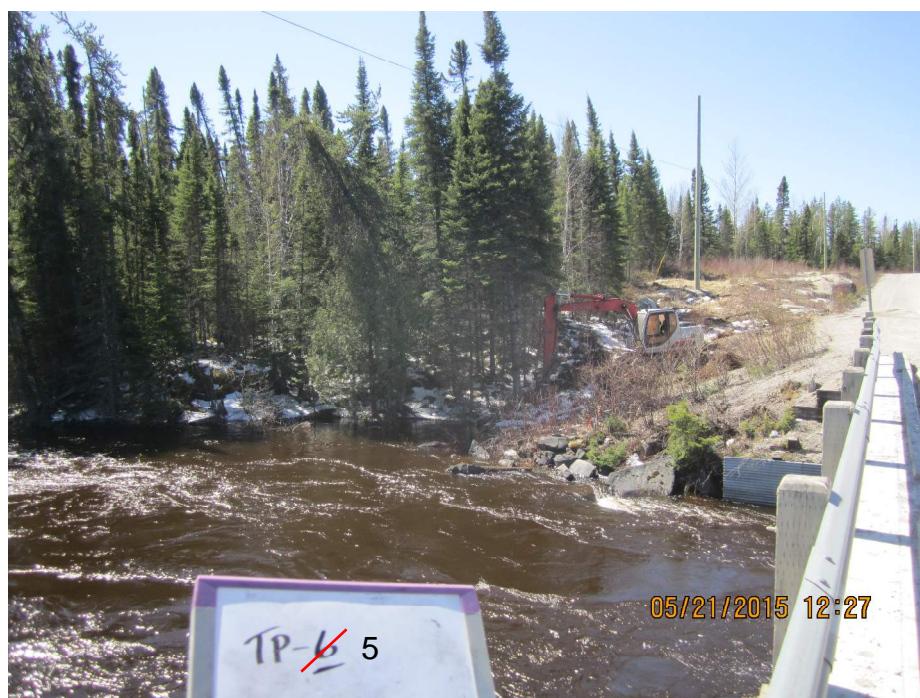
Photo 8. Water level at south shore and east of bridge

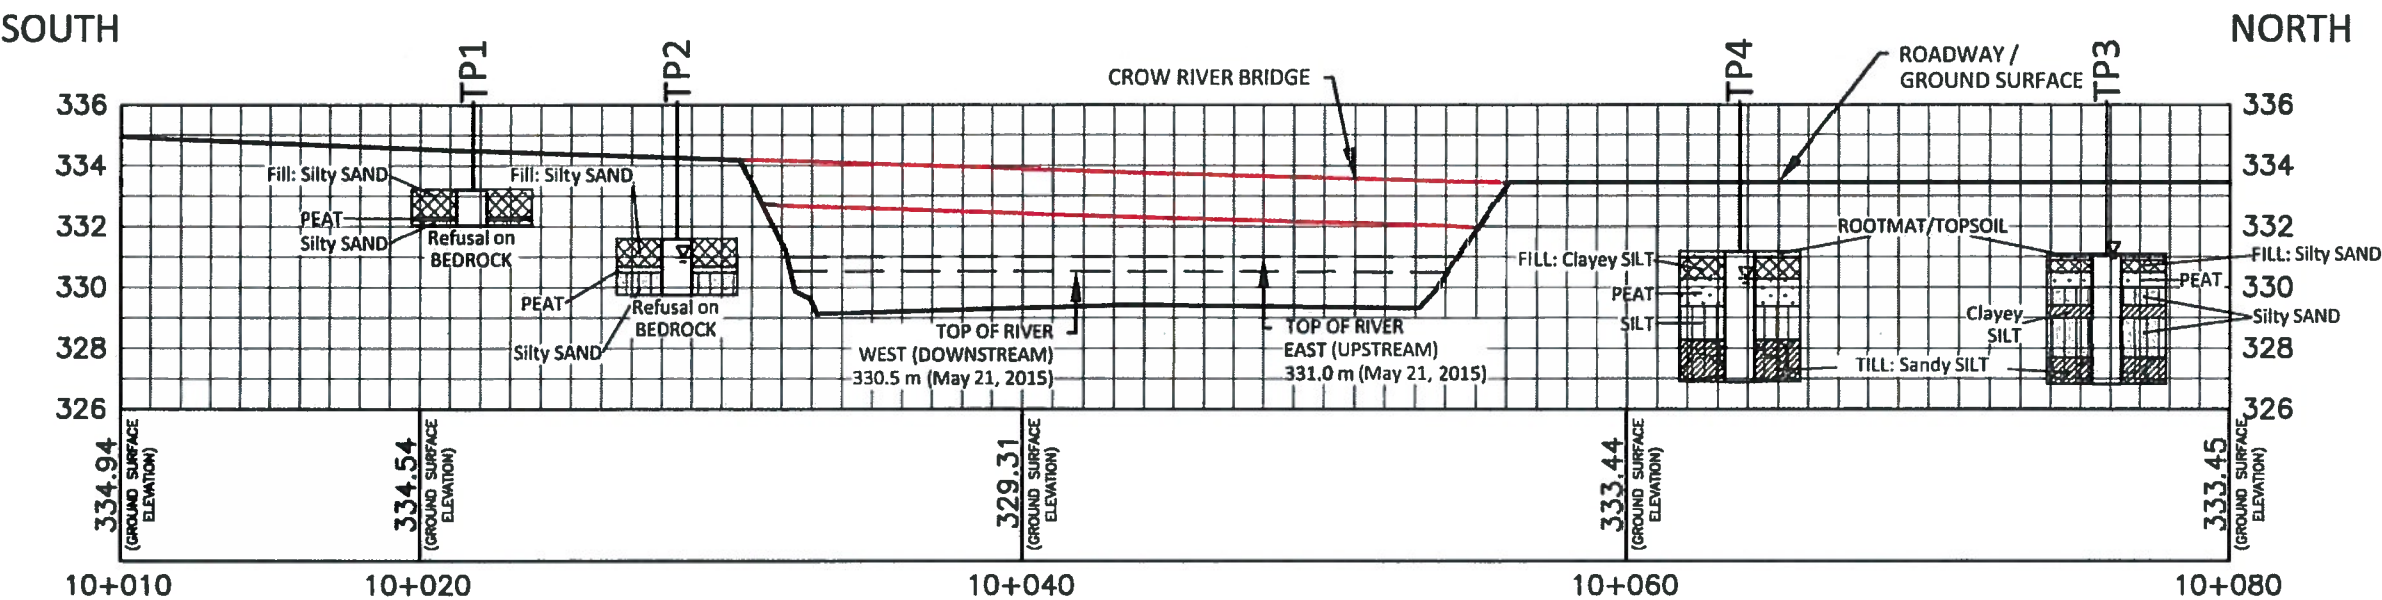
A - A'  
PROFILE OF CROW RIVER BRIDGE  
(EXISTING ALIGNMENT)

A test pit location plan and stratigraphic sections are provided in Appendix B. It should be noted that the stratigraphic boundaries indicated on the test pit log and stratigraphic sections are inferred from observations made within in the test pit and those along the test pit walls. These boundaries typically represent transitions from one soil type to another and should not be interpreted as exact planes of geological change. Furthermore, subsurface conditions may vary between and beyond the test pit locations.

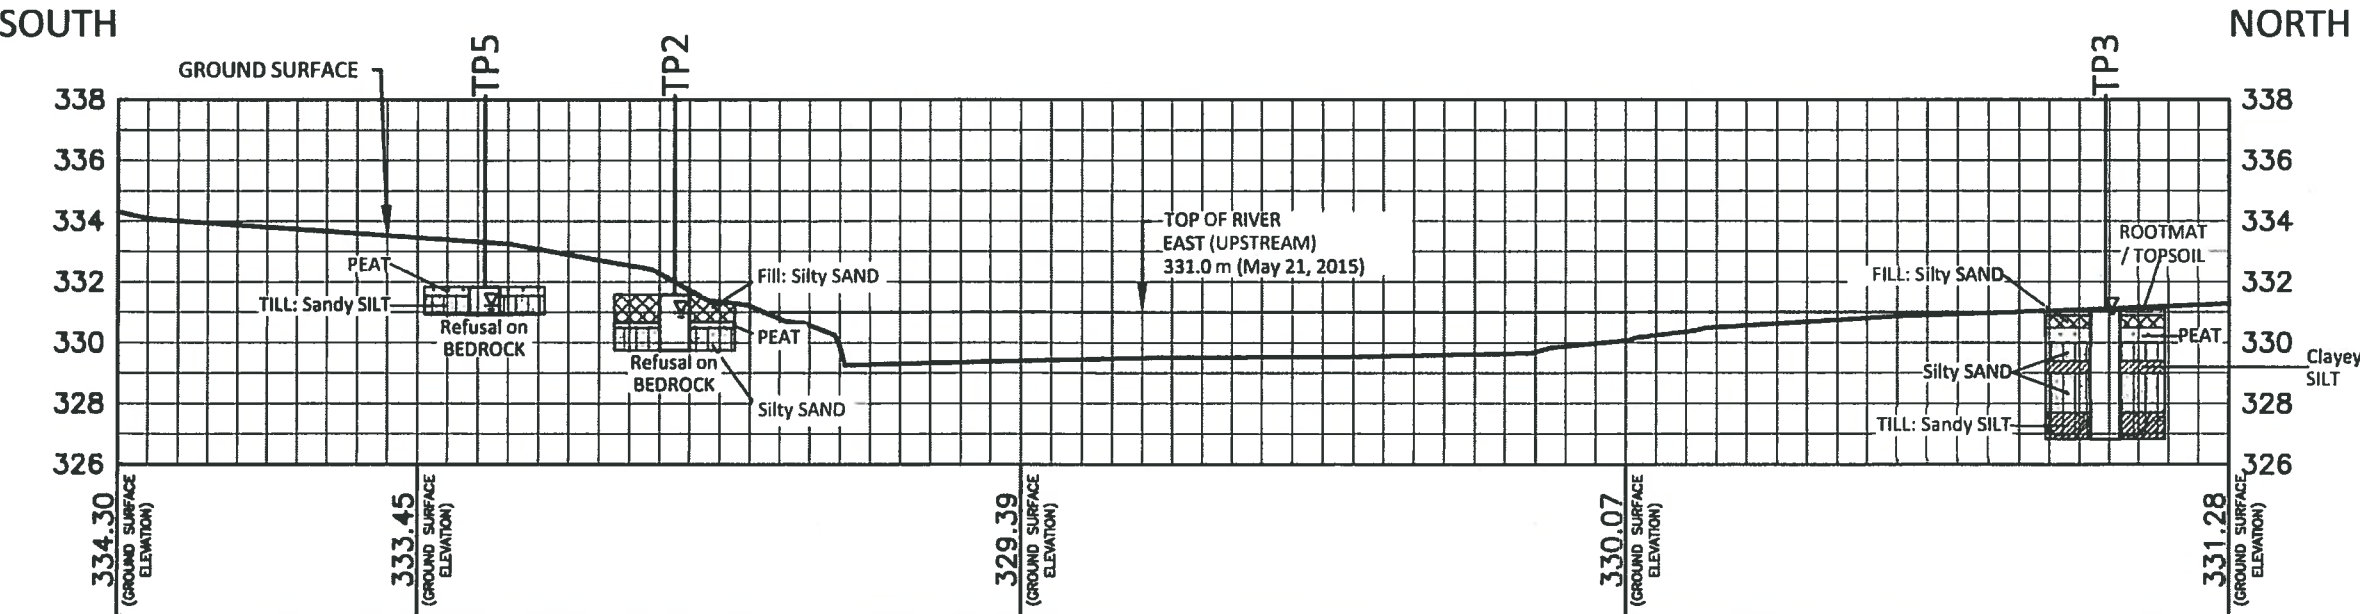
B - B'  
PROFILE OF CROW RIVER BRIDGE  
(PROPOSED TEMPORARY ALIGNMENT)

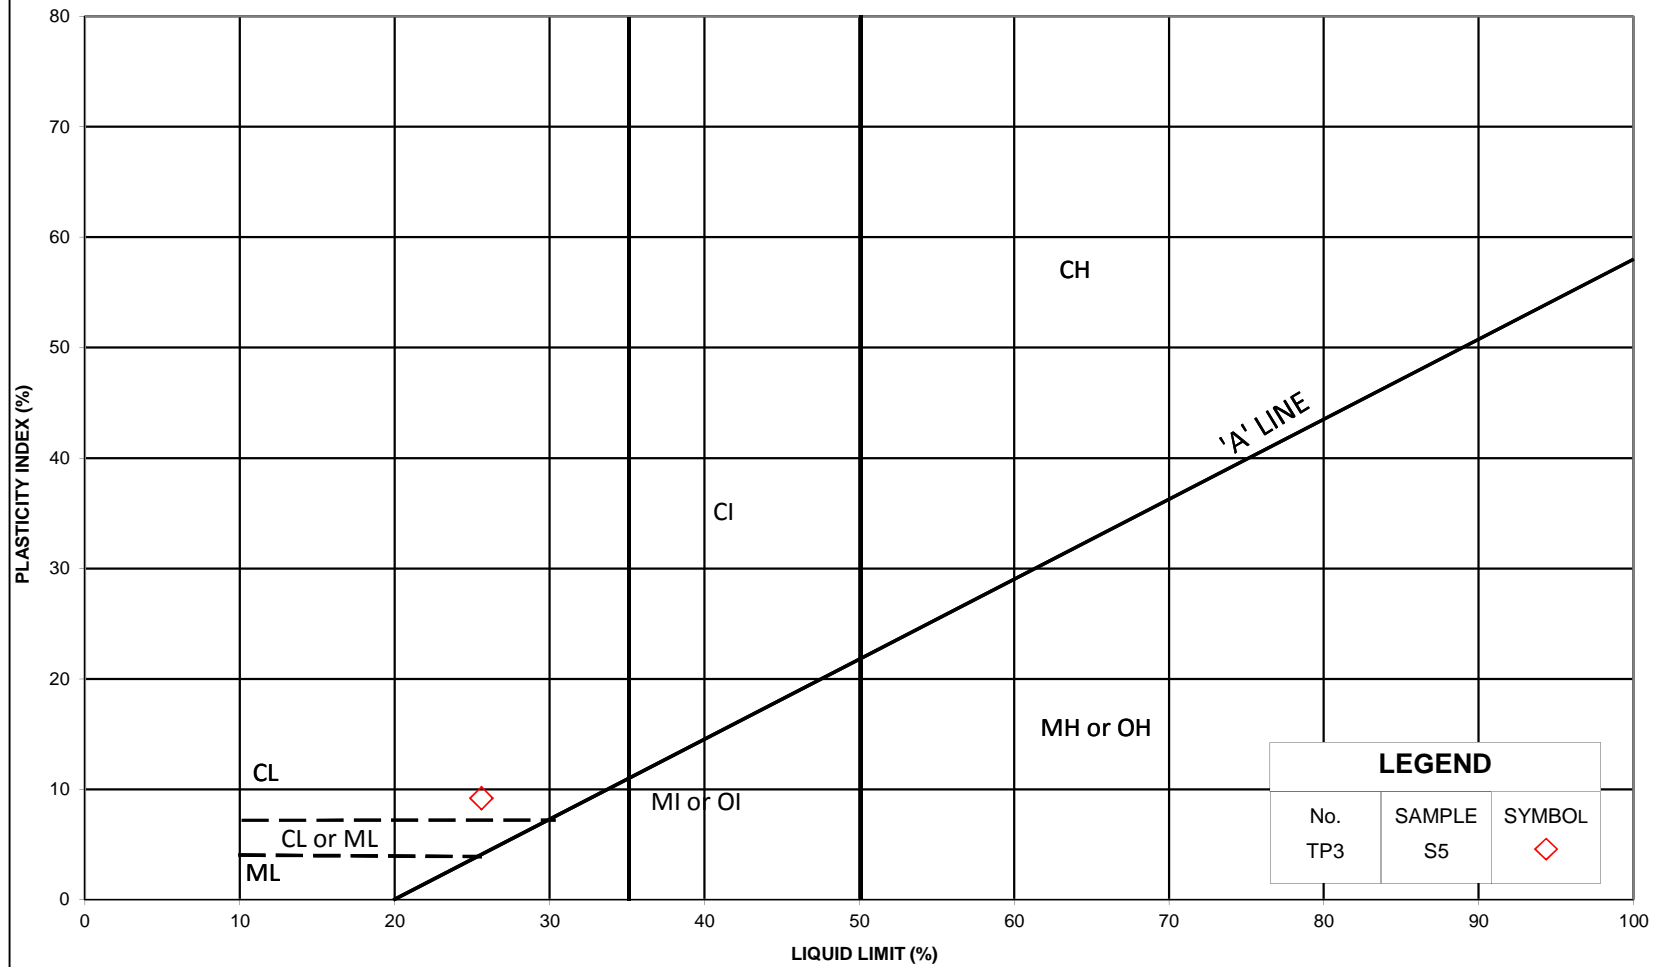
FIGURE No. 5  
 ADM-00223648-D0  
 June 2, 2015

**PLASTICITY CHART**  
**Clayey SILT (CL)**

The results of the moisture content and grain size distribution tests are provided on the record of test pit sheets in Appendix C. The results of the grain size distribution are also provided on Figures 1, 2 and 3 in Appendix D, and the Atterberg Limit results are provided on Figure 5 in Appendix D.

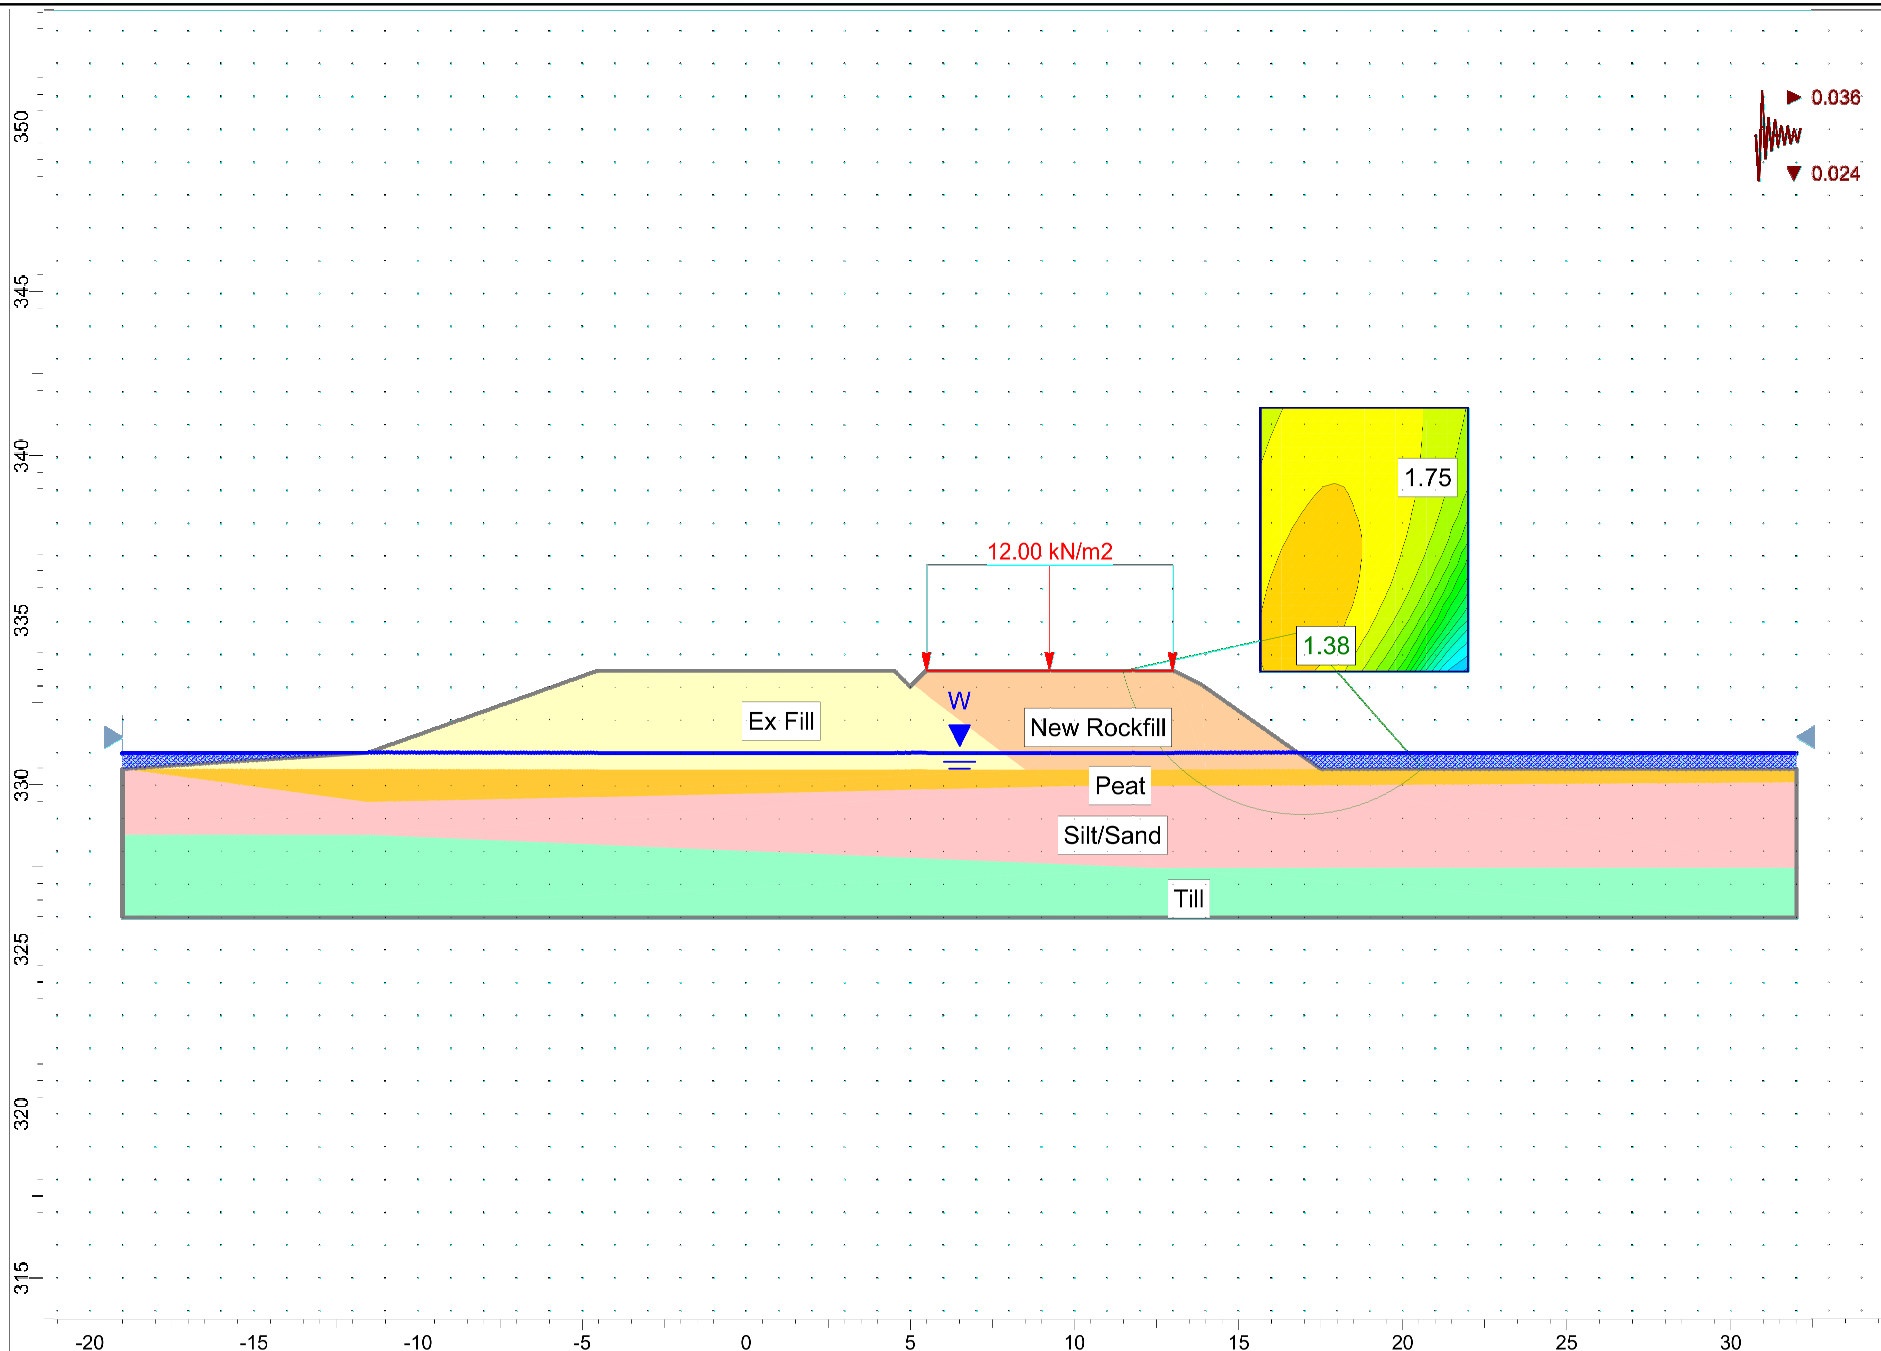
**F6 - TEMPORARY EMBANKMENT - NORTH SIDE  
ROCK FILL AT 1.5:1 SLOPE  
SEISMIC**

Slope	Condition	Minimum Desired Factor of Safety	Calculated Factor of Safety	Figure in Appendix F
Crib on North Side	Static	1.5	1.87	F1
	Seismic	1.3	1.77	F2
Existing North Side Embankment	Static	1.5	1.77	F3
	Seismic	1.3	1.75	F4
North Side Embankment Rockfill @ 1.5:1 slope	Static	1.5	1.47	F5
	Seismic	1.3	1.38	F6
North Side Embankment Granular B @ 2:1 slope	Static	1.5	1.50	F7
	Seismic	1.3	1.39	F8
South Side Embankment Rockfill @ 1.5:1 slope	Static	1.5	1.83	F9
	Seismic	1.3	1.69	F10
South Side Embankment Granular B @ 2:1 slope	Static	1.5	1.58	F11
	Seismic	1.3	1.46	F12

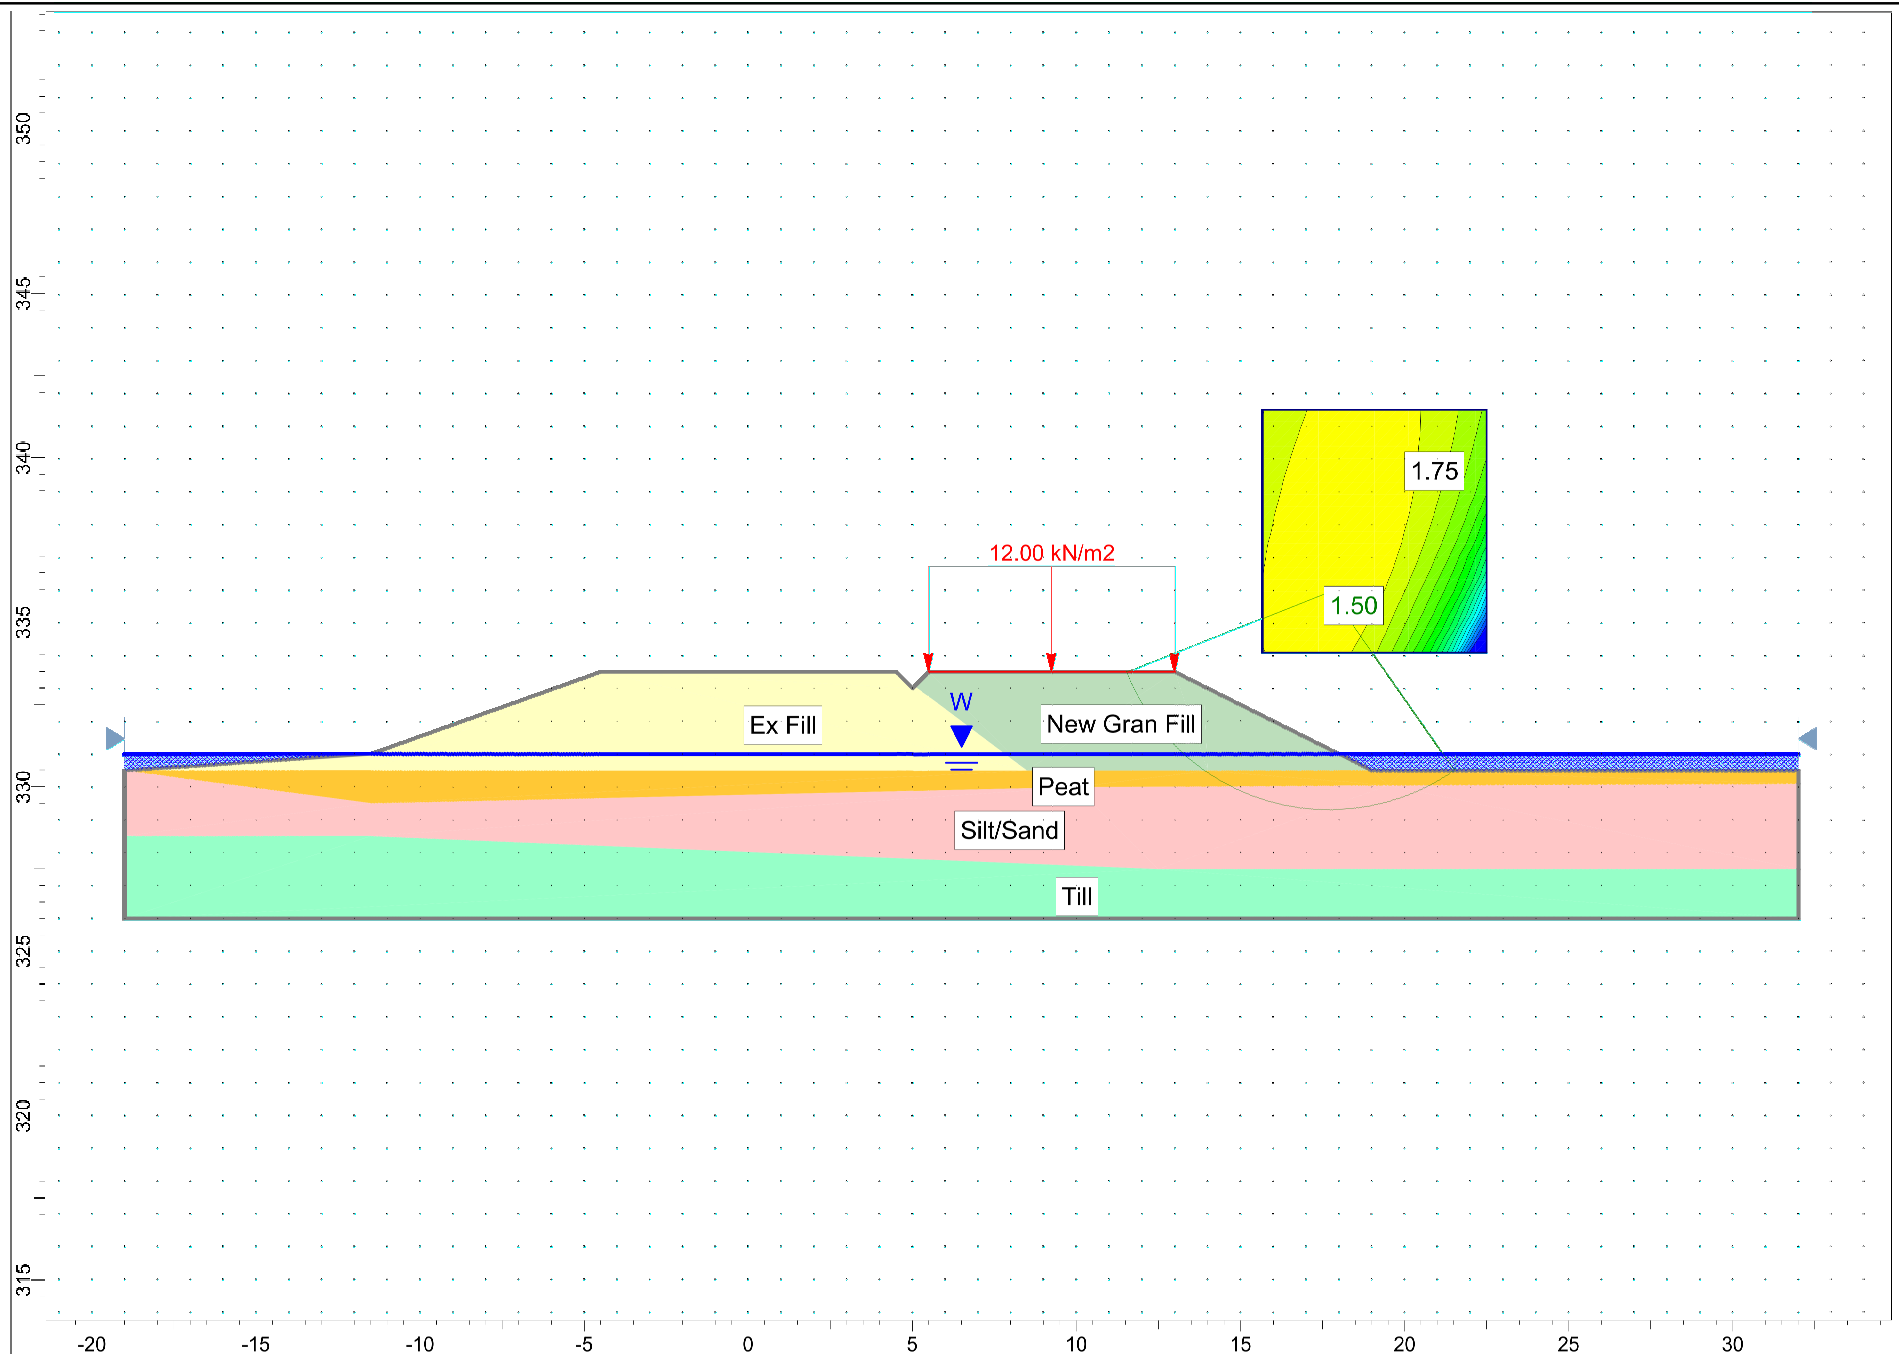
**F7 - TEMPORARY EMBANKMENT - NORTH SIDE  
GRANULAR "B" AT 2:1 SLOPE  
STATIC**

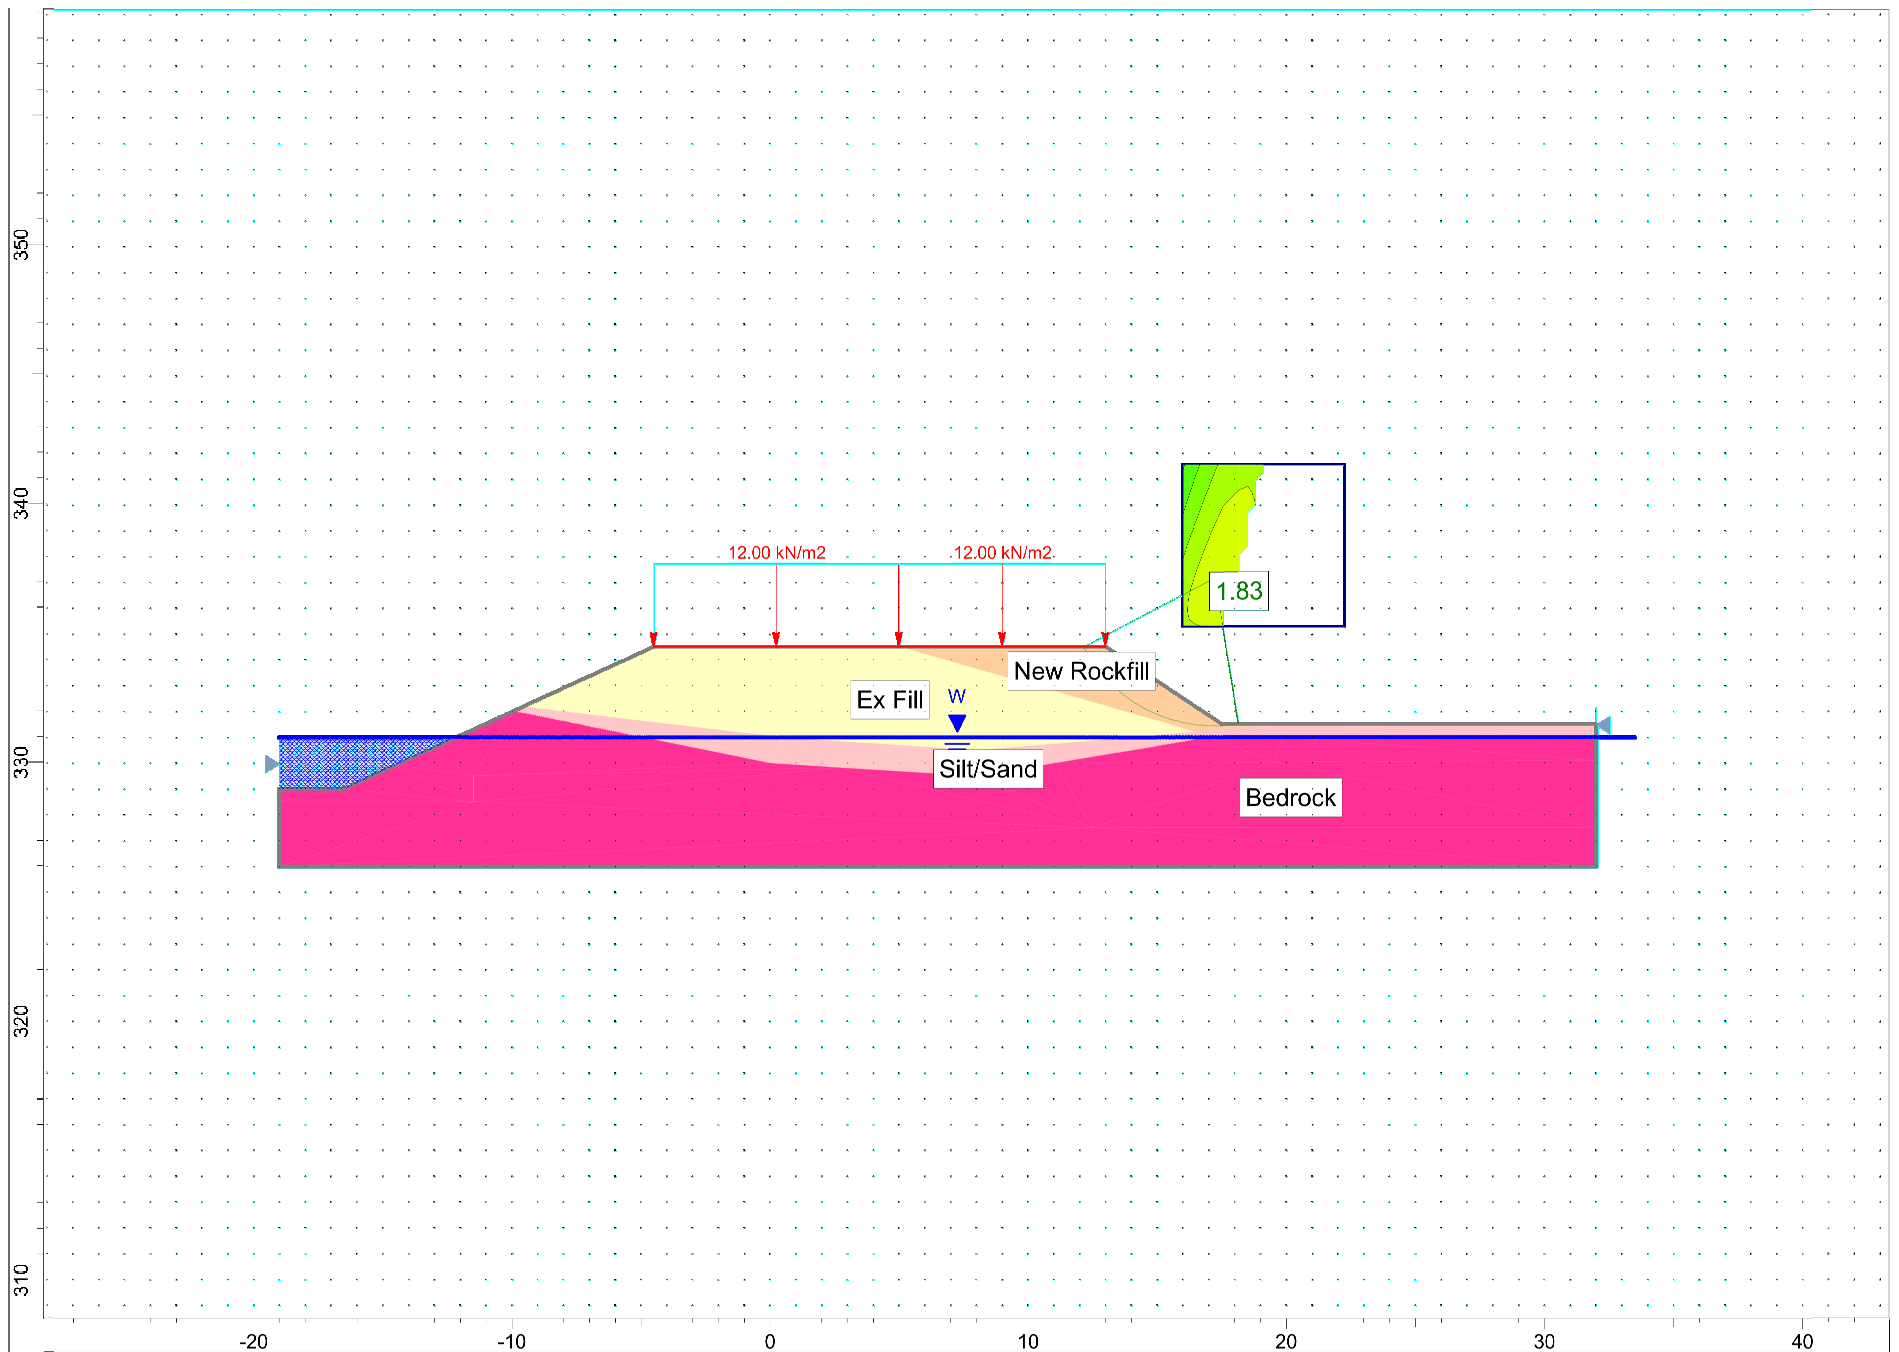
**F9 - TEMPORARY EMBANKMENT - SOUTH SIDE**  
**ROCK FILL AT 1.5:1 SLOPE**  
**STATIC**
