**FOUNDATION INVESTIGATION AND DESIGN REPORT
BLACK CREEK ROAD EMBANKMENT INSTABILITY
WEST OF HIGHWAY 11, ONTARIO**

MTO CONTRACT NO. 2007-5188

August 17, 2010

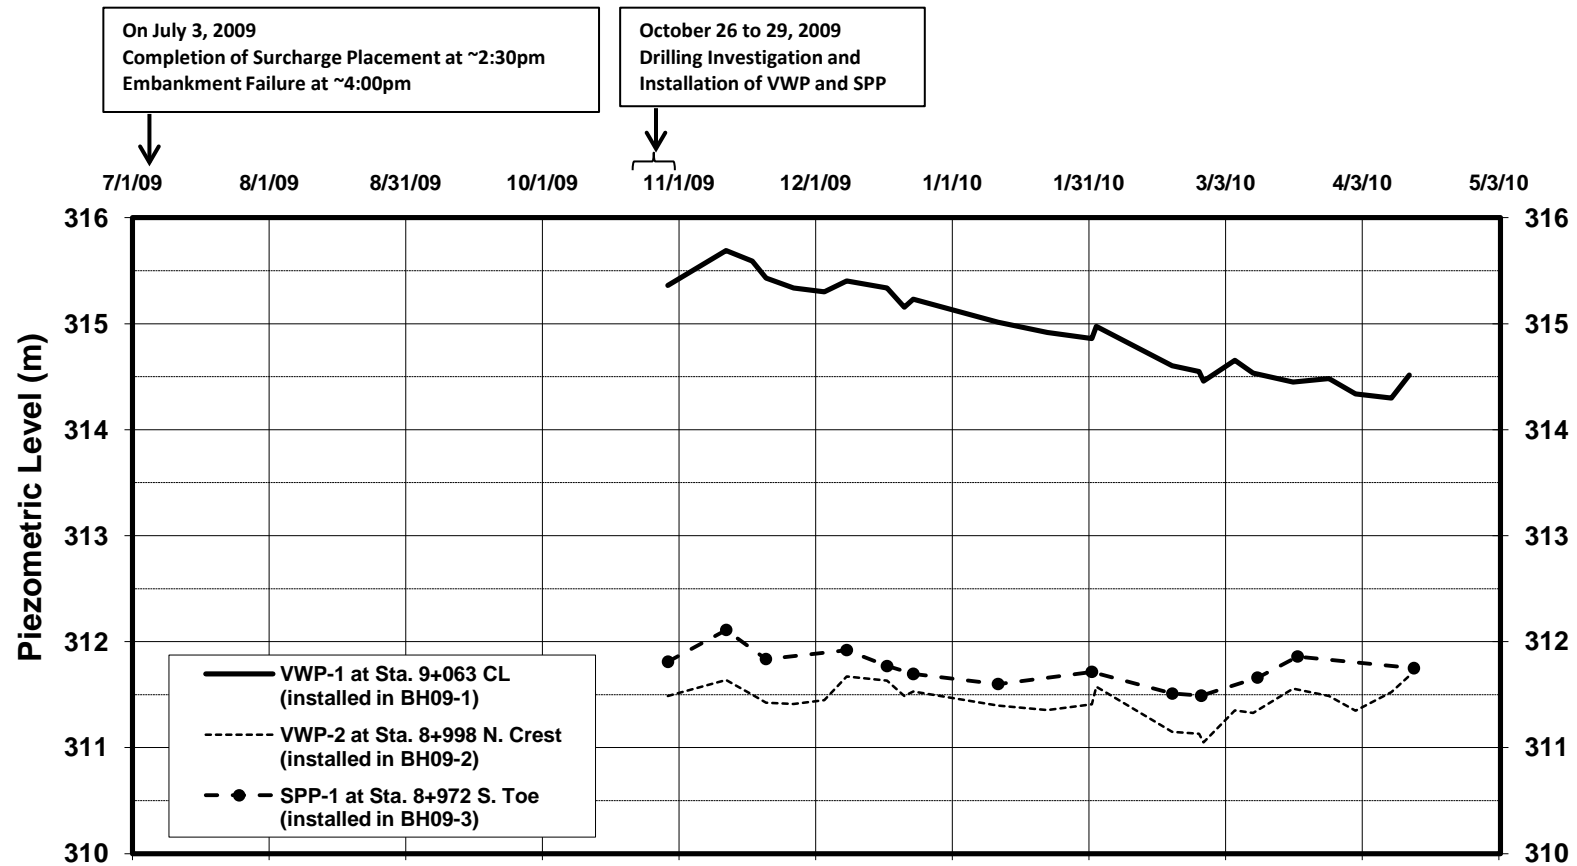
FIGURE 2

The piezometric level monitoring using VWPs was started on October 29, 2009. A plot of the measured piezometric levels is included in Figure 2. It is shown that VWP-1, located underneath the intact embankment, has a piezometric head approximately 2.7 to 3.5 m higher than the level measured in BH09-3 over the interval where data was collected. The excess pore pressure (EPP) at VWP-1 appears to dissipate slowly (~1.5 to 1.6 kPa per month) and approximately 27 kPa remains in the foundation silty clay on April 13, 2010. The piezometric levels measured in VWP-2, located underneath the crest of the embankment, are (~0 to 0.4 m) lower than the conditions measured at the toe of the embankment, and do not show evidence of significant EPP or dissipation over time at these locations.

Vibrating Wire Piezometer VWP-1, 2 / Standpipe Piezometer SPP-1

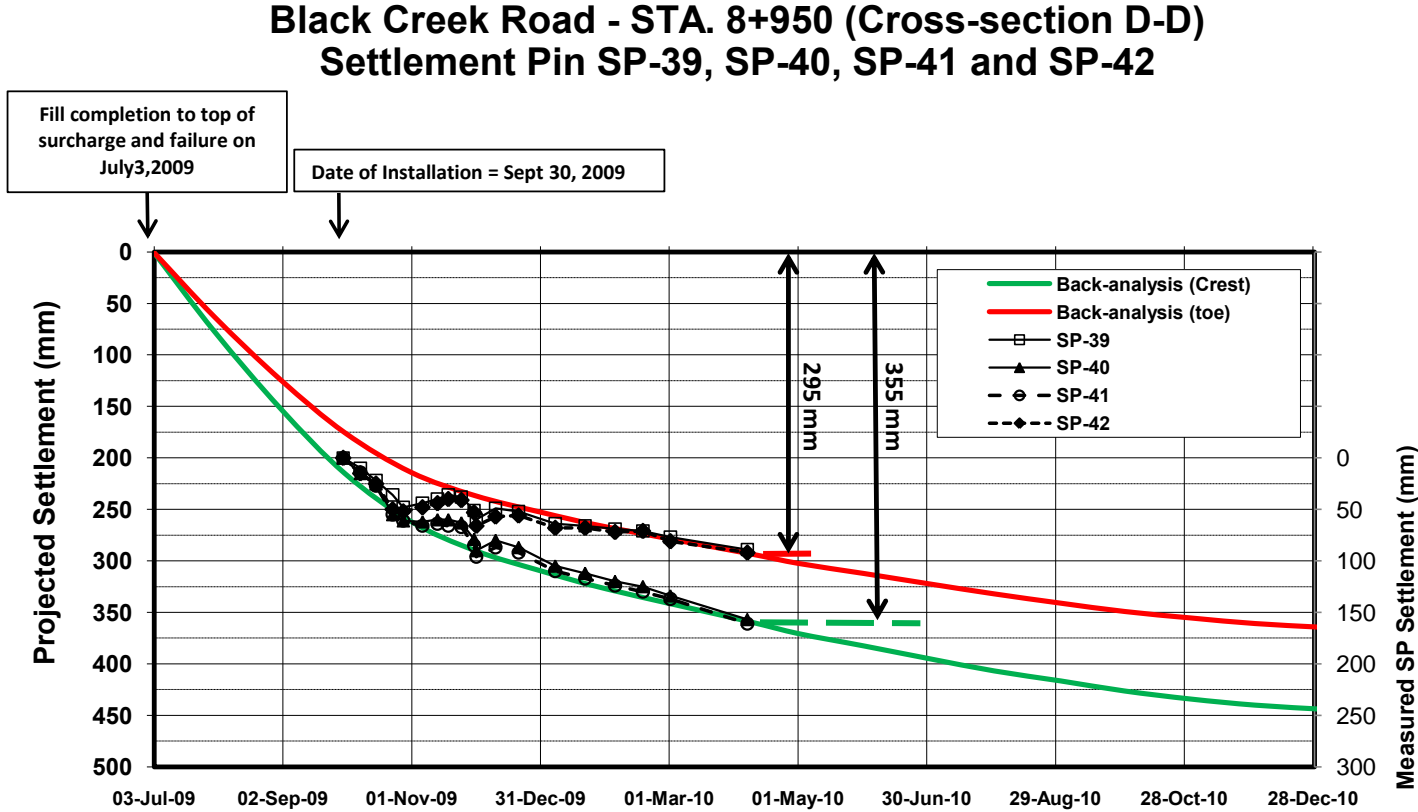
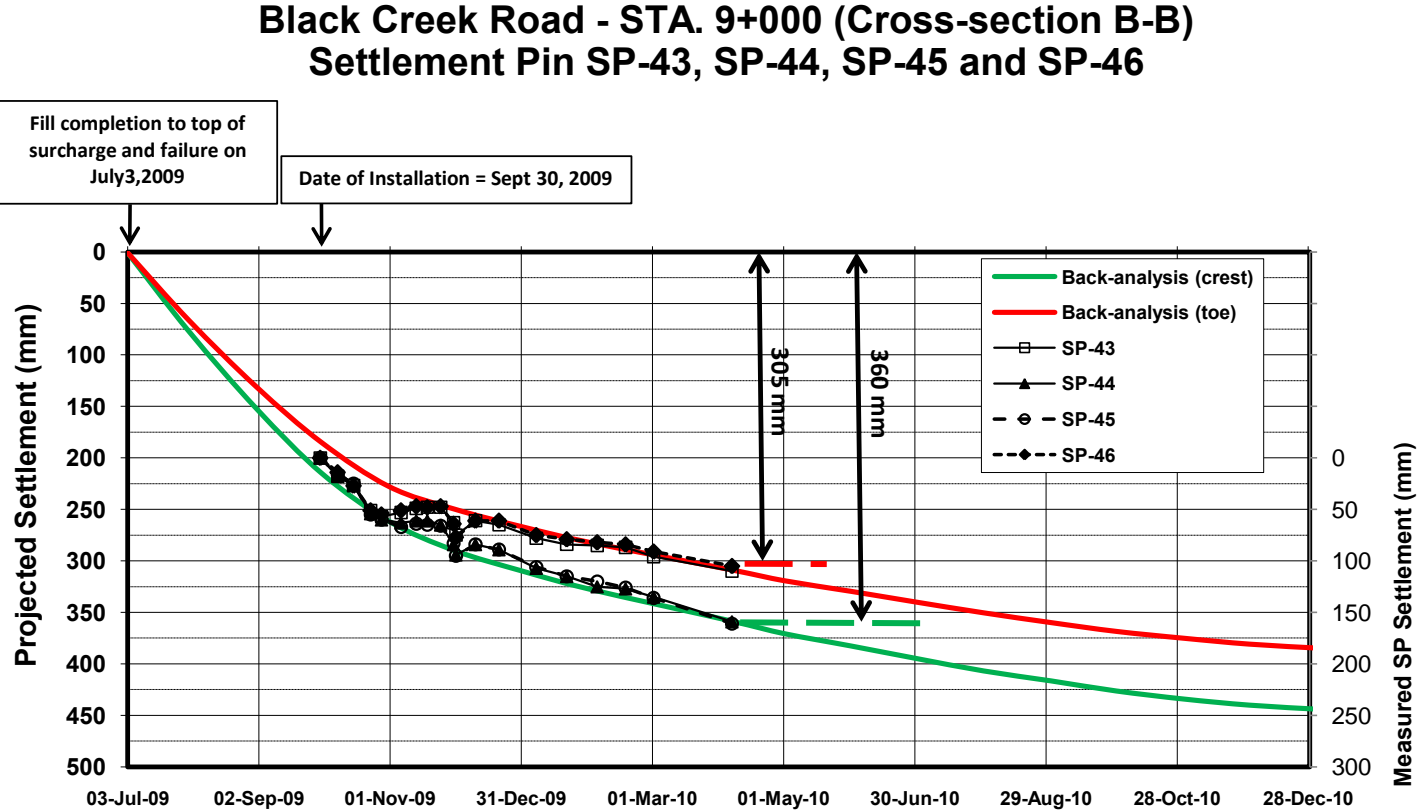
FIGURE 3

MONITORING DATA: SETTLEMENT (SP) vs. TIME PLOTS

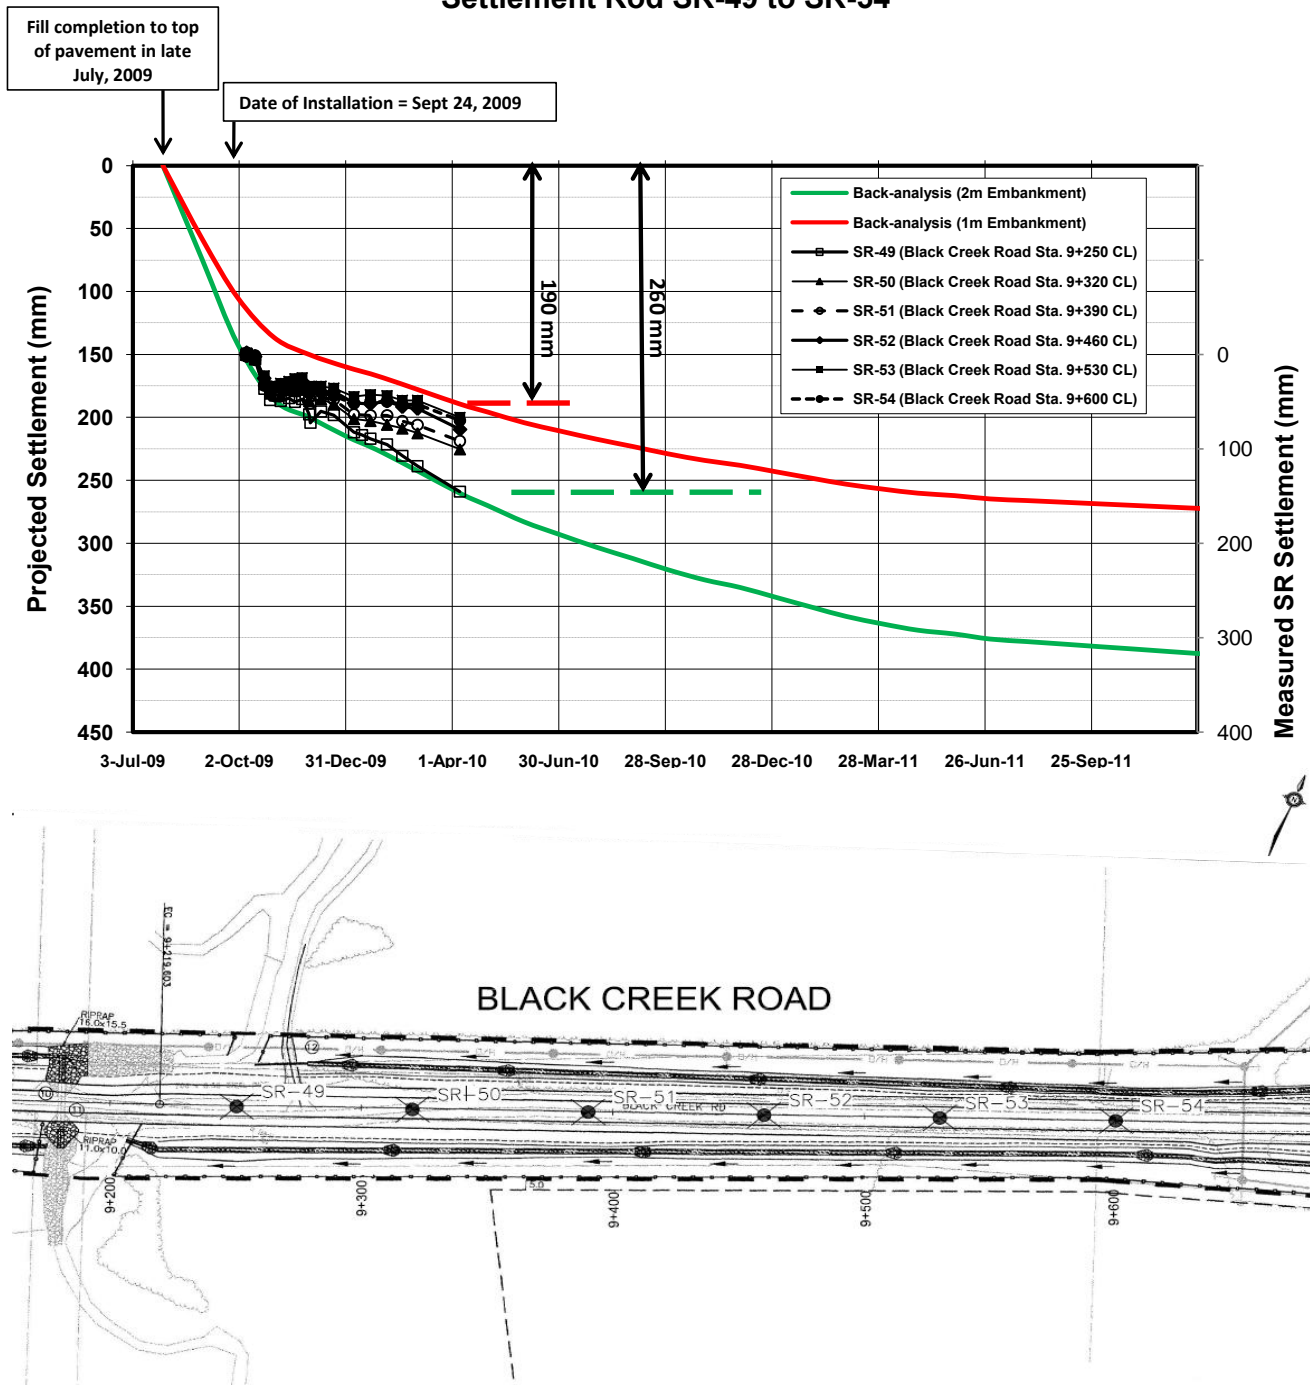
FIGURE 4

19-5161-73 Highway 11 Black Creek Road Embankment Instability MONITORING DATA: SETTLEMENT (SR) vs. TIME PLOTS

Black Creek Road - STA. 9+250 to 9+650 Settlement Rod SR-49 to SR-54

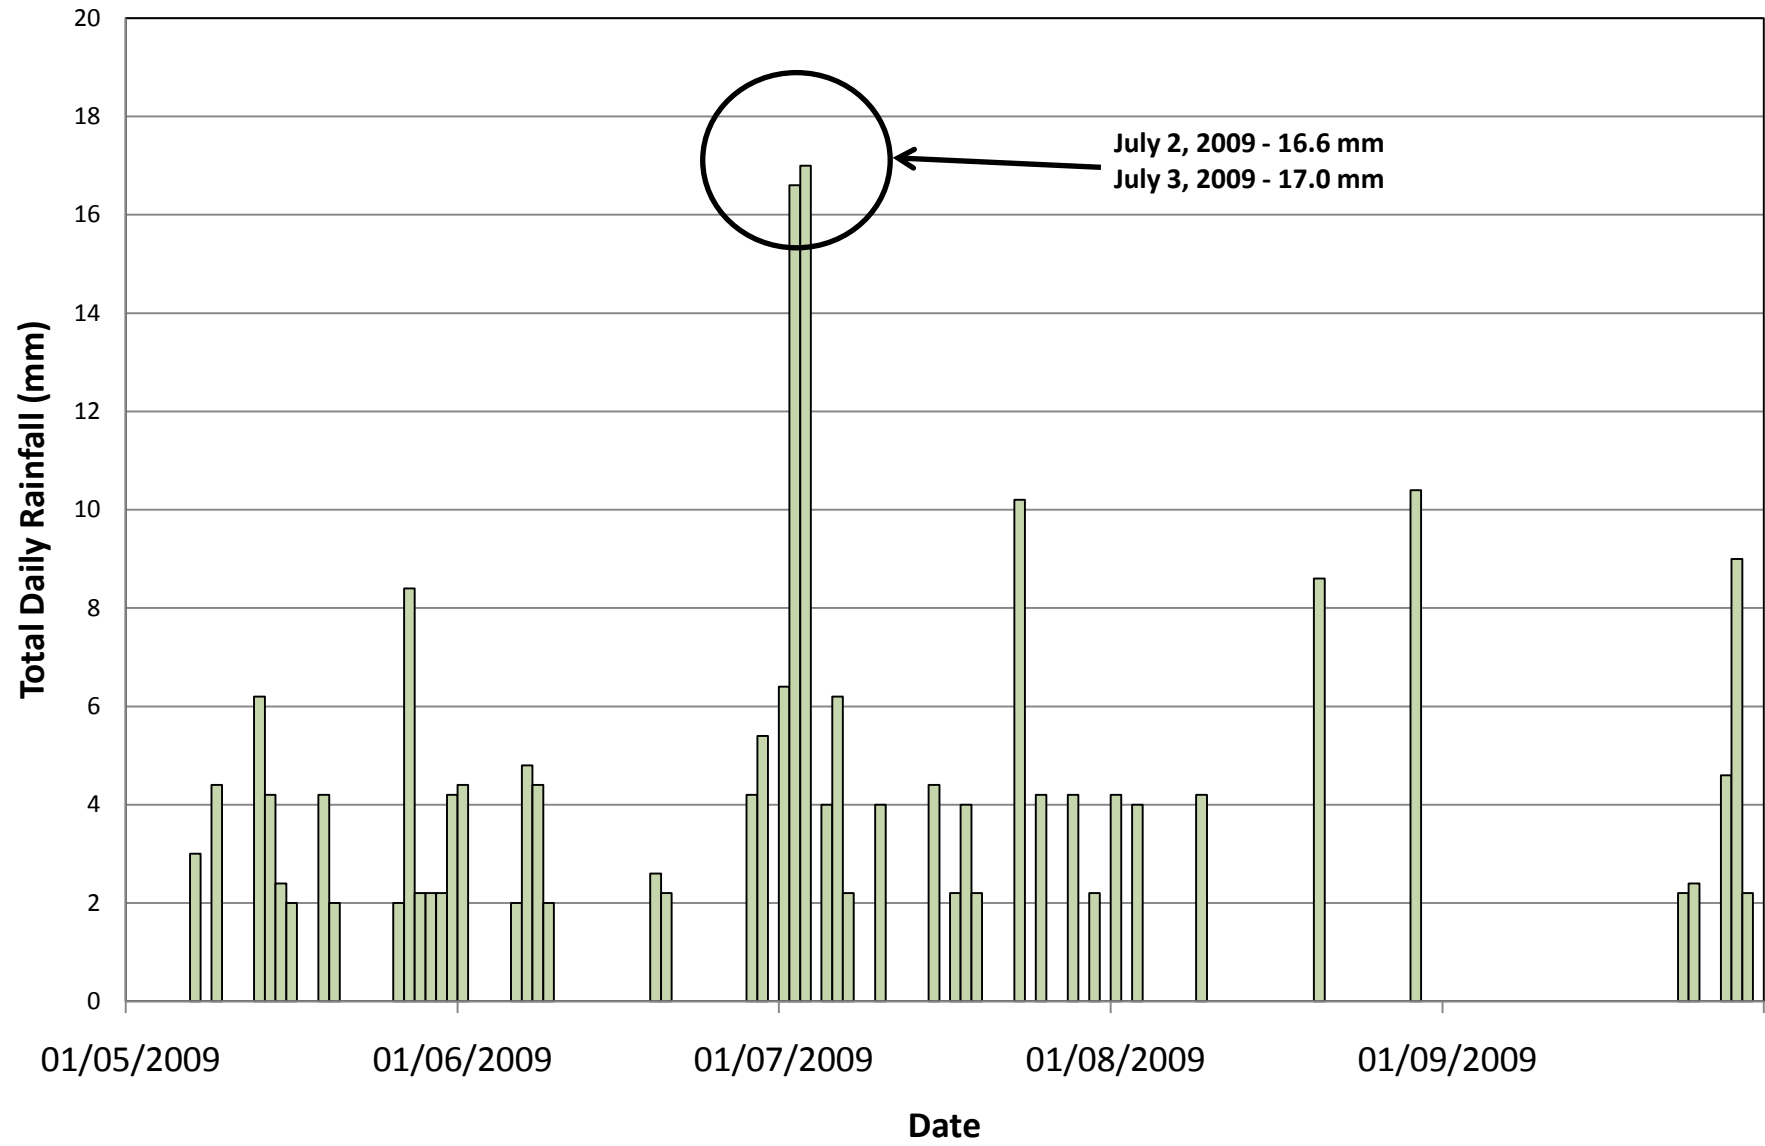
FIGURE 5

**19-5161-73 Highway 11 Black Creek Road Embankment Instability
DAILY RAINFALL IN BURK'S FALLS, ONTARIO (2009 SUMMER)**

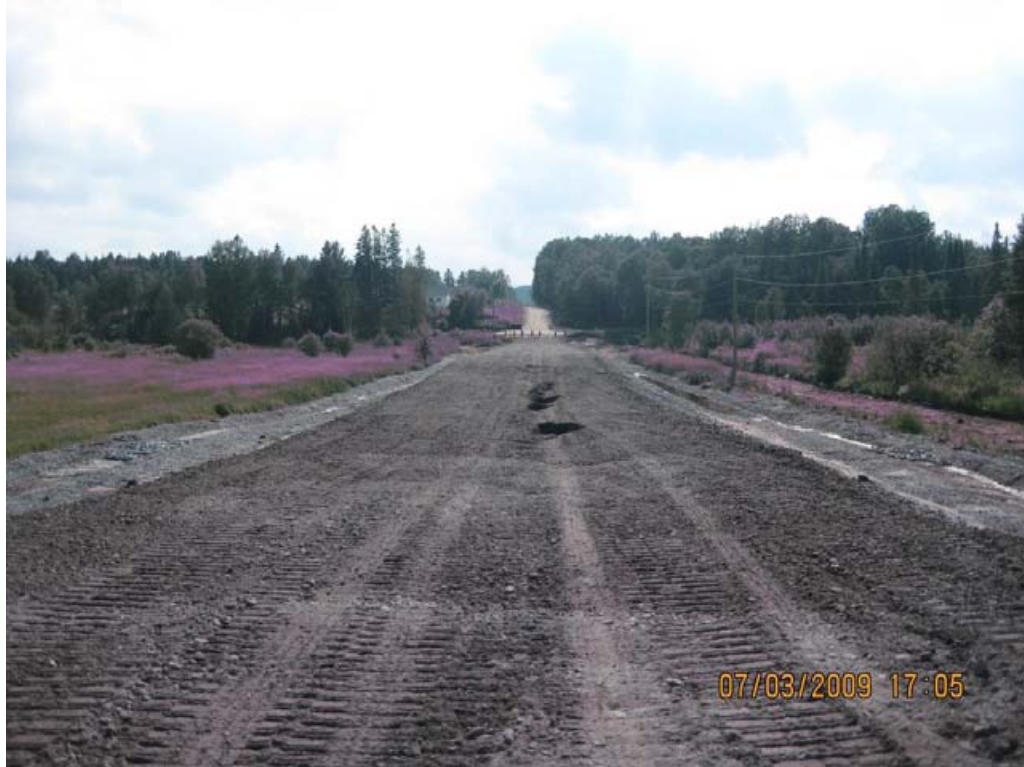
- Length of instability: ~130 to 140m
- Height of embankment (post-failure): ~3.0m
- Both sides of the embankment, north and south, slid away from the embankment centreline.
- Approximately four significant cracks were noted near the centreline of embankment (up to 1m wide and in the order of 1m deep)
- Some tension cracks were noted along the flattened SSM slope
- Toe bulging in the order of 1m at the ditches was noted at both sides blocking the ditch flow
- Two hydro poles located just north of the ditches tilted away from the road embankment (i.e. to the north)

Figure E1 – Black Creek Road Embankment Instability on July 3, 2009 (looking west)

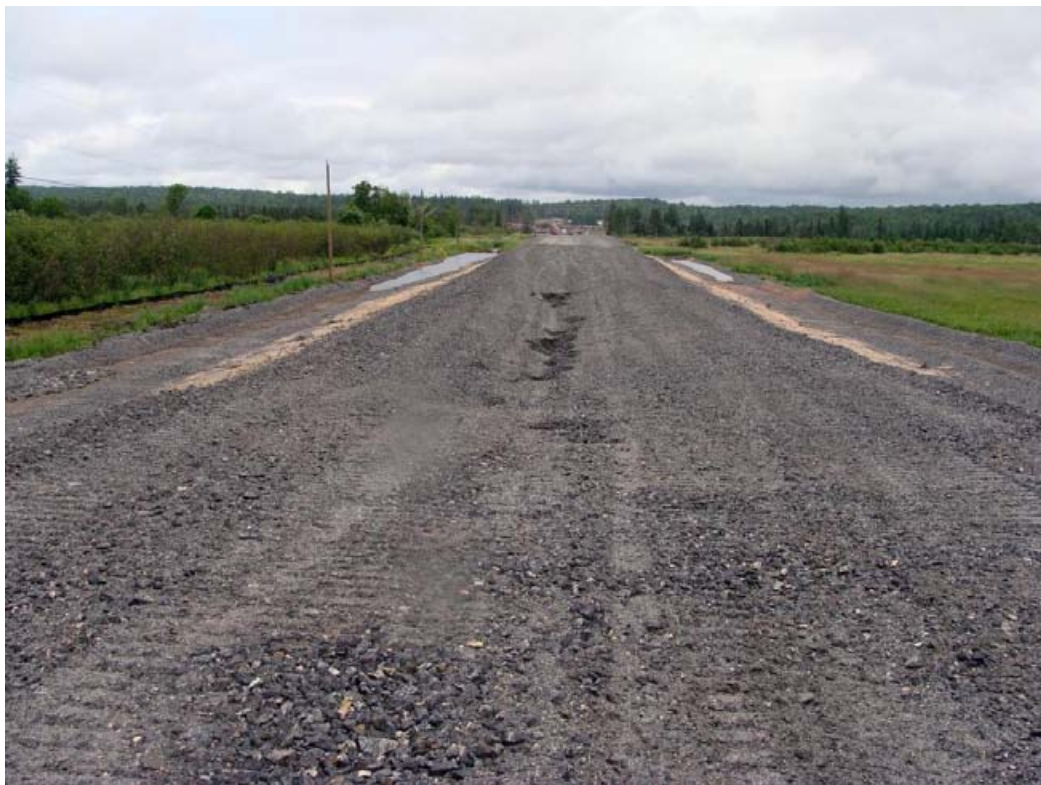
Figure E2 – Black Creek Road Embankment Instability (looking east)

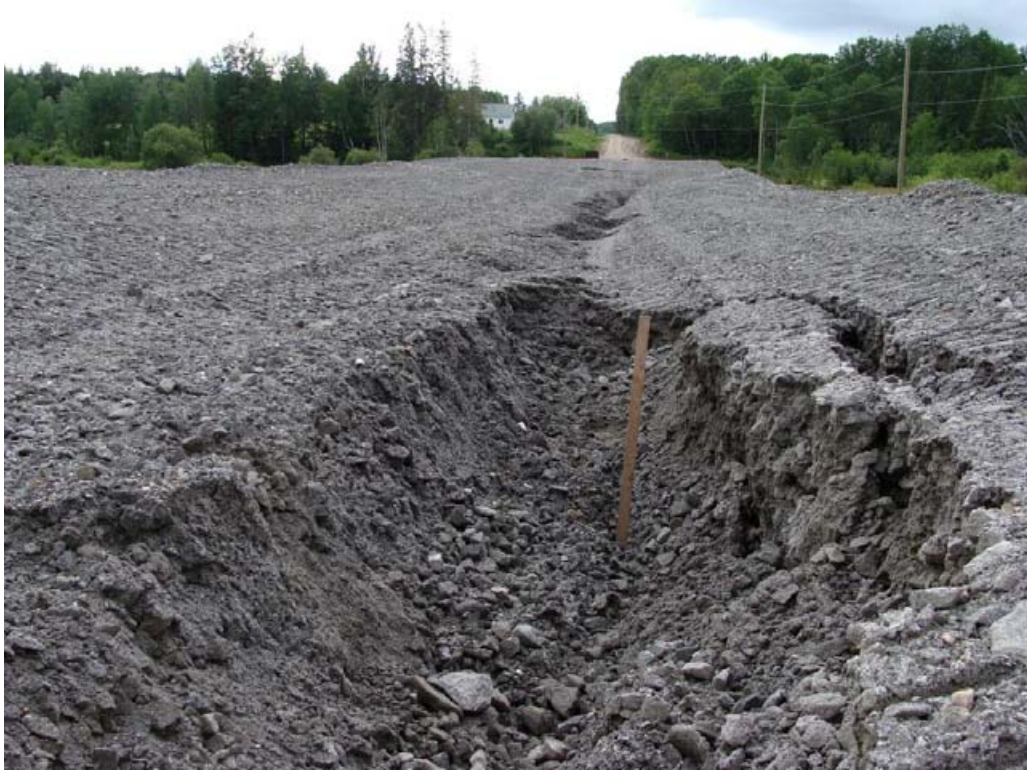
Figure E3 – Tension Cracks at the top of embankment (looking west)

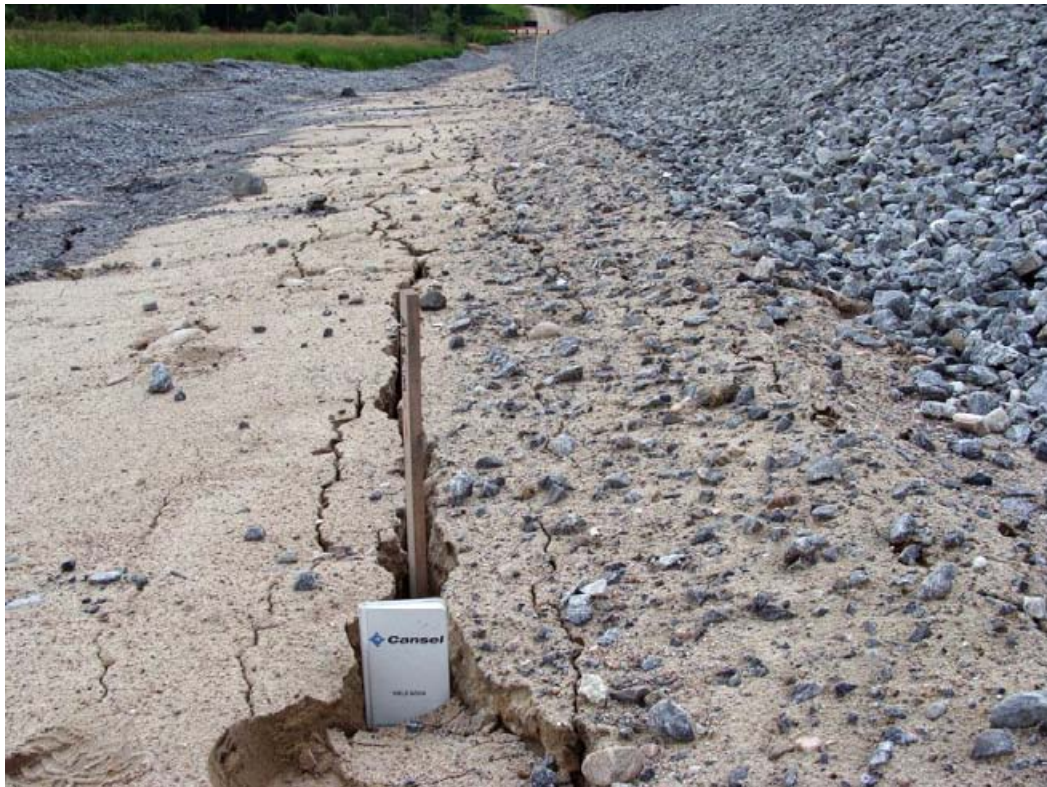
Figure E4 – Tension Cracks on the south SSM slope (looking west)

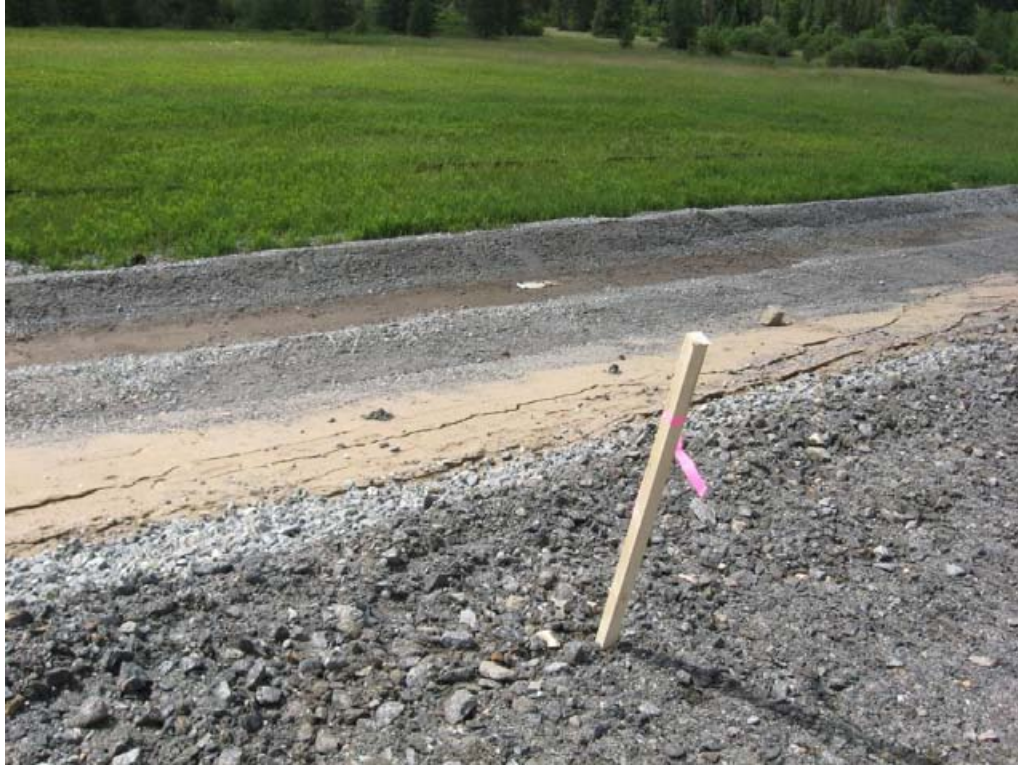
Figure E5 –South toe bulge (looking south west)

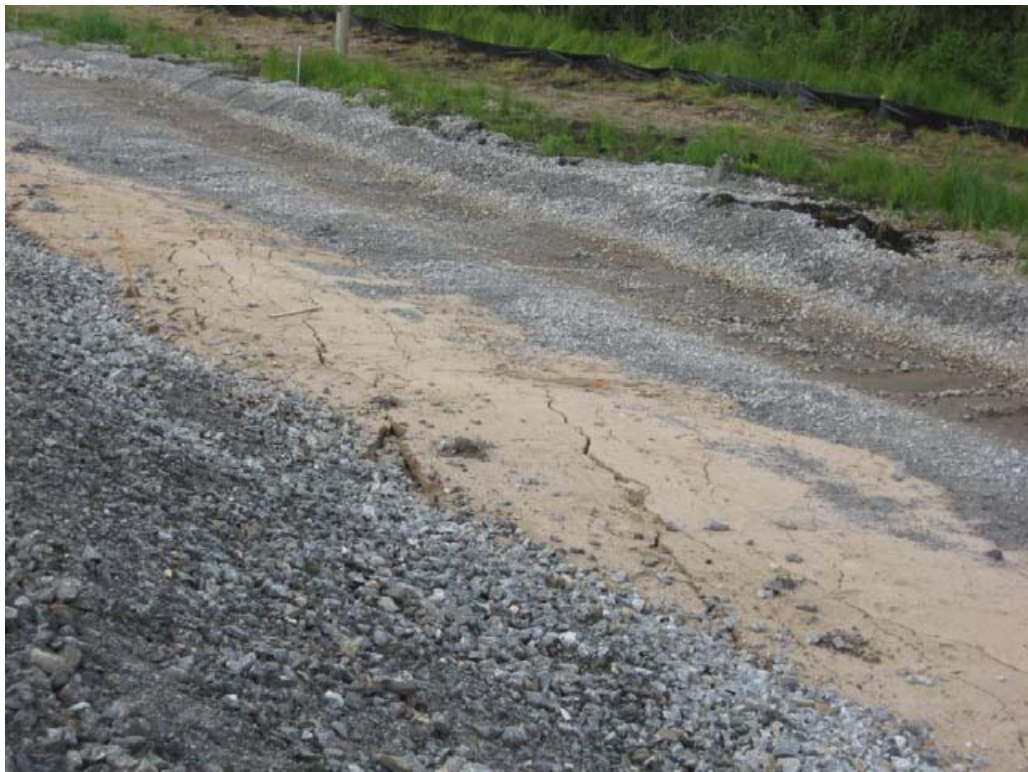
Figure E6 – north toe bulge (looking north west)

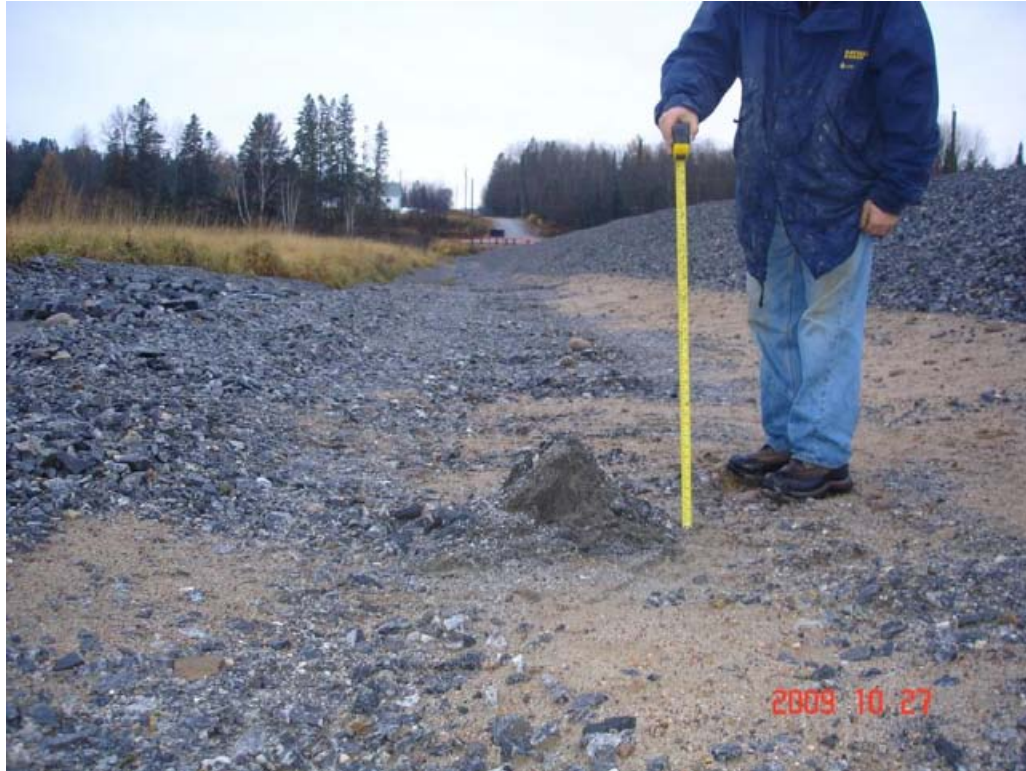
During the investigation program, multiple loose sand boils were noted on ground surface possibly indicating the occurrence of liquefaction, as discussed later. These features were documented in photographs shown in Figures E7 to E12 in Appendix E.

Figure E7 – Sand boil on south SSM slope (looking west)

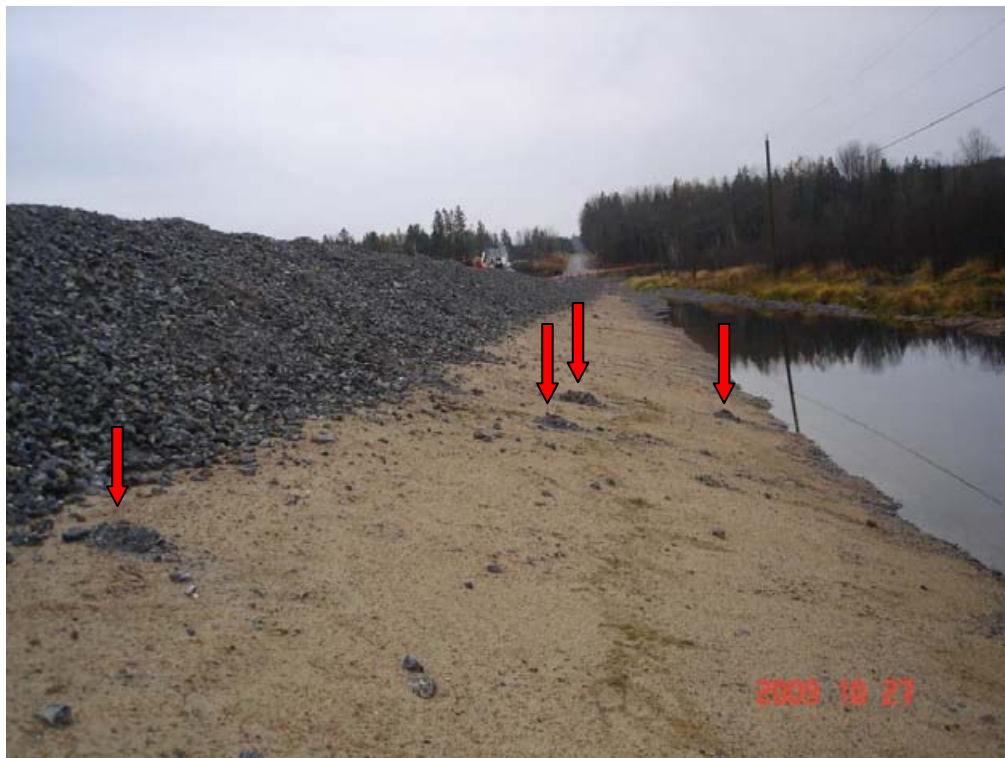
Figure E8 – More sand boils on north SSM slope (looking west)

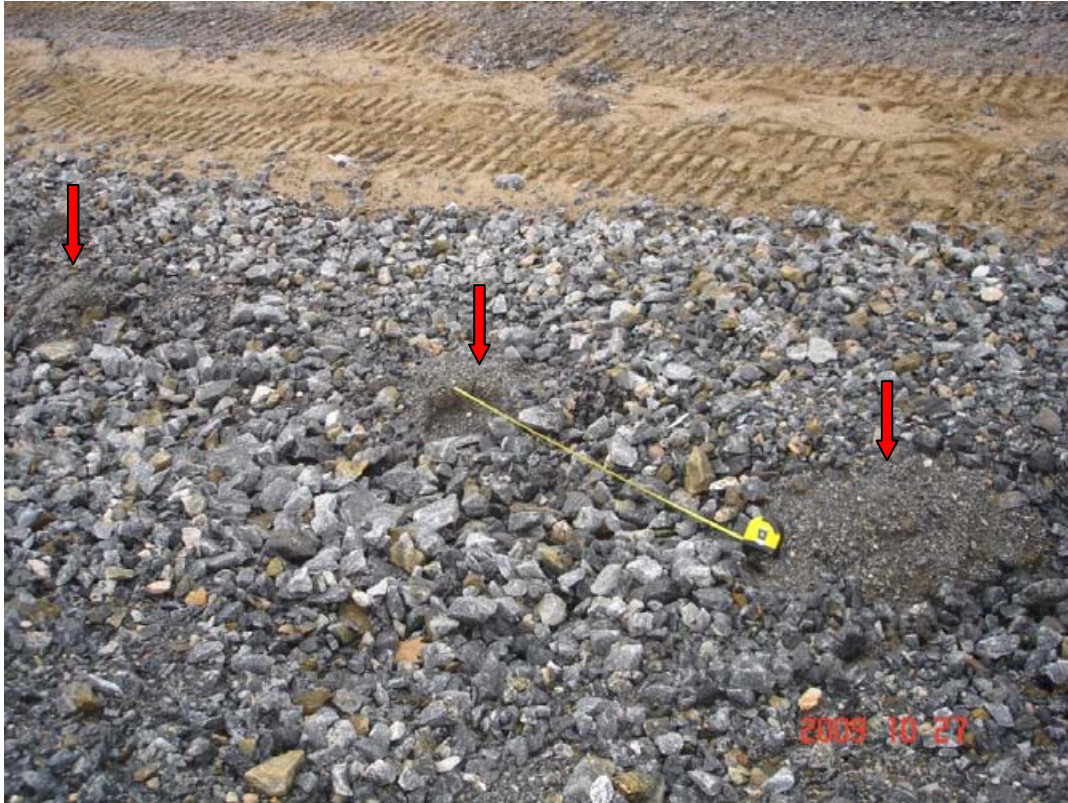
Figure E9 – Sand boils on south Granular B Type 2 Surcharge slope

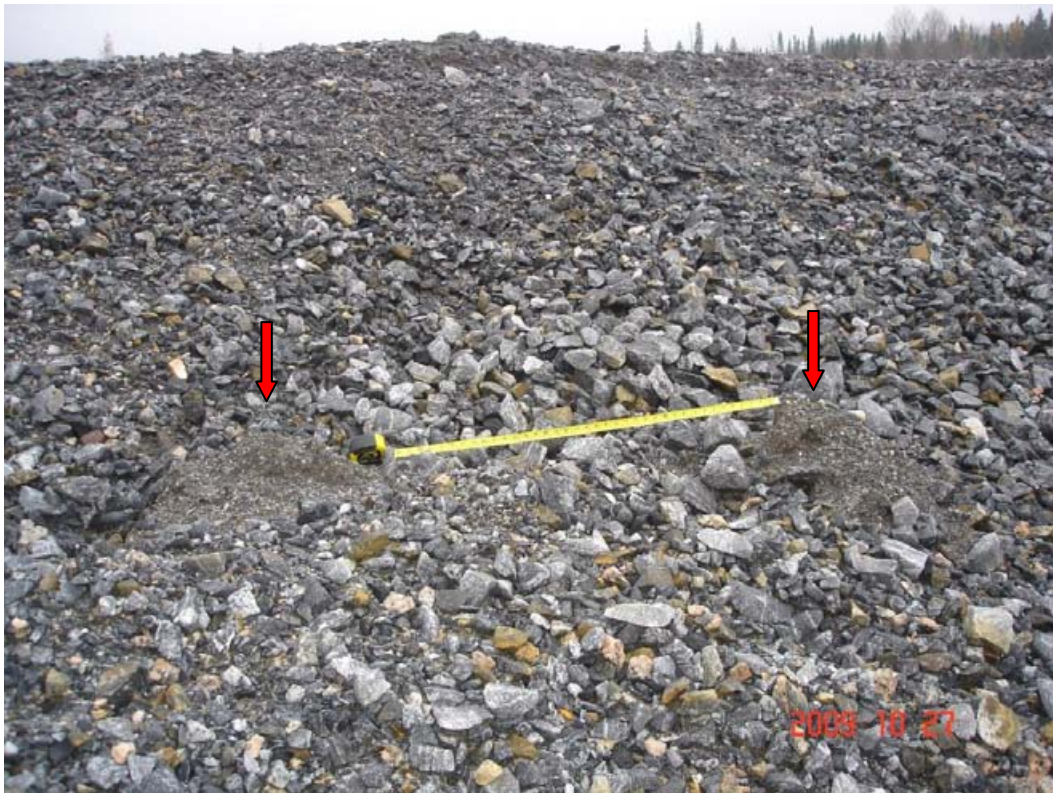
Figure E10 – More sand boils on south Granular B Type 2 Surcharge slope

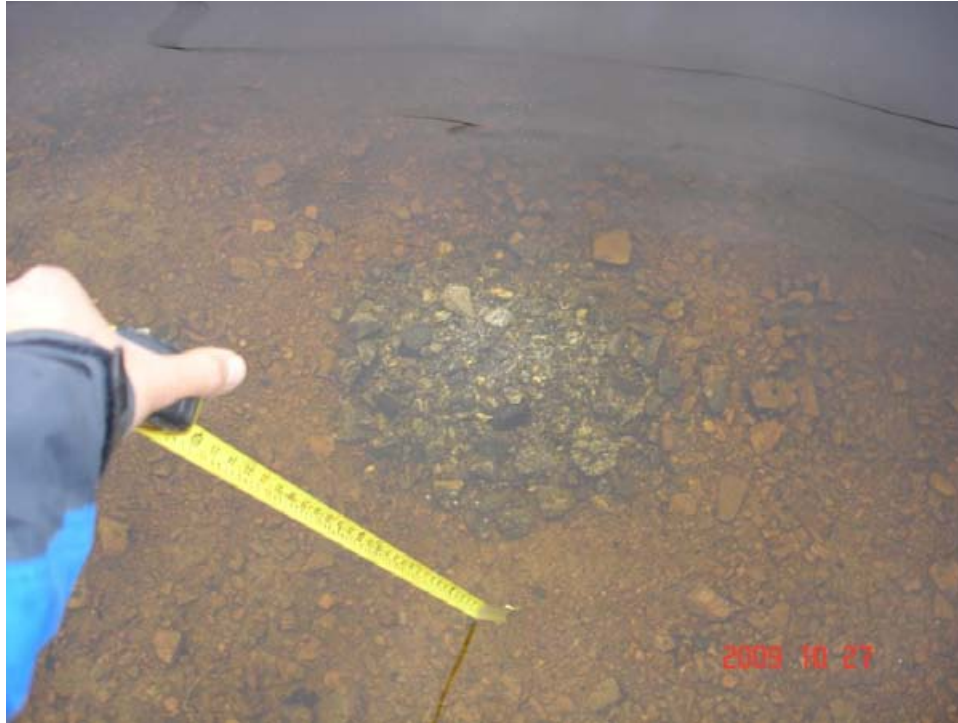
Figure E11 – Sand boil at the top of backfill in the north ditch

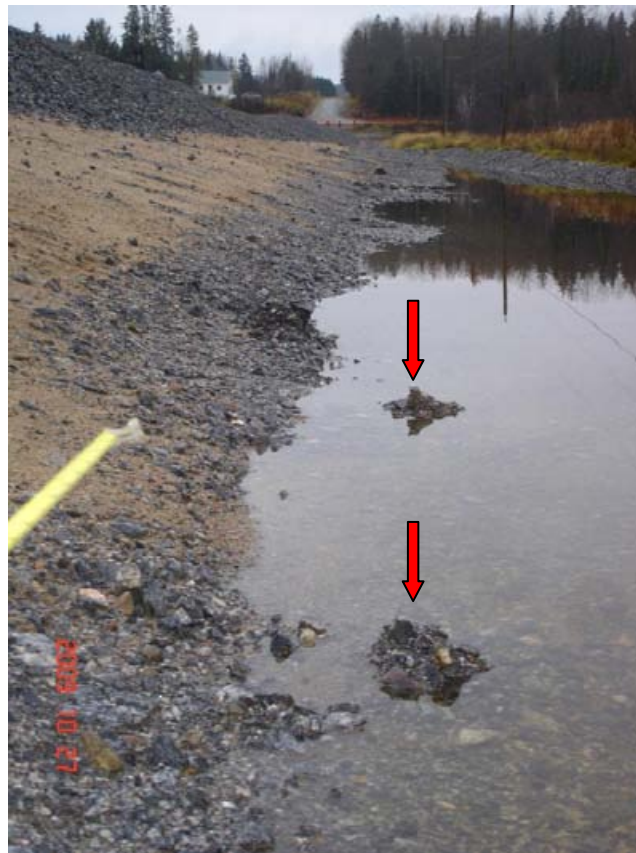
Figure E12 – More sand boils at the top of backfill in the north ditch

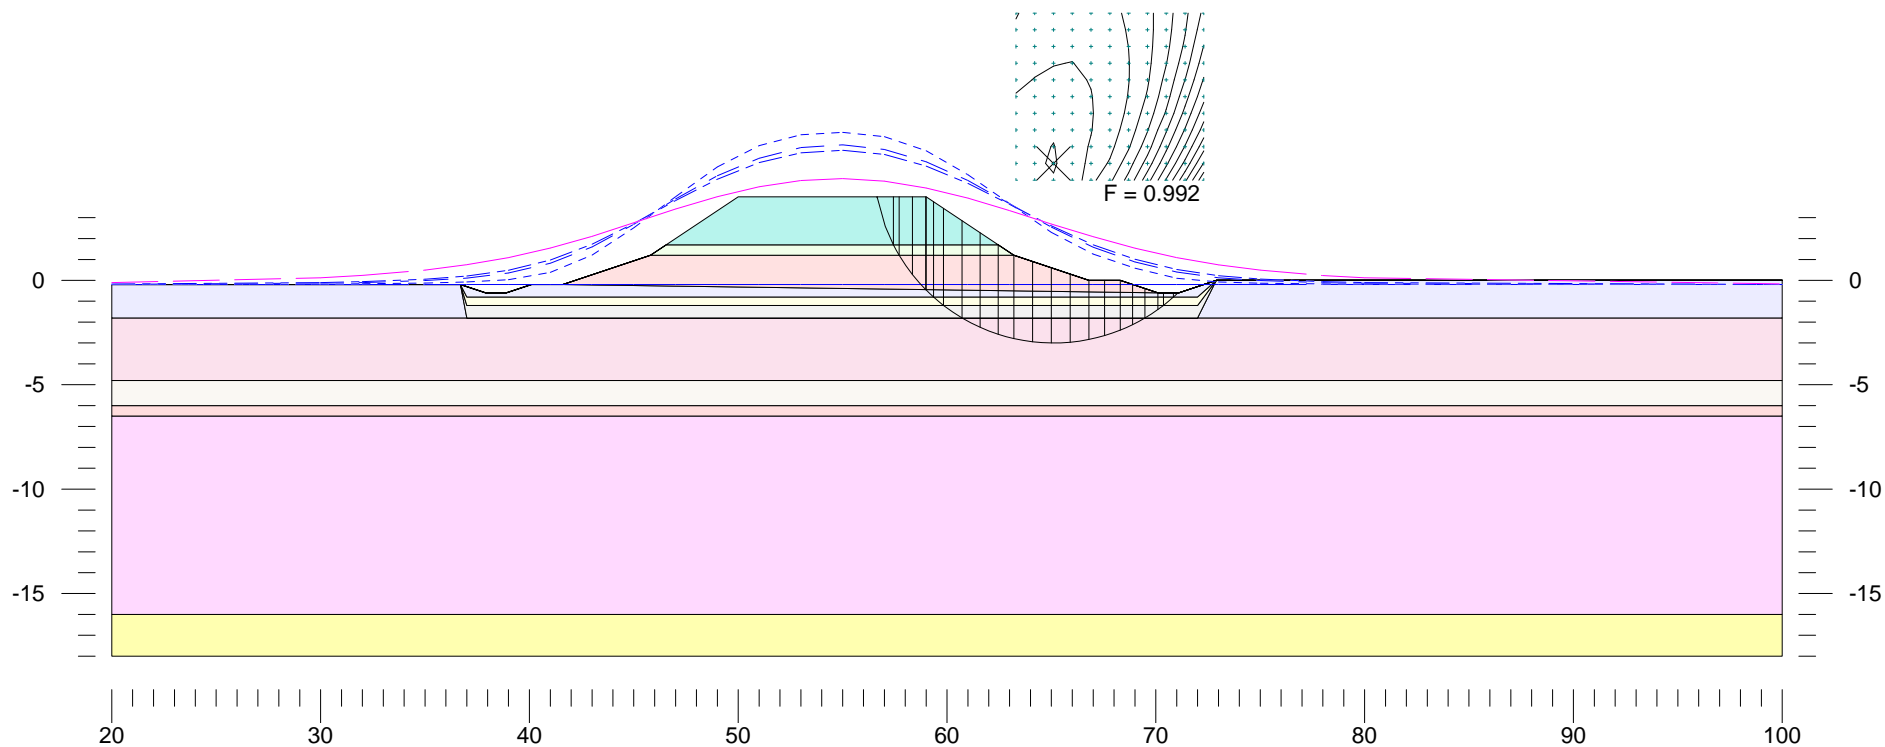
Thurber Engineering Ltd. - Toronto
 19-5161-73
 Black Creek Road Embankment Failure
 January 25, 2010
 Black Creek Road Sta.9+000 - 4m high Embankment (Surcharge at 1.5H:1V, SSM Fill at 3H:1V)
 Effective Stress Analysis

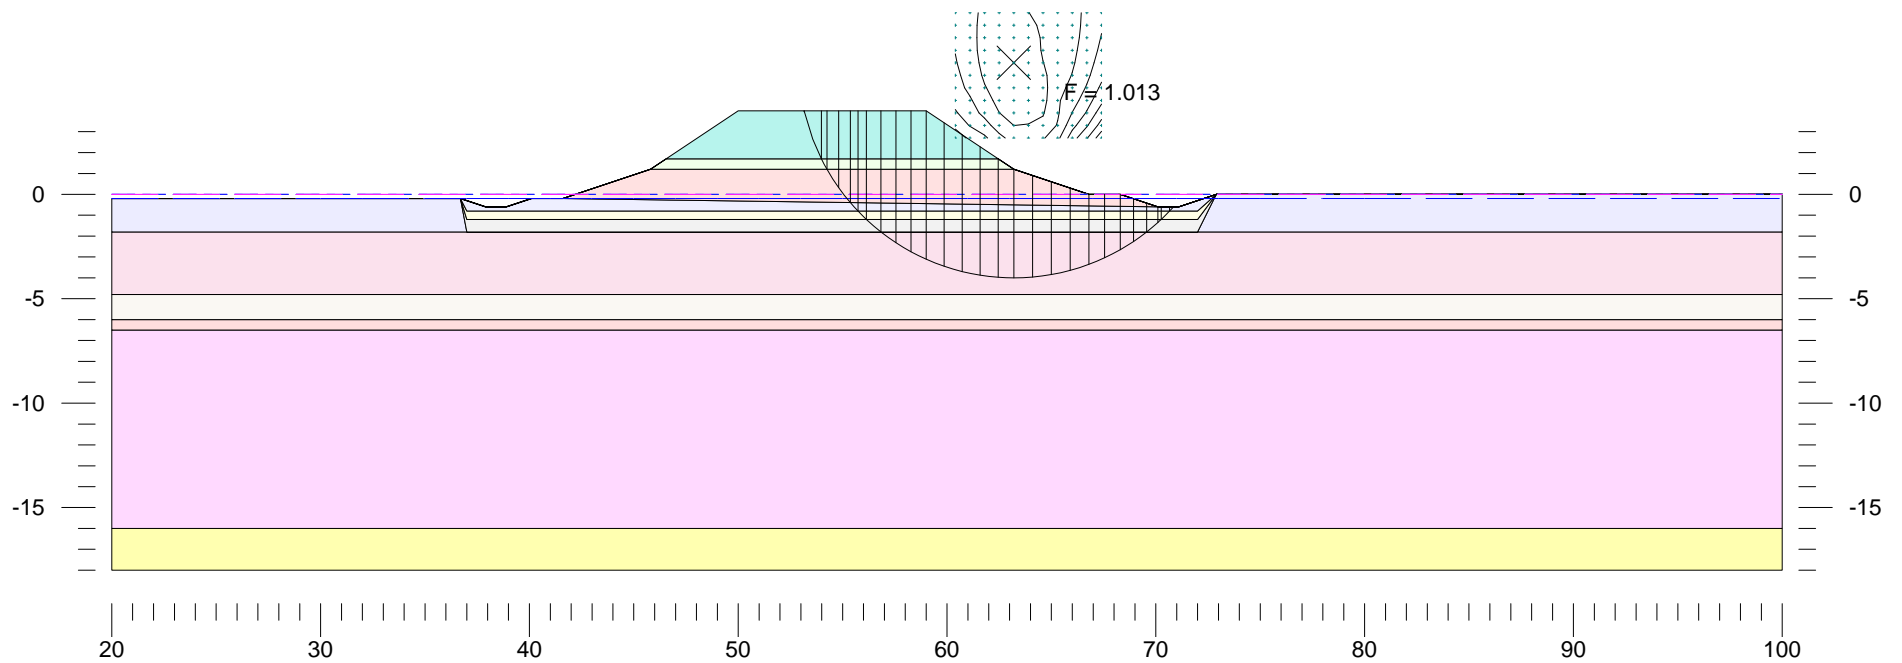
Thurber Engineering Ltd. - Toronto
19-5161-73
Black Creek Road Embankment Failure
January 25, 2010
Black Creek Road Sta.9+000 - 4m high Embankment (Surcharge at 1.5H:1V, SSM Fill at 3H:1V)
Total Stress Analysis

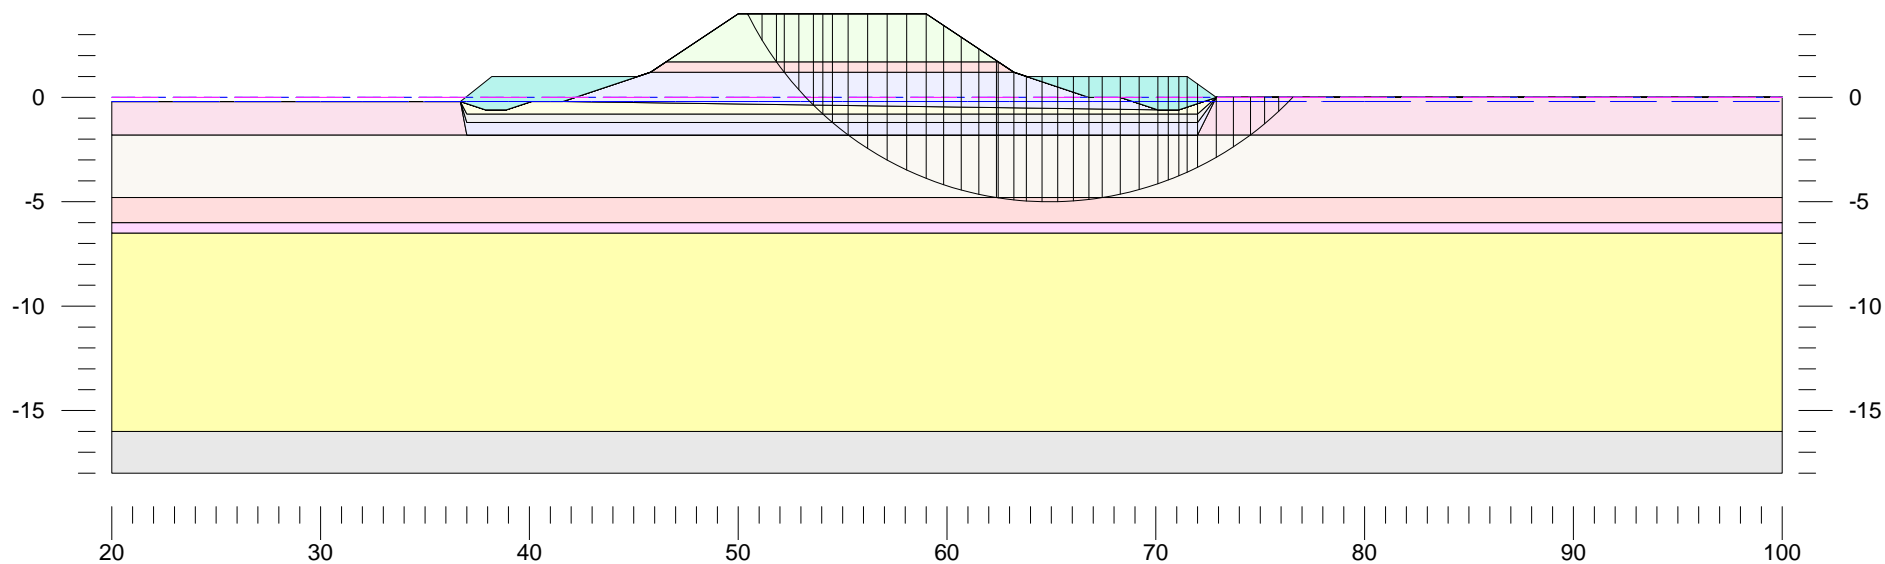
Black Creek Road Sta.9+000 - 4m high Embankment (Surcharge at 1.5H:1V, SSM Fill at 3H:1V)
Total Stress Analysis - with Stabilizing Berm (7.5 m wide and 1 m tall)

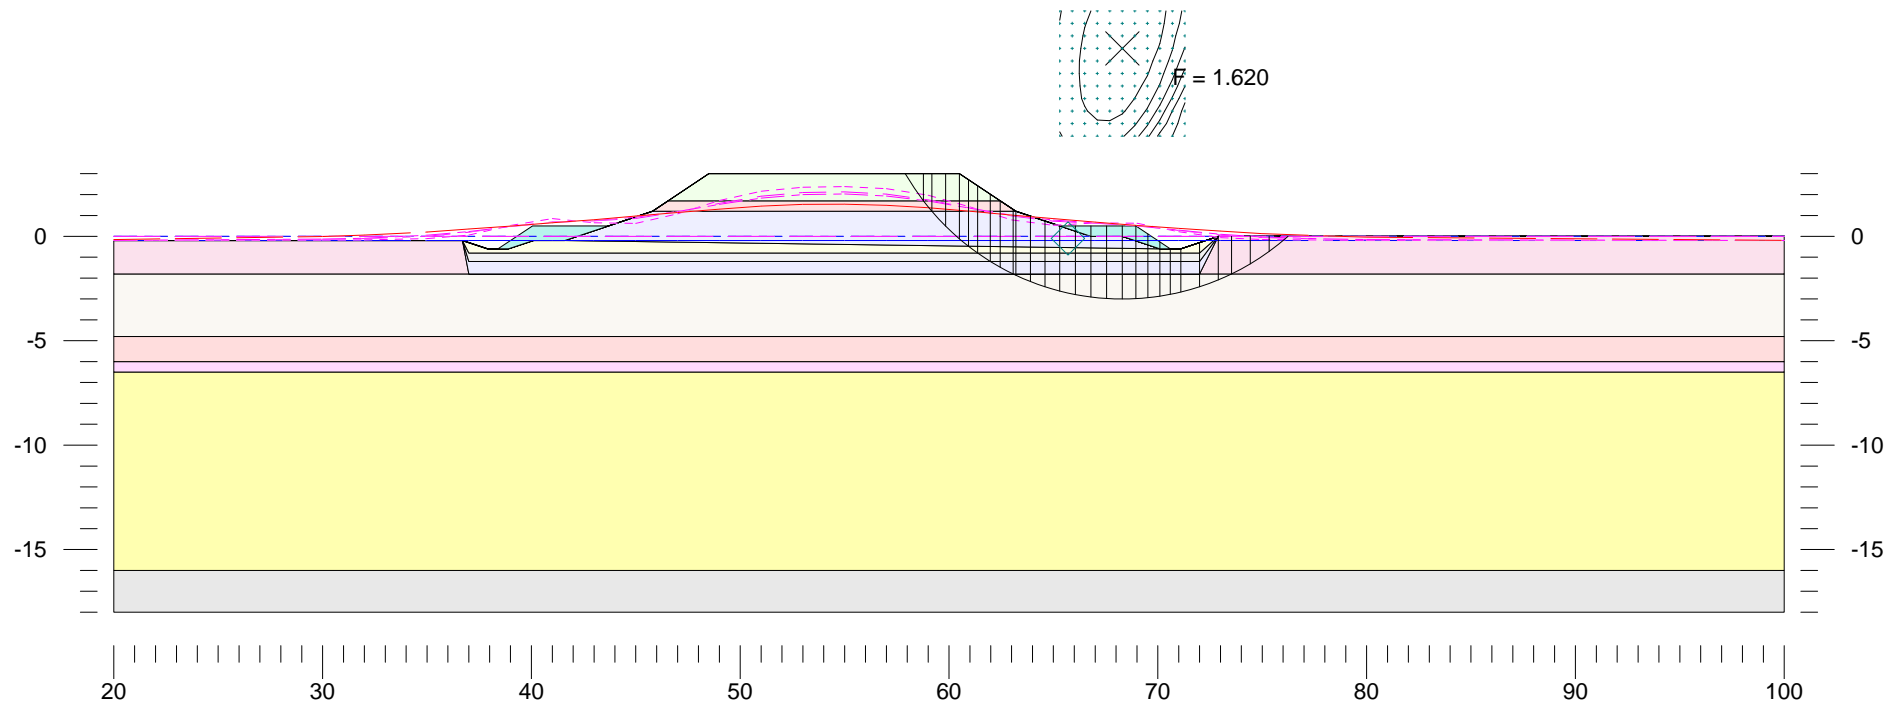
Black Creek Road Sta.9+000 - 3m high Embankment (1 m Surcharge at 1.5H:1V, SSM Fill at 3H:1V)
Effective Stress Analysis - with Stabilizing Berm (3.7 m wide and 0.5 m tall)
