**FOUNDATION INVESTIGATION AND DESIGN REPORT
BLACK CREEK ROAD EMBANKMENT INSTABILITY
WEST OF HIGHWAY 11, ONTARIO**

MTO CONTRACT NO. 2007-5188

August 17, 2010

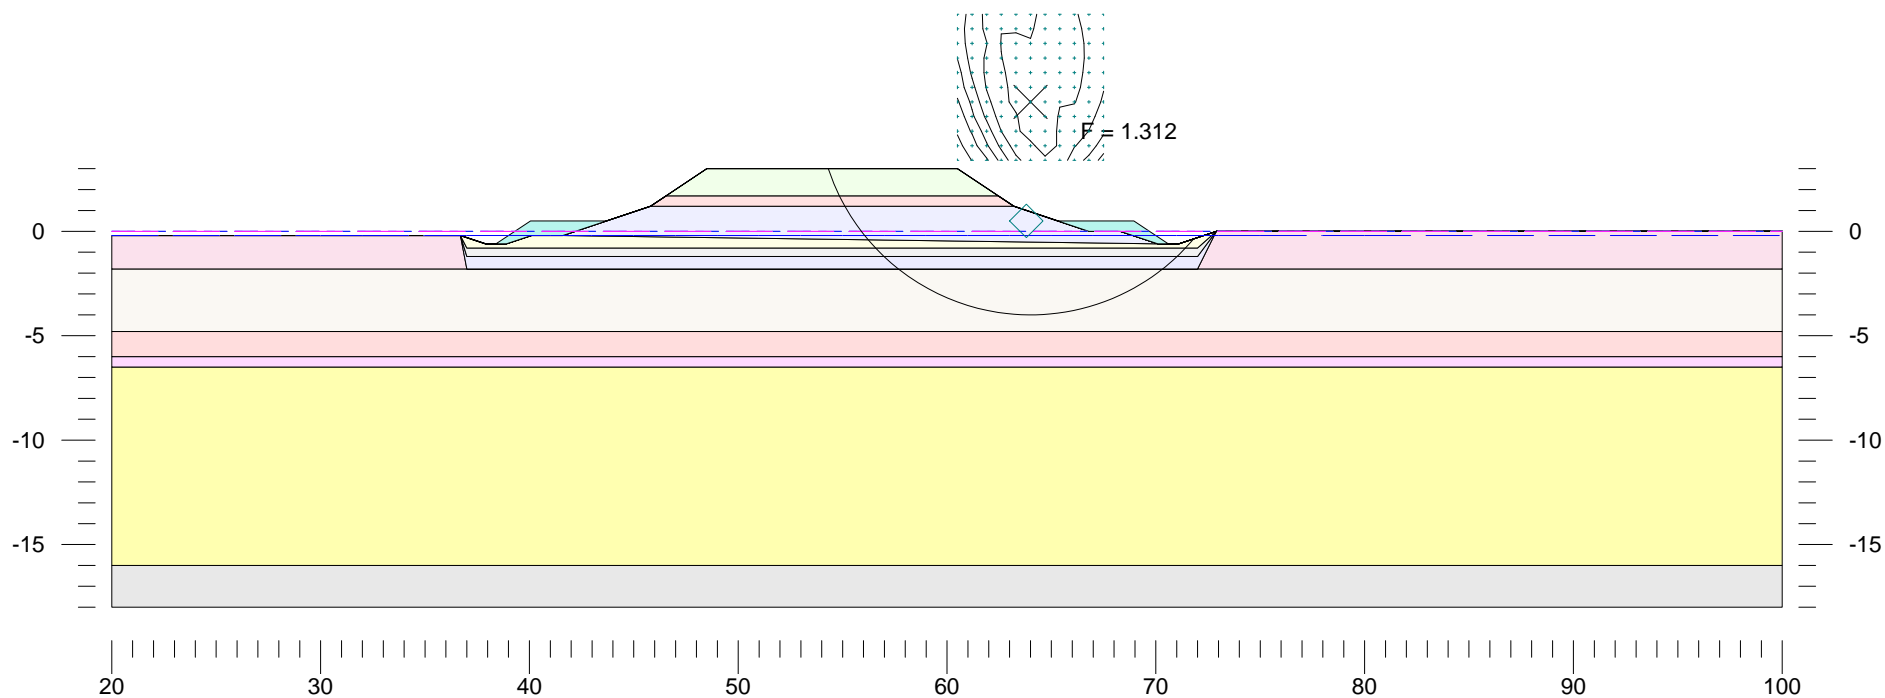
Black Creek Road Sta.9+000 - 3m high Embankment (1 m Surcharge at 1.5H:1V, SSM Fill at 3H:1V)
Total Stress Analysis - with Stabilizing Berm (3.7 m wide and 0.5 m tall)

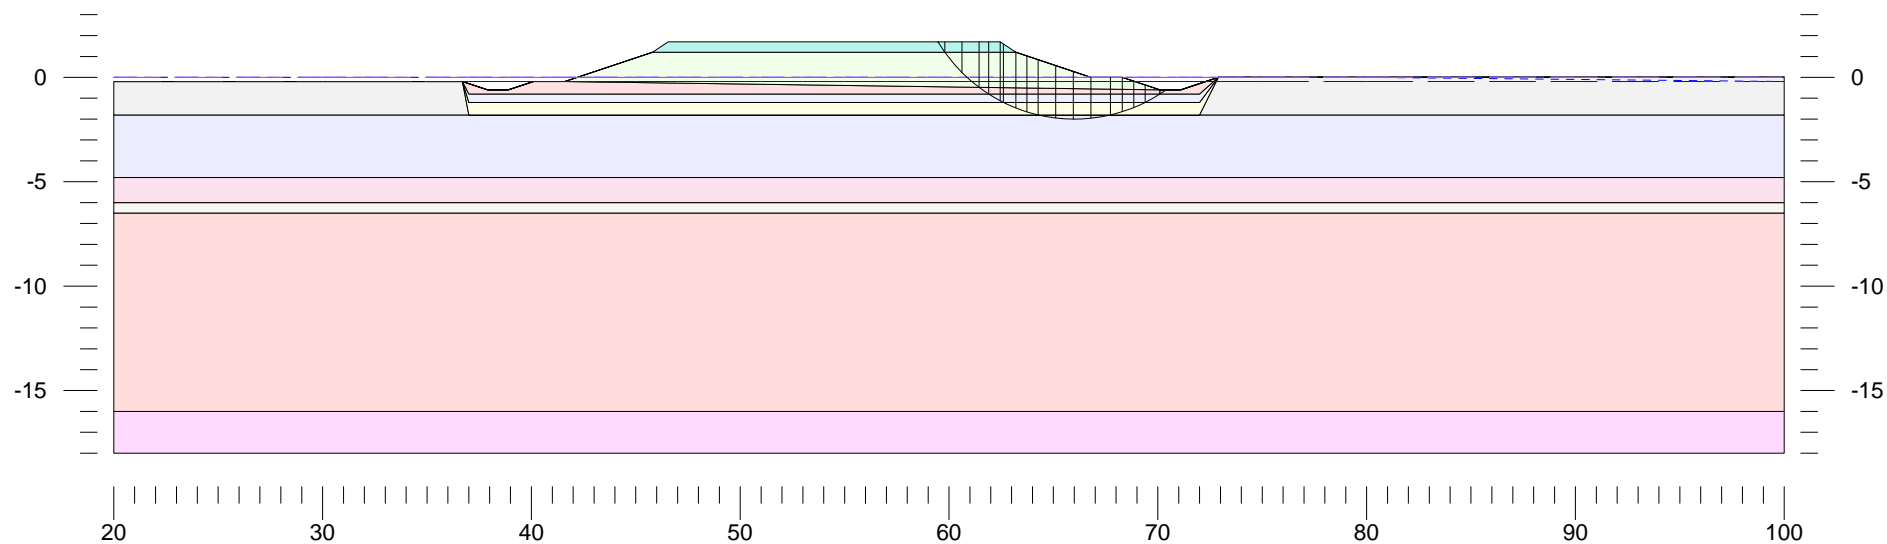
Thurber Engineering Ltd. - Toronto
19-5161-73
Black Creek Road Embankment Failure
January 25, 2010
Black Creek Road Sta.9+000 - 2m high Embankment (SSM Fill at 3H:1V)
Effective Stress Analysis - Long Term Condition
