**FOUNDATION INVESTIGATION REPORT
BOSTON CREEK BRIDGE REHABILITATION
NEW LISKEARD DISTRICT, ONTARIO
G.W.P. 5027-14-00, SITE NO. 47-098
Geocres Number: 31M-112**

Date: April 28, 2016

File: 19-5161-252

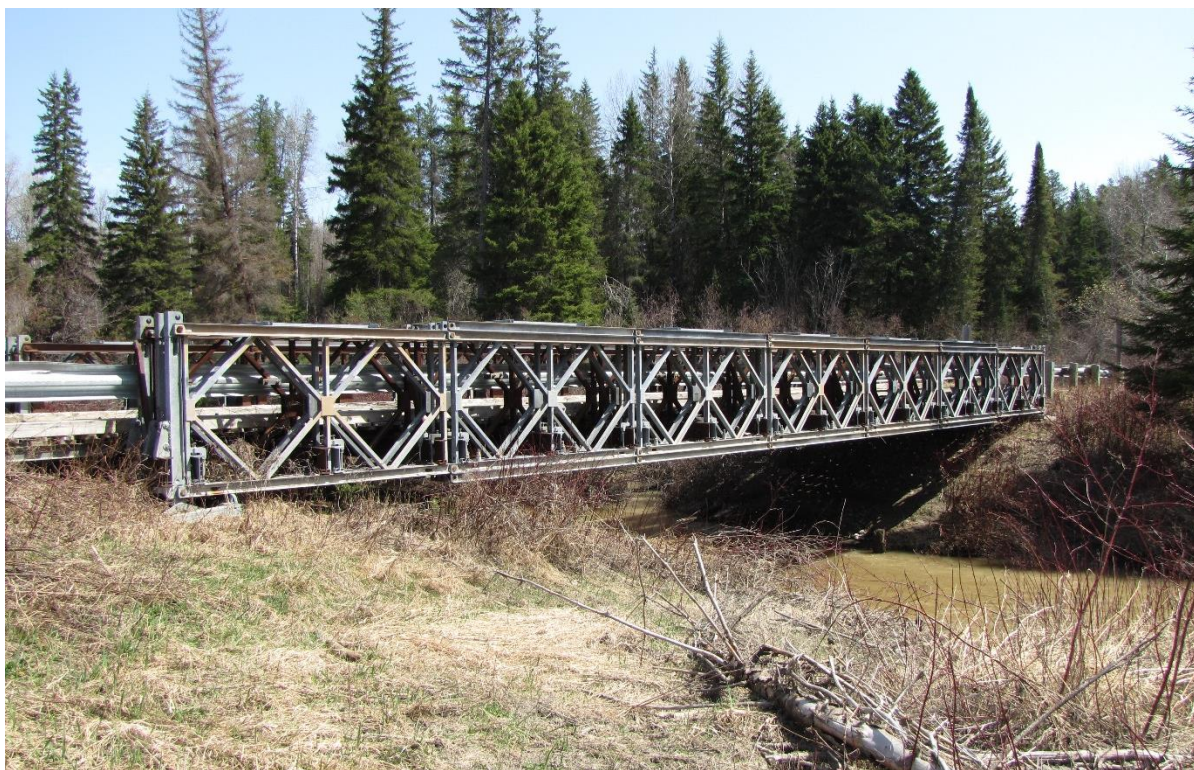
Photograph 3 – South Elevation Looking East

The existing bridge is a steel bailey bridge with a timber deck supported on timber sills. The approximate length and width of the structure is 21.6 and 3.4 m, respectively. The bridge was constructed in 1957. The structure is in fair condition; deterioration of the abutment walls and structural elements is evident.

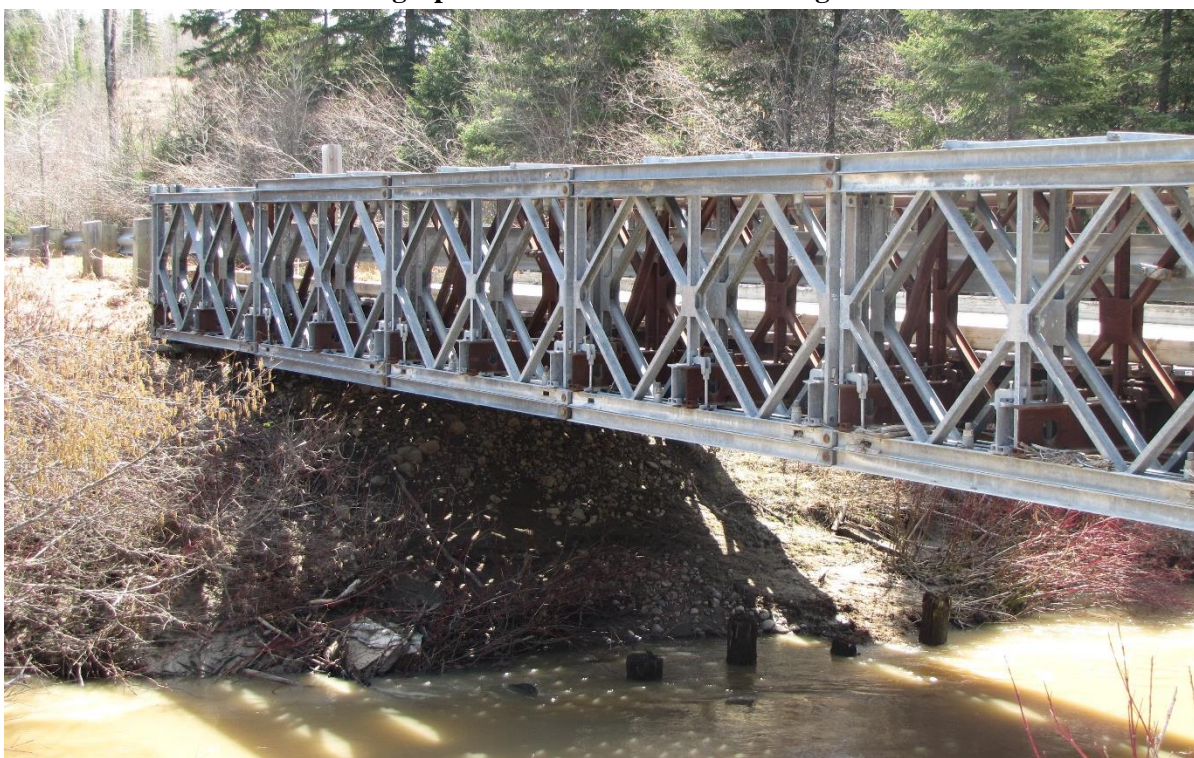
Photograph 4 – North Elevation Looking East

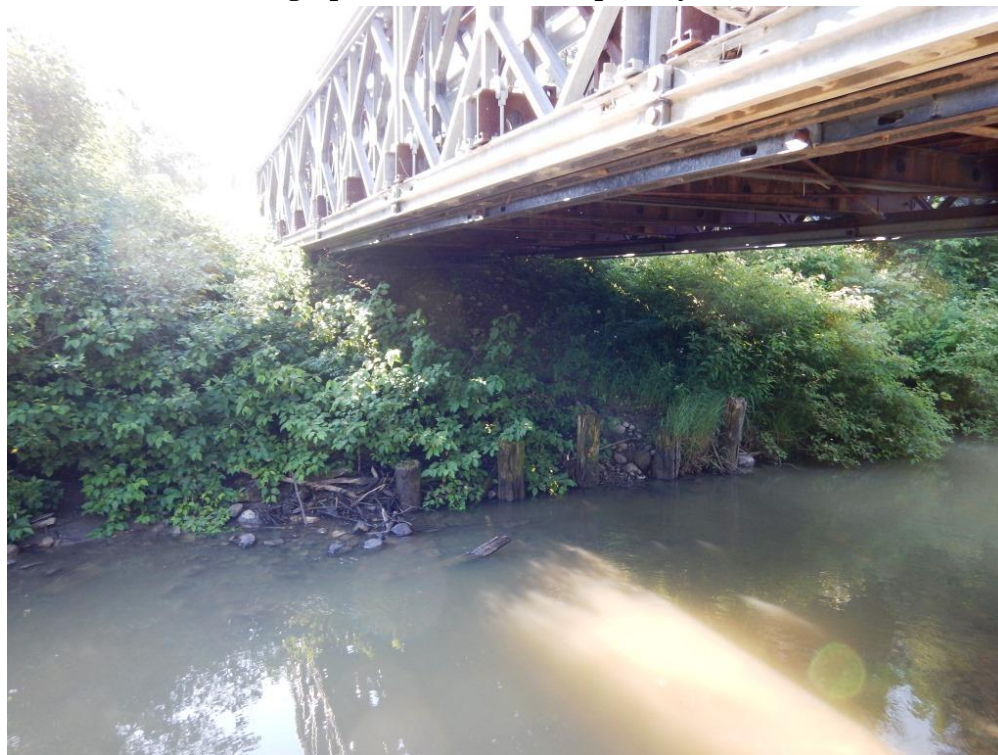
Photograph 6 - East Abutment, July 26, 2015
