THURBER ENGINEERING LTD.

FINAL
FOUNDATION INVESTIGATION REPORT
HIGHWAY 11 BULLEN CREEK CULVERTS, DISTRICT OF MUSKOKA
AGREEMENT NO. 5017-E-0003
Site Nos.: 42X-0034/C1 & 42X-0034/C2

G.W.P. 5138-13-00

Geocres No.: 31E-390

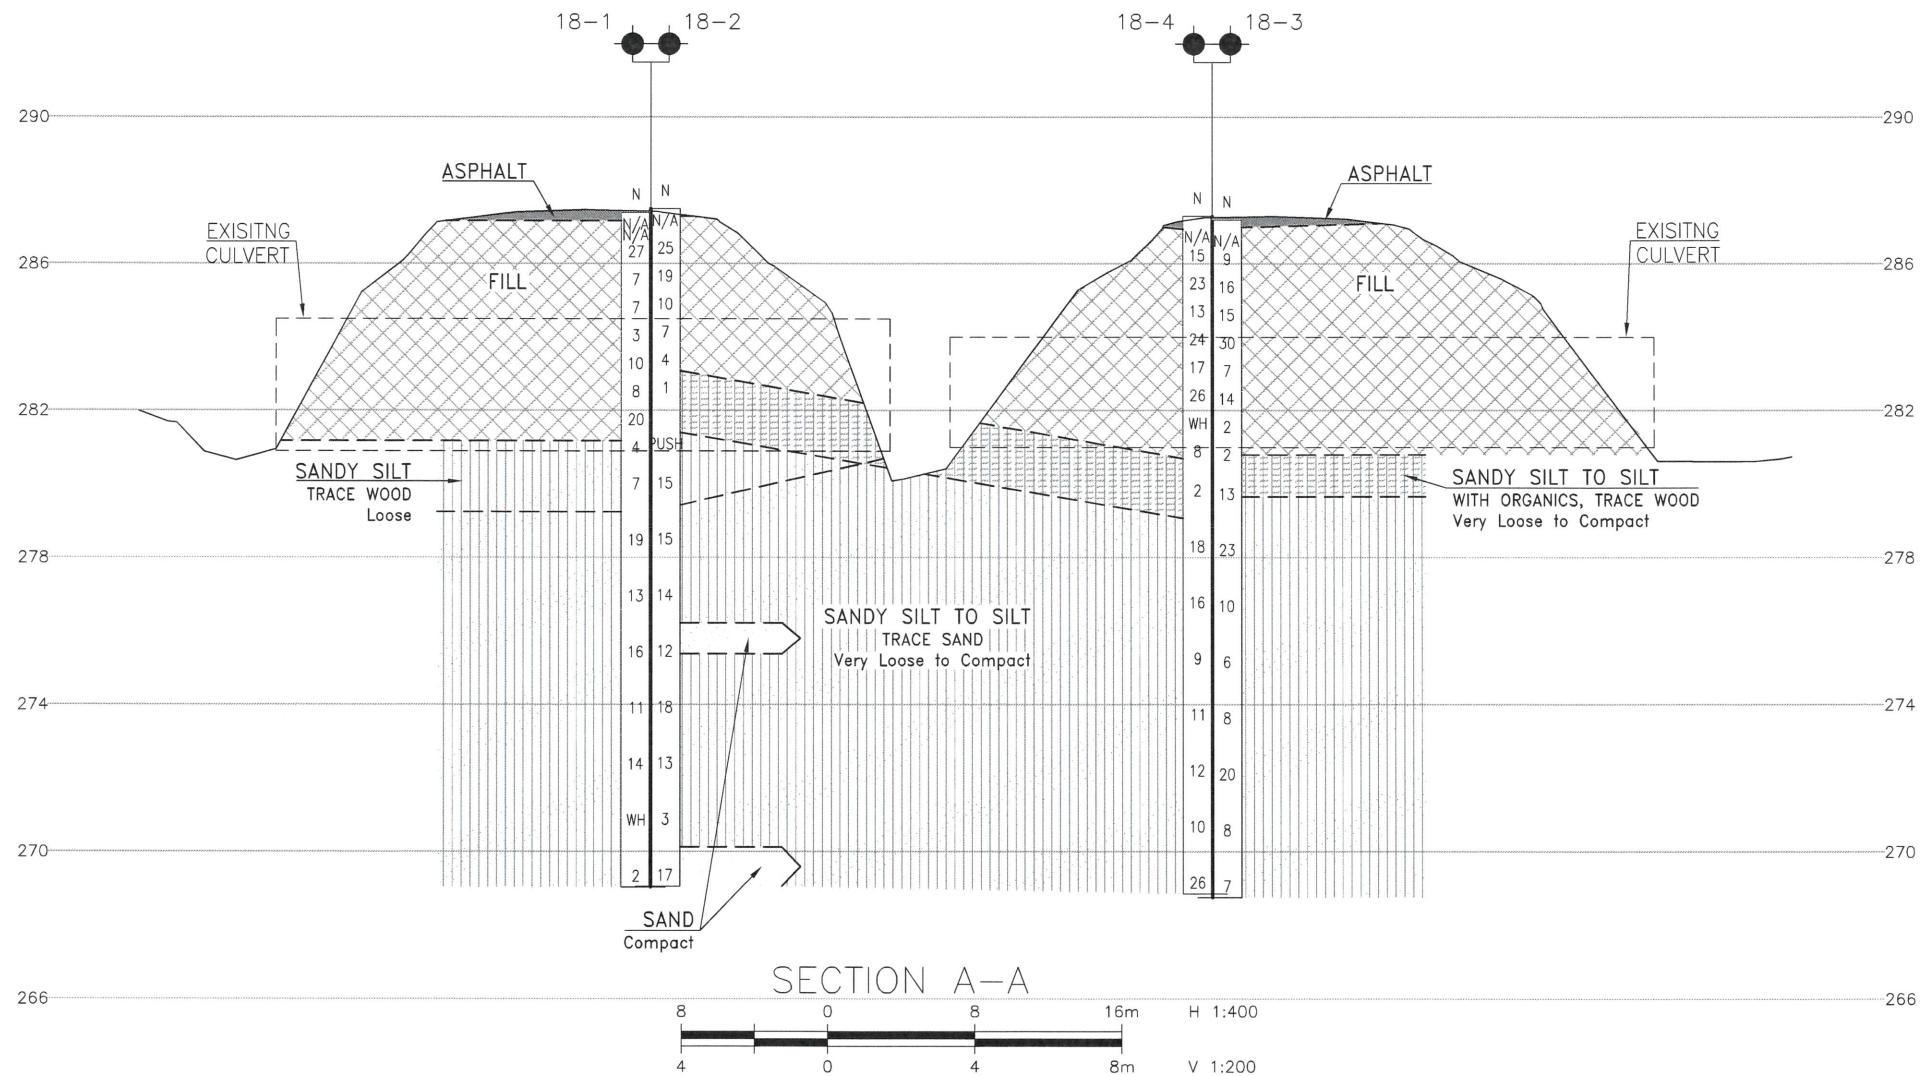
BULLEN CREEK
CULVERT REHABILITATION
BOREHOLE LOCATIONS AND SOIL STRATA

The approximate borehole locations are shown on the Borehole Locations and Soil Strata Drawing included in Appendix A. The coordinates and elevation of the boreholes are provided on this drawing and on the individual Record of Borehole sheets. The northing and easting (MTM zone 10), elevation, and termination depth of the boreholes are summarized below in Table 3-1. The borehole elevations were surveyed relative to benchmark VCP 313 (elev. 285.649 m) provided by MPCE, with a Nikon-AP-8 with an accuracy of +/- 1.5 mm. Horizontal locations were measured relative to existing site features.

Details of the encountered soil stratigraphy are presented on the Record of Borehole sheets included in Appendix B and the Borehole Location and Soil Strata drawing included in Appendix A. A general description of the stratigraphy, based on the conditions encountered in the boreholes, is given in the following paragraphs. However, the factual data presented on the Record of Borehole sheets takes precedence over this general description for interpretation of the site conditions. It must be recognized that the soil and groundwater conditions may vary between and beyond borehole locations.

NO	ELEVATION	NORTHING	EASTING
18-1	287.4	5 012 371.2	320 684.5
18-2	287.5	5 012 358.9	320 682.7
18-3	287.2	5 012 366.0	320 714.7
18-4	287.3	5 012 354.2	320 713.0

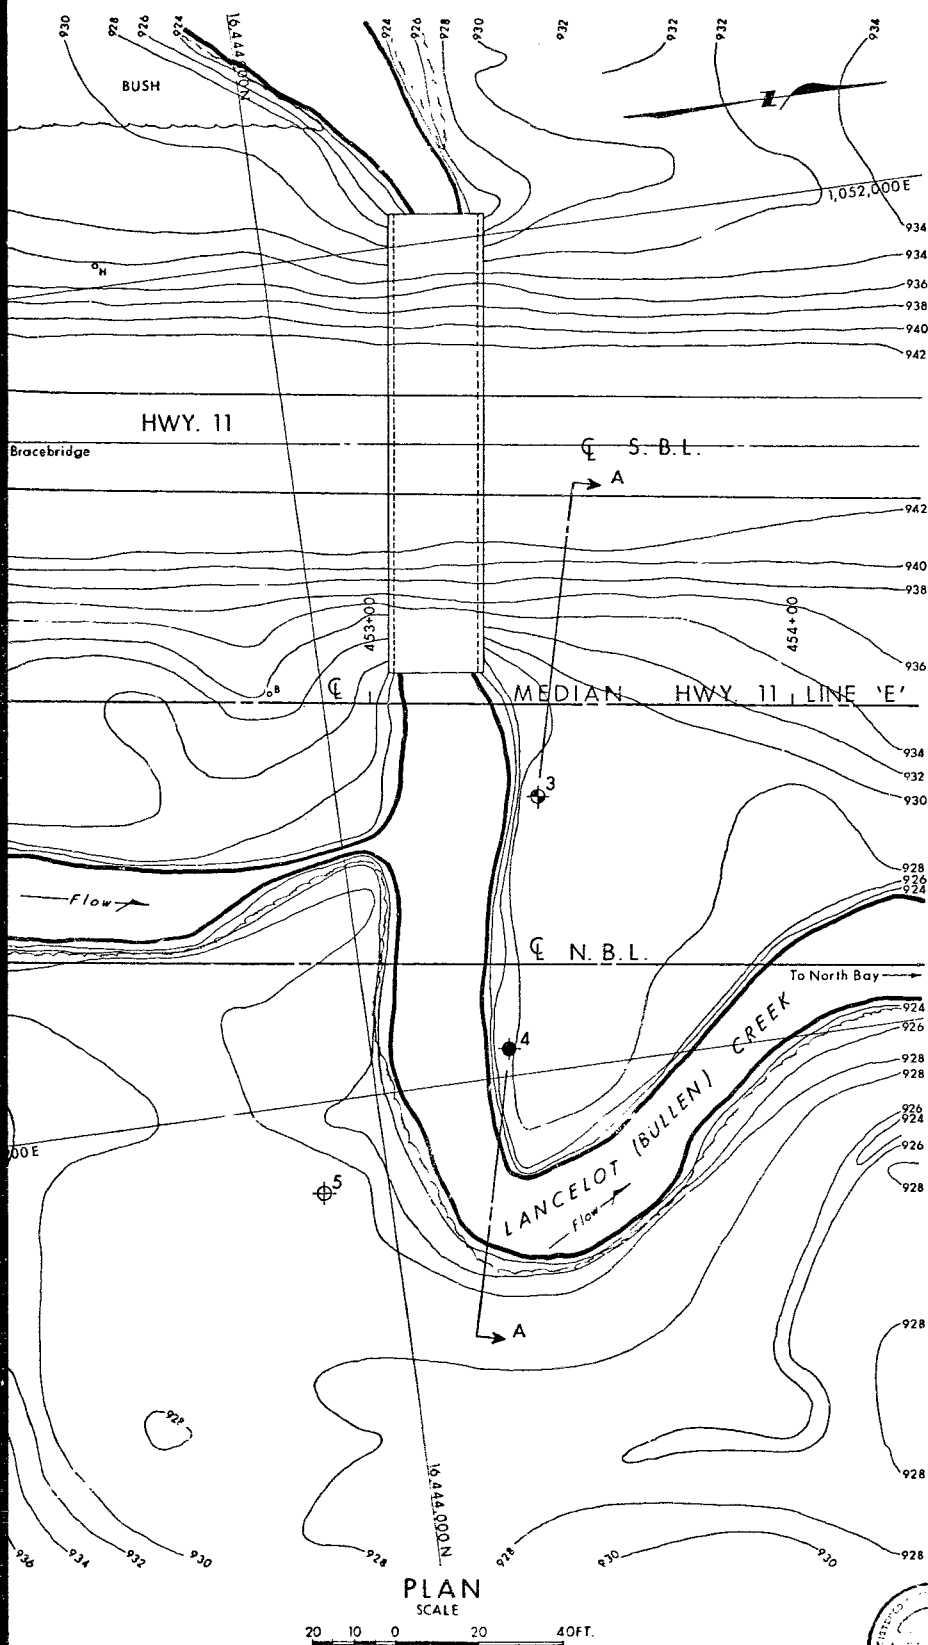
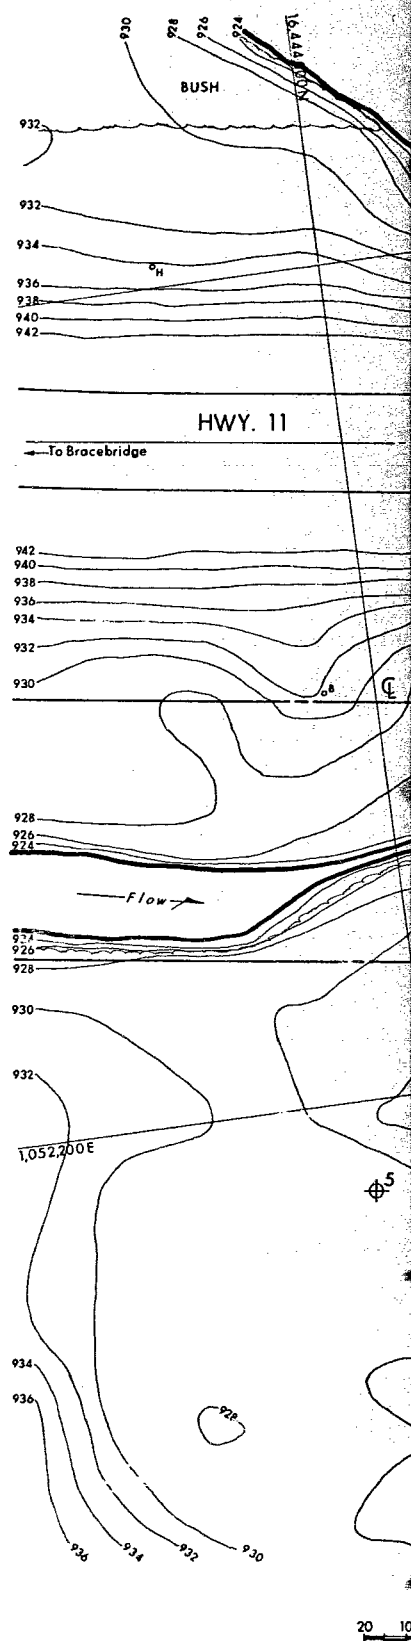
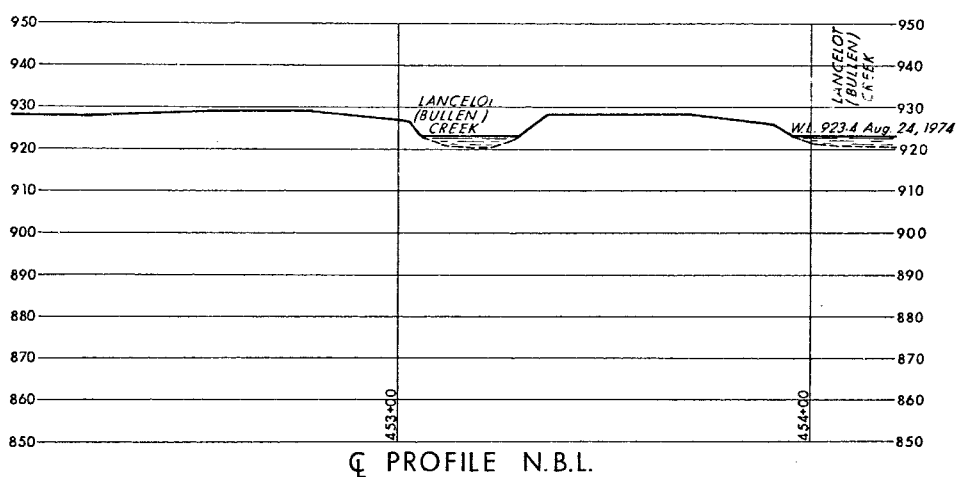
LANCELOT CREEK (BULLEN CREEK)

The historic boreholes from Geocres Report 31E-33 have also been included in Appendix B and their locations indicated on Drawing No. 1497301-B in Appendix A. The locations and ground surface elevation for these boreholes are approximate. It is expected that conditions have changed due to the roadway and culvert construction that have occurred since these holes were drilled in 1974, therefore the historic documents have not been included in the following descriptions.

SECTION A-A

NO.	ELEVATION	STATION	OFFSET
3	929.2	453+80	22' RT.
4	928.8	453+34	82' RT.
5	928.3	452+90	117' RT.

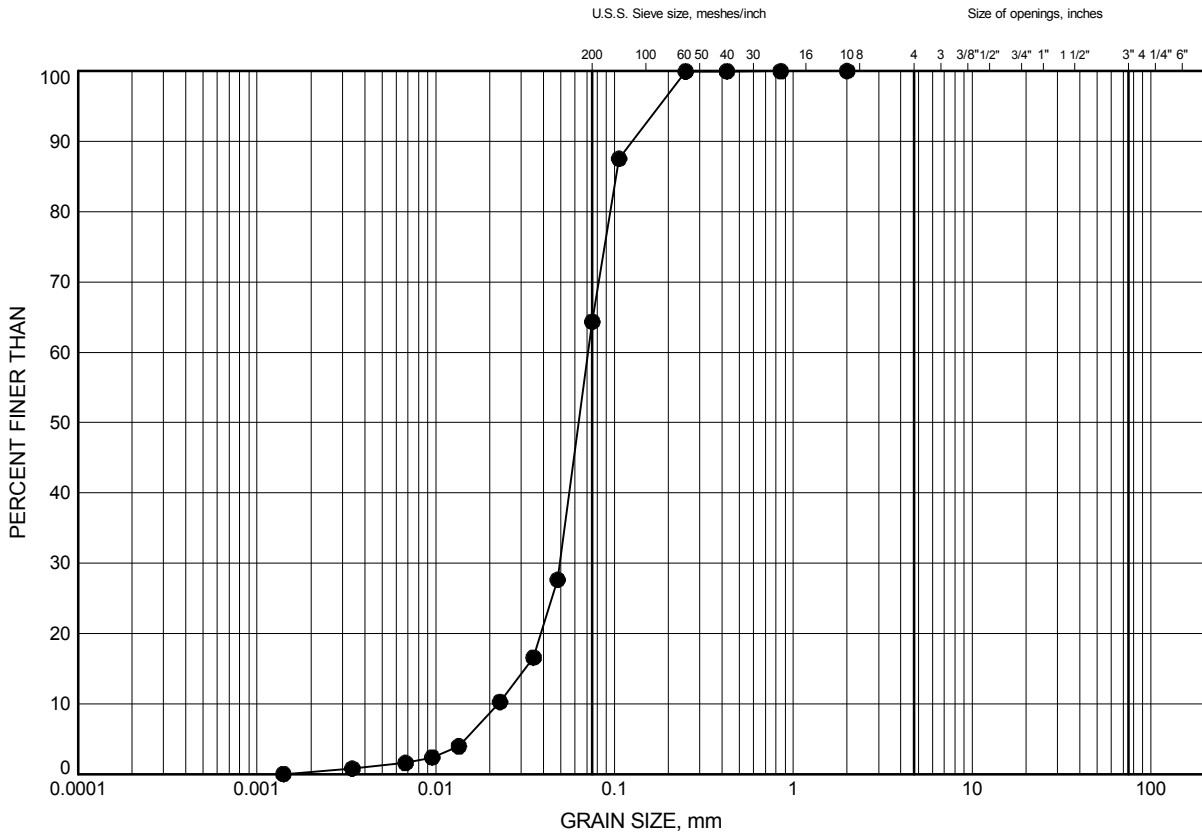
FIGURE C5

Recorded moisture contents ranged from 17 to 31%. Atterberg Limit testing on seven samples all indicated the material is non-plastic. The results of grain size analyses conducted on seven samples of the silt are summarized below and illustrated on Figures C4 and C5 in Appendix C.

SILT (ML) to SANDY SILT (ML)
