Foundation Investigation and Design Report

Temporary Works - Nicolston Culvert Rehabilitation

Highway 89, Alliston, Simcoe County, Ontario

CA0020332.0247-Fnd-R03-Rev0

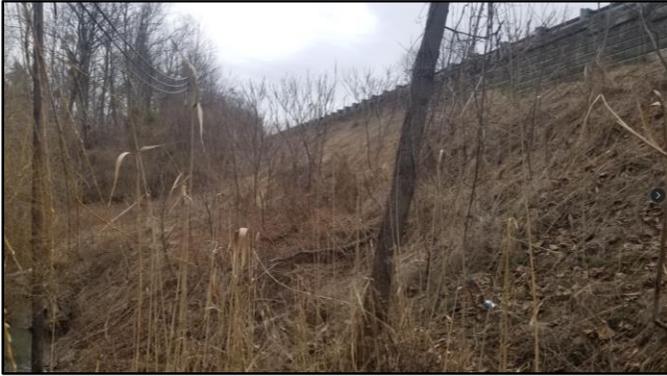
Photograph 1 – North access road location, looking east (Spring 2024)

approximately 6 m to 9 m high, with existing side slopes of about 2 Horizontal : 1 Vertical (2H:1V). There is an existing retaining wall (up to about 1.5 m high) at the crest of the embankment on the north side of Highway 89. The retaining wall was assessed as part of a separate study for this project and is considered to be performing satisfactorily with no signs of distortion or distress. The existing conditions at the proposed locations of the temporary access roads are shown in Photographs 1 and 2 below.

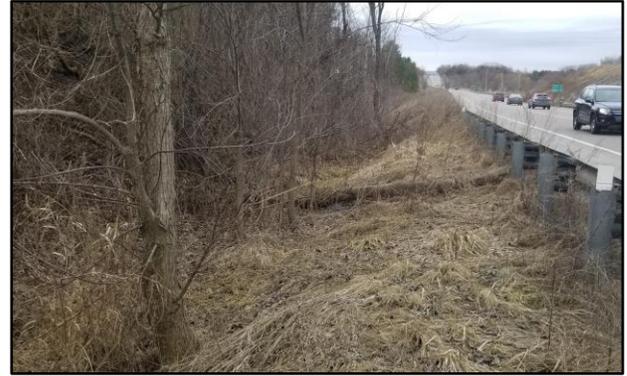
Photograph 2 – South proposed access road location, looking west (Spring 2024)

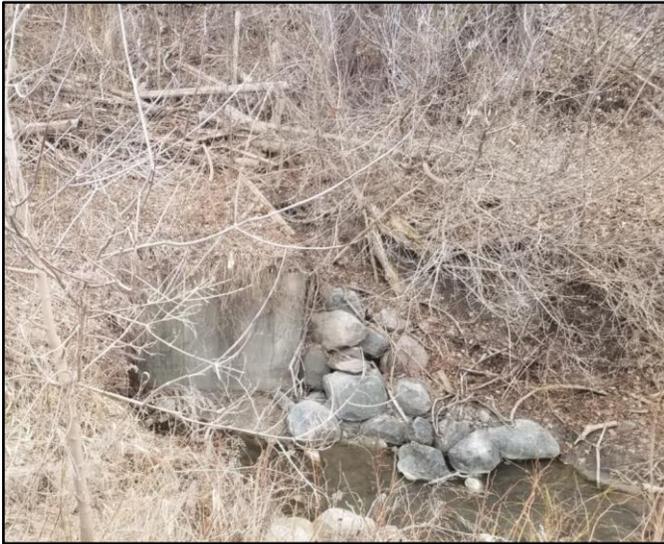
Photograph 3 – North culvert inlet, looking northwest (erosion near northeast side of culvert not shown) (Spring 2024)

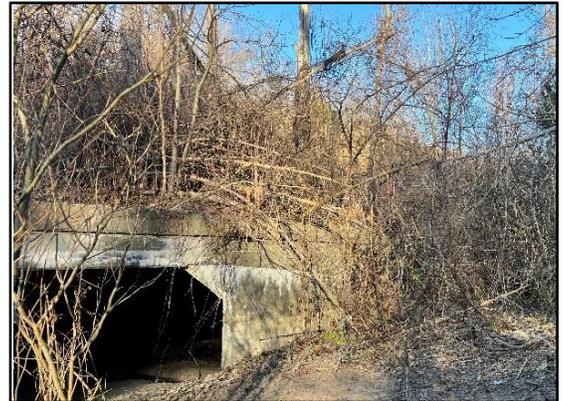
Photograph 4 – South culvert outlet, looking northeast (erosion near headwall) (Fall 2024)

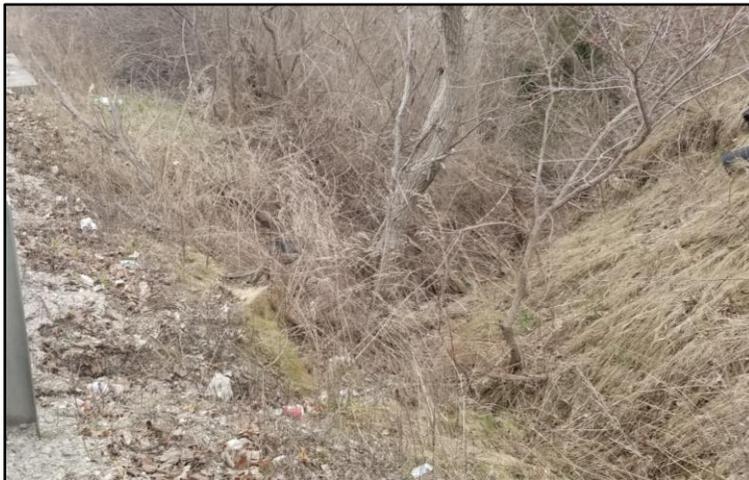
Photograph 5 – erosion east of the retaining wall, looking northwest (Spring 2024)

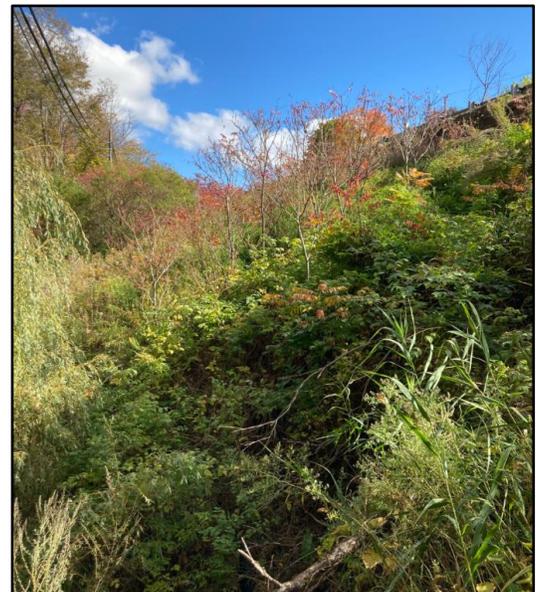
Photograph 6 – North embankment slope below retaining wall (Early Fall 2023)

Based on observations during the field investigation and the site reconnaissance of the existing retaining wall discussed in WSP's retaining wall technical memorandum³, the existing Highway 89 embankment side-slopes in the vicinity of the culvert inlet / outlet and proposed access roads appear to generally be performing adequately and visual signs of instability or active erosion were limited to some localized zones within the tributary watercourse channel near the headwall / wingwall at the inlet (north) side (see Photograph 3) and above the headwall at the outlet (south) side (see Photograph 4). Localized erosion of the natural drainage path leading from the Highway 89 ditch to the watercourse tributary, east of the retaining wall, was also observed (see Photograph 5). The majority of the embankment slope between the base of the retaining wall and the bottom of the embankment slope appeared to be stable and was heavily vegetated at the time of observation (see Photograph 6).

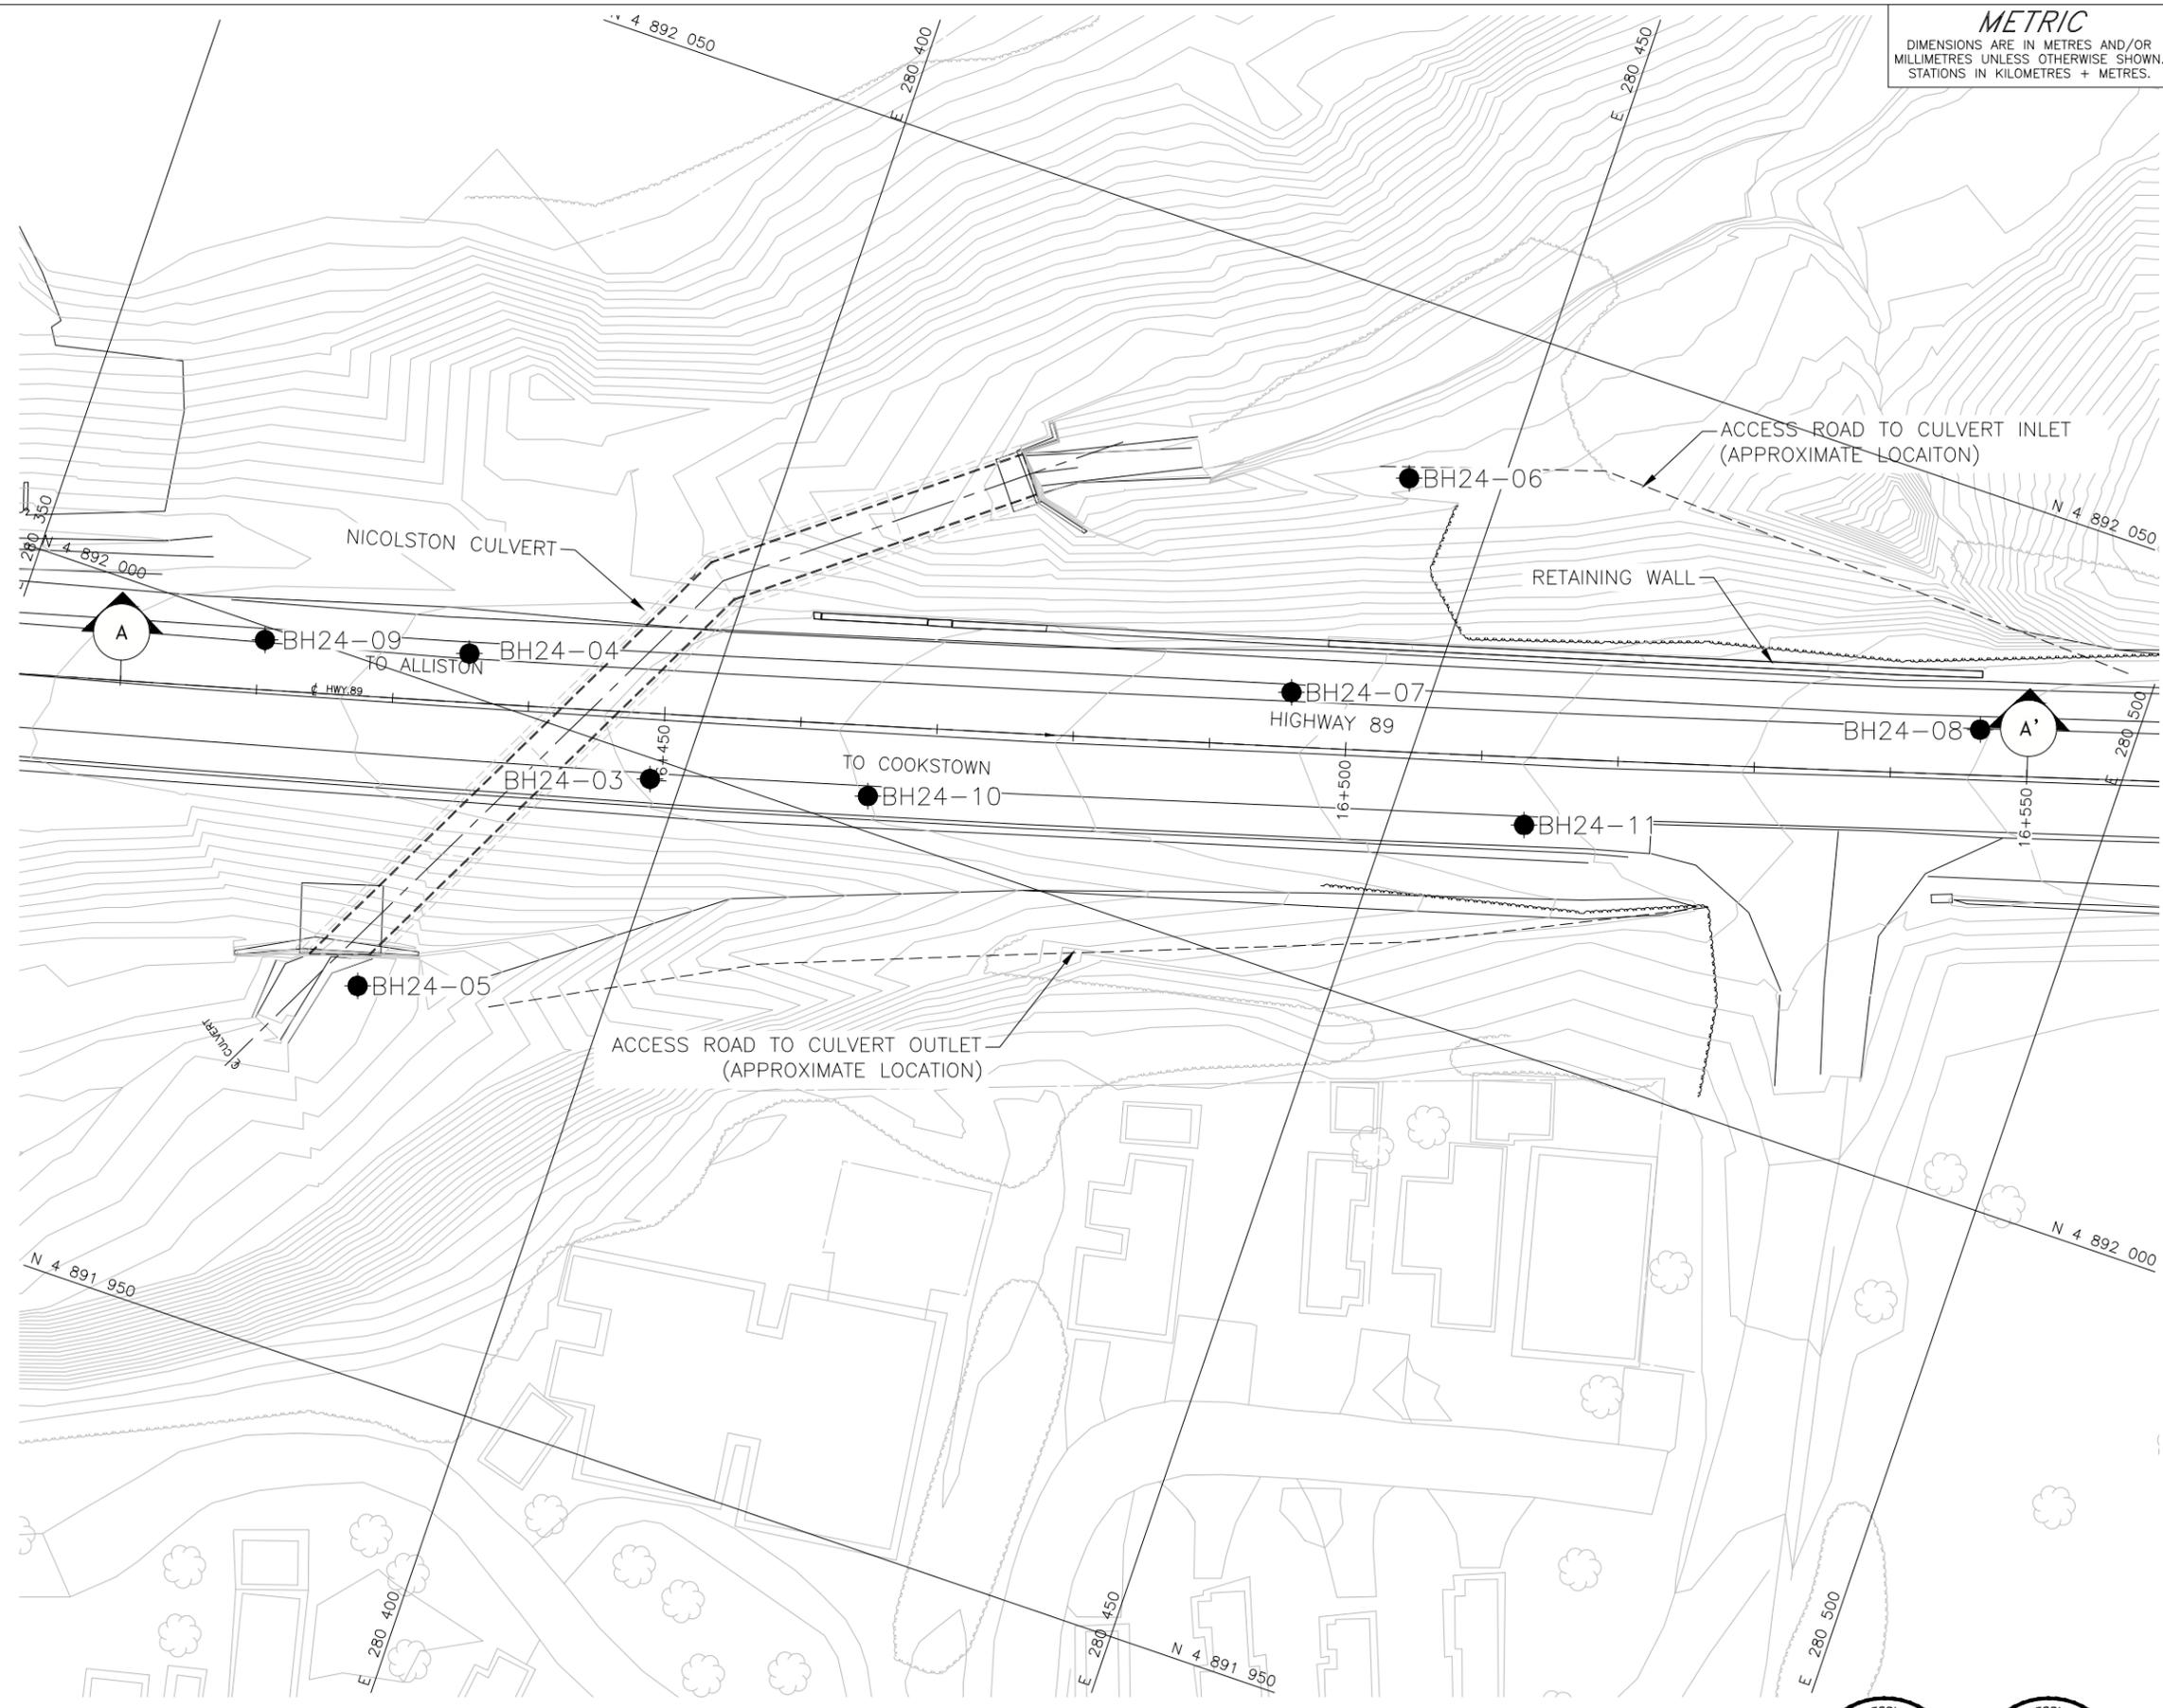
HIGHWAY 89
 NICOLSTON CULVERT TEMPORARY WORKS
 BOREHOLE LOCATIONS PLAN

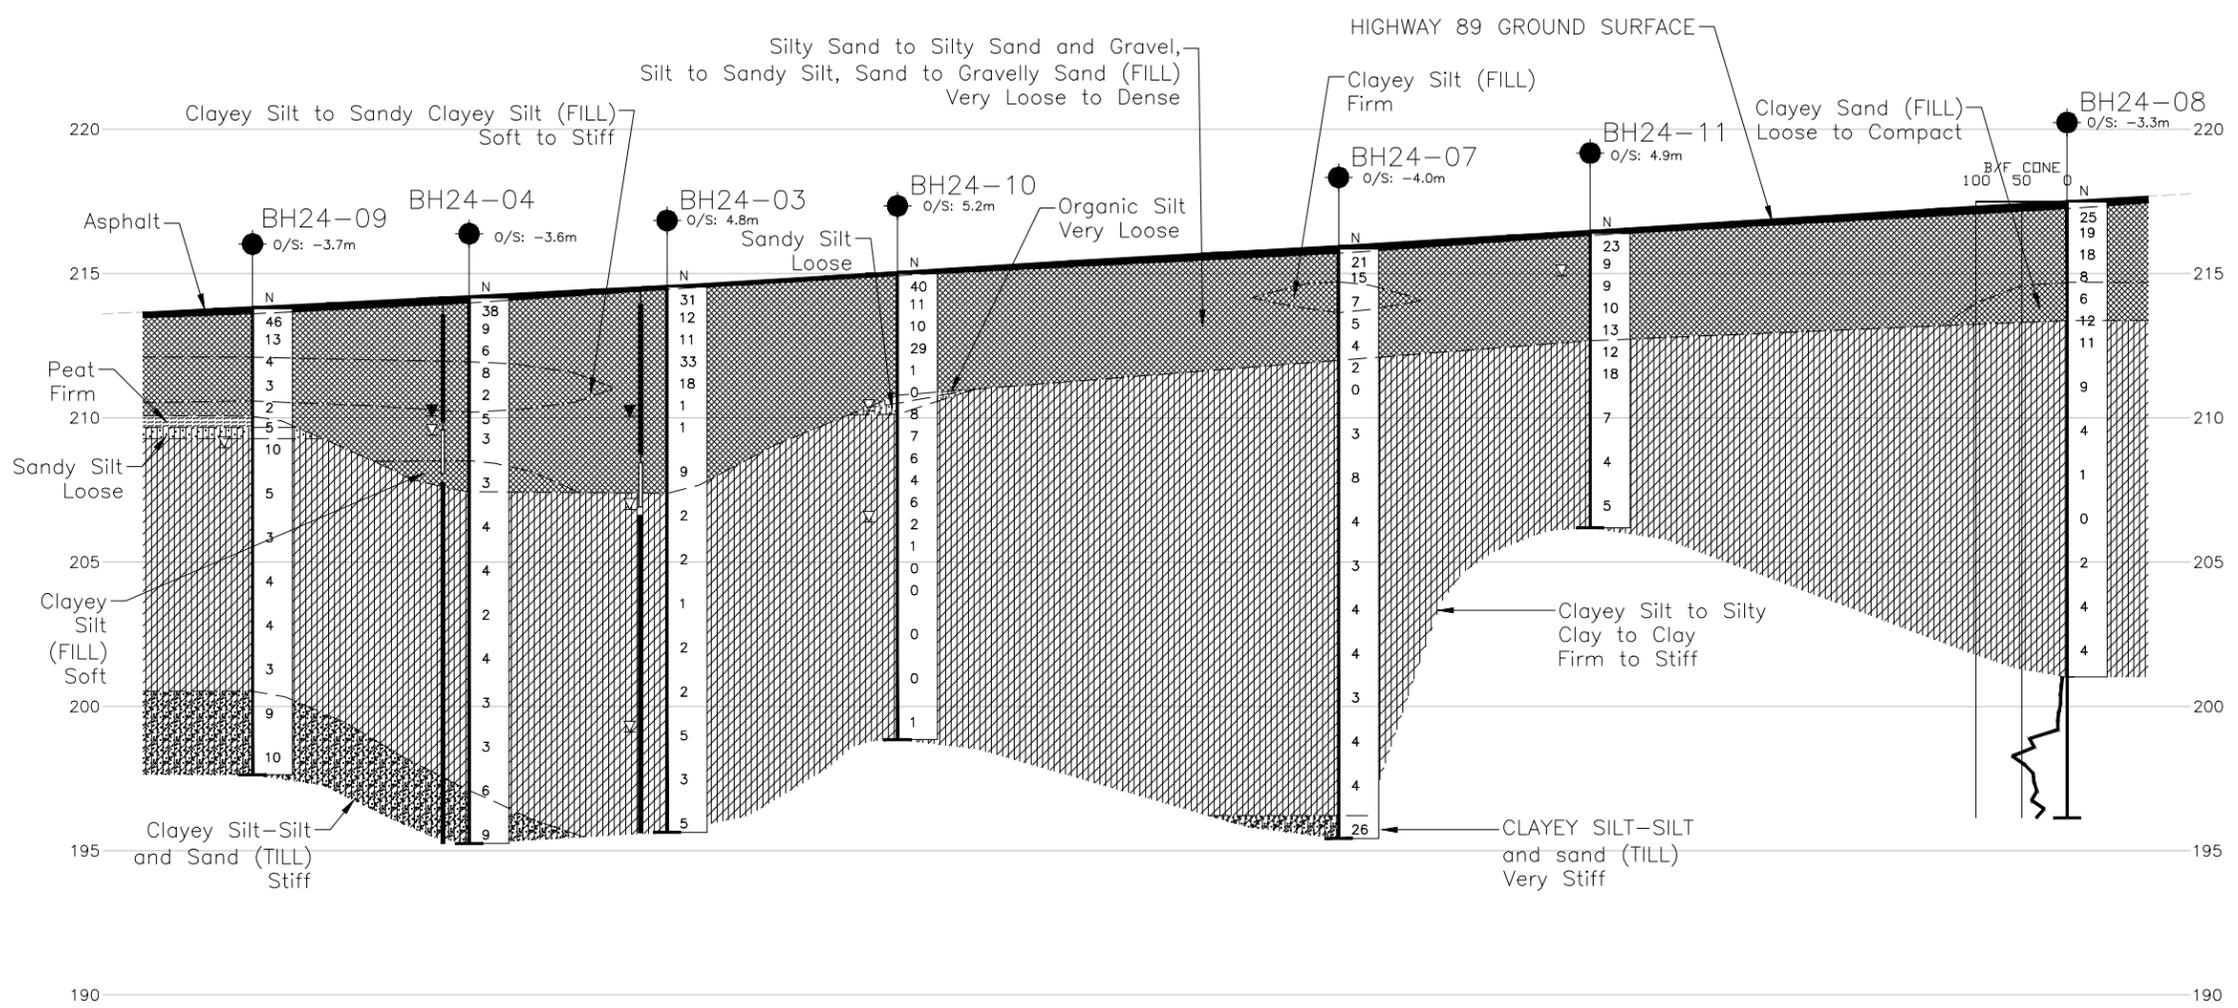
PROFILE A-A'

CONT No. WP No. 2014-23-01
HIGHWAY 89 NICOLSTON CULVERT TEMPORARY WORKS
SOIL STRATA

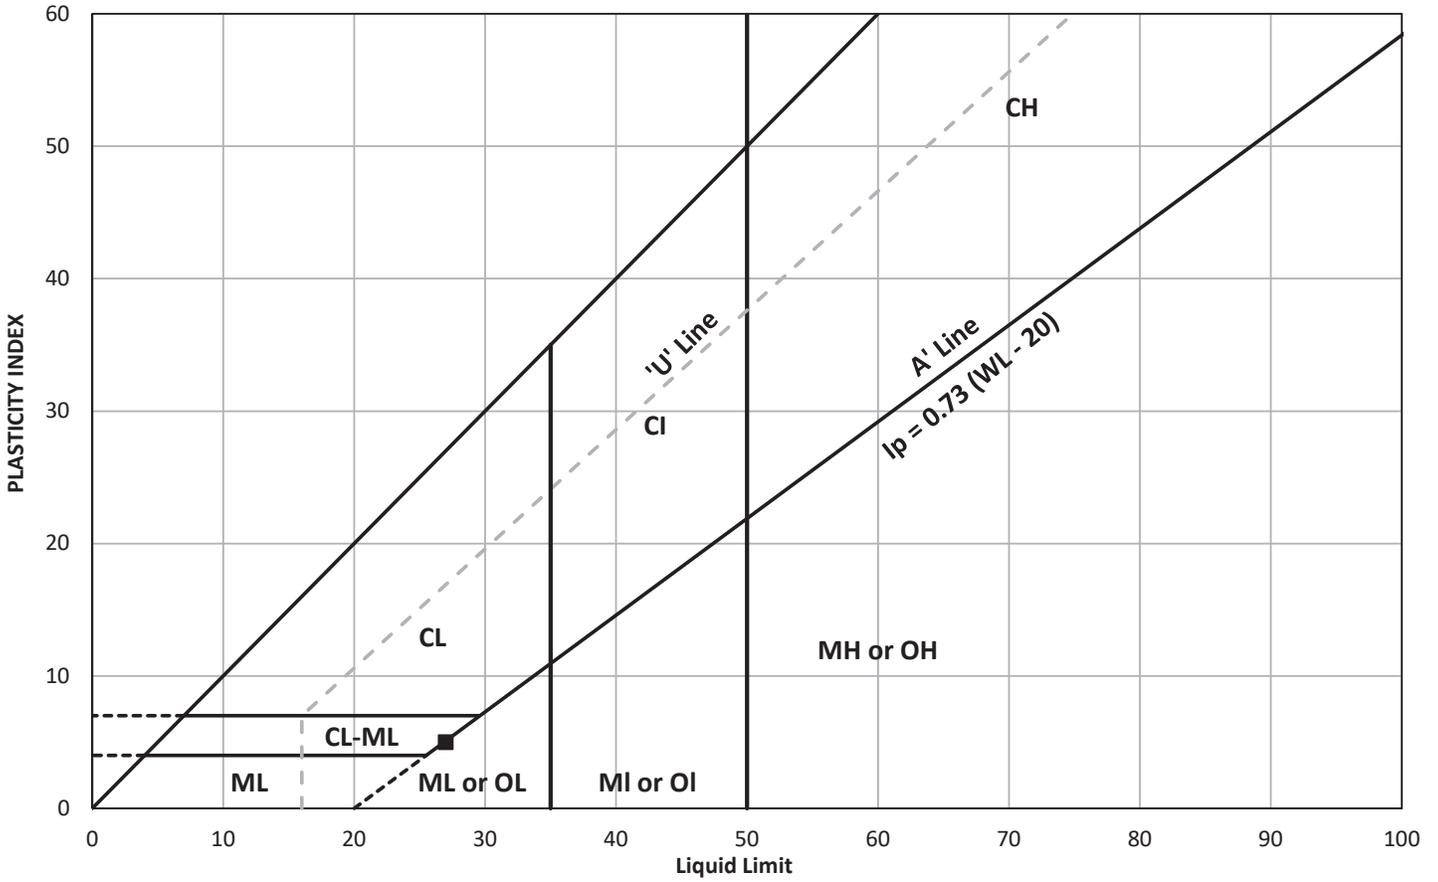
Sample Location	Sample / Specimen Number	Depth (m)	Natural Water Content (%)	Liquid Limit	Plastic Limit	Plasticity Index	Liquidity Index
■	BH24-03	8B	6.4 - 6.7	26.7	27	22	5	0.94

TITLE
Sandy SILT (ML) to SILTY SAND (SM) - FILL
 PROJECT NO. CA0020332.0247
 CONTROL: 0
 REV.: 0
 FIGURE: B2

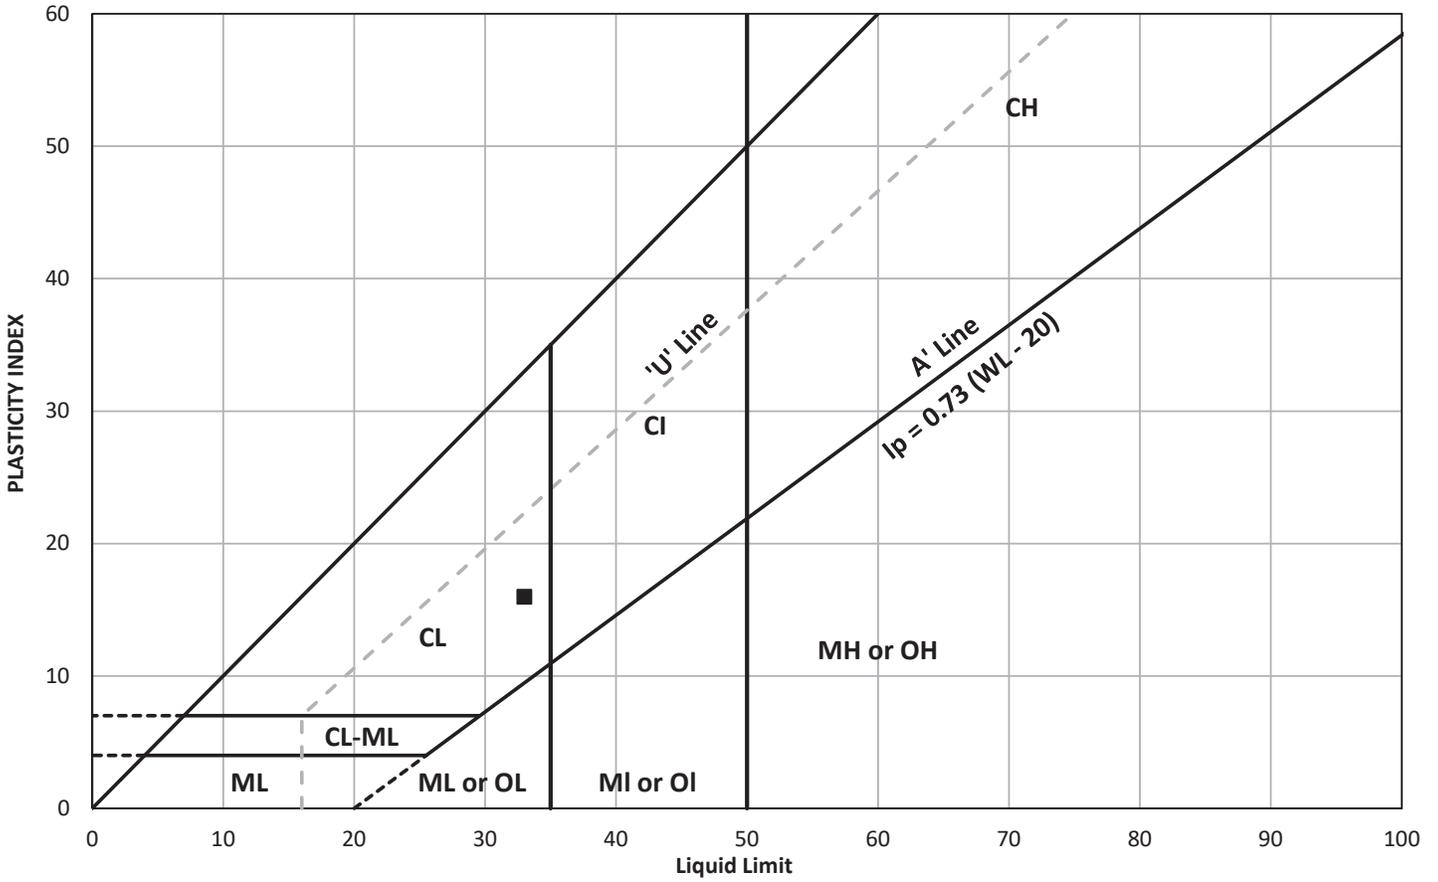
Sample Location	Sample / Specimen Number	Depth (m)	Natural Water Content (%)	Liquid Limit	Plastic Limit	Plasticity Index	Liquidity Index
■	BH24-09	4	2.4 - 2.9	25.4	33	17	16	0.53

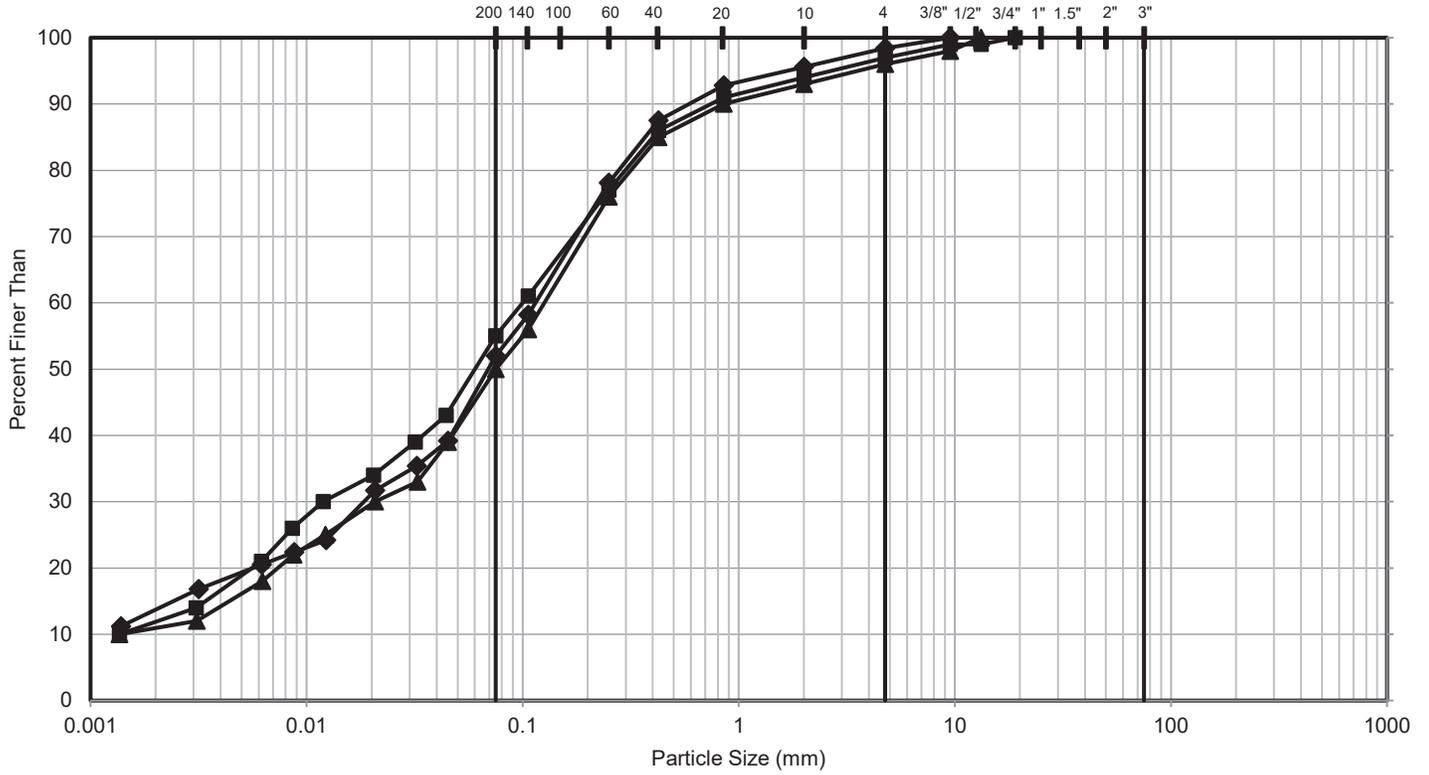
Symbol	Sample Location	Sample Number	Depth (m)	Elevation (m)
■	BH24-09	13	13.7 - 14.3	200.1 to 199.5
◆	BH24-07	17	19.8 - 20.4	196.0 to 195.4
▲	BH24-04	16	18.3 - 18.9	195.9 to 195.3

TITLE
CLAYEY SILT - SILT (CL-ML) - TILL
 PROJECT NO. CA0020332.0247 CONTROL 0 REV. 0 FIGURE B7

The natural moisture content measured on three samples of the clayey silt-silt till deposit was between about 9% and 11%.

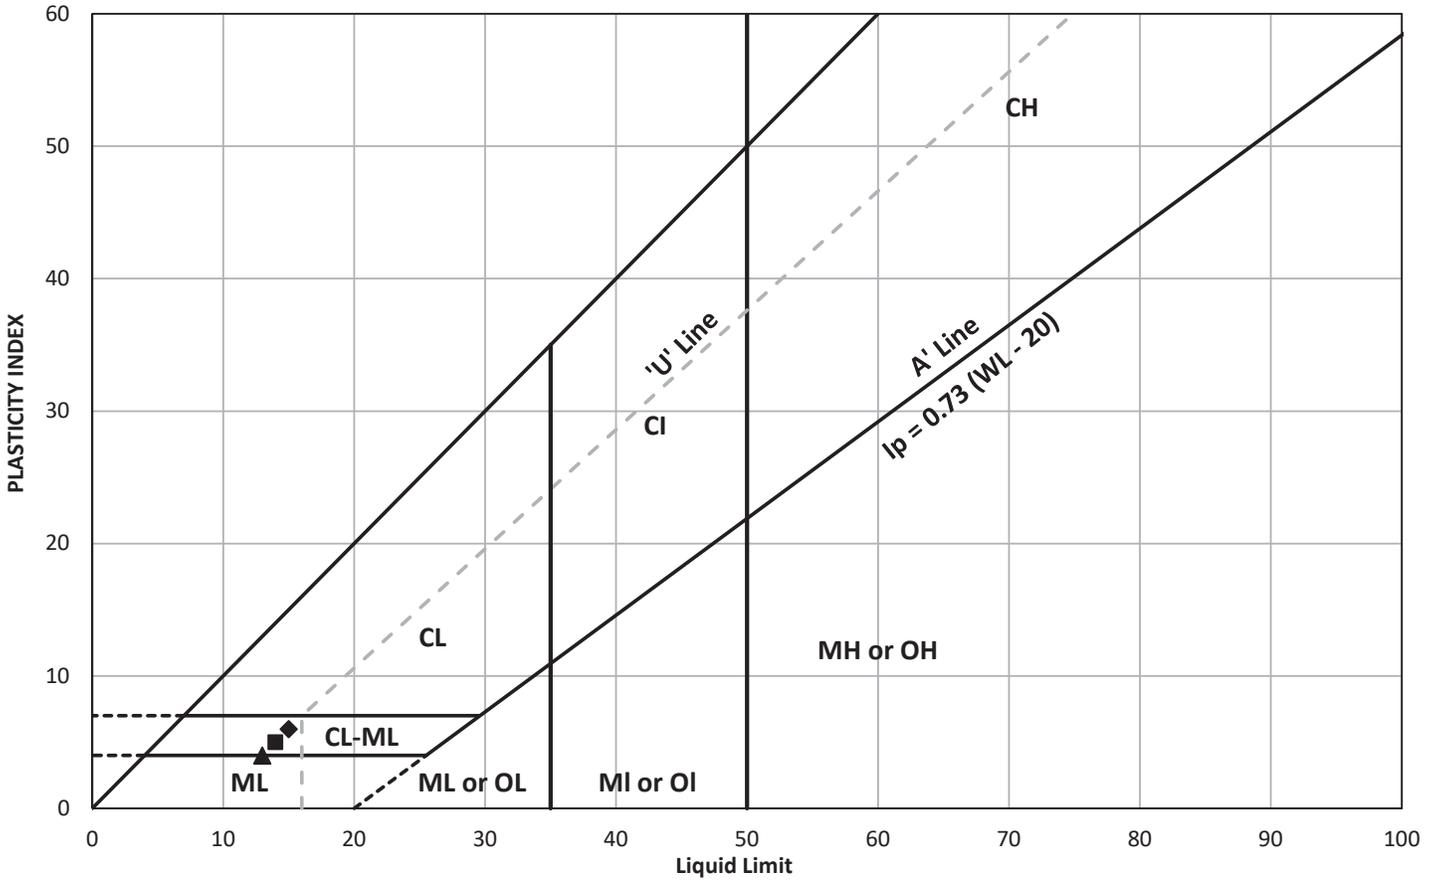
Sample Location	Sample / Specimen Number	Depth (m)	Natural Water Content (%)	Liquid Limit	Plastic Limit	Plasticity Index	Liquidity Index
■	BH24-09	13	13.7 - 14.3	10.7	14	9	5	0.34
◆	BH24-07	17	19.8 - 20.4	9.5	15	9	6	0.08
▲	BH24-04	16	18.3 - 18.9	9.3	13	9	4	0.08

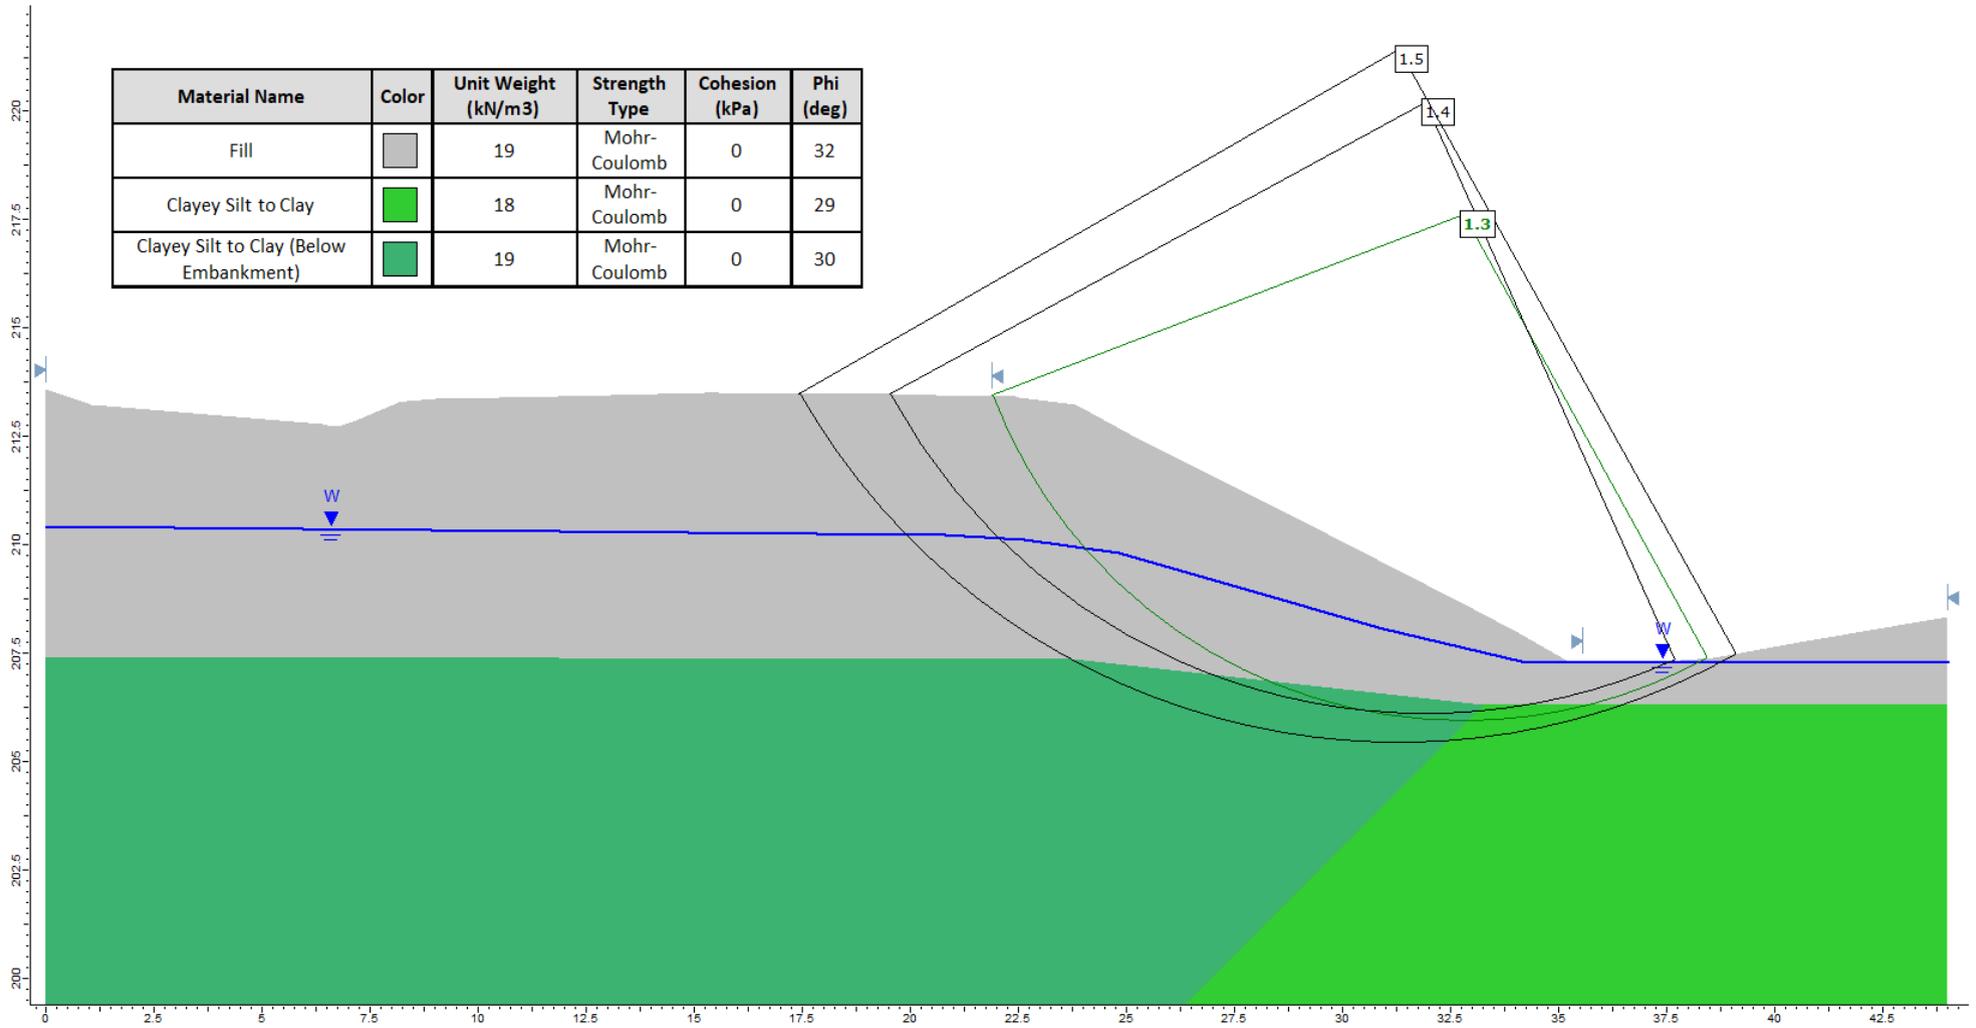
Stability Analysis Results (Drained Condition) Existing South Embankment Slope

EXISTING EMBANKMENT CONFIGURATION: Based on the results of the analyses, the Factor of Safety (FoS) against global instability for the existing embankment is about 1.3 for the long-term (drained) conditions for slip surfaces passing through the travelled highway at the south and north embankment slopes (see Figure D1 and D3). The FoS for short-term (undrained) conditions for the existing embankment, although not considered to be applicable given that excess pore pressures have dissipated, was checked at the south and north embankments and indicates a factor of safety of 1.8 and 1.2 (see Figure D2 and D4), respectively. Factors of safety equal to 1.3 and as low as 1.2 are considered typical for long-term and short-term conditions for existing highway

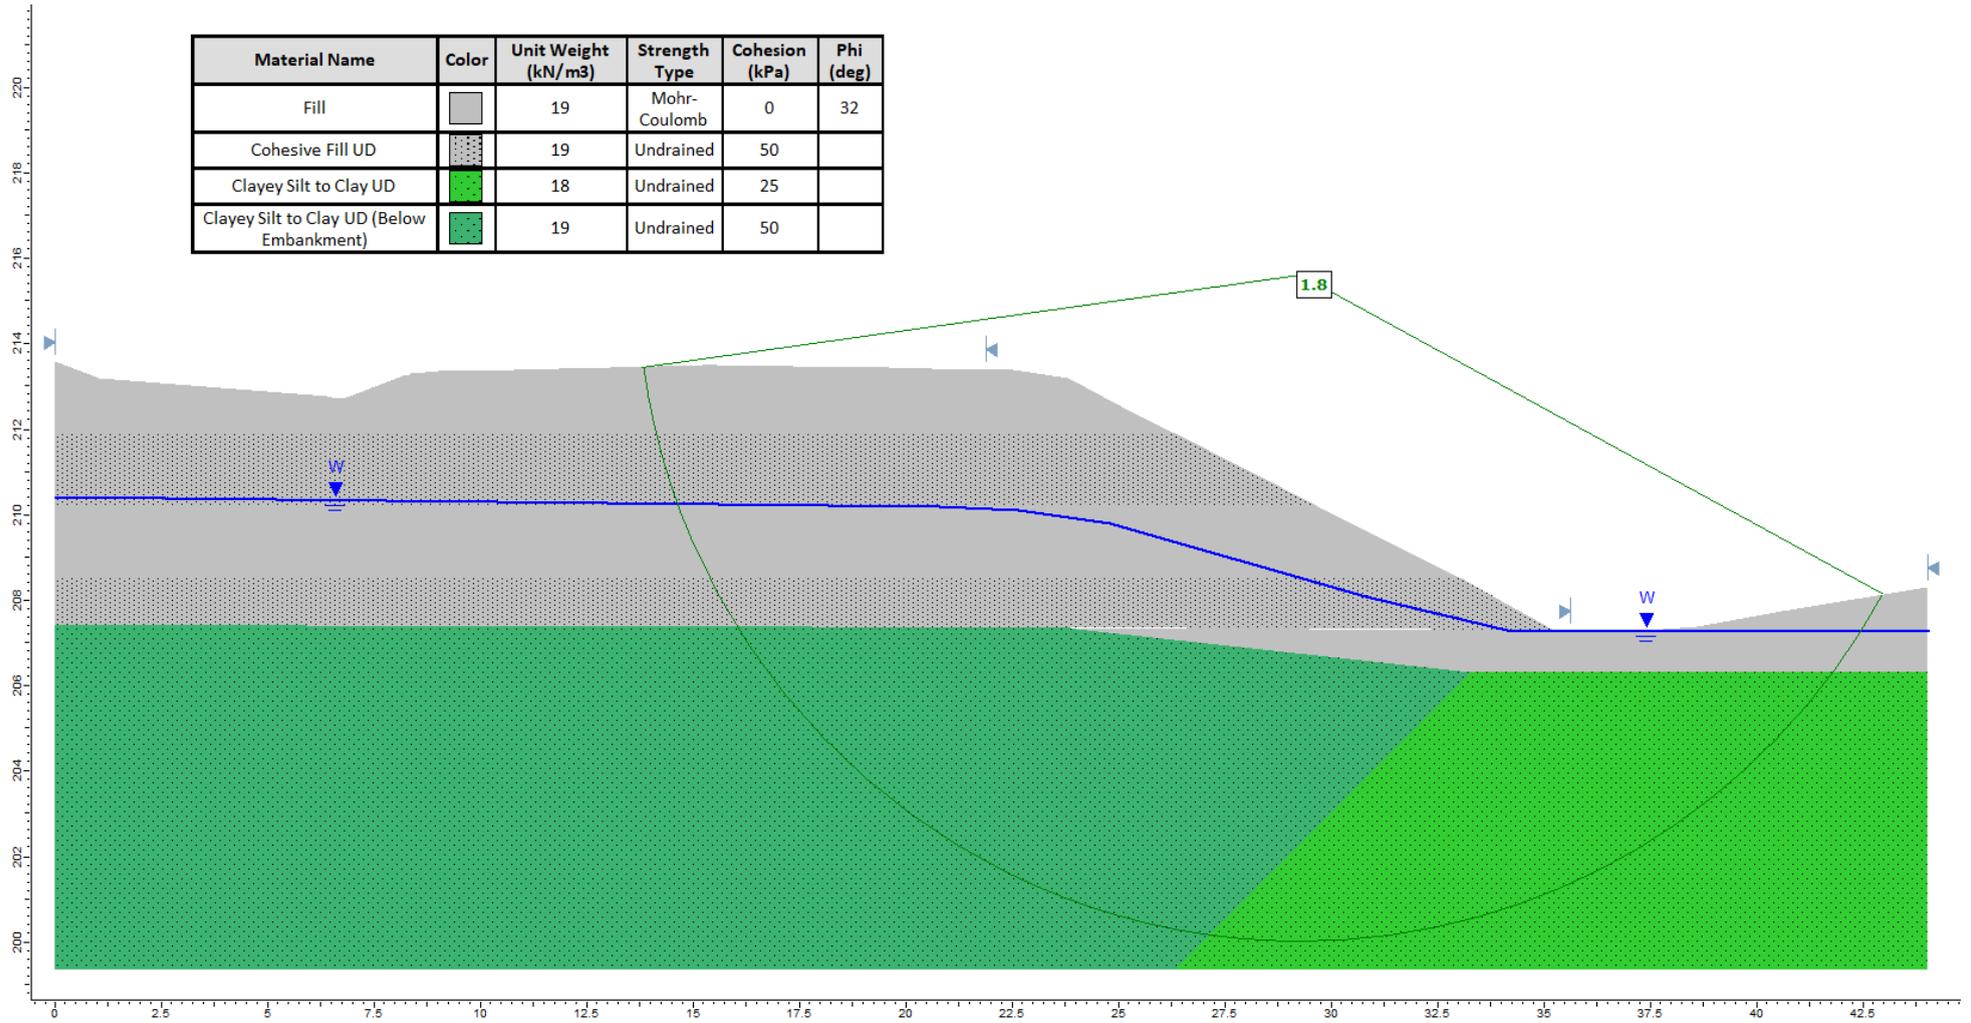
Figure D2

Stability Analysis Results (Undrained Condition) Existing South Embankment Slope

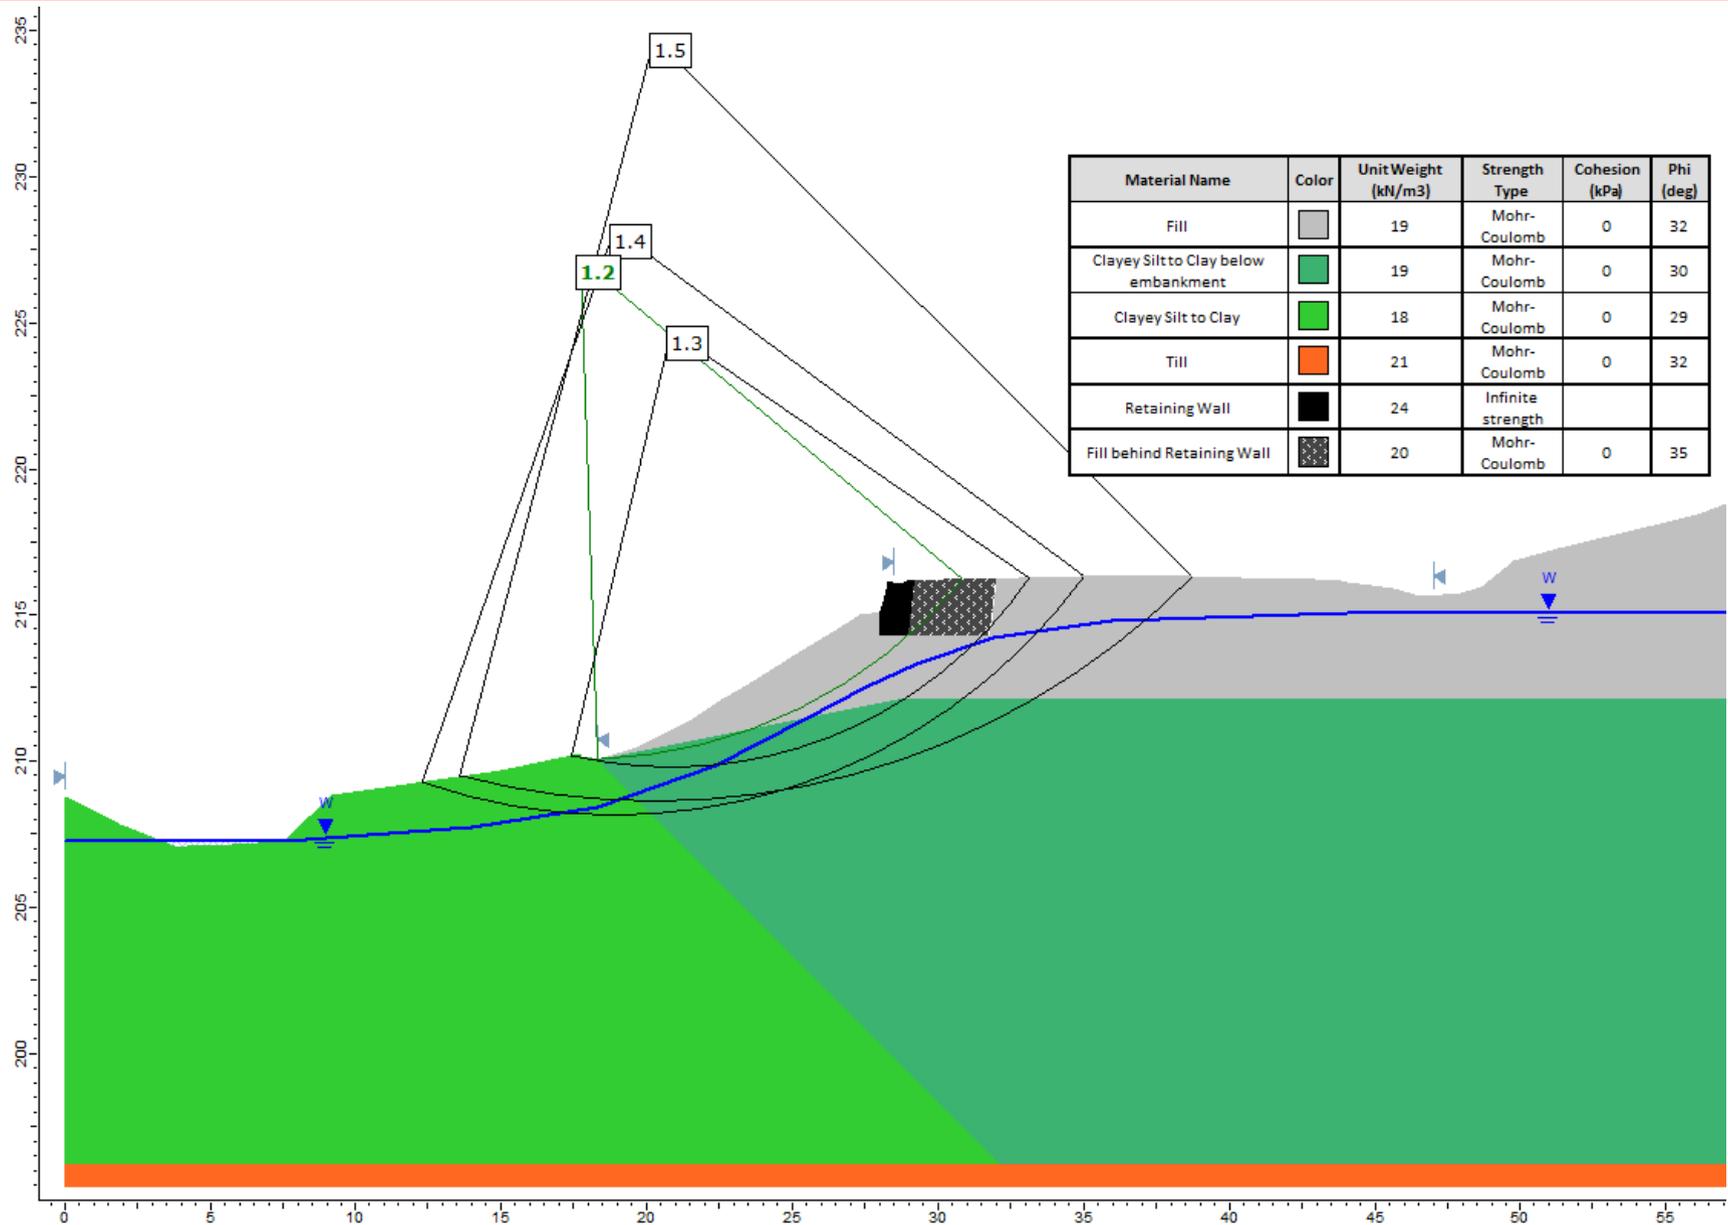
Figure D3

Stability Analysis Results (Drained Condition) Existing North Embankment Slope

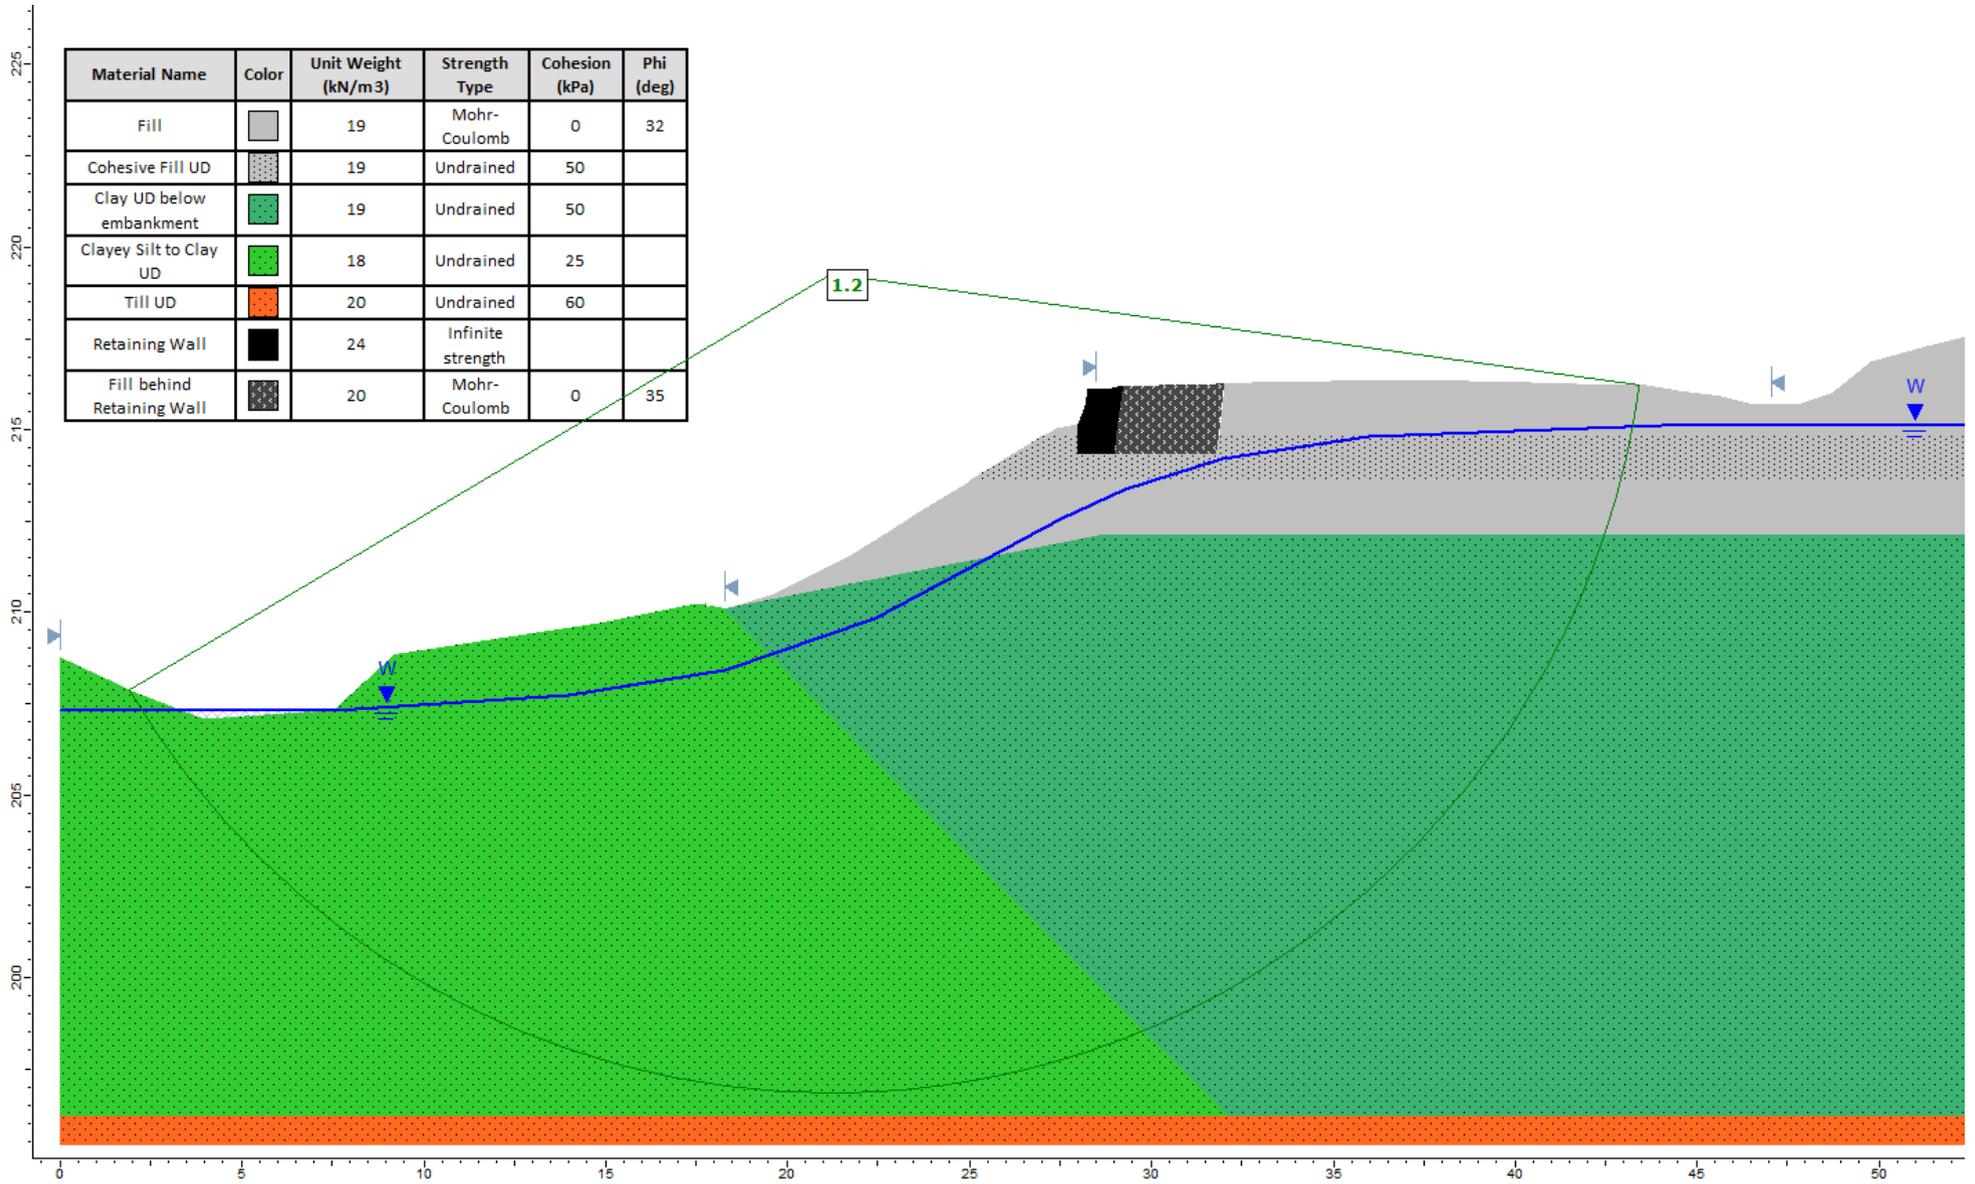
Figure D4

Stability Analysis Results (Undrained Condition) Existing North Embankment Slope
