Foundation Investigation and Design Report

Temporary Works - Nicolston Culvert Rehabilitation

Highway 89, Alliston, Simcoe County, Ontario

CA0020332.0247-Fnd-R03-Rev0

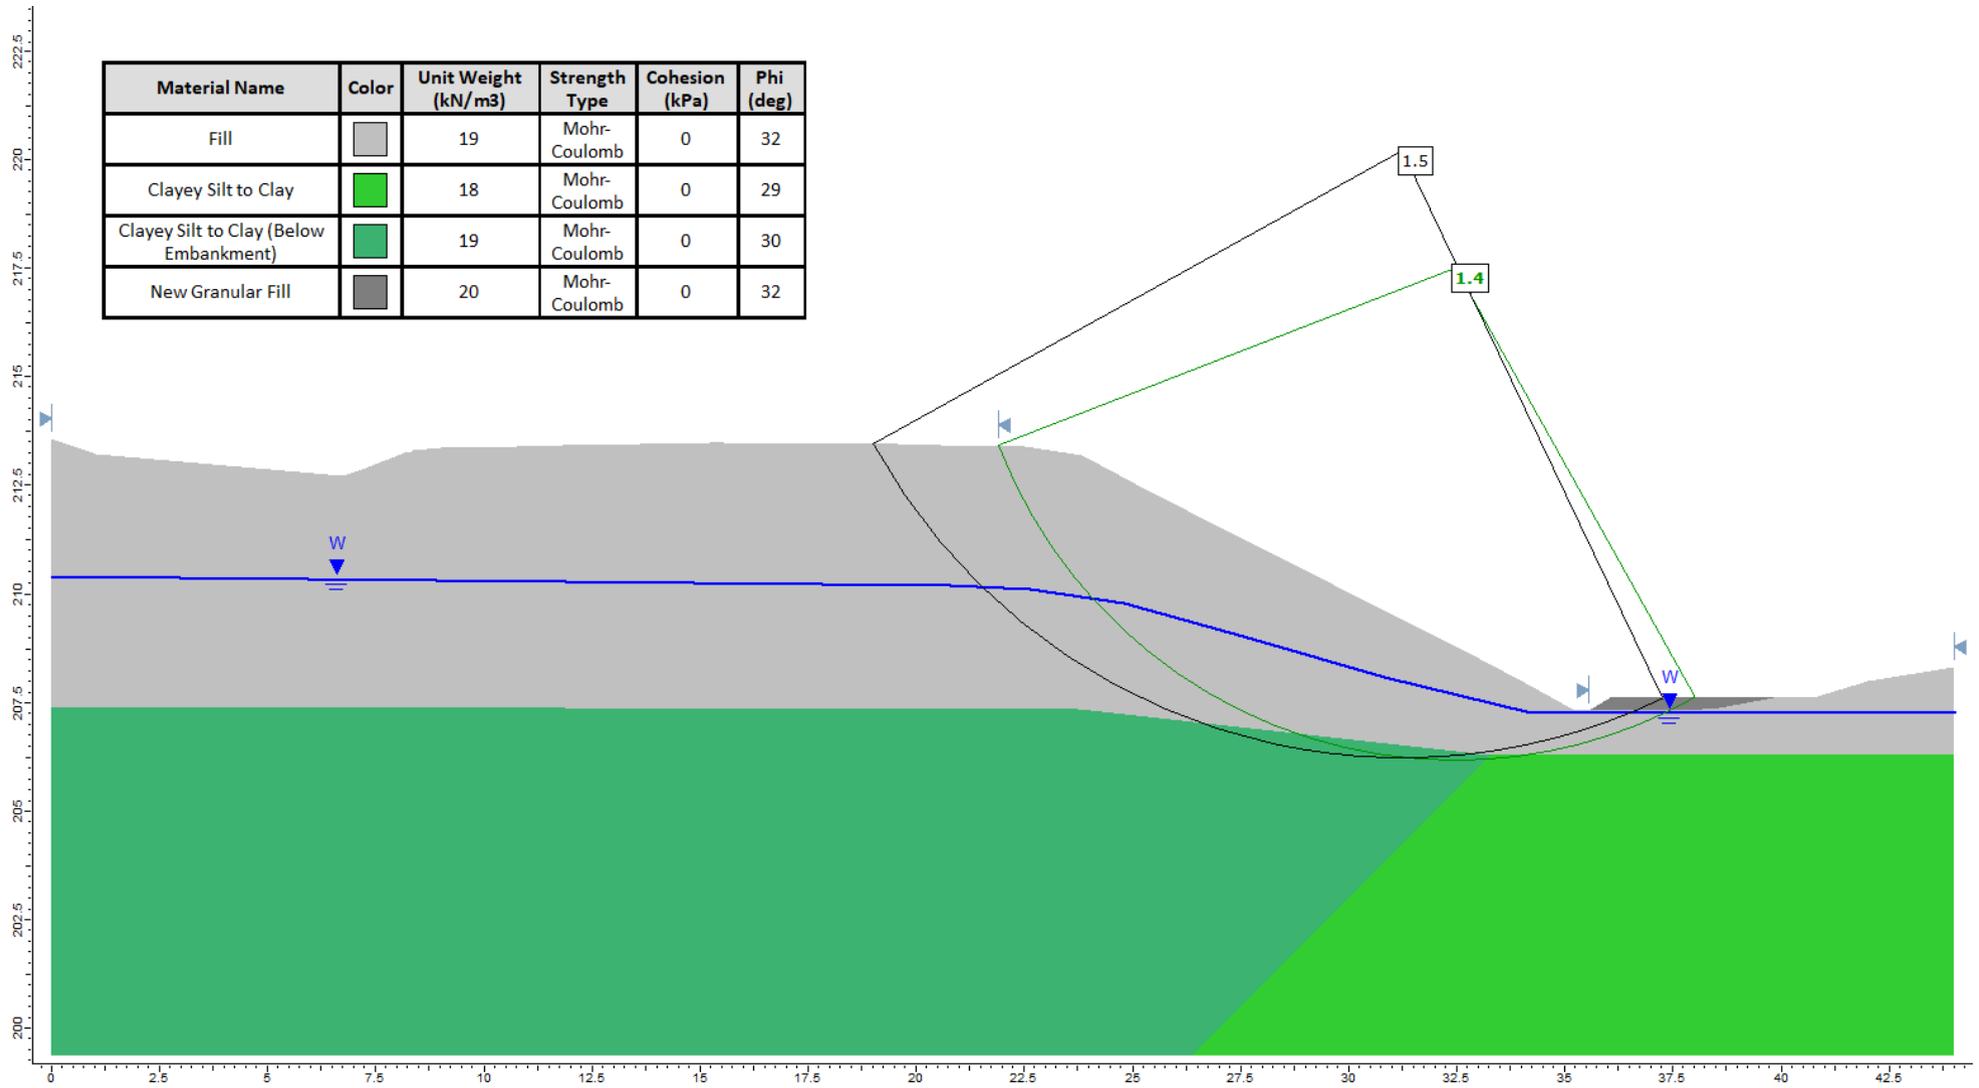
Stability Analysis Results (Drained Condition) Existing South Embankment Slope with Access Road

MODIFIED EMBANKMENT CONFIGURATION AFTER CONSTRUCTION OF ACCESS ROADS: Based on the results of the analyses and for comparison purposes, the FoS against global instability of the embankment after construction of the temporary access roads is about 1.4 and 2.0 for the long-term (drained) conditions for slip surfaces passing through the travelled highway at the south and north embankment slopes (see Figure D5 and D7), resulting in a slight increase in FoS compared to the existing conditions. The FoS for short-term (undrained) conditions for the embankment after construction of the temporary access roads was checked at the south and north embankments and indicates a factor of safety of 1.8 and 1.2 (see Figure D6 and D8), resulting in no change to the FoS compared to the existing conditions.

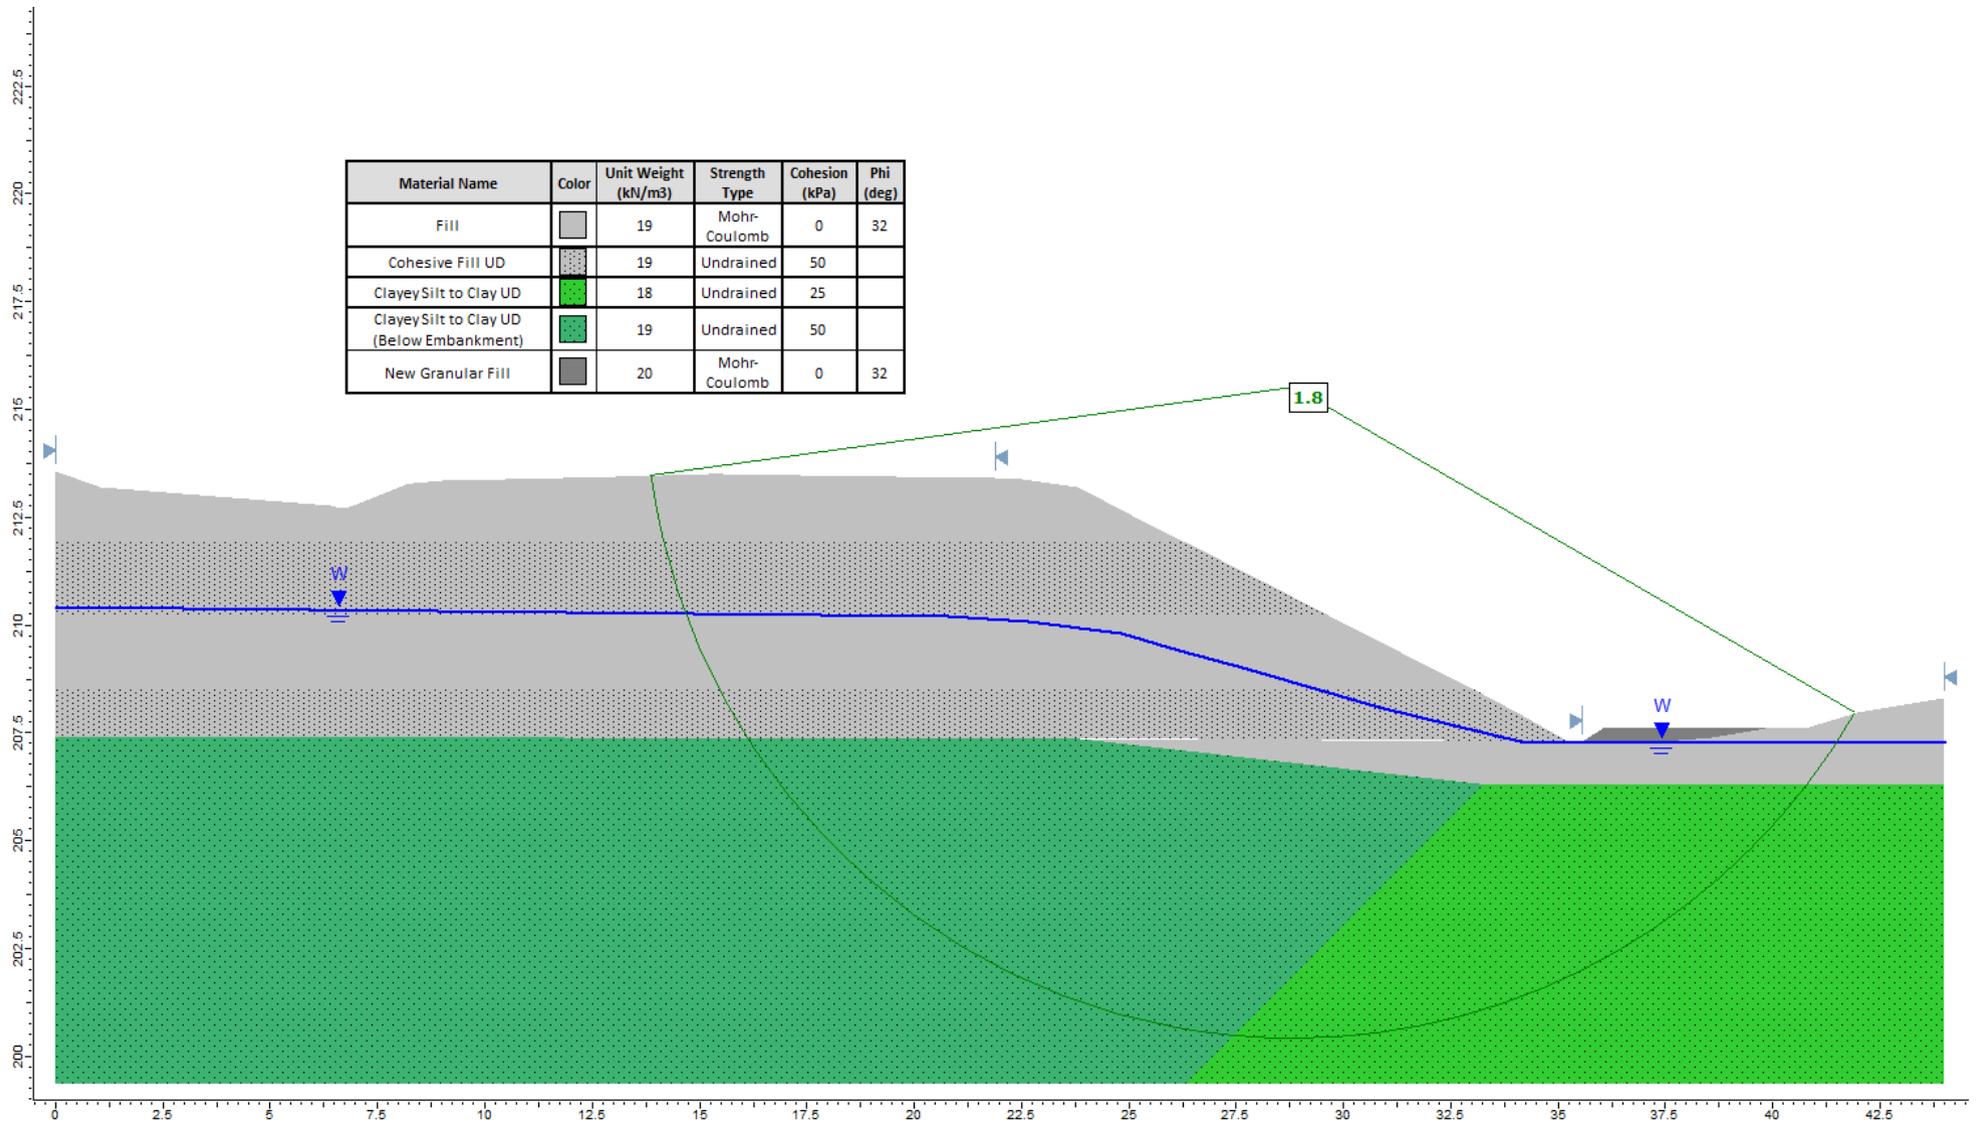
Figure D6

Stability Analysis Results (Undrained Condition) Existing South Embankment Slope with Access Road

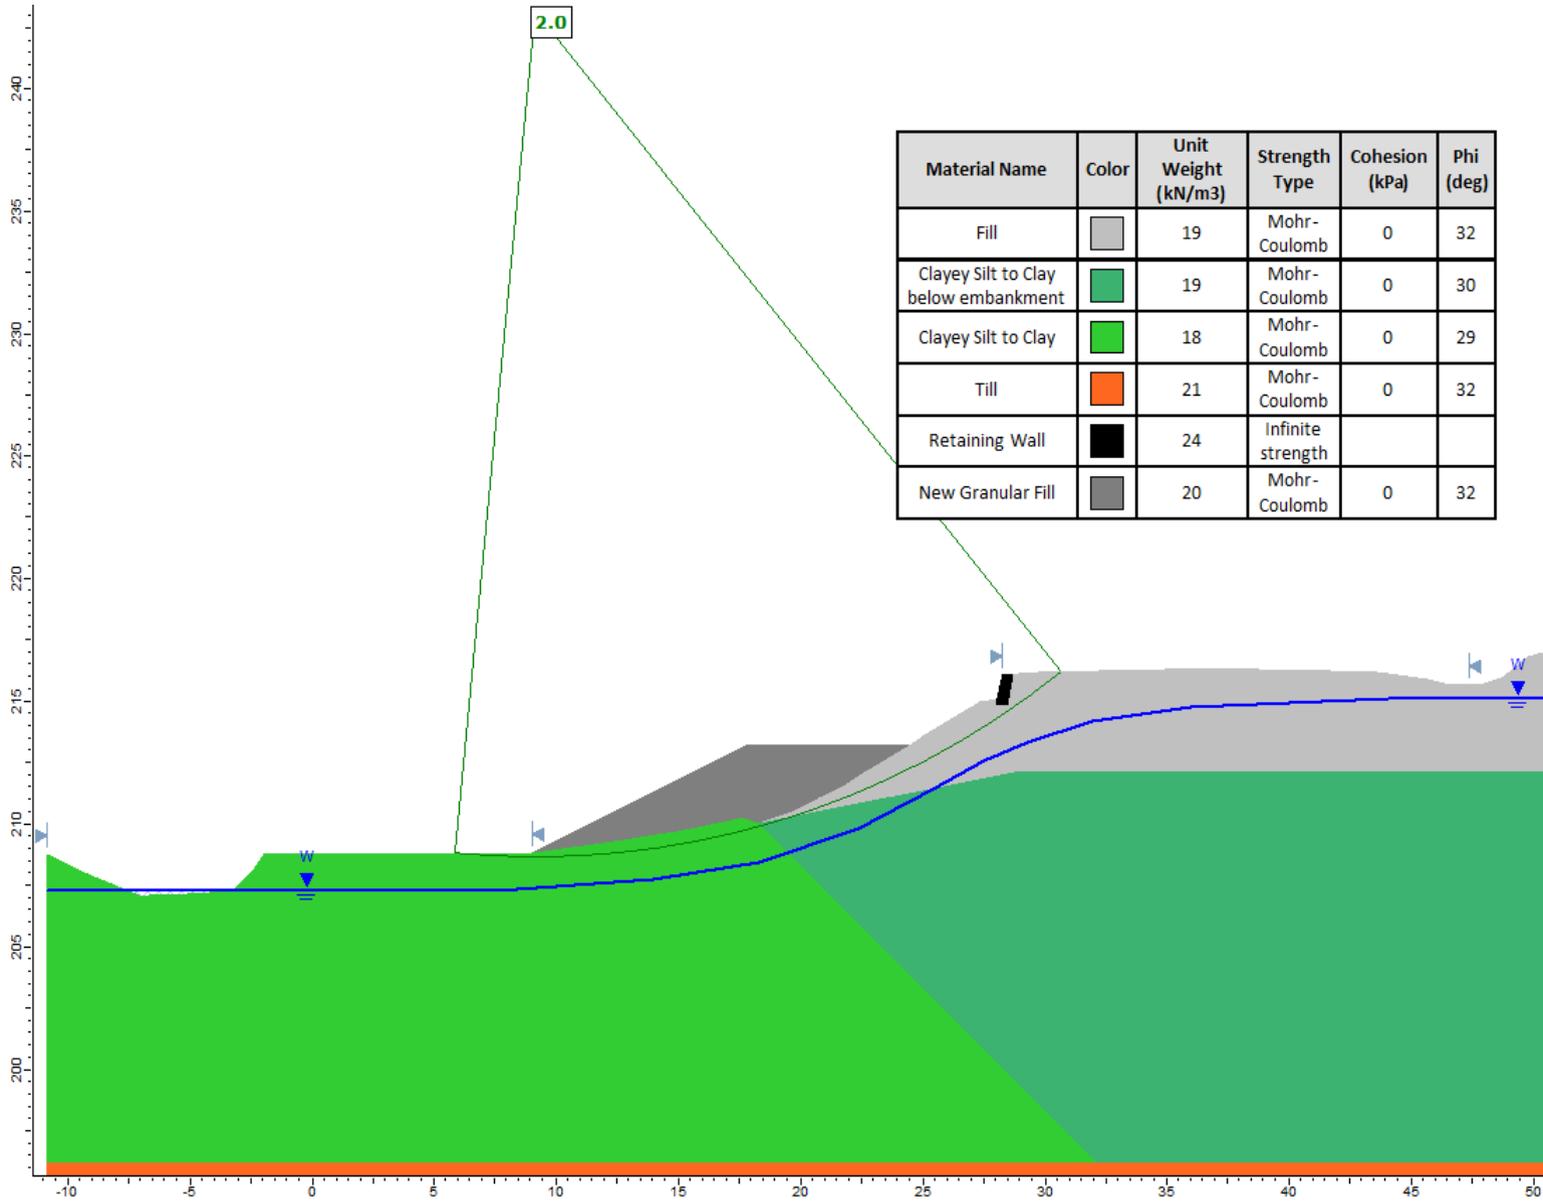
Figure D7

Stability Analysis Results (Drained Condition) Existing North Embankment Slope with Access Road

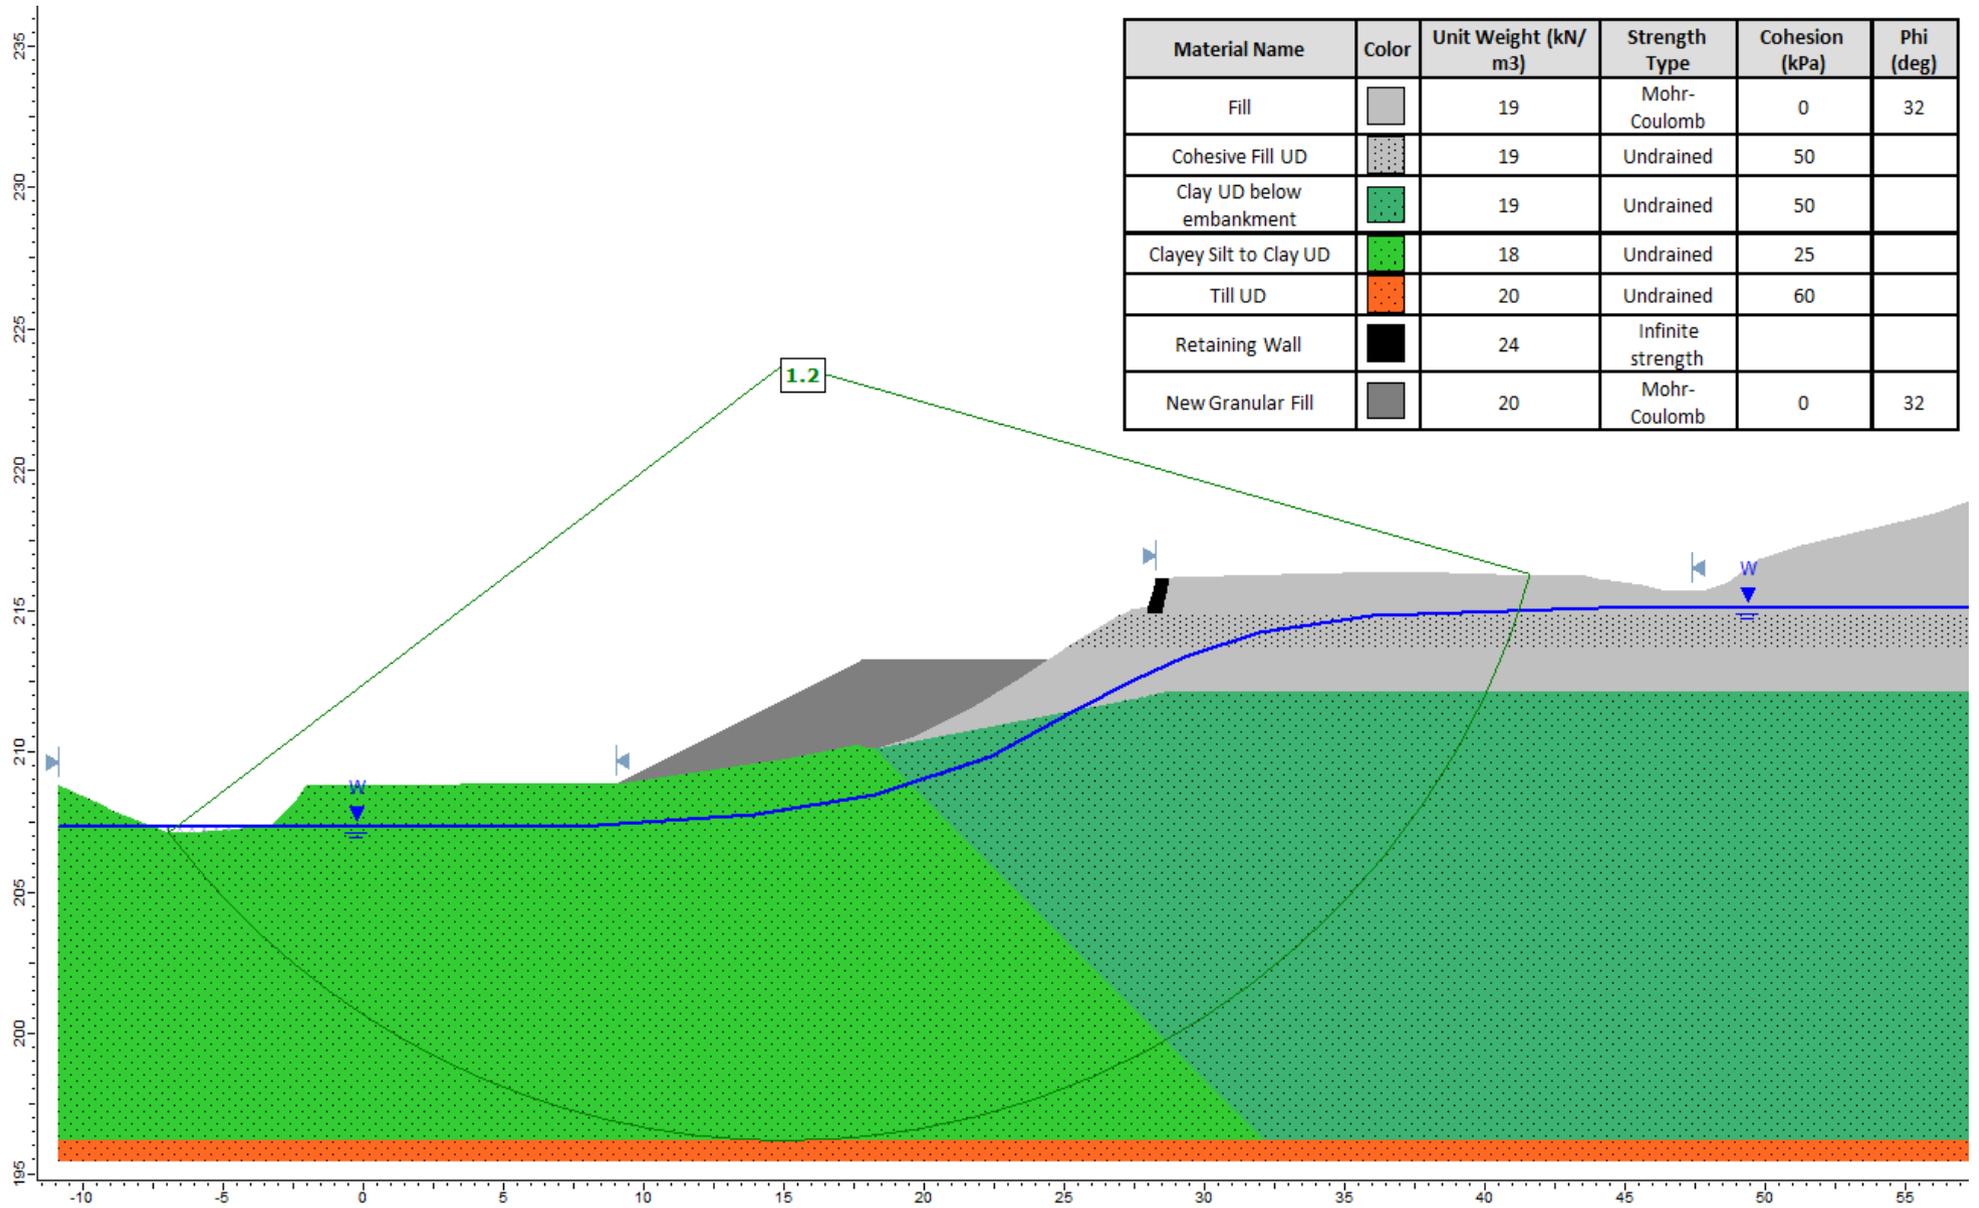
Figure D8

Stability Analysis Results (Undrained Condition) Existing North Embankment Slope with Access Road
