**FOUNDATION INVESTIGATION REPORT
LOW BAY INSPECTION BAY
CASSELMAN COMMERCIAL VEHICLE INSPECTION FACILITY
UNITED COUNTIES OF PRESCOTT AND RUSSELL
G.W.P. 4017-16-00
ASSIGNMENT NUMBER: 4015-E-0015**

GEOCRES NUMBER: 31D-257

**SUBMITTED TO
MCINTOSH PERRY CONSULTING ENGINEERS LTD. / LEA CONSULTING LTD.
JOINT VENTURE**

**JUNE 2017
15193**

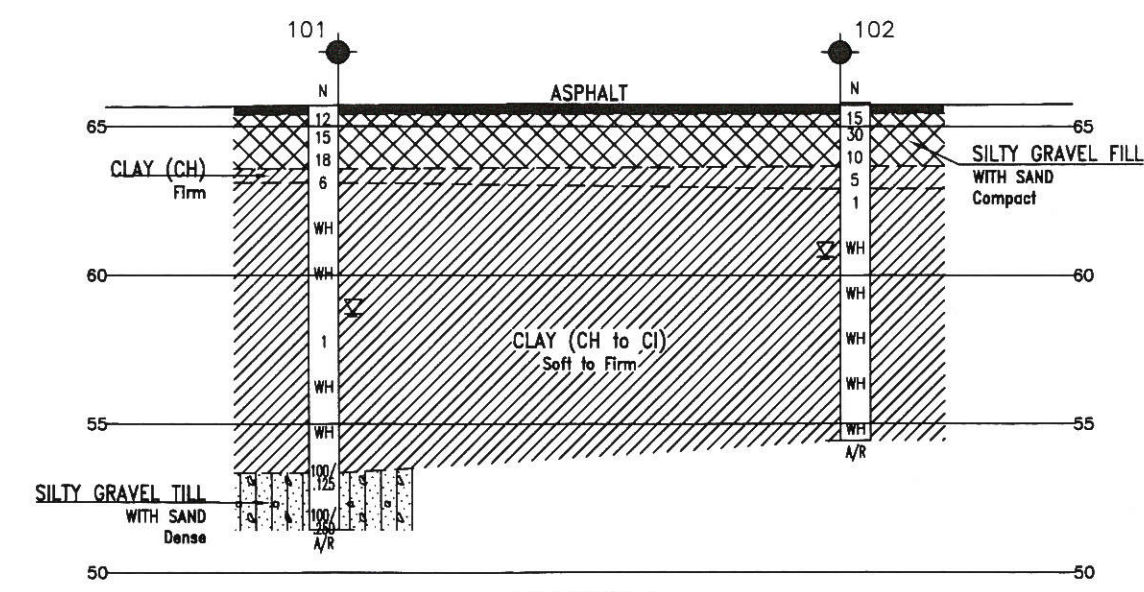
HIGHWAY 417
CASSELMAN VEHICLE
INSPECTION FACILITY
BOREHOLE LOCATIONS AND SOIL STRATA

- The boundaries between soil strata have been established only at Borehole locations. Between Boreholes the boundaries are assumed from geological evidence.
- This drawing is for subsurface information only. Surface details and features are for conceptual illustration.
- Borehole locations are shown in MTM Zone 8 coordinates.

The CVIF is located on Highway 417 westbound, approximately 1.8 km west of the Highway 417 / County Road 138 interchange, in the United Counties of Prescott and Russell, Ontario. The location of the facility is shown on the inset Key Plan on Drawing No. 1 in Appendix A.

The field investigation was carried out on November 24, 2016, and included advancing two boreholes. The approximate locations and elevations of the boreholes are shown on Drawing No. 1 provided in Appendix A and are summarized in Table 3-1.

Reference is made to the Record of Borehole sheets in Appendix B for details of the soil stratigraphy encountered in the boreholes. A stratigraphic profile for the site is presented on the Drawing No. 1 in Appendix A for illustrative purposes. An overall description of the stratigraphy is given in the following paragraphs; however, the factual data presented in the Record of Boreholes governs any interpretation of the site conditions.

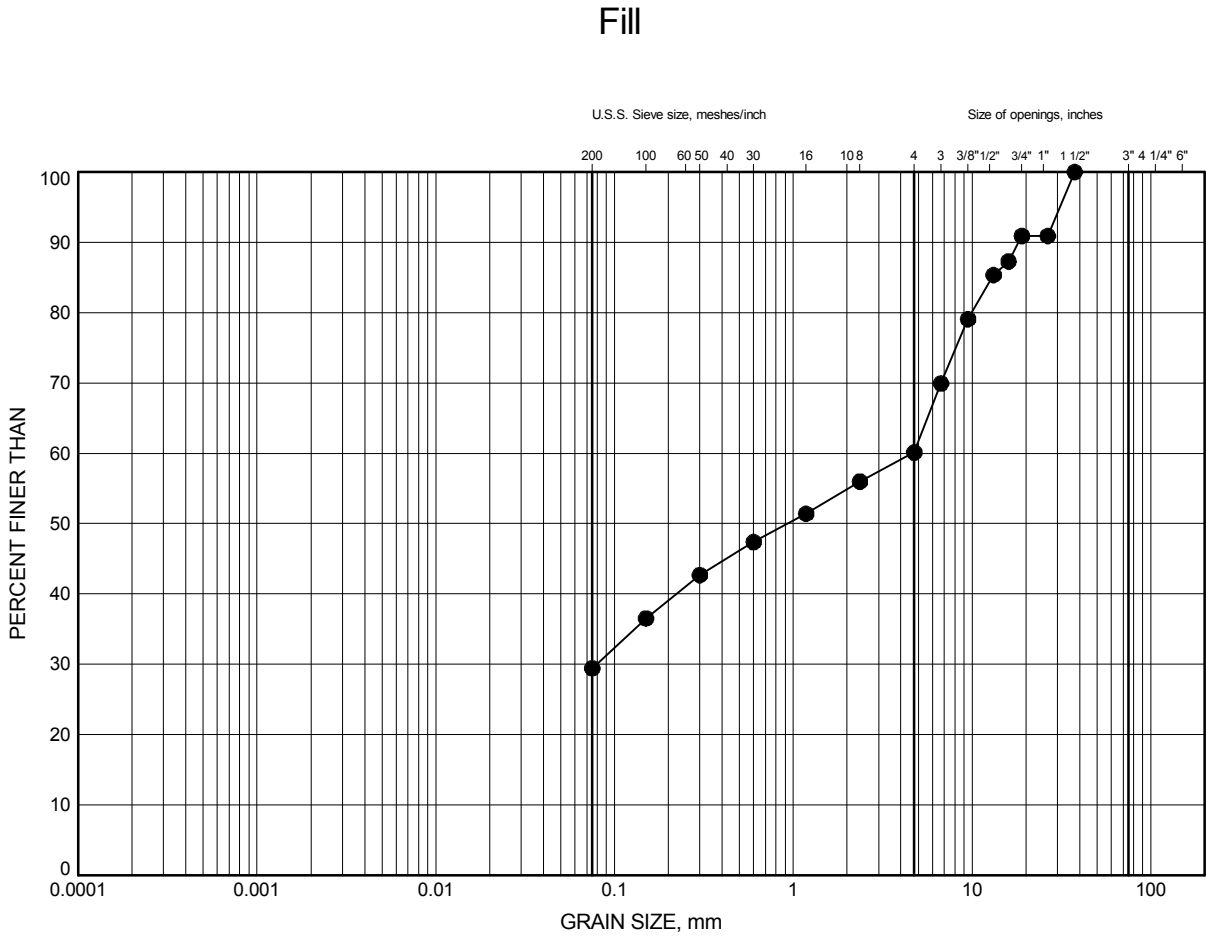
FIGURE 1

Casselman Commercial Vehicle Inspection Facility
GRAIN SIZE DISTRIBUTION

SYMBOL	BOREHOLE	DEPTH (m)	ELEV. (m)
●	101	1.07	64.63

The moisture content of the samples tested ranged from 8% to 12%. The results of a grain size analysis completed on a sample of this material indicated a gravel content of 40%, sand content of 31%, and fines content (combined silt and clay size particles) of 29%. The results indicate the this material is low to moderately susceptible to frost heave. The results of the grain size analysis are illustrated on Figure 1 in Appendix C.

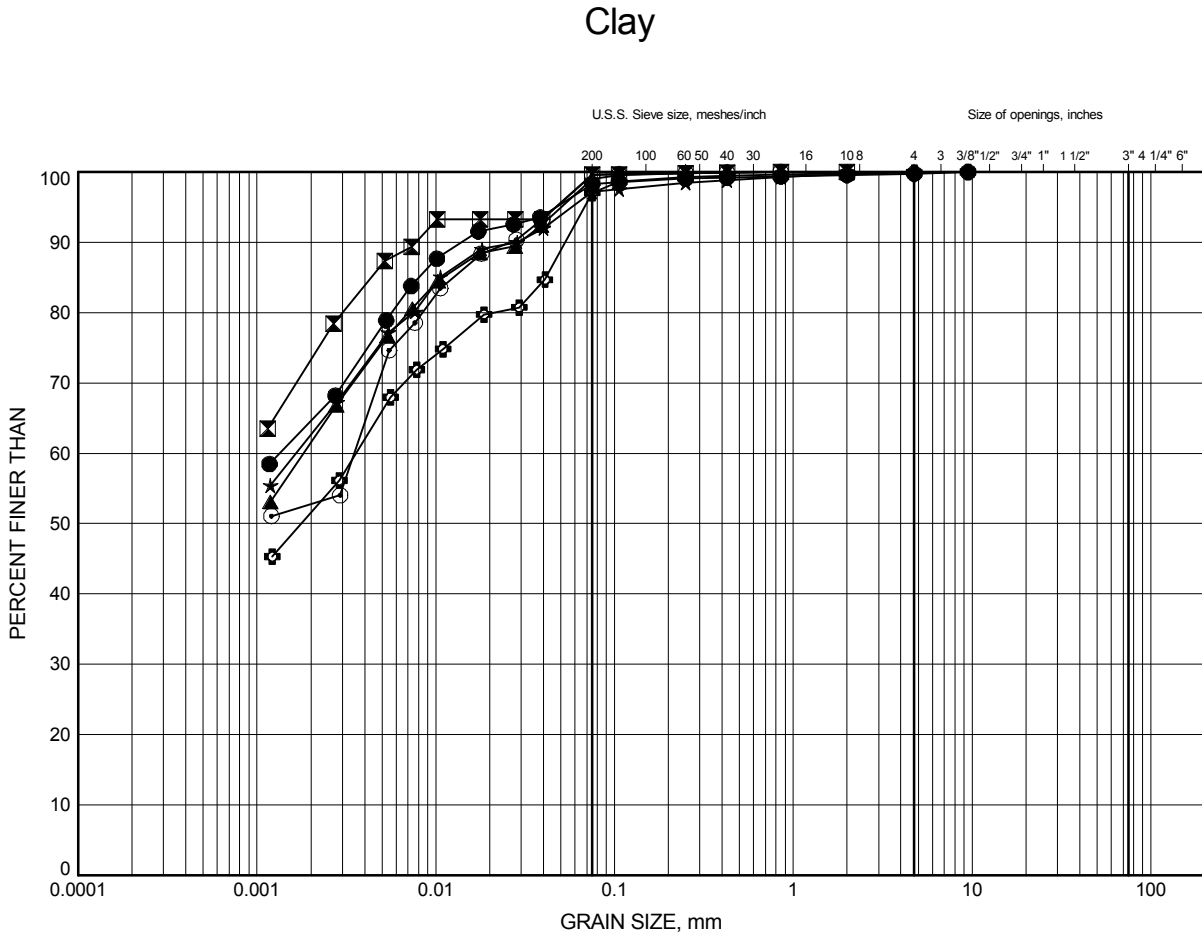
FIGURE 2

Casselman Commercial Vehicle Inspection Facility
GRAIN SIZE DISTRIBUTION

SYMBOL	BOREHOLE	DEPTH (m)	ELEV. (m)
●	101	2.44	63.26
⊠	101	5.64	60.06
▲	101	10.97	54.72
★	102	2.59	63.17
⊙	102	4.88	60.88
⊕	102	9.45	56.31

The moisture content of the samples tested were 30% and 31%. The results of grain size analysis testing completed on samples of this material indicated a gravel content of 0%, sand content of 1% and 3%, silt content of 34% and 35%, and clay content of 62% and 65%. The results of the grain size analysis are illustrated on Figure 2 in Appendix C.

The moisture content of the samples tested ranged from 48% to 83%. The results of grain size analysis completed on samples of this material indicated a gravel content of 0%, sand content ranging from 0% to 3%, silt content ranging from 26% to 47%, and clay content ranging from 51% to 74%. The results of the grain size analysis testing are illustrated on Figure 2 in Appendix C.

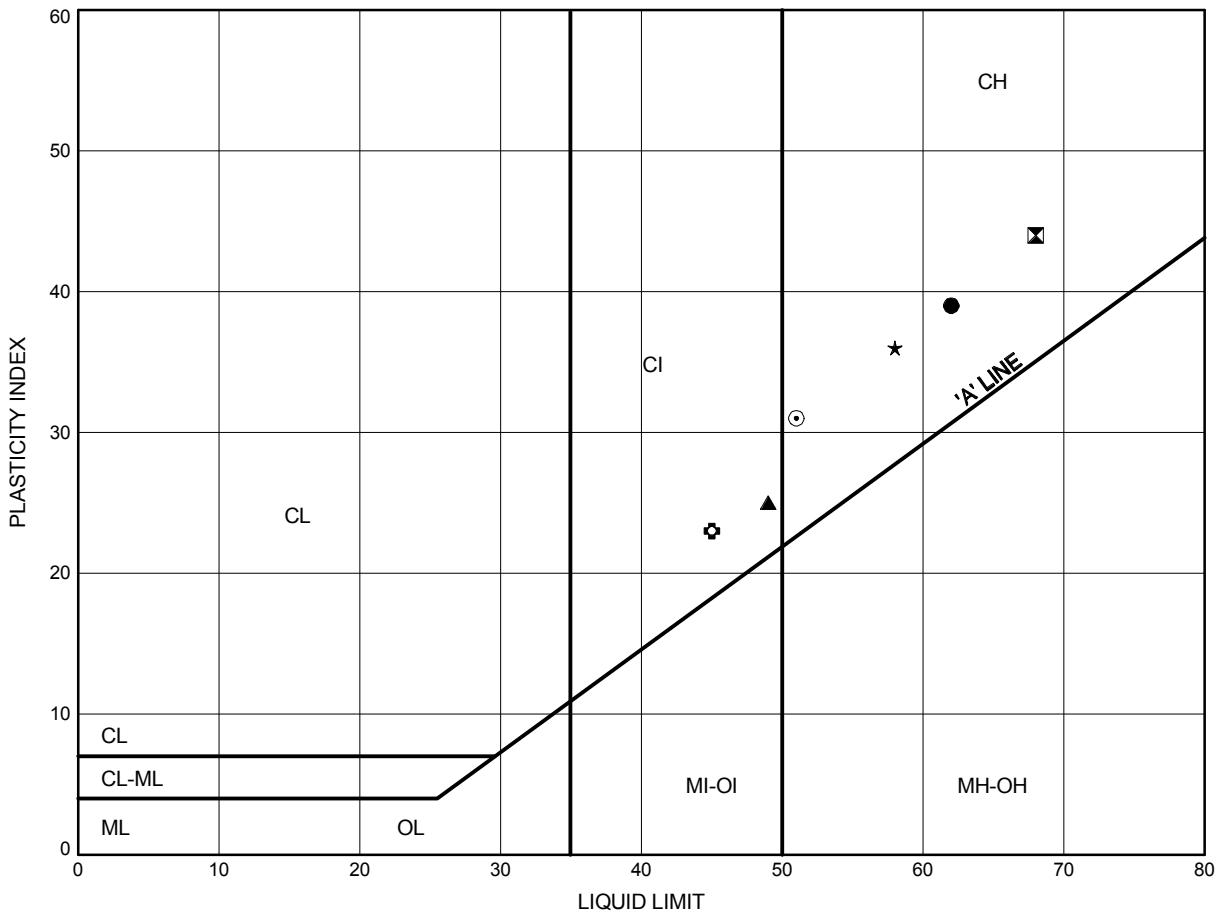
FIGURE 3

Casselman Commercial Vehicle Inspection Facility
ATTERBERG LIMITS TEST RESULTS

SYMBOL	BOREHOLE	DEPTH (m)	ELEV. (m)
●	101	2.44	63.26
⊠	101	5.64	60.06
▲	101	10.97	54.72
★	102	2.59	63.17
⊙	102	4.88	60.88
⊕	102	9.45	56.31

The results of Atterberg Limits testing completed on samples of this material indicated a liquid limit of 58 and 62, a plastic limit of 22 and 23, and plasticity index of 36 and 39, indicating a clay of high plasticity (CH). Atterberg Limits analysis results are illustrated on Figure 3 in Appendix C.

The results of Atterberg Limits testing completed on samples of this material indicated a liquid limit ranging from 45 to 68, a plastic limit ranging from 20 to 24, and plasticity index ranging from 23 to 44, indicating a clay of intermediate to high plasticity (CI to CH). Atterberg Limits analysis results are illustrated on Figure 3 in Appendix C.

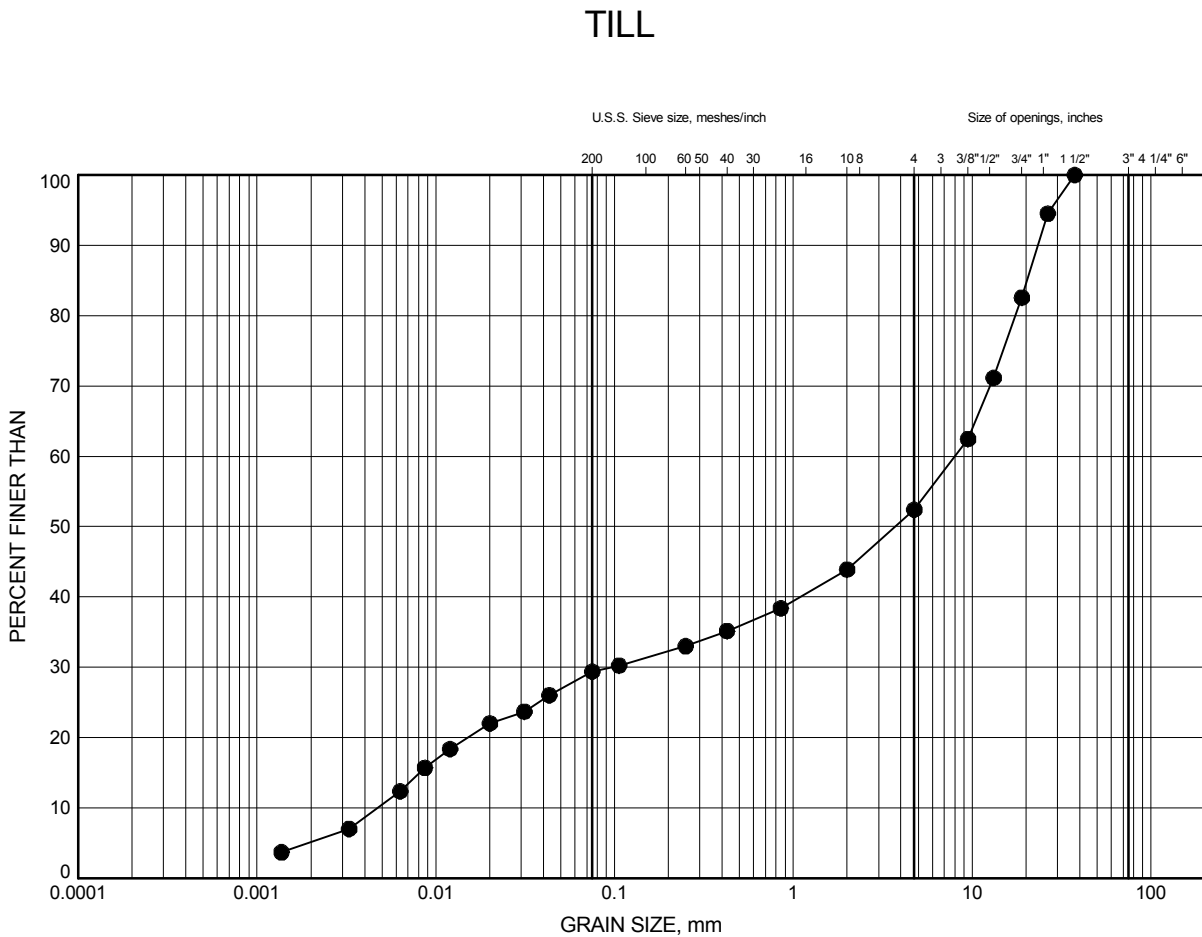
FIGURE 4

Casselman Commercial Vehicle Inspection Facility
GRAIN SIZE DISTRIBUTION

SYMBOL	BOREHOLE	DEPTH (m)	ELEV. (m)
●	101	14.02	51.67

The moisture content of a sample tested was 11%. The results of grain size analysis completed on a sample of this material indicated a gravel content of 48%, sand content of 23%, silt content of 24%, and clay content of 5%. The results of the grain size analysis testing are illustrated on Figure 4 in Appendix C.

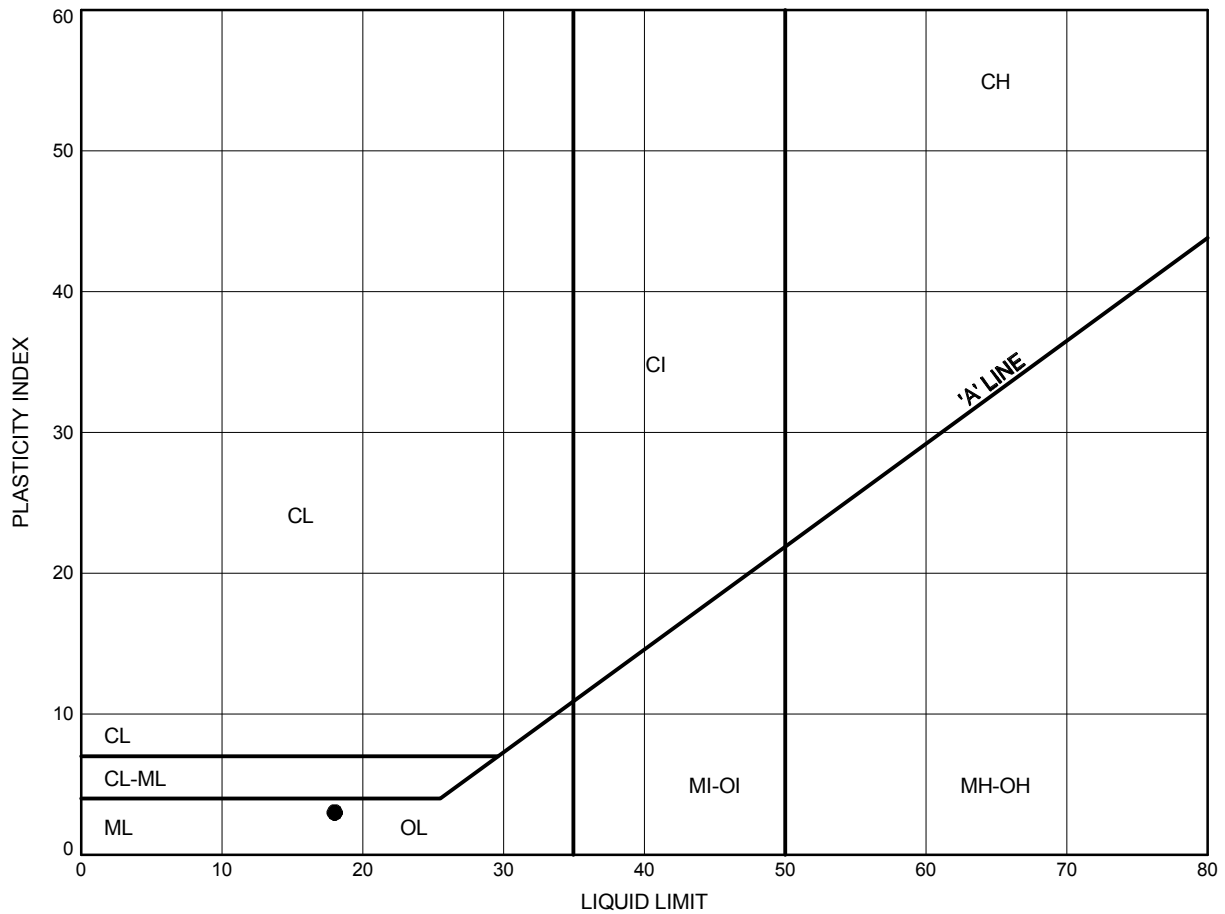
FIGURE 5

Casselman Commercial Vehicle Inspection Facility
ATTERBERG LIMITS TEST RESULTS

SYMBOL	BOREHOLE	DEPTH (m)	ELEV. (m)
●	101	14.02	51.67

Based on the results of Atterberg Limits testing the fines content is classified as non-plastic.

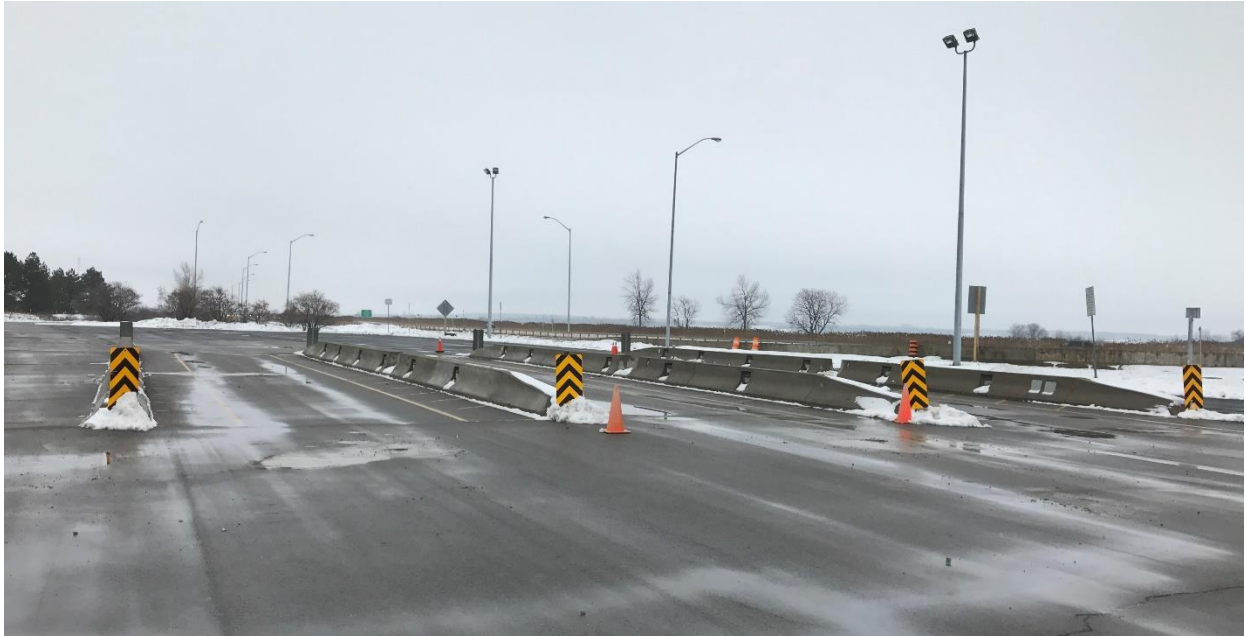
Figure 1: Casselman CVIF inspection bays looking southeast

At present, the facility includes three at-grade inspection bays separated by concrete barriers. Each bay is approximately 31 m long and 6.0 wide with an asphalt surface. The inspection bays are located in the middle of the facility to the northeast of the buildings and scales. The lands surrounding the site are flat, poorly drained and consist of agriculture fields to the north and south of Highway 417. Site photographs showing the general conditions at the site, are presented in Appendix D.

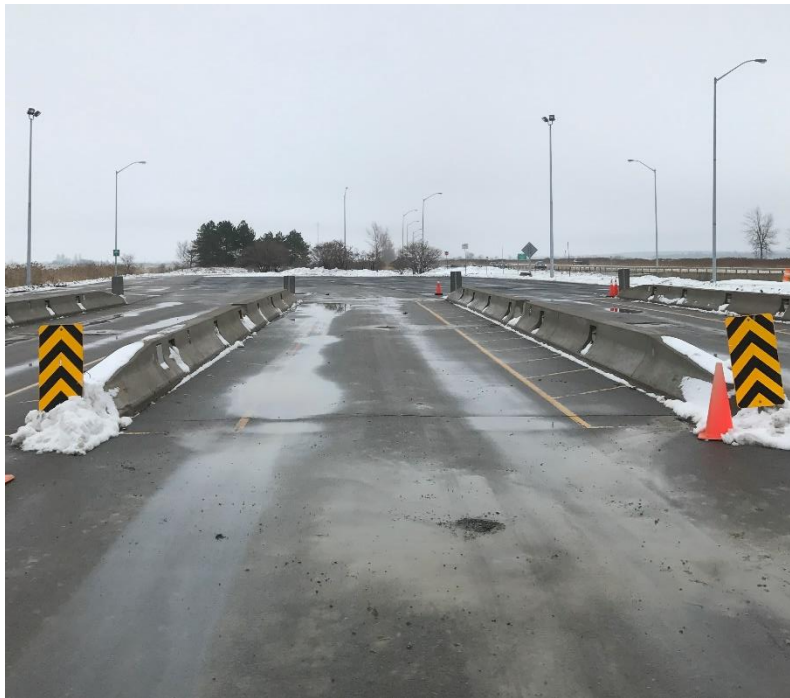
Figure 2: Bay 2, the location of the new low bay inspection bay looking east
