**FOUNDATION INVESTIGATION REPORT  
OVERHEAD SIGN SUPPORT  
CASSELMAN COMMERCIAL VEHICLE INSPECTION FACILITY  
UNITED COUNTIES OF PRESCOTT AND RUSSELL  
G.W.P. 4017-16-00  
ASSIGNMENT NUMBER: 4015-E-0015**

**GEOCRES NUMBER: 31D-258**

**SUBMITTED TO  
MCINTOSH PERRY CONSULTING ENGINEERS LTD. / LEA CONSULTING LTD.  
JOINT VENTURE**

**JUNE 2017  
18122**

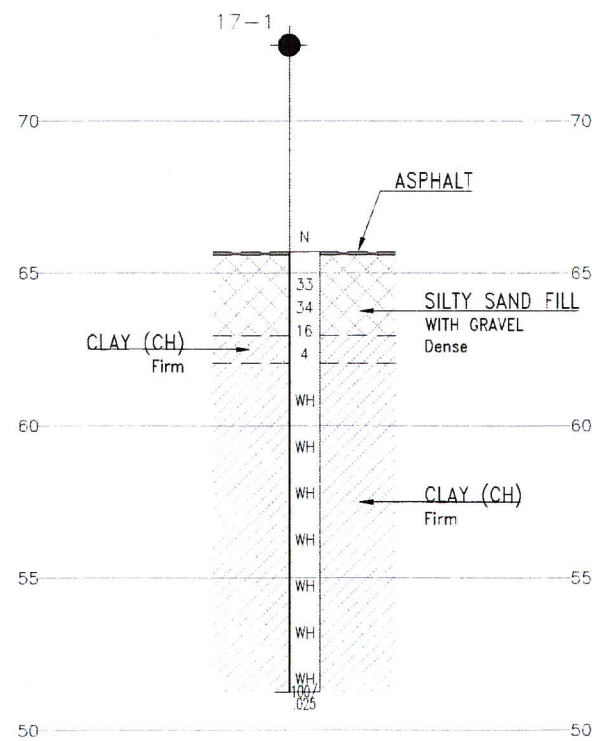
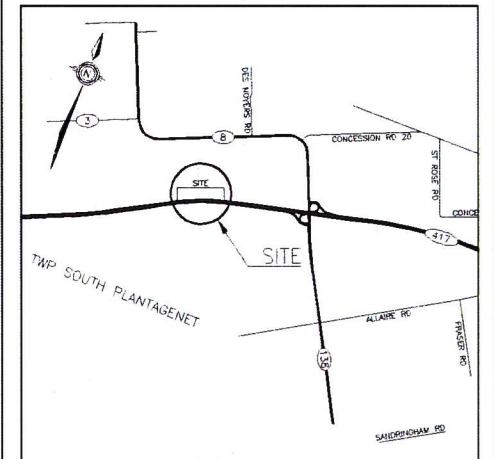
REVISIONS	DATE	BY	DESCRIPTION
DESIGN	JM	CHK -	CODE
DRAWN	MFA	CHK KCP	SITE
			LOAD
			DATE
			JUNE 2017
			STRUCT
			DWG 1

CASSELMAN VEHICLE  
INSPECTION FACILITY  
OVERHEAD SIGN SUPPORT  
BOREHOLE LOCATIONS AND SOIL STRATA

The CVIF is located on Highway 417 westbound, approximately 1.8 km west of the Highway 417 / County Road 138 interchange, in the United Counties of Prescott and Russell, Ontario. The location of the facility is shown on the inset Key Plan on Drawing No. 1 in Appendix A.

The field investigation for the traffic control sign was carried out on March 24, 2017, and included advancing one borehole. The approximate location and elevation of the borehole is shown on Drawing No. 1 provided in Appendix A and are summarized in Table 3-1. It should be noted that due to a conflict with existing buried utilities at the proposed sign location, Borehole 17-1 was advanced approximately 2 m south of the proposed sign location within the asphalt laneway.

The as-drilled location of the borehole and ground surface elevation at the borehole location was surveyed by Thurber on March 24, 2017. The temporary benchmark (TBM) used was the southwest corner of the existing garage structure. The location of the TBM is indicated on Drawing No. 1 in Appendix A. The geodetic elevation of the TBM was indicated on the drawings provided by MPCE-LEA as 65.787 m.

Reference is made to the Record of Borehole sheet in Appendix B for details of the soil stratigraphy encountered in the borehole. A stratigraphic profile for the site is presented on the Drawing No. 1 in Appendix A for illustrative purposes. An overall description of the stratigraphy is given in the following paragraphs; however, the factual data presented in the Record of Borehole governs any interpretation of the site conditions.

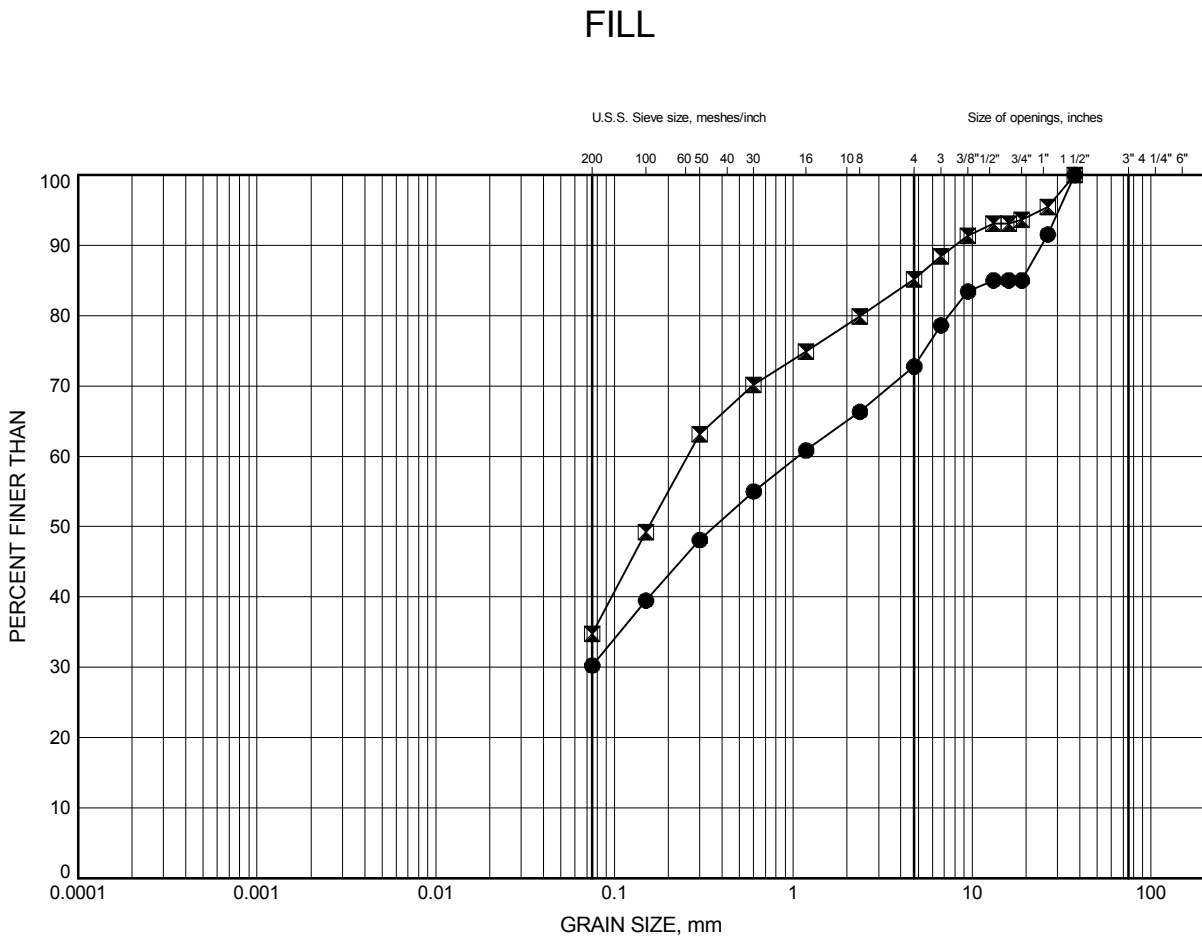
FIGURE 1

# GRAIN SIZE DISTRIBUTION

The moisture content of the samples tested ranged from 3% to 9%. The results of grain size analysis completed on samples of this material indicated a gravel content of 15% and 27%, a sand content of 43% and 50%, and a fines content (combined silt and clay size particles) of 30% and 35%. The results of the grain size analysis are illustrated on Figure 1 in Appendix C.

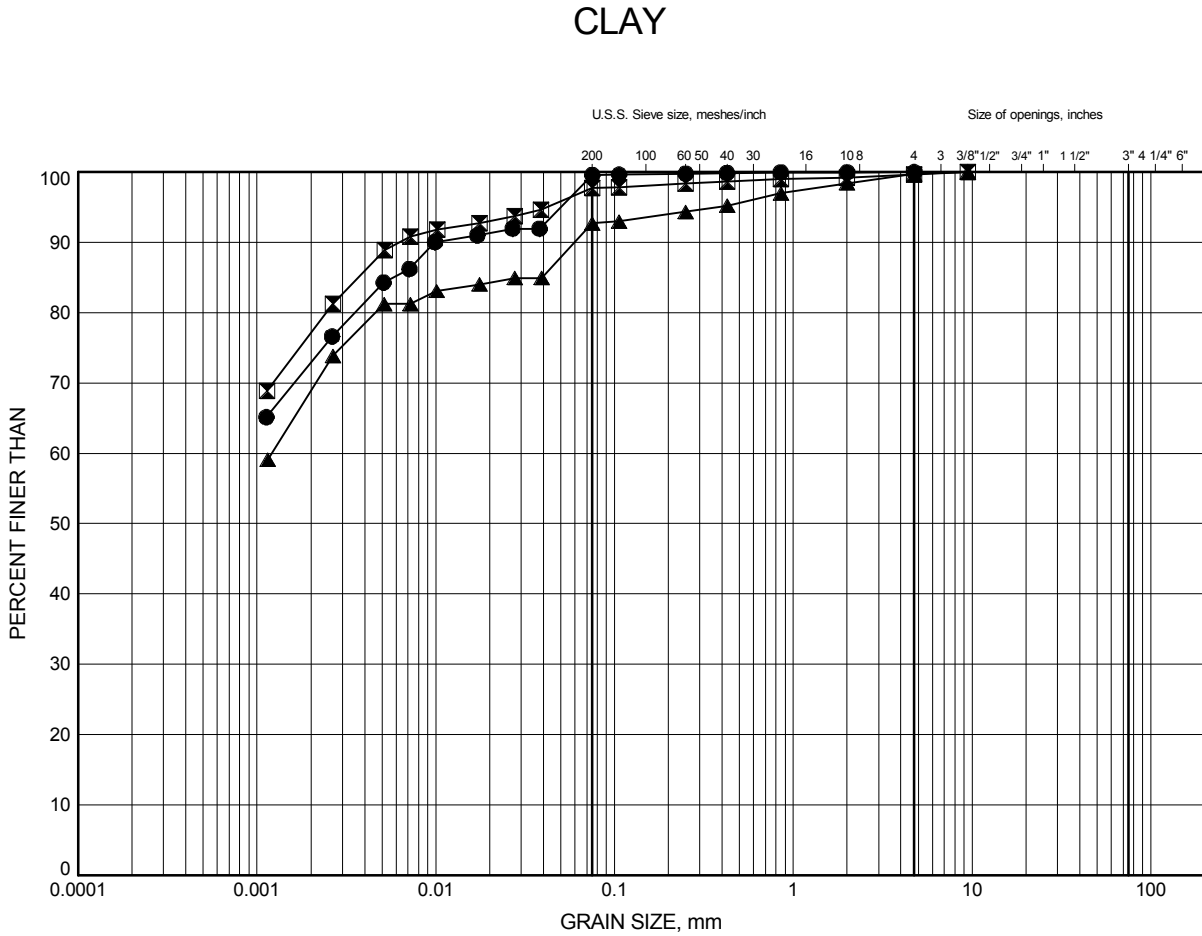
FIGURE 2

Casselman Commercial Vehicle Inspection Facility  
GRAIN SIZE DISTRIBUTION

The moisture content of the samples tested was 34% and 58%. The results of grain size analysis testing completed on a sample of this material indicated a gravel content of 0%, a sand content of 0%, a silt content of 27%, and a clay content of 73%. The results of the grain size analysis are illustrated on Figure 2 in Appendix C.

The moisture content of the samples tested ranged from 55% to 82%. The results of grain size analysis completed on samples of this material indicated a gravel content of 0%, a sand content of 2% and 7%, silt content of 21% and 24%, and clay content of 69% and 77%. The results of the grain size analysis testing are illustrated on Figure 2 in Appendix C.

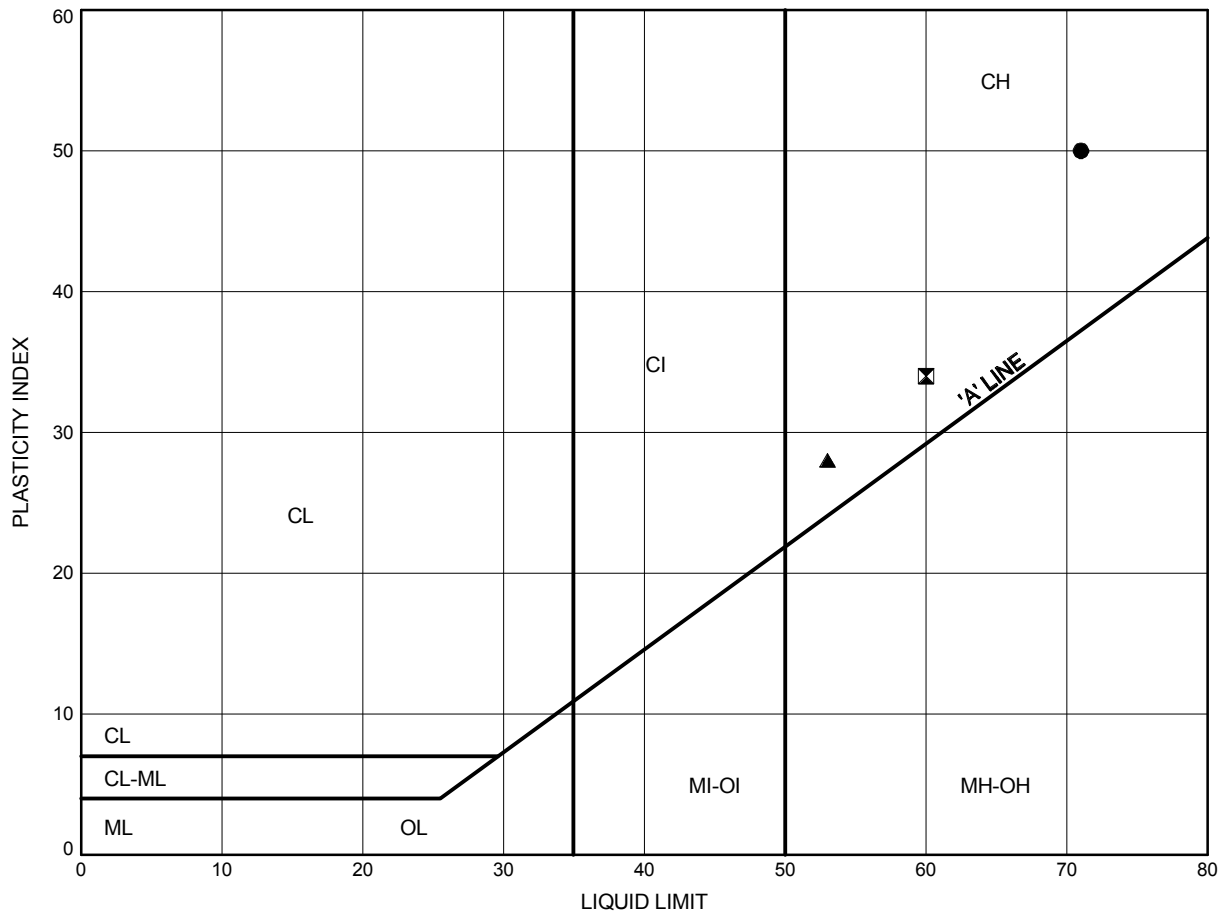
FIGURE 3

Casselman Commercial Vehicle Inspection Facility  
**ATTERBERG LIMITS TEST RESULTS**

The results of Atterberg Limits testing completed on a sample of this material indicated a liquid limit of 71, a plastic limit of 21, and plasticity index of 50, indicating a clay of high plasticity. Atterberg Limits analysis results are illustrated on Figure 3 in Appendix C.

The results of Atterberg Limits testing completed on samples of this material indicated a liquid limit of 53 and 60, a plastic limit of 25 and 26, and plasticity index of 28 and 34, indicating a clay of high plasticity. Atterberg Limits analysis results are illustrated on Figure 3 in Appendix C.
