**FOUNDATION INVESTIGATION AND DESIGN REPORT  
RETAINING WALL DISTRESS  
HIGHWAY 401 / CORNWALL CENTRE ROAD  
CORNWALL, ONTARIO**

**SITE NO. 31-209**

**Geocres Number: 31G - 232**

**MTO Eastern Region**

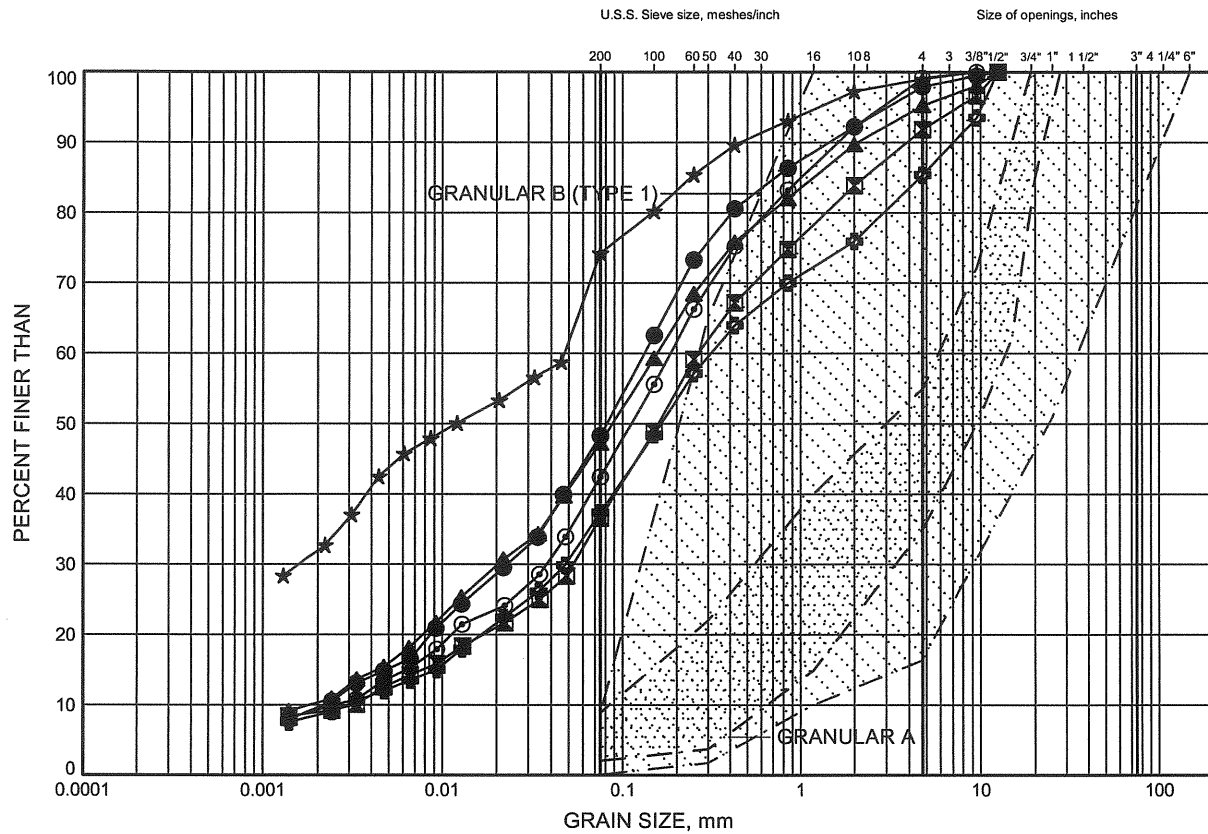
FIGURE B1

## WEST RETAINING WALL BACKFILL

SPT N-values of the silty sand fill were observed to range from 3 to 40 blows for 0.3 m of penetration indicating a very loose to dense relative density. A single N-value of 100 blows for 0.1 m of penetration was recorded in Borehole 09-03, though the high blow count may represent the presence of cobbles. Moisture contents ranged from 4 to 21% though are typically around 10%. The results of grain size distribution analyses carried out on fourteen samples of the fill are presented in Figures B1 to B4 of Appendix B.

SPT N-values in the sand and gravel backfill ranged from 6 to 40 blows for 0.3 m of penetration indicating a loose to dense relative density. Moisture contents of the backfill ranged from 4 to 11%. The results of grain size distribution analyses carried out on five samples of the fill are presented in Figures B1 to B4 of Appendix B.

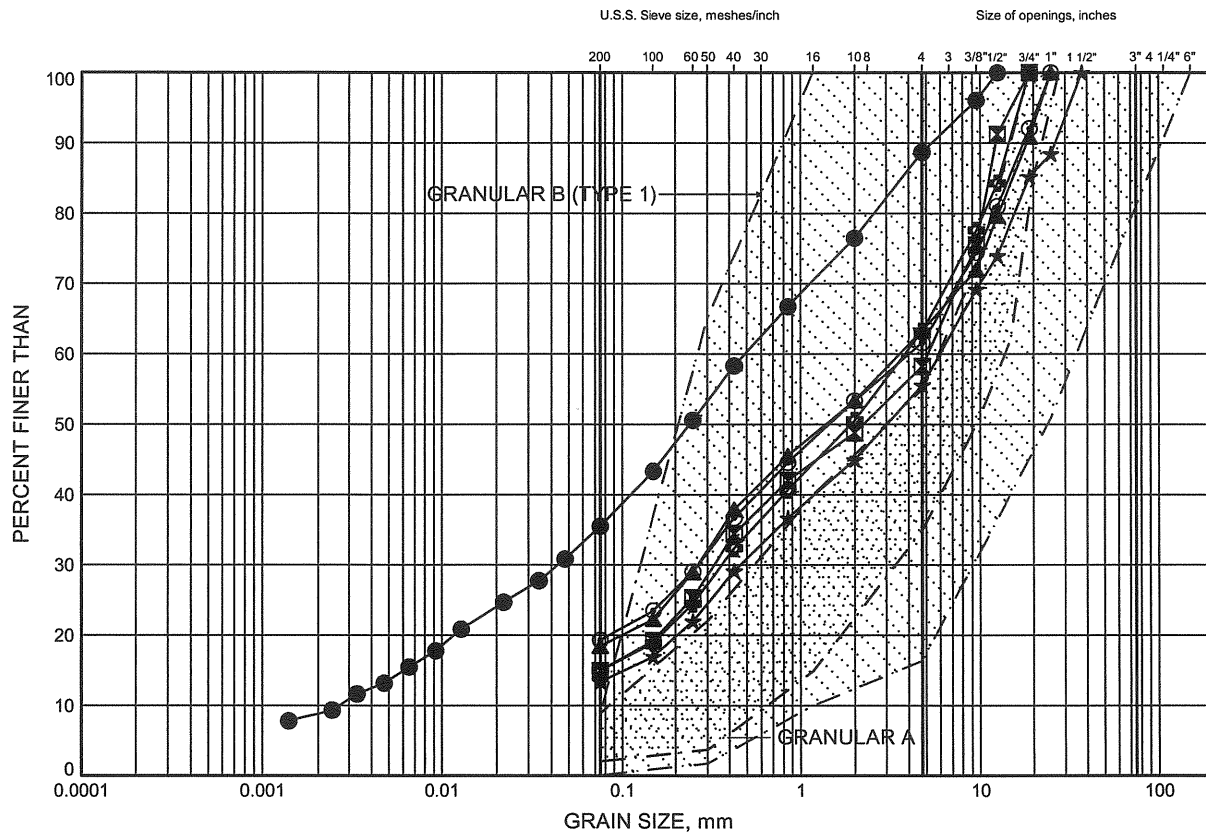
FIGURE B2

## WEST RETAINING WALL BACKFILL

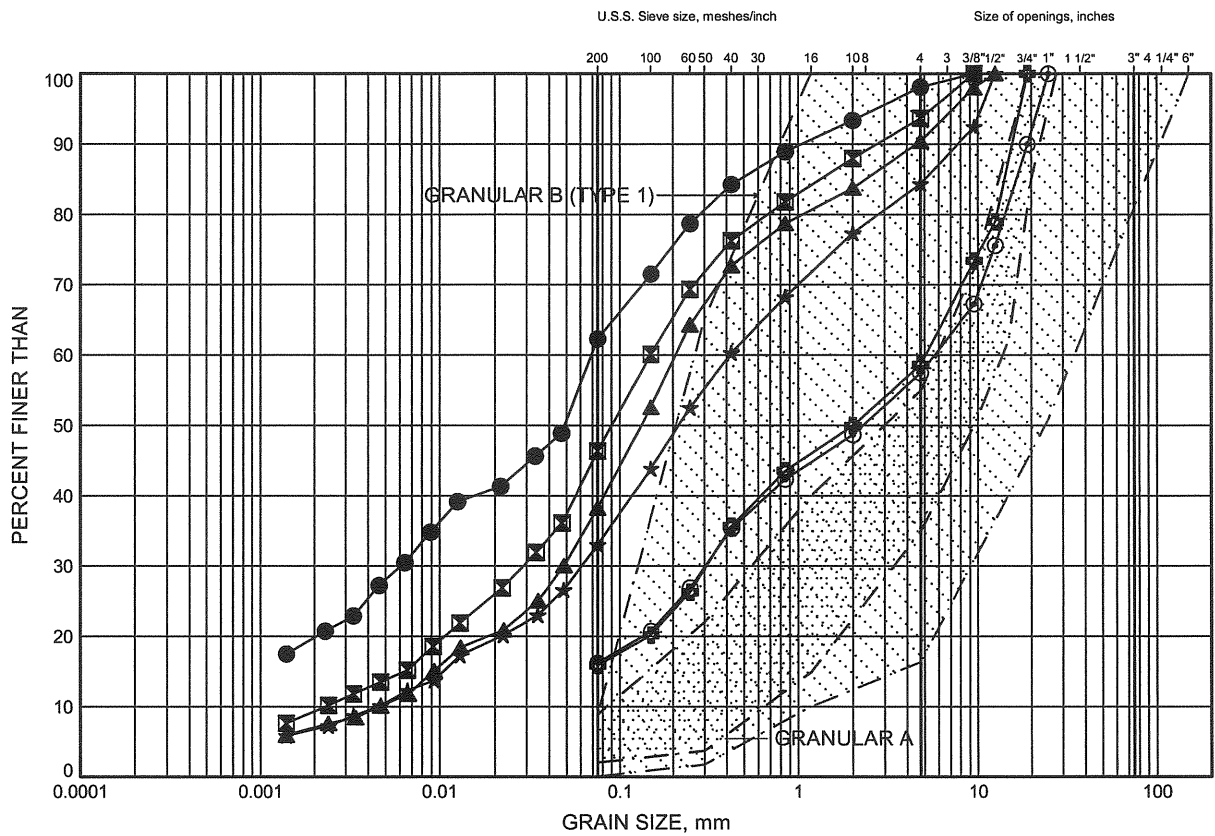
FIGURE B3

WEST RETAINING WALL BACKFILL

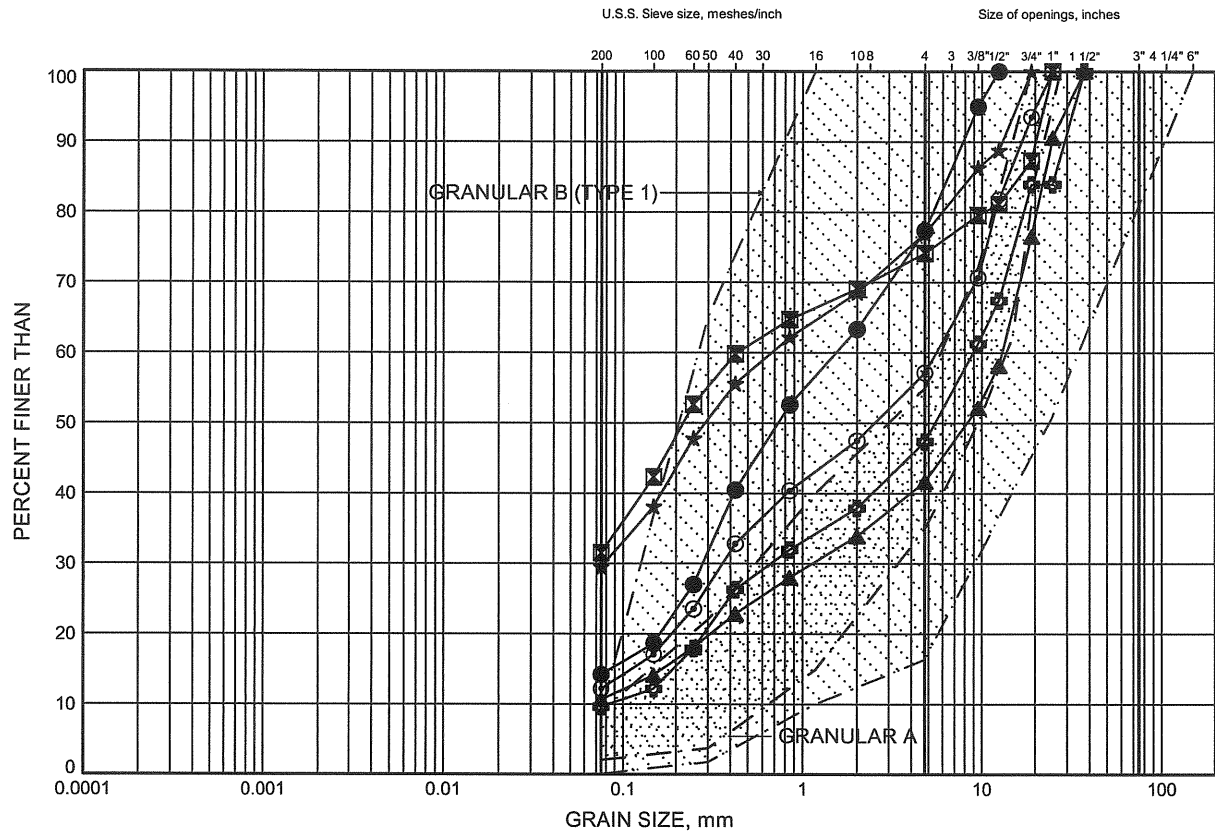
FIGURE B4

## WEST RETAINING WALL BACKFILL

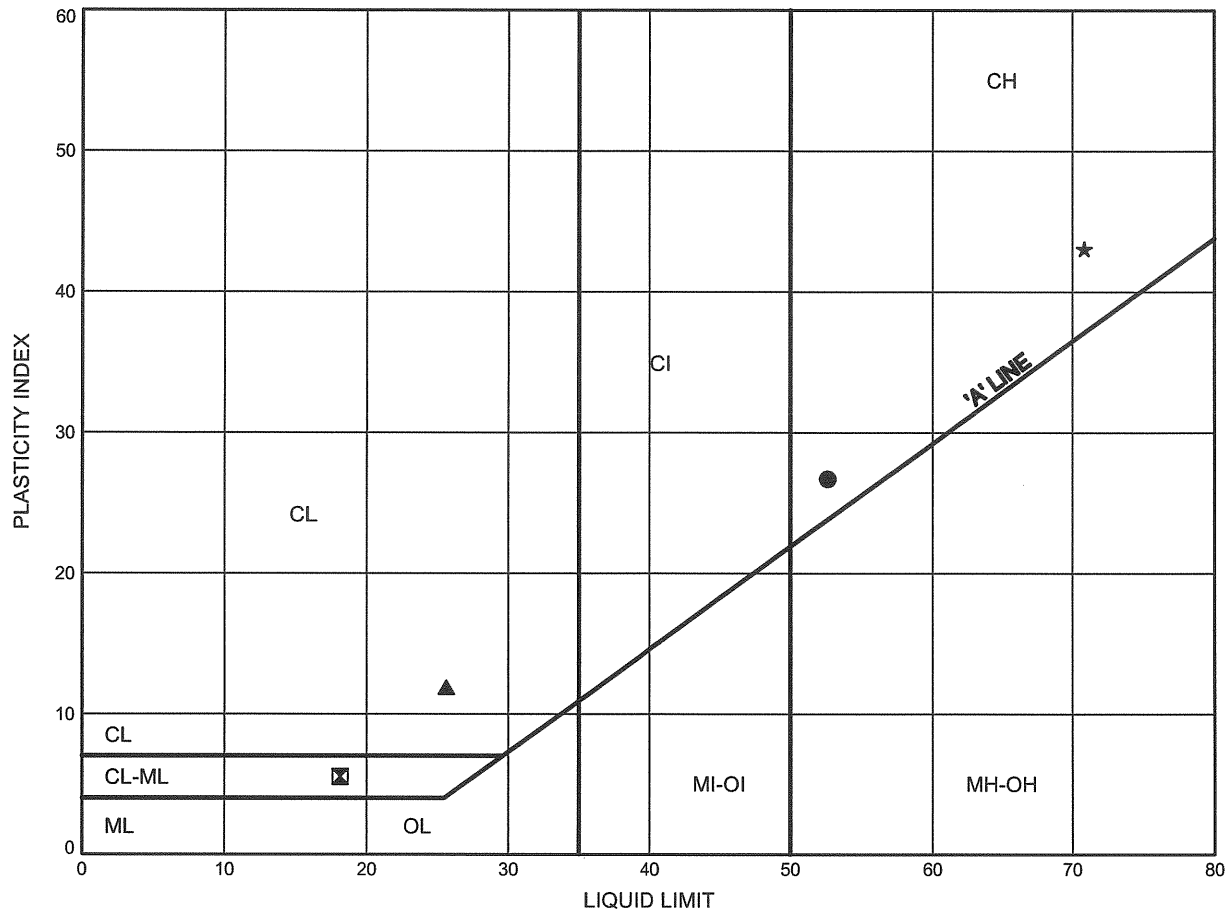
FIGURE B13

SYMBOL	BH	DEPTH (m)	ELEV. (m)
●	09-02	5.64	63.74
☒	09-02	7.16	62.22
▲	09-05	7.16	63.01
★	09-07	7.92	61.15

SPT N-values in the silty clay were recorded to range from 4 to 22 blows for 0.3 m of penetration indicating a firm to very stiff consistency. Three N-values recorded in Boreholes 09-06 and 09-09 were as high as 50 blows for 0.125 m of penetration indicating a hard consistency. Moisture contents range from 7 to 37% though is typically around 30%. The results of grain size distribution analyses tests carried out on three samples of the silty clay are presented in Figure B9 and the results of a single Atterberg Limits test is presented on Figure B13 of Appendix B, respectively.

SPT N-values in the cohesionless till layer ranged from 15 to 100 blows for 0.3 m of penetration indicating a compact to very dense relative density. Four N-values were recorded to be greater than 100 blows for 0.025 m of penetration indicating a very dense relative density. Moisture contents of the cohesionless glacial till layer range from 5 to 11%. The results of grain size distribution analyses tests carried out on six samples of the silty sand till to sand and silt till are presented in Figure B11 and the results of a single Atterberg Limits test is presented on Figure B13 of Appendix B, respectively.

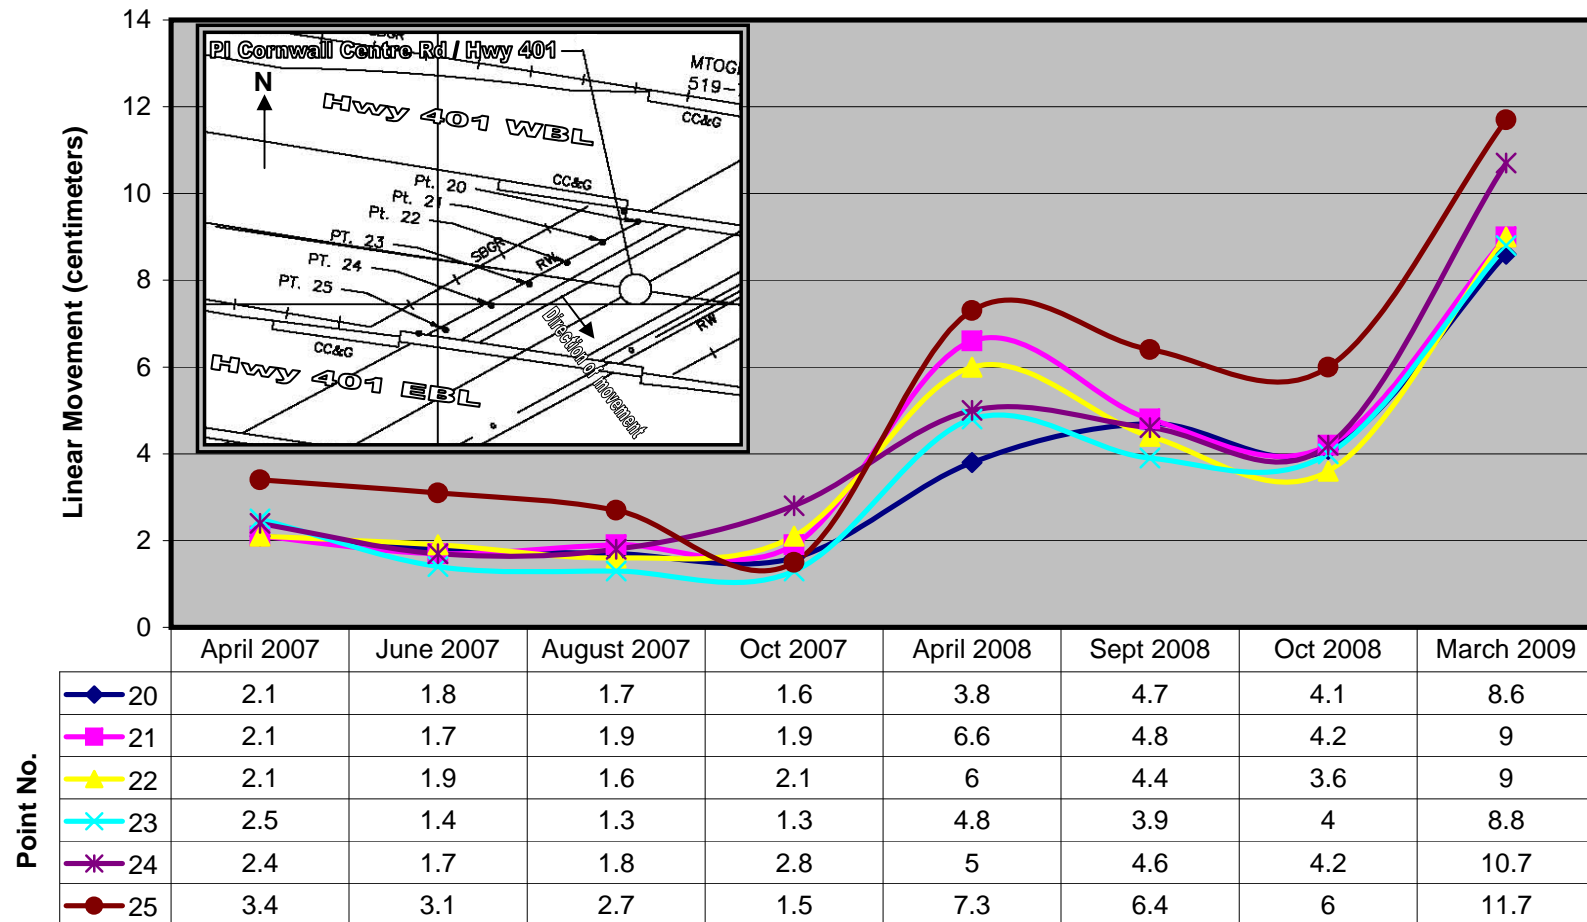
In general, an increase in retaining wall movement measured along the top of the wall has been observed in all monitoring points from October to April since 2007 with very little movement observed during the summer and autumn months. The retaining wall movements are progressively increasing each year and recently, the retaining wall movement has increased

significantly along the top of the wall when compared to readings taken in October of 2008. From October 2008 to March 2009, the displacements have increased from a minimum of 4.2 mm to a maximum of 10.7 mm. The largest displacements have been observed along the southern portion of the west wall where the retaining structure is in contact with the 401 overpass structure.

## Hwy 401 - Cornwall Centre Rd. - West Retaining Wall Movement

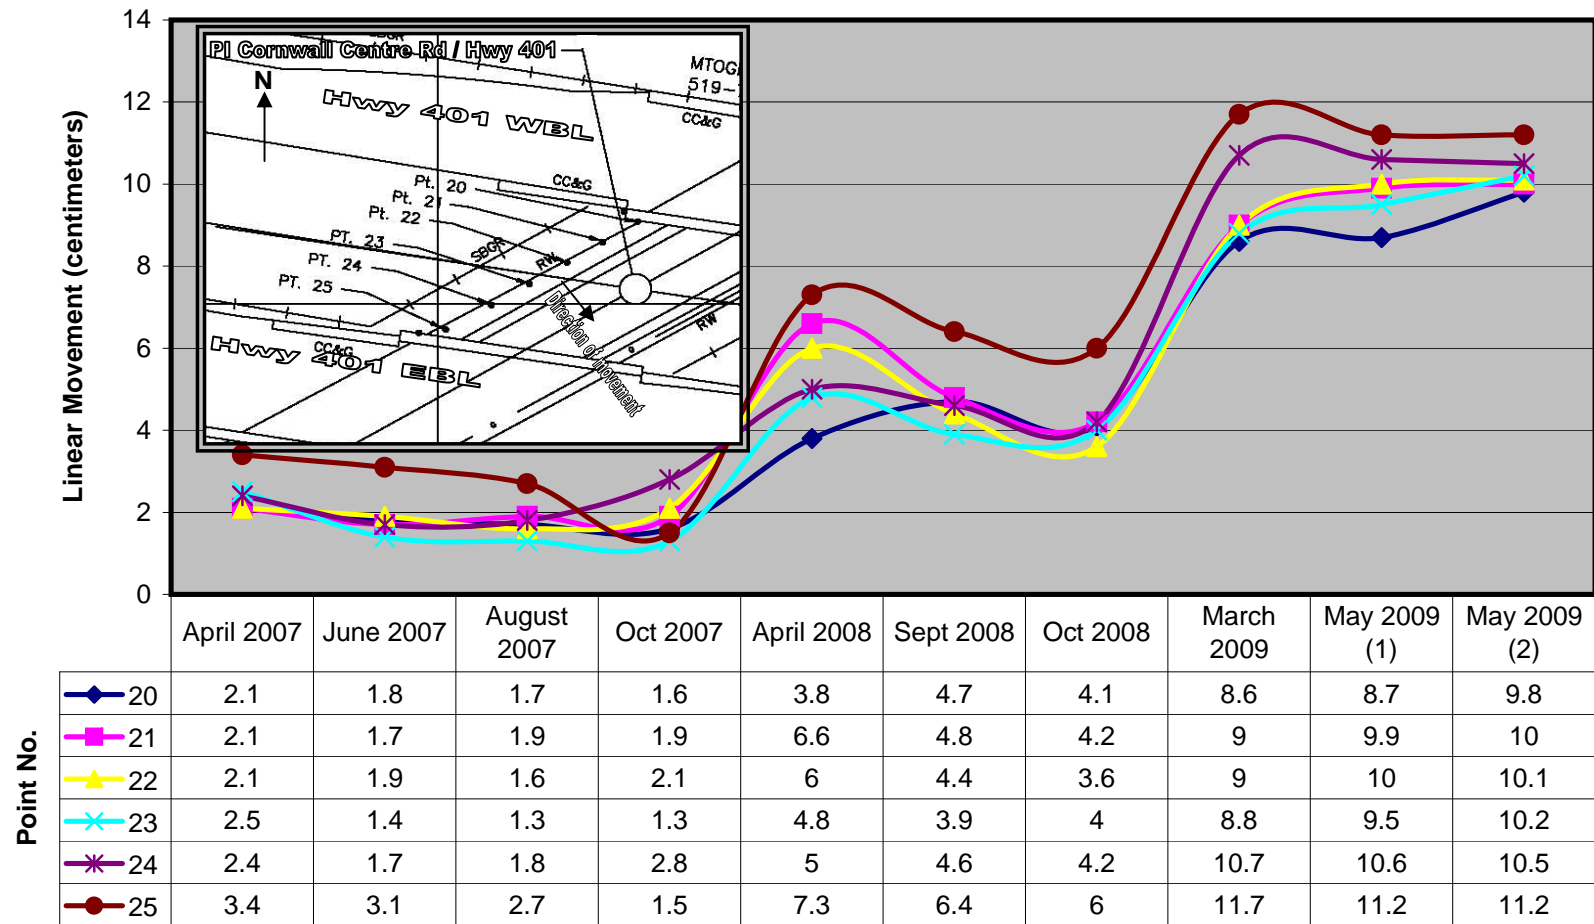
## Hwy 401 - Cornwall Centre Rd. - West Retaining Wall Movement

Movement Since February 2007

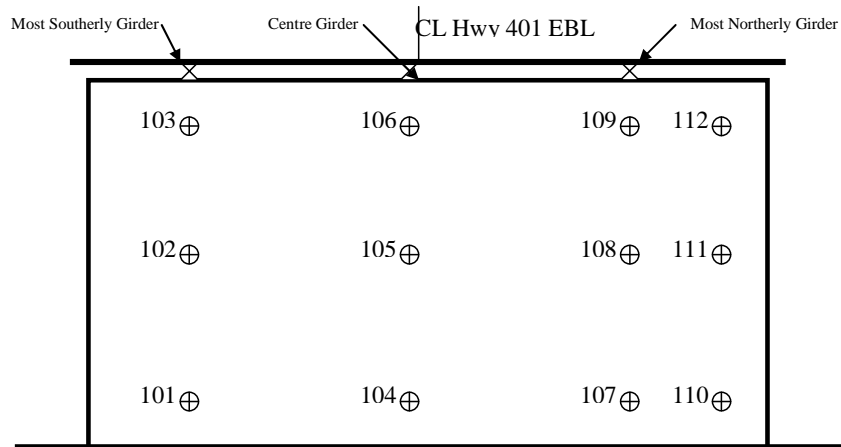
**West Abutment Wall Monitor Points**

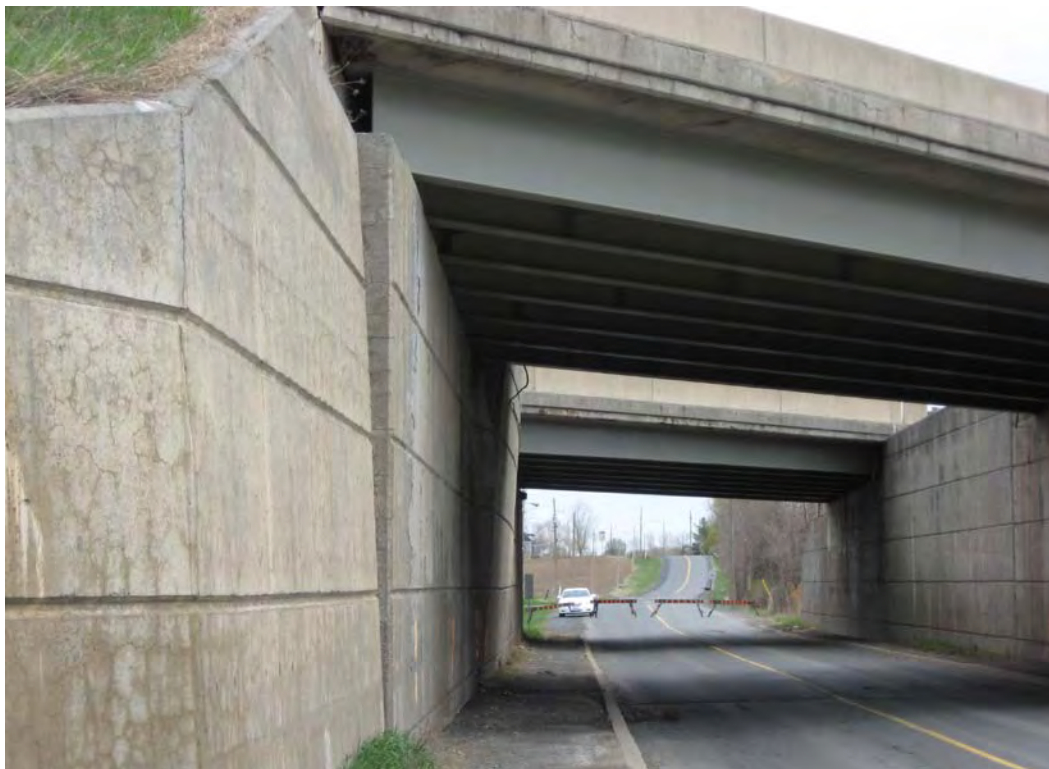
- The face of the west wall exhibits a number of vertical or near vertical cracks, the worst of which is near the middle of the wall which have opened significantly;

Plate 2 – Western retaining wall distress (EBL and median)

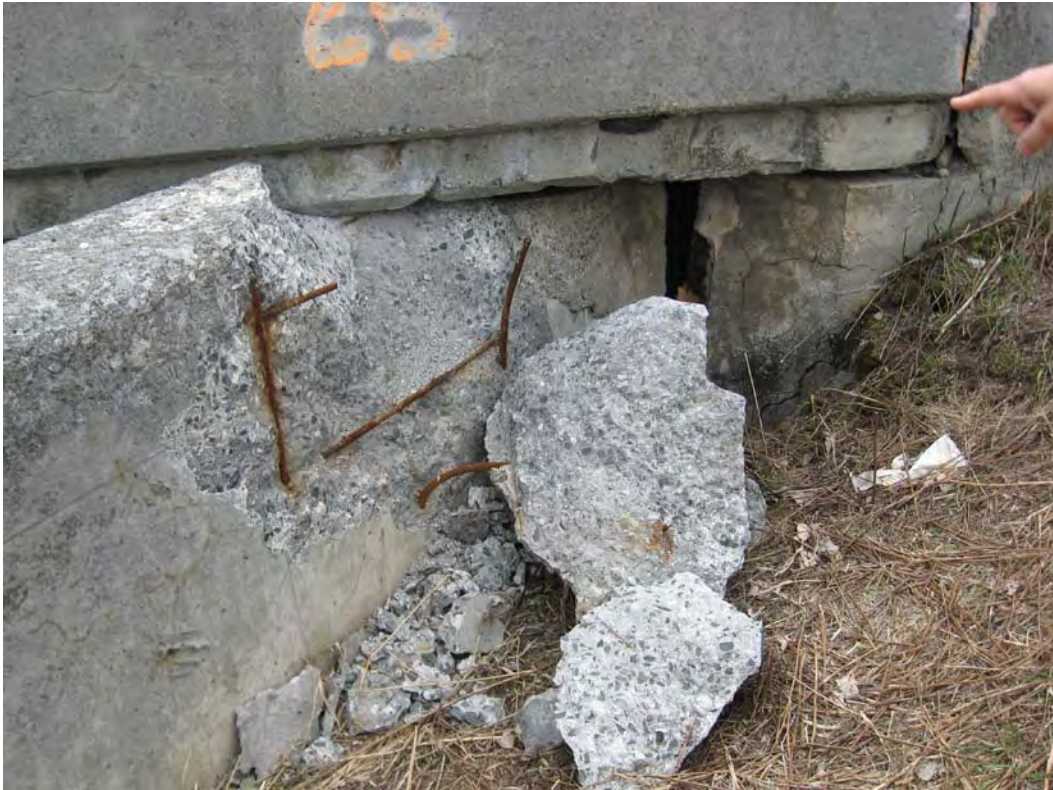
- The skewed structure arrangement has resulted in more severe damage where the retaining wall meets the west abutment of the EBL structure. Here, the wall is in hard contact with, and is wedged under the bridge soffit which has resulted in spalling of concrete pieces from the top of the wall and damage to the bridge;

Plate 3 – Retaining wall contact with EBL and associated damage

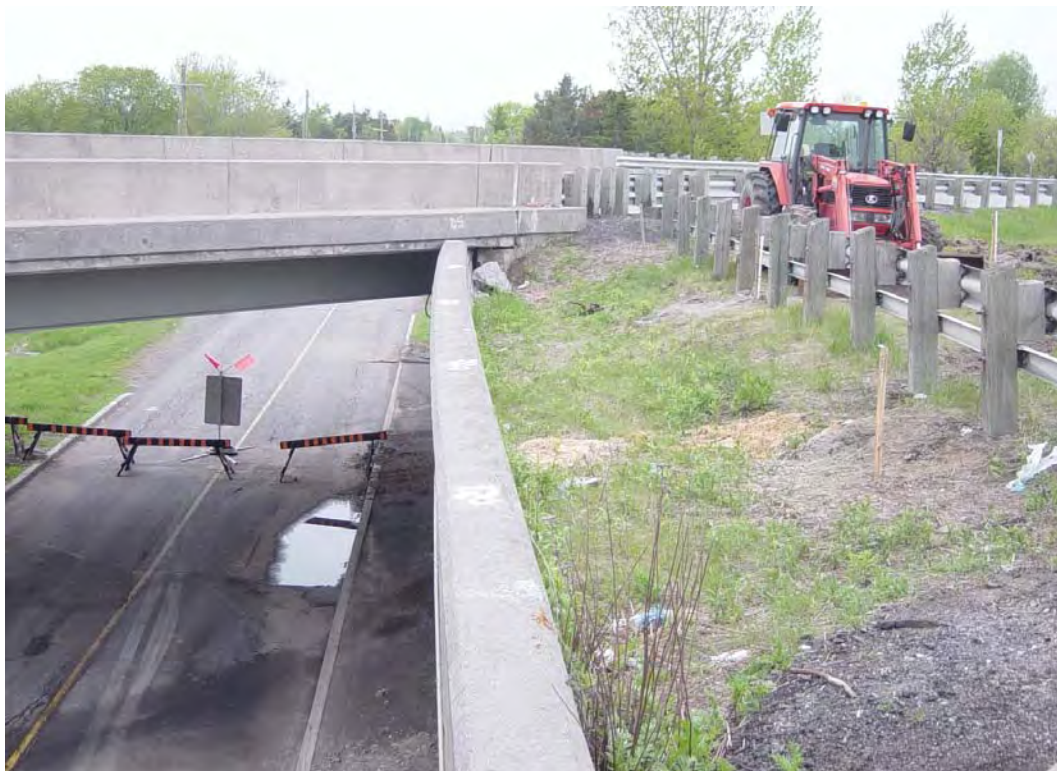
Plate 4 – Median retaining wall distress (facing south)

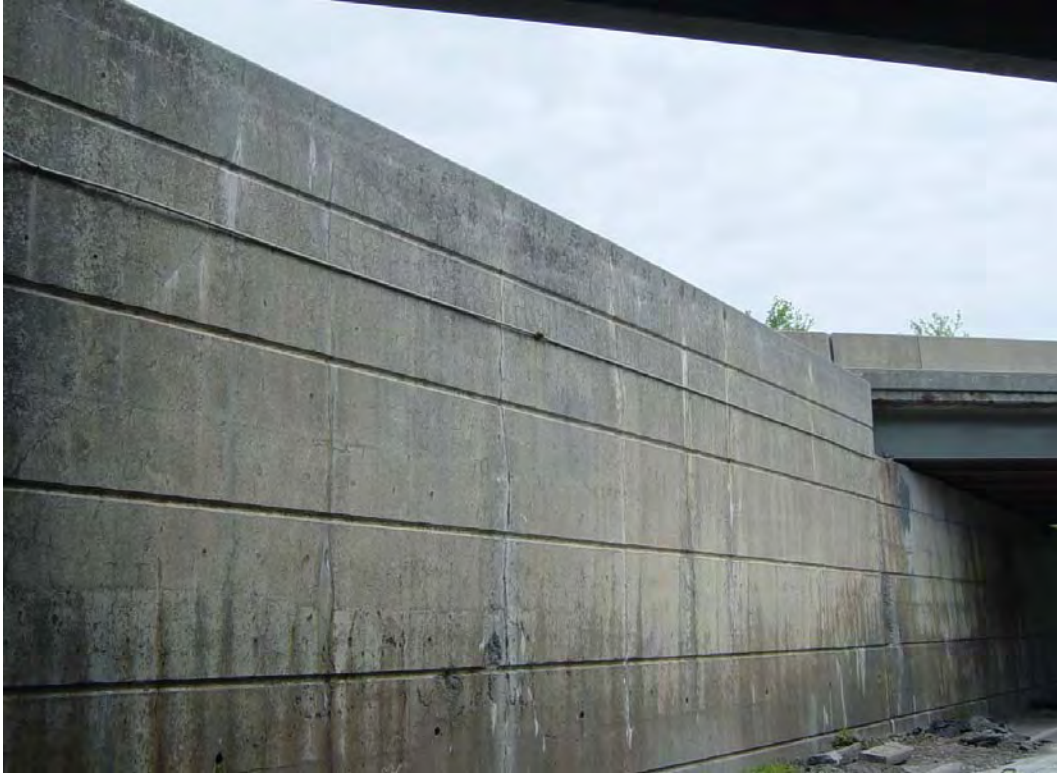
Plate 5 – Vertical cracks in median retaining wall

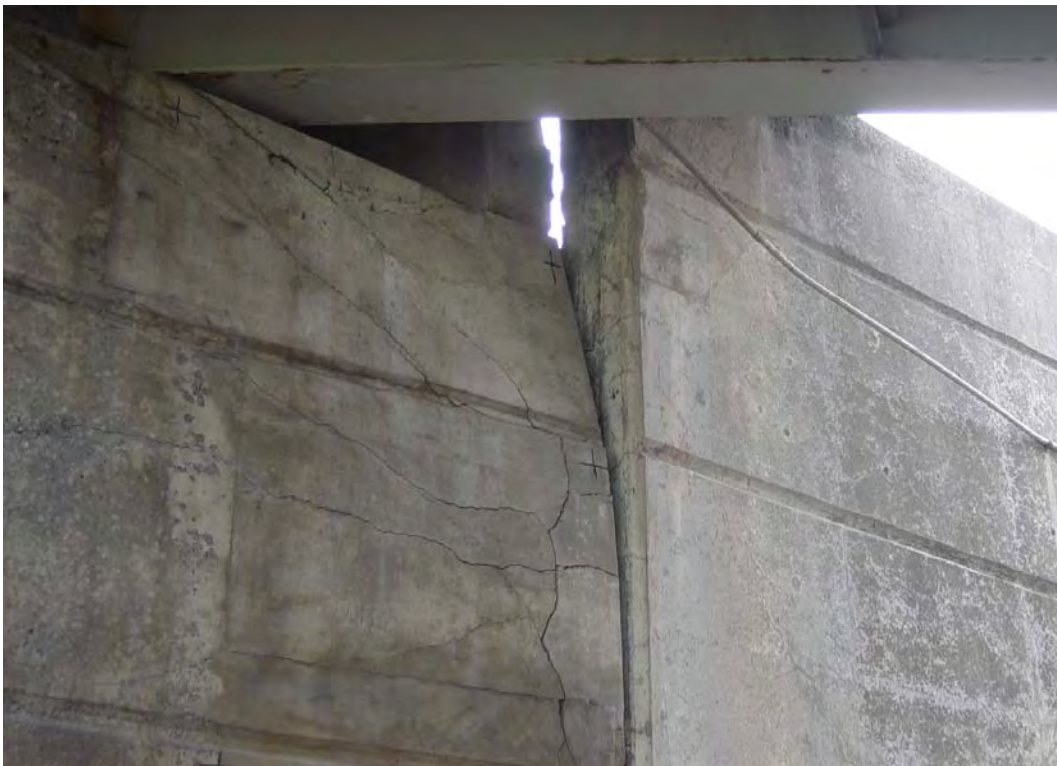
- The west wall had originally been keyed into the abutments and these keys have been sheared off by the forces driving the wall movement (certainly near the top of the wall) and damage has resulted to the abutment walls;

Plate 6 – Distress at EBL abutment and median retaining wall

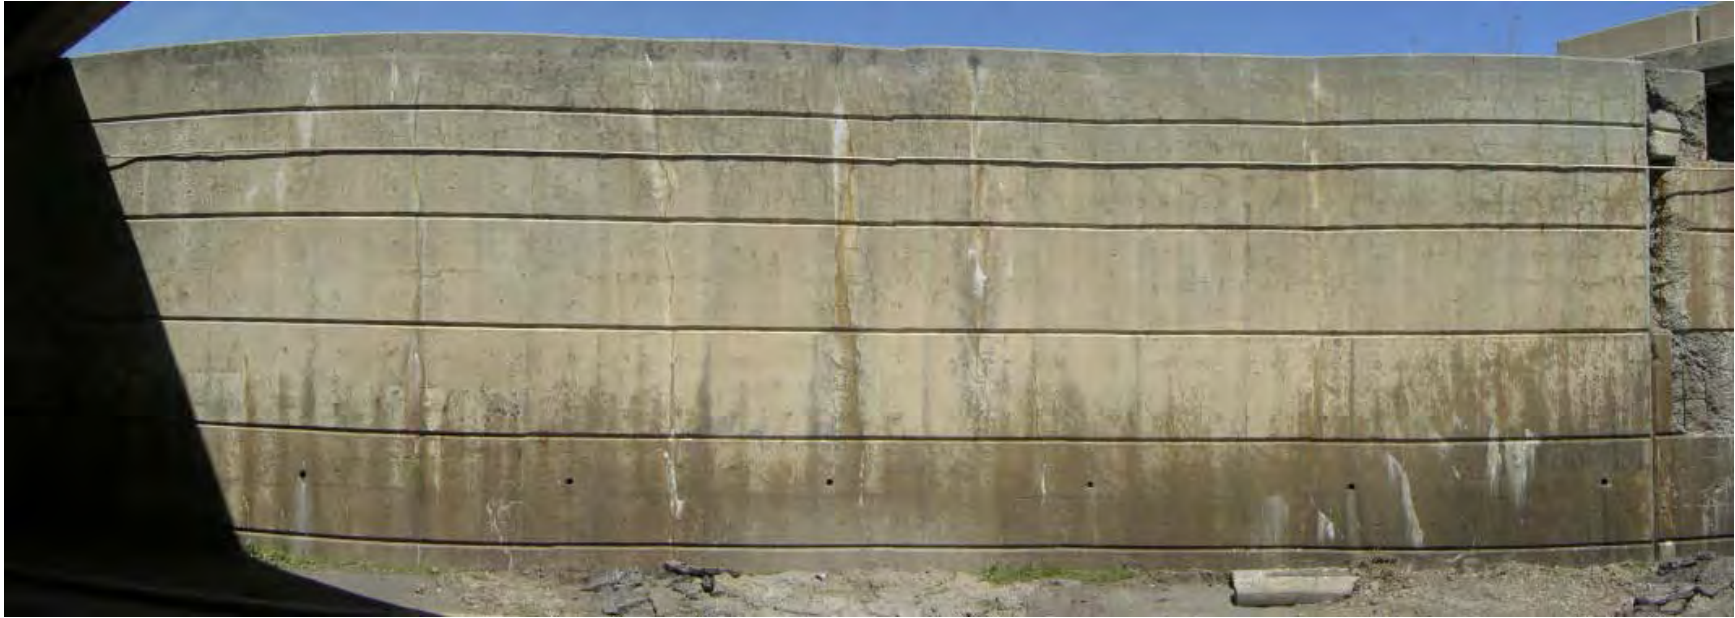
Plate 7 – Panoramic view of centre median retaining wall

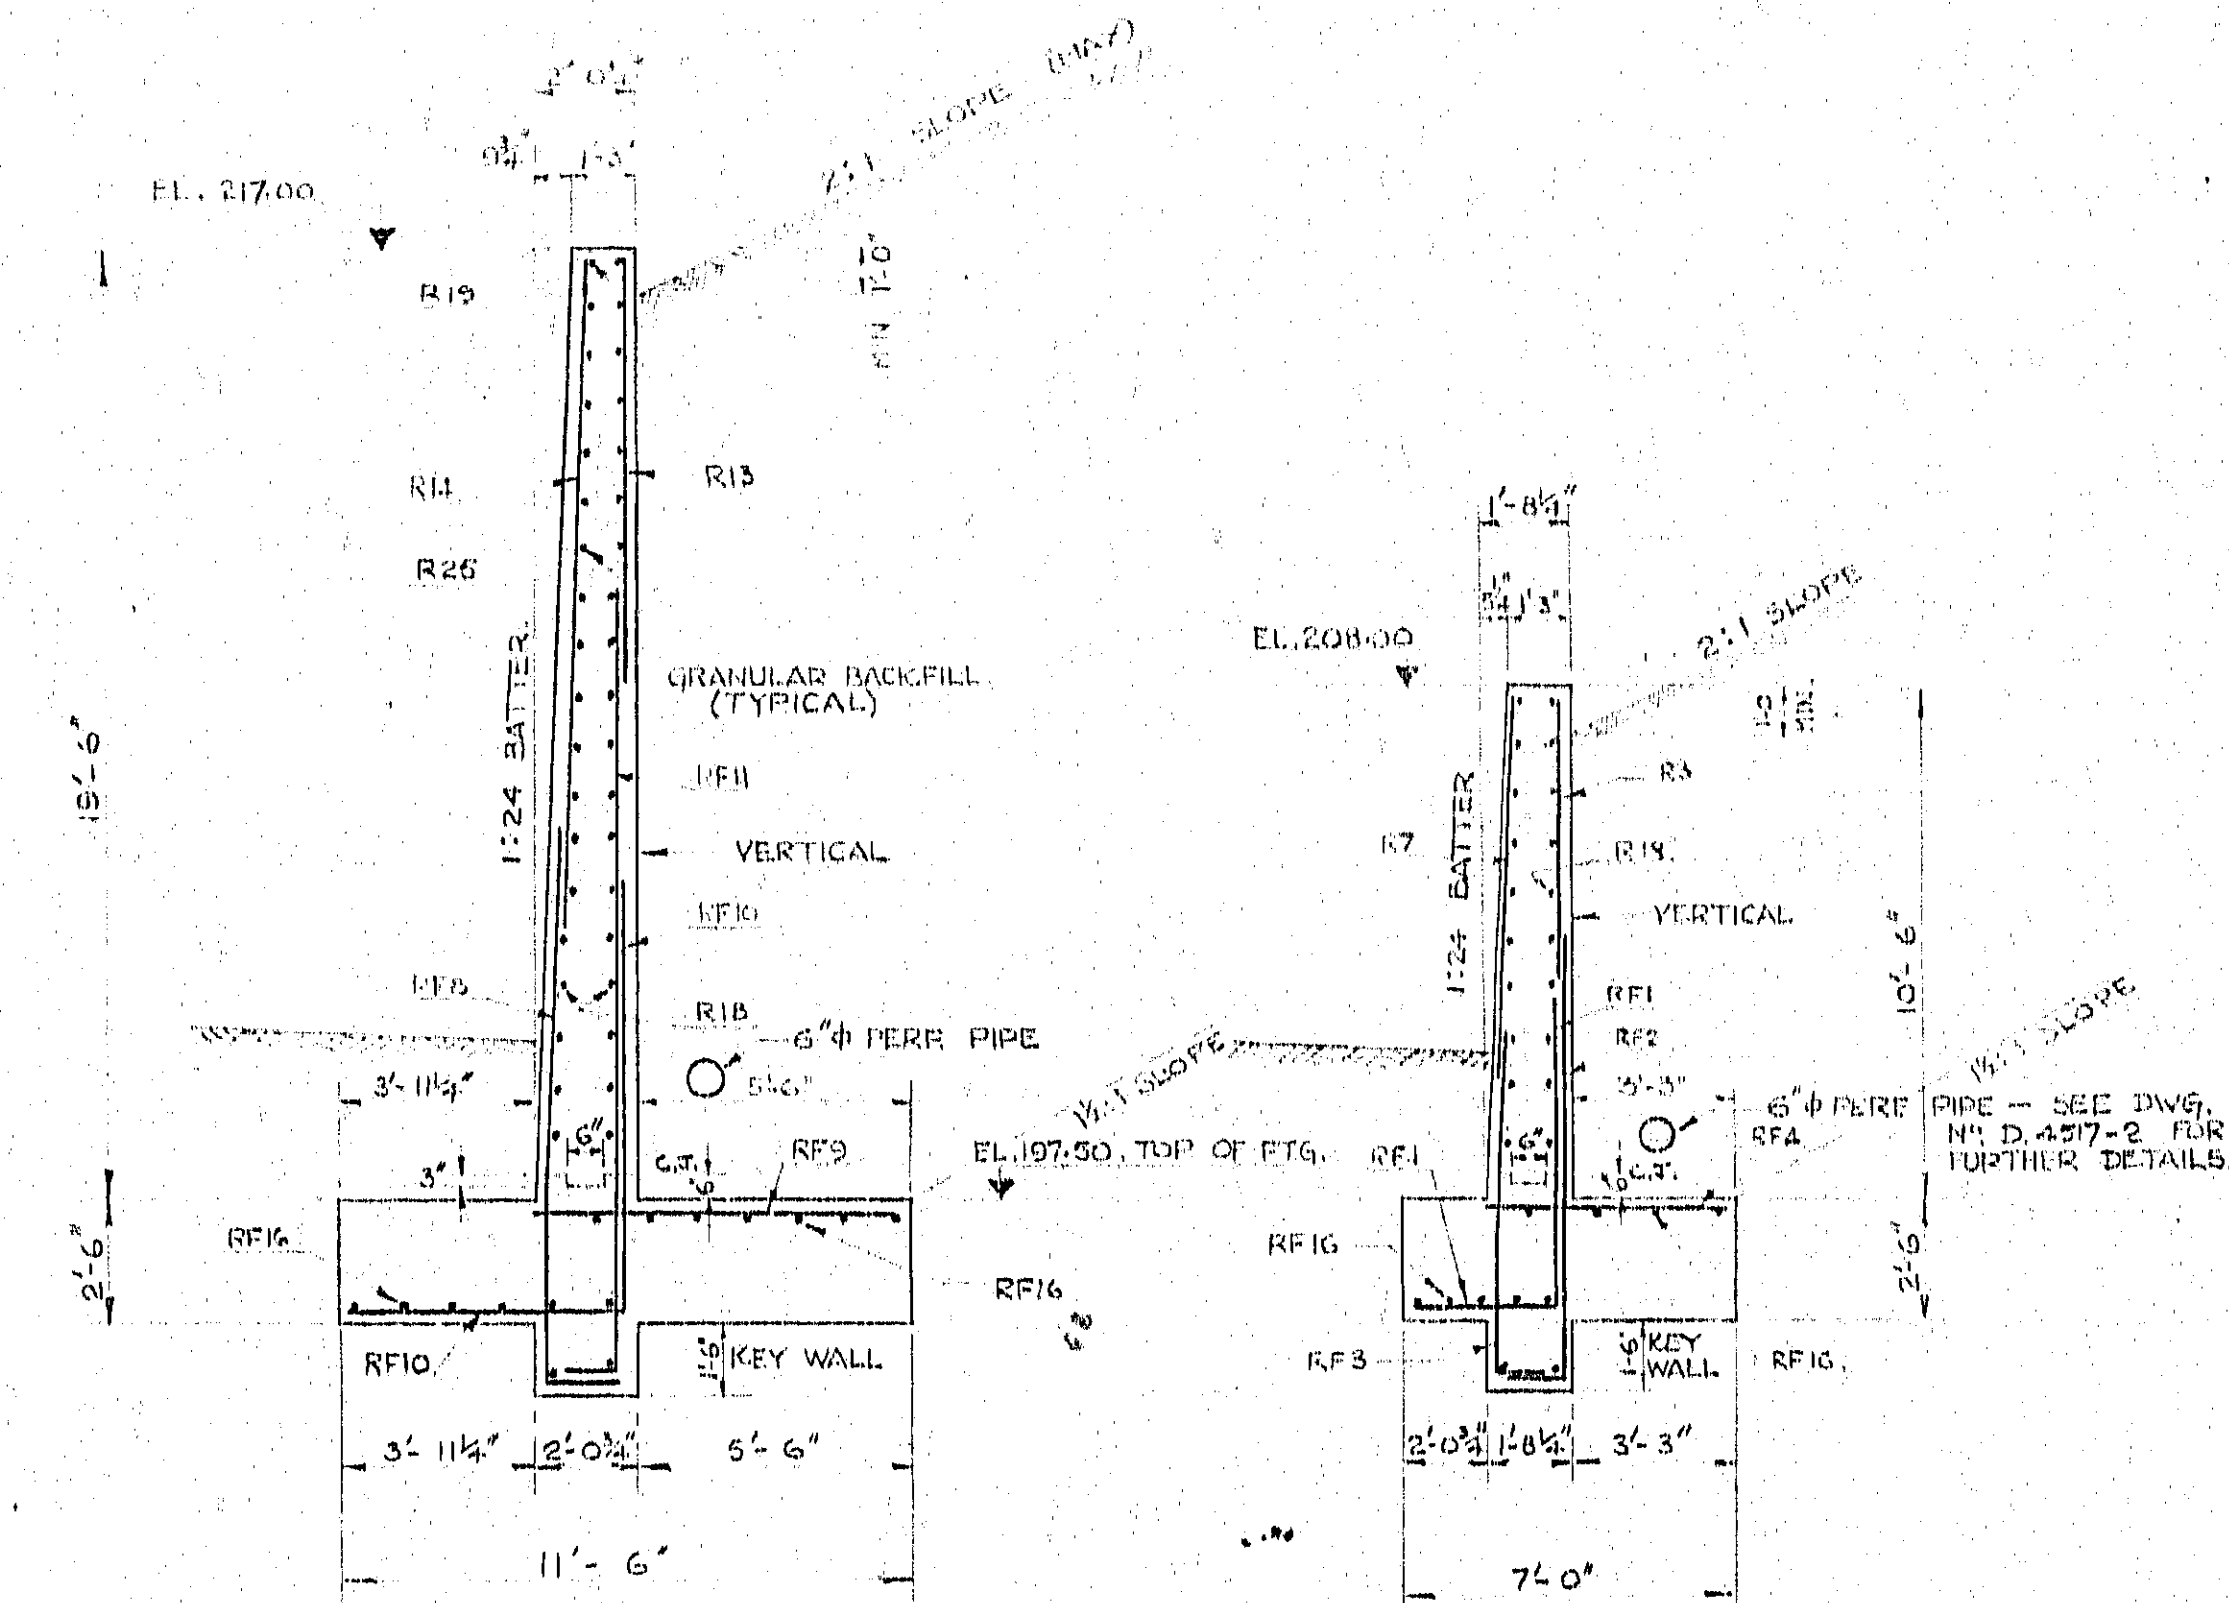
SECTION A-A

SECTION B-B

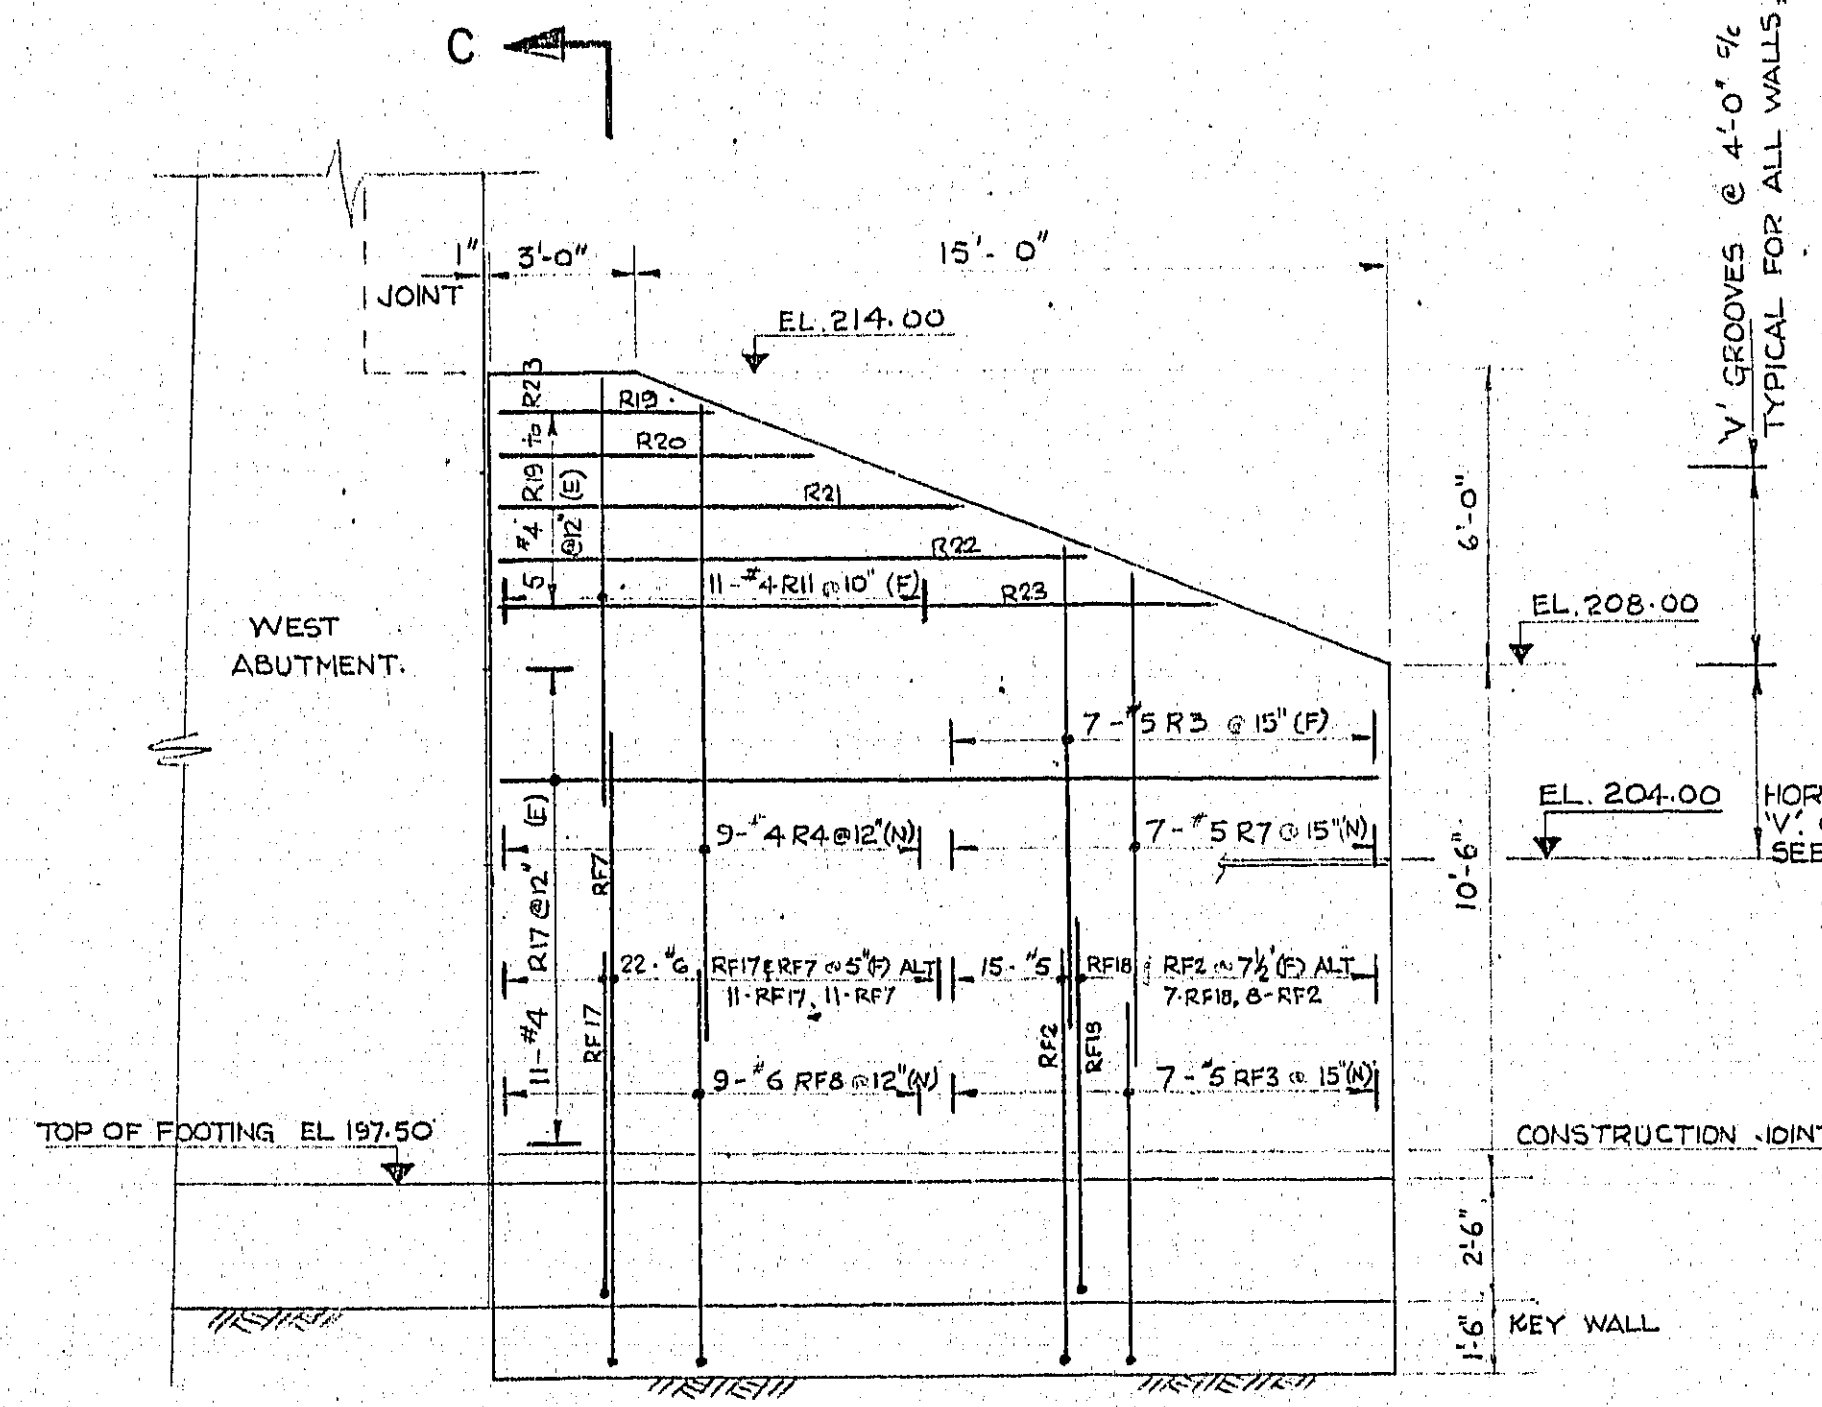
ELEVATION  
NORTH-WEST RETAINING WALL
