**FOUNDATION INVESTIGATION AND DESIGN REPORT  
DEAD HORSE CREEK CONCRETE ARCH REHABILITATION  
HIGHWAY 17, WALSH TOWNSHIP  
DISTRICT OF THUNDER BAY, ONTARIO  
LATITUDE: 48.817896°, LONGITUDE: -86.686889°**

**G.W.P. No. 6811-14-00, SITE No. 48E-21/C**

**GEOCRES Number: 42D-51**

Date: August 31, 2018  
File: 15595

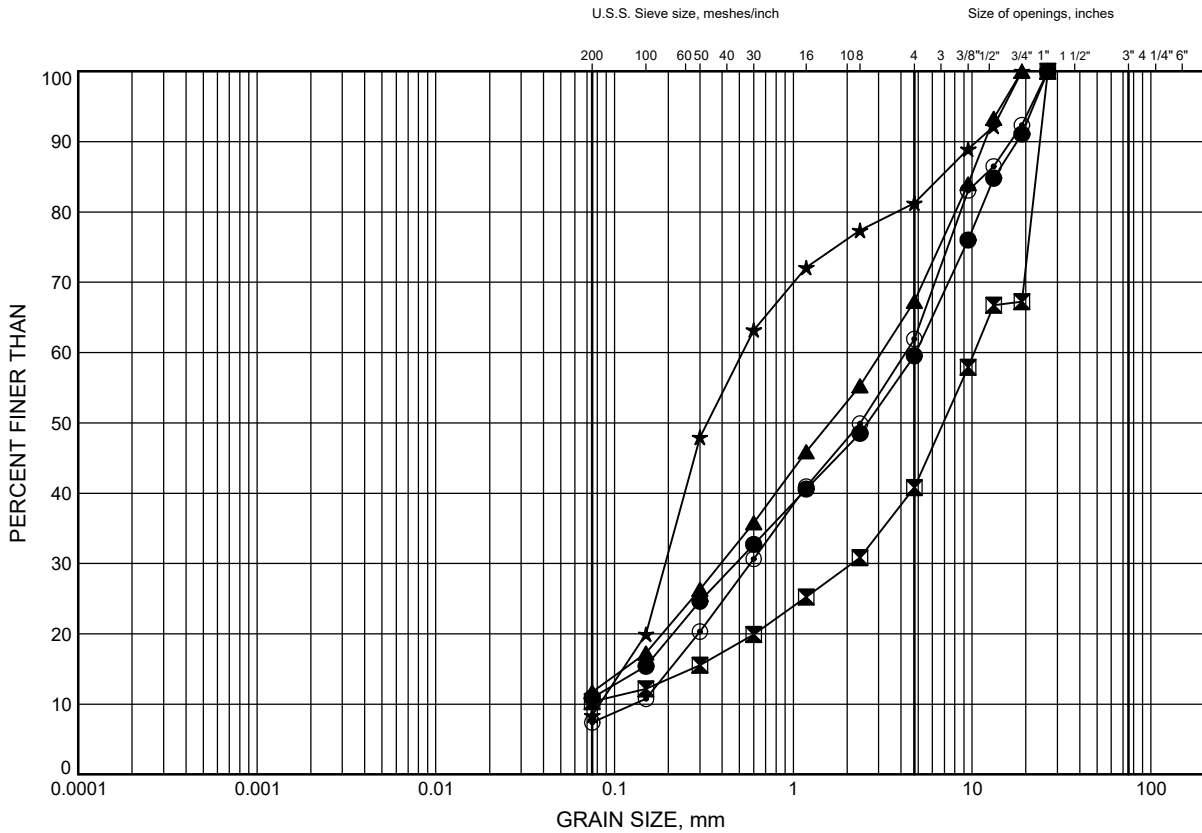
FIGURE B1

### Sandy GRAVEL to Gravelly SAND FILL

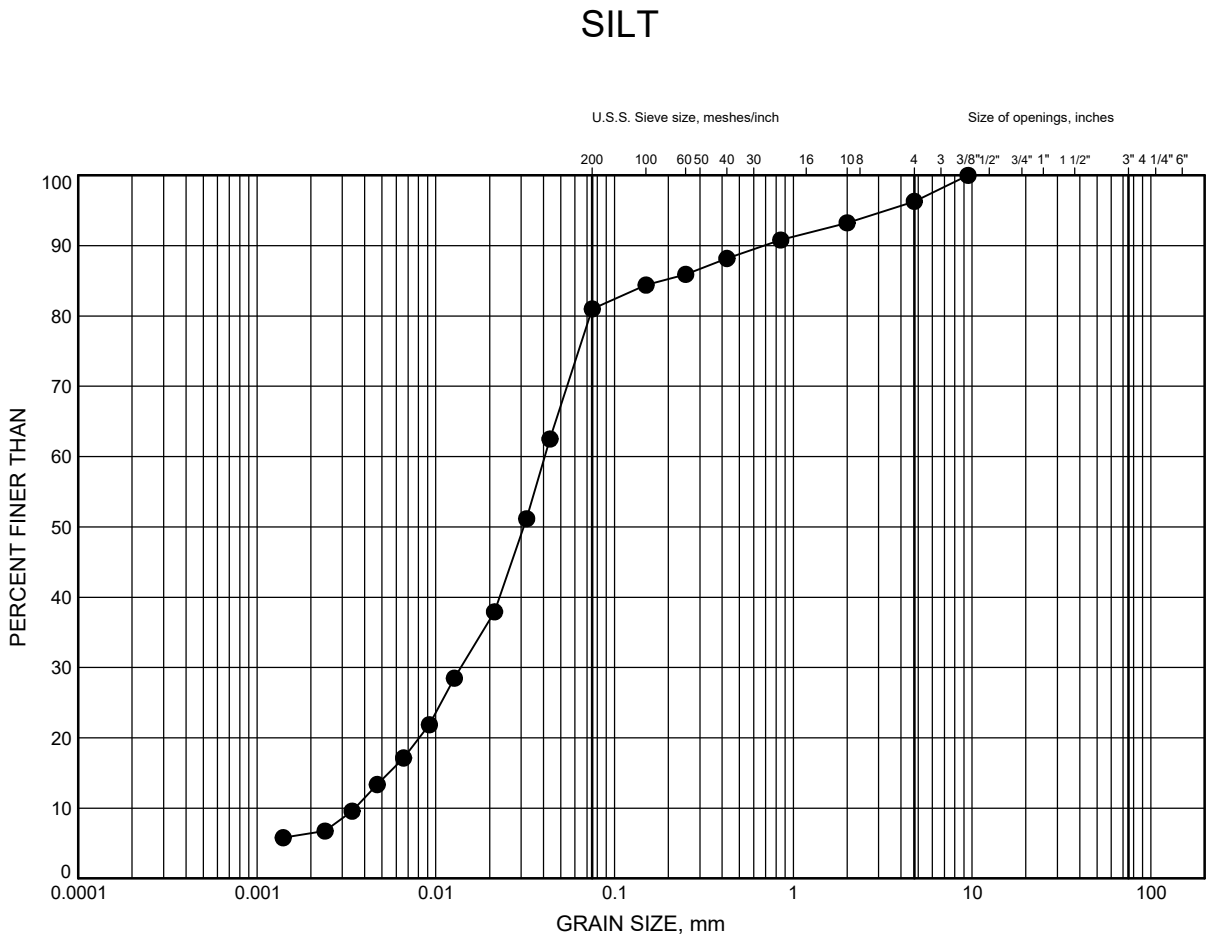
FIGURE B2

## GRAIN SIZE DISTRIBUTION

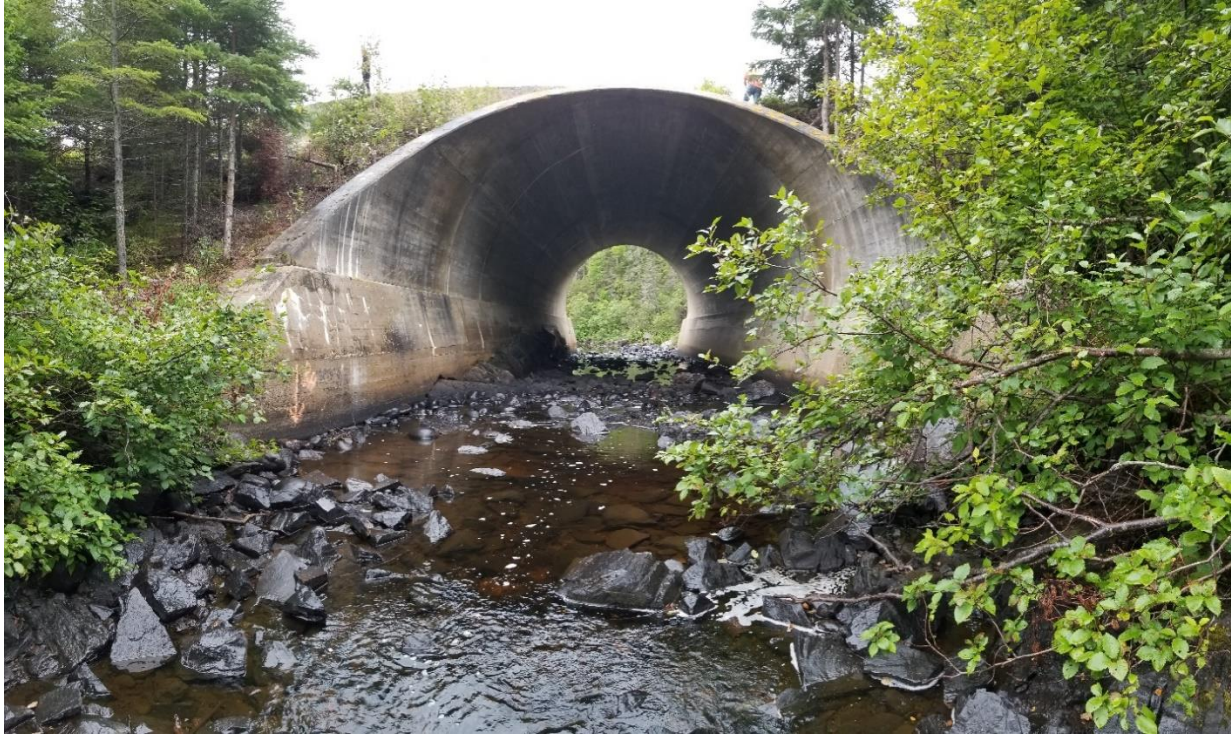
**Photo 3: Dead Horse Creek Culvert inlet (Taken: August 27, 2017)**

The underside of the west footing was not visible and likely extended below the creek bed, with the exception of the north end (inlet) where the footing base was observed to be resting on fractured/jointed rock with soil infilling. Boreholes drilled from the top of embankment or on the side slope approximately 10 to 20 m west of the west footing encountered bedrock at Elevations 235.0 and 235.7 m, which are approximately 9 to 10 m higher than the base of the west footing.

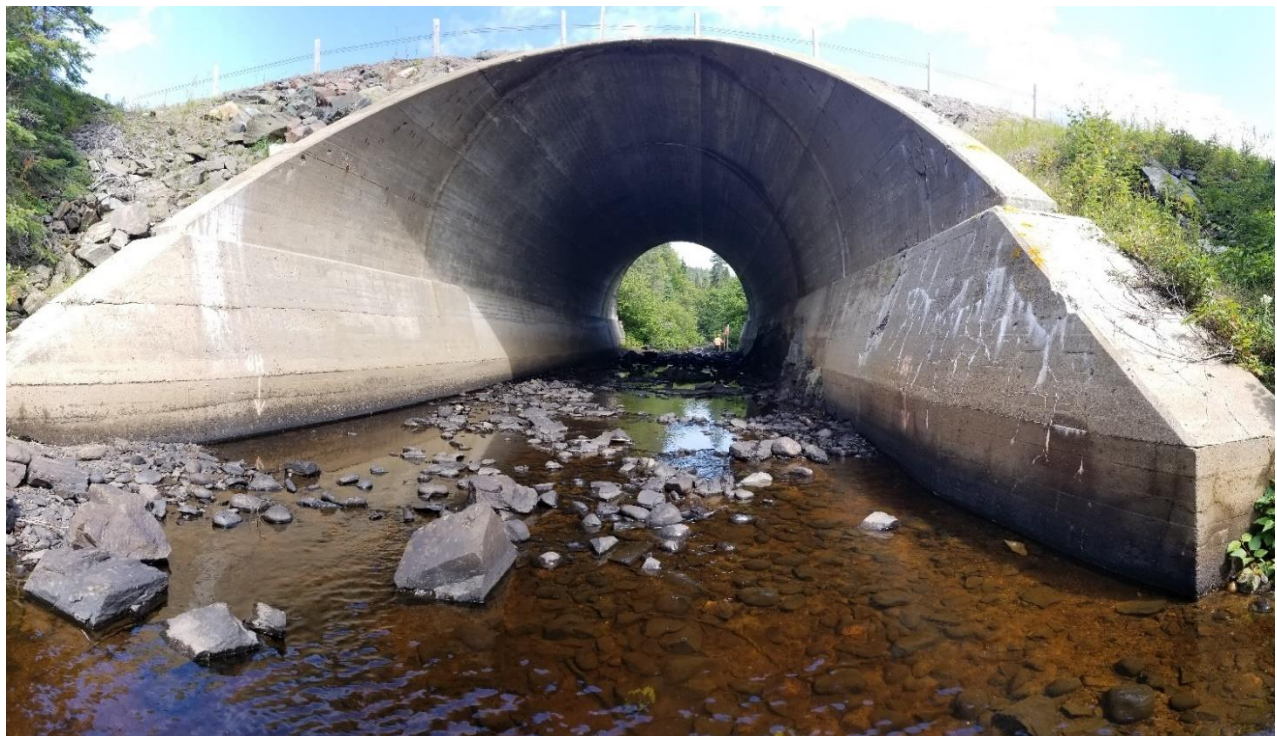
**Photo 4: Dead Horse Creek Culvert outlet (Taken: August 27, 2017)**

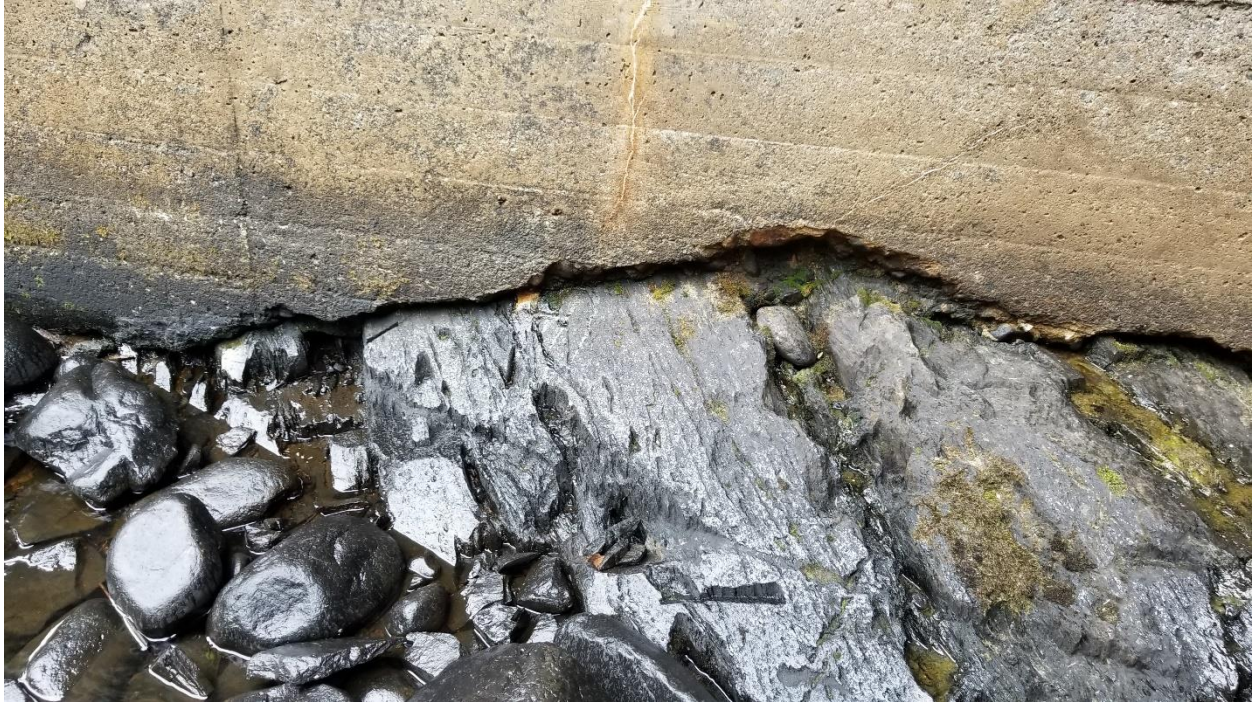
**Photo 5: Voids beneath east footing near north end (Taken: August 27, 2017)**

Visual observations during field investigation suggest that the east footing is founded on exposed bedrock in the middle section. Embedment of the east footing below the creek bed near the inlet and outlet could not be visually confirmed but is likely shallow given the nearby outcrops. Borehole 17-28 drilled near the north end of the east footing encountered bedrock at a depth of 1.8 m overlain by cobbles and boulders. Voids are visible between the underside of footing and the exposed bedrock at several locations along the footing. Photos 5 and 6 of Appendix C show examples of voids at the north end and south end of the east footing wall, respectively. exposed bedrock is slightly to moderately weathered and locally split or fractured along foliations.

- 2) The entire length of the footing should be inspected to assess the contact between the rock and footing concrete. Any gap or void between footing base and founding bedrock, if detected, must be filled with flowable concrete to re-establish the founding stratum and avoid stress concentration in the footings. Temporary formwork could be erected in front of the footings and flowable concrete could be pumped in as a possible method of filling the voids or gaps beneath the footings. Any voids or gaps that are exposed during any rock excavation should also be grouted.

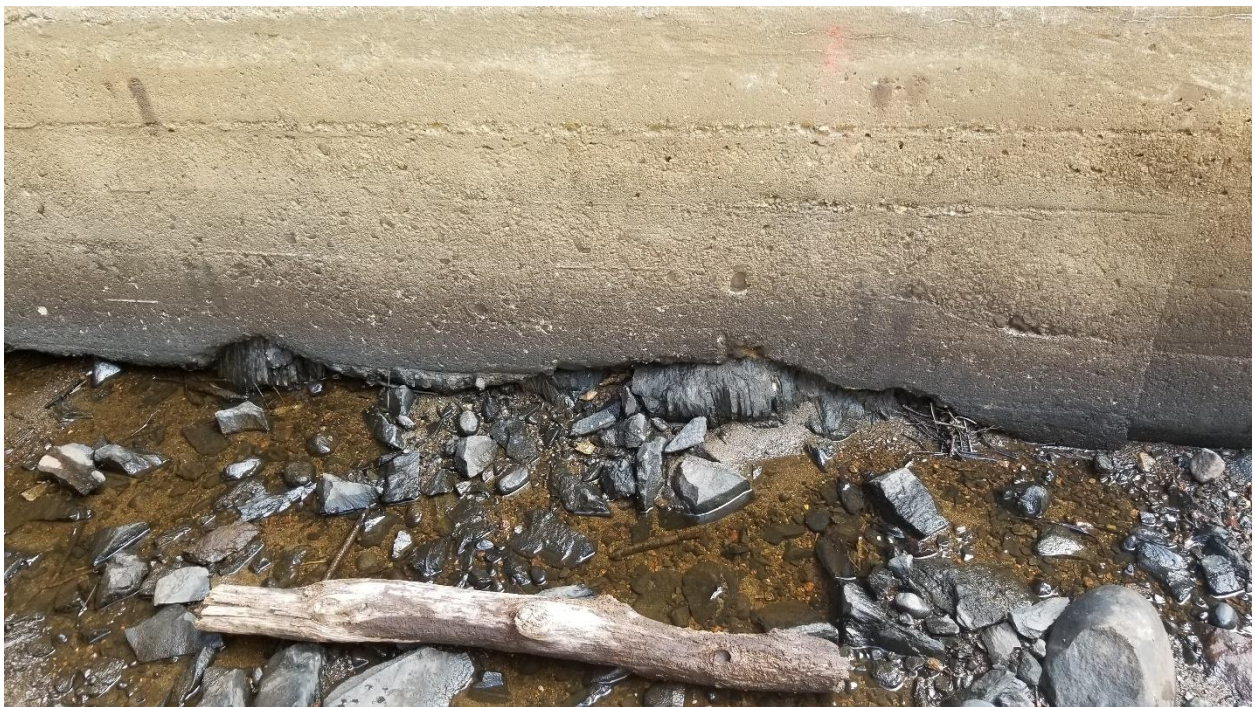
**Photo 6: Voids beneath east footing near south end (Taken: August 27, 2017)**

The Ontario Structure Inspection Manual (Inspection Form) indicates that the arch structure was in an overall fair condition during the time of inspection. No severe structural distress was observed in the concrete arch and both footings except where multiple vertical to sub-vertical cracks were visible in the sloped portion of the arch above the south end (outlet) of the east footing. Deterioration (spalling, cracking, honeycombing, etc.) of the footing concrete immediately below the cracks was also visible. The OSIM Inspection Form attributed these damages to localized weathering of rock under the east footing near south end and localized scour/voids

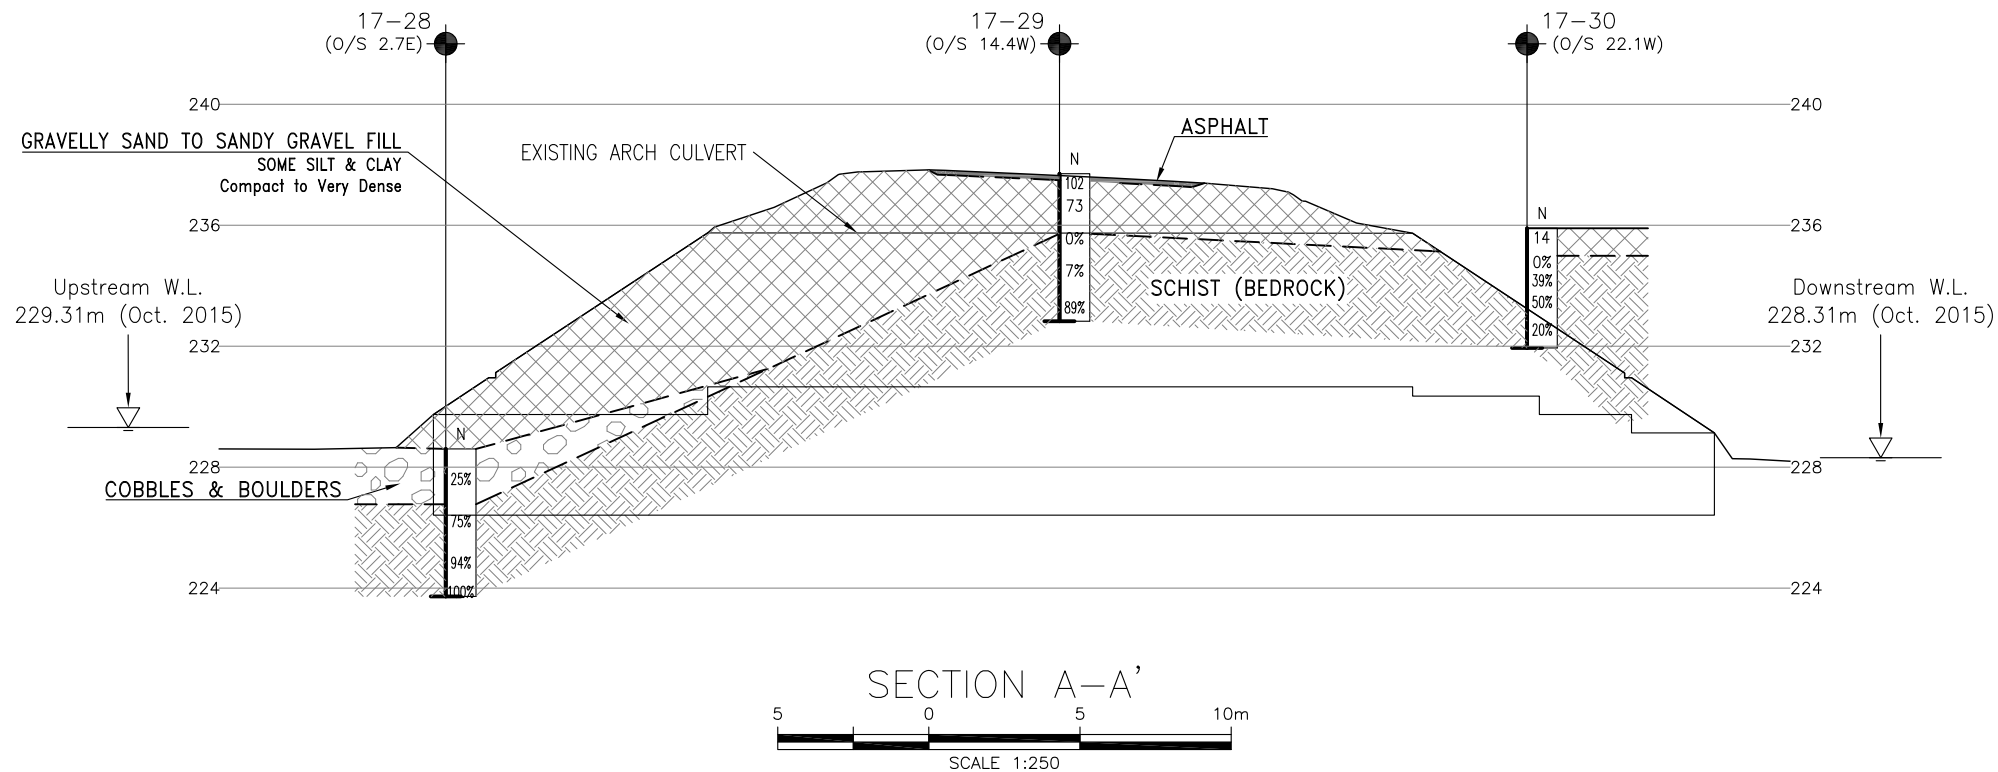
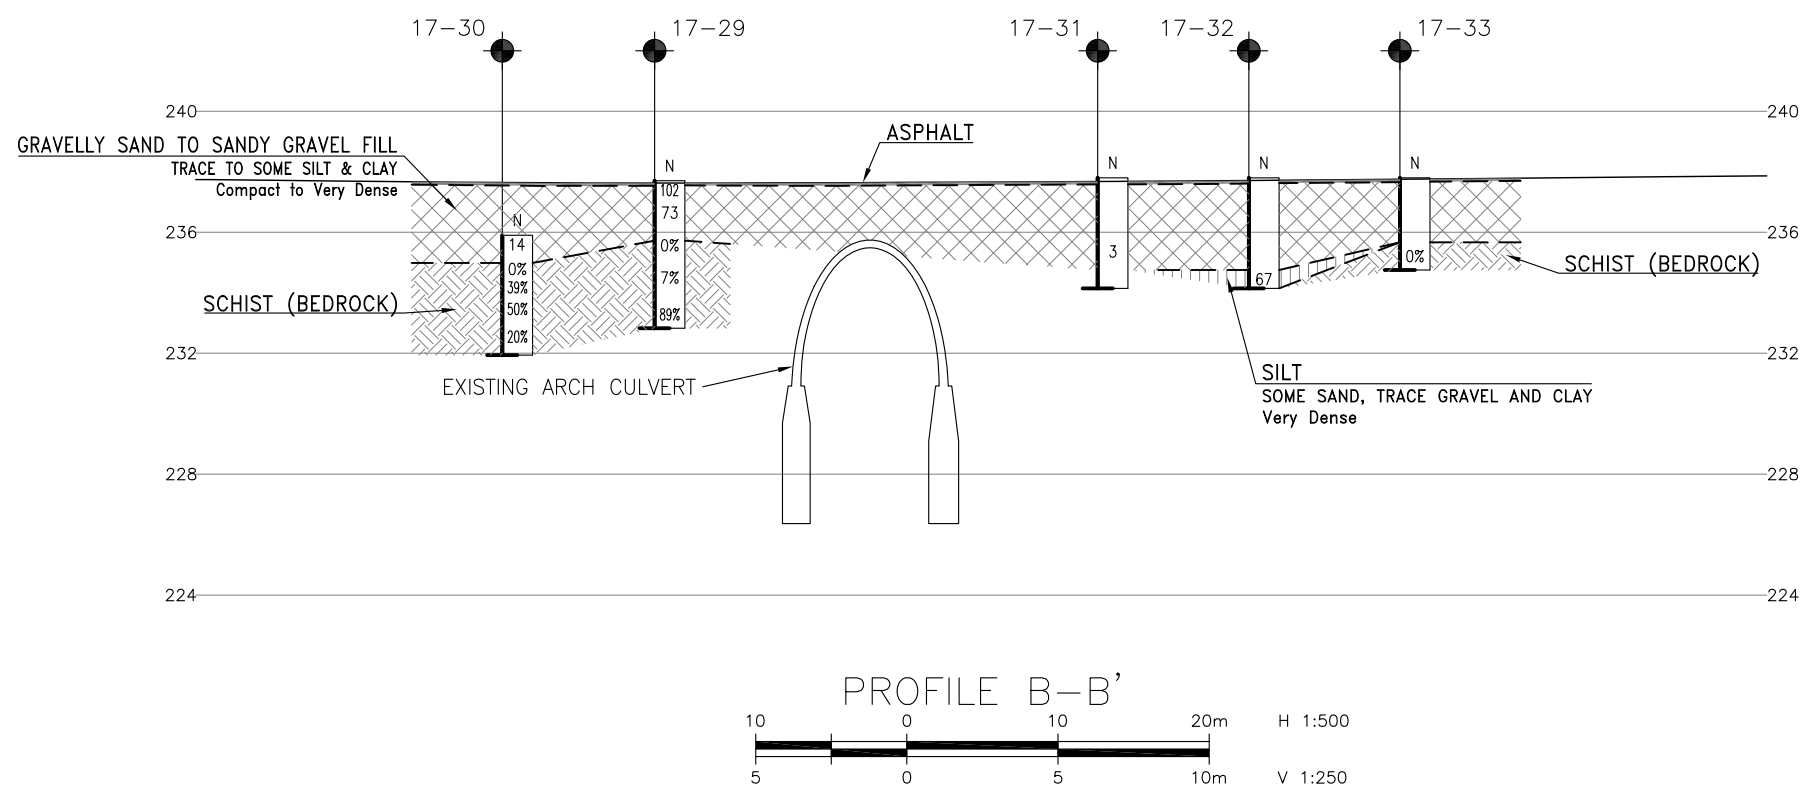
SHEET  
4

HIGHWAY 17  
DEAD HORSE CREEK  
CULVERT  
BOREHOLE LOCATIONS AND SOIL STRATA

Utility clearances were obtained prior to the start of drilling. The ground surface elevations for the boreholes were derived from cross-sections and topographic drawings provided by Hatch. The coordinate system MTM NAD 83, Zone 14 was used for the approximate locations of the boreholes shown on the Borehole Locations and Soil Strata Drawing included in Appendix D.
