Final Foundation Investigation and Design Report (FIDR)

Highway 559 Earth Management Berm

Station 26+850 to 27+035, Township of Carling

Ontario Ministry of Transportation (MTO)

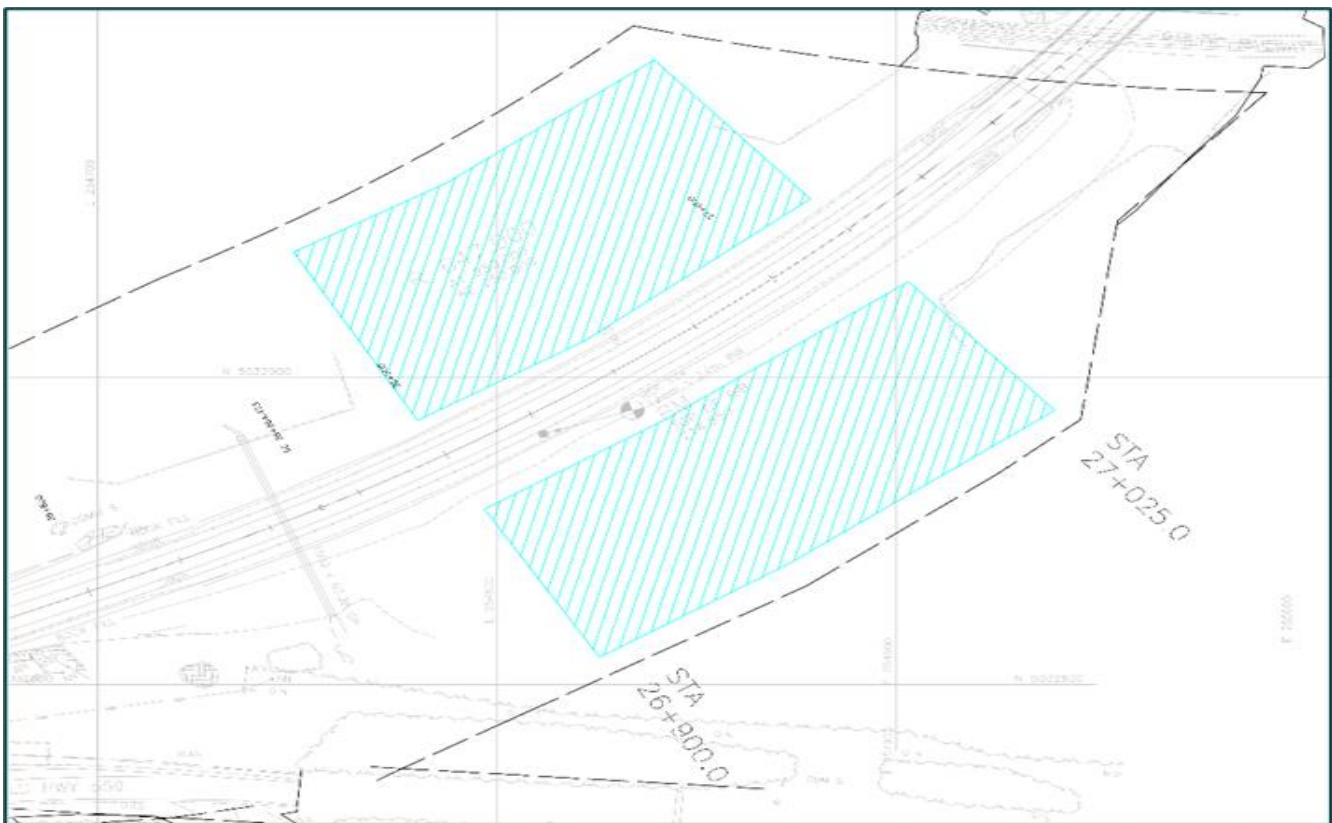
Figure 2.1 – Potential Earth Berm locations adjacent to Highway 559 (Sta. 26+900 to 27+025)

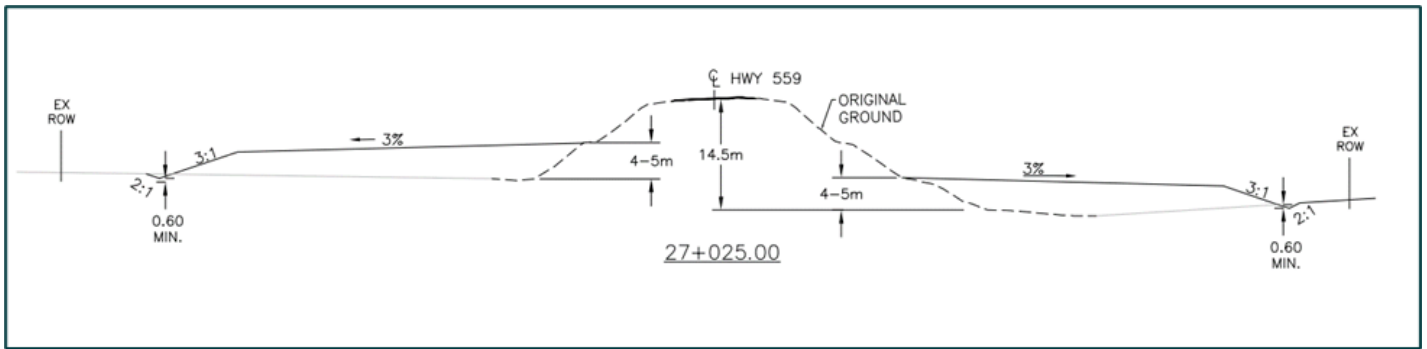
Figure 2.2 – Cross section of the potential earth berms adjacent to Highway 559

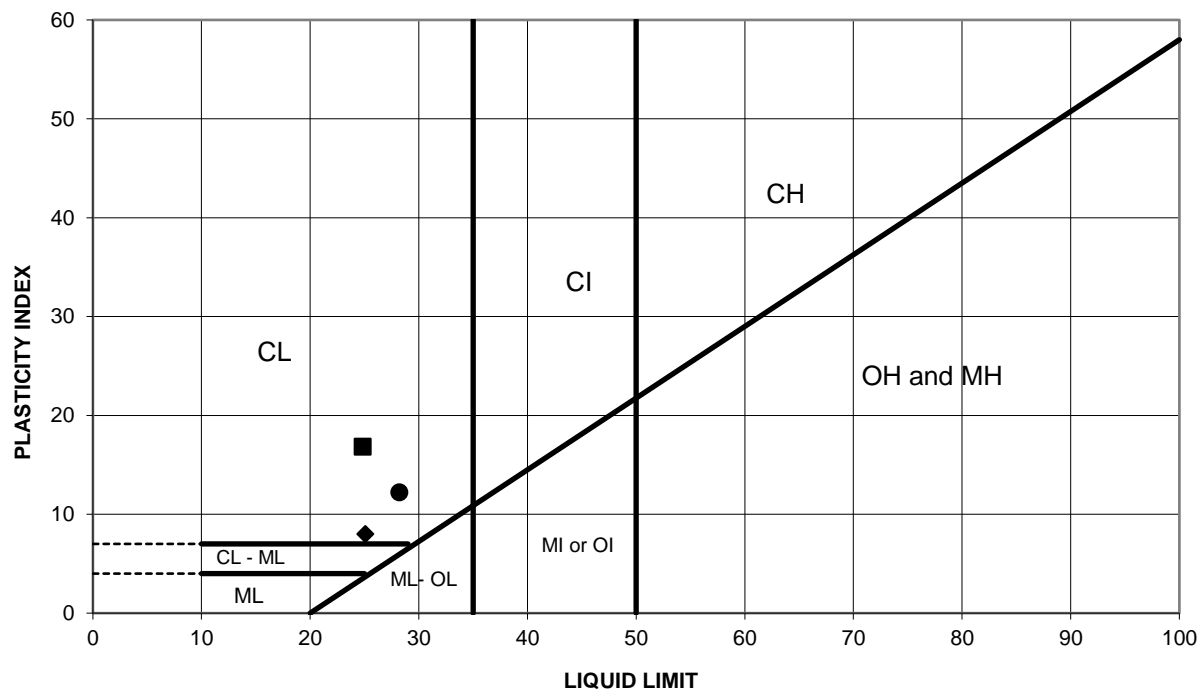
FIGURE L-3

ATTERBERG INDICES

SYMBOL	BH No.	Sa No.	Depth (m)	Plasticity Index	Plastic Limit	Liquid Limit	NMC %
●	1	2	1.1	12.2	16.0	28.2	17.7
■	2	2	1.1	16.9	8.0	24.8	23.2
◆	2	4	2.6	8.0	17.1	25.1	31.1

The natural moisture contents measured on samples recovered from the deposit ranged from 18 to 31%. Two (2) gradation analyses and two (2) Atterberg were carried out on samples from this deposit, and the results are summarized in Table 4 and provided in Figure Nos. L-2 and L-3, Appendix C.

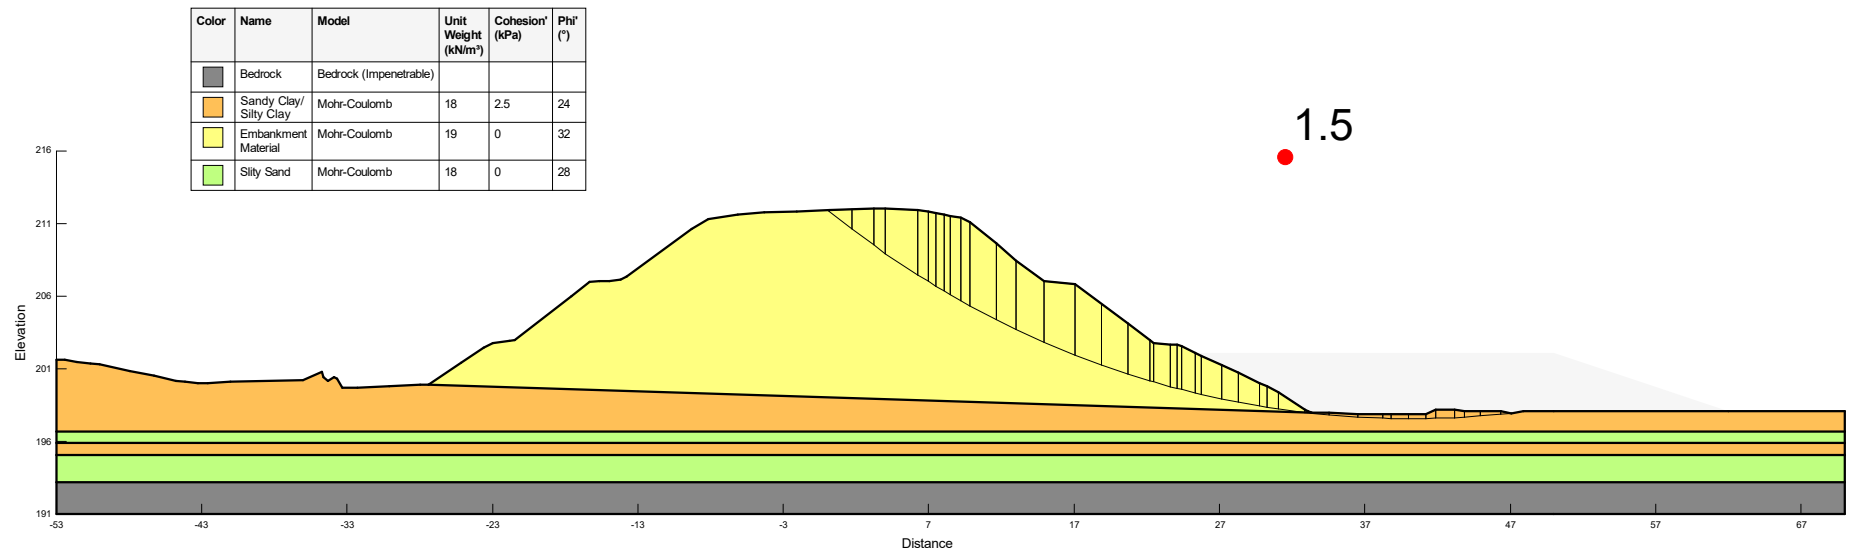
Slope Stability-Existing condition	S1
Highway 559 -Earth Berm Station 26+850.gsz	
2023-01-13	1:520

The analysis indicated that the factor of safety was estimated at 1.2 to 1.3 for the existing embankment slopes, see Figure Nos. S1 and S2 (Slope Stability for Existing Condition), Appendix D.

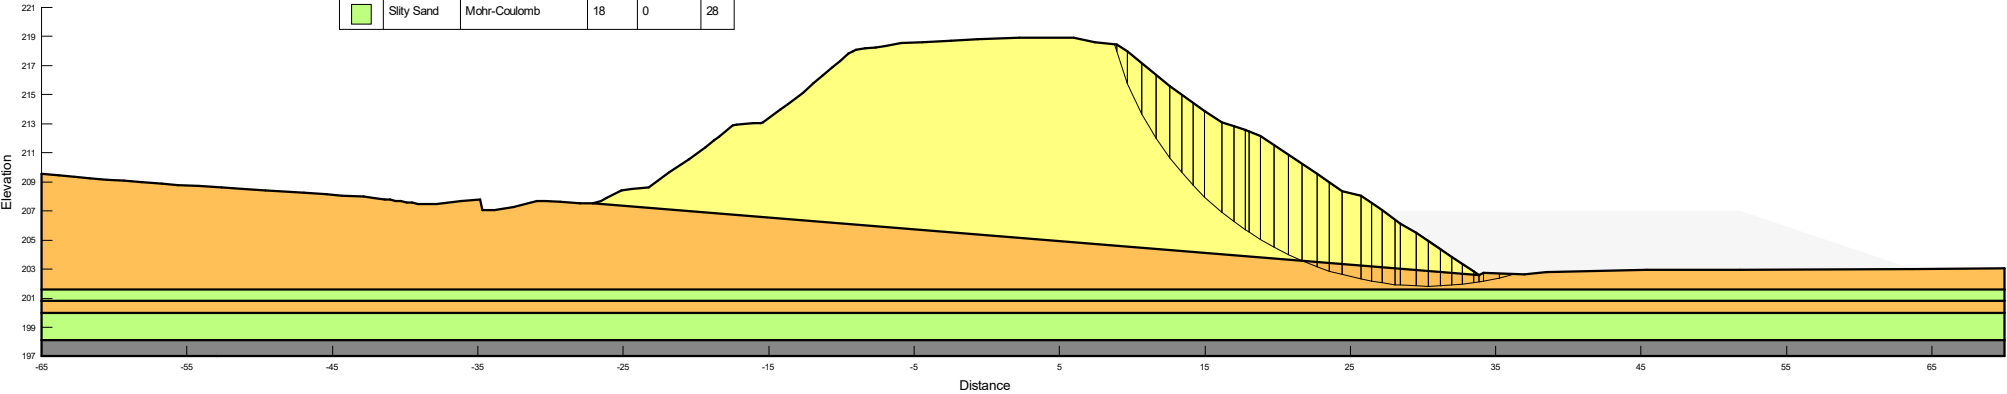
Slope Stability-Existing Condition	S3
Highway 559 -Earth Berm Station 27+035.gsz	
2023-01-13	1:520

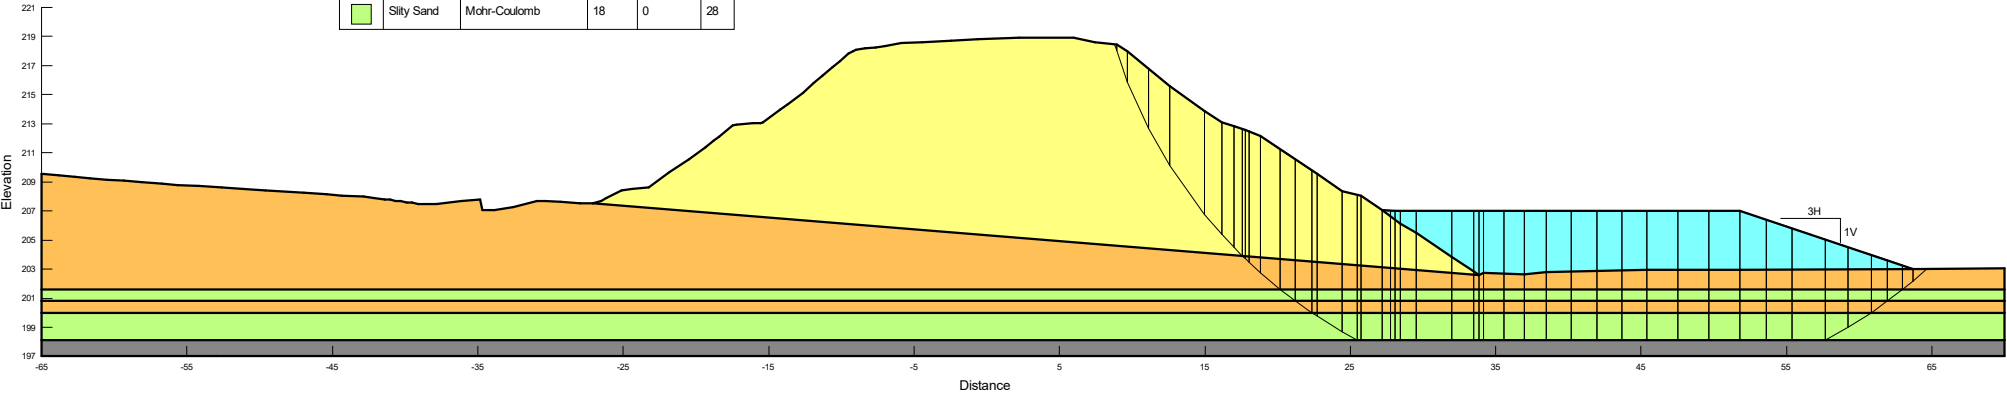
Slope Stability-with Berm	S4
Highway 559 -Earth Berm Station 27+035.gsz	
2023-01-13	1:520

If the new berm is constructed adjacent to the embankment slopes with side slopes established at an angle of 3H:1V, a higher factor of safety is achieved (between 2.4 to 2.8) as the new berm will provide additional rotational resistance to the embankment slope, see Figure Nos. S3 and S4 (Slope Stability with Berm), Appendix D.

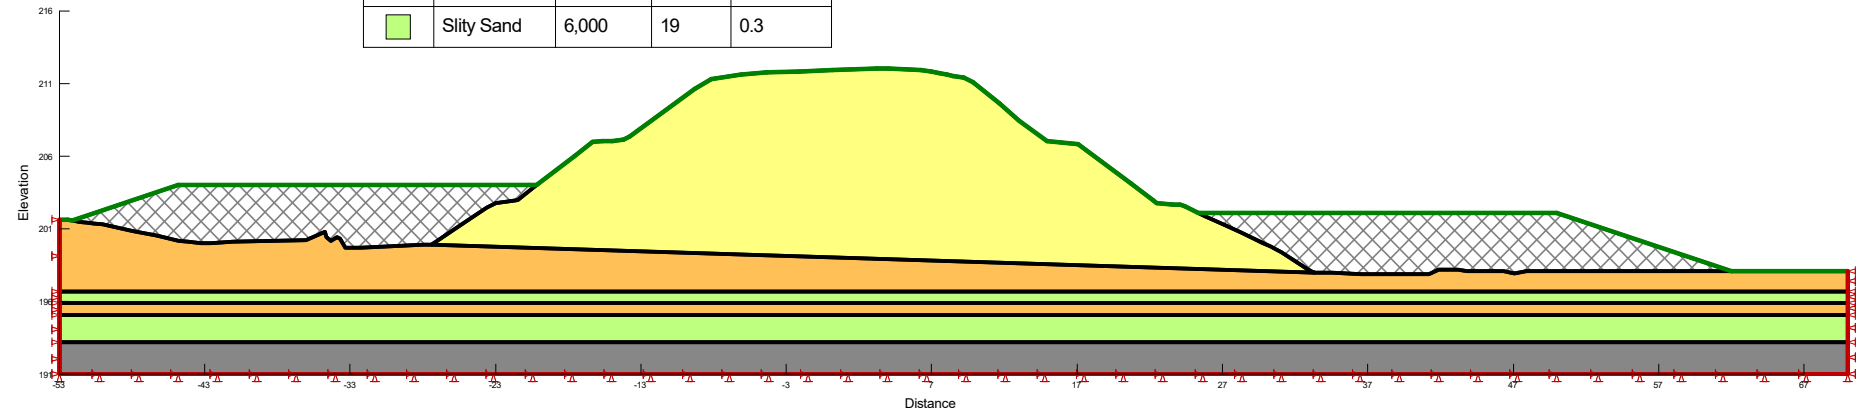
With side berms	S5
Highway 559 -Earth Berm Station 26+850 -settlement.gsz	
2023-01-25	1:520

The results of the settlement analysis are provided in Figure Nos. S5 and S6, Appendix D. As shown in Figure No. S6, the existing highway embankment will not be affected by the new berms and zero settlement is anticipated under the highway embankment centreline.

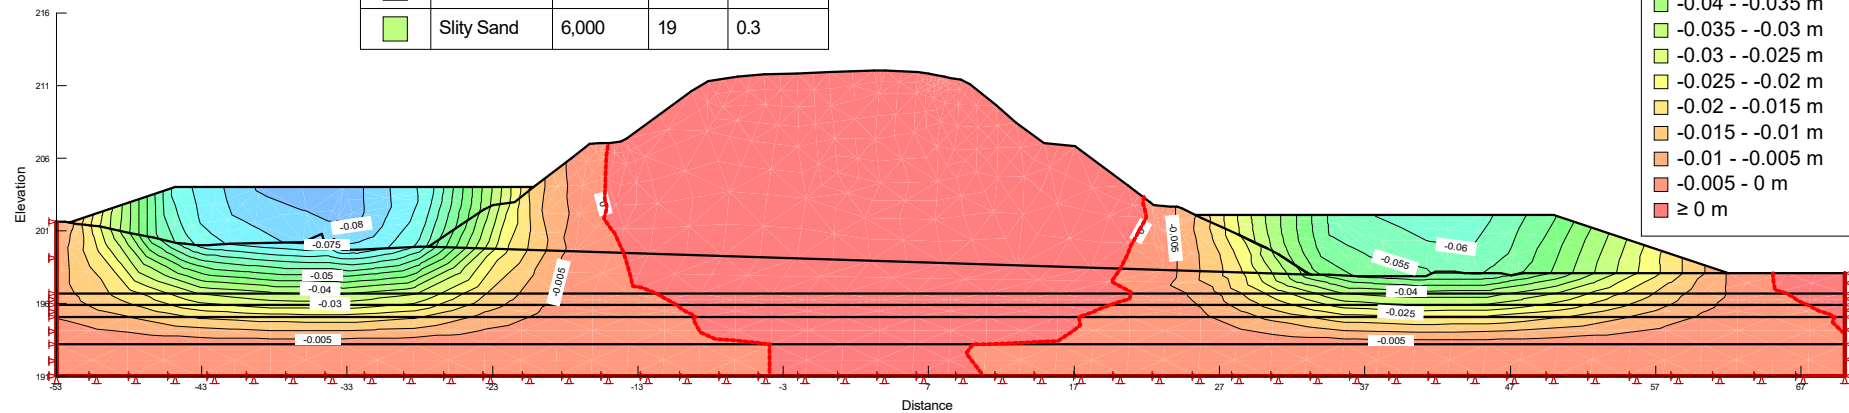
With side berms	S6
Highway 559 -Earth Berm Station 26+850 -settlement.gsz	
2023-01-25	1:520
