FOUNDATION INVESTIGATION AND DESIGN REPORT

PROPOSED OVERHEAD SIGN SUPPORT STRUCTURES

TOWN OF NIAGARA-ON-THE-LAKE NIAGARA REGION, ONTARIO

GWP 2423-15-00

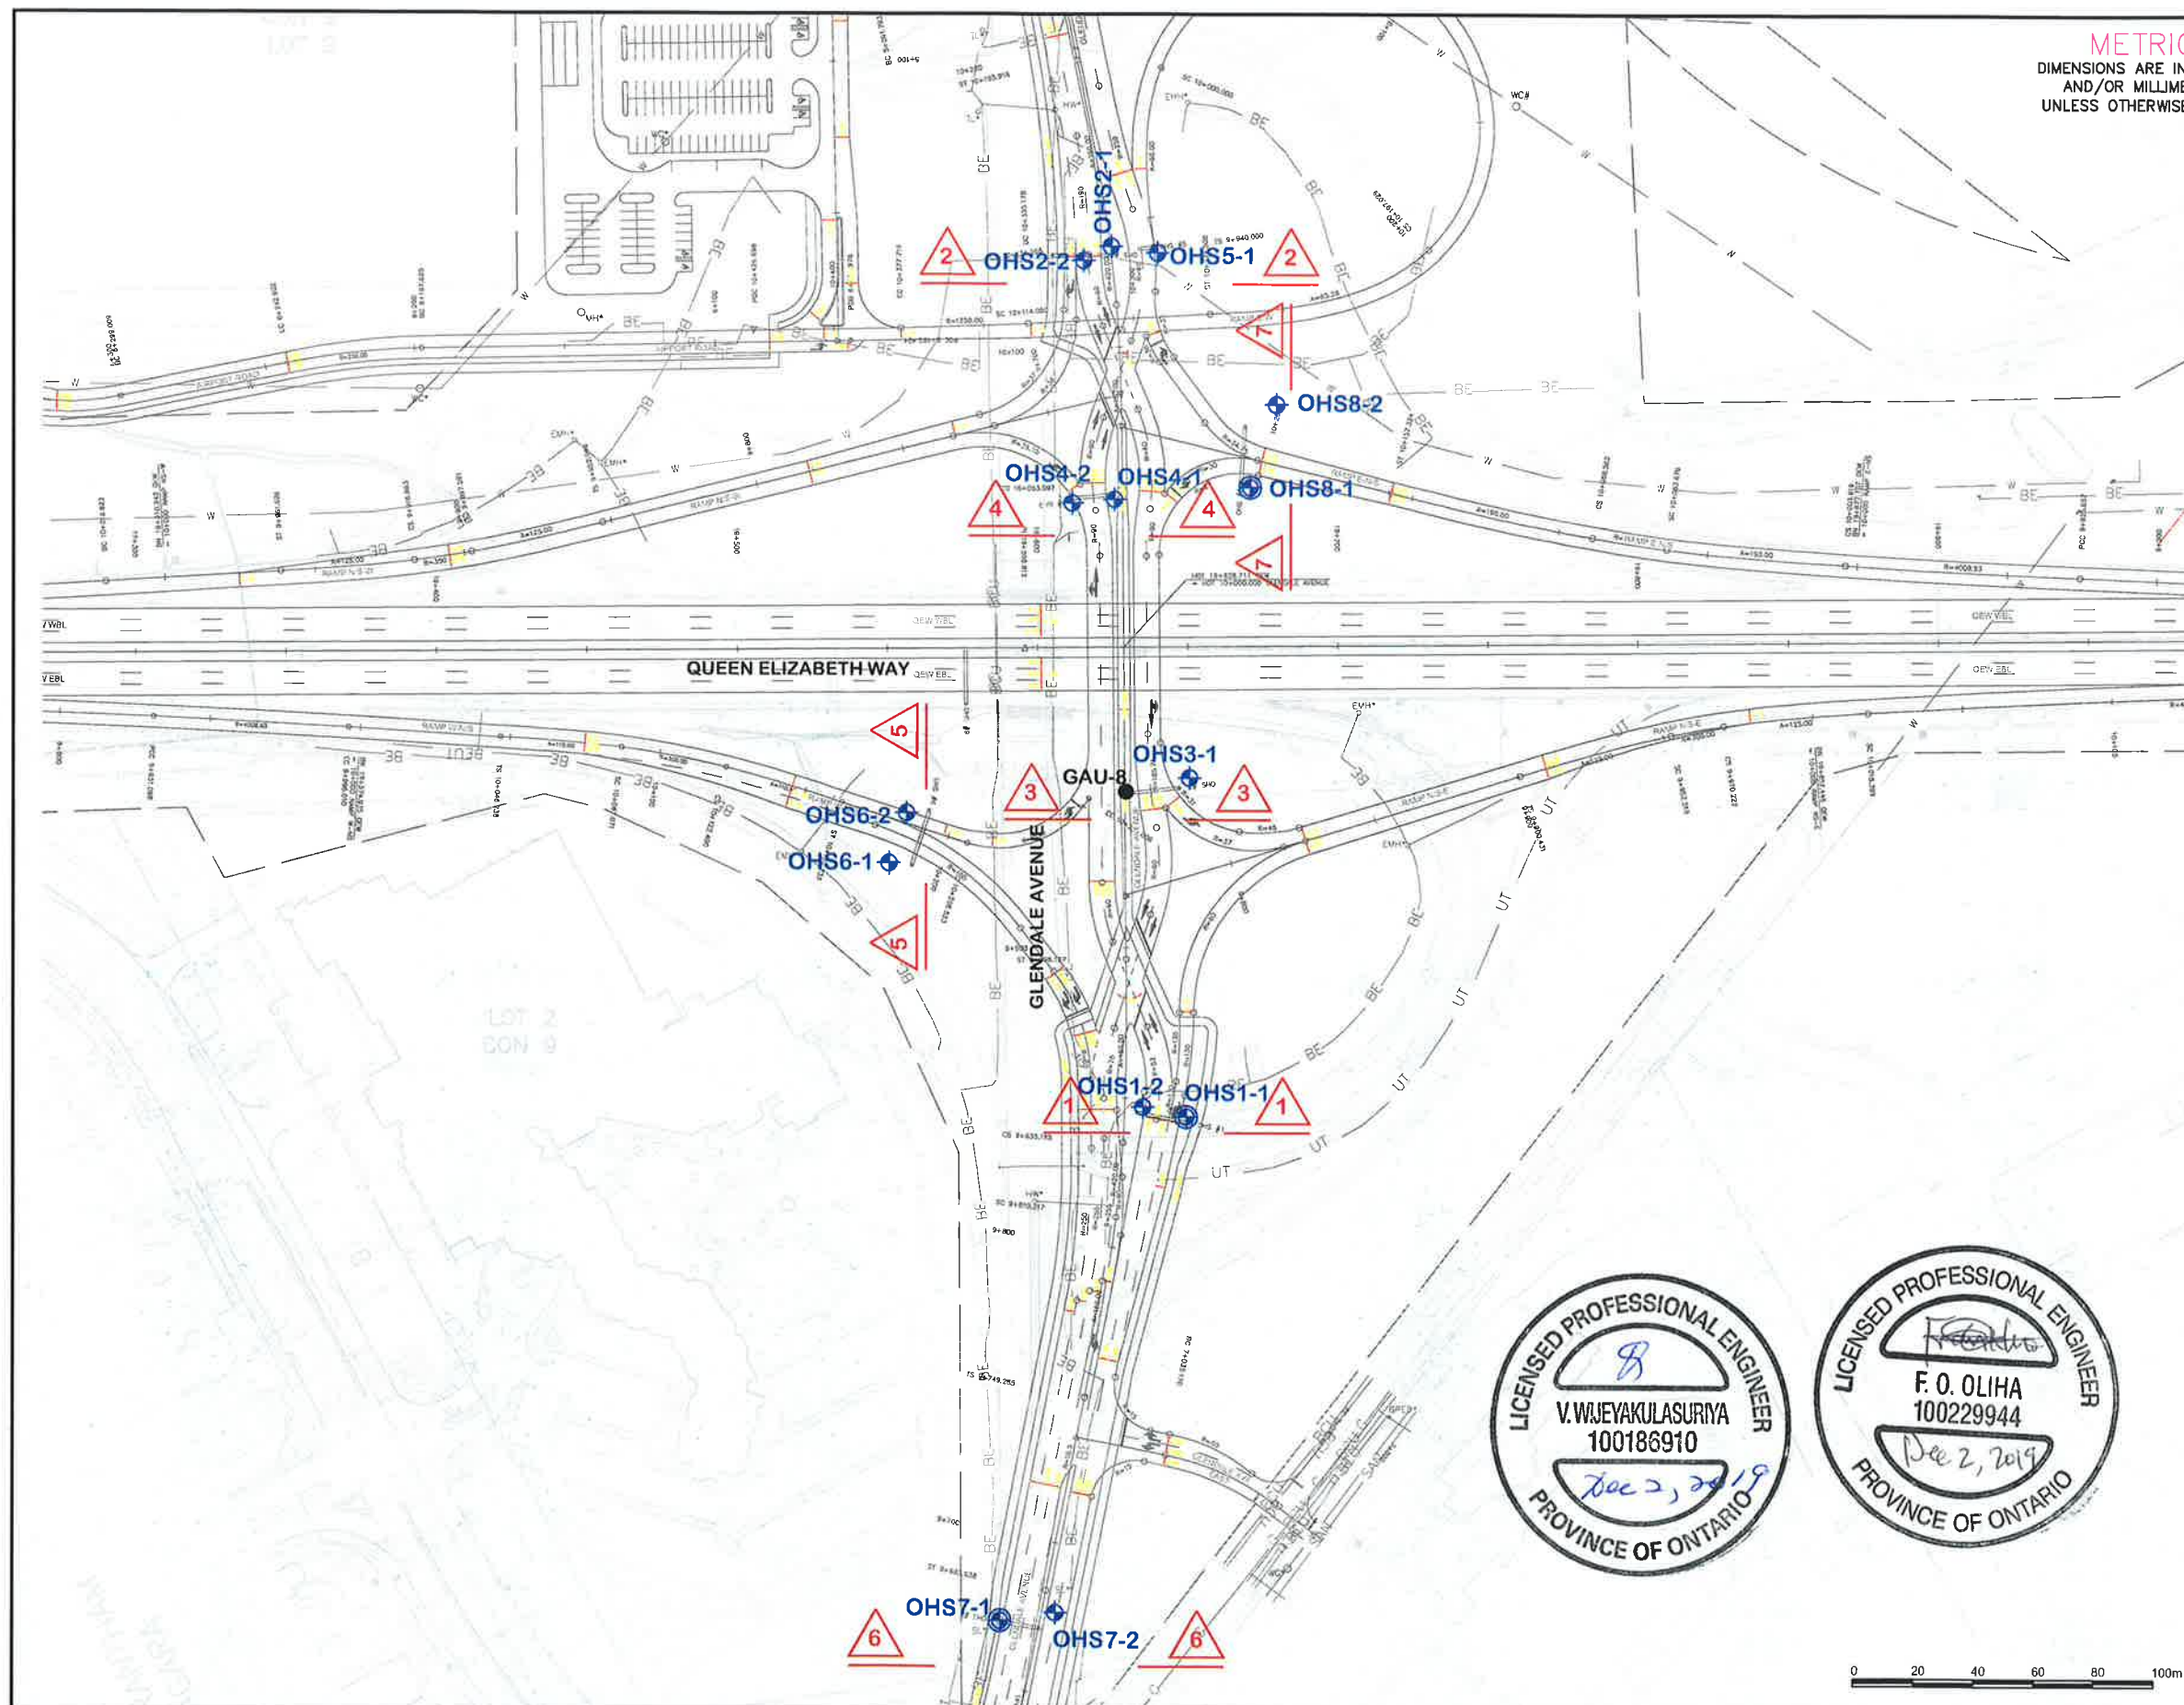
SHEET
S-1

The subsurface conditions encountered at the overhead sign locations are described in the following sections. The borehole location plan is shown on **Drawing 1**. The soil descriptions are based on visual and tactile observations and complemented by the results of field and laboratory soil test results.

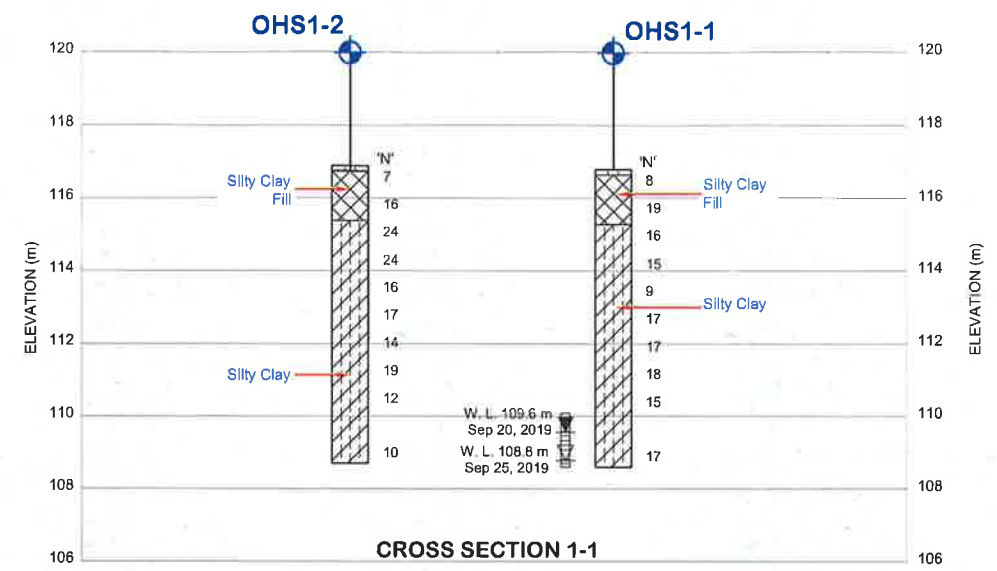
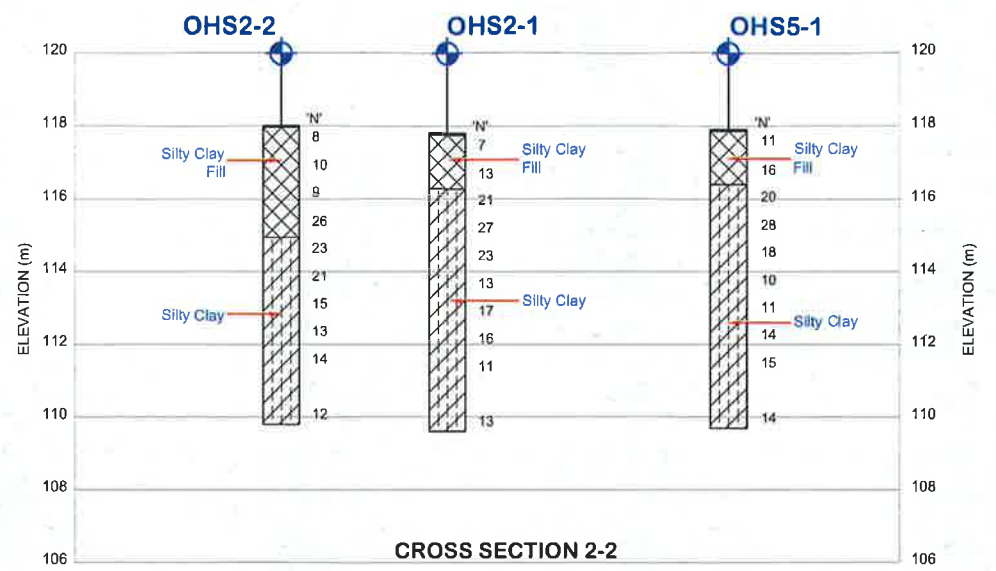
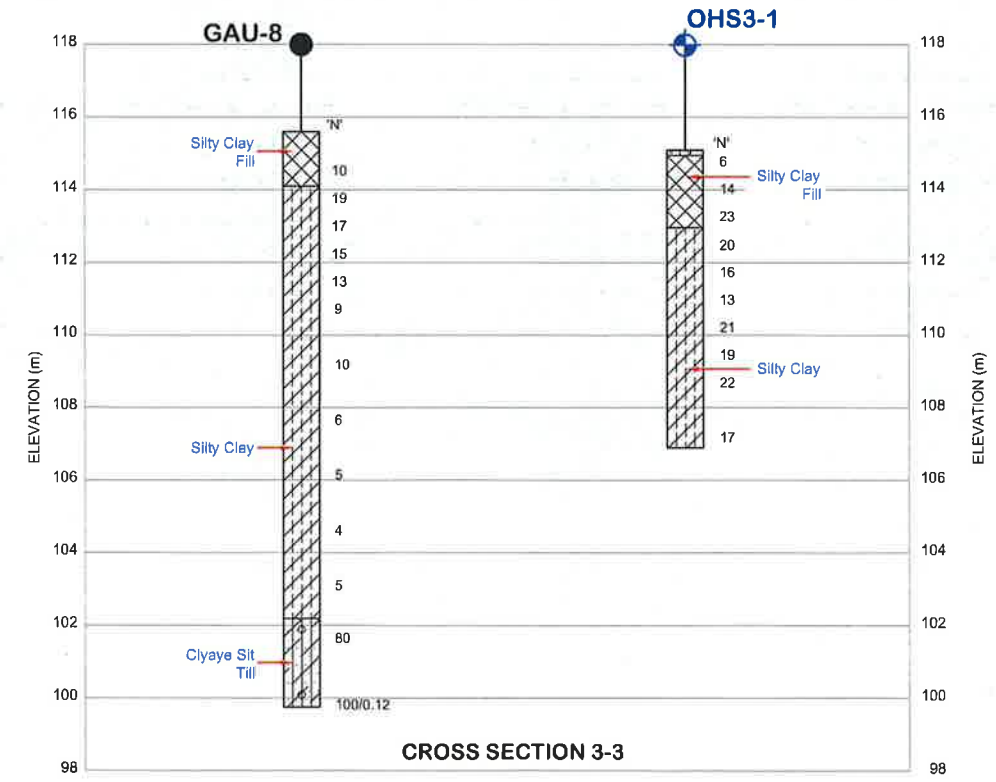
SHEET
S-2

- LEGEND
- Topsoil
 - Fill (Silty Clay/ Gravelly Sand/ Clayey Silt)
 - Clayey Silt Till
 - Asphalt
 - Silty Clay

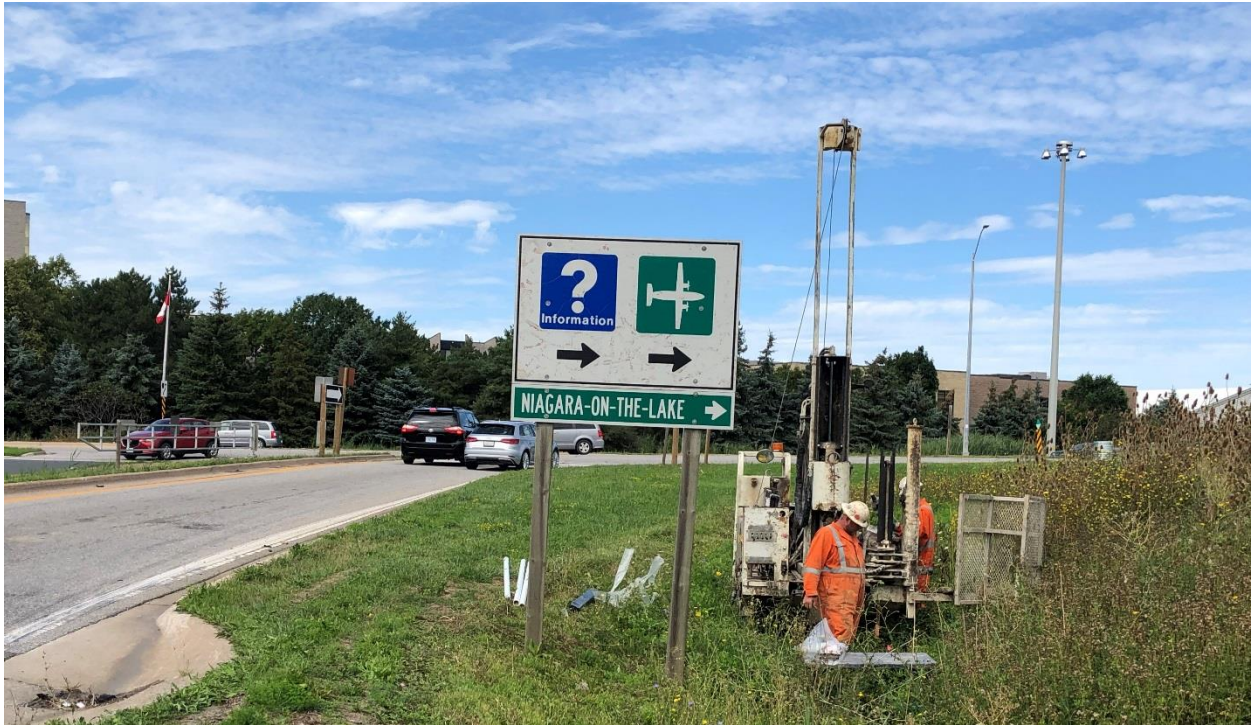
Photo C2-1 Field investigation on BH OHS1-1 with M5T Track Mount Rig (Aug 2019)

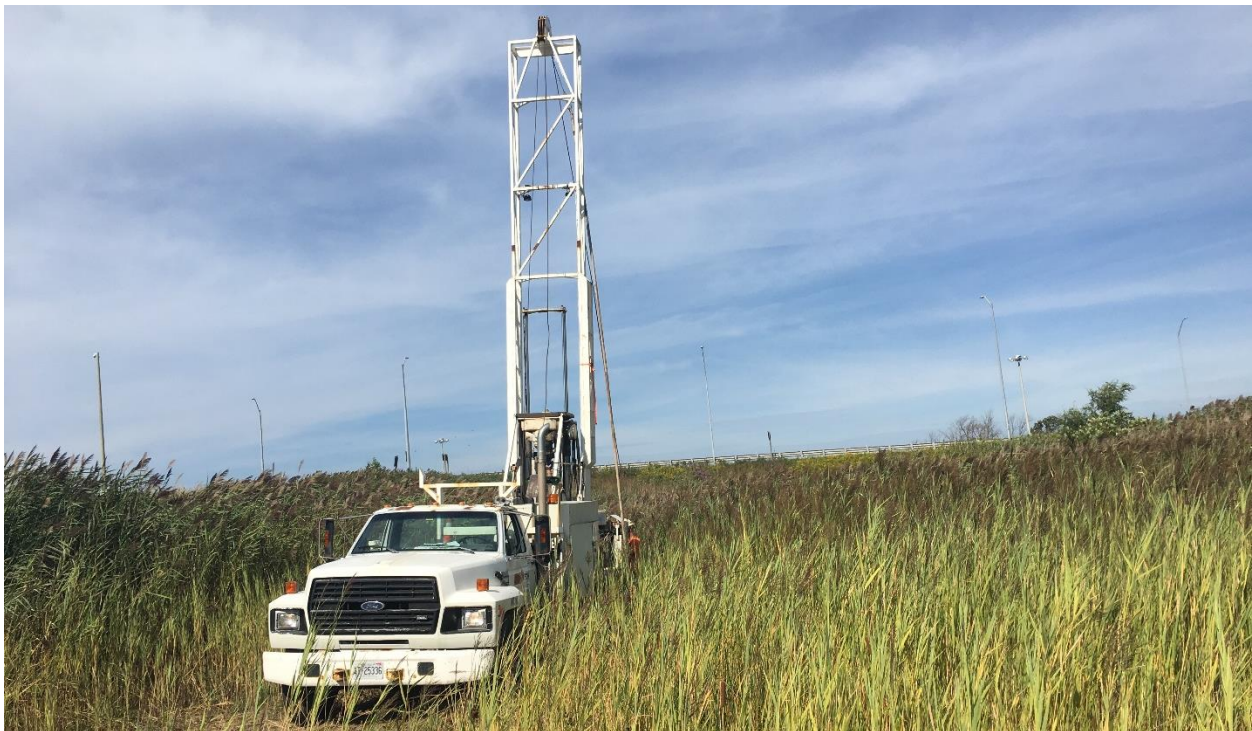
Photo C2-2 Field investigation on BH OHS8-2 with CME 55 Truck Mount Rig (Sept 2019)

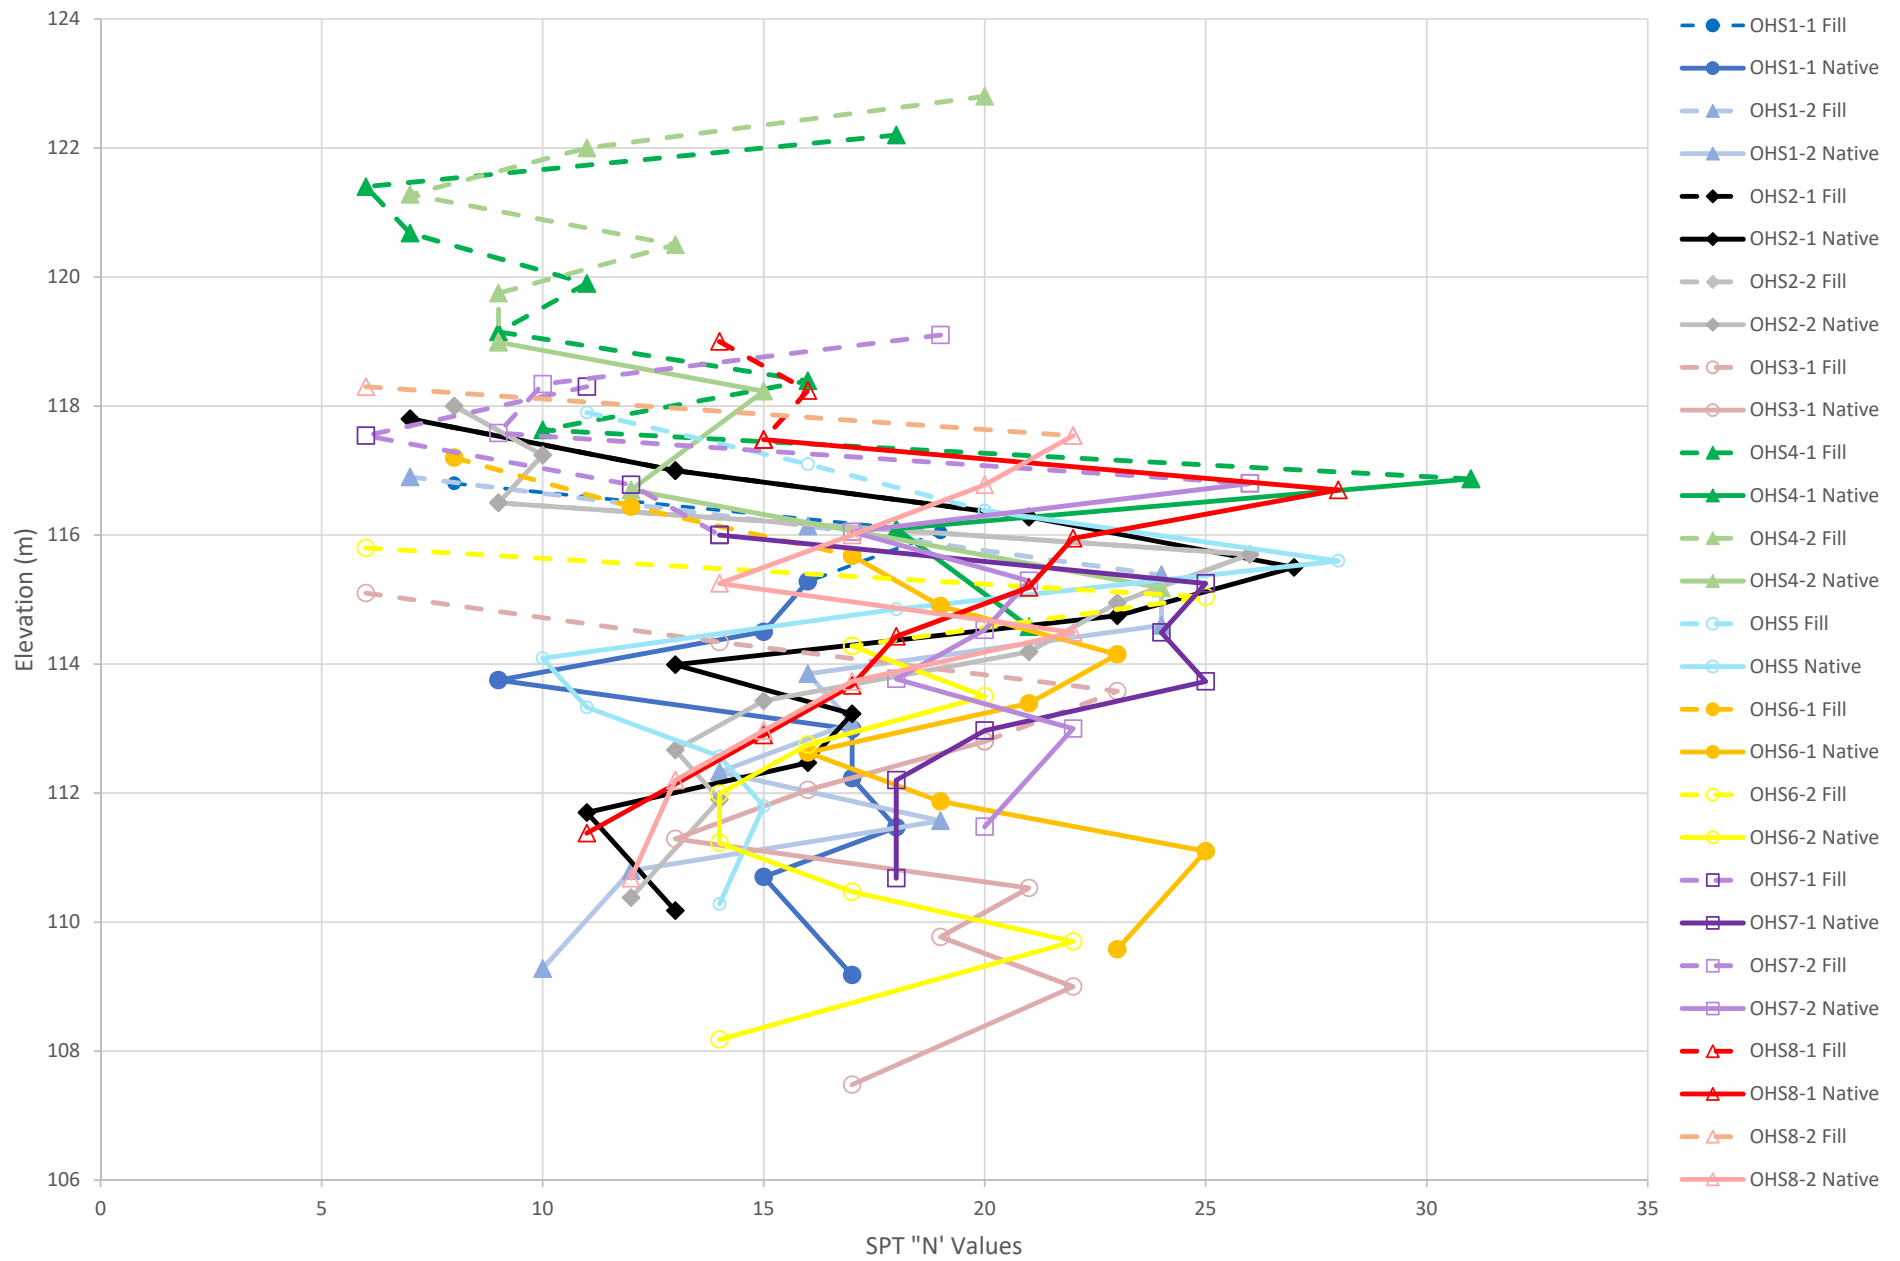
OHS

SPT 'N' Value Vs Elevation

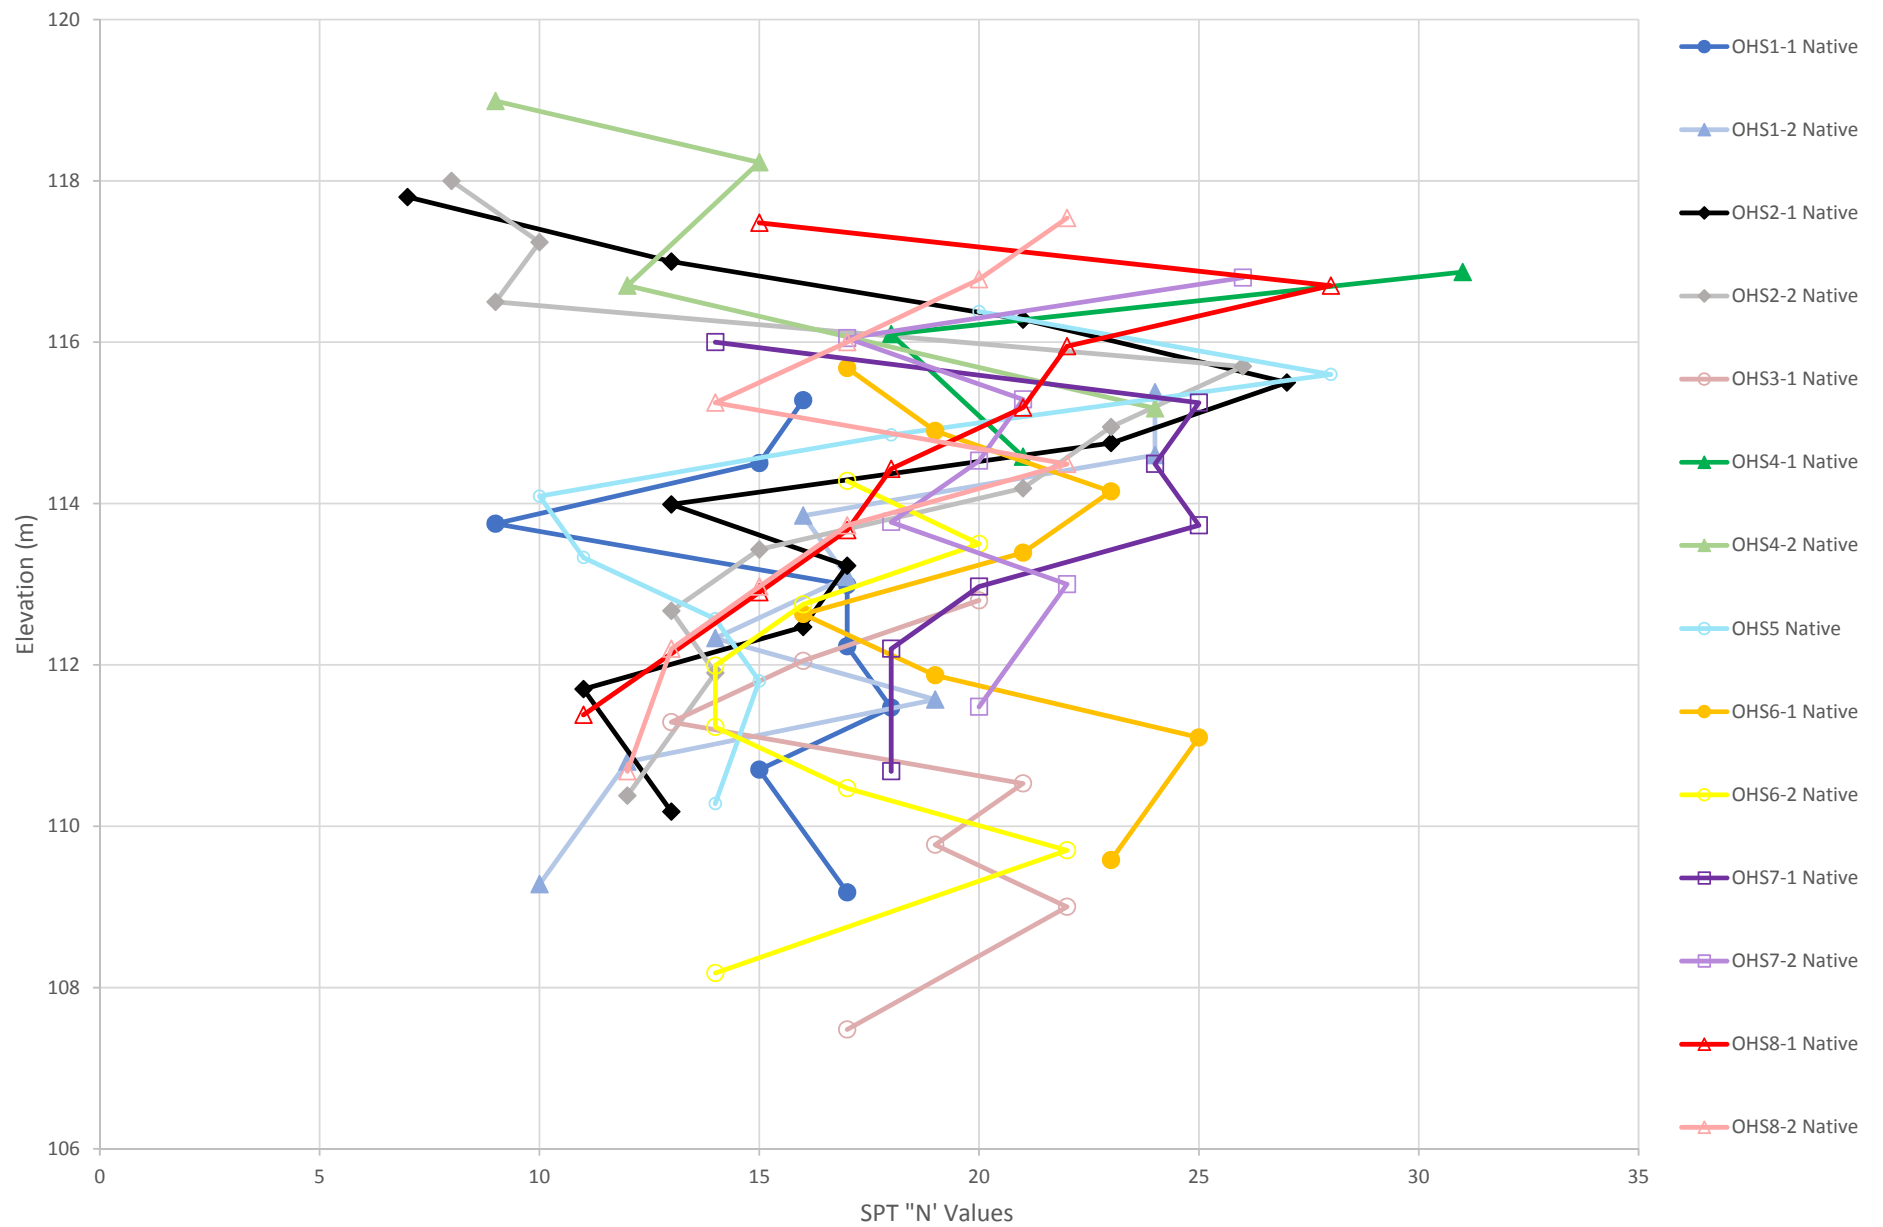
OHS Native

SPT 'N' Value Vs Elevation

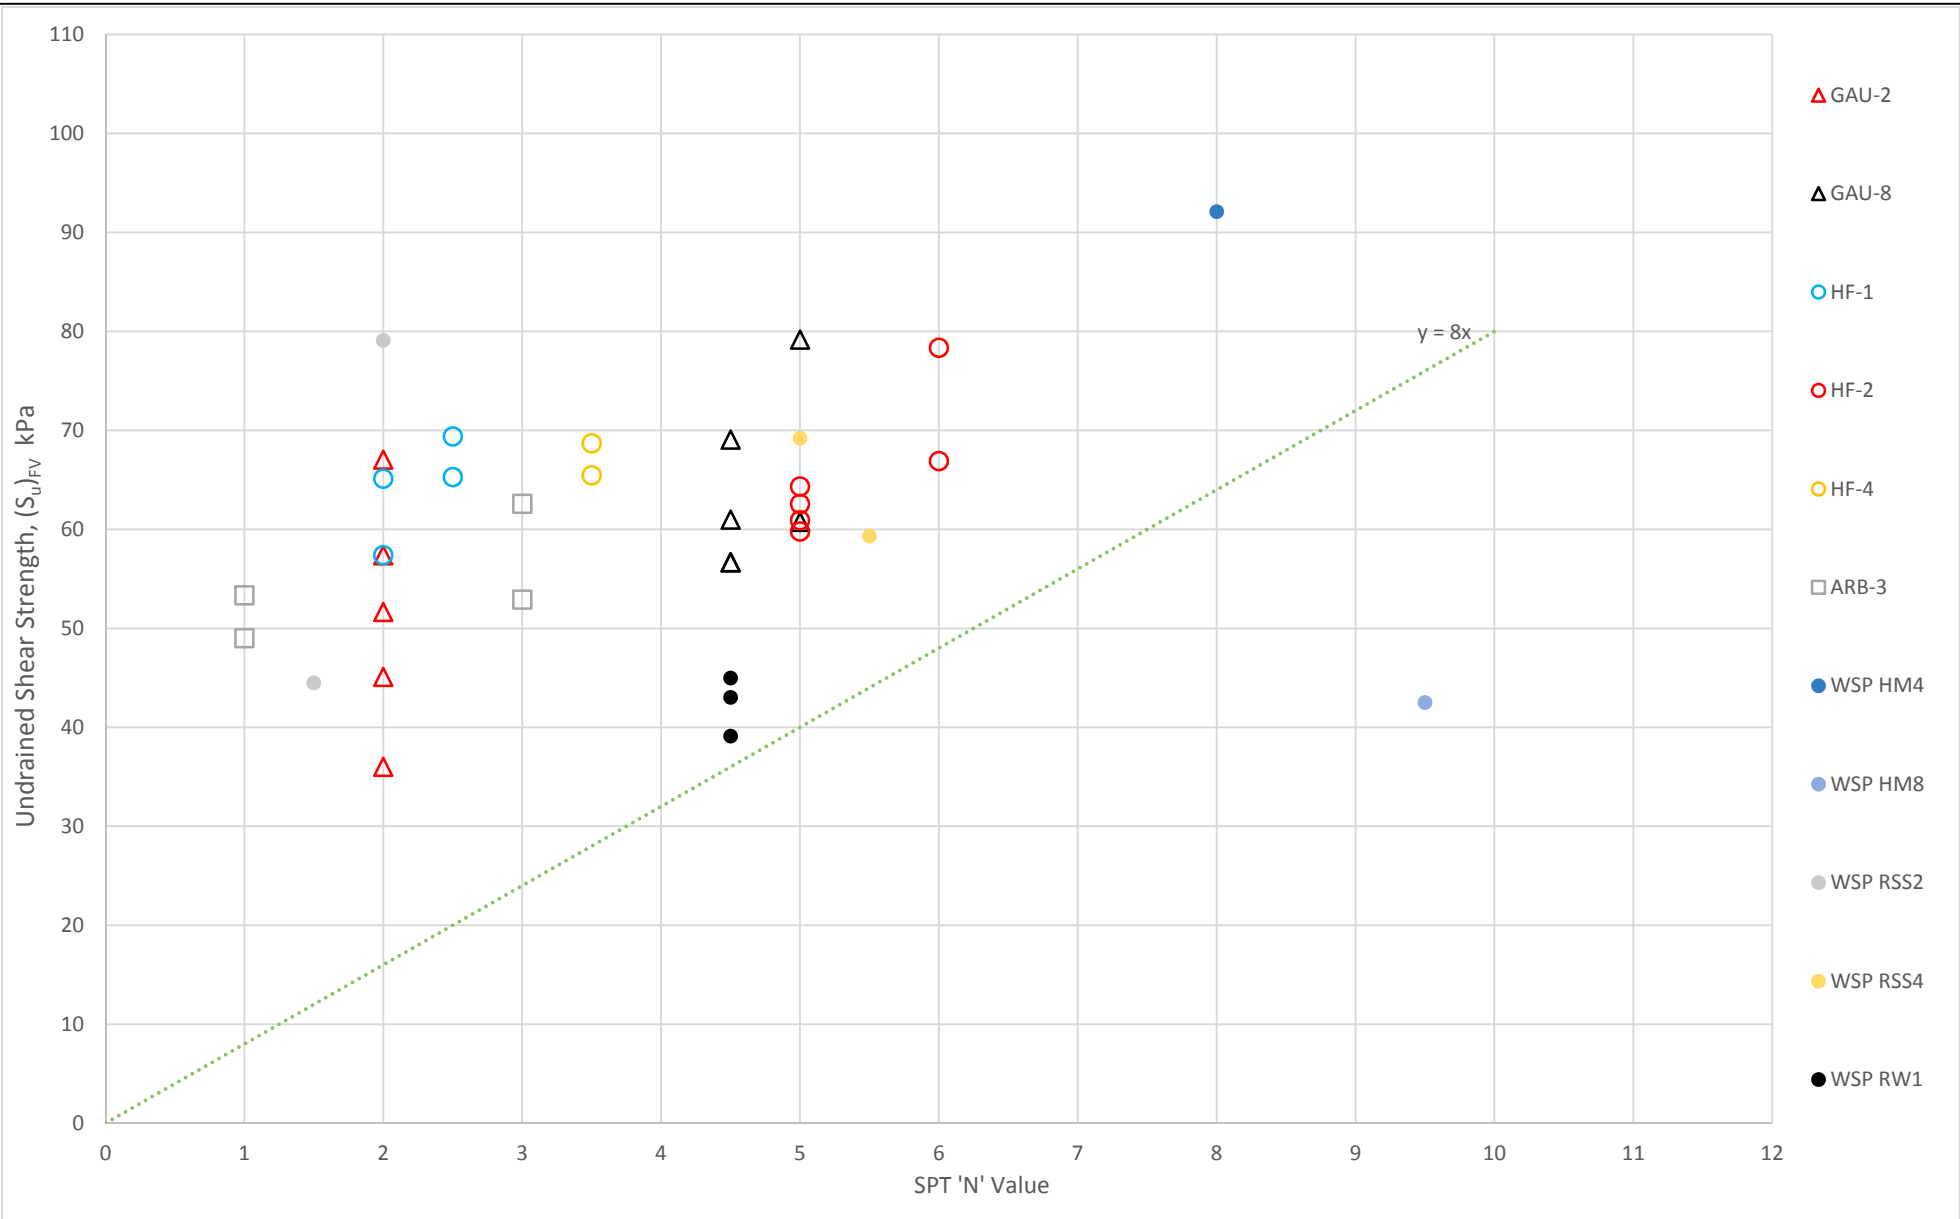
Figure No: 4

SPT 'N' Value vs. Undrained Shear Strength (kPa)
Native Deposits

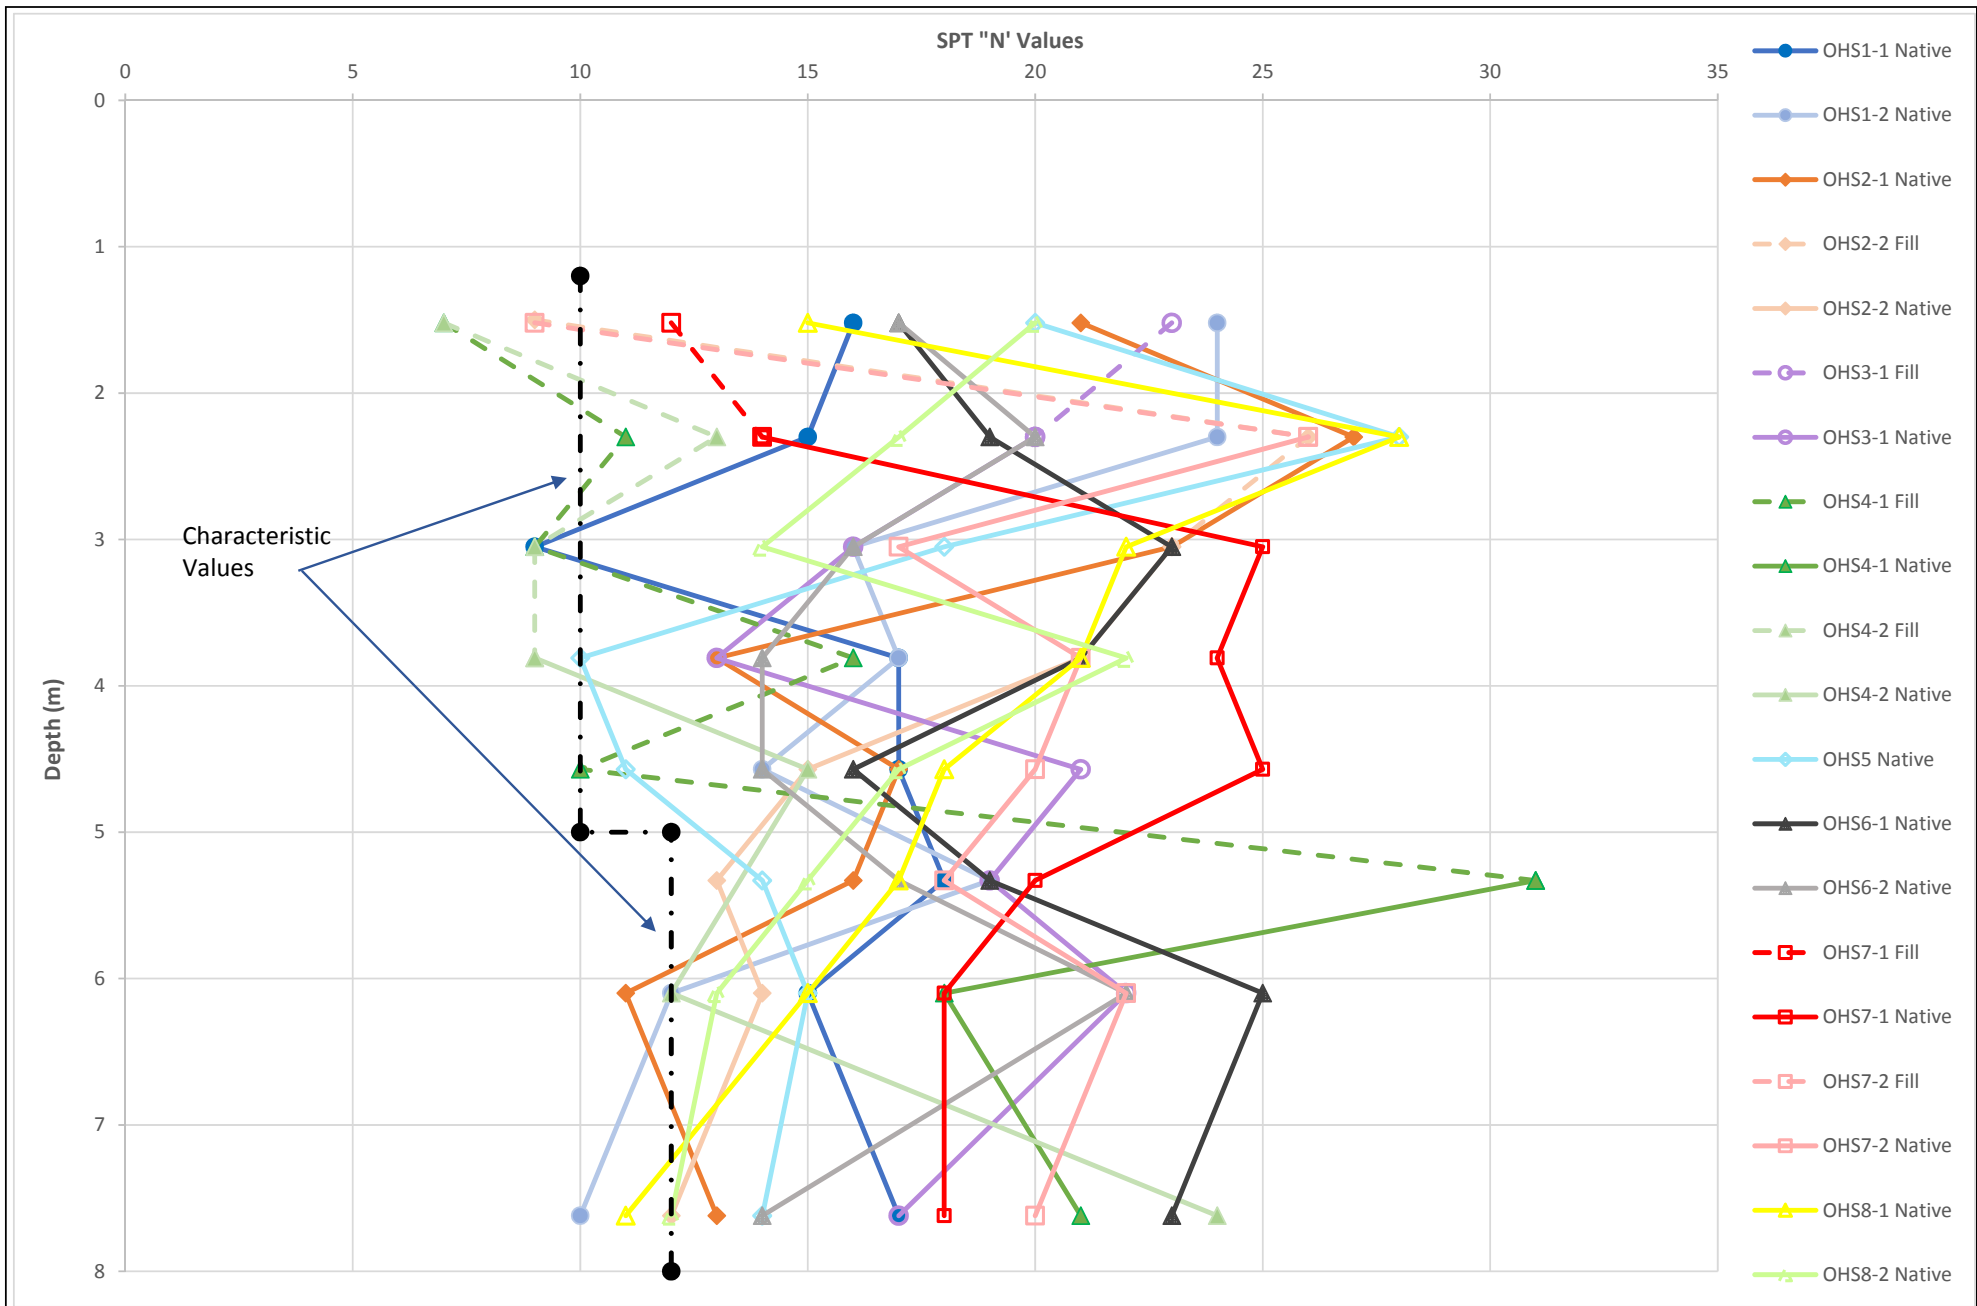
Figure No.	5
Project No.	18M-01021-12
Date :	Dec. 01-2019

Characteristic SPT 'N' Profile for Indicative Analysis
OHS (Below Frost Depth)
