Foundation Investigation and Design Report

HIGHWAY 17 WIDENING
AREA 1 (STA. 10+400 – 10+600), AREA 2 (STA. 11+050 – 11+160)
AREA 3 (STA. 11+525 – 11+600), AREA 4 (STA. 12+350 – 12+480)
TOWNSHIP OF DAMBROSSIO
AREA 7 (STA. 16+700 – 16+825)
TOWNSHIP OF LALIBERT
DISTRICT OF ALGOMA
BETWEEN WHITE RIVER AND WAWA, ONTARIO

AGREEMENT NO. 5017-E-0043
WORK ITEM: #5
GWP 5031-18-00

Part A - Foundation Investigation Report

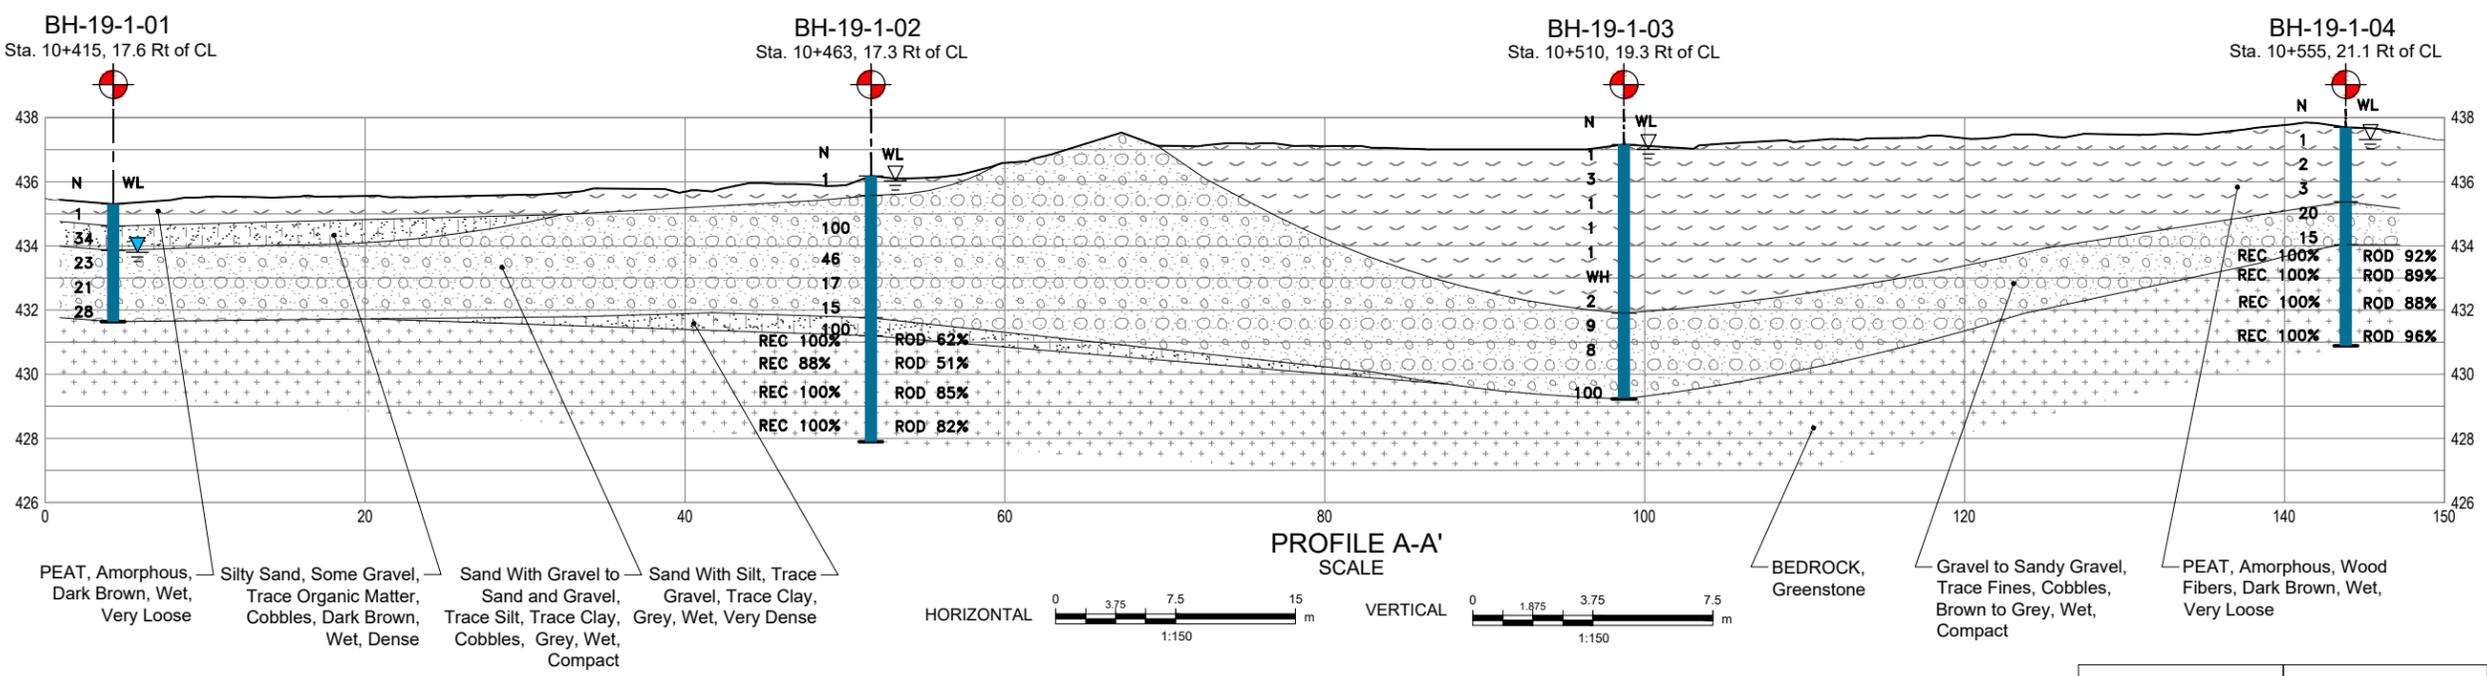
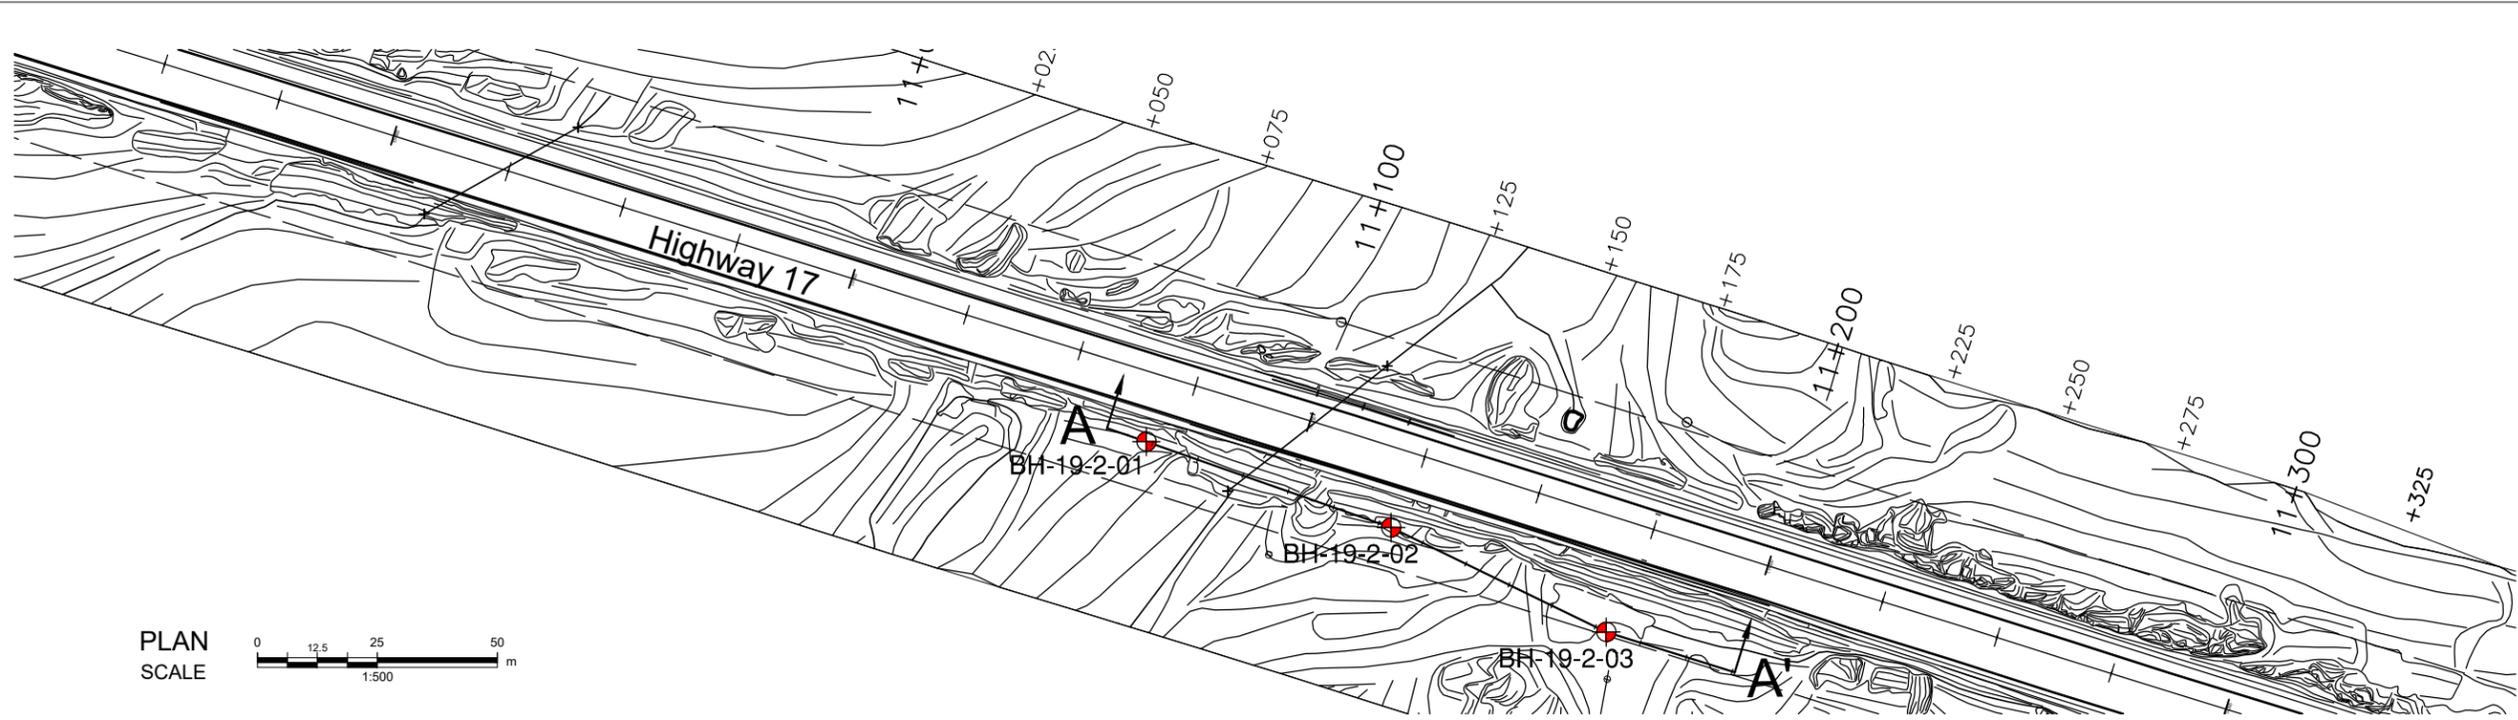
GEOCREs No.: 42C-047			
SUBMTD:	LY	HWY No.:	17
DRAWN:	AW	DIST:	Algoma
CHECKED:	LY	SITE:	Area 1
APPROVED:	NM	DATE:	2020.02.03
		DWG:	2

Borehole Location Plan
 and Soil Strata

In Area 1, the foundation investigation involved drilling four (4) boreholes (BH-19-1-01, BH-19-1-02, BH-19-1-03, and BH-19-1-04), along the west toe of the existing embankment. The boreholes were drilled to the depth of 3.7 m to 6.8 m. To confirm the presence and depth of the bedrock, rock coring was conducted in two (BH-19-1-02 and BH-19-1-04) of these boreholes. In addition, two (2) boreholes (BH-19-1-05 and BH-19-1-06) were advanced through the left lane of the exiting road embankment. Boreholes through the embankment were drilled to the depth of 2.8 m to 5.9 m, with rock coring carried out in BH-19-1-05. Drawing 2 in Enclosure 1 presents the borehole location plan for Area 1.

Details of the subsurface conditions encountered at the project areas are graphically presented on individual soil strata profiles provided on Drawings 2 to 5 in Enclosure 1, and on the logs in Appendix B. The profiles represent a transition from one soil type to another along the lines of cross sections, and should not be inferred to represent an exact plane of geological or stratigraphic change, as the subsurface and groundwater conditions may vary between and beyond the borehole locations.

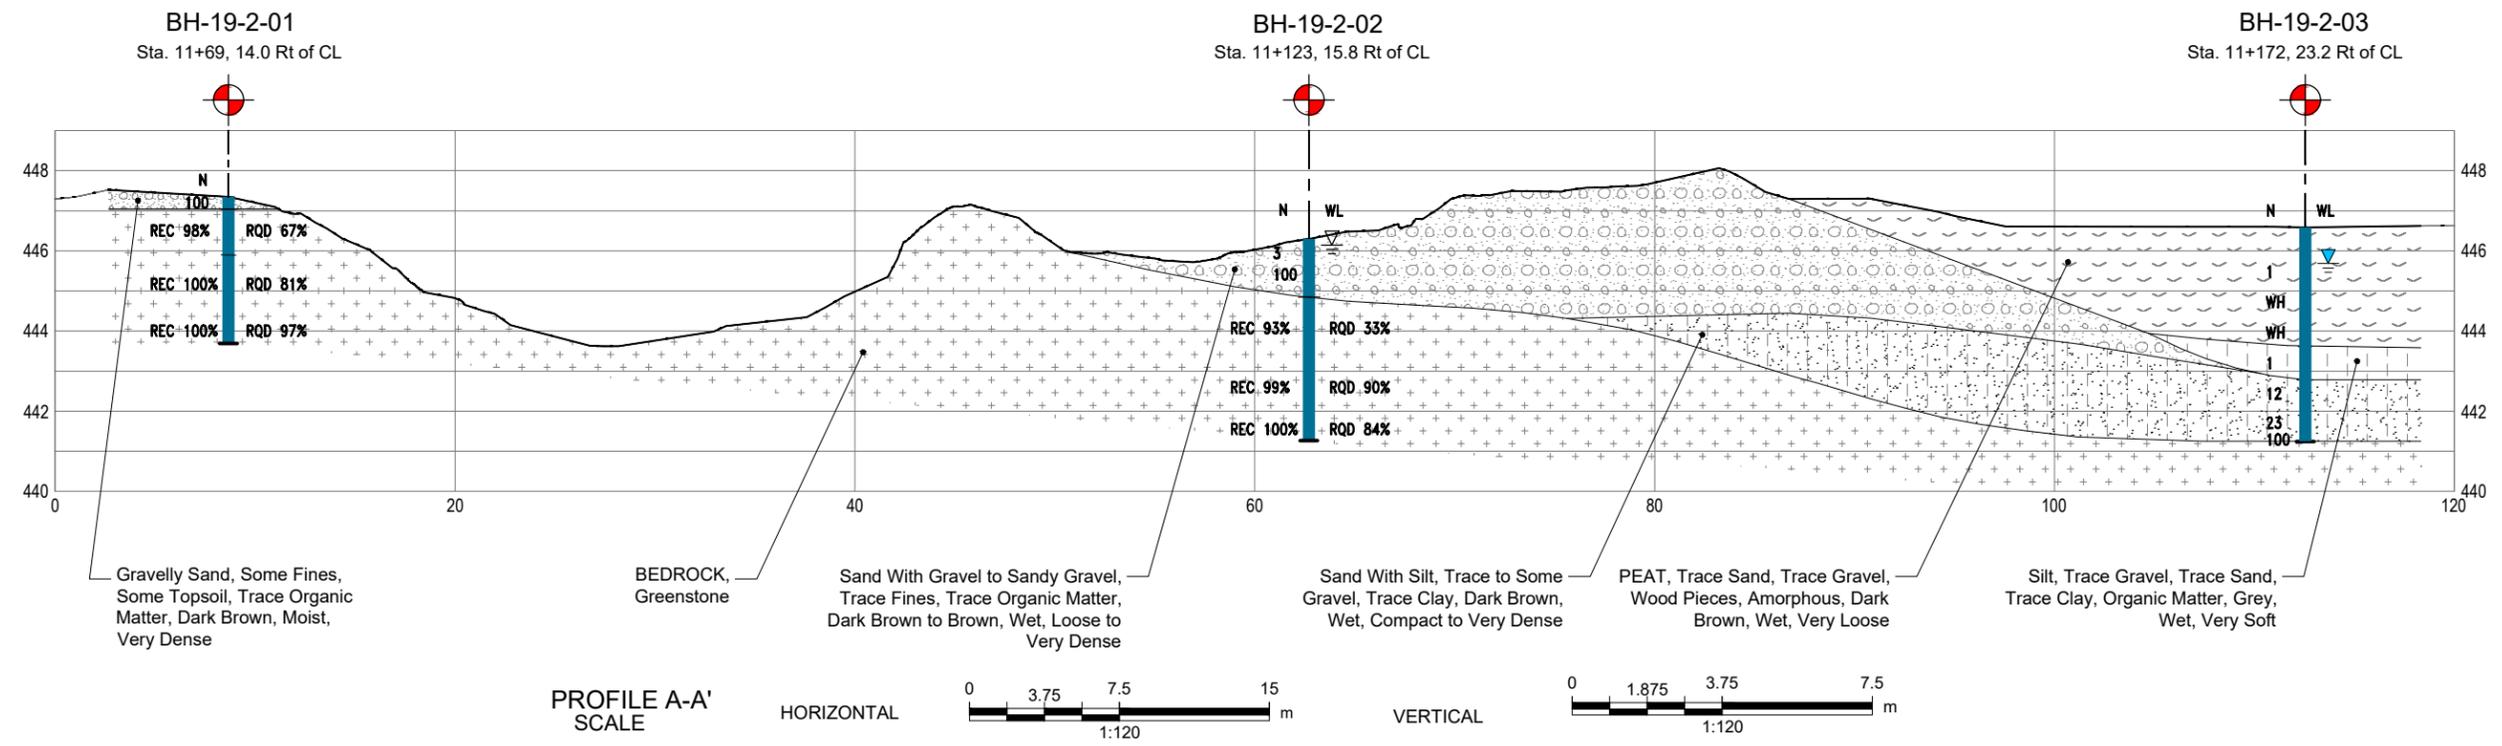
SUBMID:	LY	HWY No.:	17	DATE:	2020.02.03
DRAWN:	AW	DIST:	Algoma	DWG:	3
CHECKED:	LY	SITE:	Area 2		
APPROVED:	NM

CONT No.: Agreement No.: 5017-E-0043 Work Item No.: 5 G.W.P. No.: 5031-18-00	
Borehole Location Plan and Soil Strata	Sheet

In Area 2, the foundation investigation consisted of three (3) boreholes (BH-19-2-01, BH-19-2-02, and BH-19-2-03) advanced along the west toe of the existing embankment. The boreholes were drilled to the depth of 3.7 m to 5.3 m. Rock coring was initially required in one of the boreholes. However, because of the presence of shallow bedrock, rock coring was conducted in two of the boreholes (BH-19-2-01 and BH-19-2-02). No boreholes were required through the embankment. Drawing 3 in Enclosure 1 provides the location of the three (3) boreholes in the area.

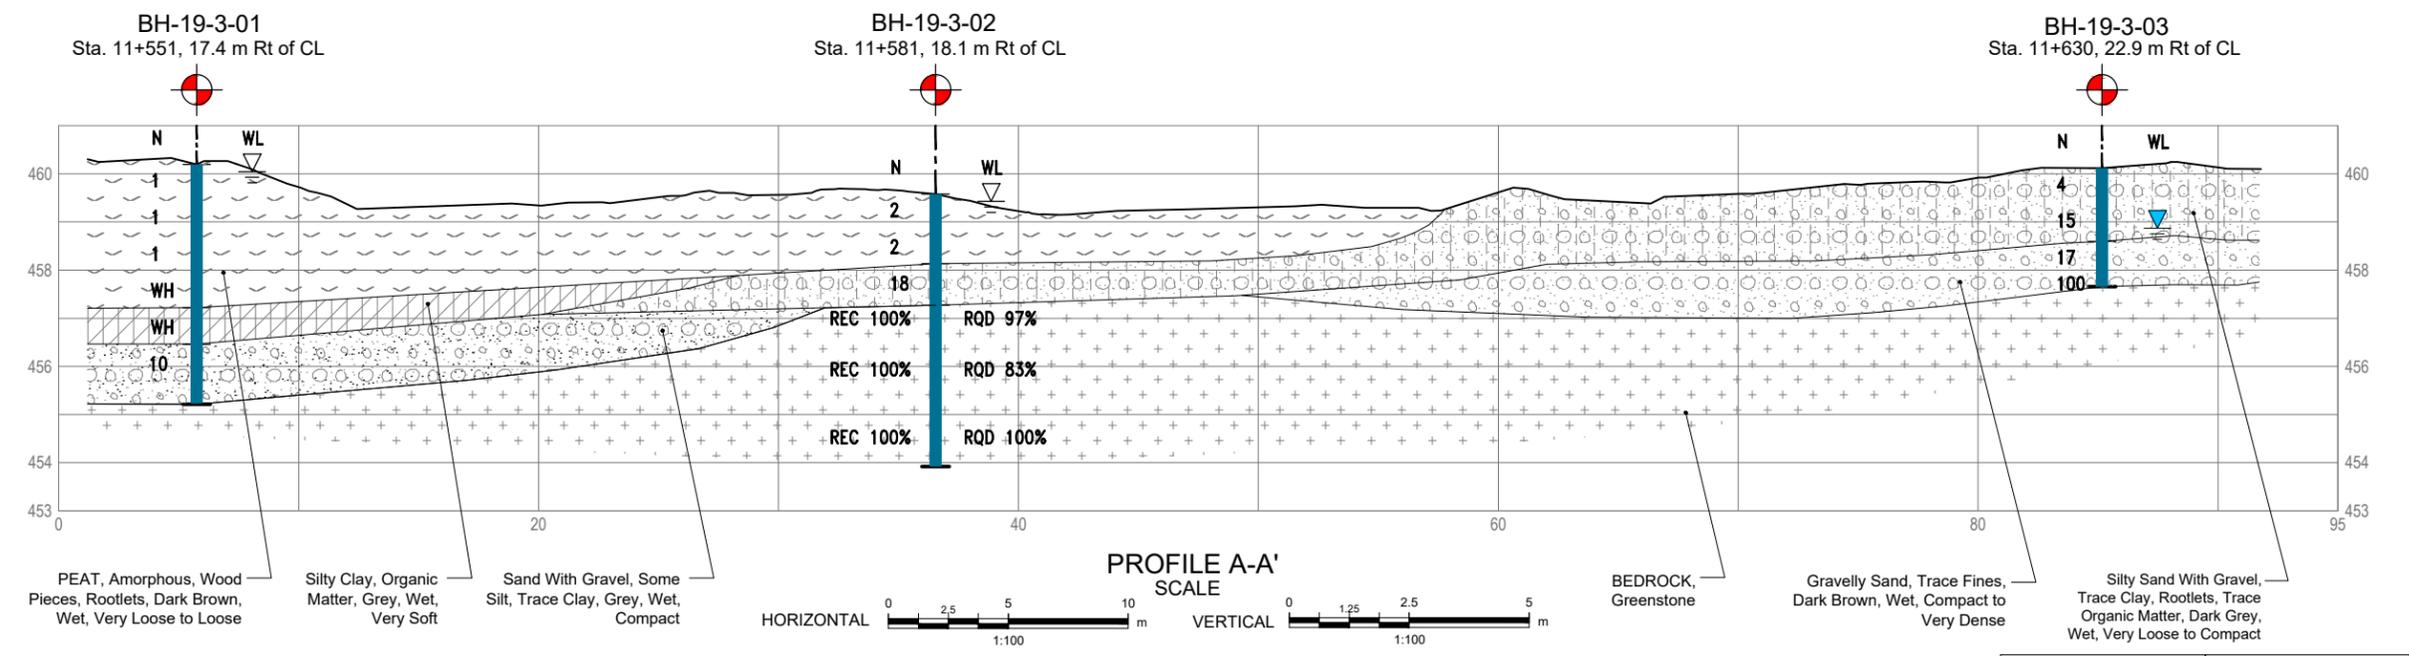
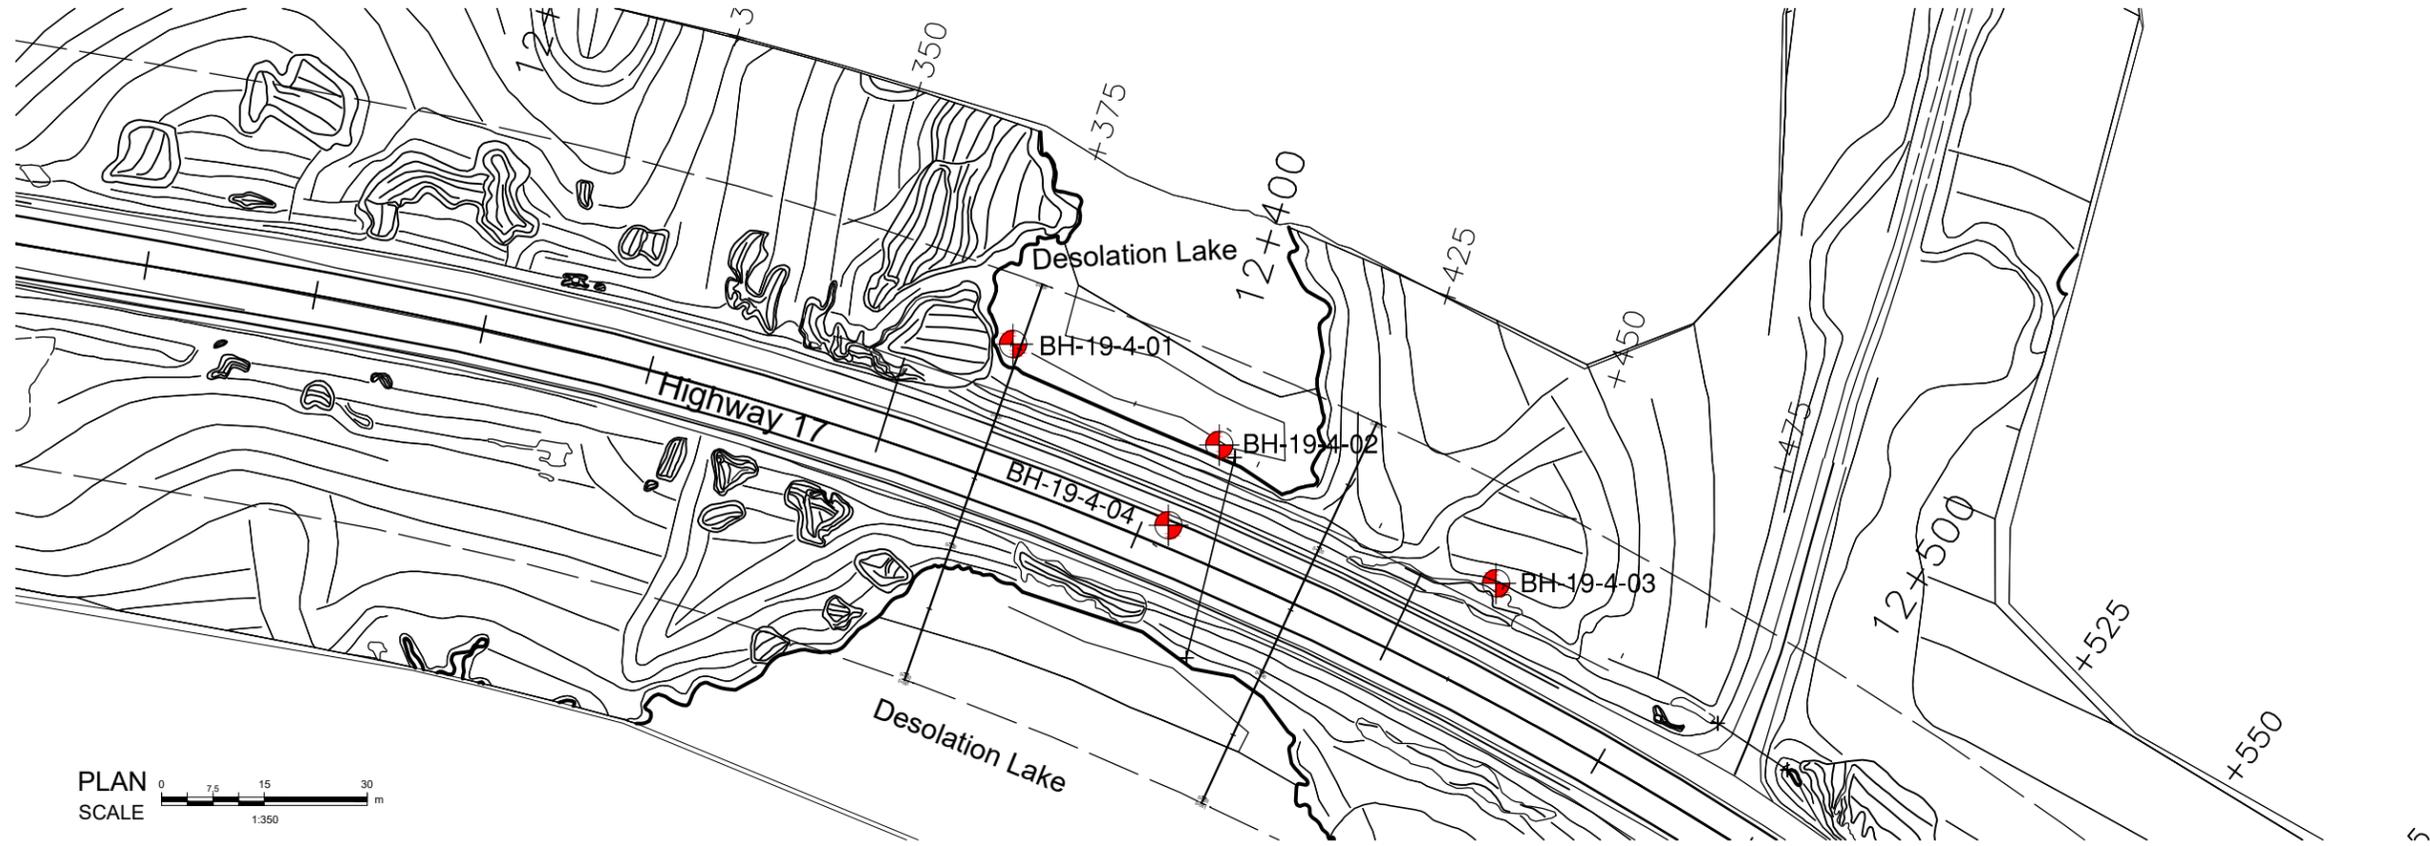
SUBMID:	LY	HWY No.:	17	DATE:	2020.02.03
DRAWN:	AW	DIST:	Algoma	DWG:	4
CHECKED:	LY	SITE:	Area 3		
APPROVED:	NM

Borehole Location Plan and Soil Strata

The foundation investigation in Area 3 involved drilling three (3) boreholes (BH-19-3-01, BH-19-3-02, and BH-19-3-03) along the west toe of the existing embankment. The boreholes were drilled to the depth in the range of 2.5 m to 5.7 m, with rock coring conducted in BH-19-3-02. In addition, two (2)

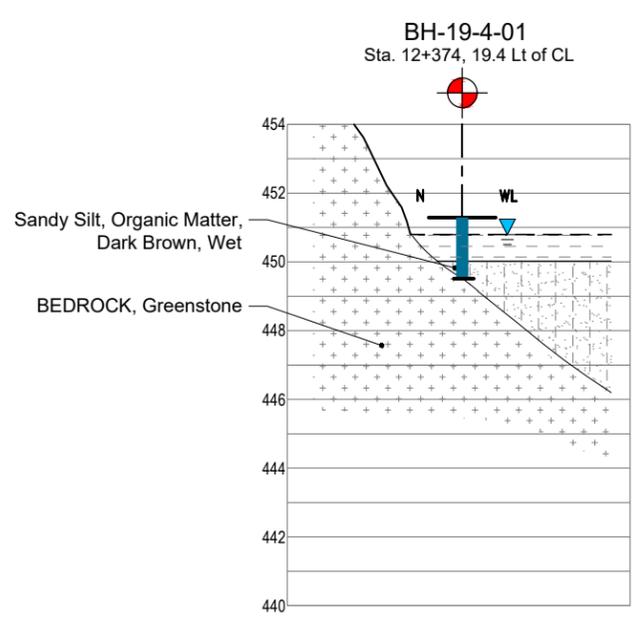
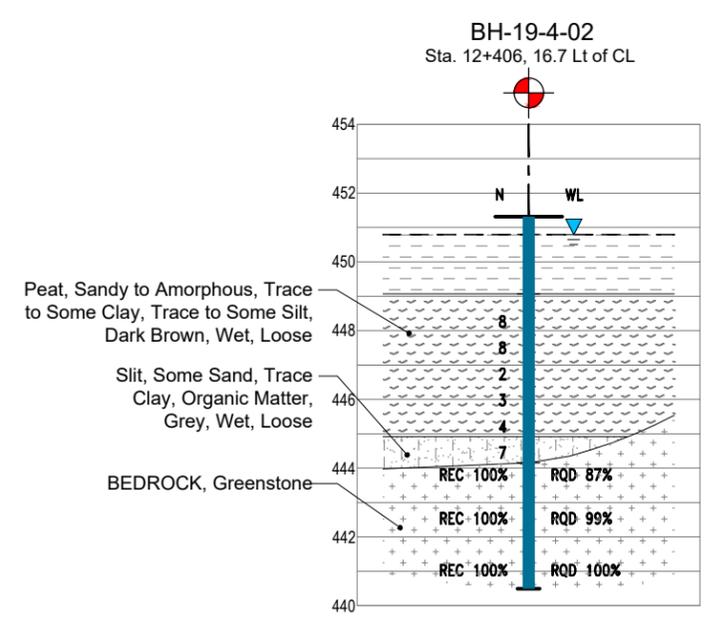
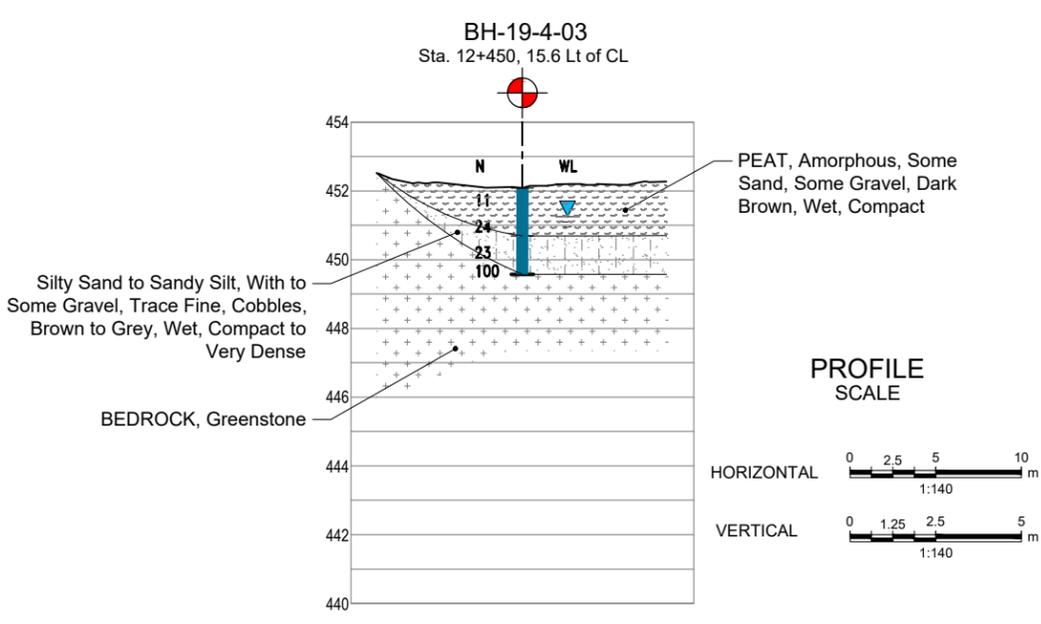
SUBMD:	LY	HWY No.:	17	DATE:	2020.02.03
DRAWN:	AW	DIST:	Algoma	DWG:	5
CHECKED:	LY	SITE:	Area 4		
APPROVED:	NM

CONT No.: Agreement No.: 5017-E-0043 Work Item No.: 5 G.W.P. No.: 5031-18-00	
Borehole Location Plan and Soil Strata	Sheet

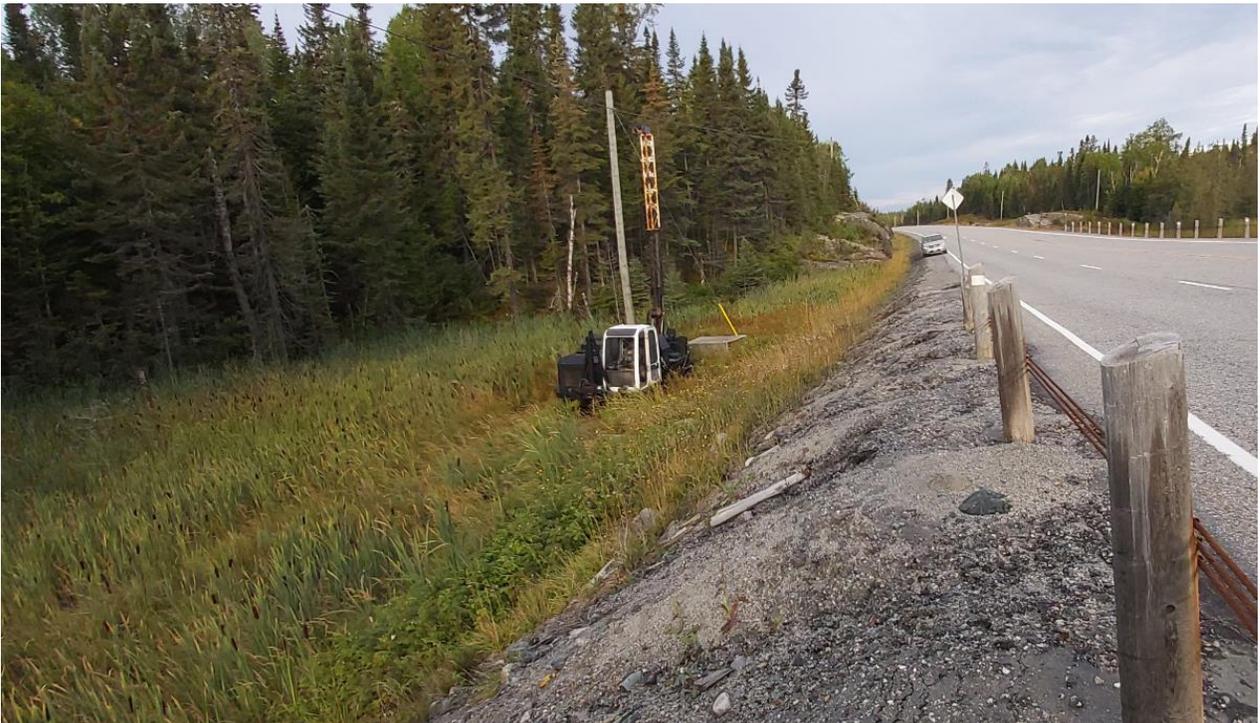
Photo 6 – Highway 17 - Area 1 – Drilling at BH-19-1-01 - Looking West

Drilling started in Area 1 using an Acker Soil Sentry track-mounted drilling rig equipped with hollow stem augers. Rock coring was carried out using swivel-type double tube core barrels. The drilling equipment was owned and operated by a specialist drilling contractor known as Tatry Environmental Drilling (Tatry) of Timmins, Ontario. In the time between September 03, 2019 and September 13, 2019, Tatry completed four (4) boreholes in Area 1, and was later replaced by Marathon Underground Constructors Corp. (Marathon) of Greely, Ontario. The remaining boreholes in Area 1 and all boreholes in Area 2, Area 3 and Area 4 were completed by Marathon using CME 55 track mounted drilling rig equipped with hollow stem augers and capable of rock coring.

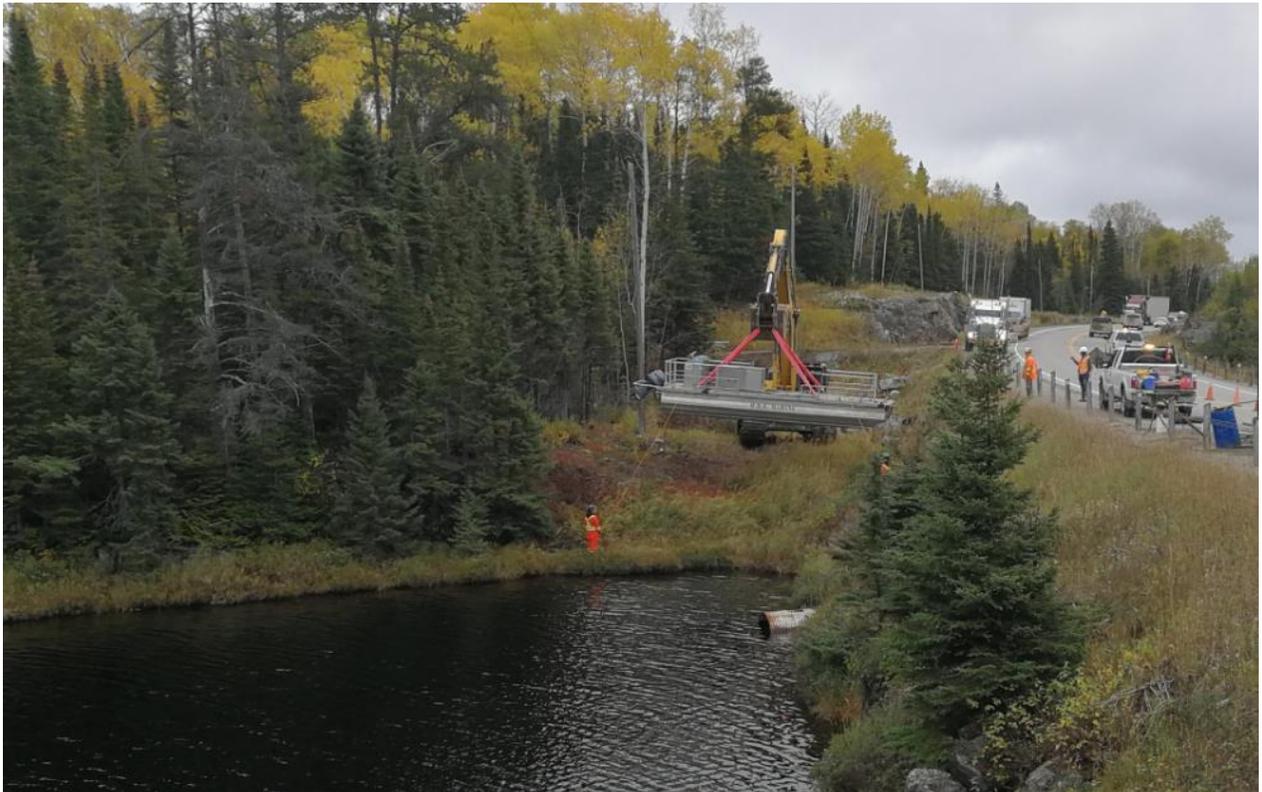
Photo 13 – Highway 17 - Area 4 – Boat Unloading and Setup – Looking East

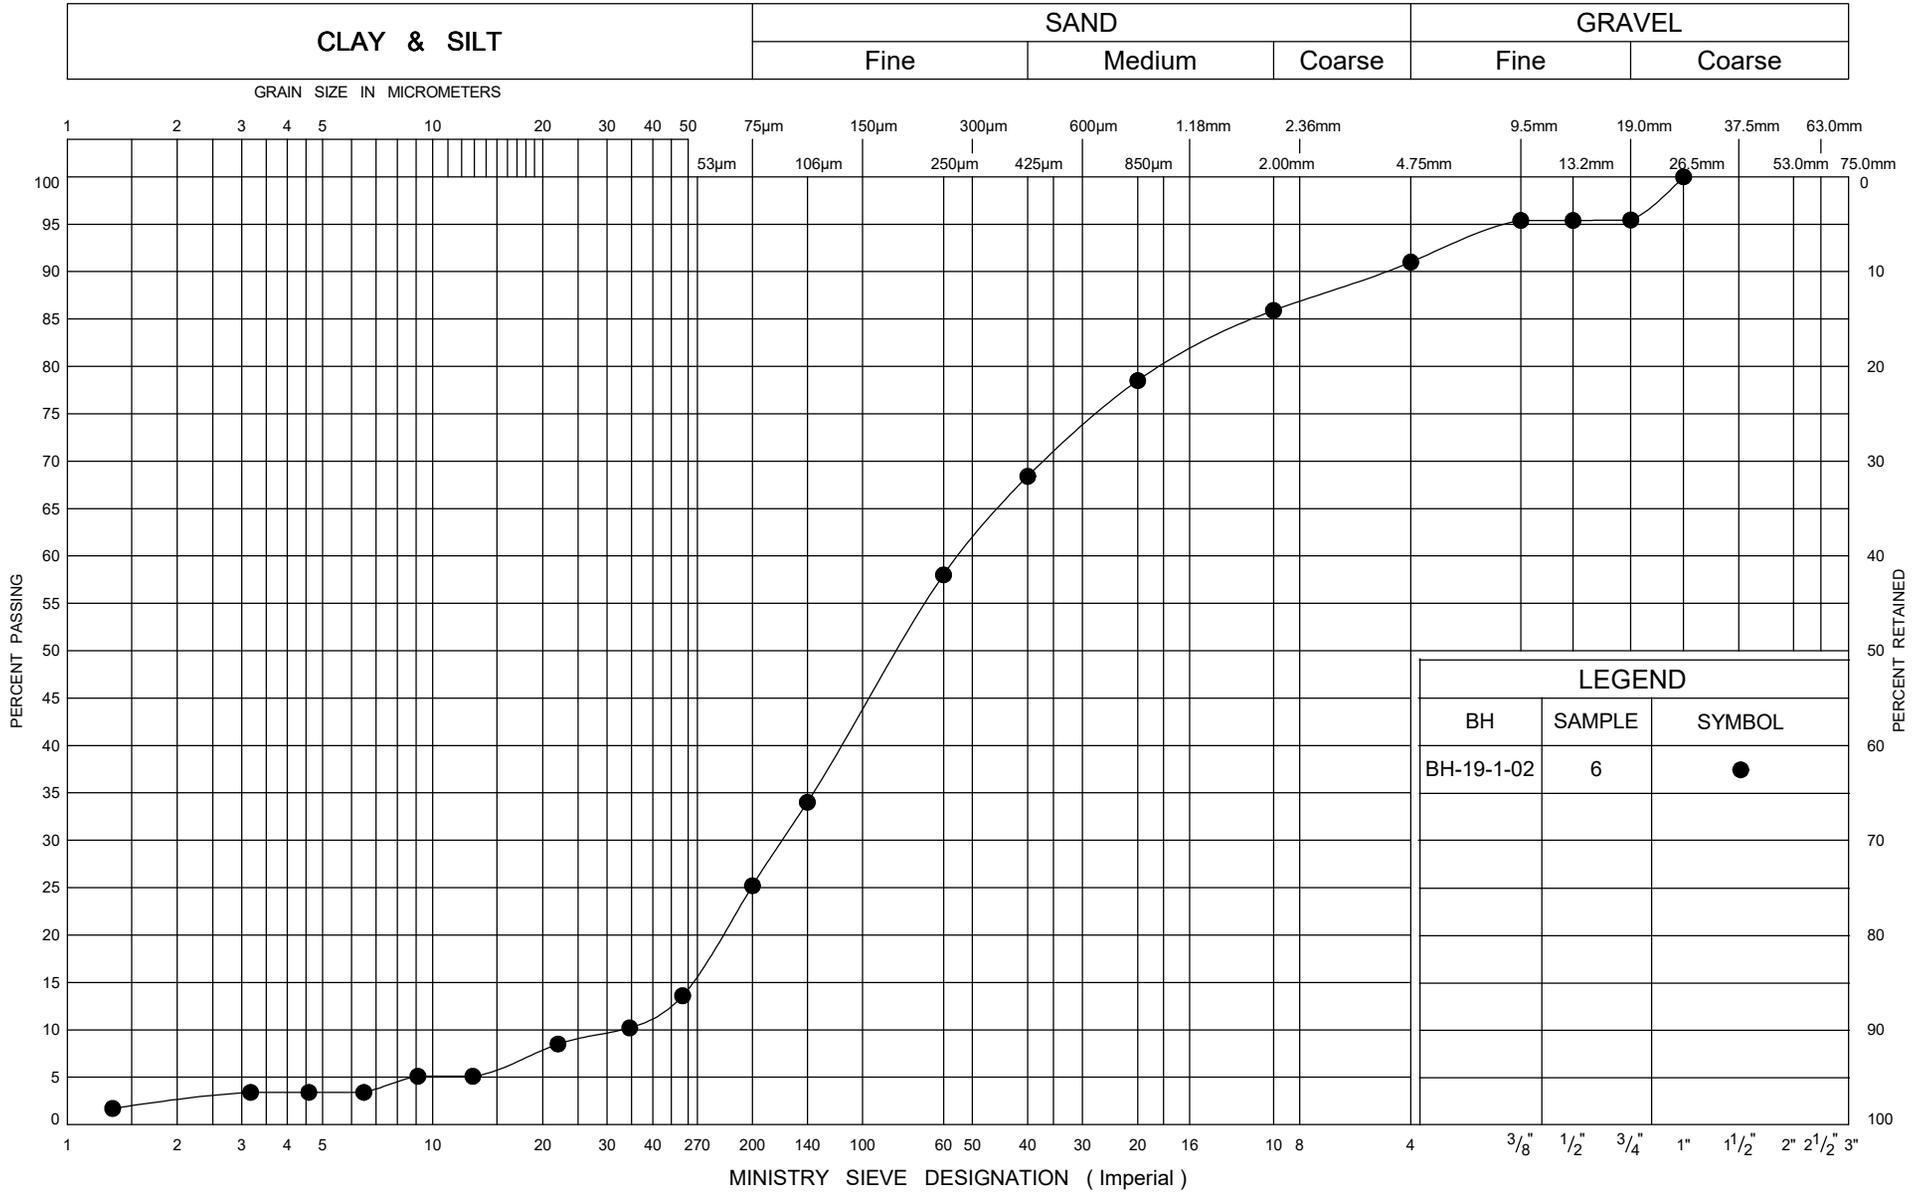
FIG No.:	GSA-1-2
Agreement No.:	5017-E-0043
Work Item No.:	5
G.W.P. No.:	5031-18-00

GRAIN SIZE DISTRIBUTION

Sand with Silt, Trace Gravel, Trace Clay

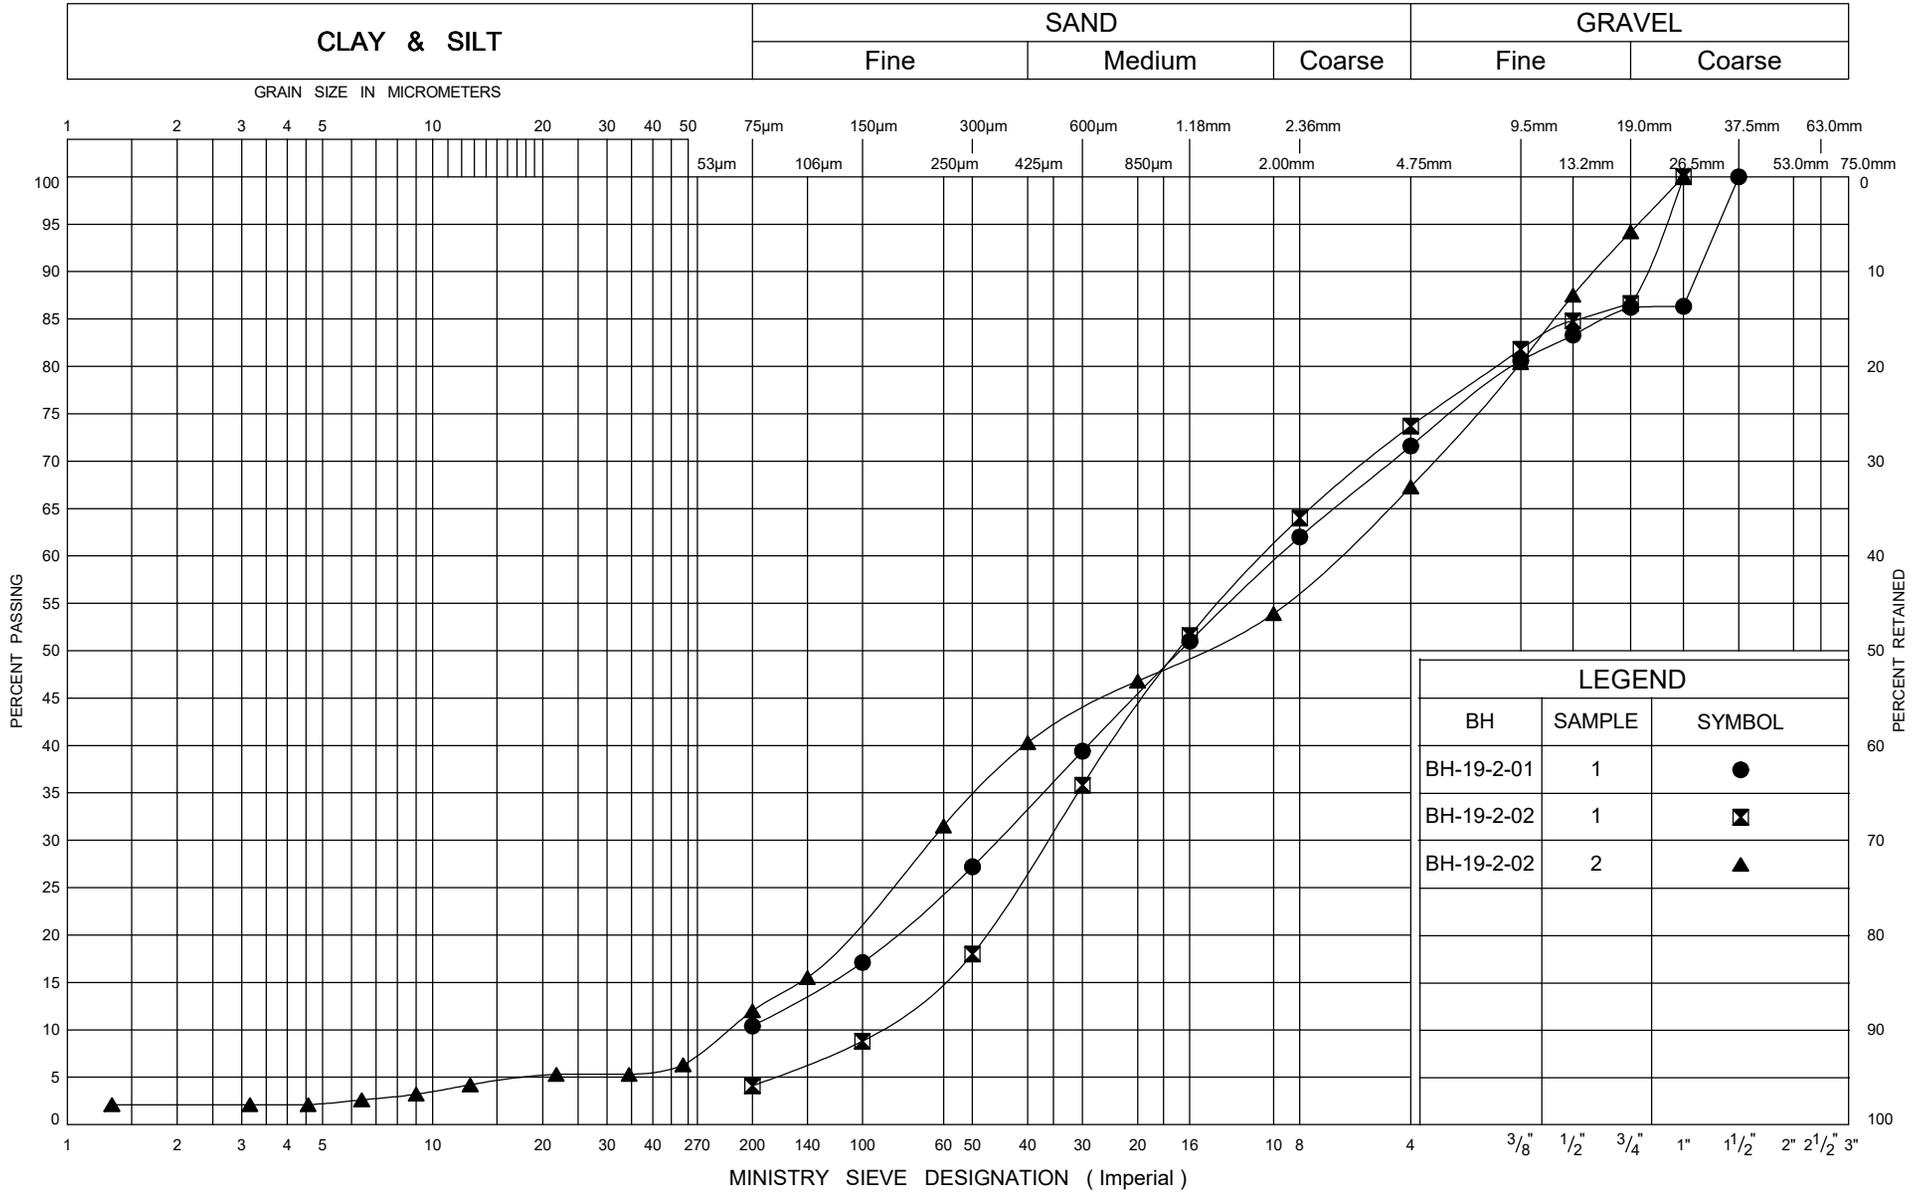
FIG No.:	GSA-2-1
Agreement No.:	5017-E-0043
Work Item No.:	5
G.W.P. No.:	5031-18-00

GRAIN SIZE DISTRIBUTION
Gravelly Sand / Sand with Gravel, Trace to Some Fines

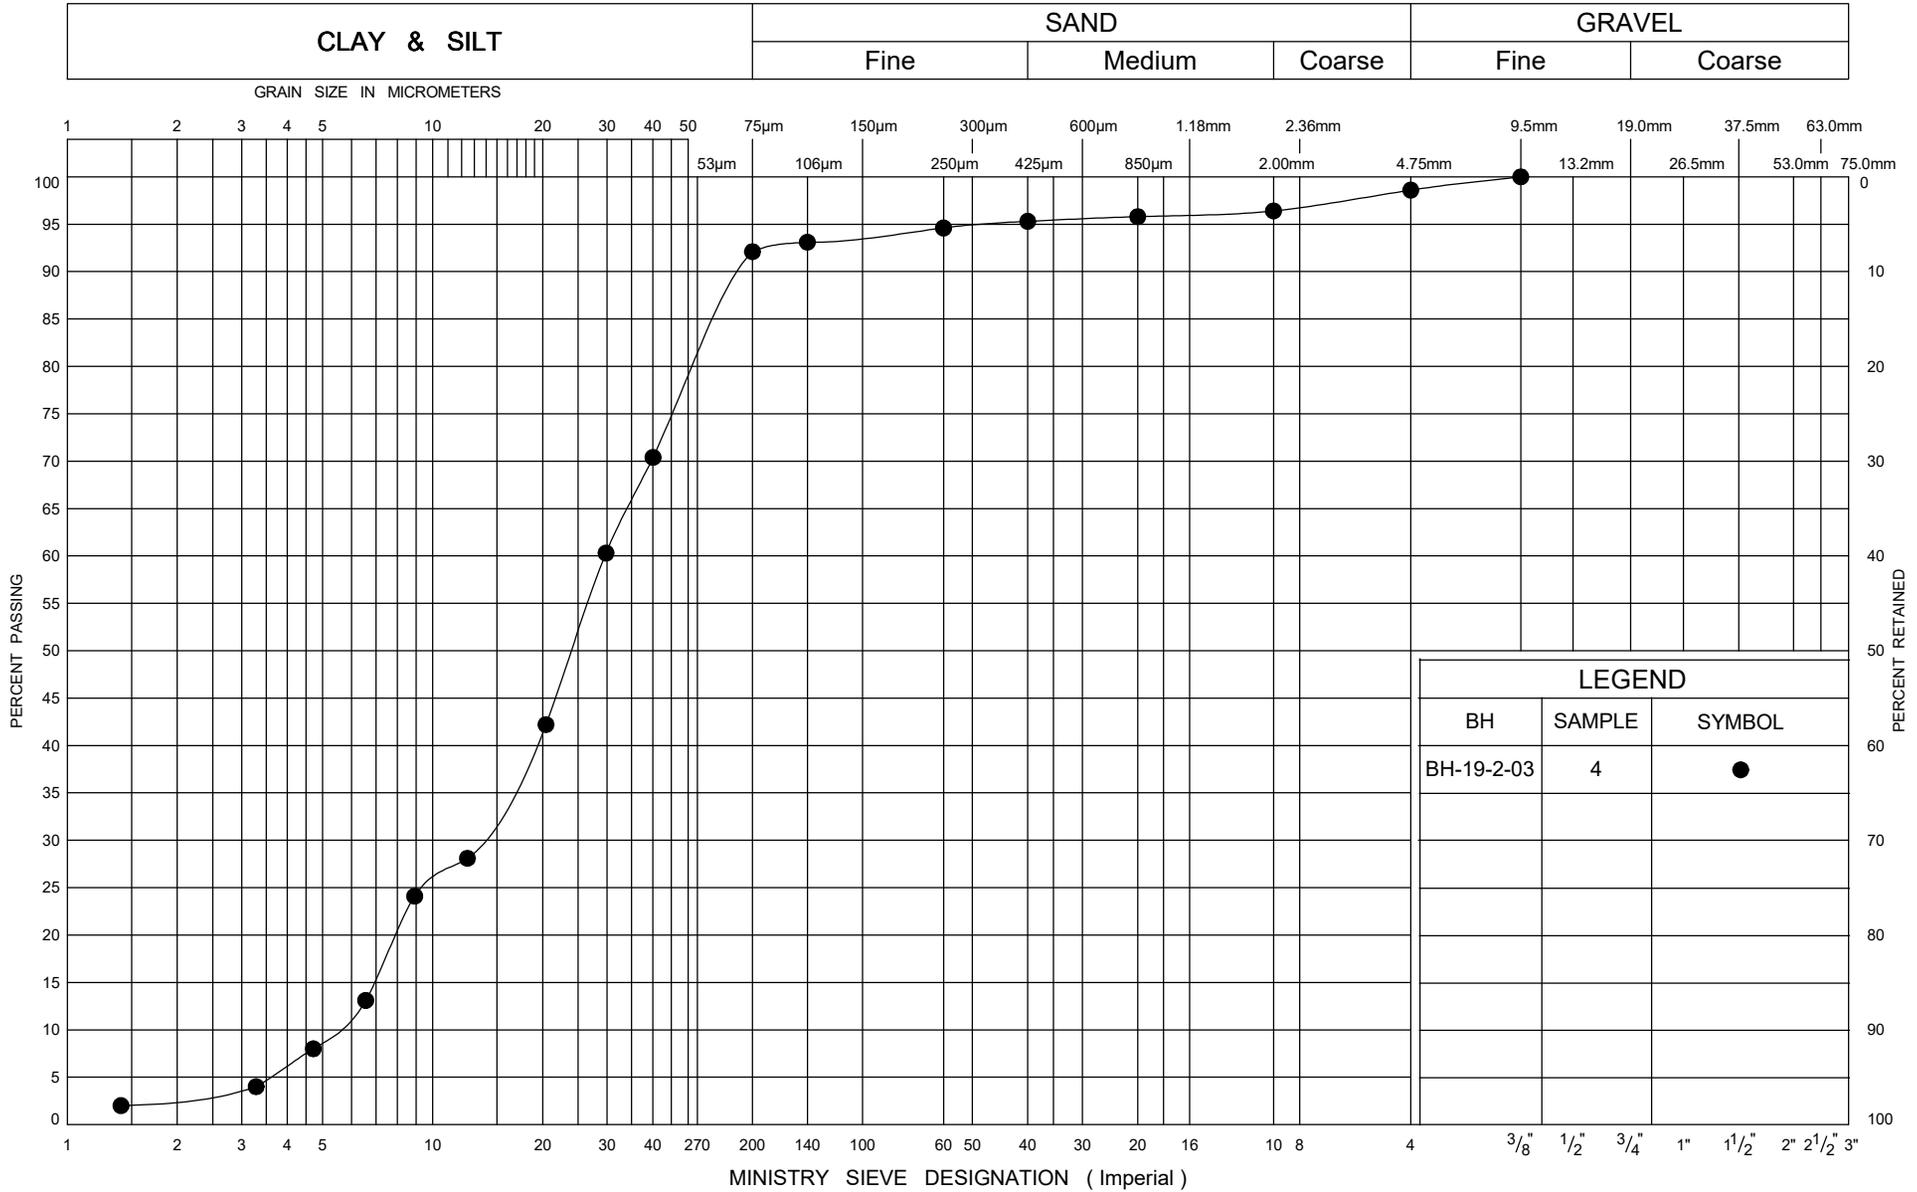
FIG No.:	GSA-2-2
Agreement No.:	5017-E-0043
Work Item No.:	5
G.W.P. No.:	5031-18-00

GRAIN SIZE DISTRIBUTION
Silt, Trace Gravel, Trace Sand, Trace Clay

The moisture content of a sample of the silt was reported to be 91%.

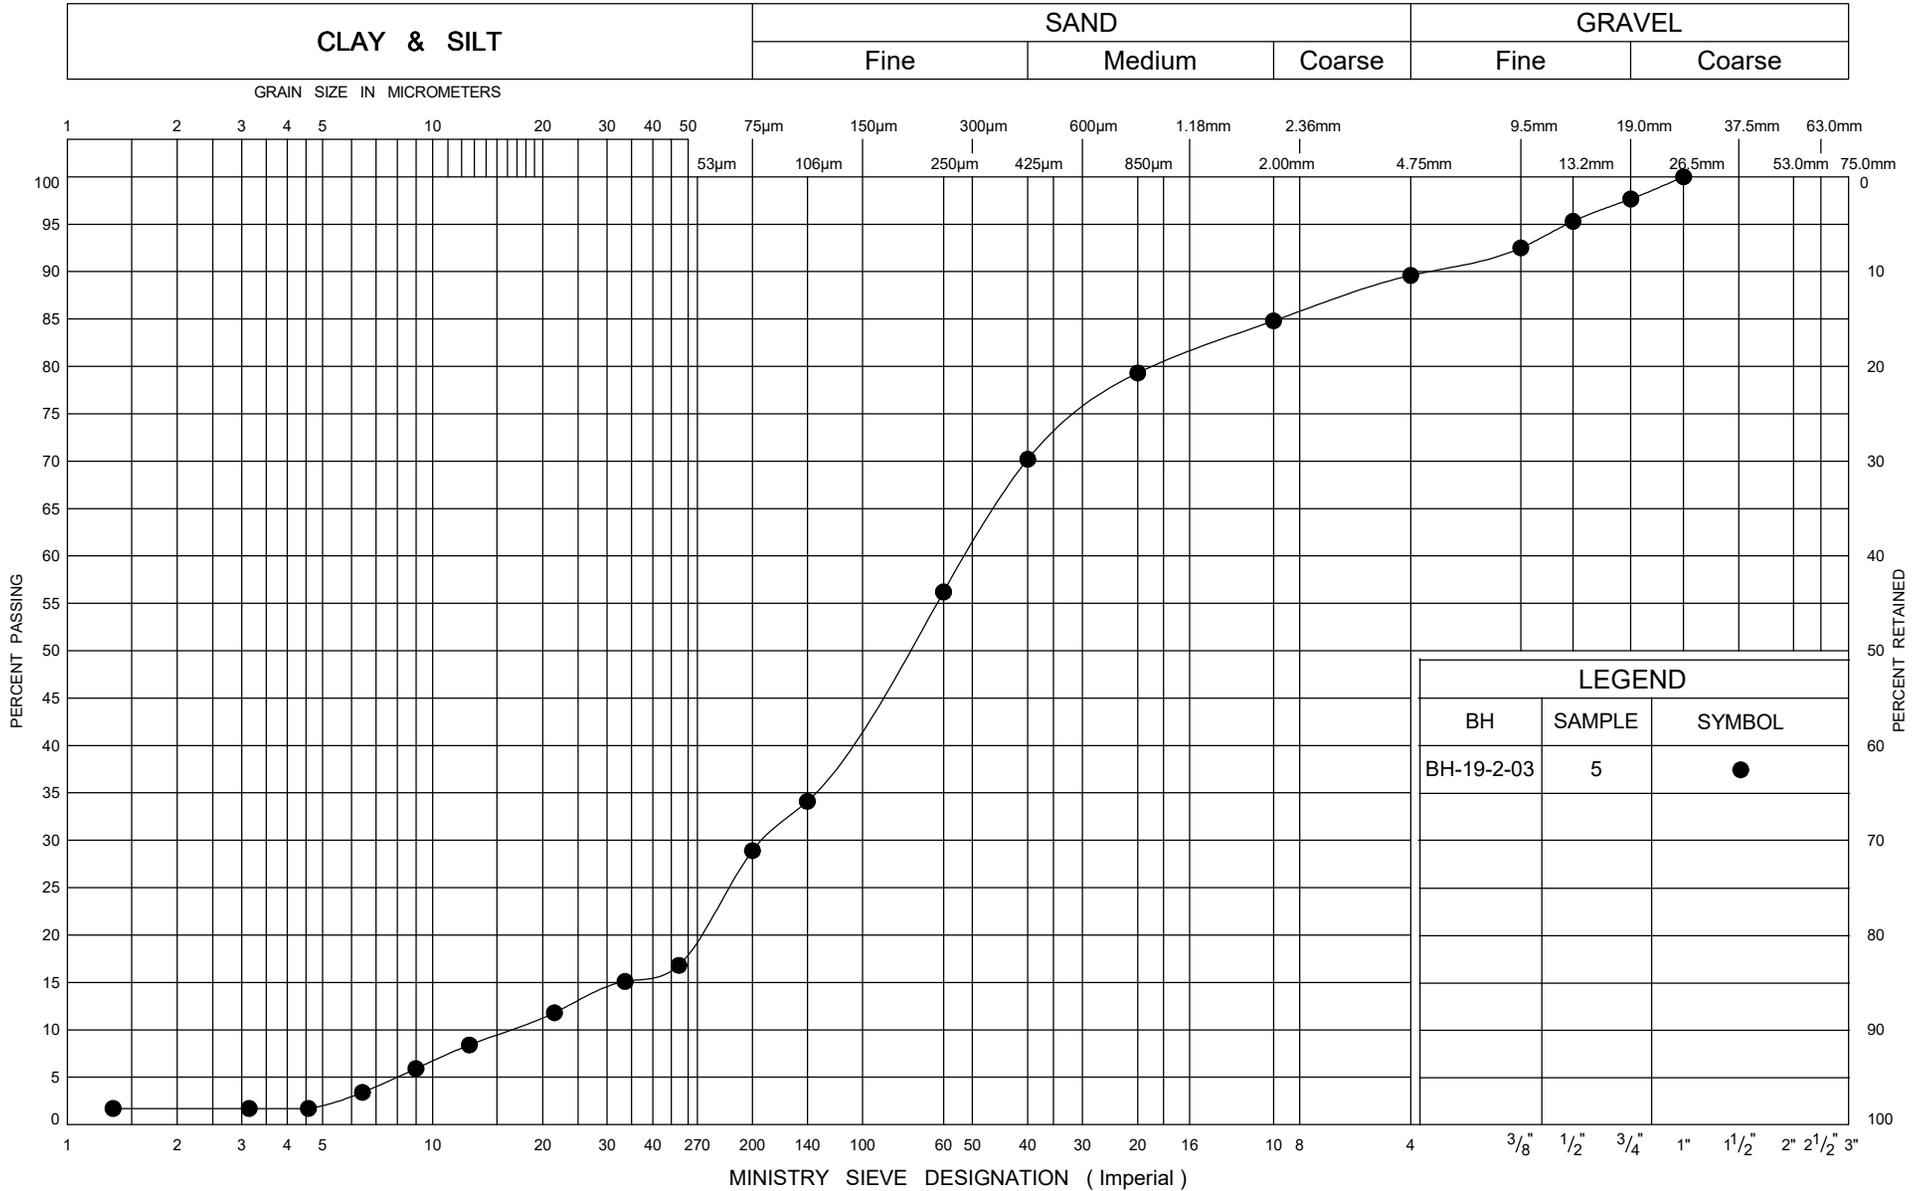
FIG No.:	GSA-2-3
Agreement No.:	5017-E-0043
Work Item No.:	5
G.W.P. No.:	5031-18-00

GRAIN SIZE DISTRIBUTION

Sand with Silt, Trace to Some Gravel, Trace Clay
