Foundation Investigation and Design Report

HIGHWAY 17 WIDENING
AREA 1 (STA. 10+400 – 10+600), AREA 2 (STA. 11+050 – 11+160)
AREA 3 (STA. 11+525 – 11+600), AREA 4 (STA. 12+350 – 12+480)
TOWNSHIP OF DAMBROSSIO
AREA 7 (STA. 16+700 – 16+825)
TOWNSHIP OF LALIBERT
DISTRICT OF ALGOMA
BETWEEN WHITE RIVER AND WAWA, ONTARIO

AGREEMENT NO. 5017-E-0043
WORK ITEM: #5
GWP 5031-18-00

Part A - Foundation Investigation Report

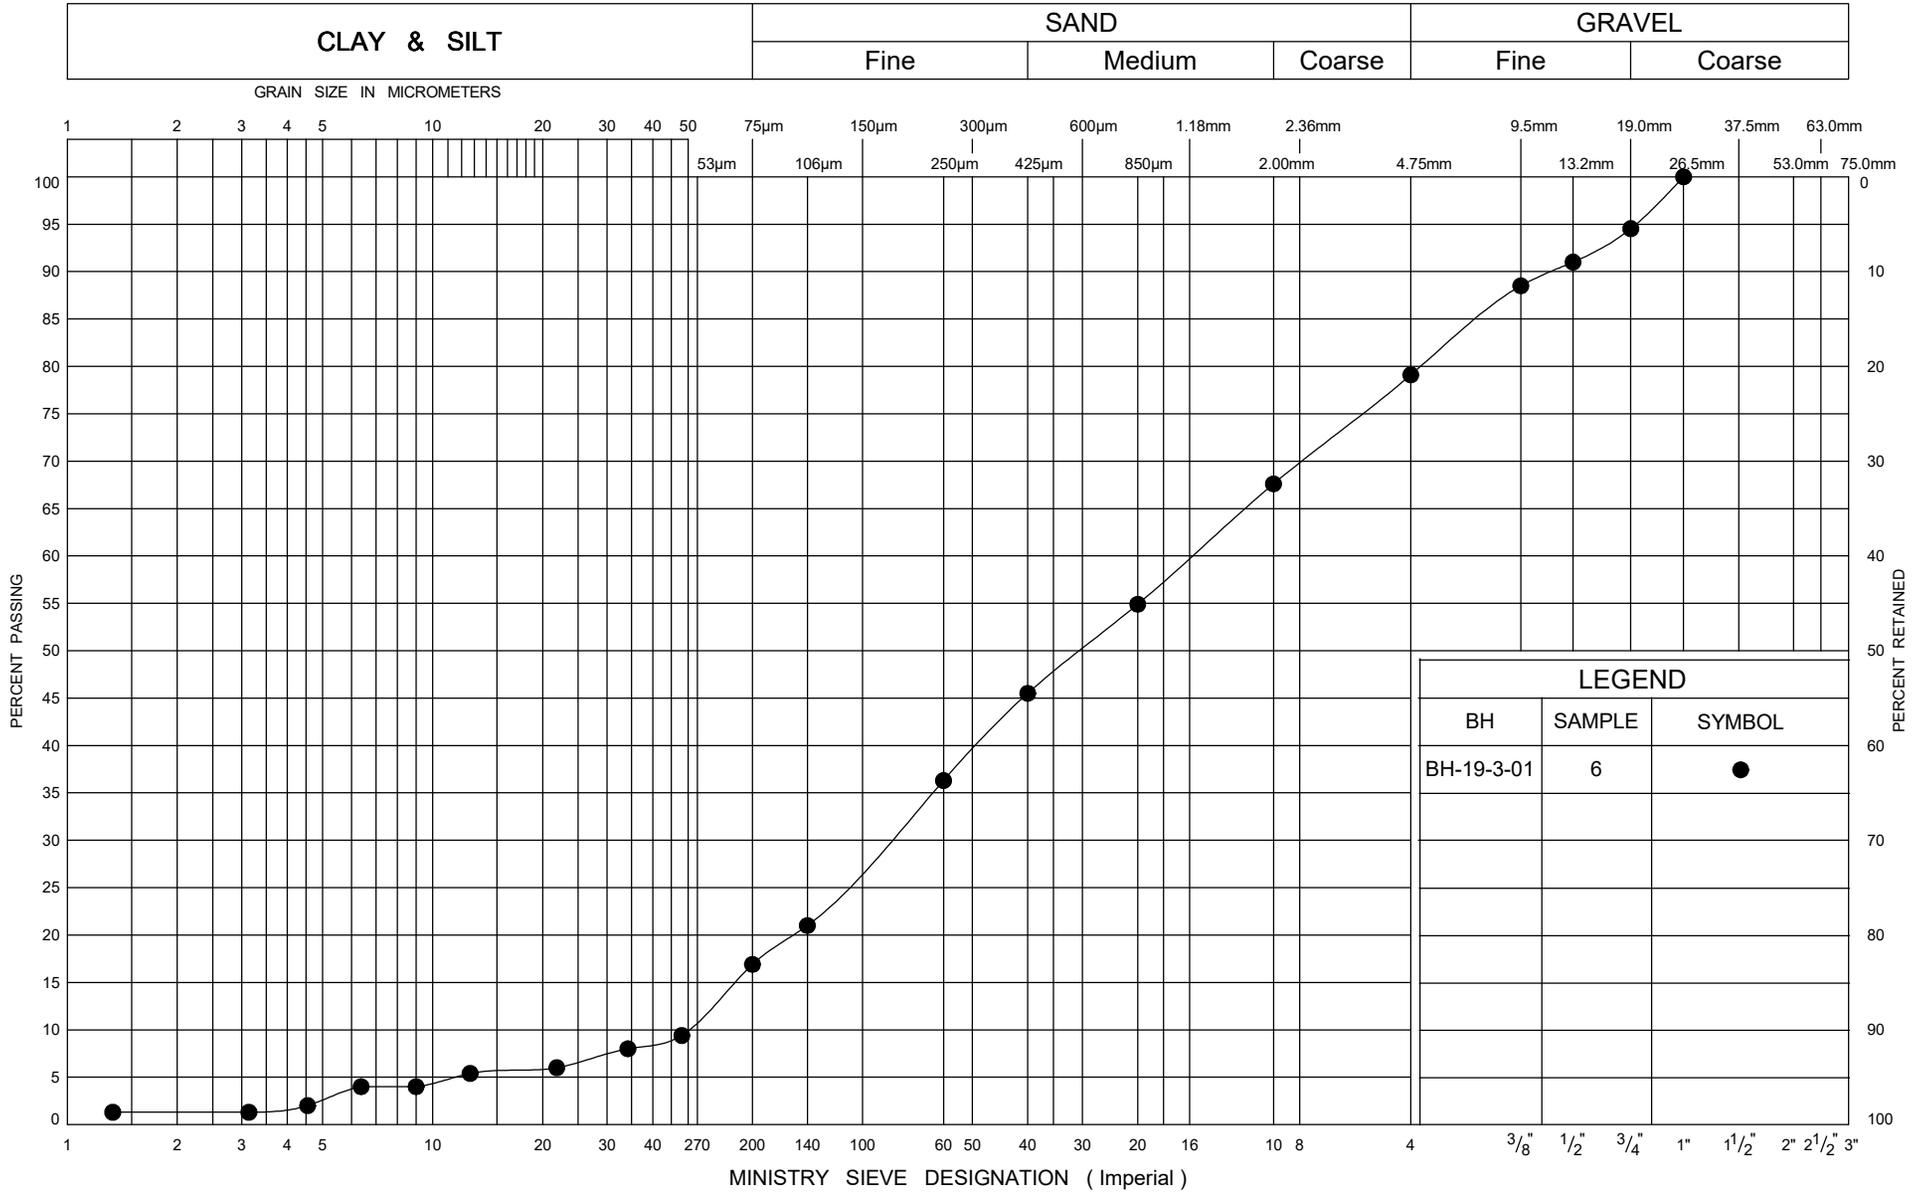
FIG No.:	GSA-3-1
Agreement No.:	5017-E-0043
Work Item No.:	5
G.W.P. No.:	5031-18-00

GRAIN SIZE DISTRIBUTION
Sand with Gravel, Some Silt, Trace Clay

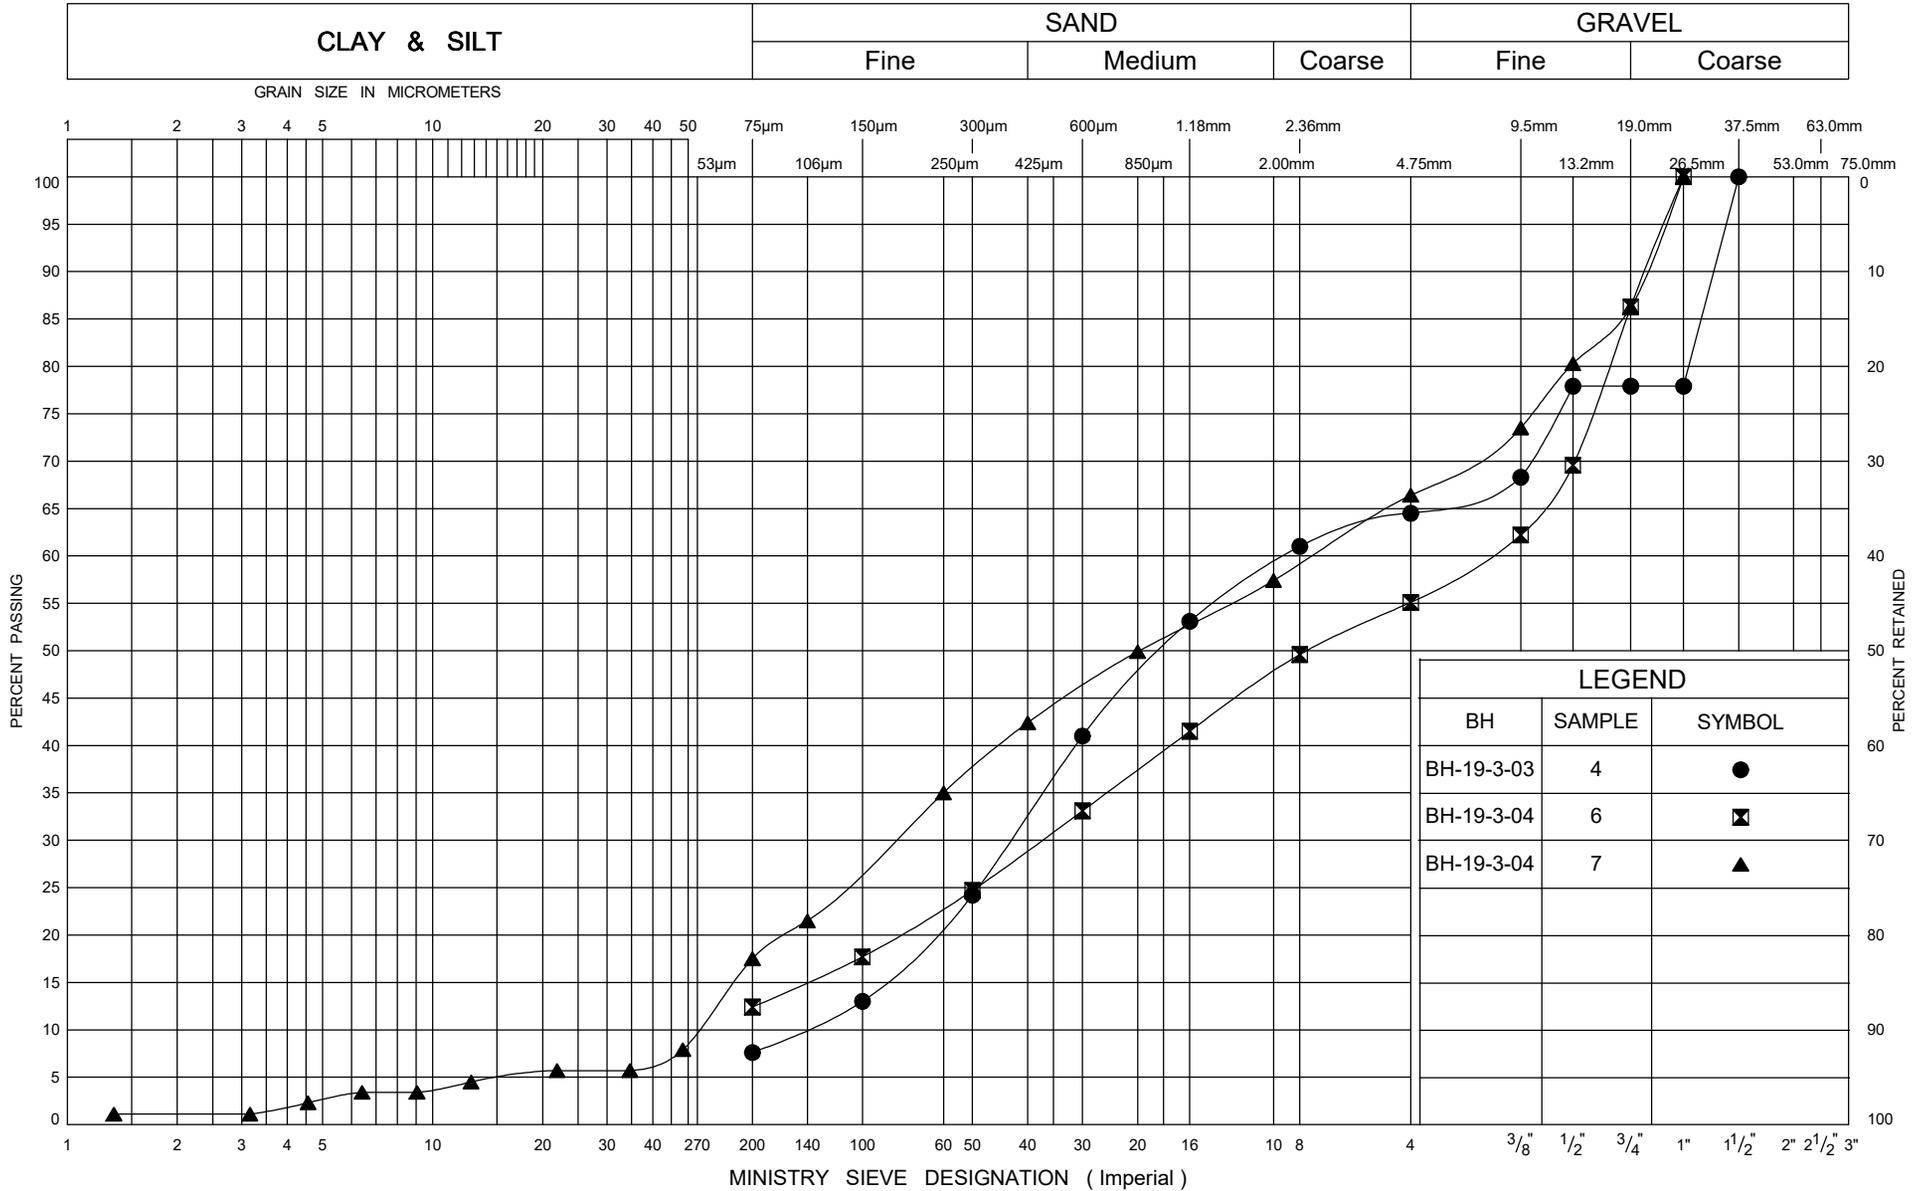
FIG No.:	GSA-3-3
Agreement No.:	5017-E-0043
Work Item No.:	5
G.W.P. No.:	5031-18-00

GRAIN SIZE DISTRIBUTION
Gravelly Sand, Trace to Some Silt, Trace Clay

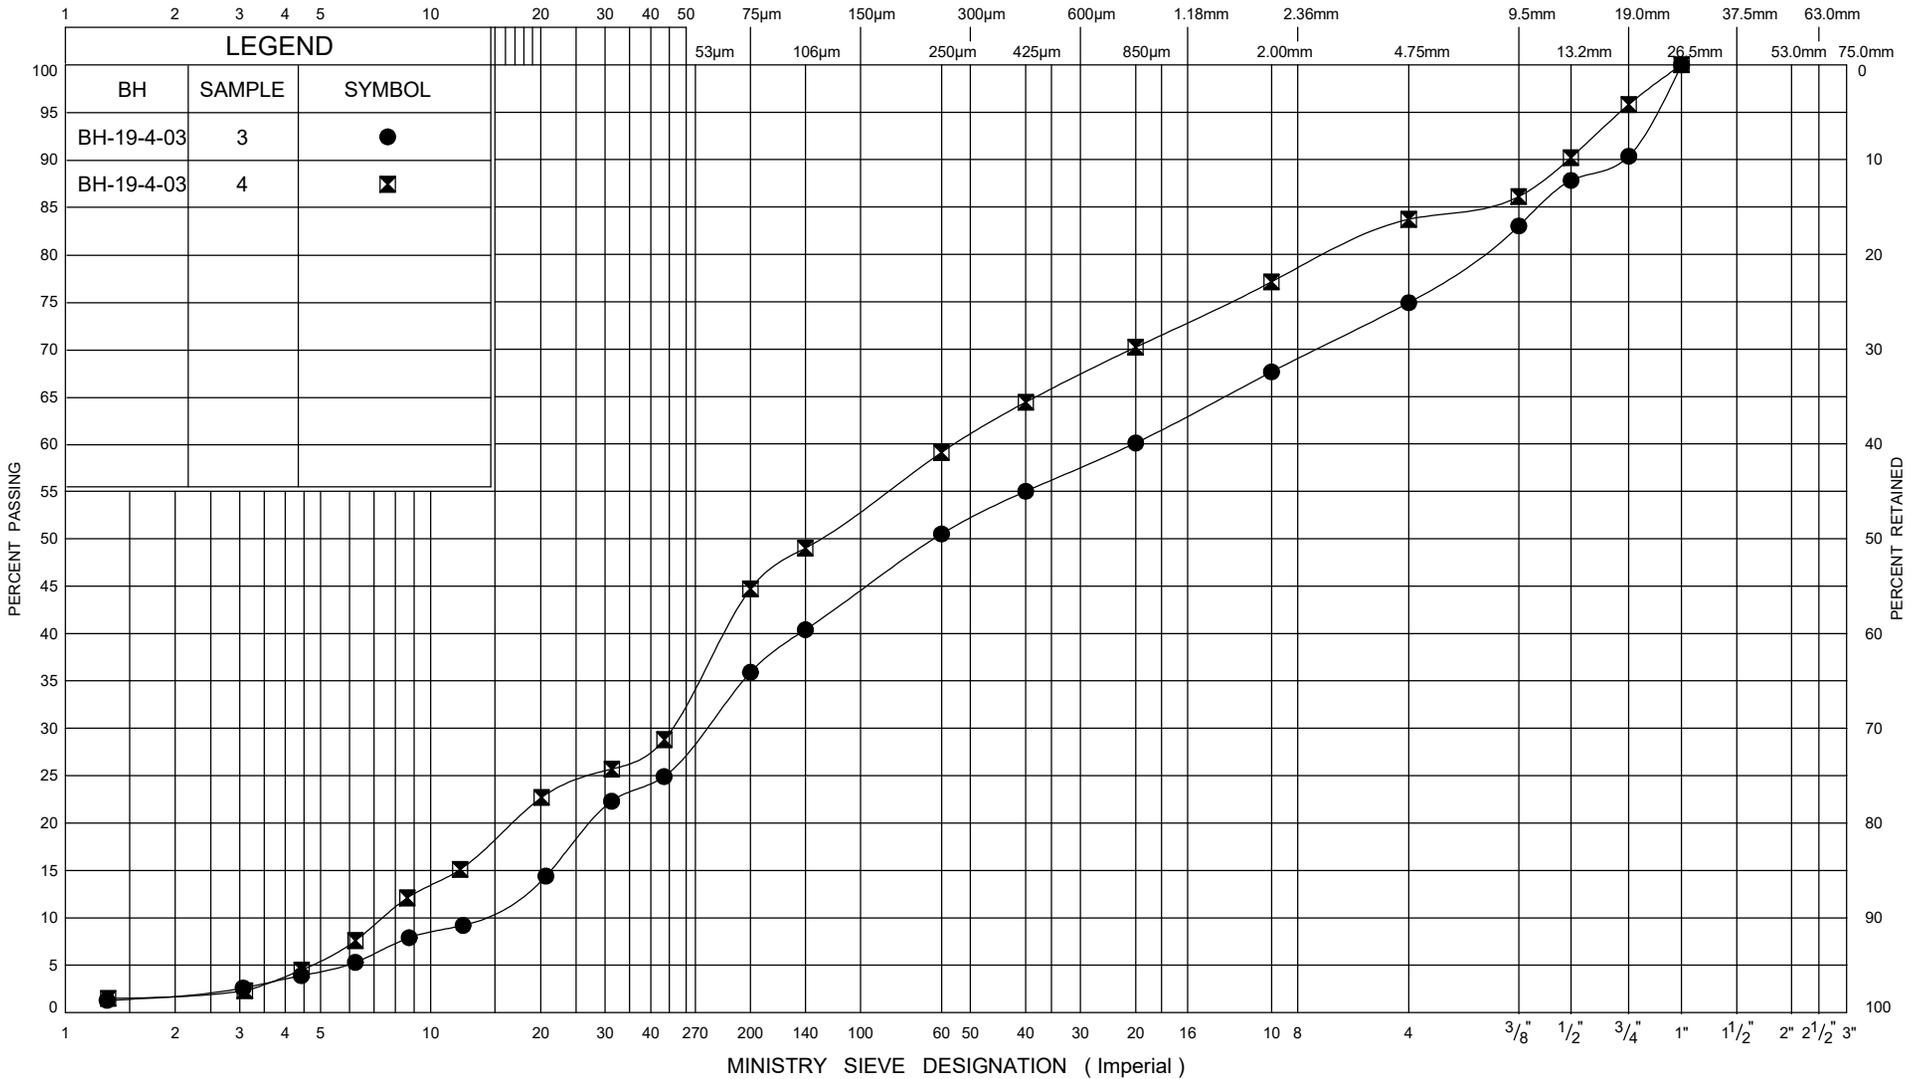
FIG No.:	GSA-4-1
Agreement No.:	5017-E-0043
Work Item No.:	5
G.W.P. No.:	5031-18-00

GRAIN SIZE DISTRIBUTION
 Silty Sand to Sandy Silt, Trace to Some Gravel, Trace Clay

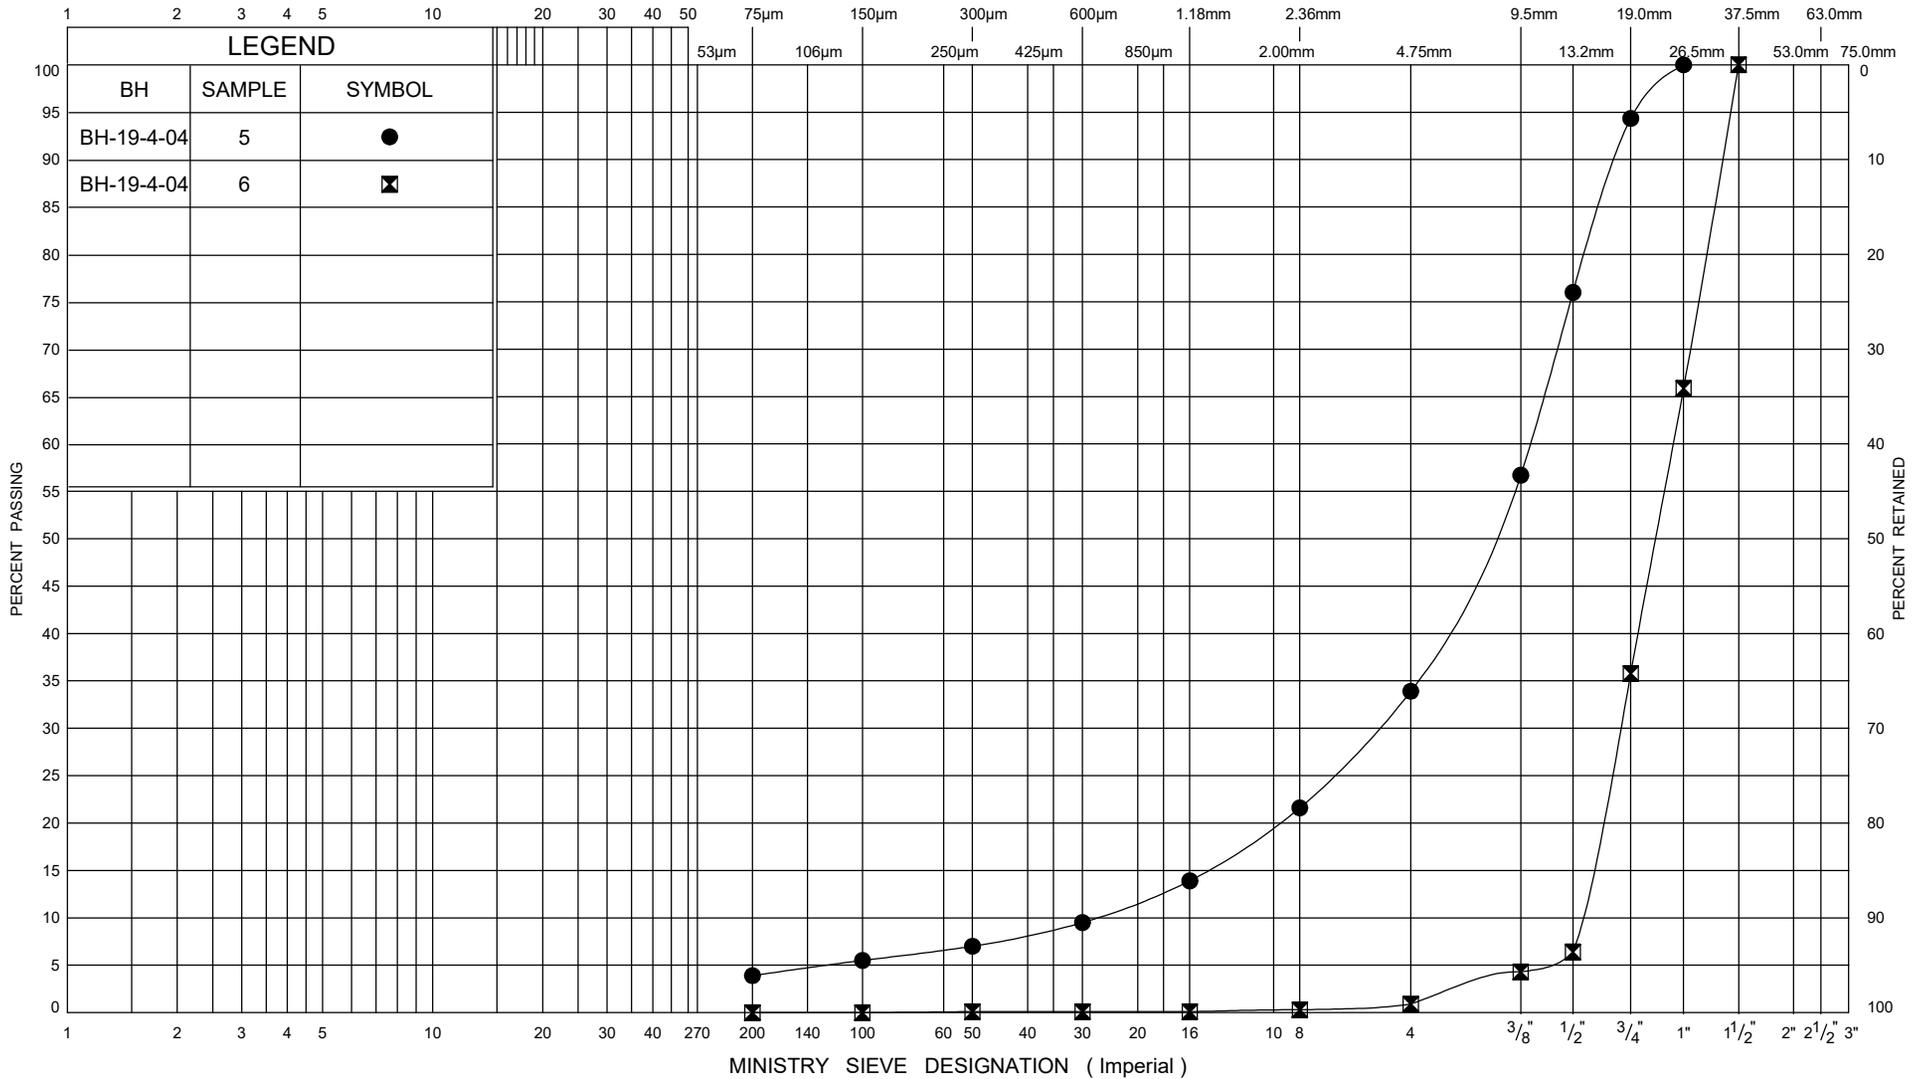
GRAIN SIZE DISTRIBUTION
Sandy Gravel to Gravel, Some Cobbles

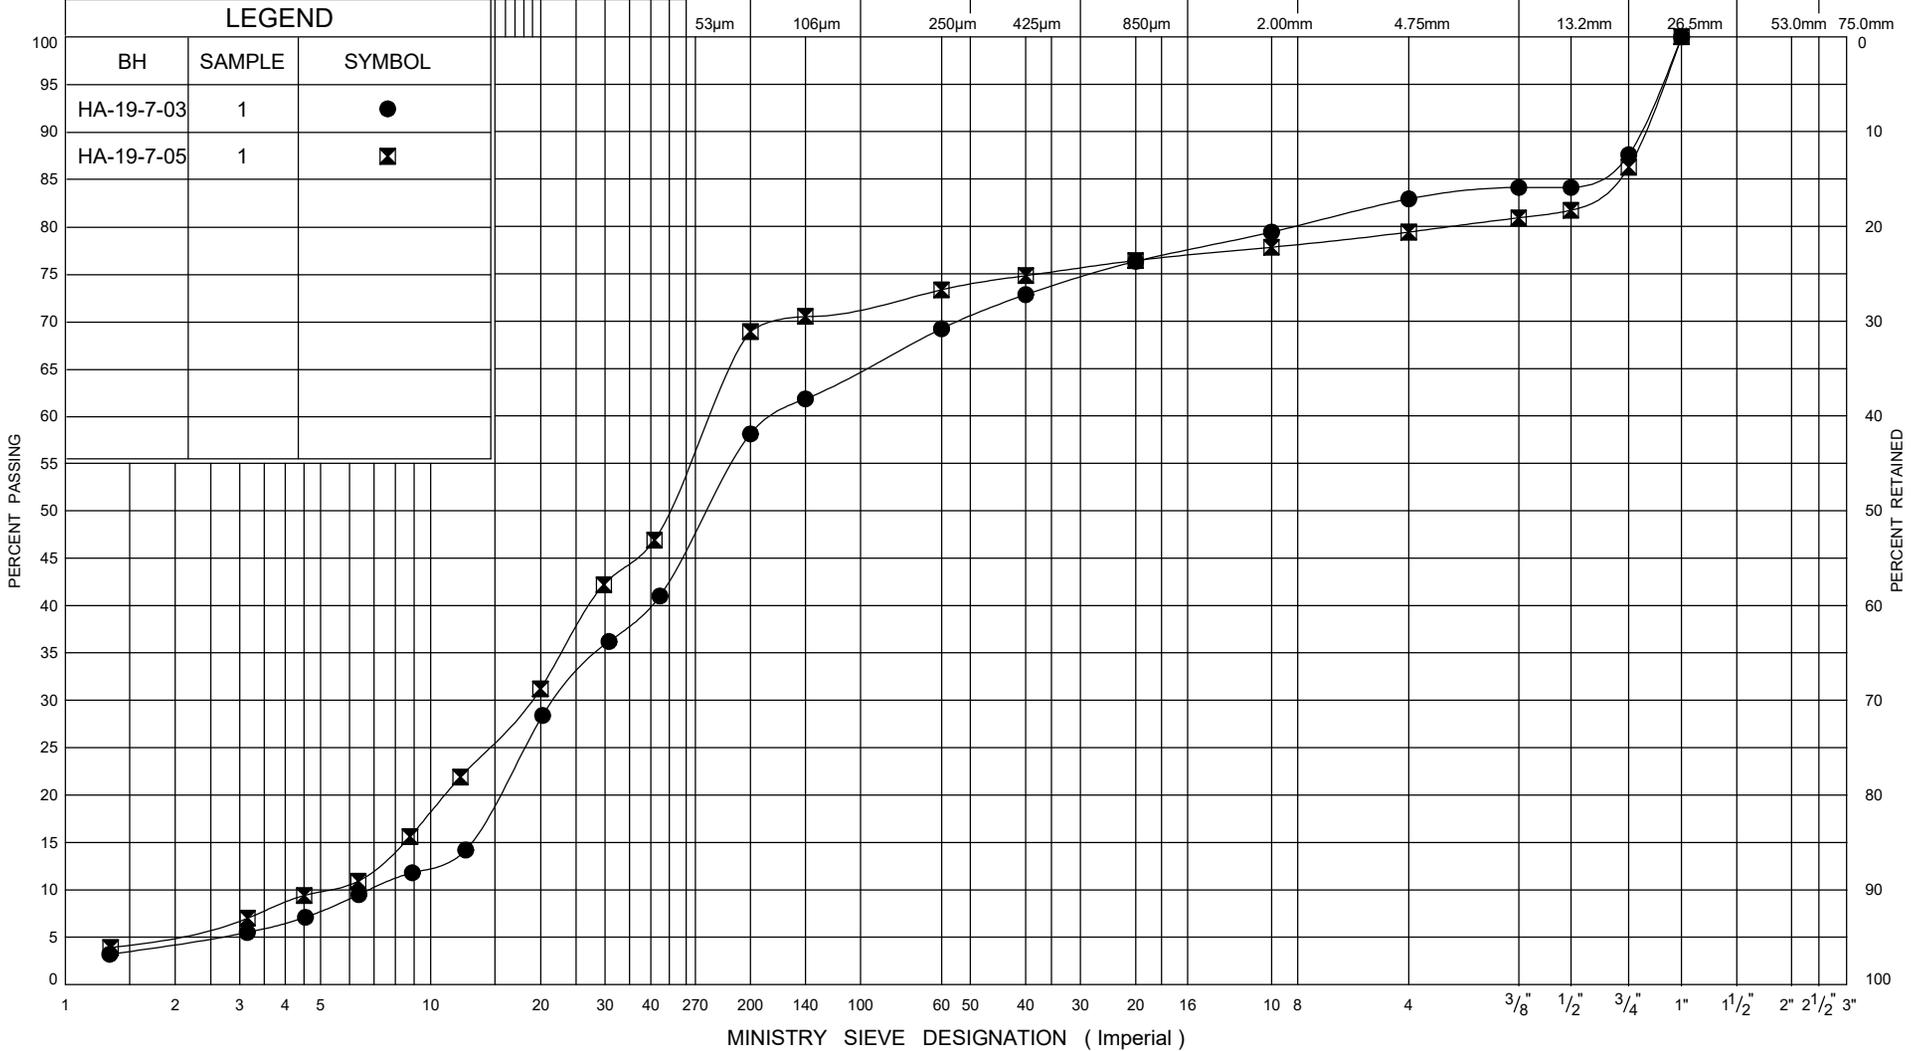
GRAIN SIZE DISTRIBUTION

Sandy Silt / Silt with Sand, Trace to Some Gravel, Trace Clay

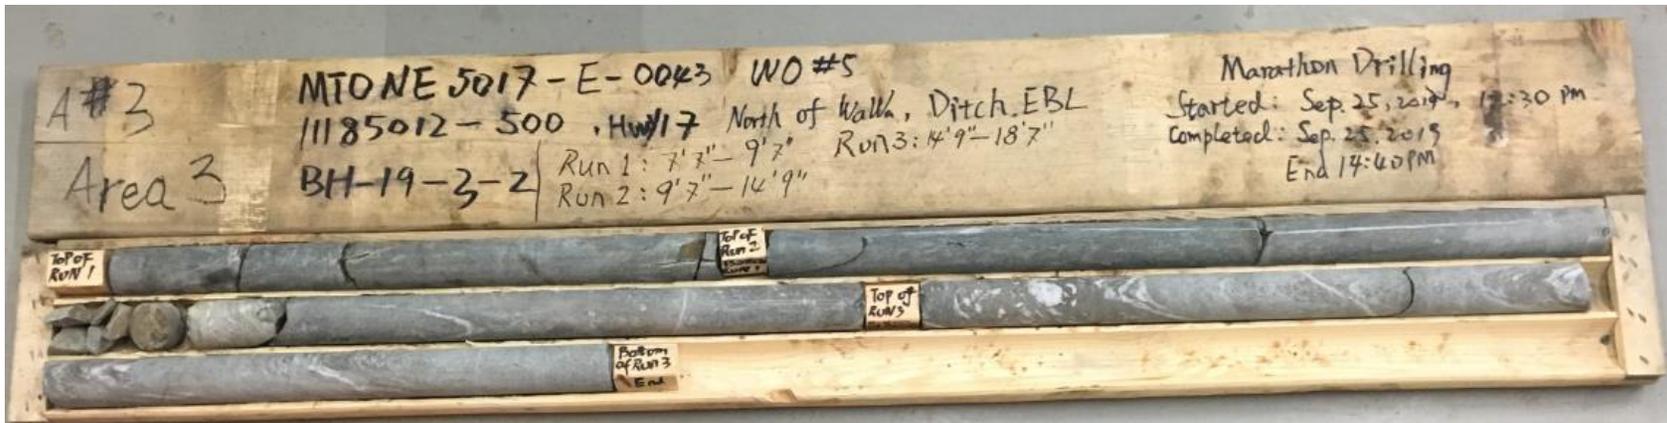
Photo 24 – Highway 17 - Area 3 - BH-19-3-02, R1 = 2.3 m – 2.8 m, R2 = 2.8 m – 4.5 m, R3 = 4.5 m – 5.7 m

The bedrock encountered in all three boreholes was described to be Greenstone. It was dark green to black in color, fine to medium grained, weakly to moderately foliated, and consisted of quartz and plagioclase crystals in a fine matrix of dark minerals. The rock cores were slightly weathered and moderately to well fractured, and were medium to hard (based on geological hammer and knife test).

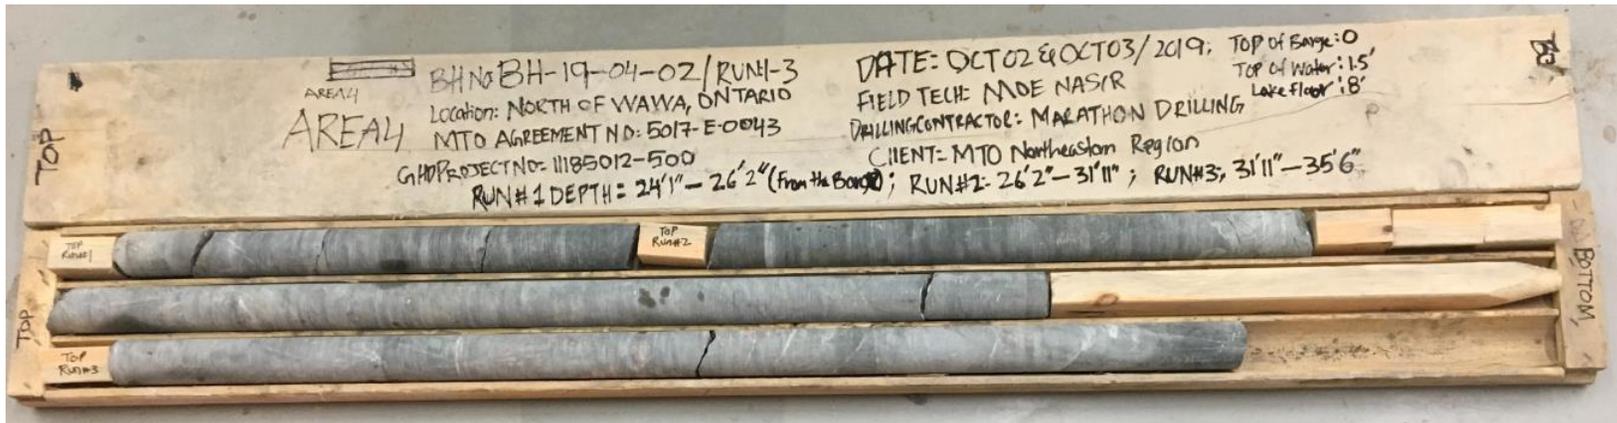
Photo 25 – Highway 17 – Area 4 - BH-19-4-02, R1 = 7.2 m – 7.8 m, R2 = 7.8 m – 9.8 m, R3 = 9.8 m – 10.8 m

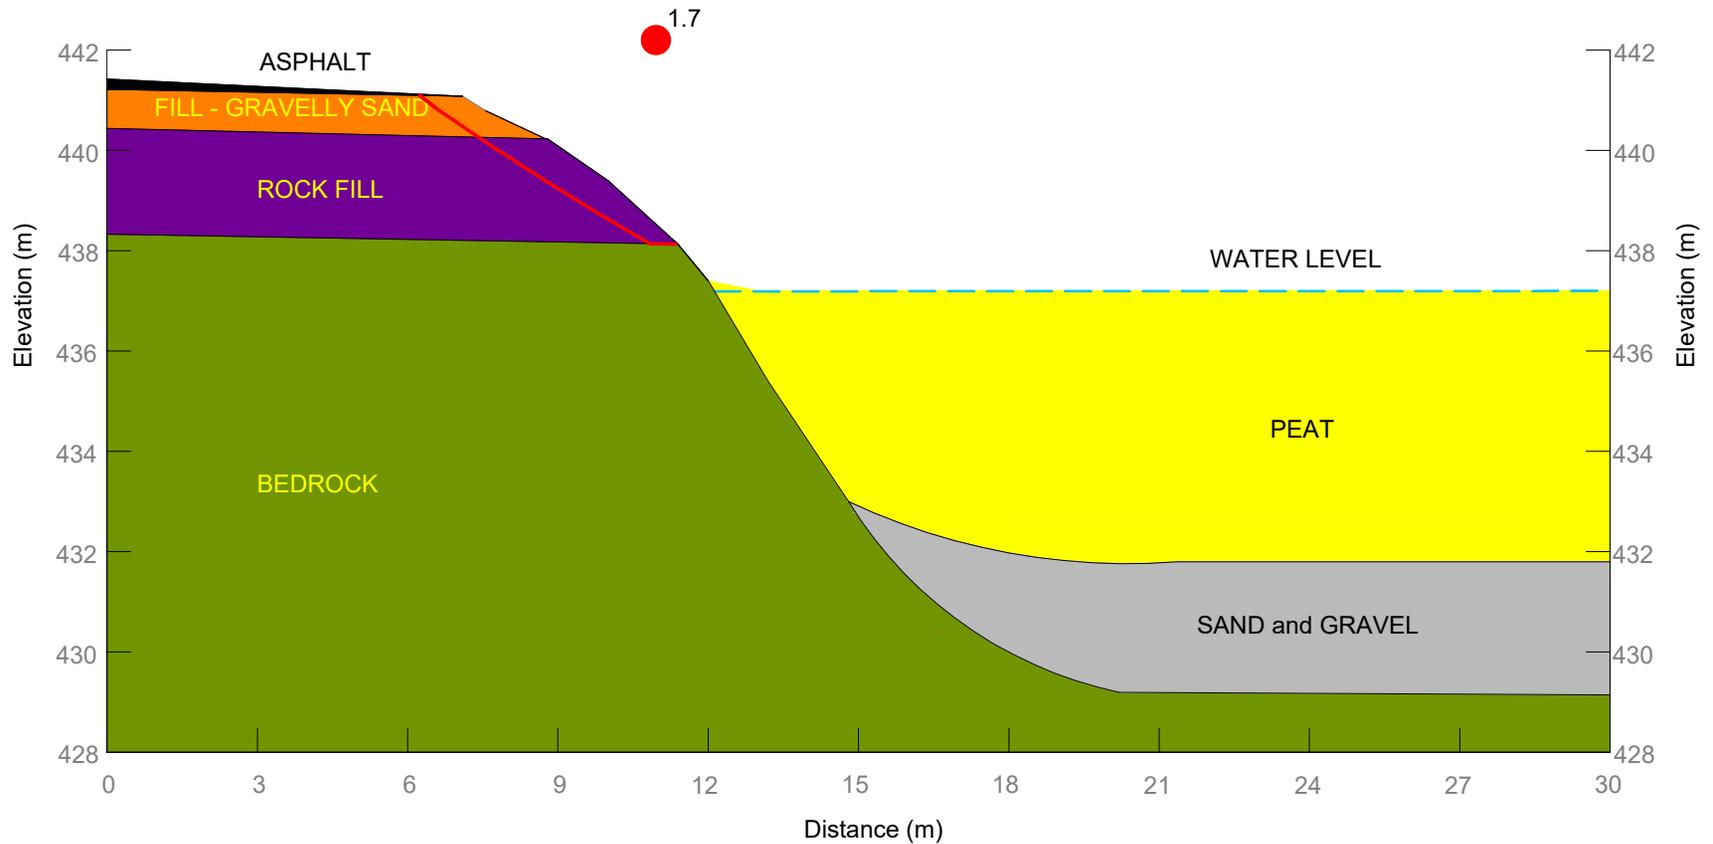
Soil Strength Parameter

Property \ Material	Asphalt	Fill - Gravelly Sand	Rock Fill	Peat	Sand and Gravel	Bedrock
Bulk Unit Weight (kN/m ³)	-	21	21	10	21	-
Internal Friction Angle (°)	-	28	40	10	30	-
Undrained Shear Strength, (Cohesion) (kPa)	-	-	-	5	-	-

Existing Slope Typical - Slope Stability Analysis

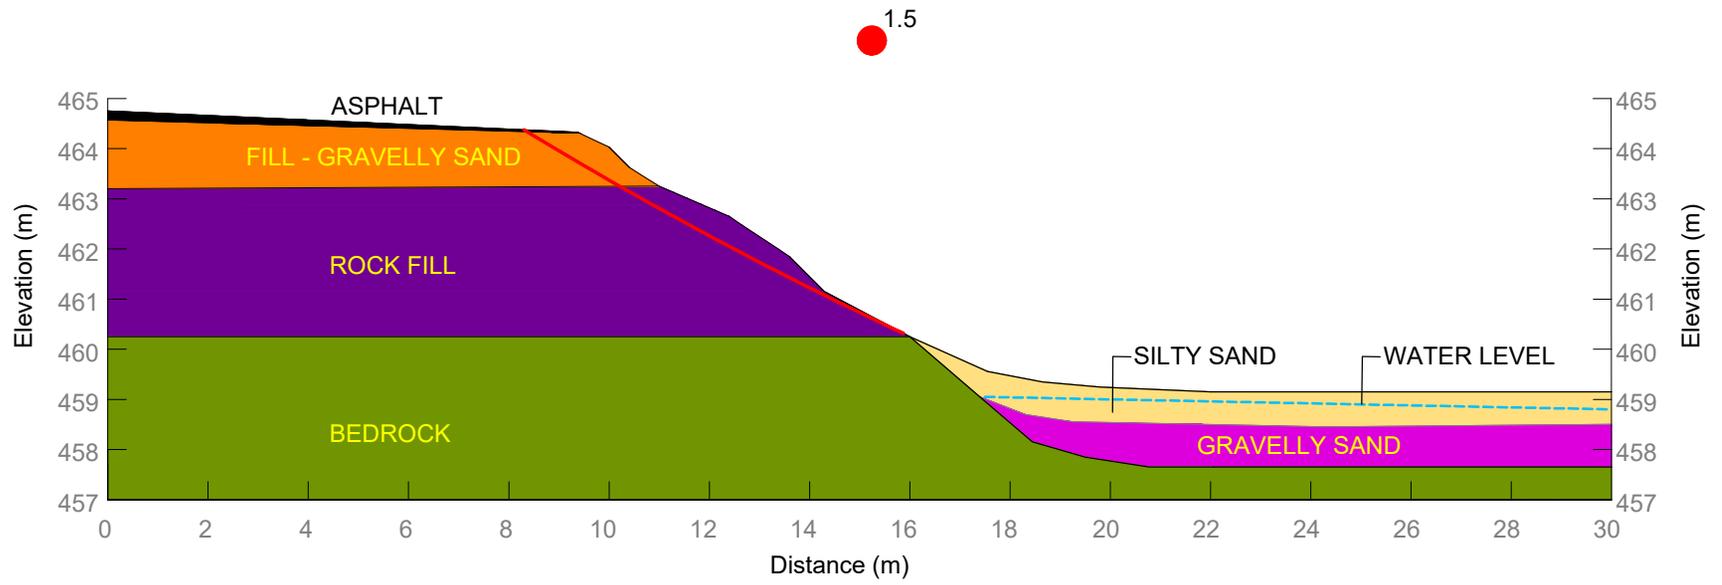
Agreement:	5017-E-0043	Work Item: #5	Drawn:	AW	Project No.:	11185012 (500)
G.W.P.:	5031-18-00	Hwy No.: 17	Checked:	LY	Revision:	
Township:	Dambrossio		Reviewed:	LY	Date:	2020.01.17
District:	Algoma		Approved:	NM	Drawing:	8

Property \ Material	Asphalt	Fill - Gravelly Sand	Rock Fill	Silty Sand	Gravelly Sand	Bedrock
Bulk Unit Weight (kN/m ³)	-	21	21	19	21	-
Internal Friction Angle (°)	-	28	40	20	30	-
Undrained Shear Strength, (Cohesion) (kPa)	-	-	-	-	-	-

Existing Slope Typical - Slope Stability Analysis
 Foundation Investigation and Design
 Highway 17 - Widening, Between White River and Wawa
Area 3

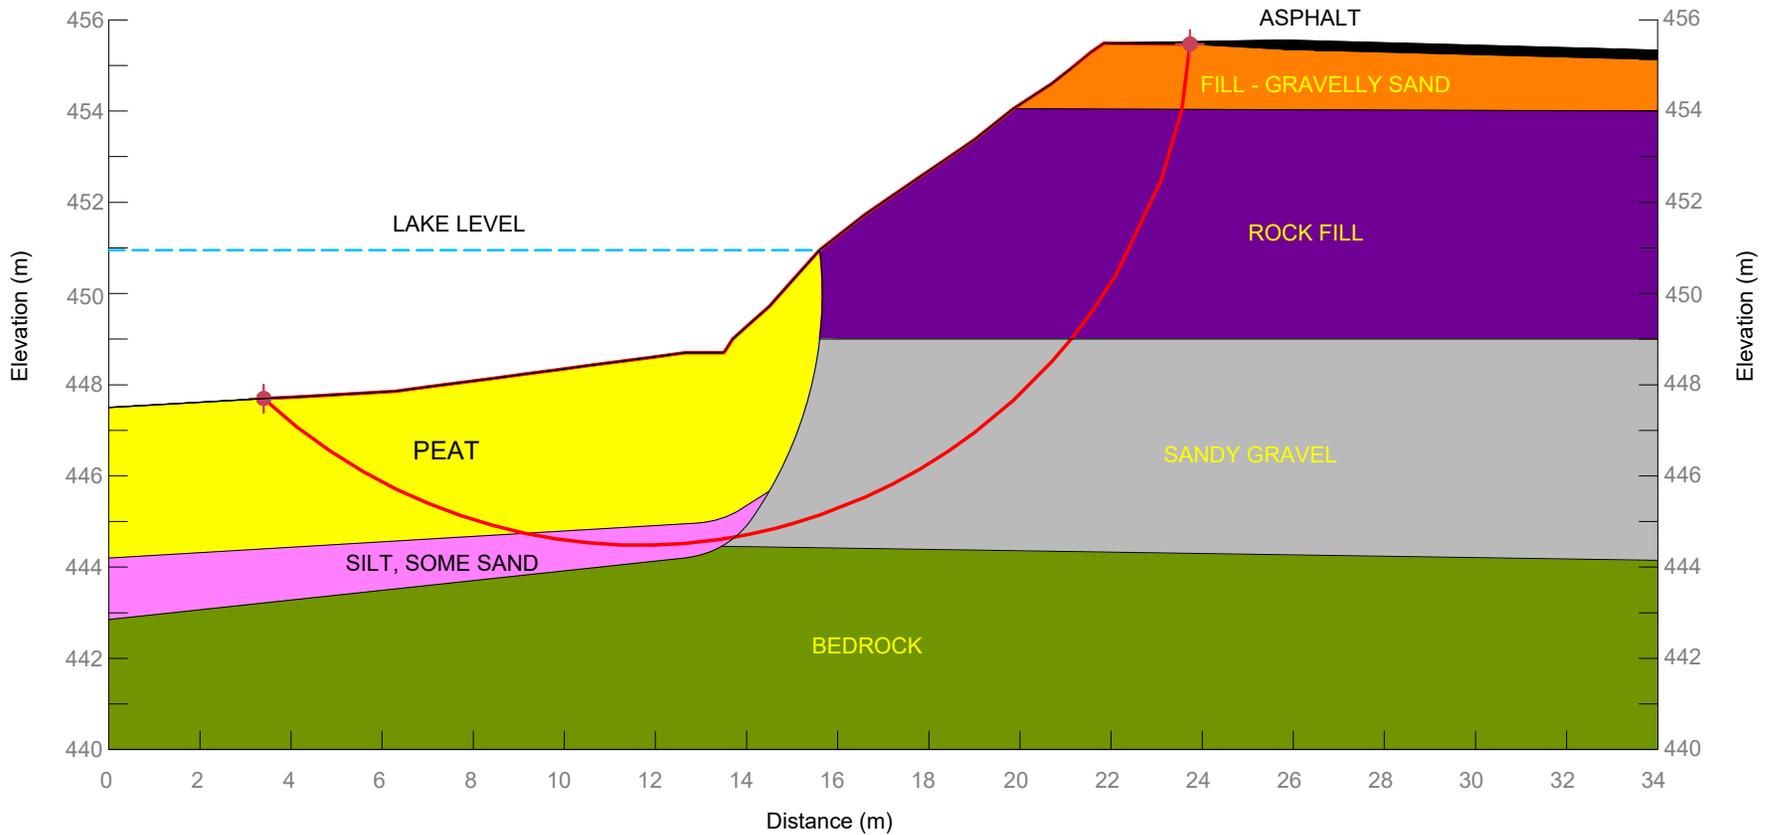
Agreement:	5017-E-0043	Work Item: #5	Drawn:	AW	Project No.:	11185012 (500)
G.W.P.:	5031-18-00	Hwy No.: 17	Checked:	LY	Revision:	
Township:	Dambrossio		Reviewed:	LY	Date:	2020.01.17
District:	Algoma		Approved:	NM	Drawing:	9

Existing Slope Typical - Slope Stability Analysis
 Foundation Investigation and Design
 Highway 17 - Widening, Between White River and Wawa
Area 4

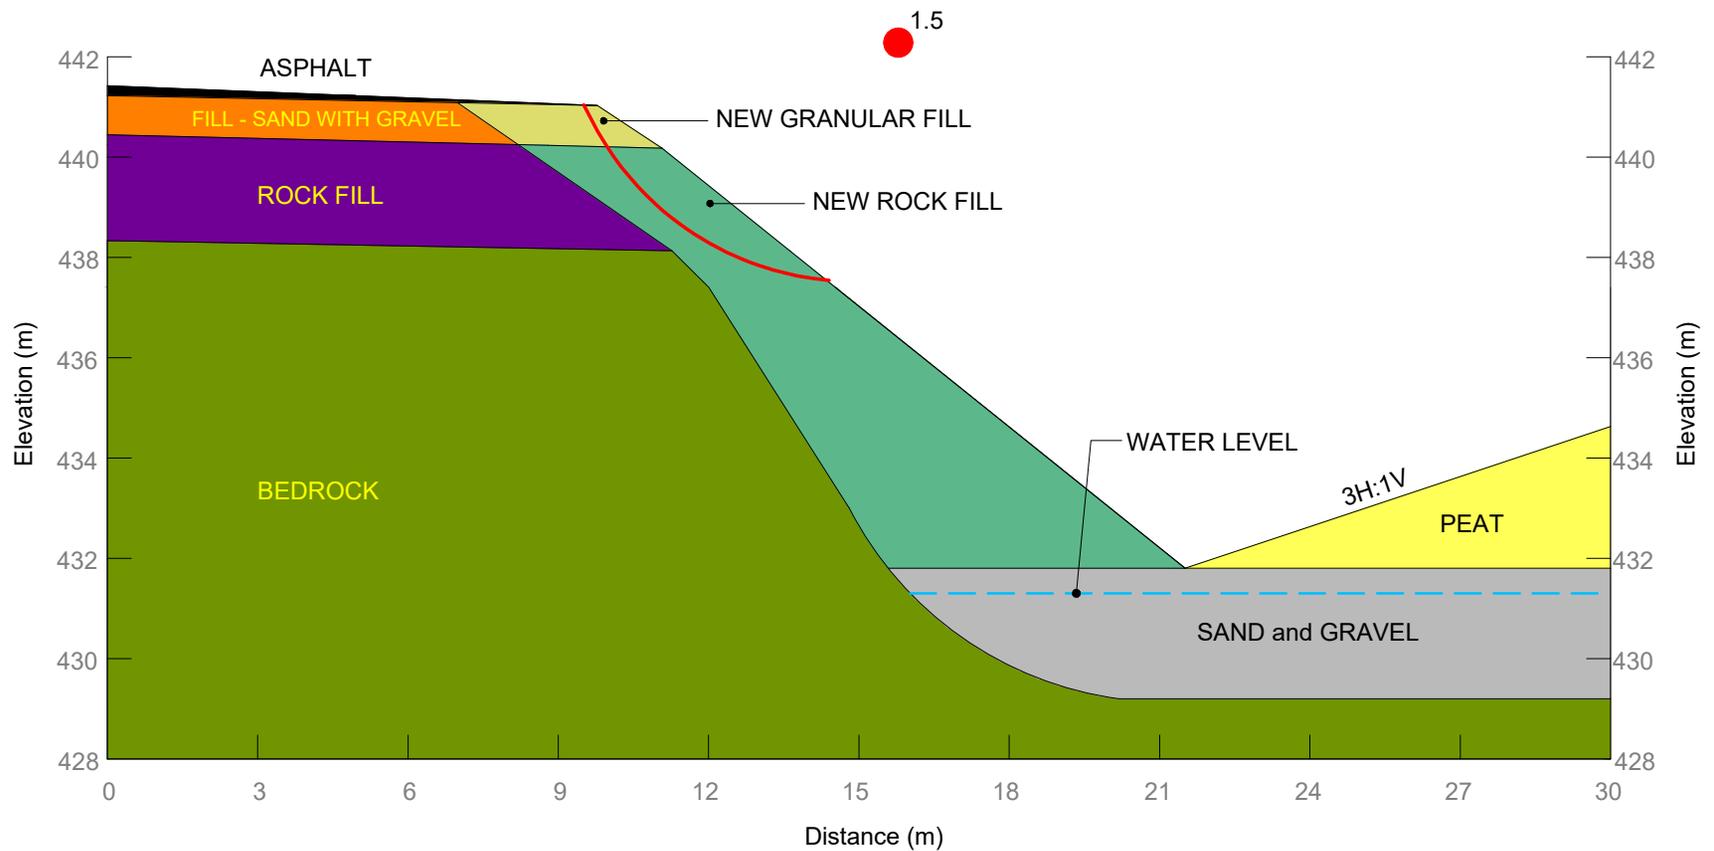
Property \ Material	Asphalt	Fill - Sand With Gravel	Rock Fill	Peat	Sand and Gravel	Bedrock	New Granular Fill	New Rock Fill
Bulk Unit Weight (kN/m ³)	-	20	19	10	20	-	20	19
Internal Friction Angle (°)	-	30	40	25	32	-	30	40
Undrained Shear Strength, (Cohesion) (kPa)	-	-	-	10	-	-	-	-

Proposed Slope (1.25H:1V) Slope Stability Analysis

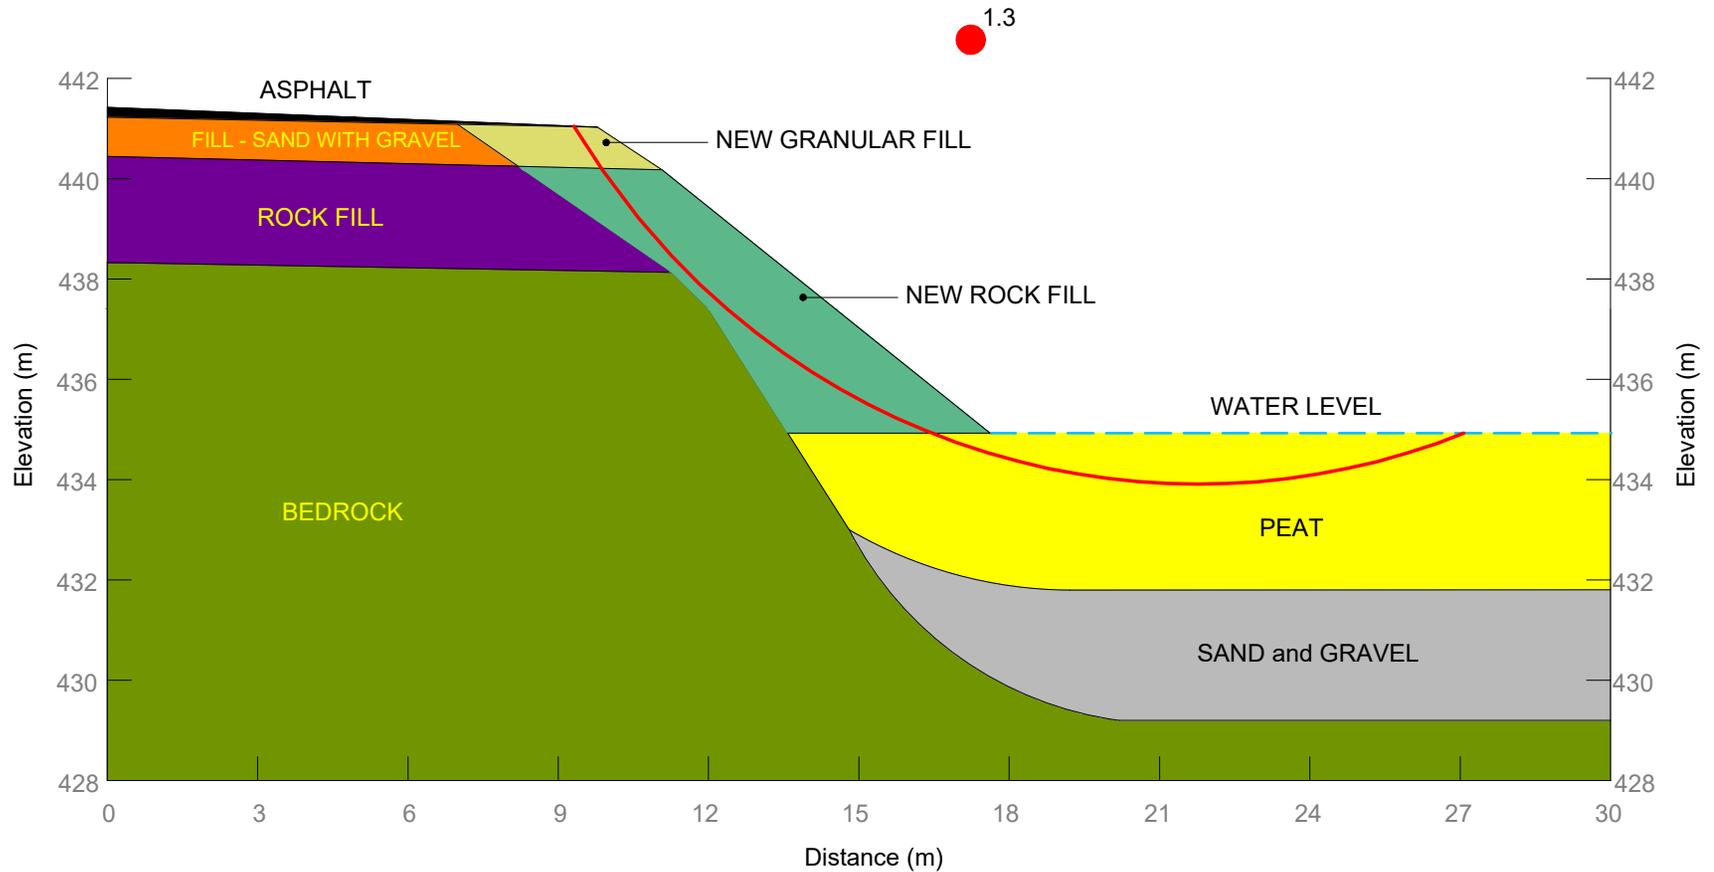
Property \ Material	Asphalt	Fill - Sand With Gravel	Rock Fill	Peat	Sand and Gravel	Bedrock	New Granular Fill	New Rock Fill
Bulk Unit Weight (kN/m ³)	-	20	19	10	20	-	20	19
Internal Friction Angle (°)	-	30	40	25	32	-	30	40
Undrained Shear Strength, (Cohesion) (kPa)	-	-	-	10	-	-	-	-

Proposed Slope (1.25H:1V) Slope Stability Analysis

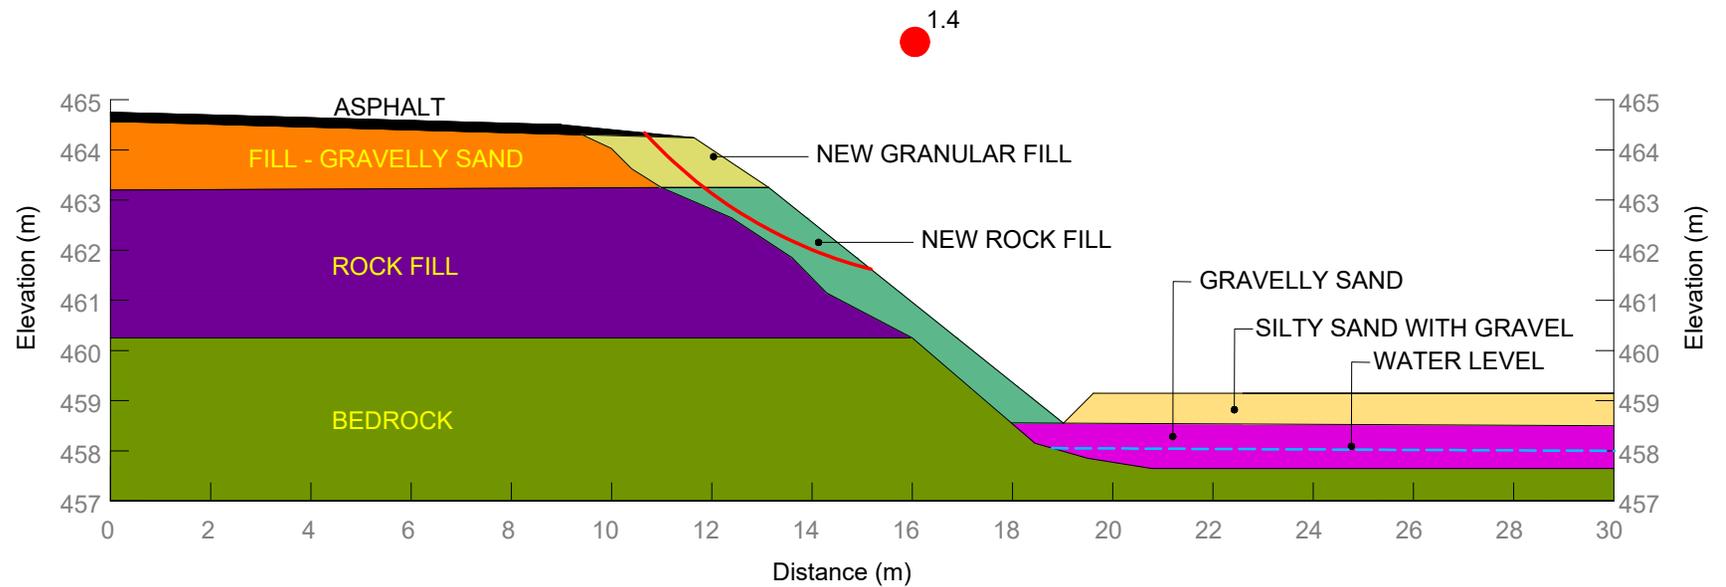
Property	Material	Asphalt	Fill - Gravelly Sand	Rock Fill	Silty Sand With Gravel	Gravelly Sand	Bedrock	New Granular Fill	New Rock Fill
Bulk Unit Weight (kN/m ³)		-	20	19	19	20	-	20	19
Internal Friction Angle (°)		-	32	40	25	32	-	30	40
Undrained Shear Strength, (Cohesion) (kPa)		-	-	-	-	-	-	-	-

Proposed Slope (1.25H:1V) Slope Stability Analysis

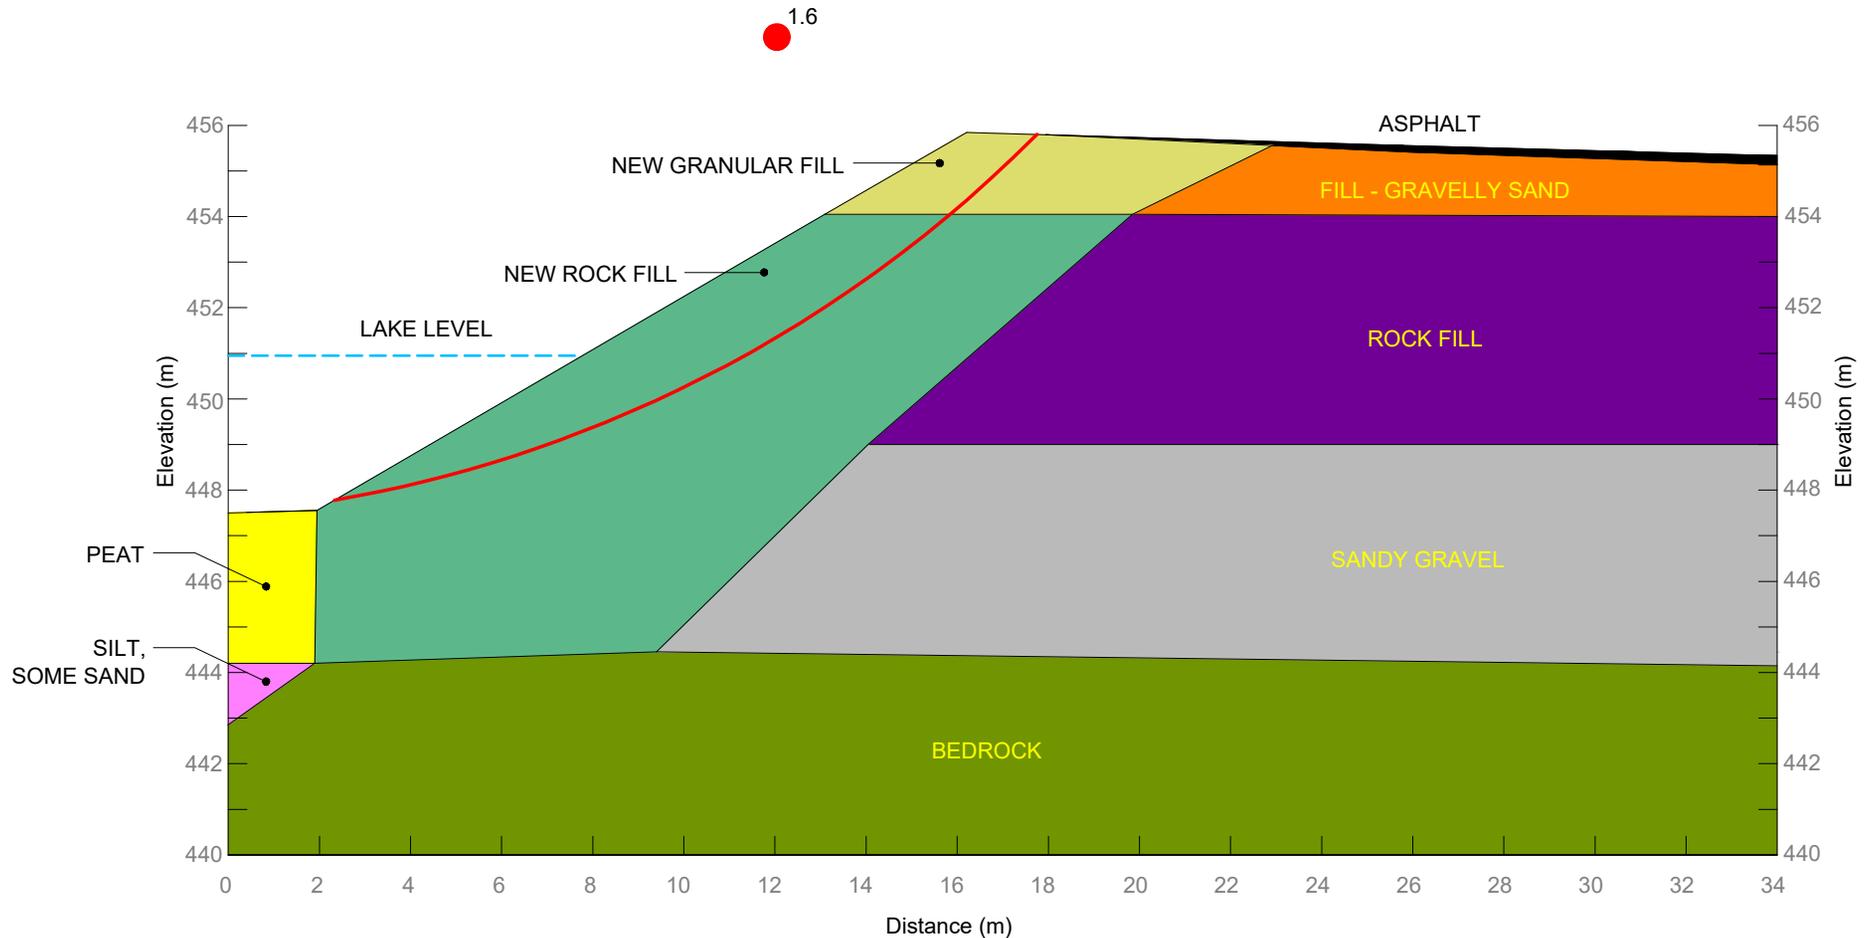
Property \ Material	Asphalt	Fill - Gravelly Sand	Rock Fill	Sandy Gravel	Peat	Silt, Some Sand	Bedrock	New Granular Fill	New Rock Fill
Bulk Unit Weight (kN/m ³)	-	20	19	20	10	19	-	20	19
Internal Friction Angle (°)	-	32	40	35	25	20	-	30	40
Undrained Shear Strength, (Cohesion) (kPa)	-	-	-	-	10	-	-	-	-

Proposed Slope (1.25H:1V) Slope Stability Analysis
