**FINAL  
FOUNDATION INVESTIGATION AND DESIGN REPORT  
WOLFE ISLAND FERRY AND DOCKING IMPROVEMENTS  
NAVIGATIONAL CHANNEL  
COUNTY OF FRONTENAC  
AGREEMENT NO.: 4017-E-0015, ASSIGNMENT 5**

**GEOCRES NO.: 31C-280**

May 2019  
Thurber File No.: 19777

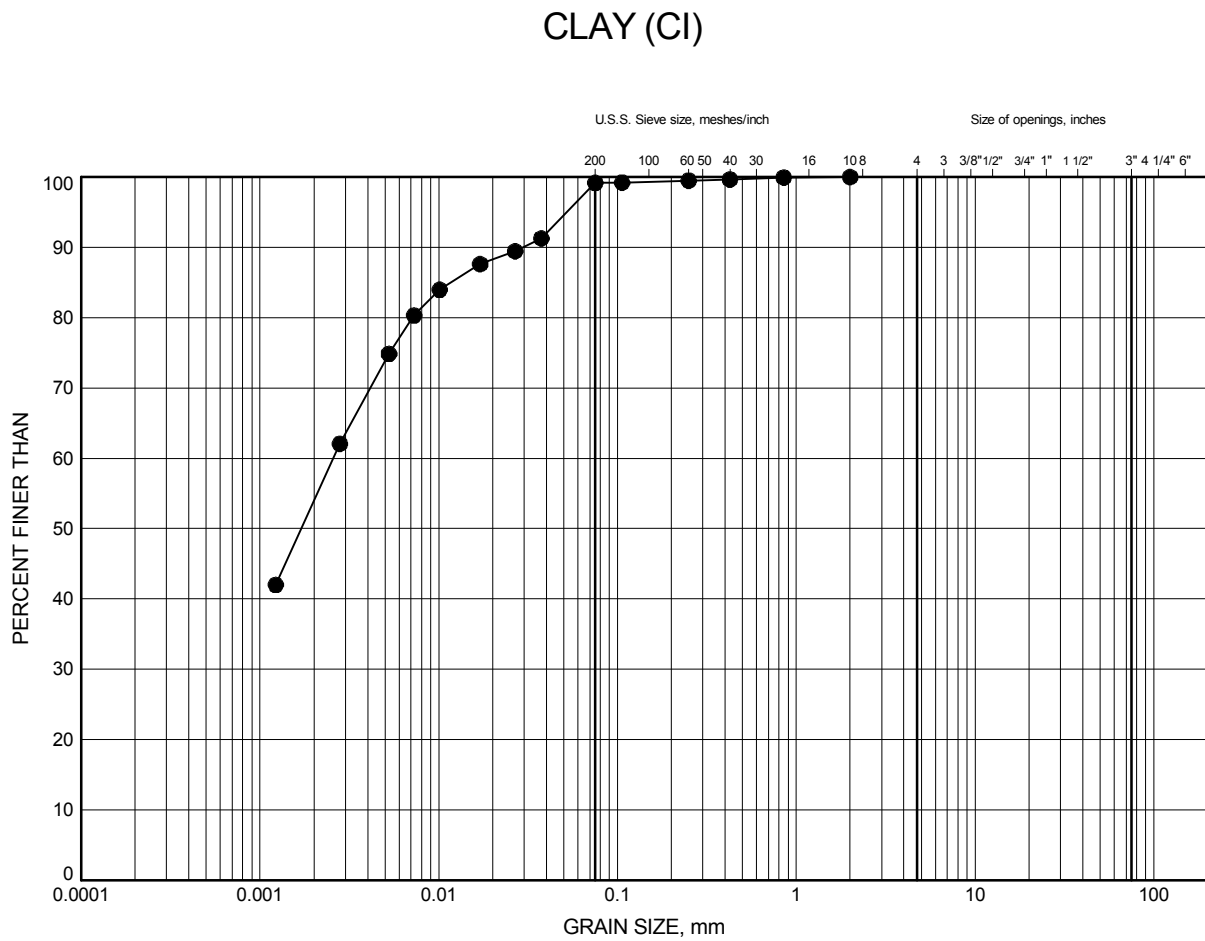
FIGURE C1

# Wofle Island Ferry GRAIN SIZE DISTRIBUTION

Recorded moisture contents ranged from 23 to 36%. Gradation analysis was completed on one sample of the clay. The results are summarized on the Record of Borehole sheet in Appendix B and the grain size distribution curve for this sample is included in Figure C1 of Appendix C. The results of the laboratory tests are summarized as follows:

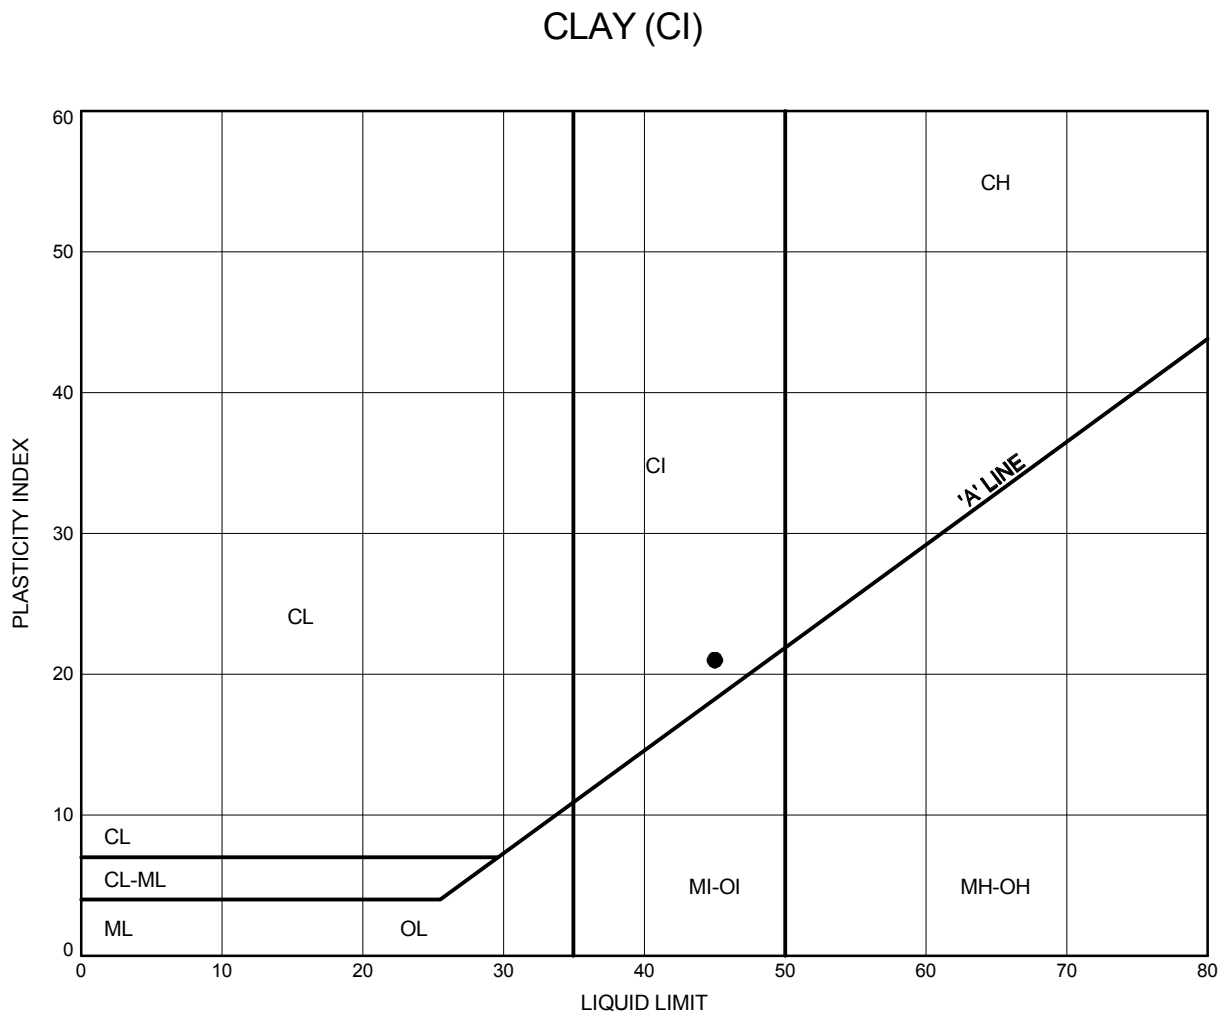
FIGURE C2

Wofle Island Ferry  
**ATTERBERG LIMITS TEST RESULTS**

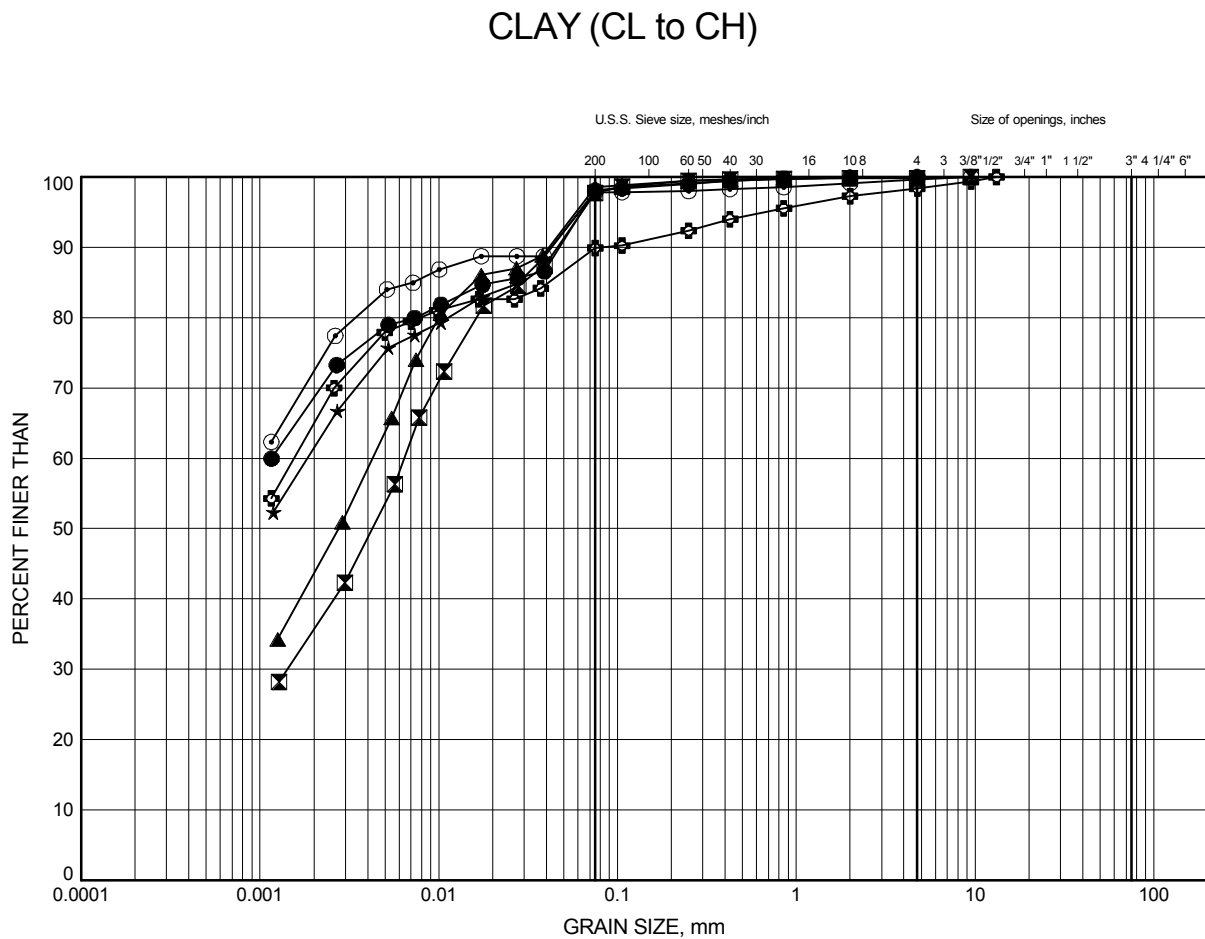
FIGURE C3

## GRAIN SIZE DISTRIBUTION

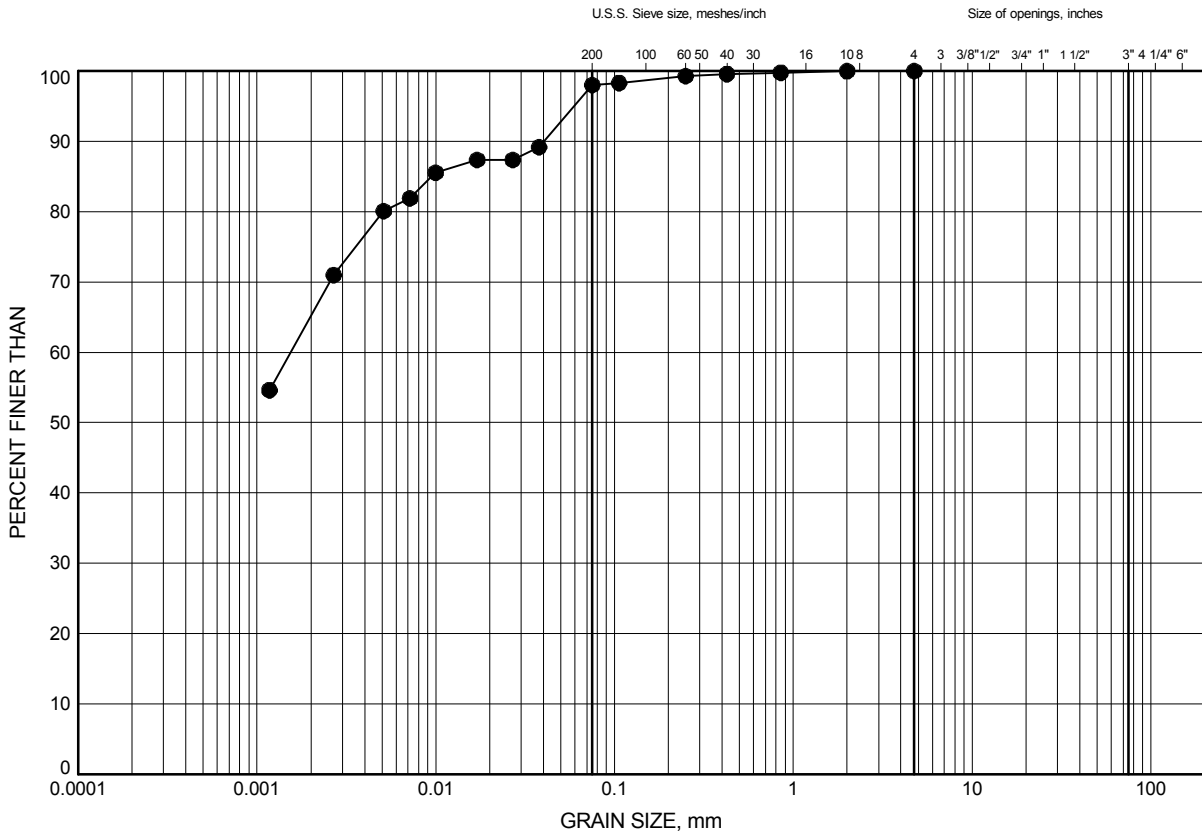
FIGURE C4

CLAY (CL to CH)

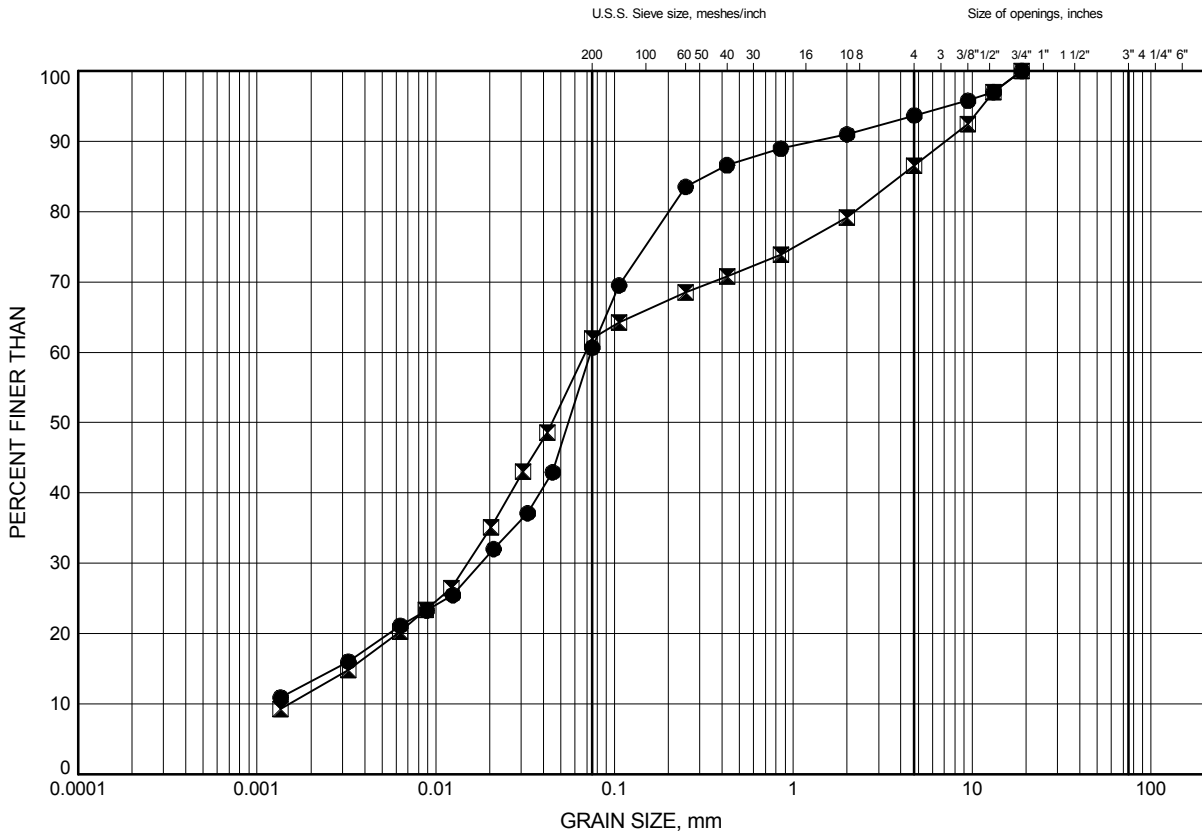
FIGURE C5

### SANDY SILT

SPT tests performed within the sandy silt gave an N-value ranging from 9 to 20 blows indicating loose to compact relative consistency. Recorded moisture contents ranged from 15 to 21%.

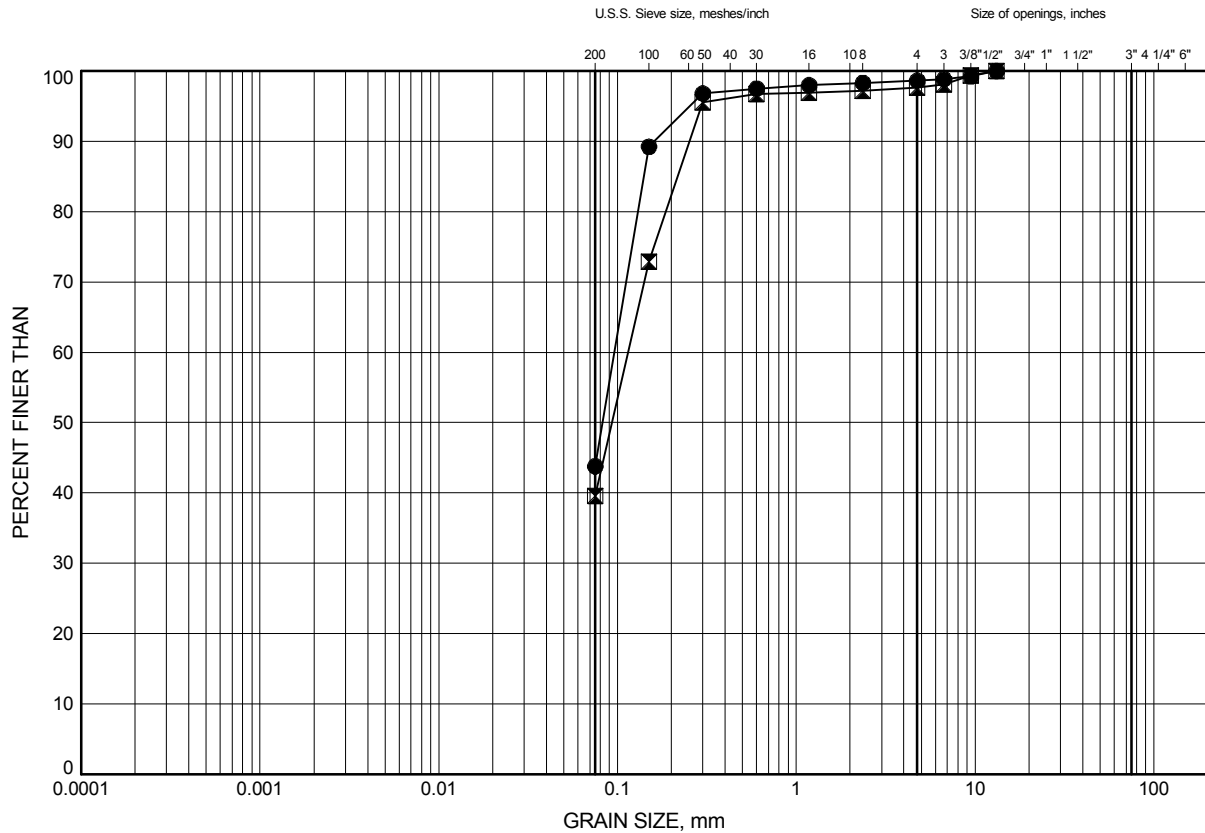
FIGURE C6

### SILTY SAND

SPT tests performed within the silty sand gave N-values ranging from 4 to greater than 100 blows indicating loose to very dense relative density. Recorded moisture contents ranged from 4 to 22%.

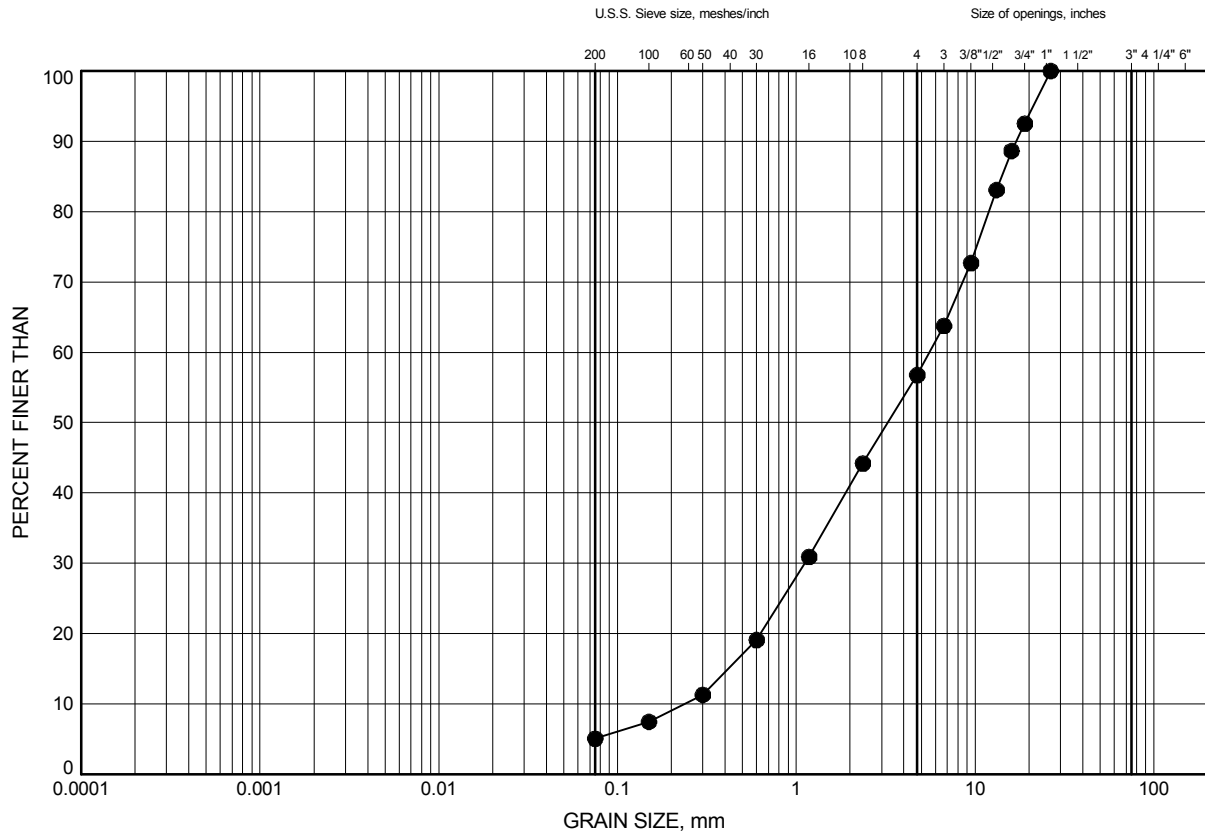
FIGURE C7

**SAND with SILT and GRAVEL**

SPT tests performed within the sand gave N-values ranging from 17 to 33 blows indicating a compact to dense material. Recorded moisture contents ranged from 3 to 13%.

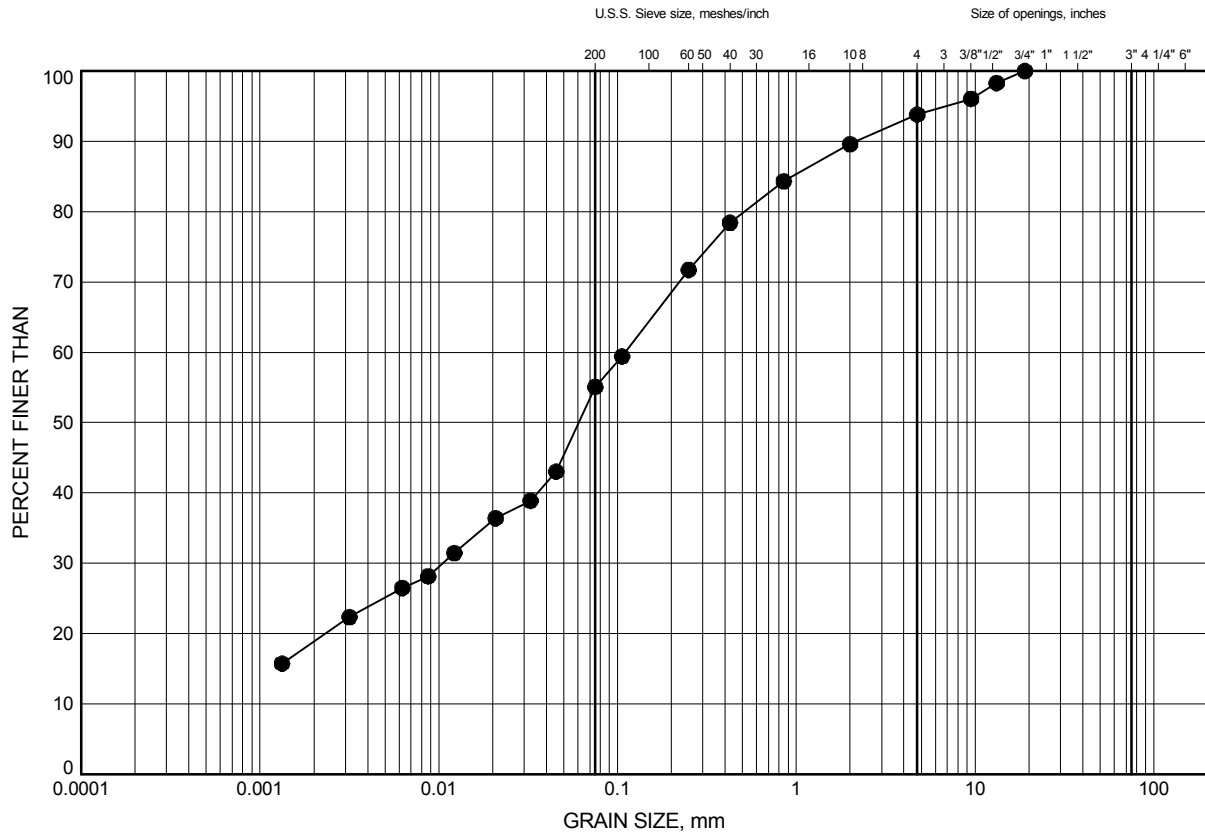
FIGURE C8

CLAY TILL (UPPER)

SPT tests performed within the clay gave N-values ranging from 69 blows per 300 mm of penetration to 100 blows for 200 mm of penetration indicating a very stiff to hard relative consistency. Coring was required to advance through the upper part of till in M17-02. Recorded moisture contents ranged from 7 to 19%.

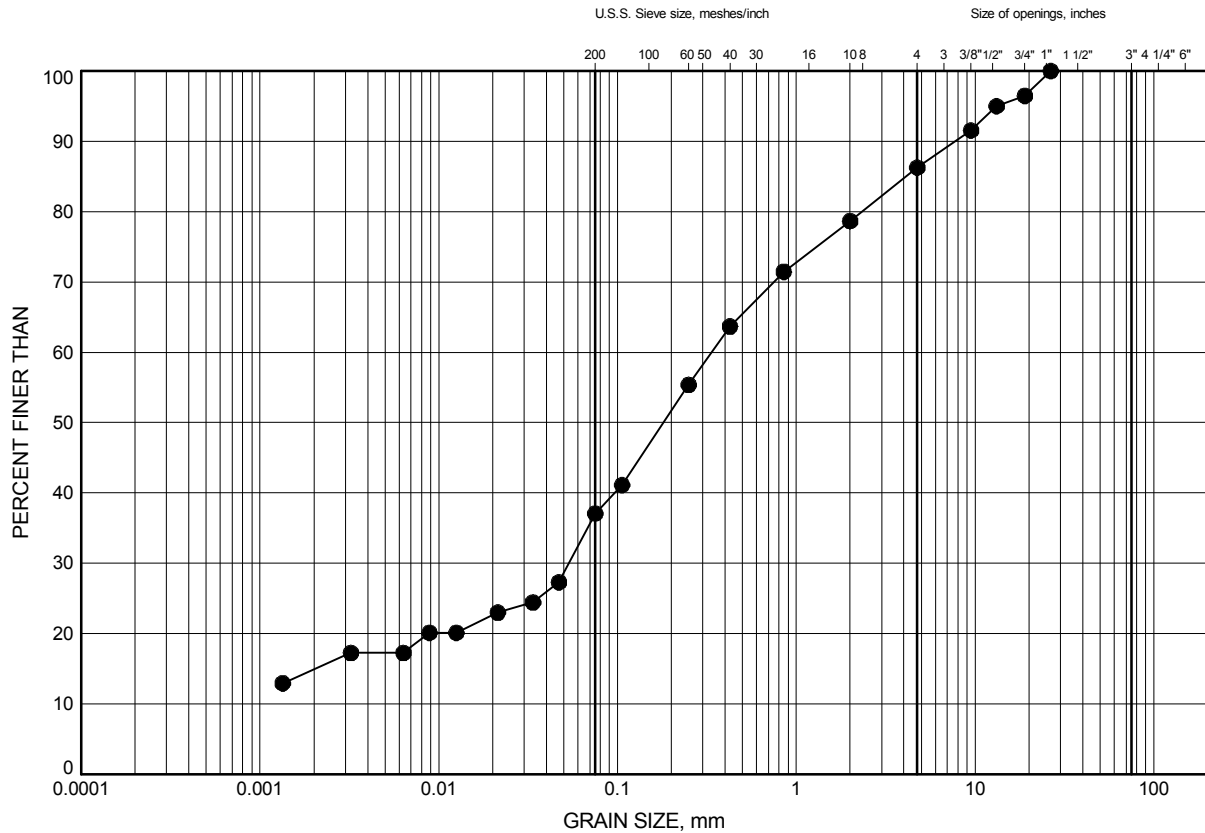
FIGURE C9

SILTY SAND TILL

SPT tests performed within the sand gave N-values ranging from 13 blows per 300 mm of penetration to 100 blows for 250 mm of penetration indicating a loose to very dense relative density. Recorded moisture contents ranged from 8 to 22%.

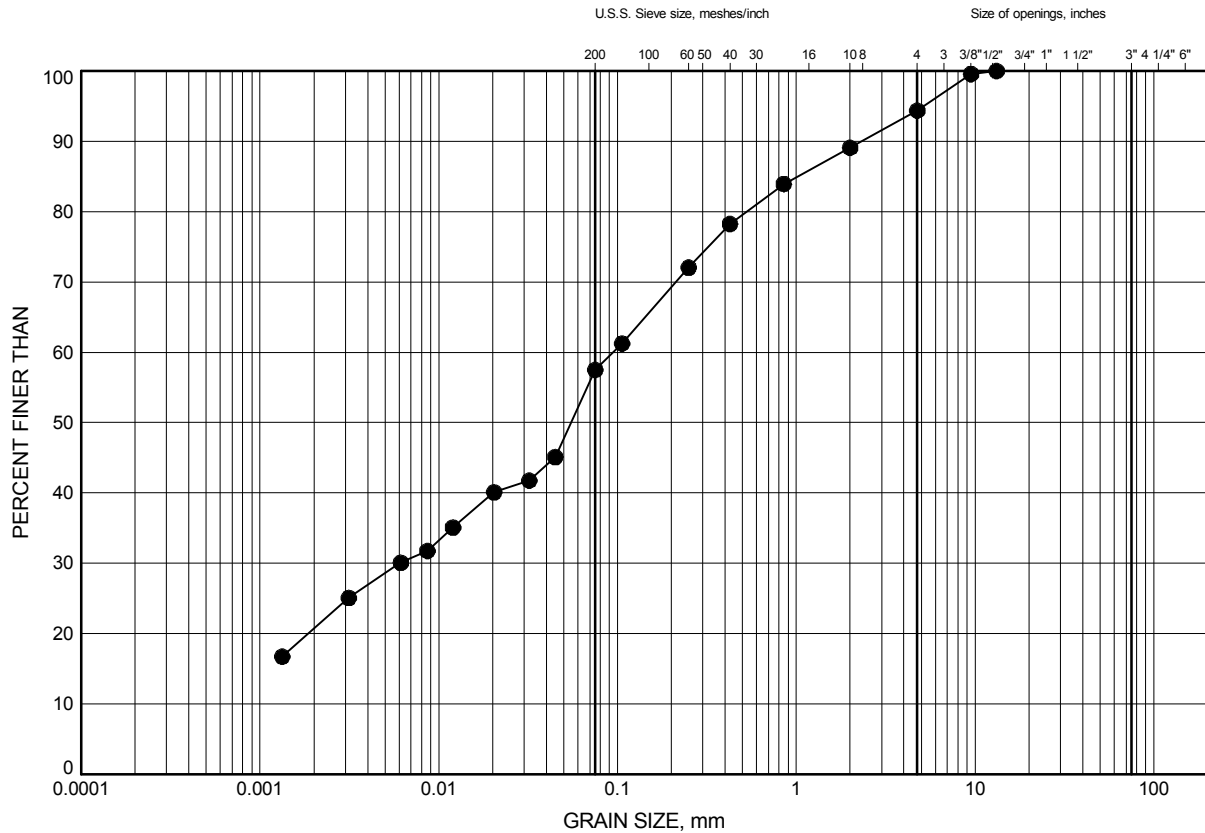
FIGURE C10

### CLAY TILL (LOWER)

A lower layer of sandy clay till with gravel was encountered below the silty sand till in Borehole M17-01. The thickness of this layer was 2.0 m with an underside elevation of 47.2 m. An SPT test performed within the sandy clay gave an N-value of 55 blows indicating a hard material. A moisture content of 13% was recorded.

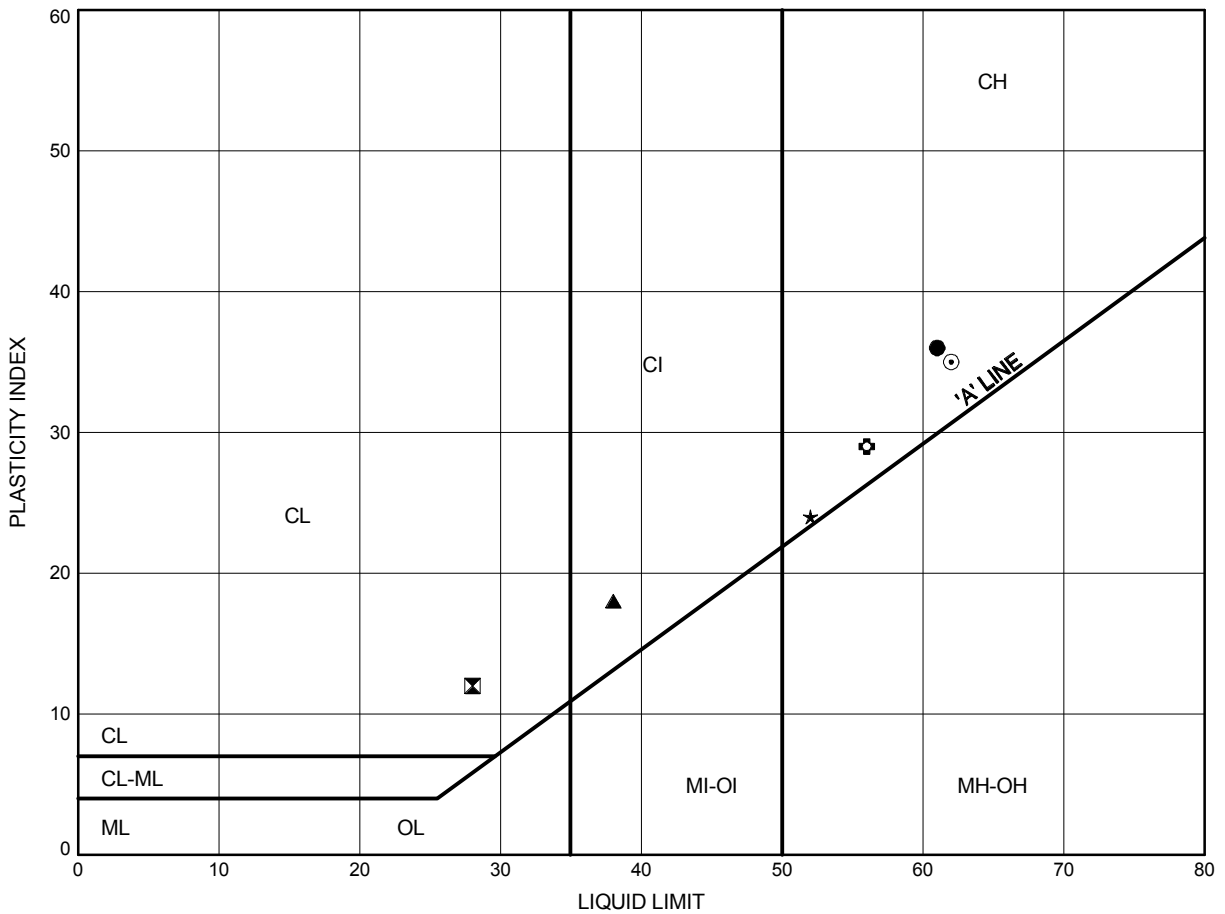
FIGURE C11

CLAY (CL to CH)

SYMBOL	BOREHOLE	DEPTH (m)	ELEV. (m)
●	M17-01	3.1	72.0
⊠	M17-01	6.1	69.0
▲	M17-02	4.7	70.4
★	M18-2	5.3	69.6
⊙	M18-4	6.1	68.8
⊕	M18-6	7.0	67.9

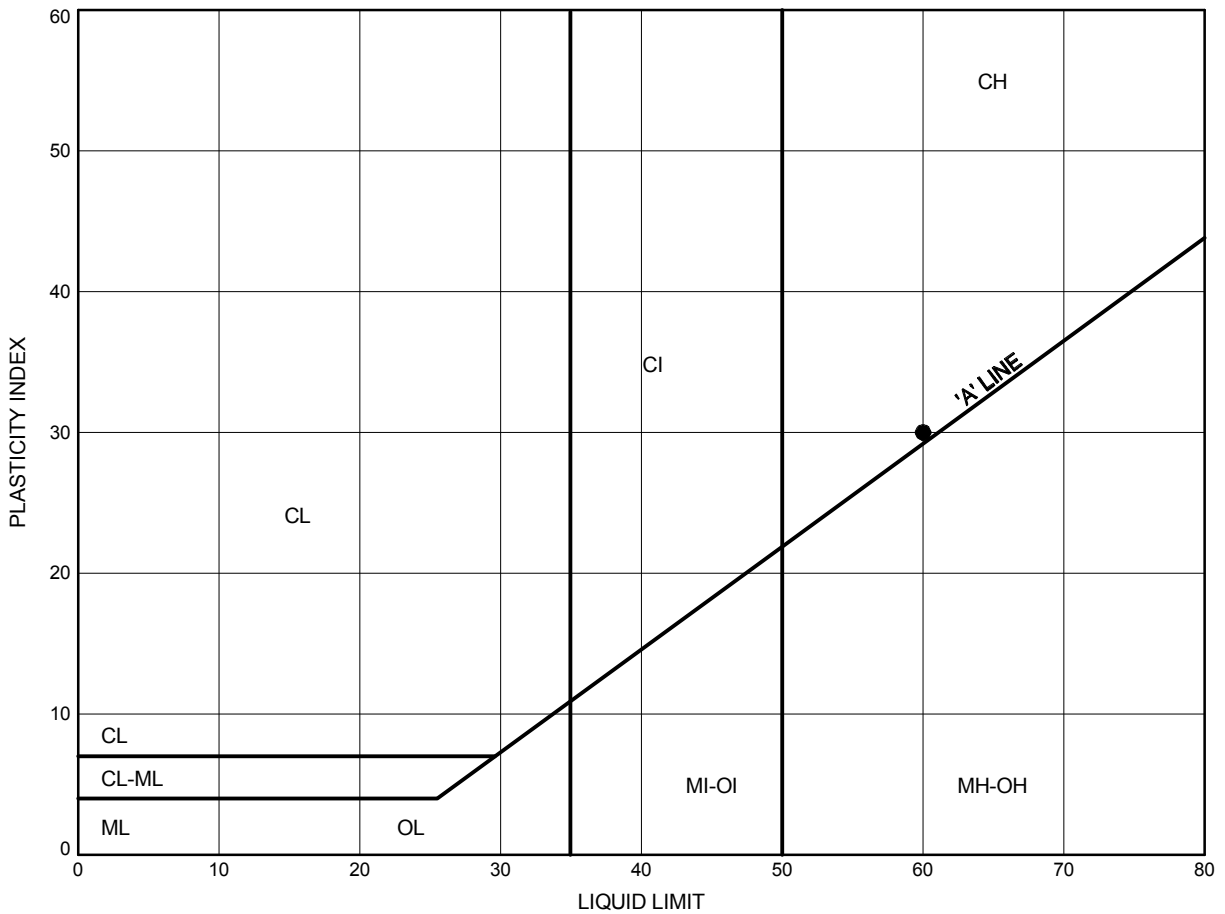
FIGURE C12

CLAY (CL to CH)

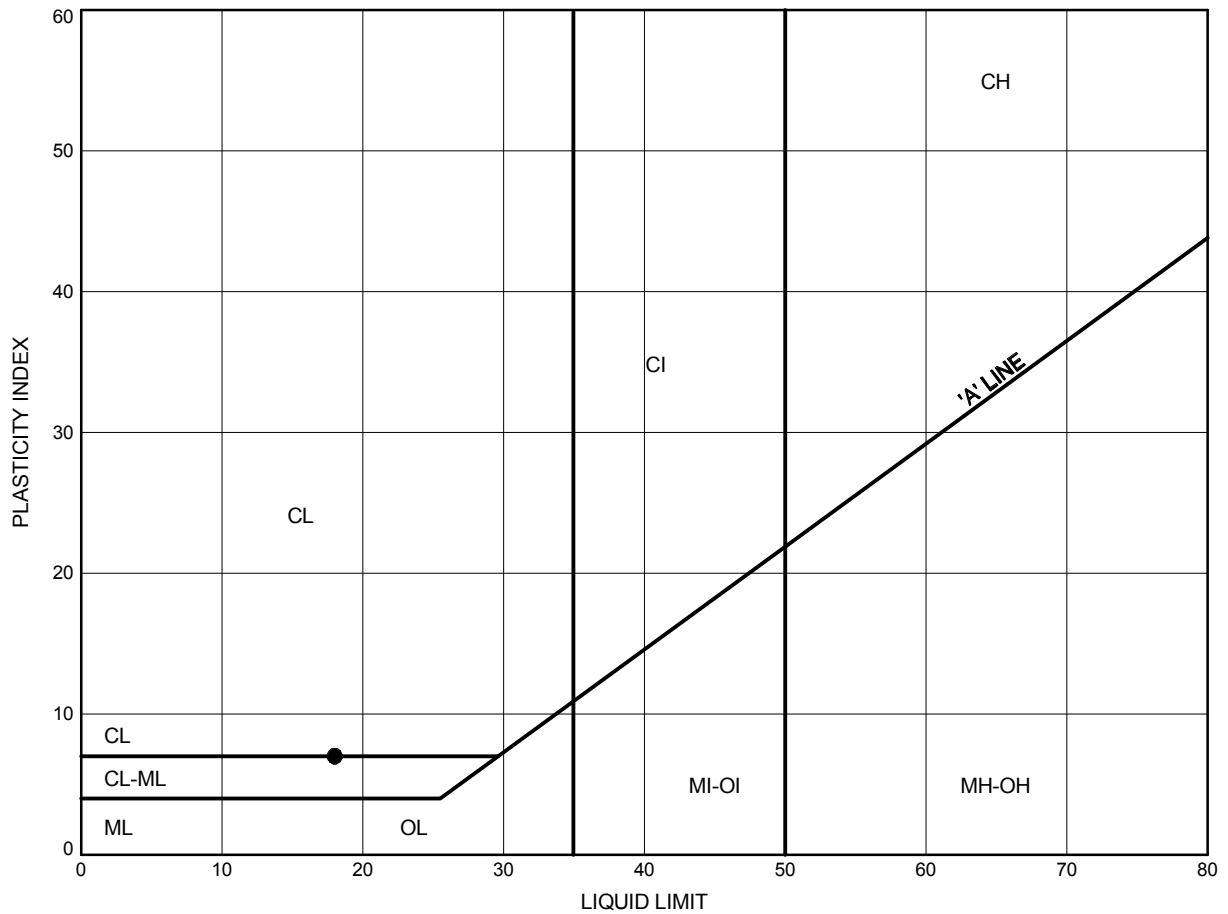
FIGURE C13

**CLAY TILL (UPPER)**

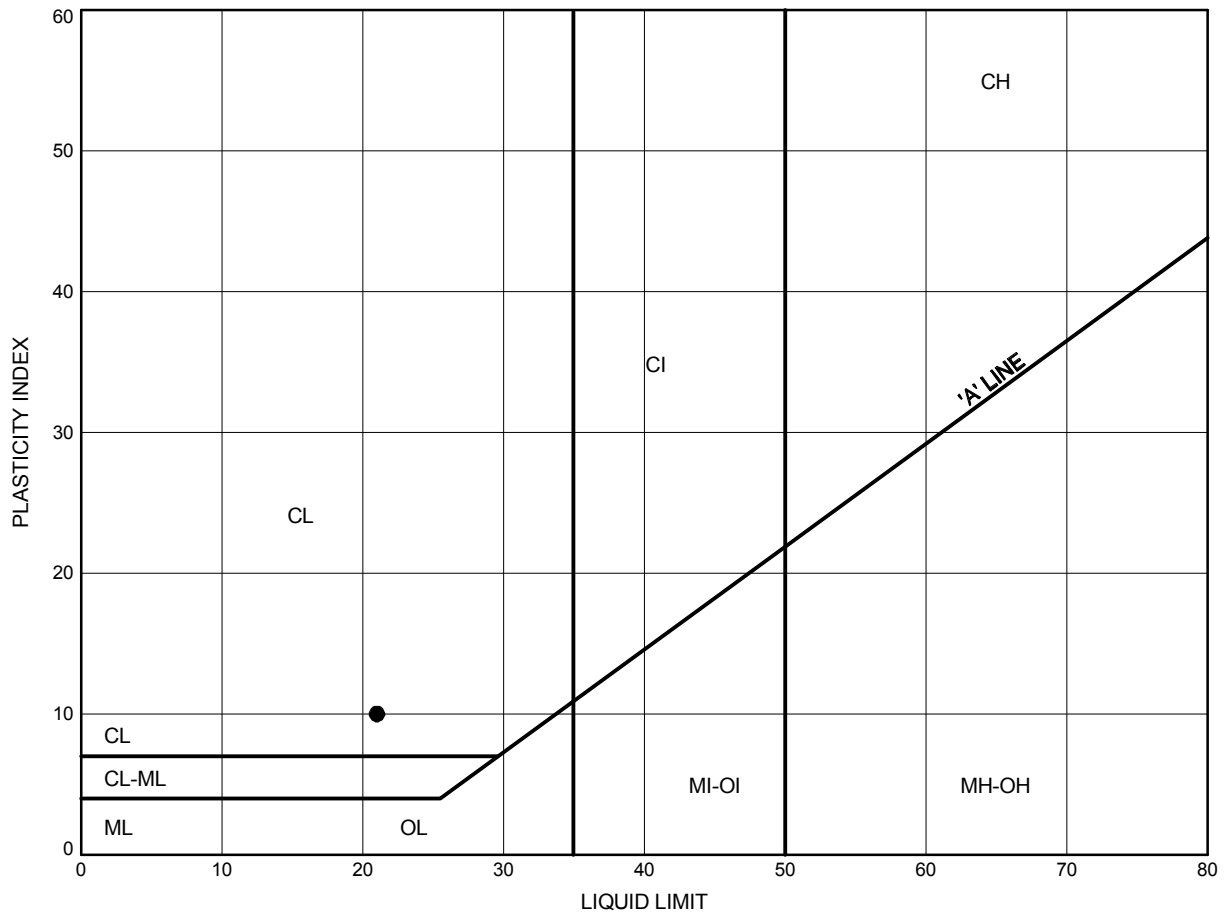
FIGURE C14

**CLAY TILL (LOWER)**

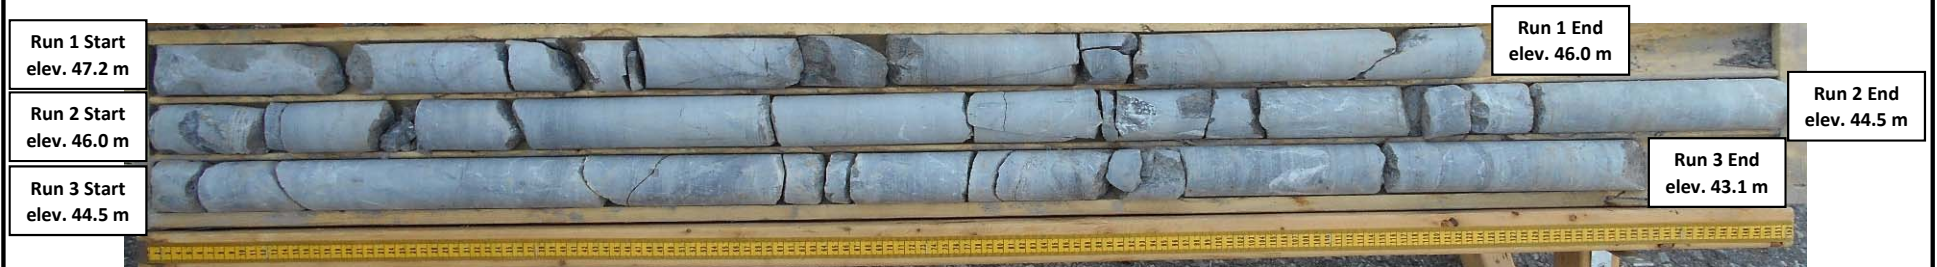
**Borehole M17-01**  
**Run 1 to 3 (of 3)**  
**Elevation 47.2 m to 43.1 m**

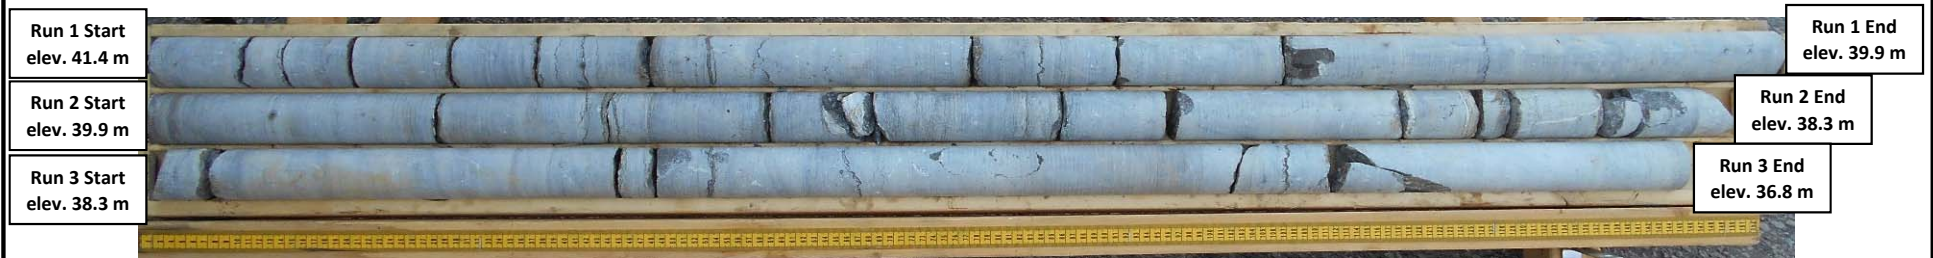
**Borehole M17-02**  
**Run 1 to 3 (of 3)**  
**Elevation 41.4 m to 36.8 m**

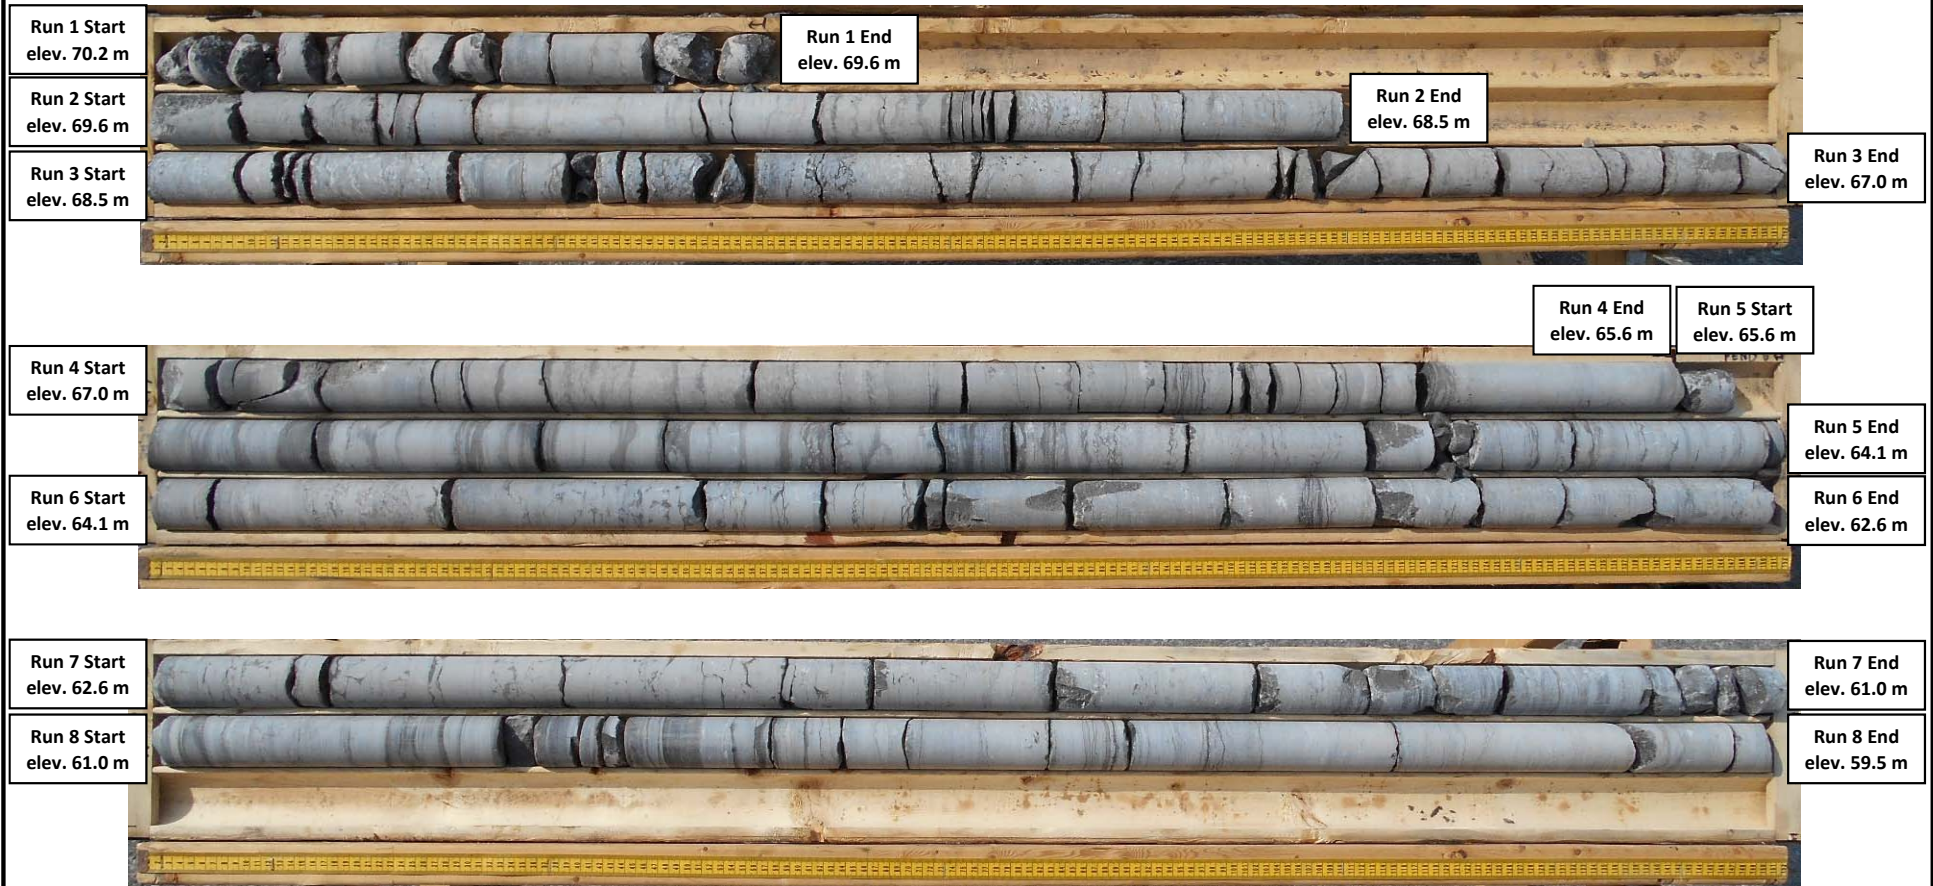
**Borehole M17-03**  
**Run 1 to 8 (of 8)**  
**Elevation 70.2 m to 59.5 m**

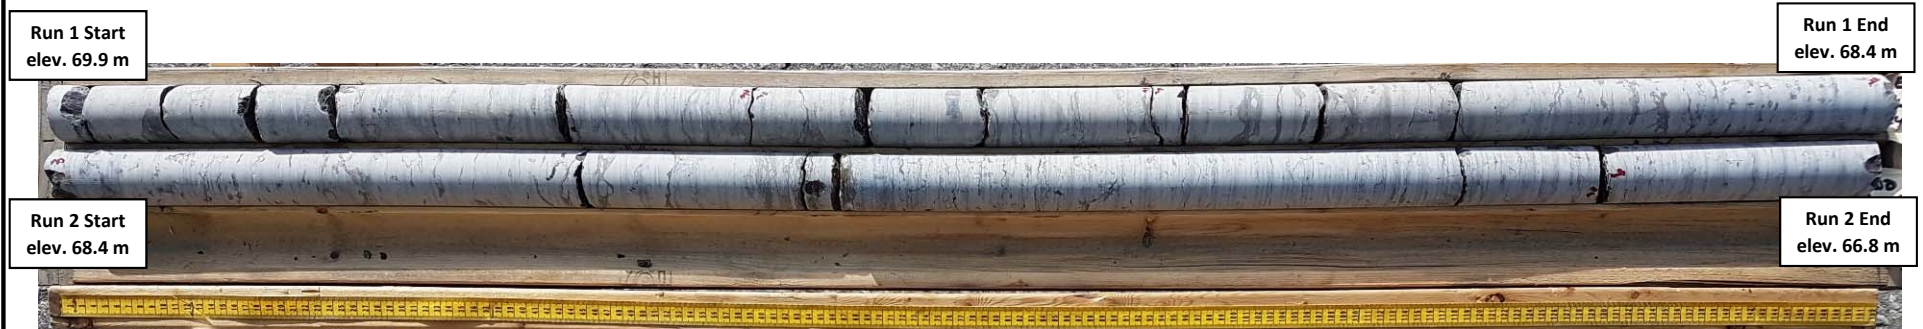
**Borehole M18-01**  
**Run 1 to 2 (of 2)**  
**Elevation 69.9 m to 66.8 m**

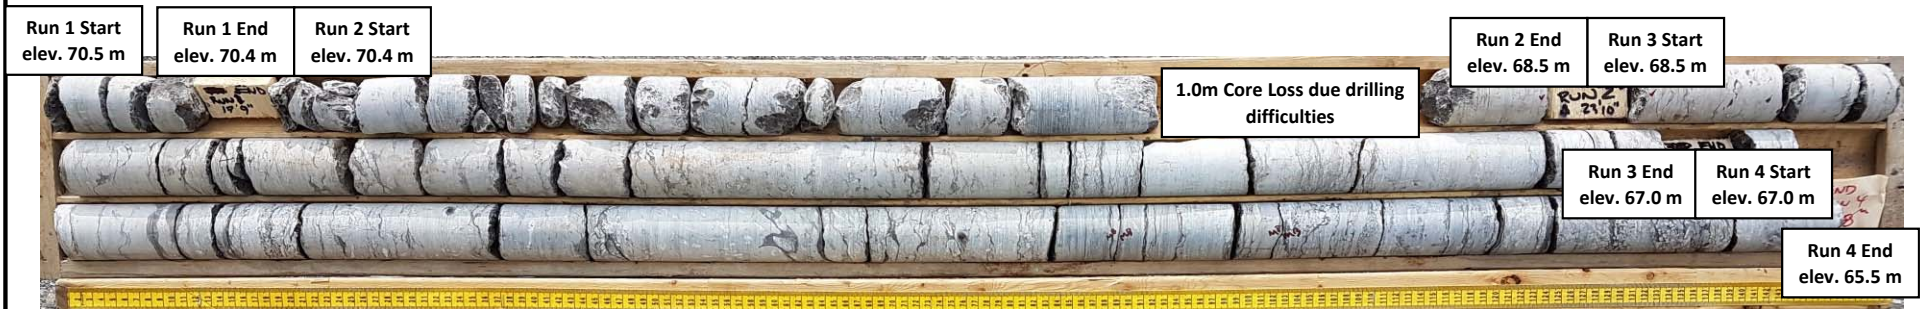
# Borehole M18-03

Run 1 to 4 (of 4)  
Elevation 70.5 m to 65.5 m

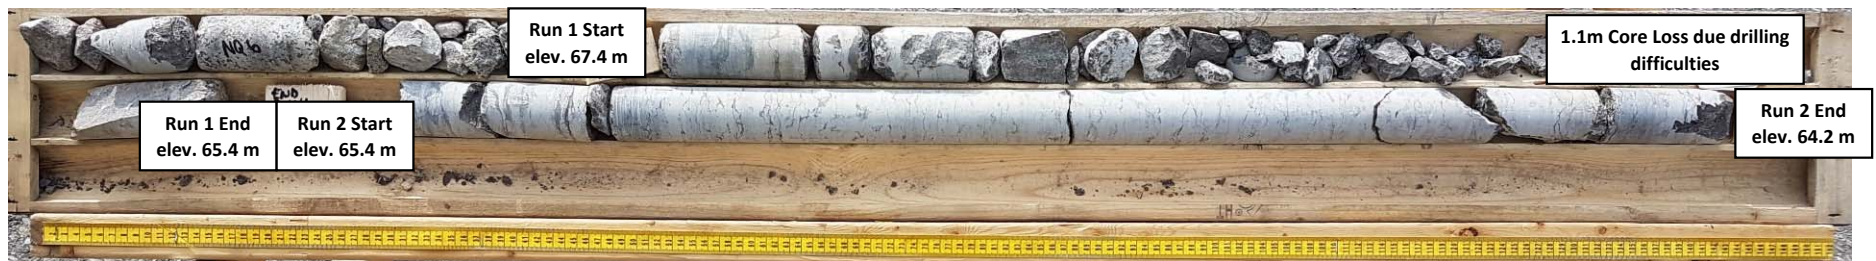
**Borehole M18-05**  
**Run 1 to 2 (of 2)**  
**Elevation 67.4 m to 64.2 m**

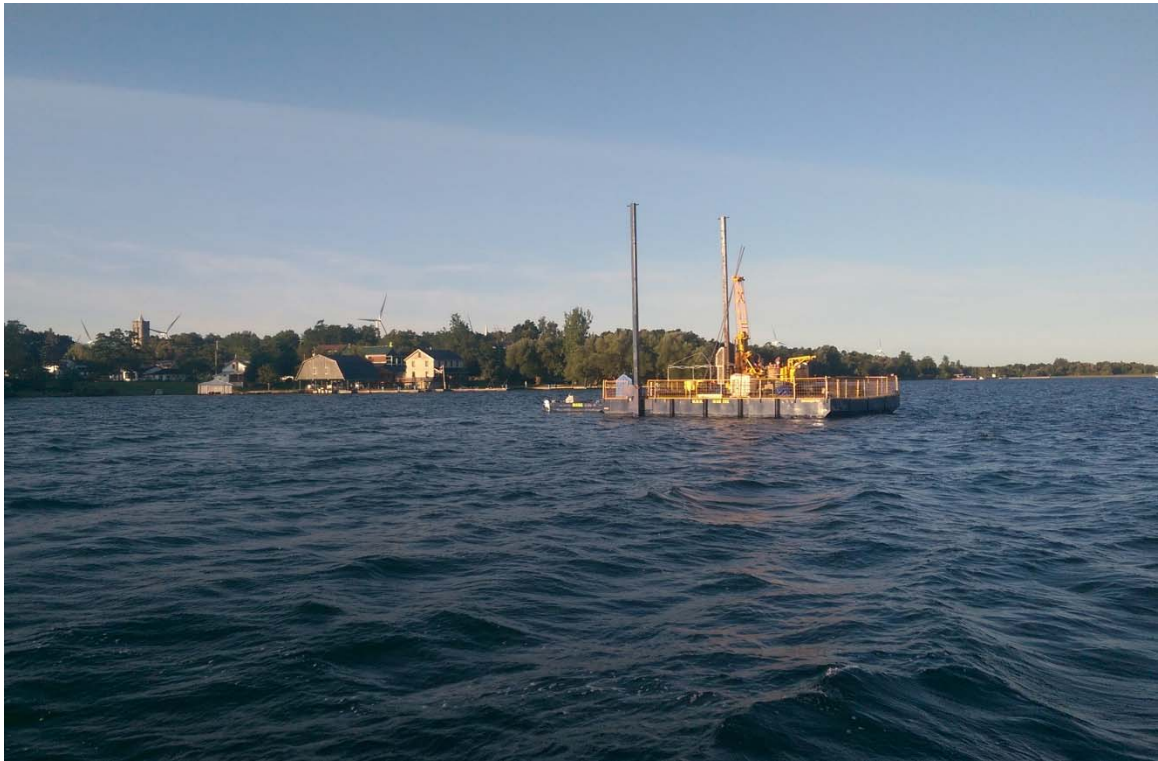
**Photo 3. Barge Setup, Supported with Spuds, Near Marysville Terminal (taken July 2018)**
