**PRELIMINARY FOUNDATION INVESTIGATION AND DESIGN REPORT
HIGHWAY 401 WIDENING, HIGHWAY 16 TO MAITLAND ROAD
HIGHWAY 401W-416N RAMP REHABILITATION, SITE NO. 16X-0306
GWP 4024-20-00 / ASSIGNMENT NO. 4019-E-0010.2**

Geocres No.: 31B-109

March 2023
Thurber File No.: 29381

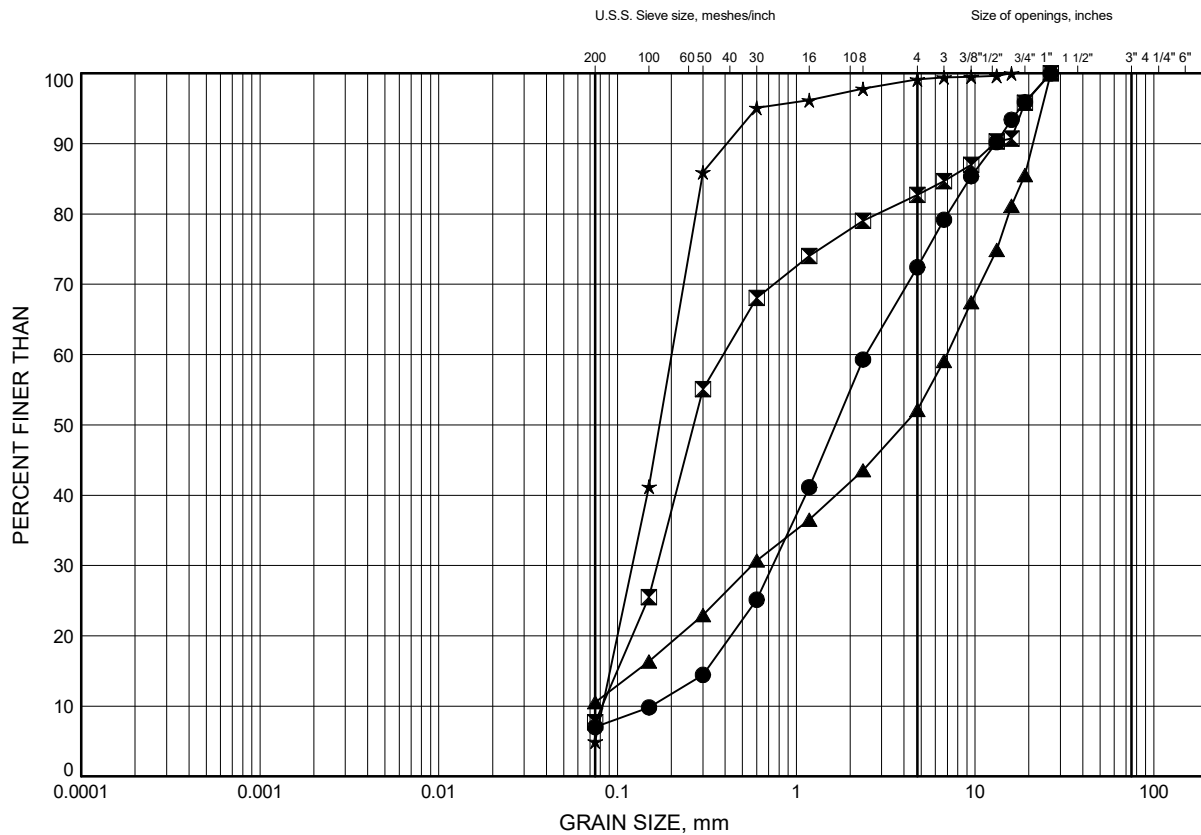
FIGURE C1

EMBANKMENT FILL

The moisture content of the fill samples tested ranged from about 2 to 9%, and one moisture content of 17% in Borehole 306-21-2. The results of grain size analysis testing conducted on four samples of the embankment fill are summarized below and are illustrated on Figure C1 in Appendix C.1.

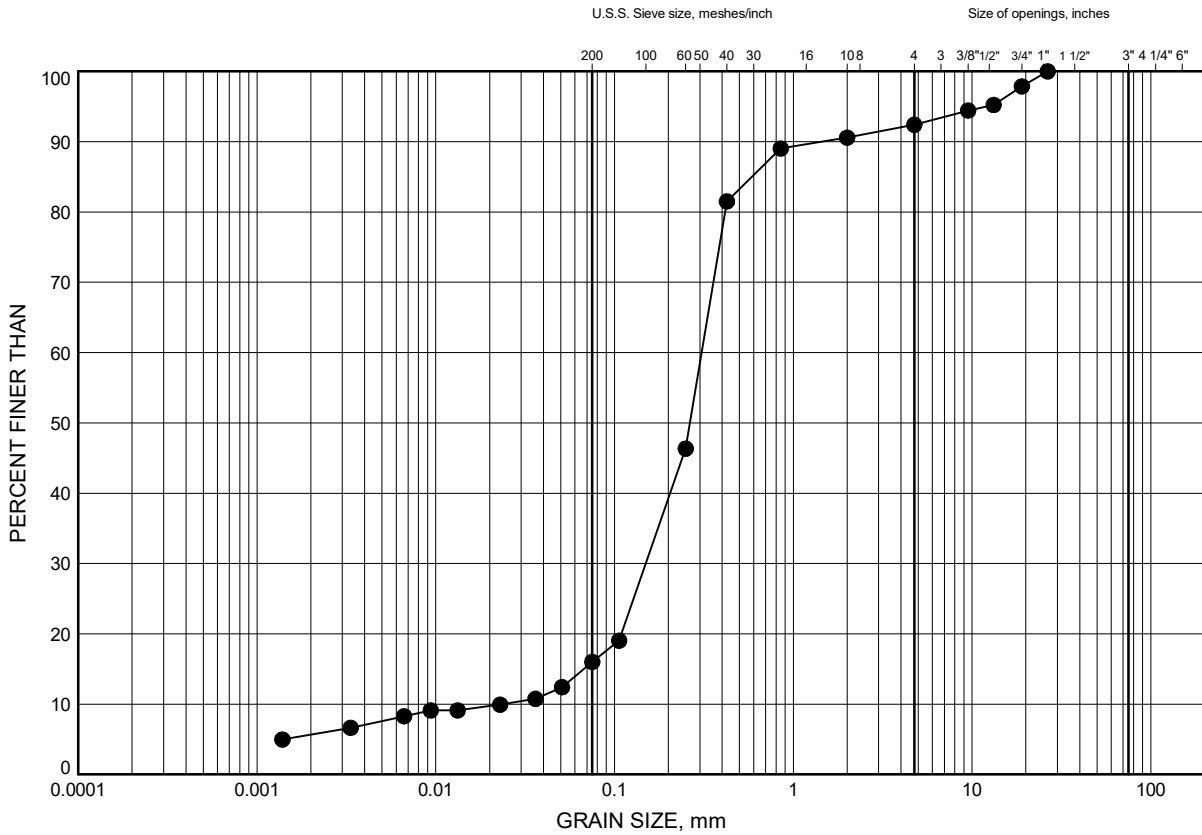
FIGURE C2

SAND

The moisture content of one sample tested was 23%. The results of a grain size analysis test conducted on a sample of this material obtained in Borehole 306-21-1 is summarized below and is illustrated on Figure C2 in Appendix C.1.

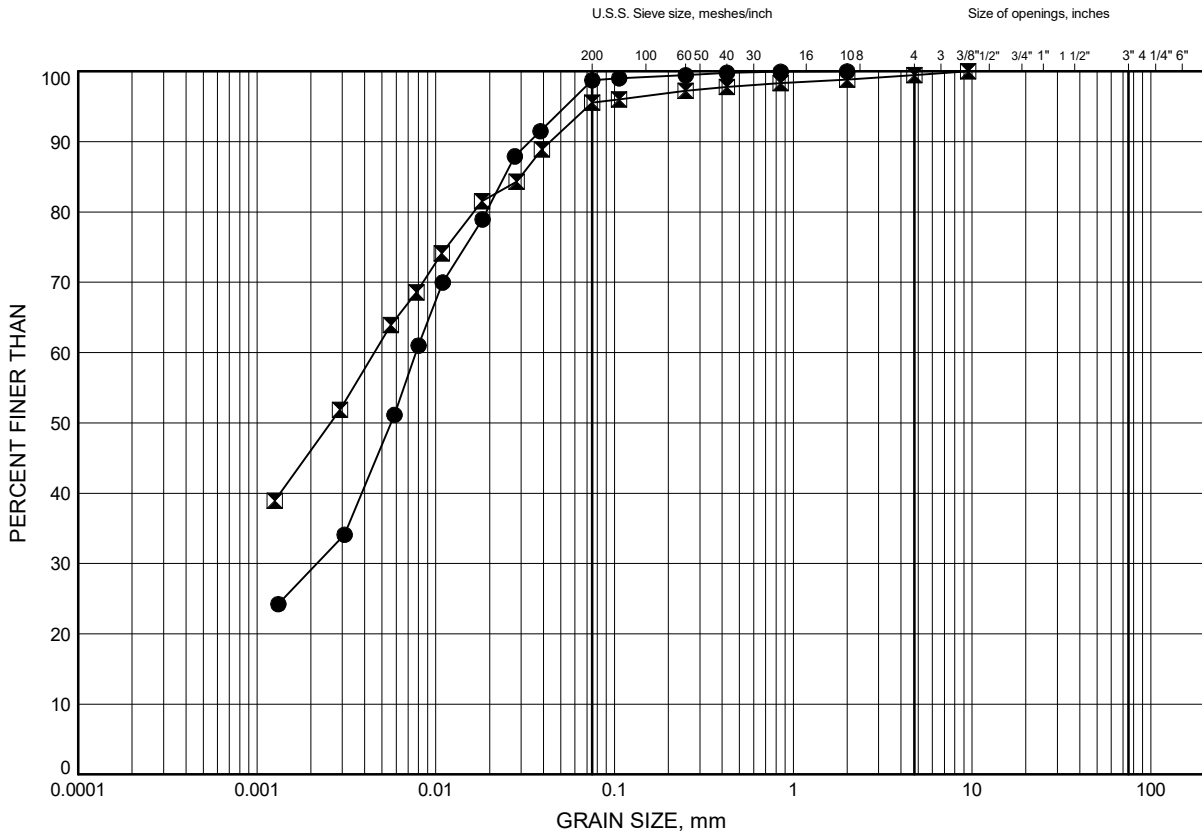
GRAIN SIZE DISTRIBUTION

CLAYEY SILT TO SILTY CLAY

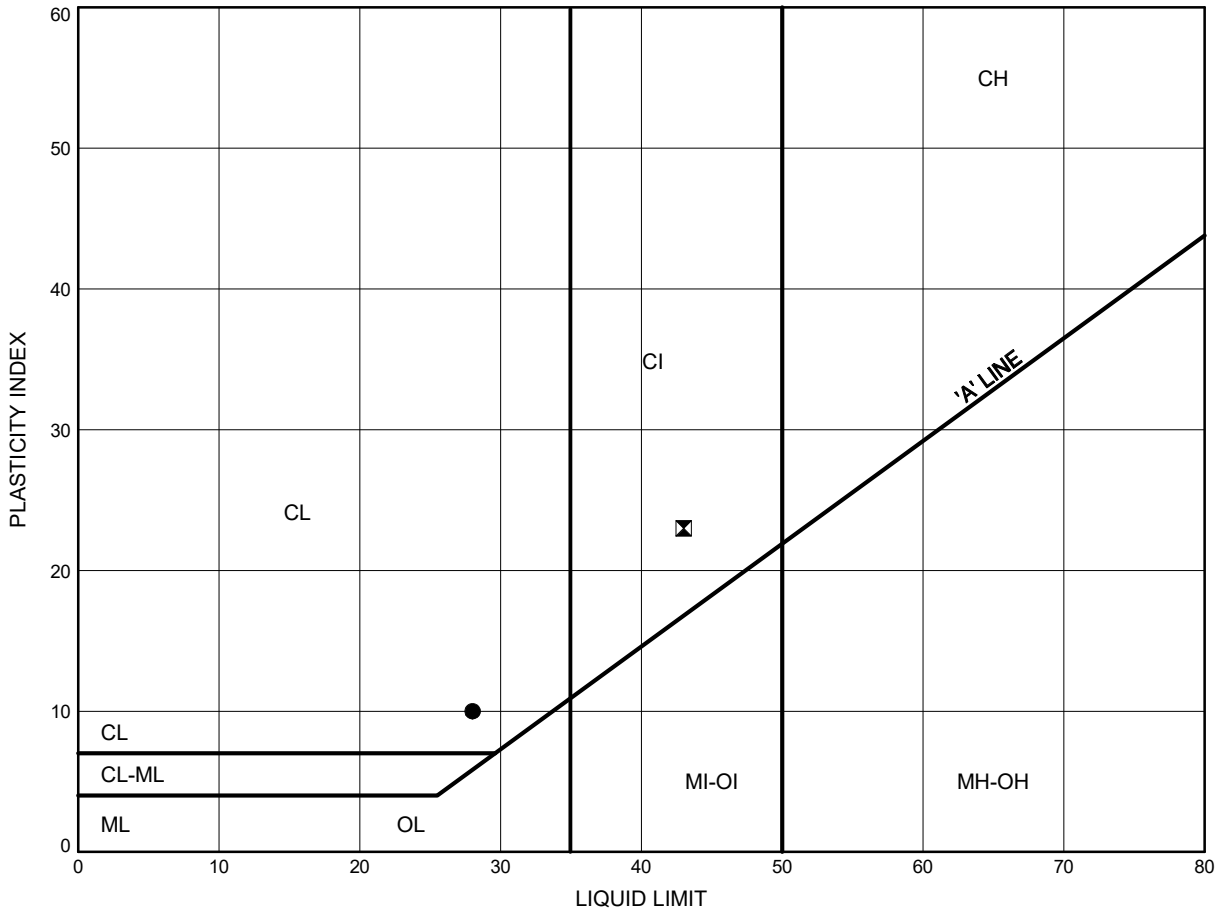
FIGURE C4

CLAYEY SILT TO SILTY CLAY

SYMBOL	BOREHOLE	DEPTH (m)	ELEV. (m)
●	306-21-1	12.5	82.3
⊠	306-21-2	9.4	86.0

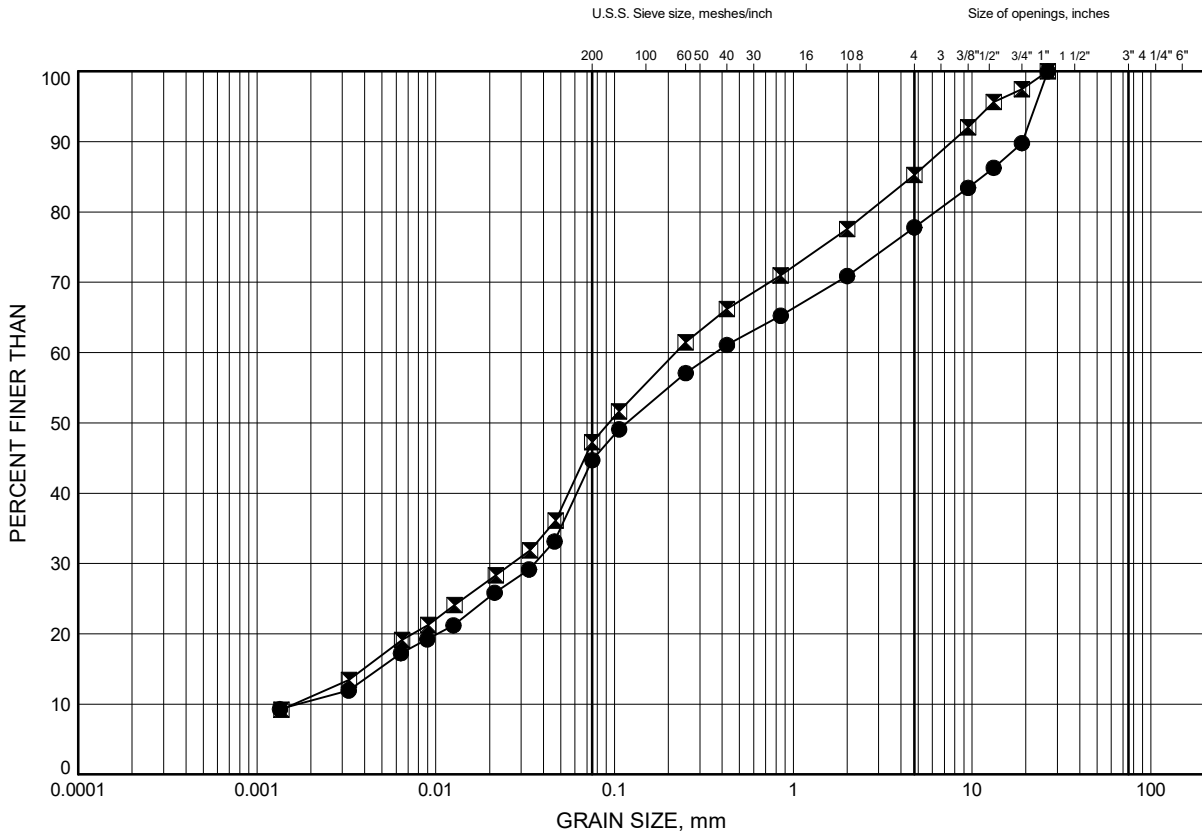
GRAIN SIZE DISTRIBUTION

GLACIAL TILL

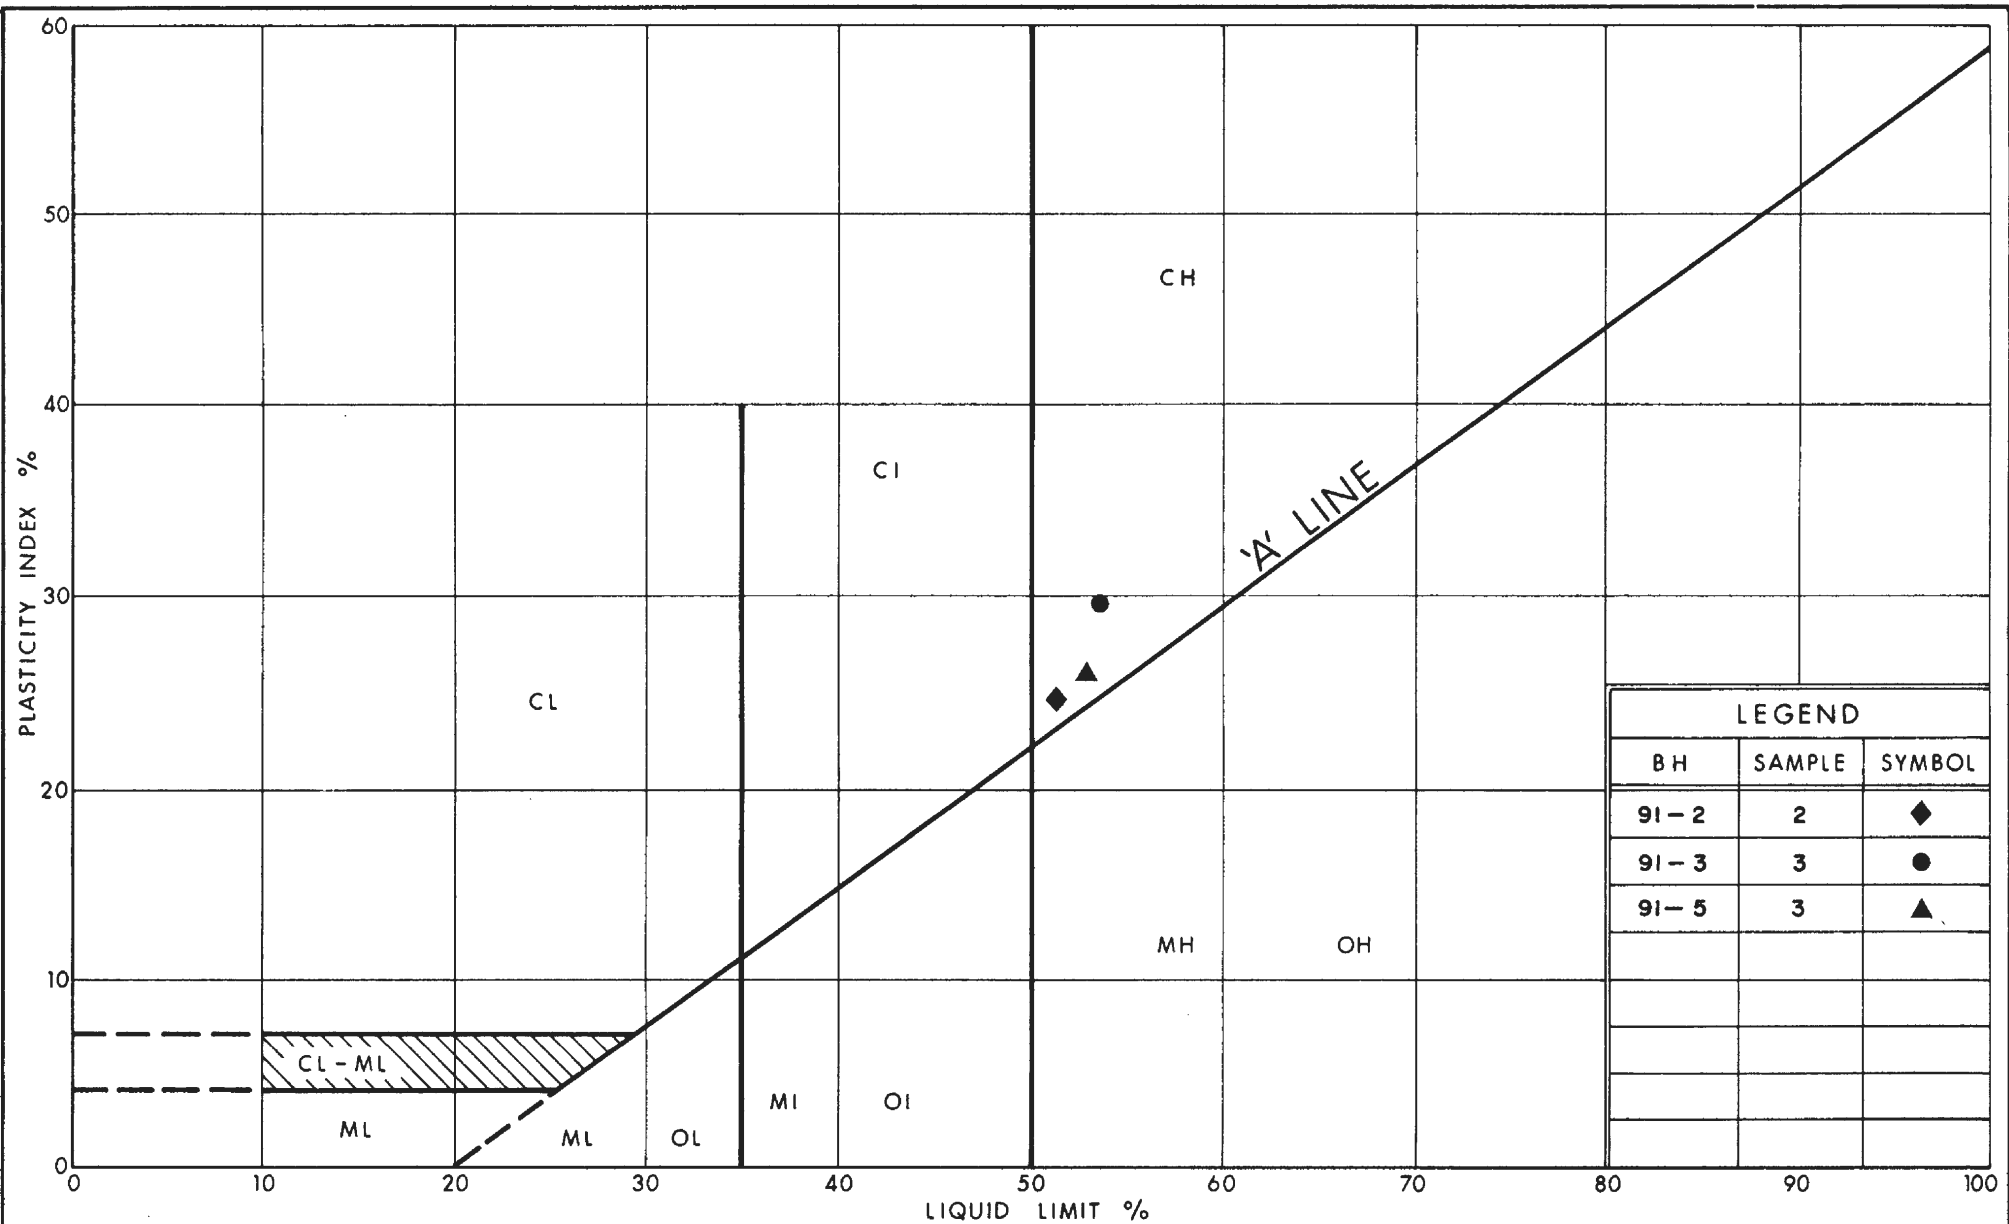
PLASTICITY CHART CLAY

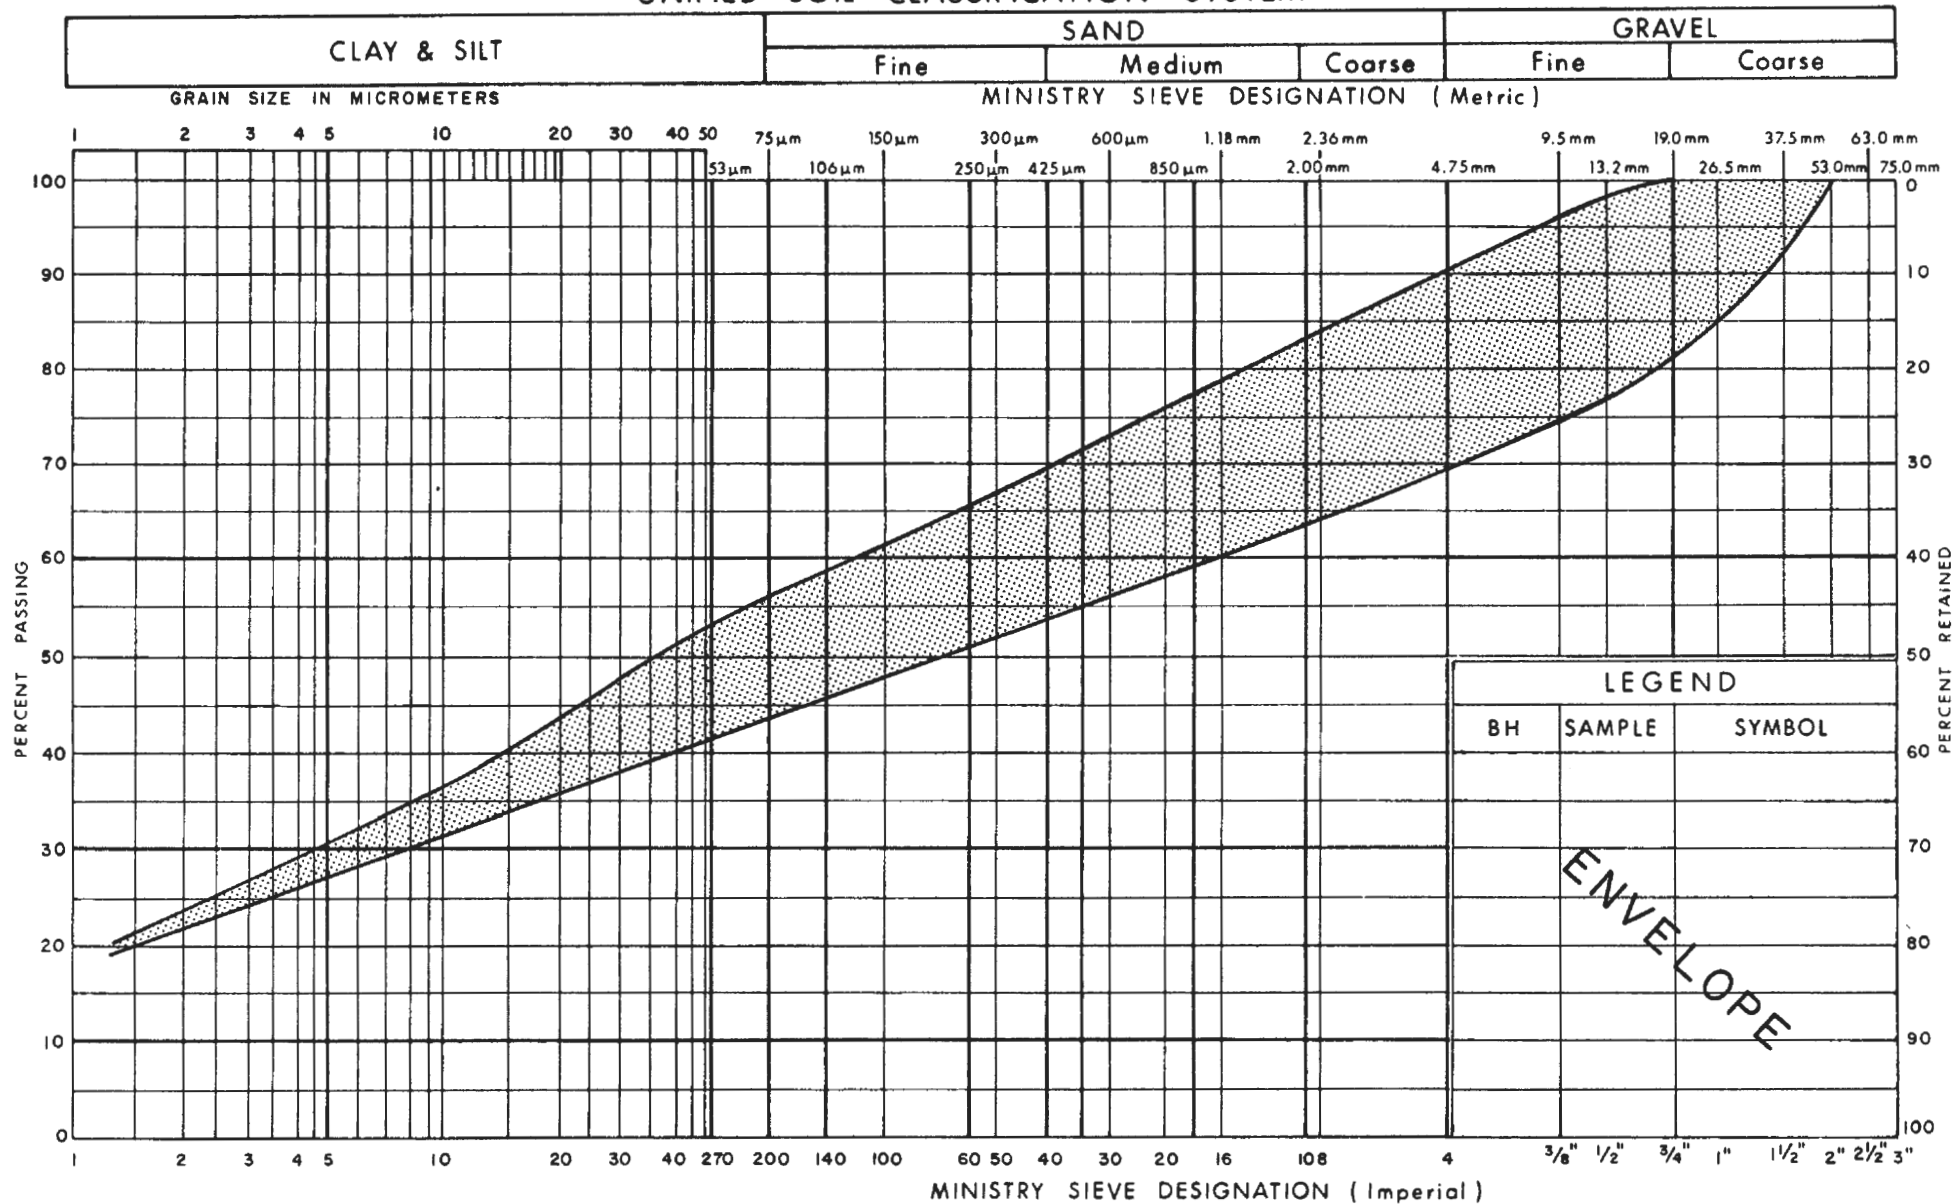
FIG No 3

GRAIN SIZE DISTRIBUTION
HET MIXTURE OF SILTY SAND,
SOME CLAY & GRAVEL, OCCASIONAL BOULDERS (Glacial Till)

The moisture content of samples obtained from this unit ranged from 7 to 14%. The results of grain size distribution testing carried out on six samples of the till from the 1991 and 2021 investigations are summarized in the table above. The results from the 2021 investigation are illustrated on Figure C5 in Appendix C.1 and an envelope summarizing the results from the 1991 investigation is illustrated on Figure 3 in Appendix C.2.

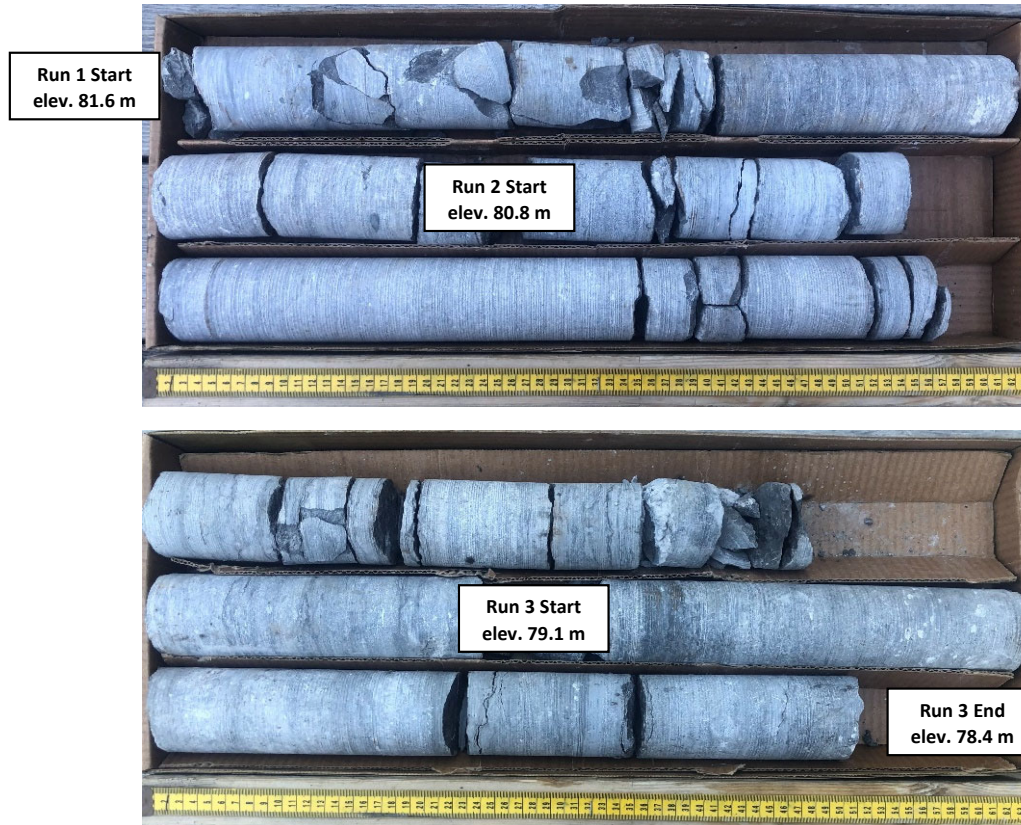
Borehole 306-21-1
Run 1 to 3 (of 3)
Elevation 81.6 m to 78.4 m
Dry

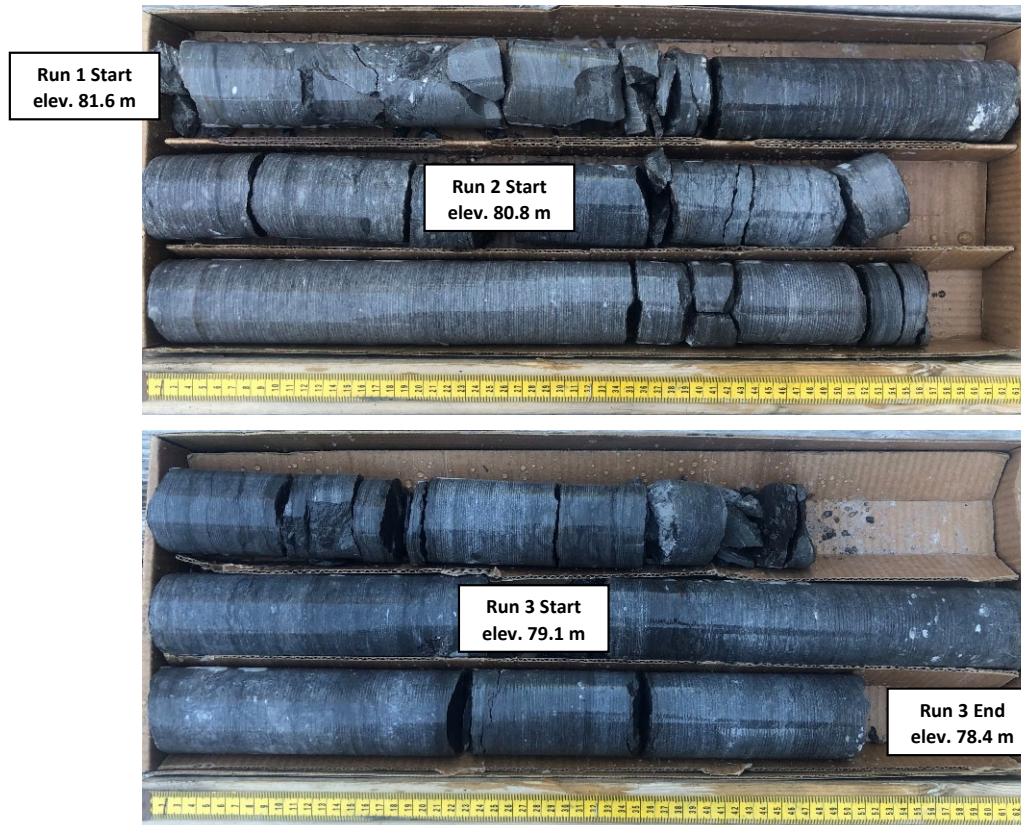
Borehole 306-21-1
Run 1 to 3 (of 3)
Elevation 81.6 m to 78.4 m
Wet

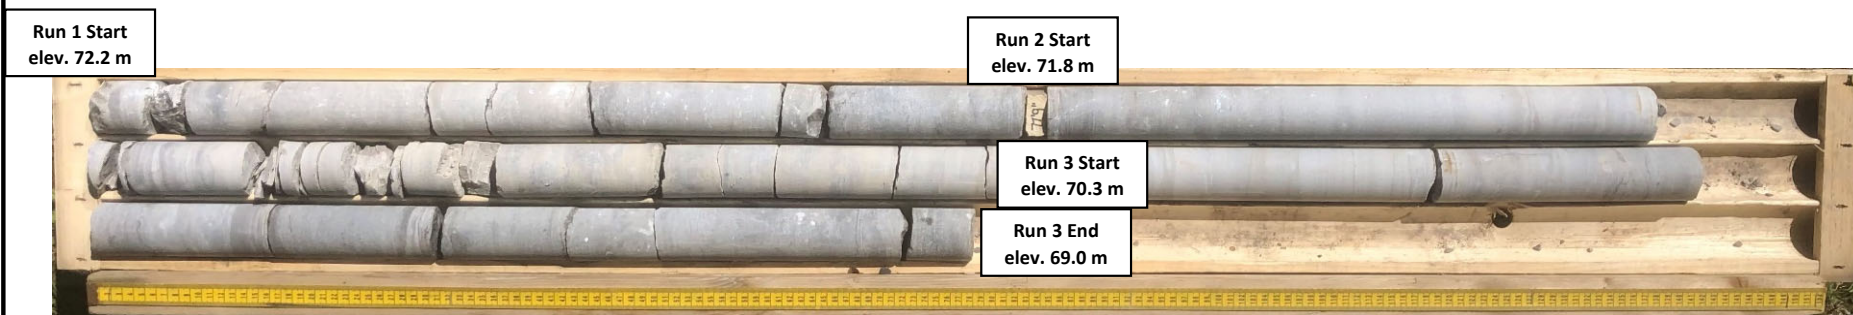
Borehole 306-21-2
Run 1 to 3 (of 3)
Elevation 72.6 m to 69.0 m
Dry

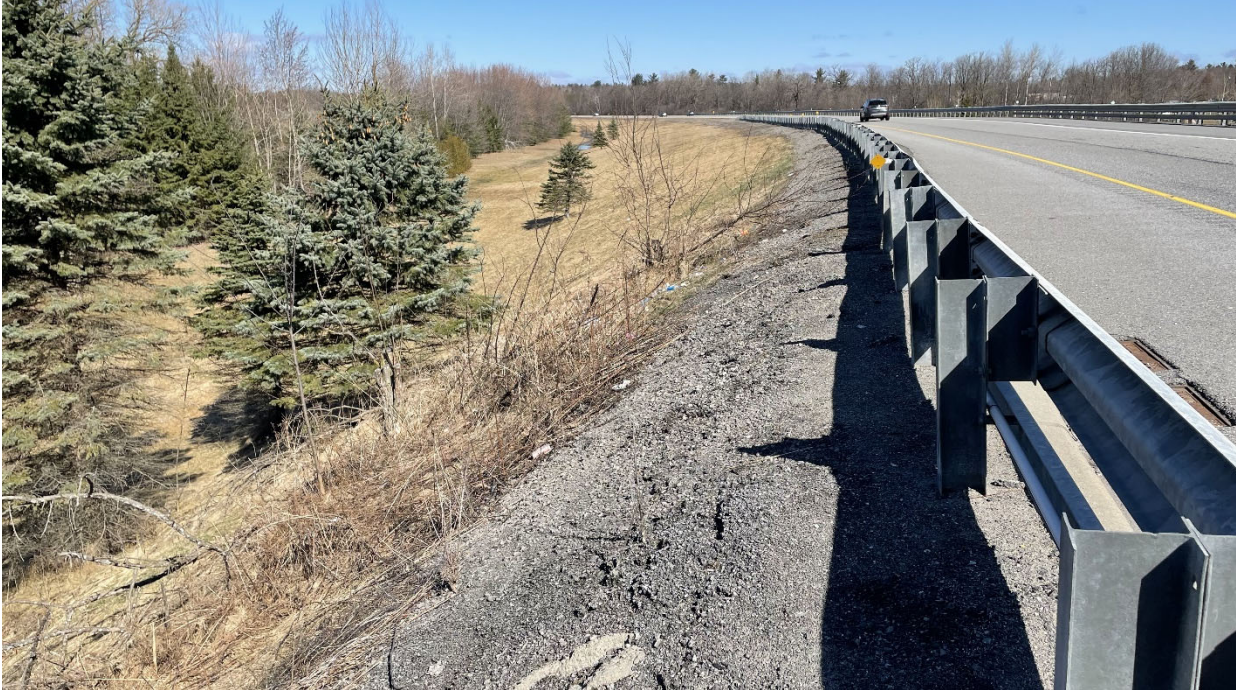
Photo 1. Looking north at northwest embankment (2021/03/29)

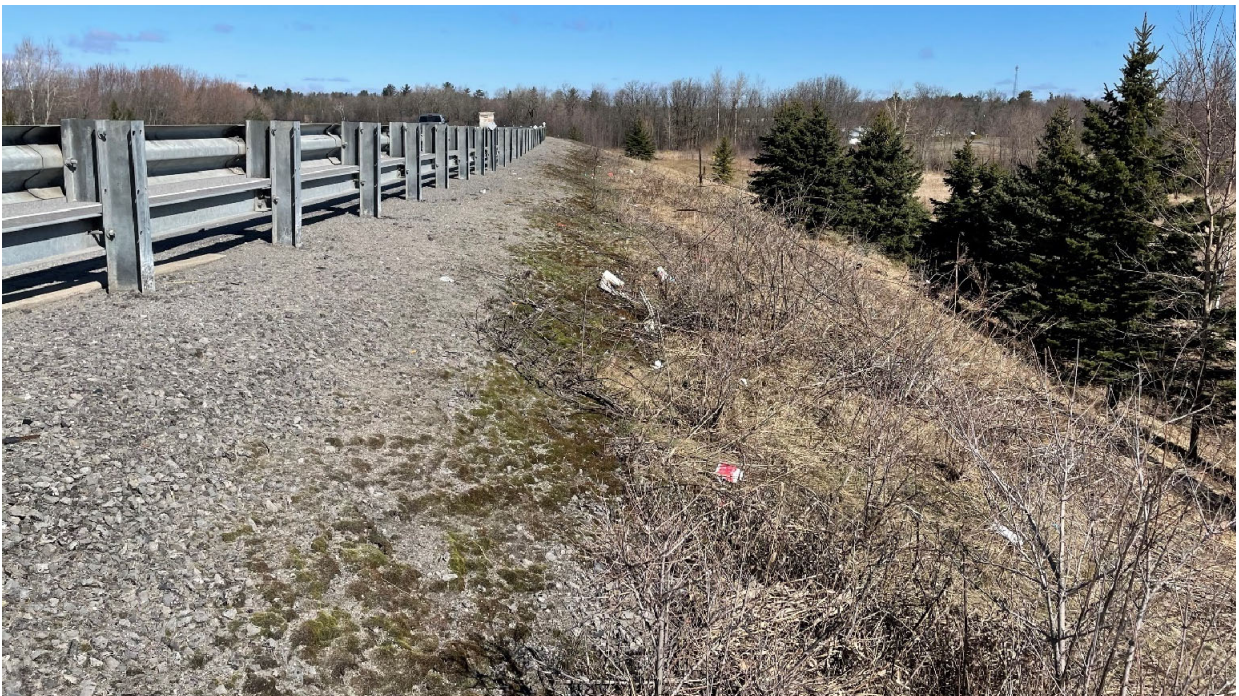
Photo 2. Looking north at northeast embankment (2021/03/29)

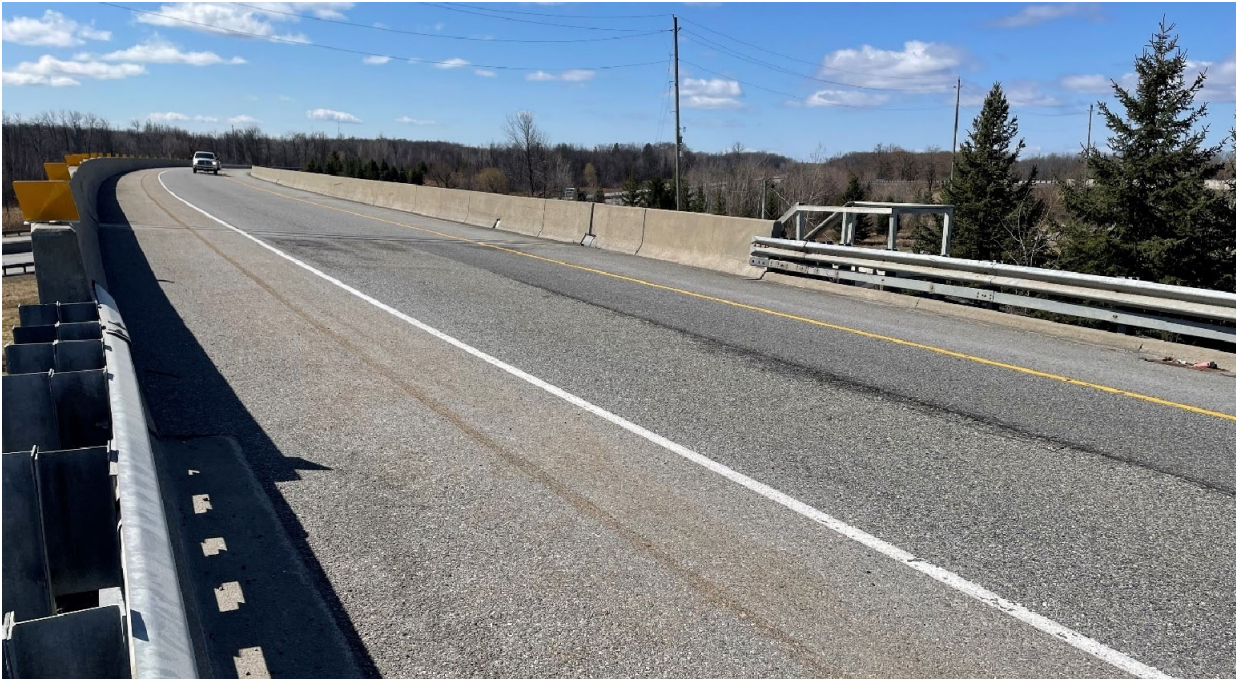
Photo 3. Looking south along deck. (2021/03/29)

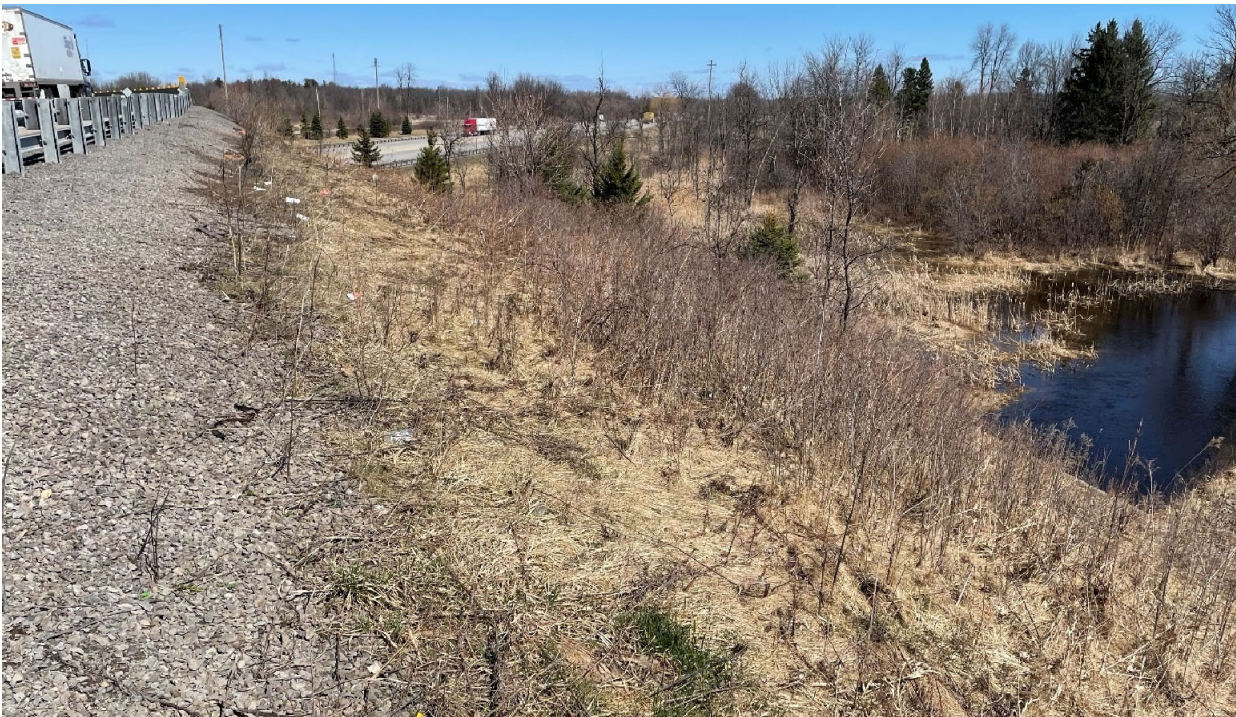
Photo 4. Looking north at southeast embankment and culvert 16-259/C outlet (below/right). (2021/03/29)

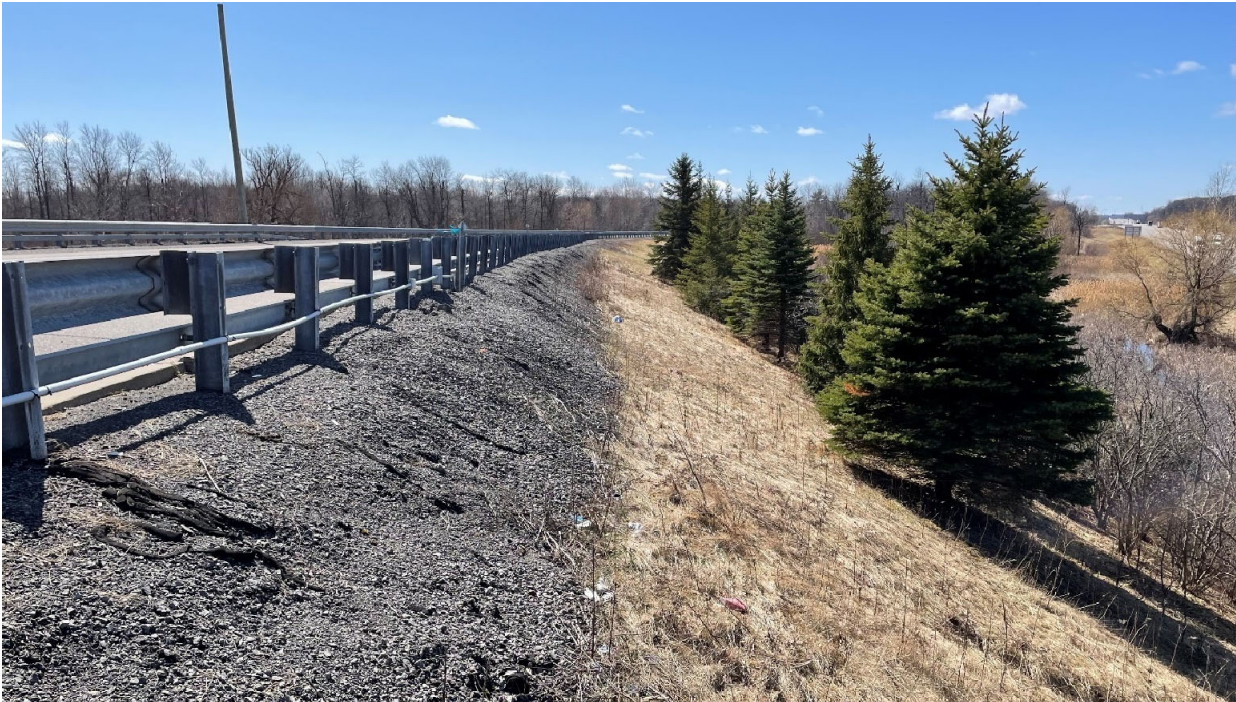
Photo 5. Looking south at southwest embankment. (2021/03/29)

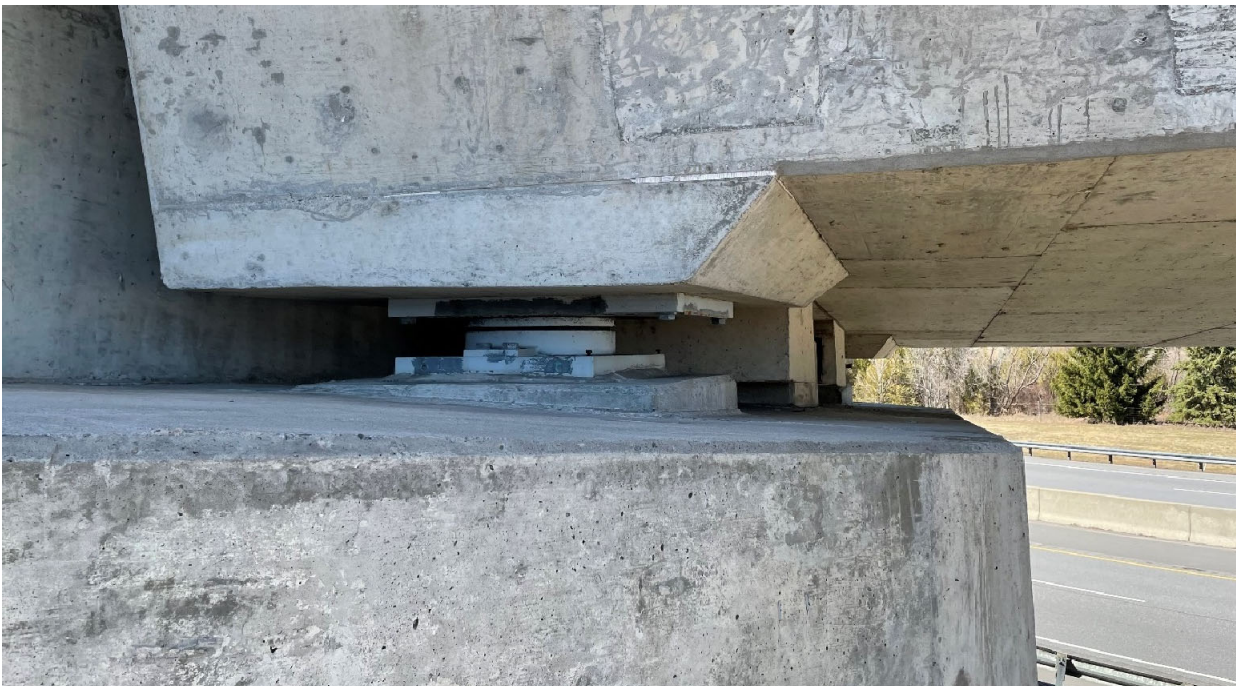
Photo 6. Looking west at south abutment bearings. (2021/03/29)

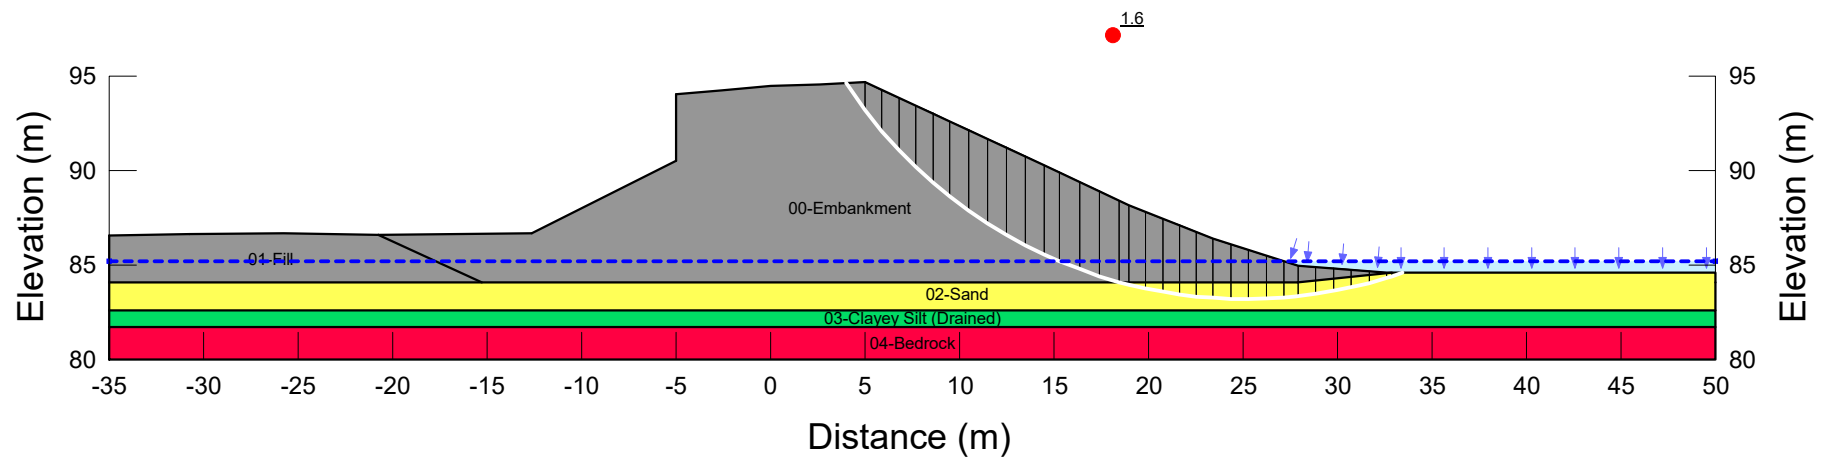
Project 401W-416N Ramp (Site 16-306) South Embankment		
Analysis Permanent		
Seismic Coefficient H: g, V: g	Last Run 01/04/2022, 09:47:12 AM	Scale 1:400

Additional Details
 Name: 2D Geometry
 Comments:
 Method: Morgenstern-Price, Half-Sine
 Minimum Slip Surface Depth: 0.1 m
 Entry: (3.996, 94.624167) m, Exit: (33.456467, 84.61) m
 Center: (25.135863, 108.47344) m, Radius: 25.272437 m

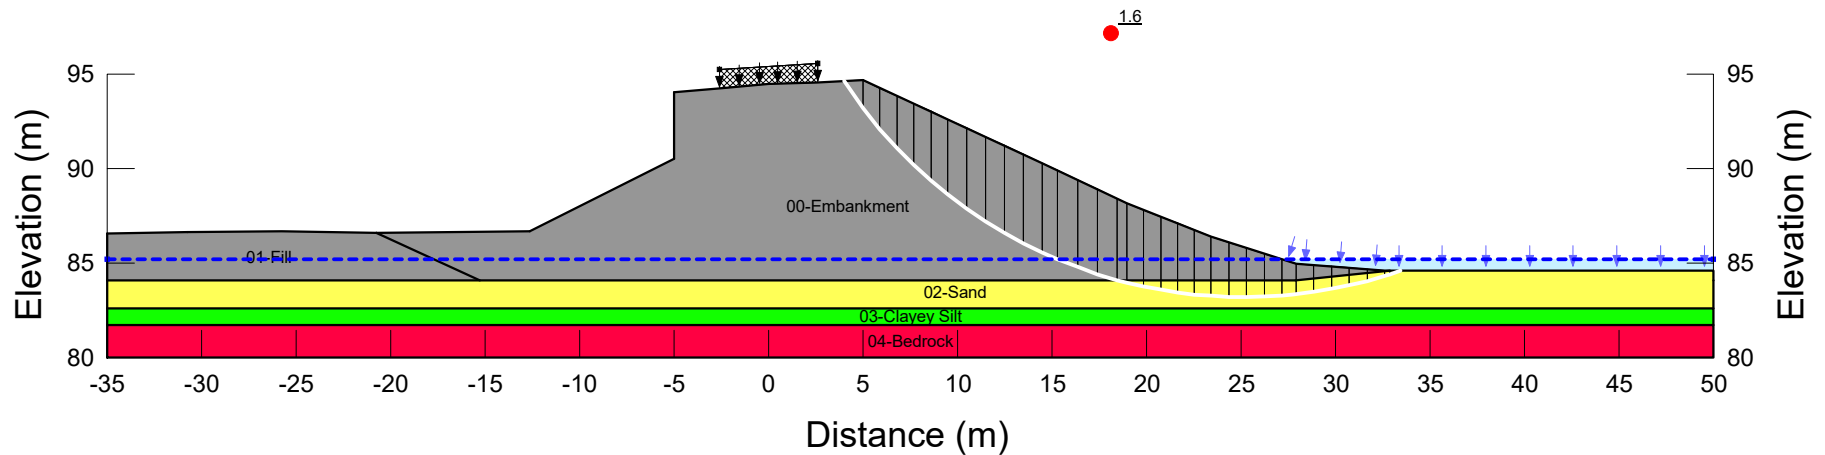
Project 401W-416N Ramp (Site 16-306) South Embankment		
Analysis Temporary - Traffic		
Seismic Coefficient H: g, V: g	Last Run 01/04/2022, 09:47:08 AM	Scale 1:400

Additional Details
Name: 2D Geometry
Comments:
Method: Morgenstern-Price, Half-Sine
Minimum Slip Surface Depth: 0.1 m
Entry: (3.996, 94.624167) m, Exit: (33.456467, 84.61) m
Center: (25.135863, 108.47344) m, Radius: 25.272437 m

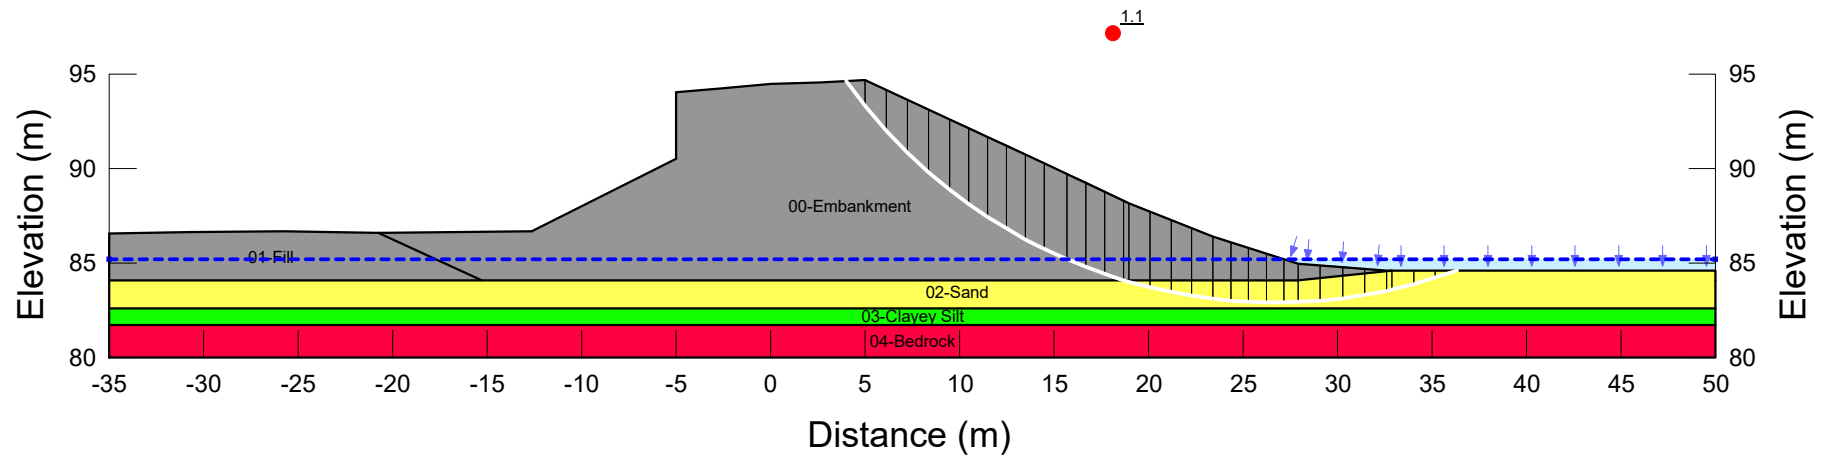
Project 401W-416N Ramp (Site 16-306) South Embankment		
Analysis Temporary - Pseudo-Static (2,475-year EQ)		
Seismic Coefficient H: 0.14g, V: g	Last Run 01/04/2022, 09:47:16 AM	Scale 1:400

Additional Details
 Name: 2D Geometry
 Comments:
 Method: Morgenstern-Price, Half-Sine
 Minimum Slip Surface Depth: 0.1 m
 Entry: (3.996, 94.624167) m, Exit: (36.3088, 84.61) m
 Center: (26.728943, 110.83767) m, Radius: 27.922471 m

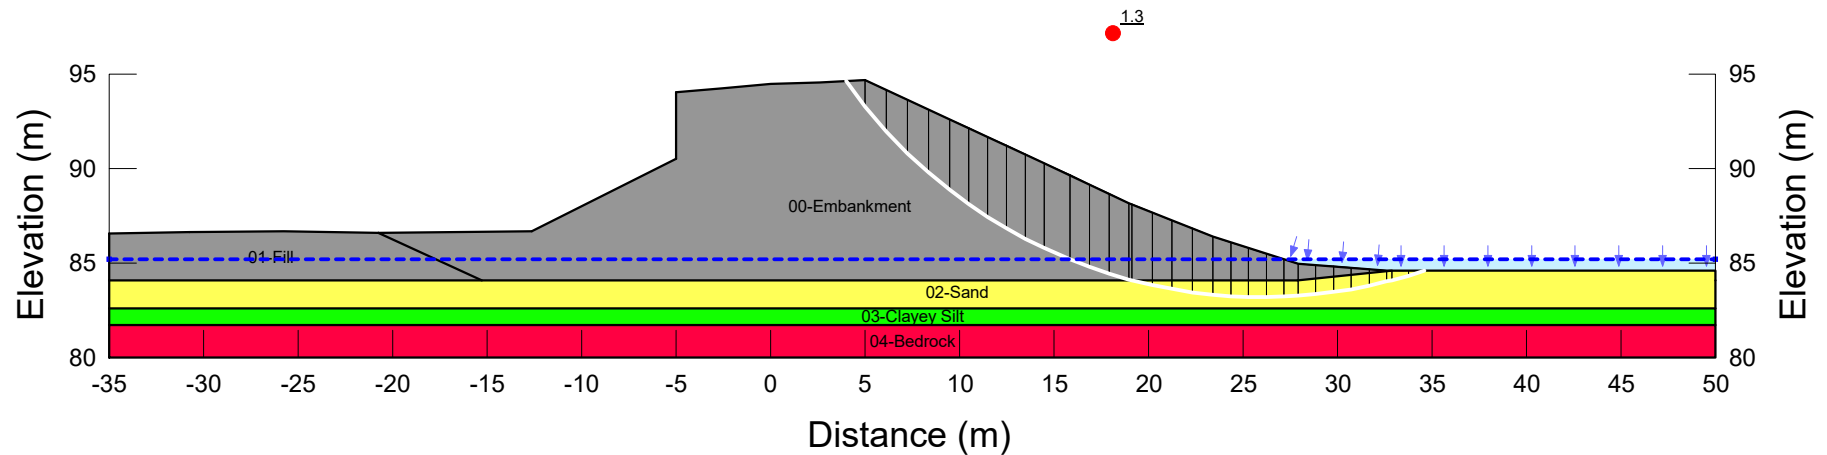
Project 401W-416N Ramp (Site 16-306) South Embankment		
Analysis Temporary - Pseudo-Static (475-year EQ)		
Seismic Coefficient H: 0.06g, V: g	Last Run 01/04/2022, 09:47:18 AM	Scale 1:400

Additional Details
Name: 2D Geometry
Comments:
Method: Morgenstern-Price, Half-Sine
Minimum Slip Surface Depth: 0.1 m
Entry: (3.996, 94.624167) m, Exit: (34.5974, 84.61) m
Center: (26.003724, 110.11248) m, Radius: 26.911479 m
