**PRELIMINARY FOUNDATION INVESTIGATION AND DESIGN REPORT
HIGHWAY 401 WIDENING, HIGHWAY 16 TO MAITLAND ROAD
HWY 416 SBL - CEDAR GROVE RD OVERPASS, SITE NO. 16X-0307
GWP 4024-20-00 / ASSIGNMENT NO. 4019-E-0010.2**

January 2023
Thurber File No.: 29381

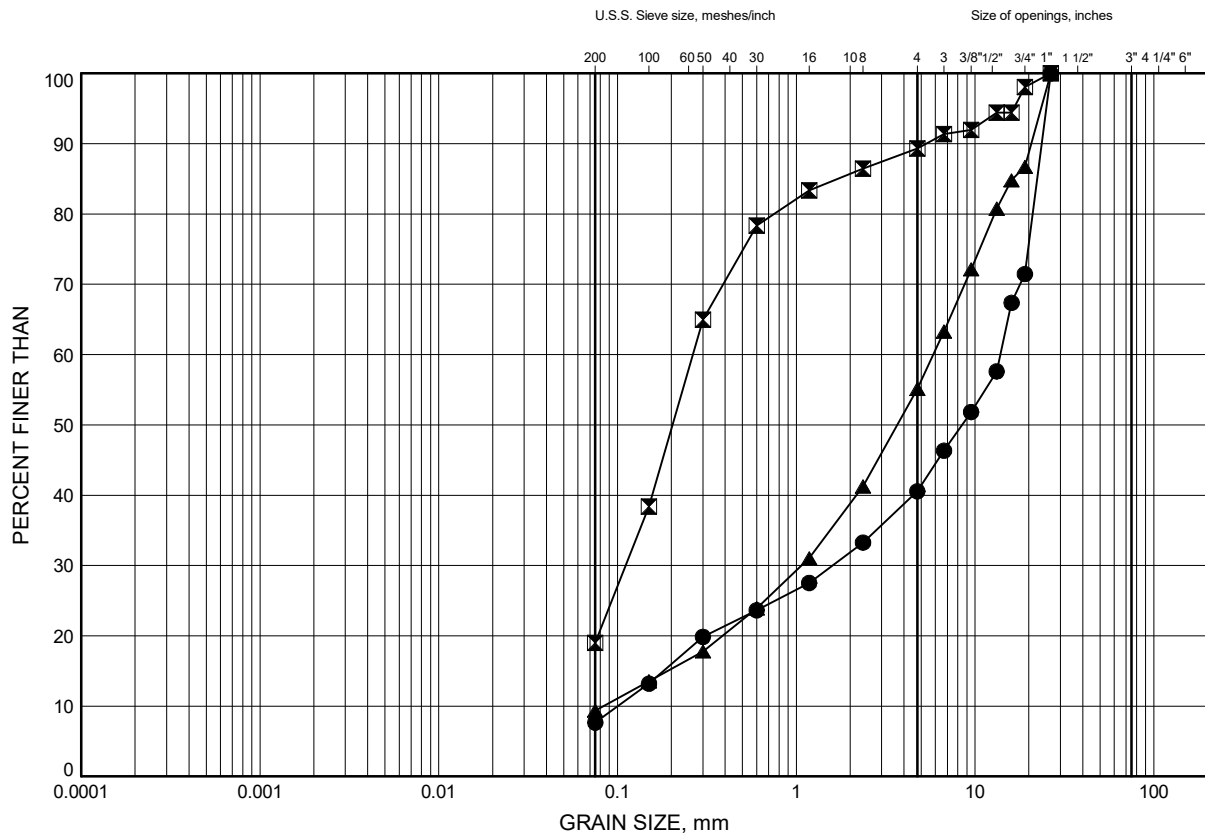
GRAIN SIZE DISTRIBUTION

EMBANKMENT FILL

The moisture content of the tested embankment fill samples ranged from 1 to 20%. The results of grain size analyses conducted on three samples of the embankment fill are summarized below and are illustrated on Figure C1 in Appendix C.1.

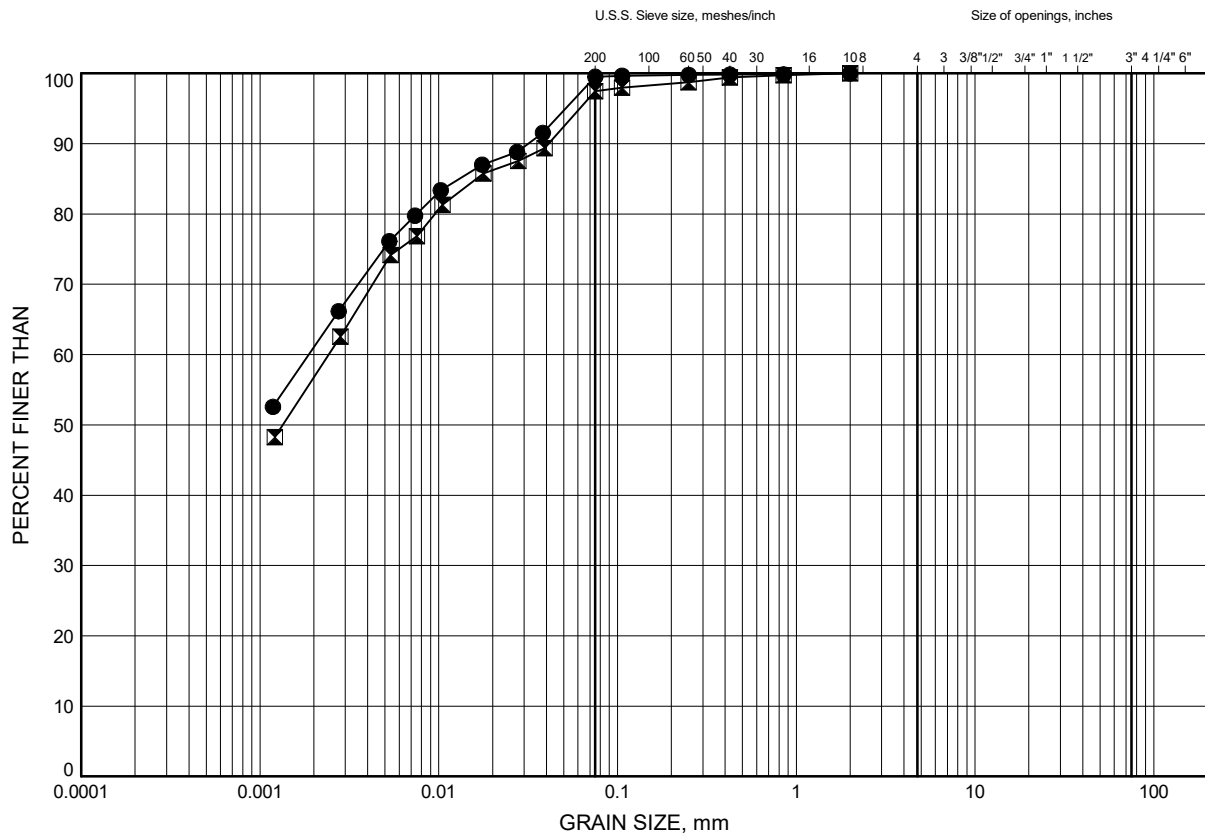
GRAIN SIZE DISTRIBUTION

SILTY CLAY TO CLAY

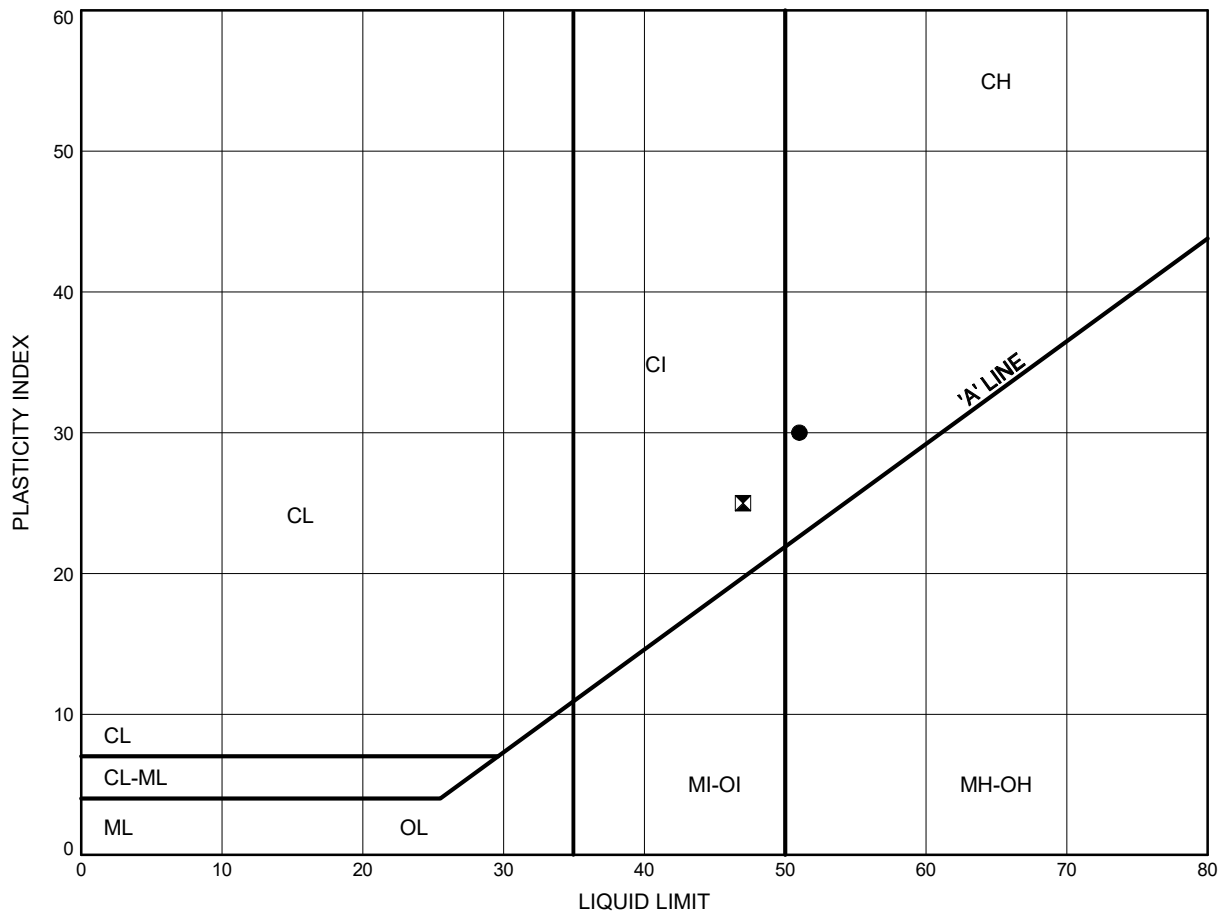
ATTERBERG LIMITS TEST RESULTS

SILTY CLAY TO CLAY

SYMBOL	BOREHOLE	DEPTH (m)	ELEV. (m)
●	307-21-1	11.0	83.4
⊠	307-21-2	9.4	84.3

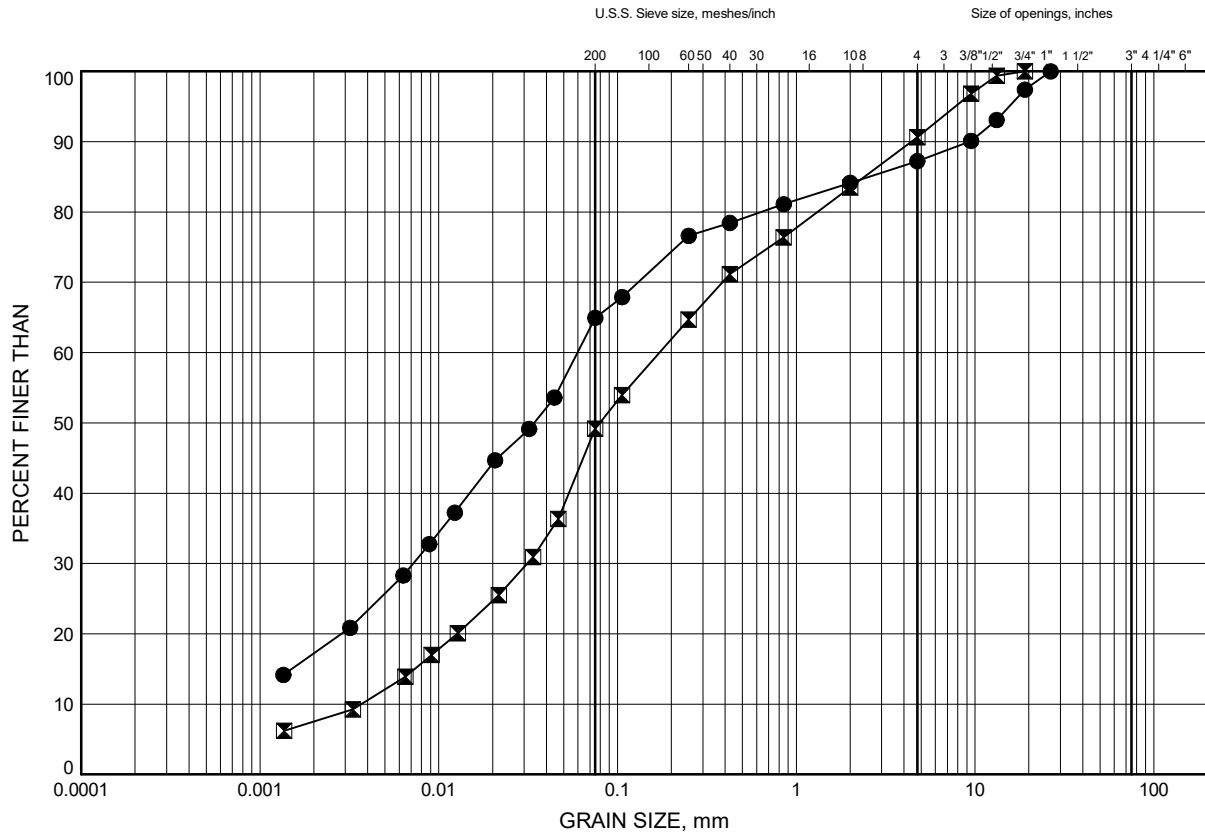
GRAIN SIZE DISTRIBUTION

GLACIAL TILL

The moisture content of this unit ranged from 7 to 18%. The results of grain size distribution testing carried out on three samples of the till are summarized below and are illustrated on Figure C4 in Appendix C.1 and Figure 4 in Appendix C.2.

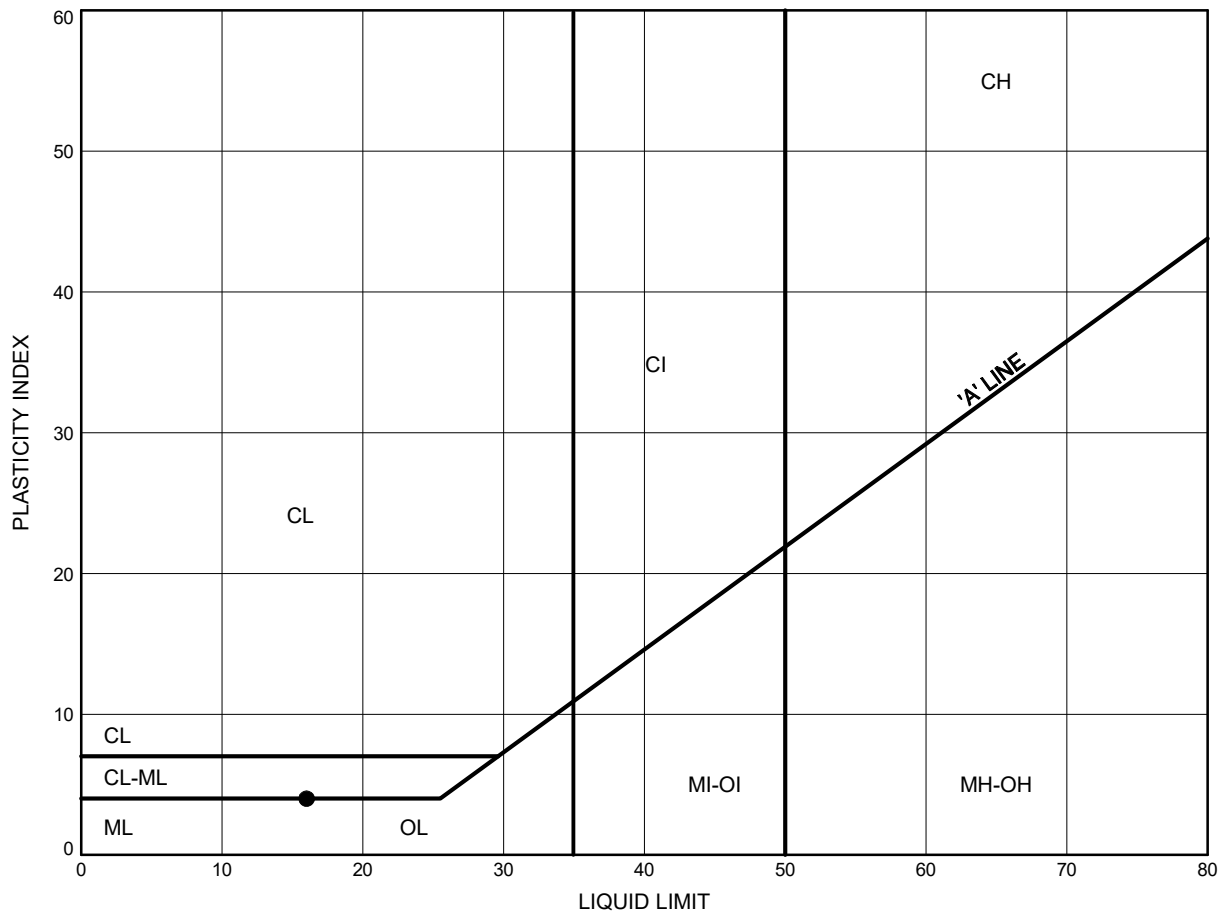
ATTERBERG LIMITS TEST RESULTS

GLACIAL TILL

SYMBOL	BOREHOLE	DEPTH (m)	ELEV. (m)
●	307-21-1	12.6	81.7

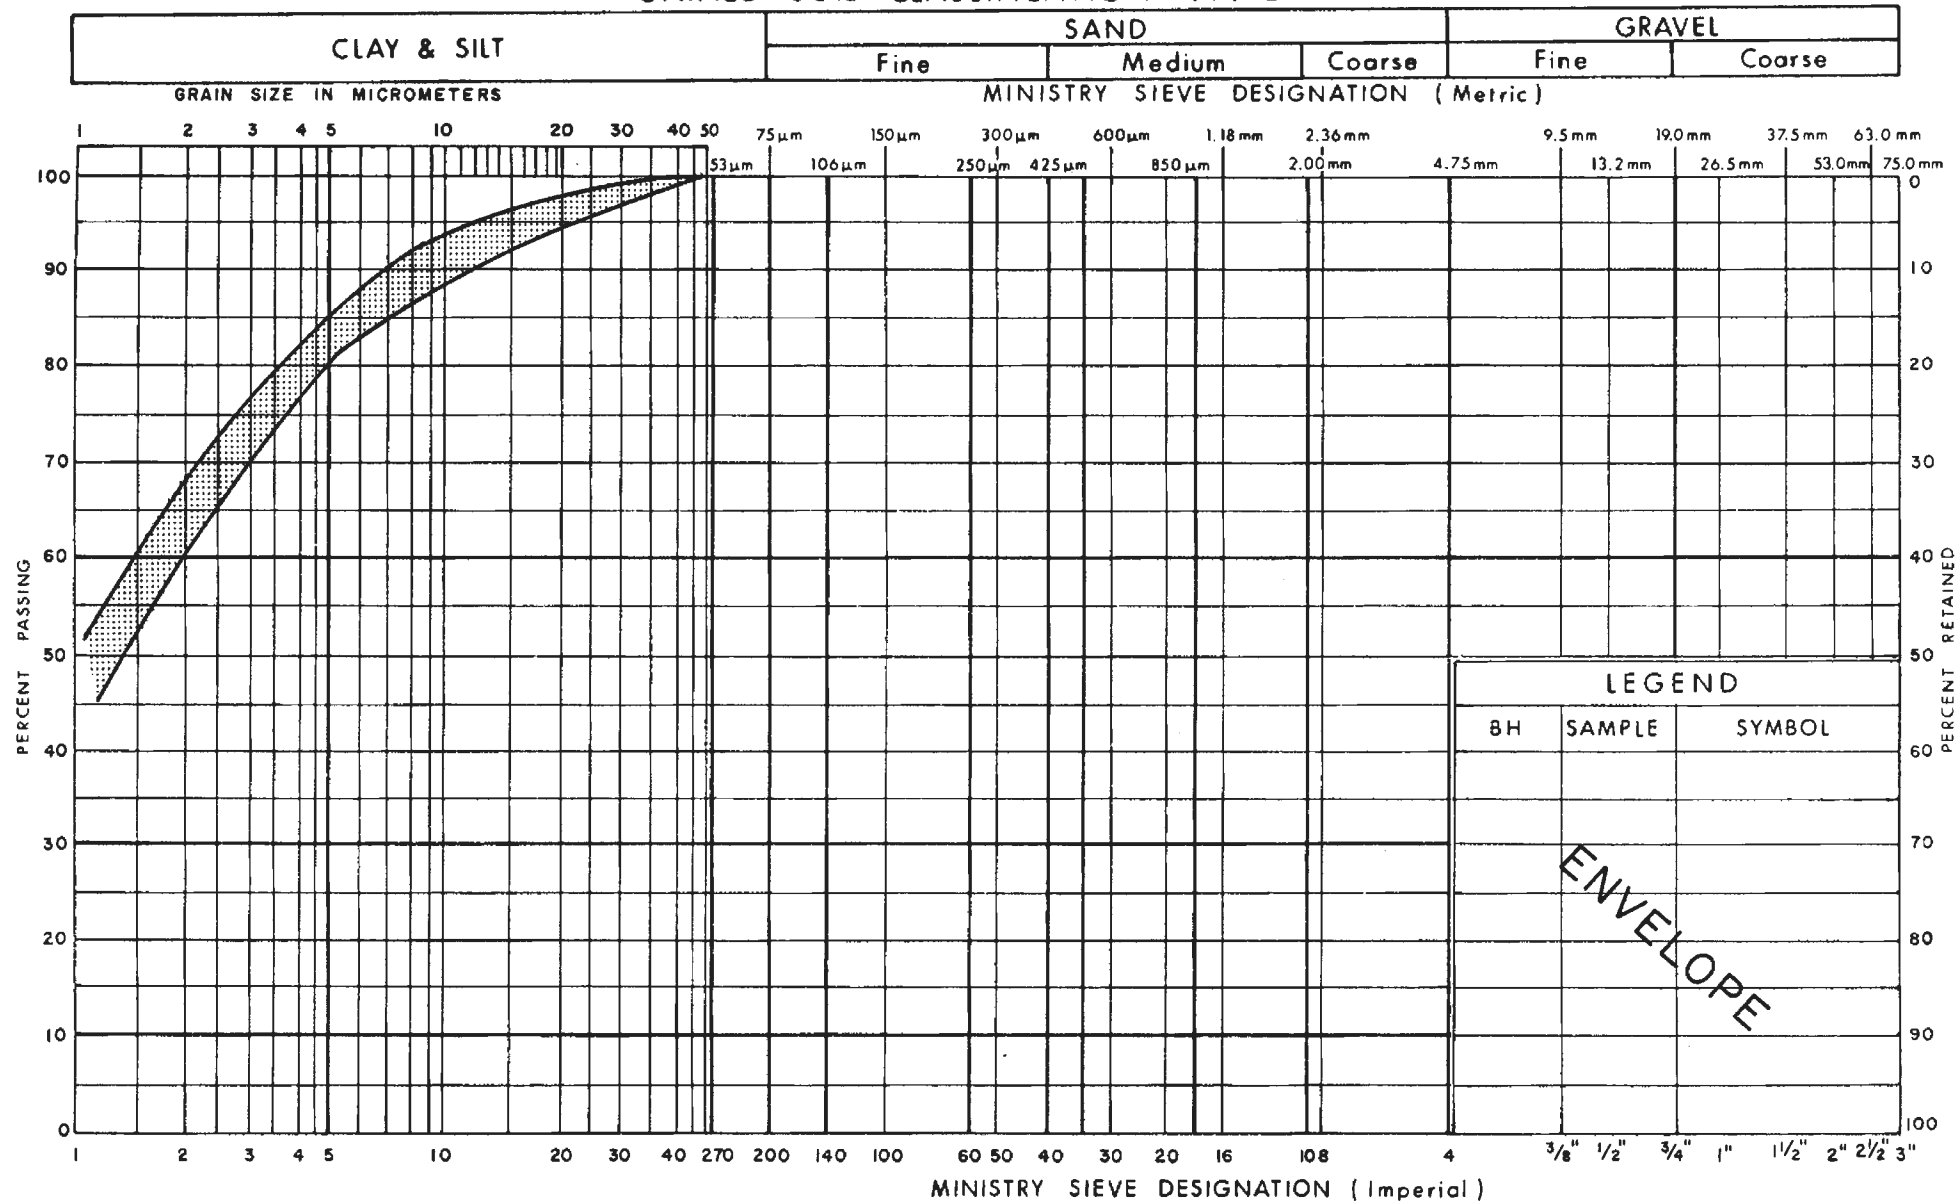
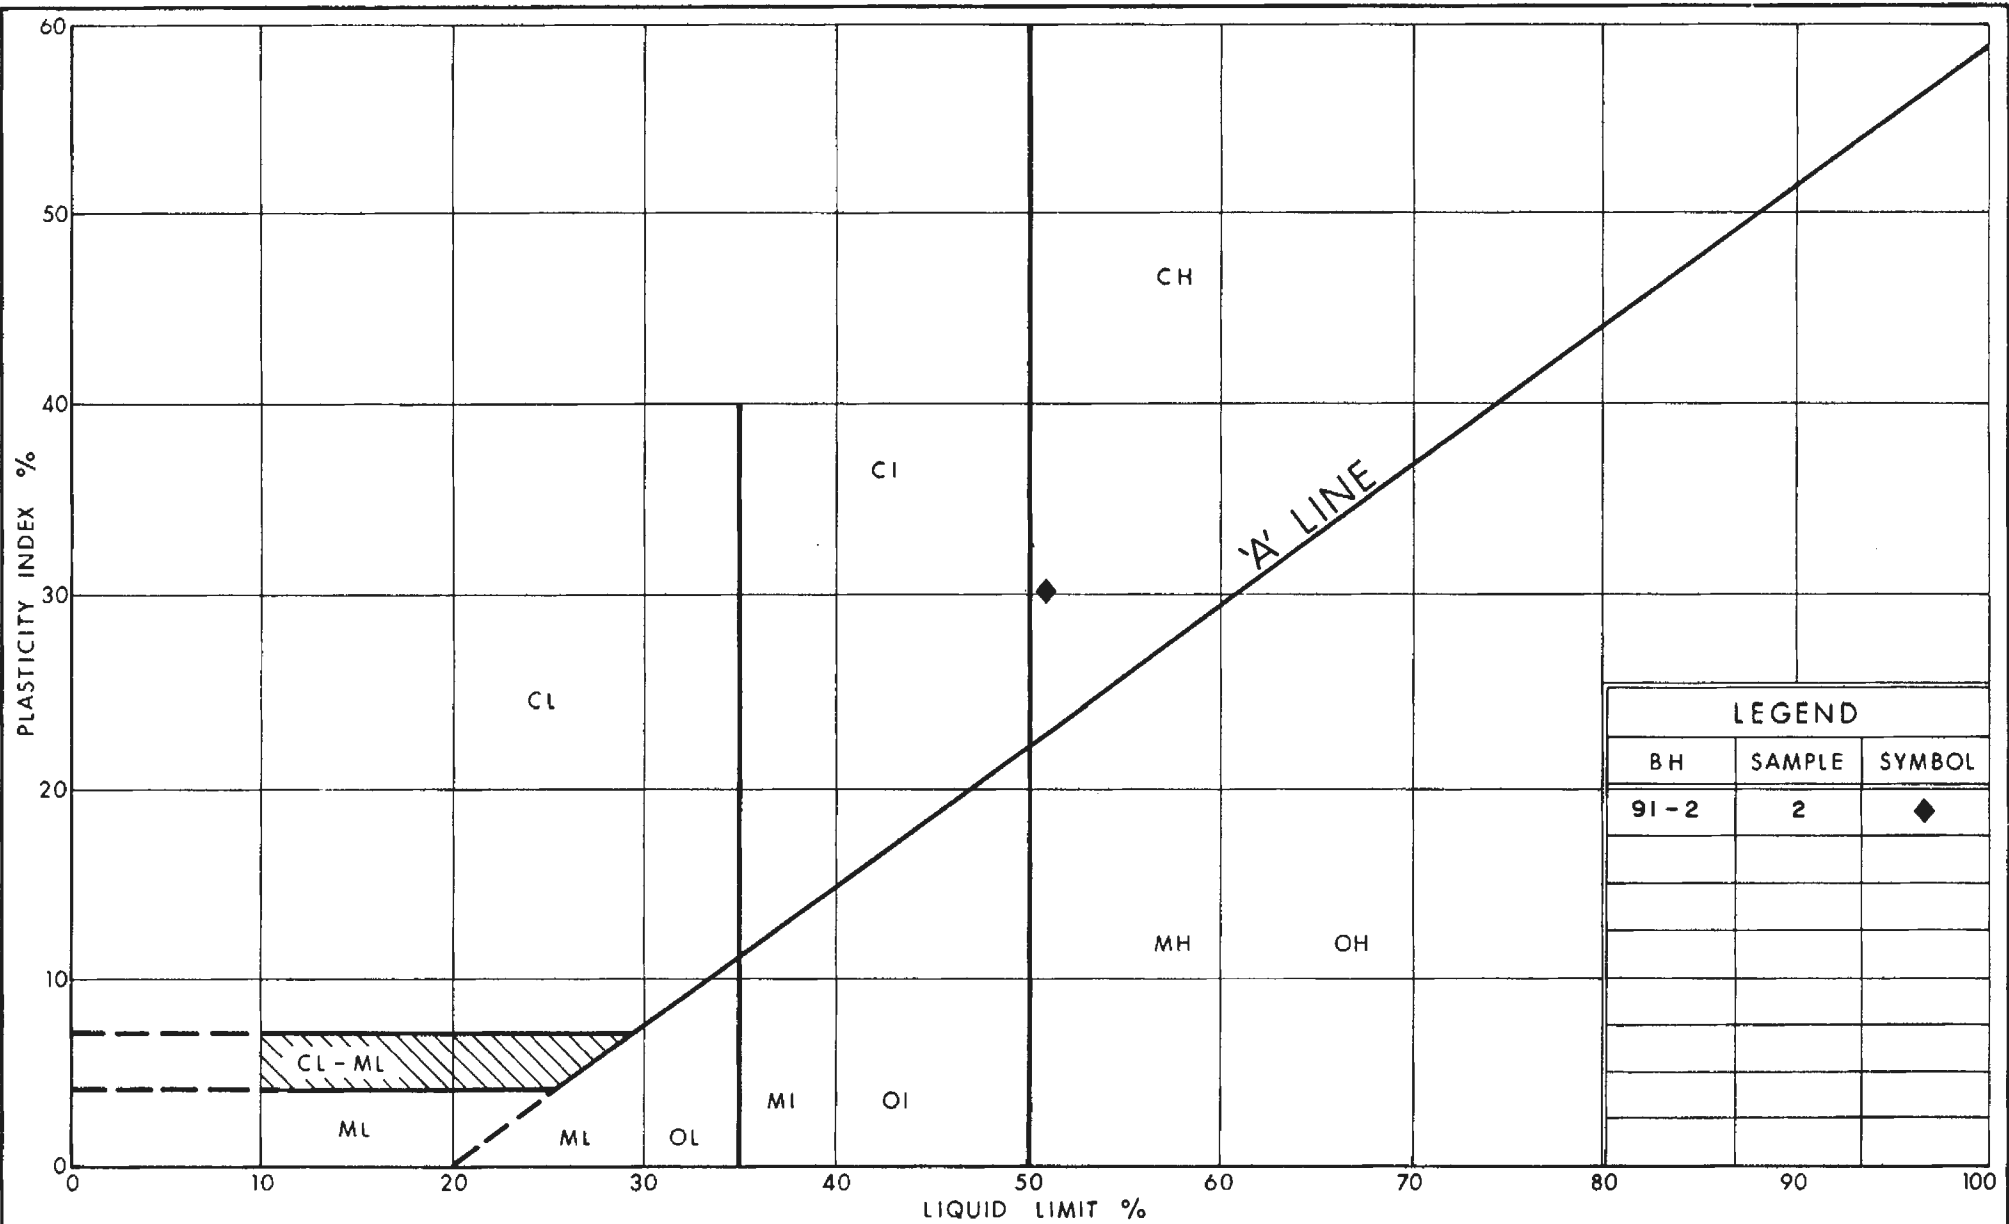
FIG No 1

GRAIN SIZE DISTRIBUTION
SILTY CLAY

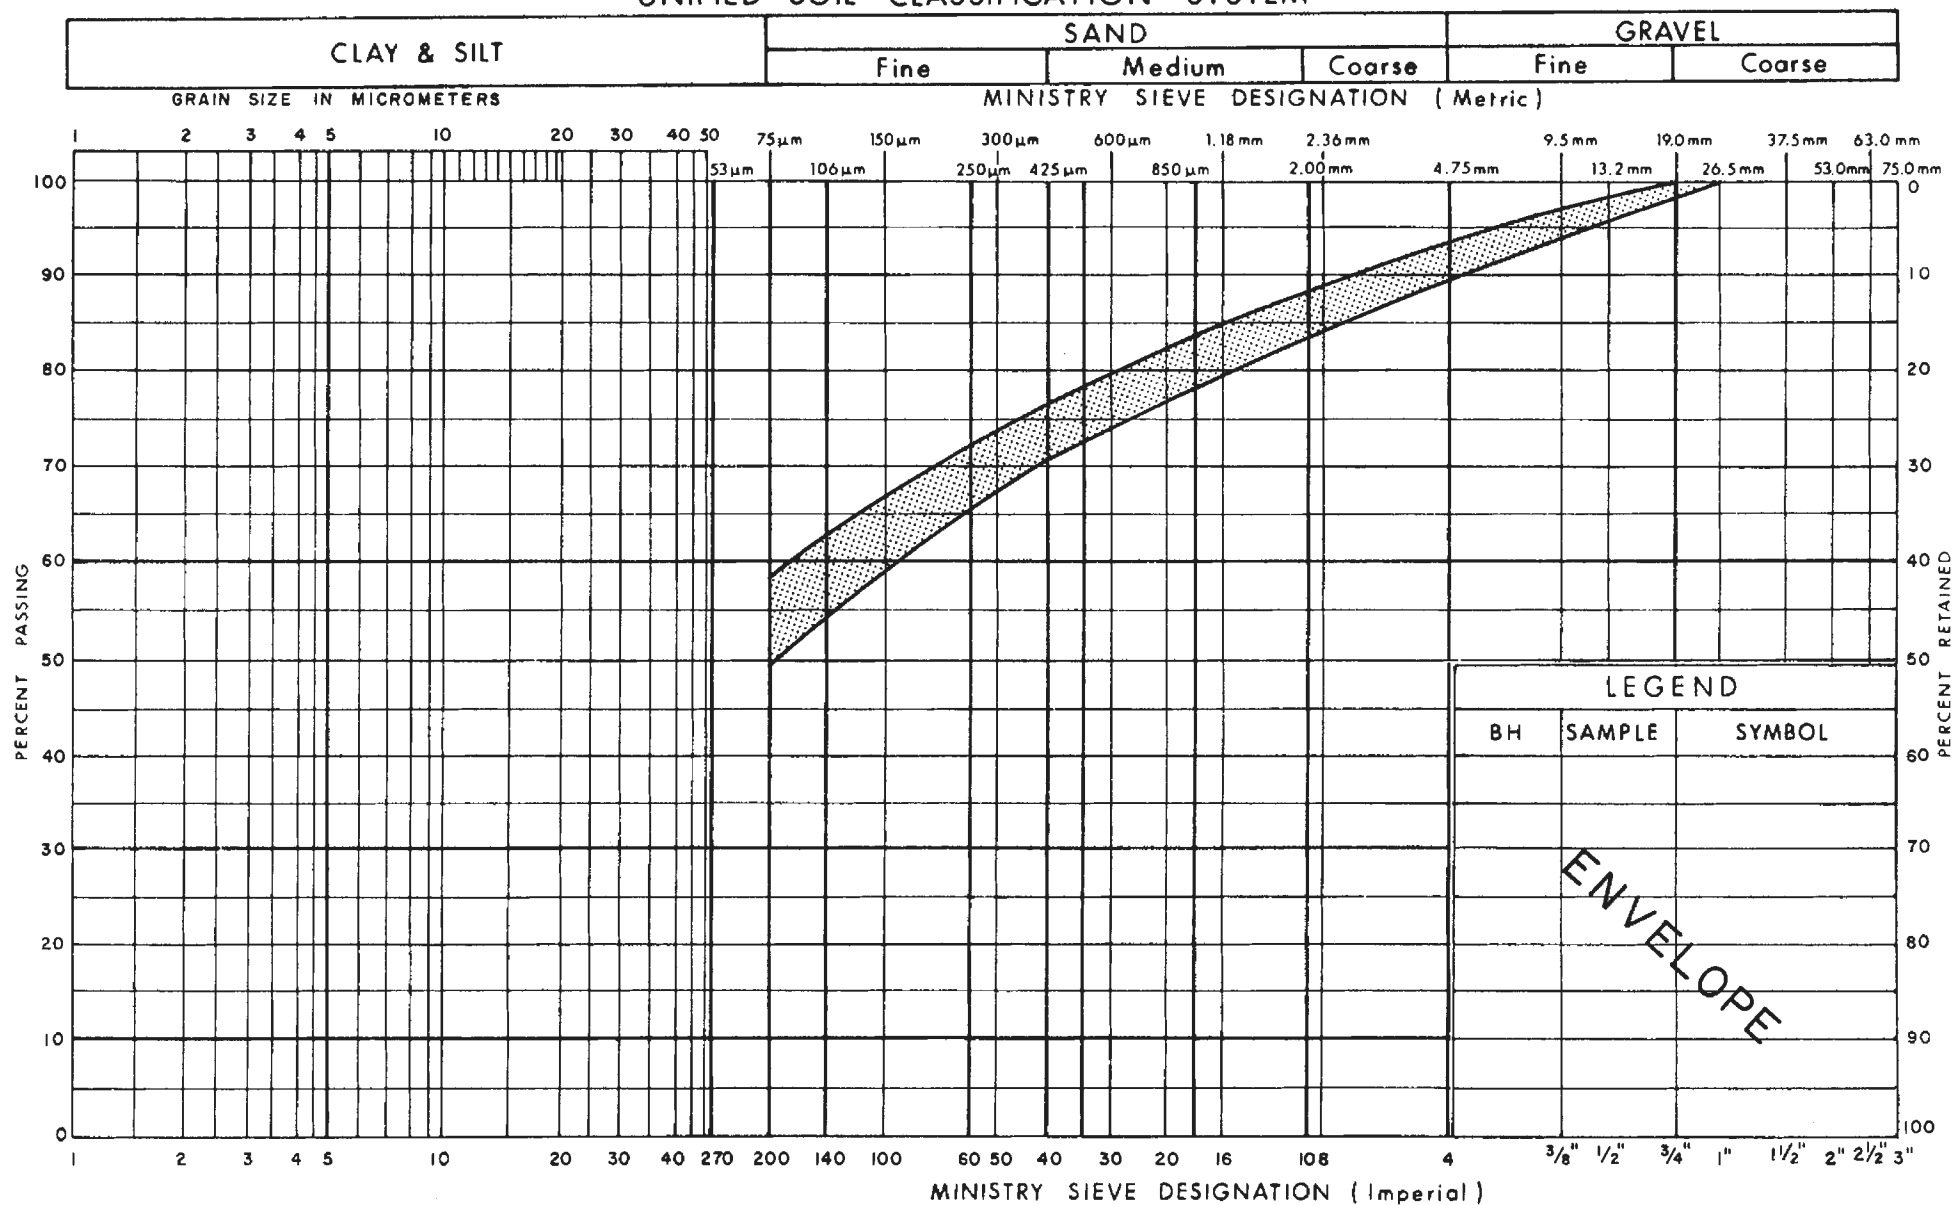
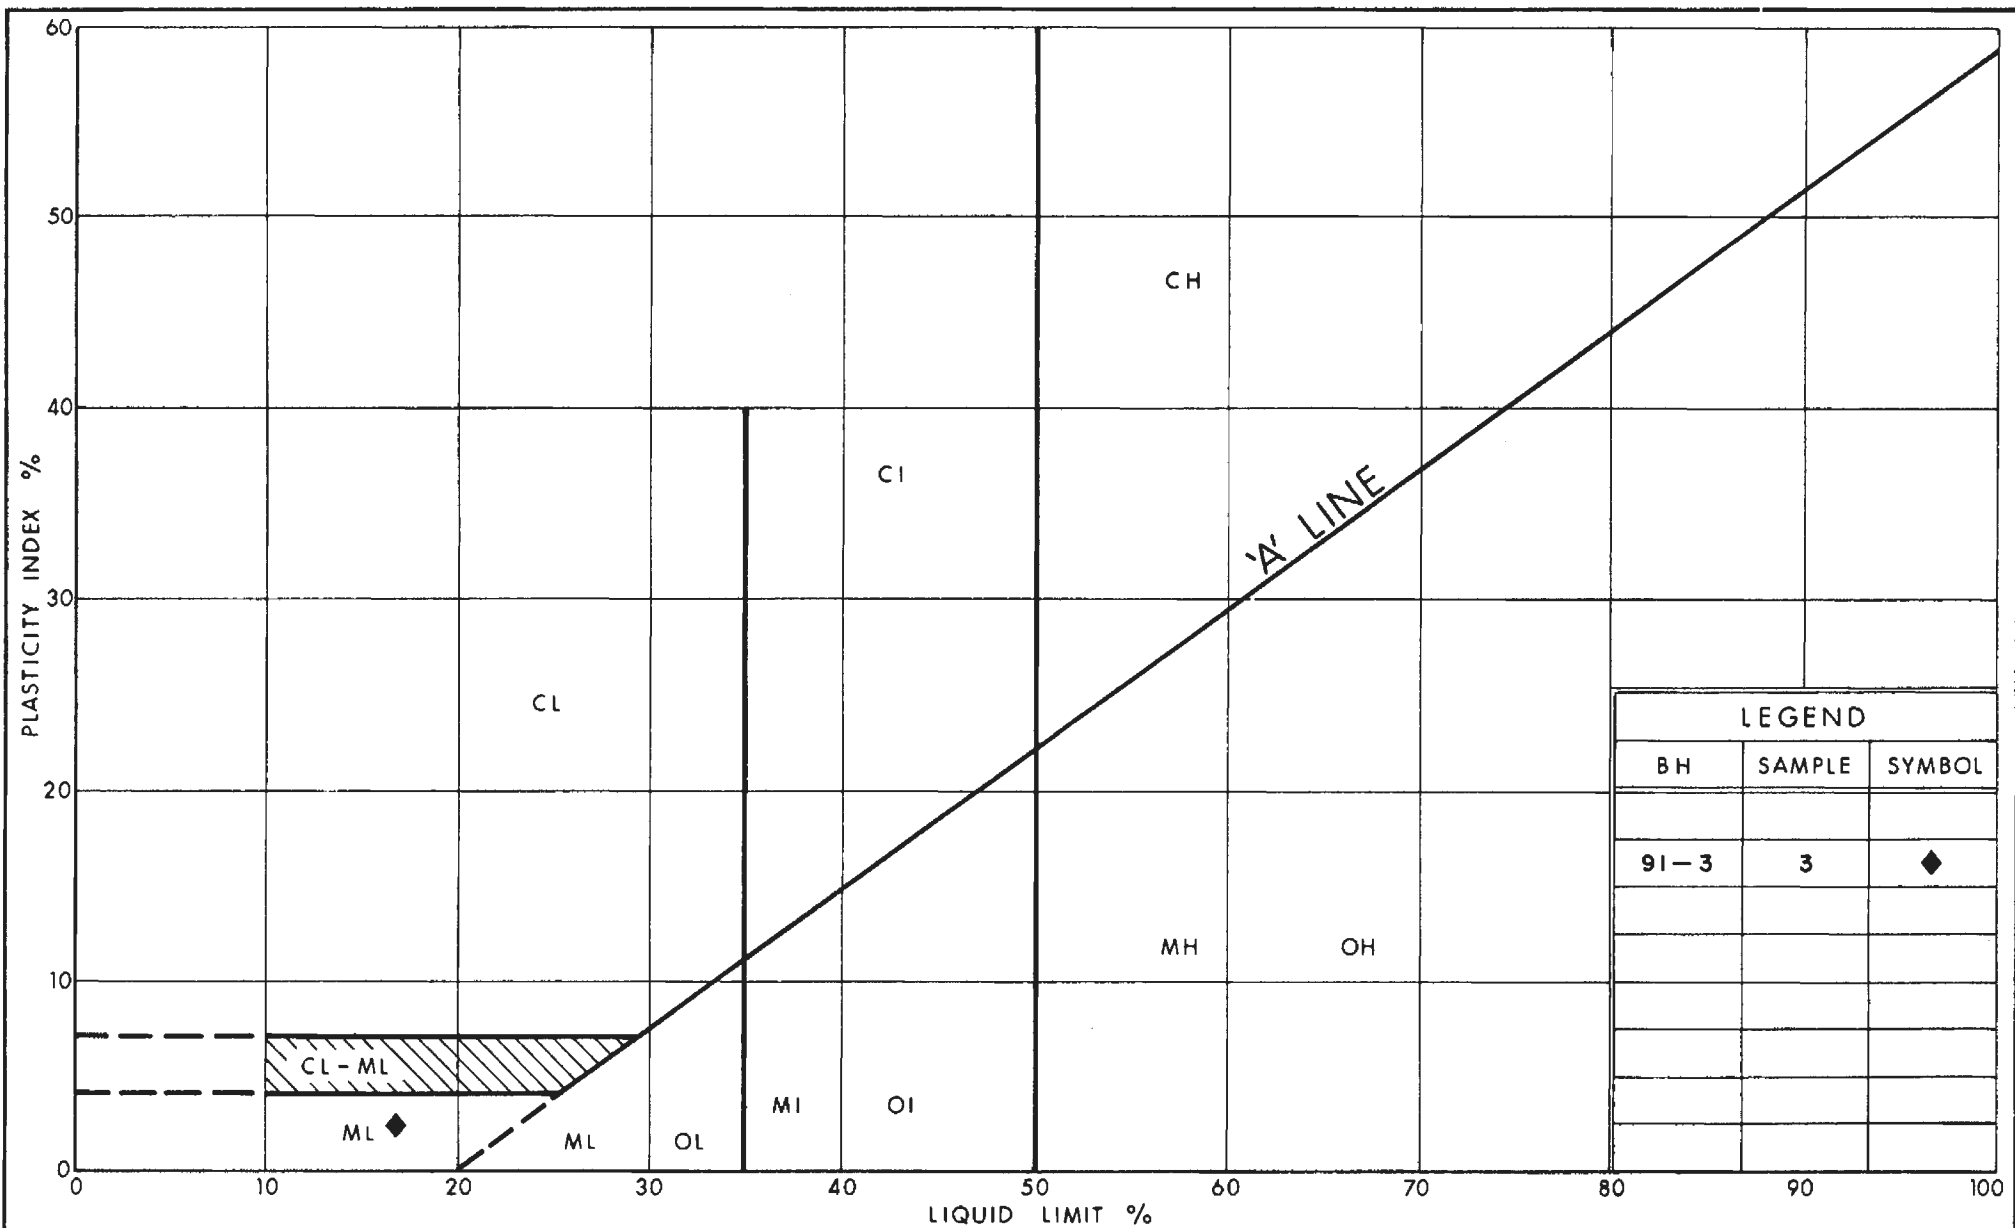
FIG No. 4

GRAIN SIZE DISTRIBUTION
HET MIXTURE OF SANDY SILT,
SOME CLAY & GRAVEL, OCCASIONAL BOULDERS (Glacial Till)

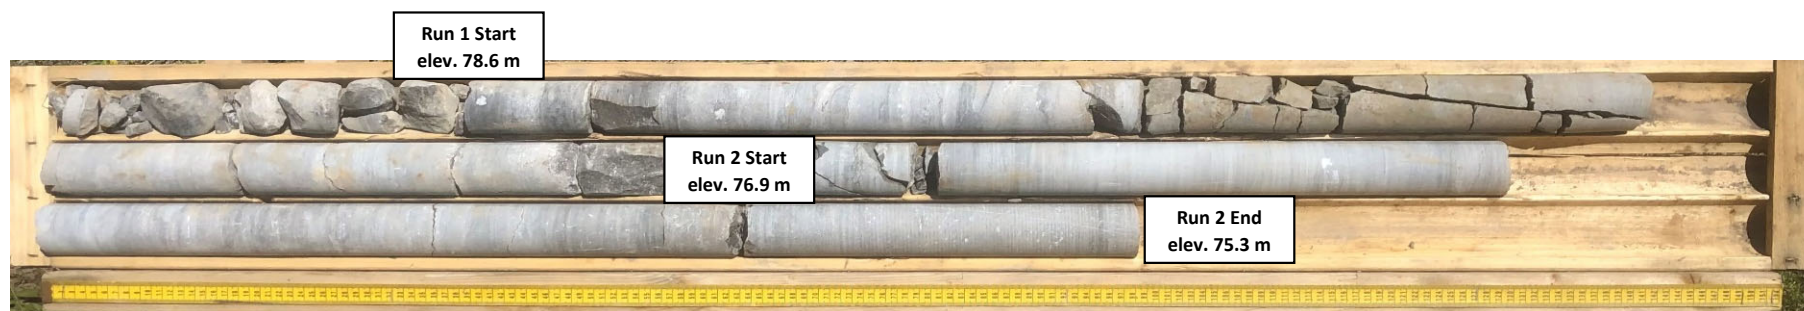
Borehole 307-21-1
Run 1 to 2 (of 2)
Elevation 78.8 m to 75.4 m
Dry

Based on the average RQD value, the bedrock is classified as good quality. It is noted that vertical fractures were observed in the core recovered from Borehole 307-21-1. Unconfined compressive strength (UCS) testing was carried out on one sample of the bedrock from Borehole 307-21-1. The result of 162 MPa indicates a very strong rock, and is included in Appendix C. A summary of the bedrock surface information is provided in Table 5-1, below:

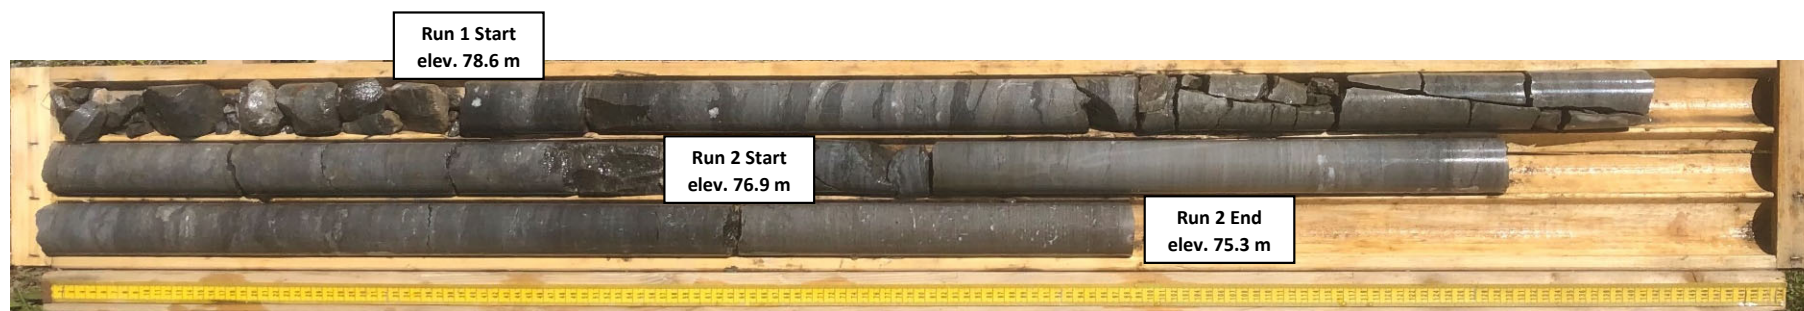
Borehole 307-21-1
Run 1 to 2 (of 2)
Elevation 78.8 m to 75.4 m
Wet

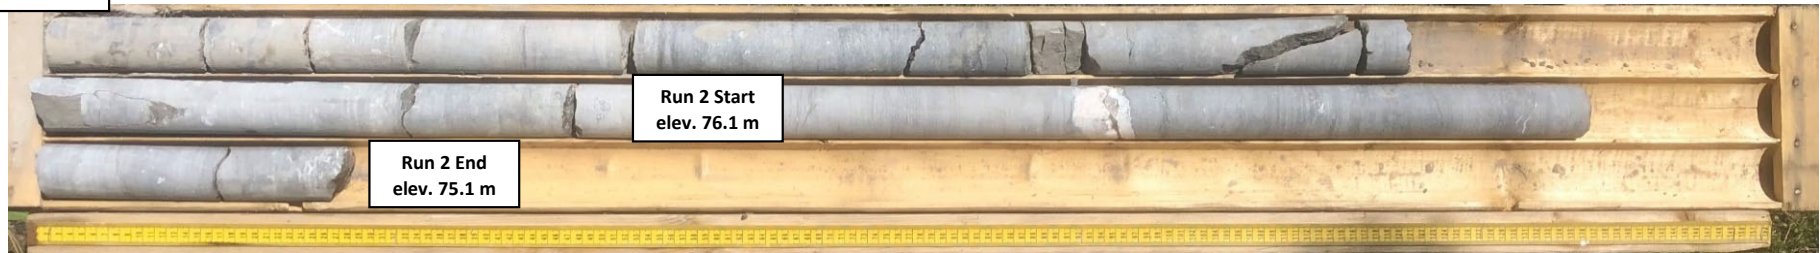
Borehole 307-21-2
Run 1 to 2 (of 2)
Elevation 77.9 m to 75.0 m

Run 1 Start
elev. 77.9 m

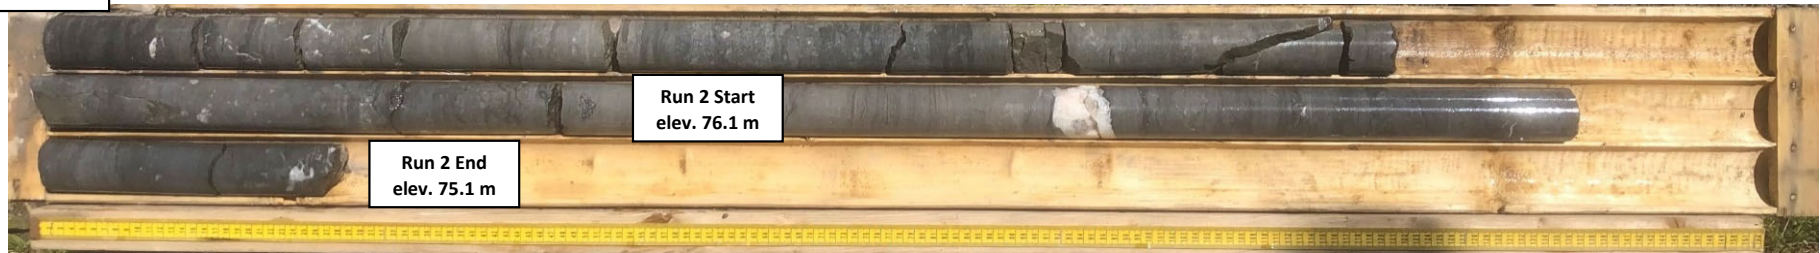
Borehole 307-21-2
Run 1 to 2 (of 2)
Elevation 77.9 m to 75.0 m

Run 1 Start
elev. 77.9 m

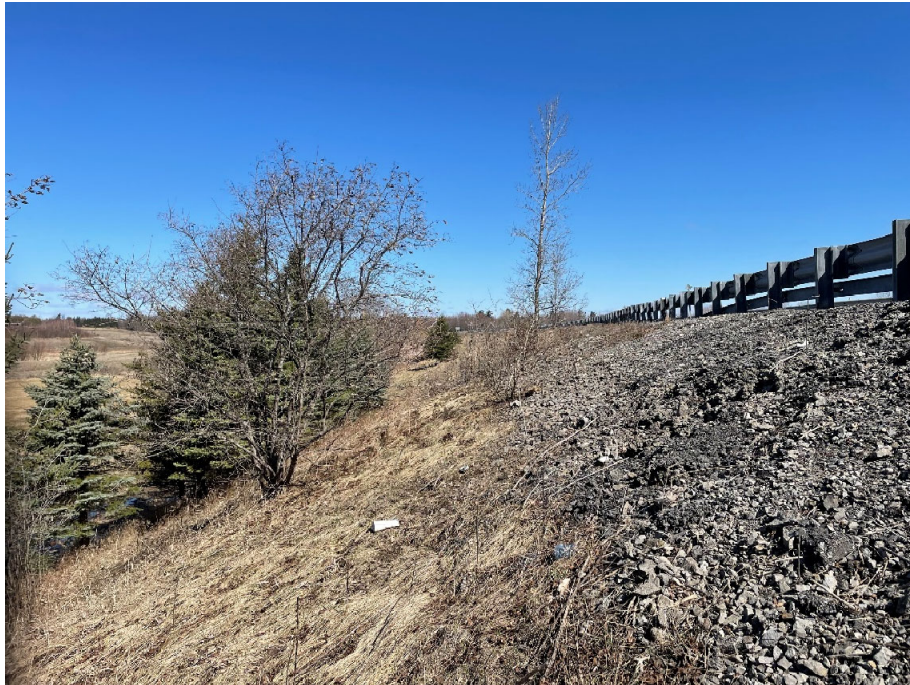
Photo 1. Looking north at the west side of the north embankment (2021/03/29)

The side slopes were observed during the current field investigation and were generally grass-covered, with bushes and small trees growing around the abutments. Rockfill material was exposed on the upper portions of the west slope of both the north and south approaches (see Photos 1 and 7 in Appendix D). At the time of the field work, the side slopes appeared to be 2H:1V in all quadrants and did not show any visible signs of distress or other performance issues. Steel beam guiderails are present along the approaches and abut the concrete barrier walls along the bridge.

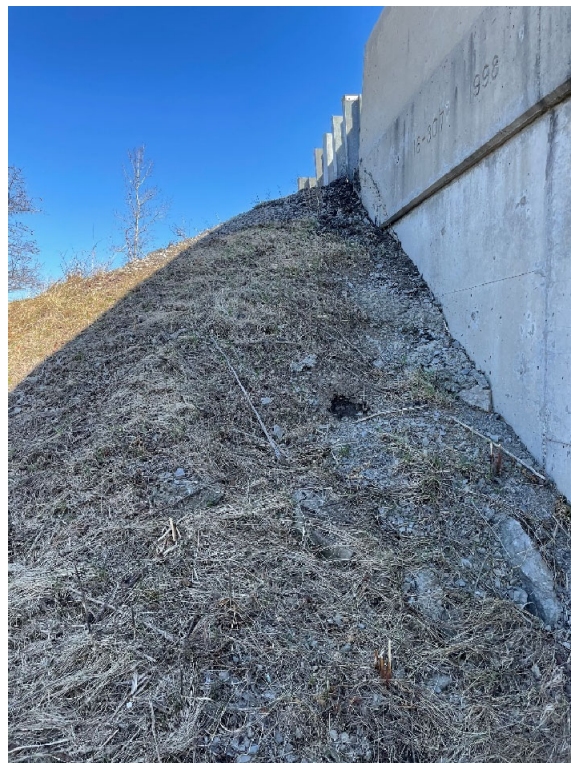
Photo 2. West side of north abutment (2021/03/29)

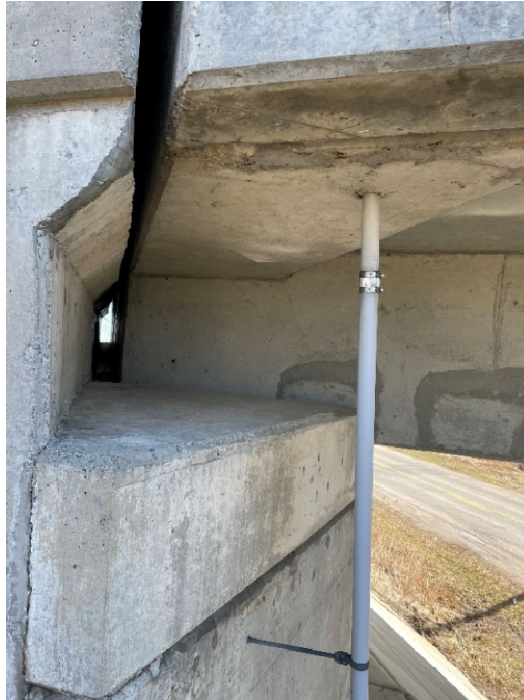
Photo 3. North deck and abutment (2021/03/29)

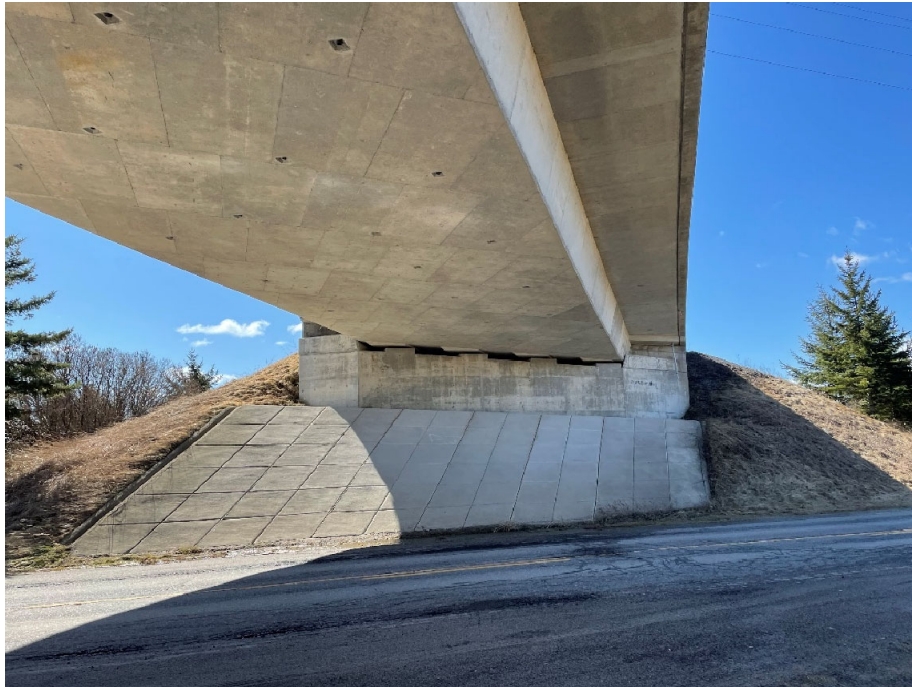
Photo 5. Looking south at south abutment (2021/03/29)

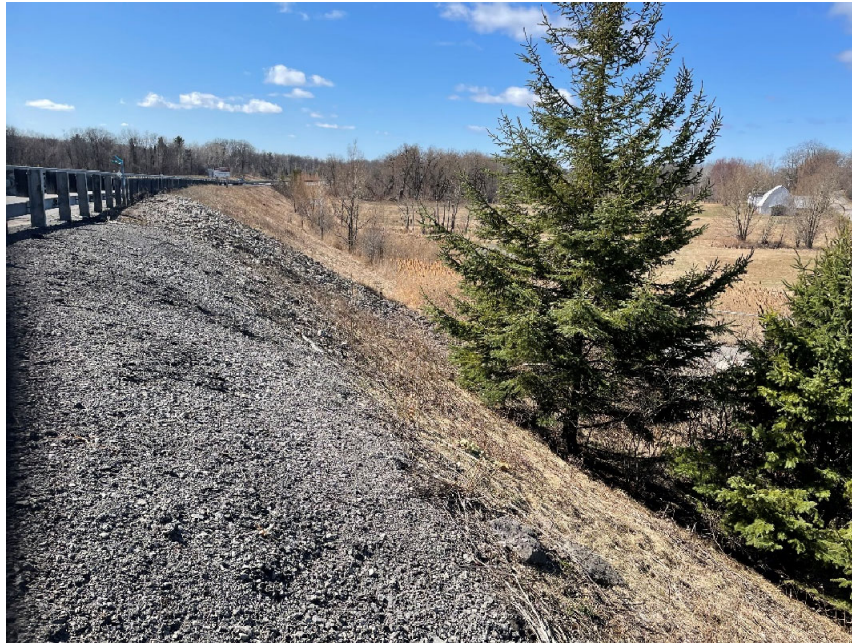
Photo 7. Looking south at the west side of the south embankment (2021/03/29)

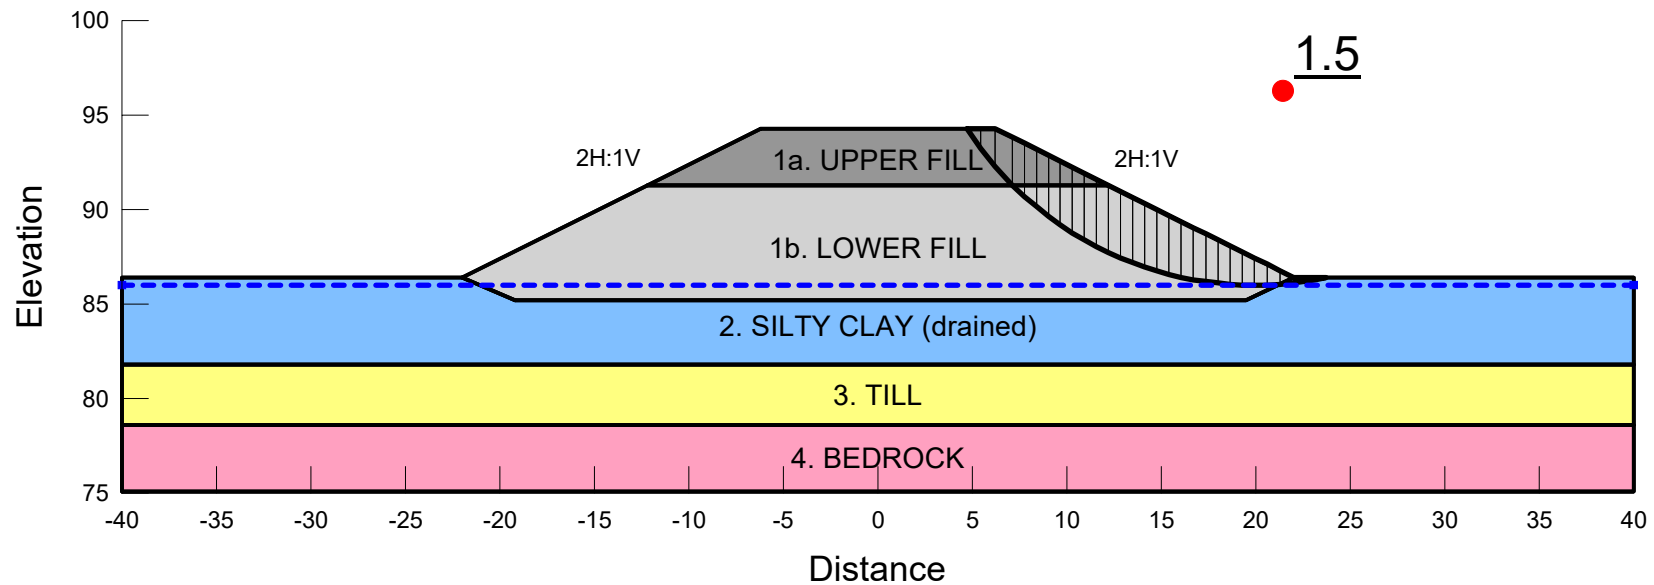
Project Hwy 416 Cedar Grove Road Overpass SBL (Site 16-307)		
Analysis Permanent (Drained)		
Seismic Coefficient H: 0g, V: g	Last Run 11/24/2021, 11:08:55 AM	Scale 1:400

Additional Details
Name: 16-307: 2H:1V Existing Embankment
Comments:
Method: Morgenstern-Price, Half-Sine
Minimum Slip Surface Depth: 1.5 m
Entry: (4.7, 94.3) m, Exit: (23.705, 86.4) m
Center: (19.920271, 104.10522) m, Radius: 18.105219 m

Table 6.2 of the CHBDC for embankment fills with a typical degree of understanding and a Ψ of 1.0 generates minimum Factors of Safety of 1.5 and 1.3 for static permanent and static temporary conditions respectively.

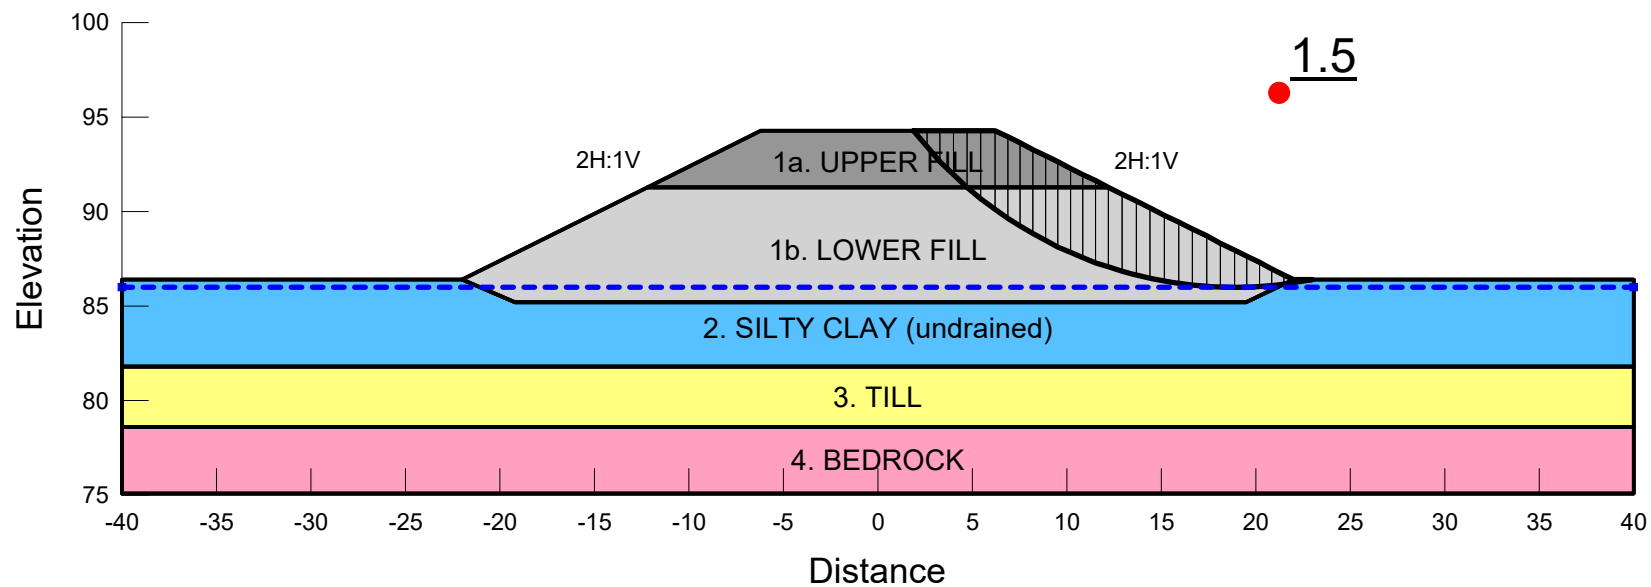
Project		
Hwy 416 Cedar Grove Road Overpass SBL (Site 16-307)		
Analysis		
Temporary - Pseudo-Static (2,475-year EQ)		
Seismic Coefficient	Last Run	Scale
H: 0.14g, V: g	11/24/2021, 11:08:59 AM	1:400

Additional Details
Name: 16-307: 2H:1V Existing Embankment
Comments:
Method: Morgenstern-Price, Half-Sine
Minimum Slip Surface Depth: 1.5 m
Entry: (1.88, 94.3) m, Exit: (23, 86.4) m
Center: (18.868542, 107.53618) m, Radius: 21.536179 m

For seismic analysis, Table 6.3 in Section 6.14.4.1 of the CHBDC indicates a minimum resistance factor of 0.95 ($\phi_{gu, static(temporary)} = 0.75 + 0.2$) for force-based design and 1.0 for performance-based design. Based on these values and Ψ of 1.0, a target Factor of Safety of 1.1 for this temporary condition with a typical degree of understanding is appropriate for the pseudo-static seismic analysis. However, as is stated in Section 6.14.9.1, some embankment displacement can occur where the pseudo-static Factor of Safety is less than 1.3. In that case, the bridge foundations must be designed to withstand the permanent deformations and/or slope stabilizing measures shall be incorporated into the design. Where the pseudo-static Factor of Safety is at least 1.3, the slope is considered to be seismically stable with deformations of less than 50 mm.
