**PRELIMINARY FOUNDATION INVESTIGATION AND DESIGN REPORT
HIGHWAY 401 WIDENING, HIGHWAY 16 TO MAITLAND ROAD
HWY 416 SBL - CEDAR GROVE RD OVERPASS, SITE NO. 16X-0307
GWP 4024-20-00 / ASSIGNMENT NO. 4019-E-0010.2**

January 2023
Thurber File No.: 29381

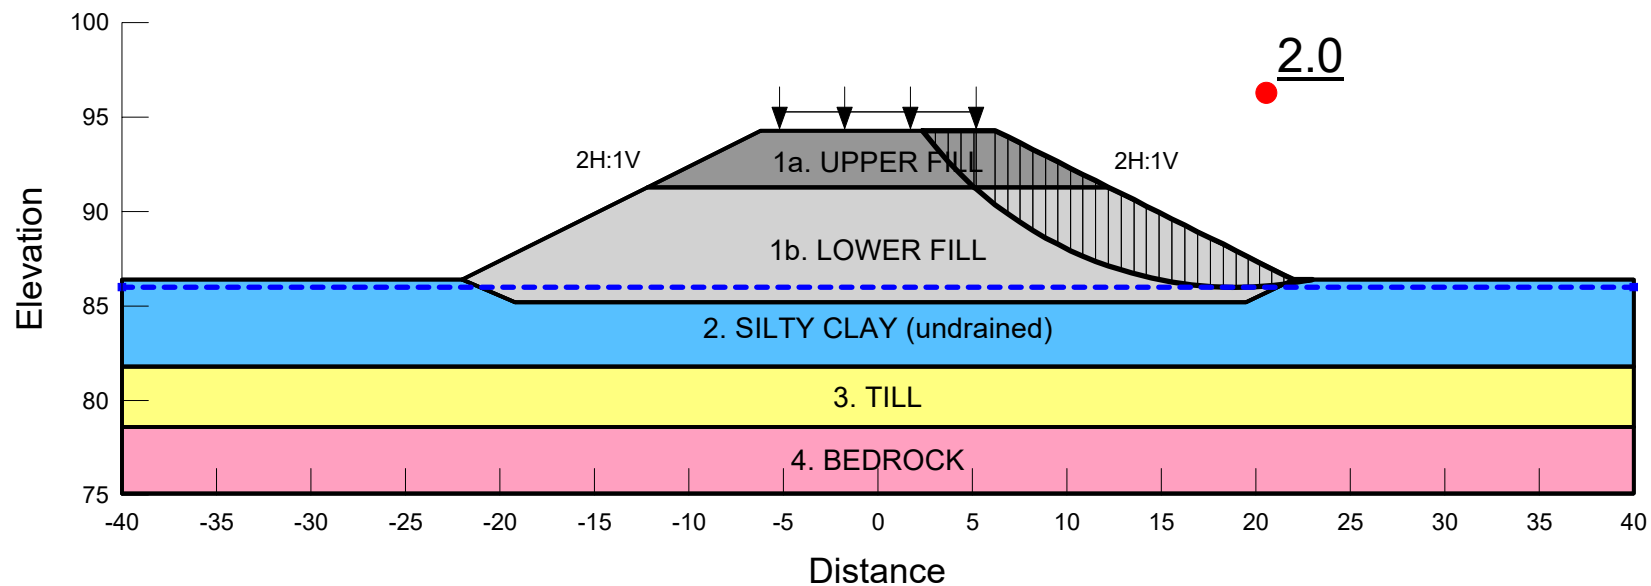
Project Hwy 416 Cedar Grove Road Overpass SBL (Site 16-307)		
Analysis Temporary - Traffic		
Seismic Coefficient H: 0g, V: 0g	Last Run 11/24/2021, 11:08:51 AM	Scale 1:400

Additional Details
Name: 16-307: 2H:1V Existing Embankment
Comments:
Method: Morgenstern-Price, Half-Sine
Minimum Slip Surface Depth: 1.5 m
Entry: (2.35, 94.3) m, Exit: (23, 86.4) m
Center: (18.946135, 106.74227) m, Radius: 20.742272 m

Table 6.2 of the CHBDC for embankment fills with a typical degree of understanding and a Ψ of 1.0 generates minimum Factors of Safety of 1.5 and 1.3 for static permanent and static temporary conditions respectively.
