FINAL REPORT

FOUNDATION INVESTIGATION AND DESIGN REPORT

Otasawian River Bridge, Highway 11 (Site No. 39W-002)
Township of Kohler – New Liskeard (Cochrane) Area, ON

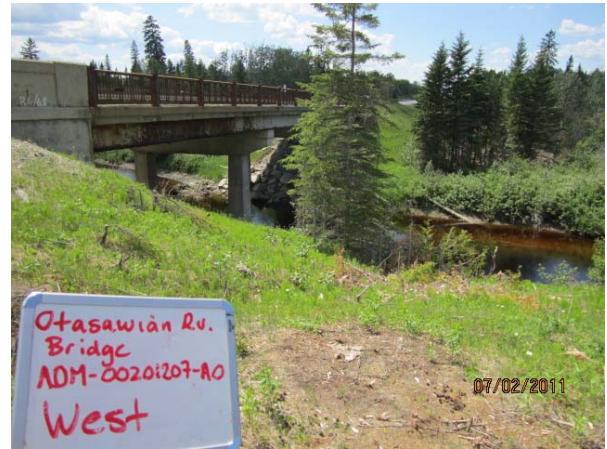
Photograph 1: Looking west at the bridge.
East pier shown.

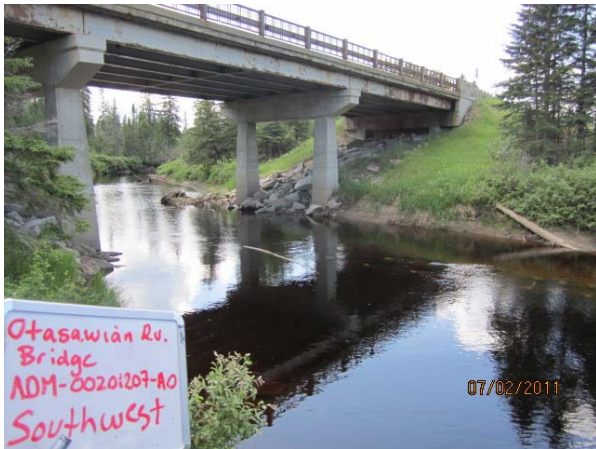
Photograph 2: Looking southwest under the
bridge. East and west piers shown. BH2
location is located across river on right side
(north) of bridge.

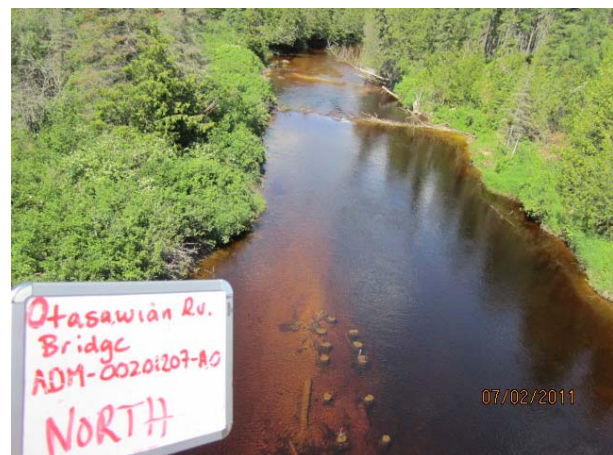
Photograph 3: Looking north from on top of
bridge. The existing timber piles (11 or 20) are
noted in river.

Existing timber piles (20) were noted in the river, north of the bridge. These are assumed to be from an abandoned pile bent at the time of original construction. The piles were located in two rows (i.e. pairs) in north / south direction and the lengths separating the piles in the east / west direction and north / south direction ranged between about 1.1 m and 1.4 m, and 0.6 m and 1.8 m, respectively. In addition, the pile located furthest north and furthest south were single piles (i.e. not paired). Details of the timber piles are shown on Figure 7 and are summarized in Table 1-3 below:

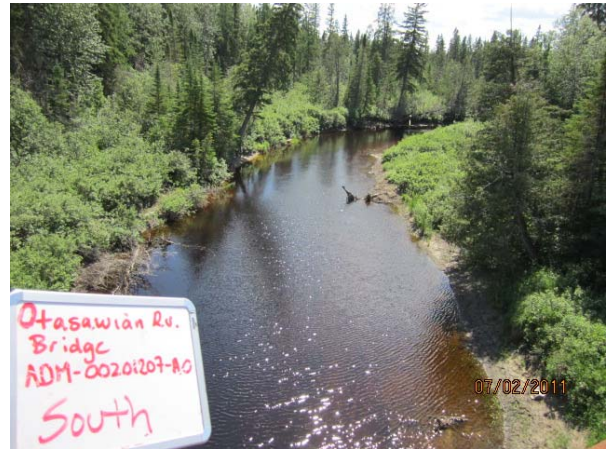
Photograph 4: Looking south from on top of bridge.

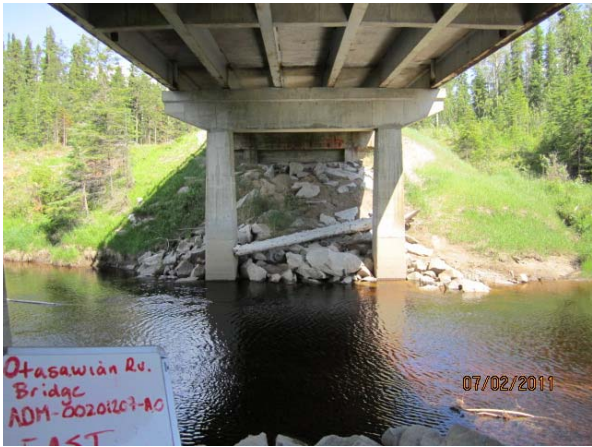
Photograph 5: Looking east at east pier. BH3 location located on right side (south).
